THE ARCHAEOLOGY CO.

Dock Road, Lytham St. Annes

Archaeological Strip and Record Report

September 2022

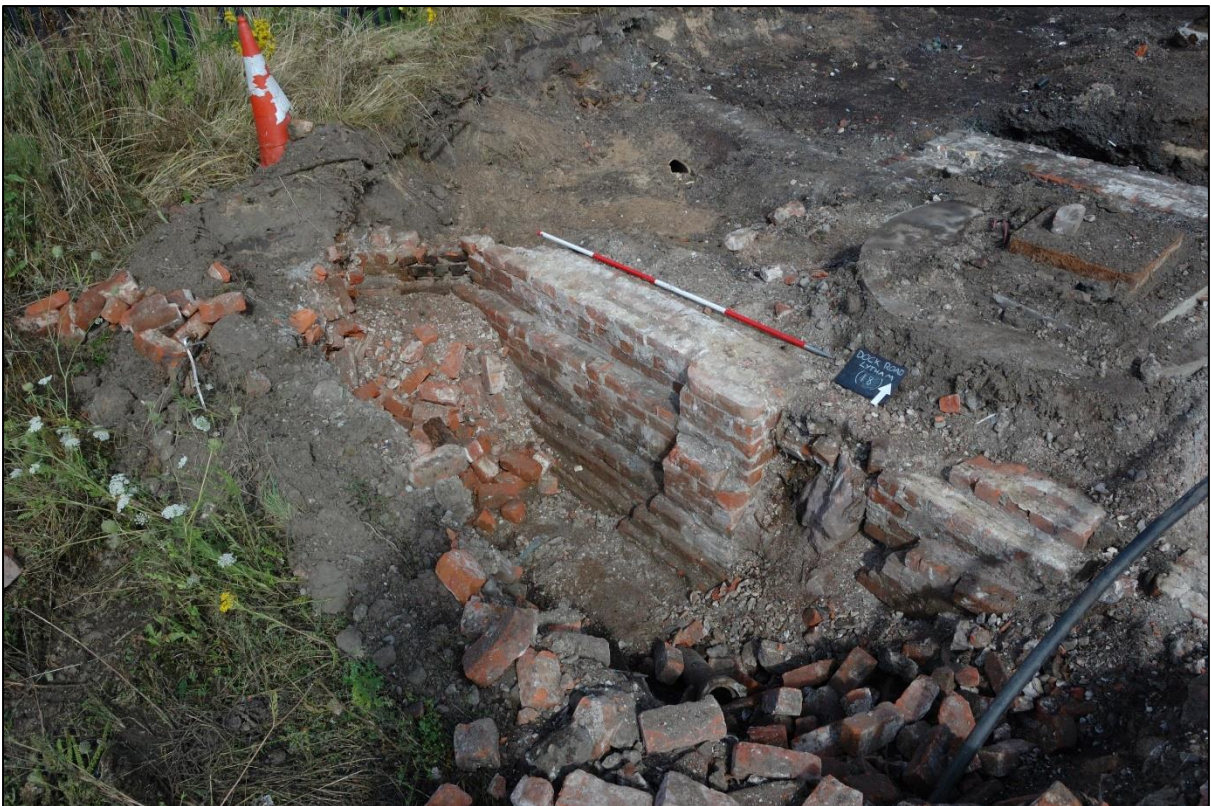
Plate 22: Cellared space at west end of wall [18]

- 6.7 The southern edge of the site contained a wall (Plate 21) context [18], which, was 12m long by 0.6m wide and 1.1m high. The wall was aligned east west and made up of headers and stretchers with a stepped foundation, and contained a cellared space at its western end (Plate 22). This was backfilled by a brick and beige mortar backfill context (22) measuring 4.7m in width, 4.7m long and 1.05m deep. This deposit was only partially excavated as it went beyond the limit of excavation (Plate 23).

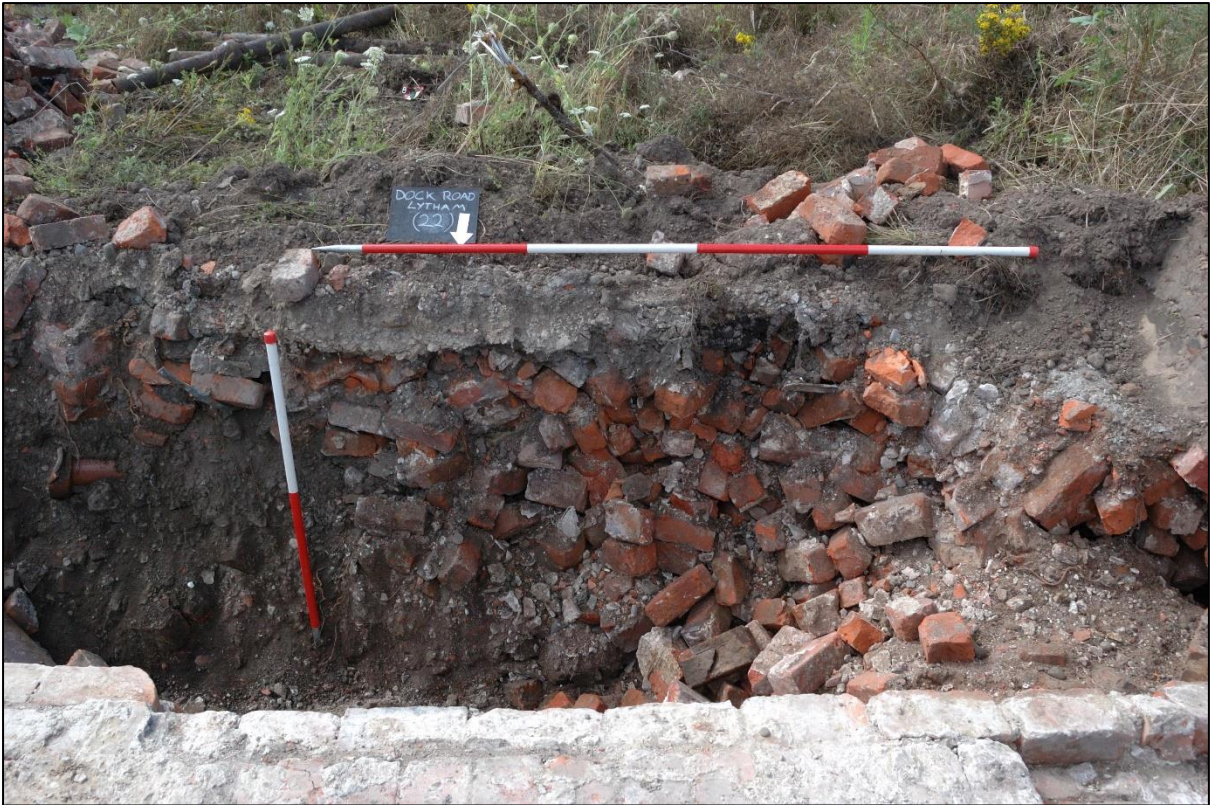
Plate 23: Fill of cellar [22]

(22) The brick backfill located to the south of wall [18]. A mix of bricks and white mortar 4.7m long by 1.36m wide and 1.05m deep filling a subterranean space.

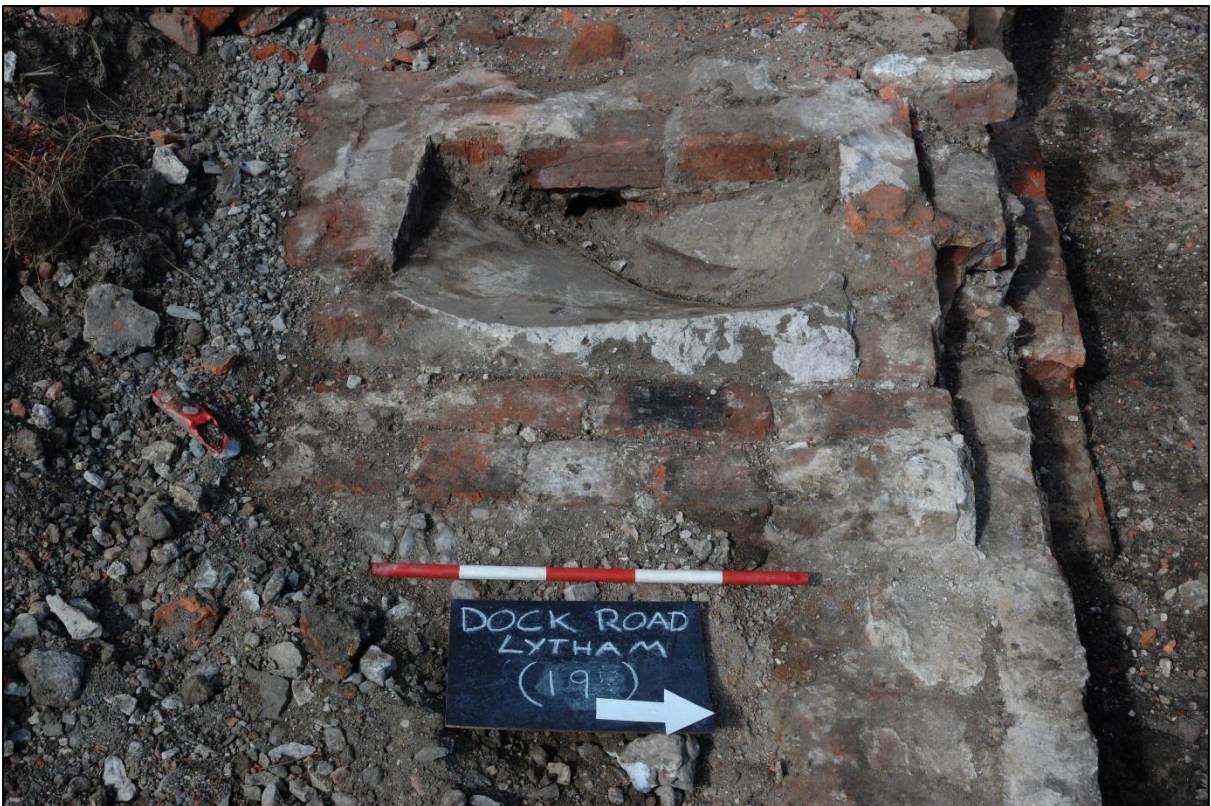
Plate 24: Concrete and brick drain [19]

- 6.8 To the east of the cellar was a concrete and brick drain (Plate 24) context [19] measuring 0.9m by 0.9m. To the east of the drain was a truncated concrete floor numbered context [25] measuring 1.05m by 1.1m with a cast iron fitting for a stanchion protruding from its surface (Plate 25). A small area of concrete floor with a thin layer of bitumen on its surface had survived next to concrete floor [25] the floor context [28] measured 2.07m long by 1.05m wide and 0.13m thick (Plate 26). A small building was seen protruding from wall [18] with wall [15] as its northern elevation wall (Plate 27) [16] as its western elevation (Plate

[19] A brick and concrete drain 0.9m long by 0.9m wide, was located to the south of wall [18]. Constructed of stretchers and concrete.

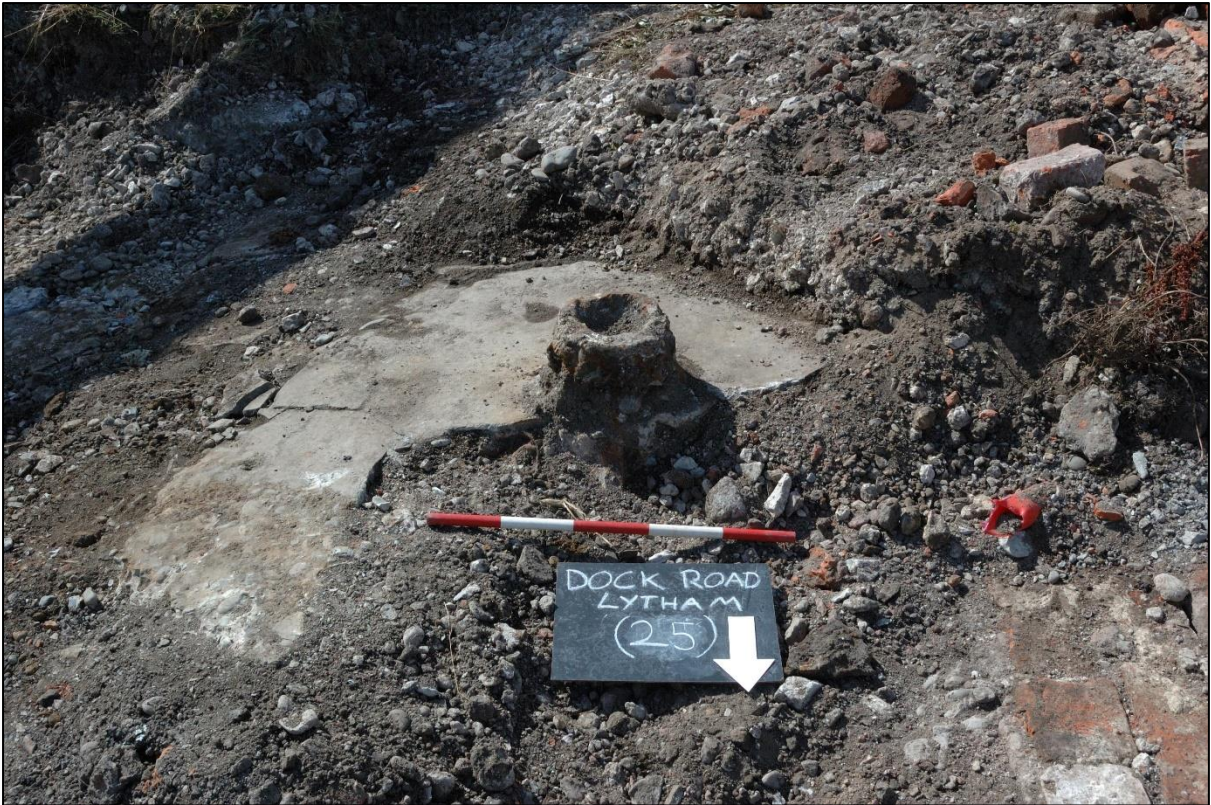
Plate 25: Cast iron stanchion within concrete floor [25]

[25] A concrete and iron fitting 1.05m long by 1.1m wide located to the south of wall [18]. The iron component was designed to house a stanchion.

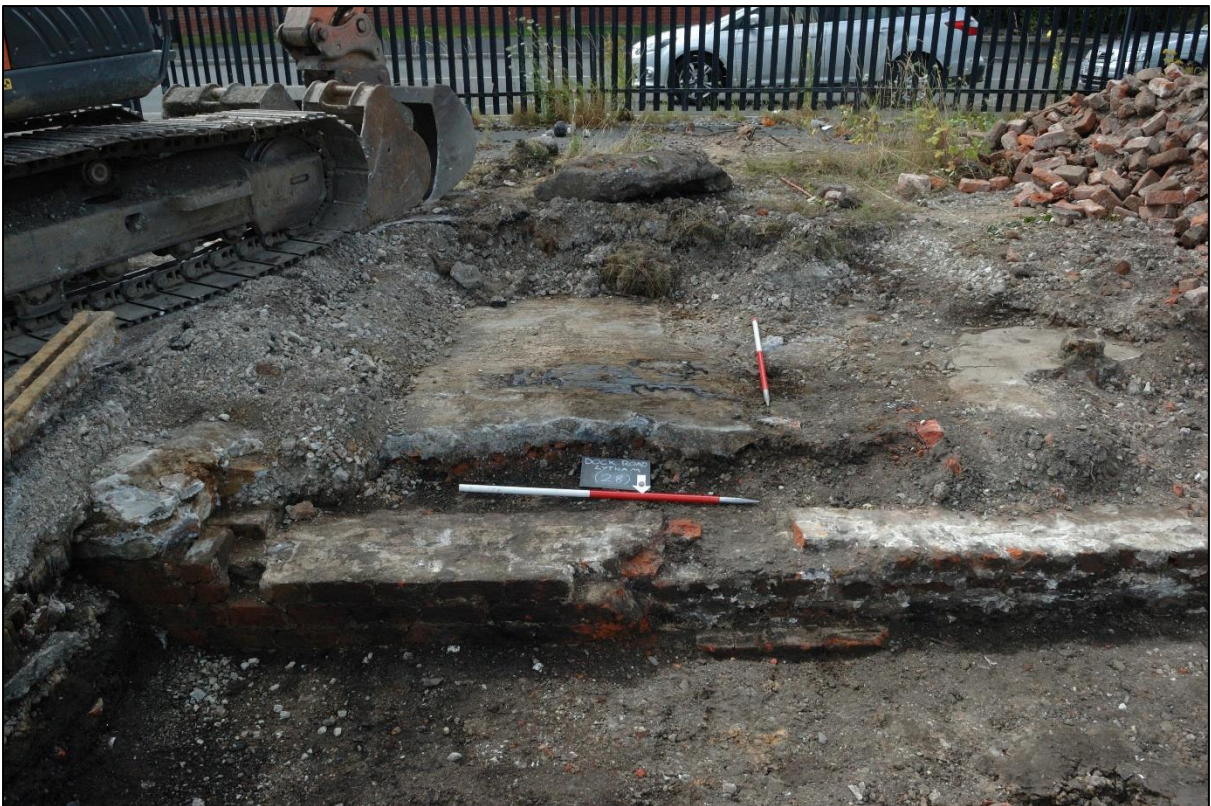
Plate 26: Concrete with bitumen [28]

[28] A small area of concrete floor with remnant bitumen on its surface measured 2.07m long by 1.5m wide and 0.13m thick, was located on the south side of wall [18].

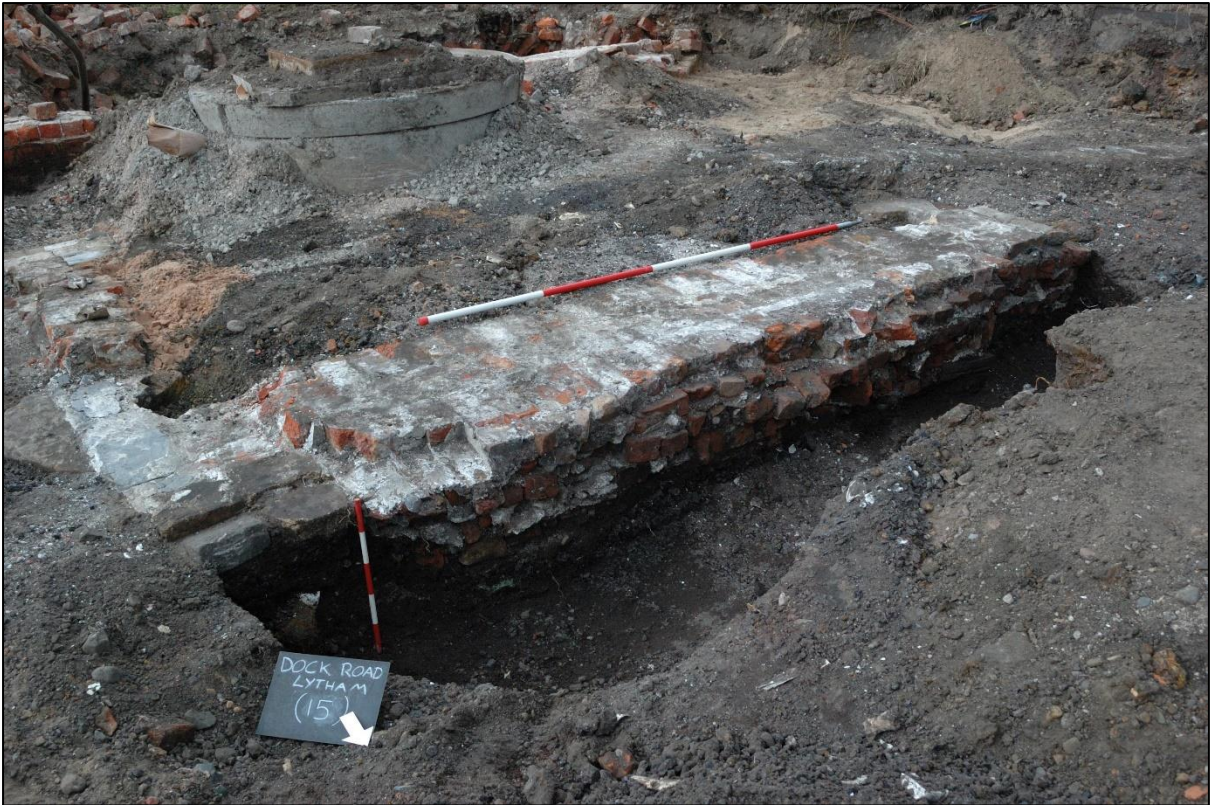
Plate 27: Small building comprising walls [15], [16], [17] and [18]. North elevation

[15] A brick and sandstone wall orientated east west was 4.1m long by 0.76m wide and 0.4m high, it was located at the southern end of site, forming the northern elevation of a small building. The wall was made of headers, stretchers and half bricks bonded with a white gritty lime mortar. The wall was for the most part made of bricks with a couple of small sandstone slabs at its ends. The wall was a subterranean footing indicated by its roughly built north facing elevation.

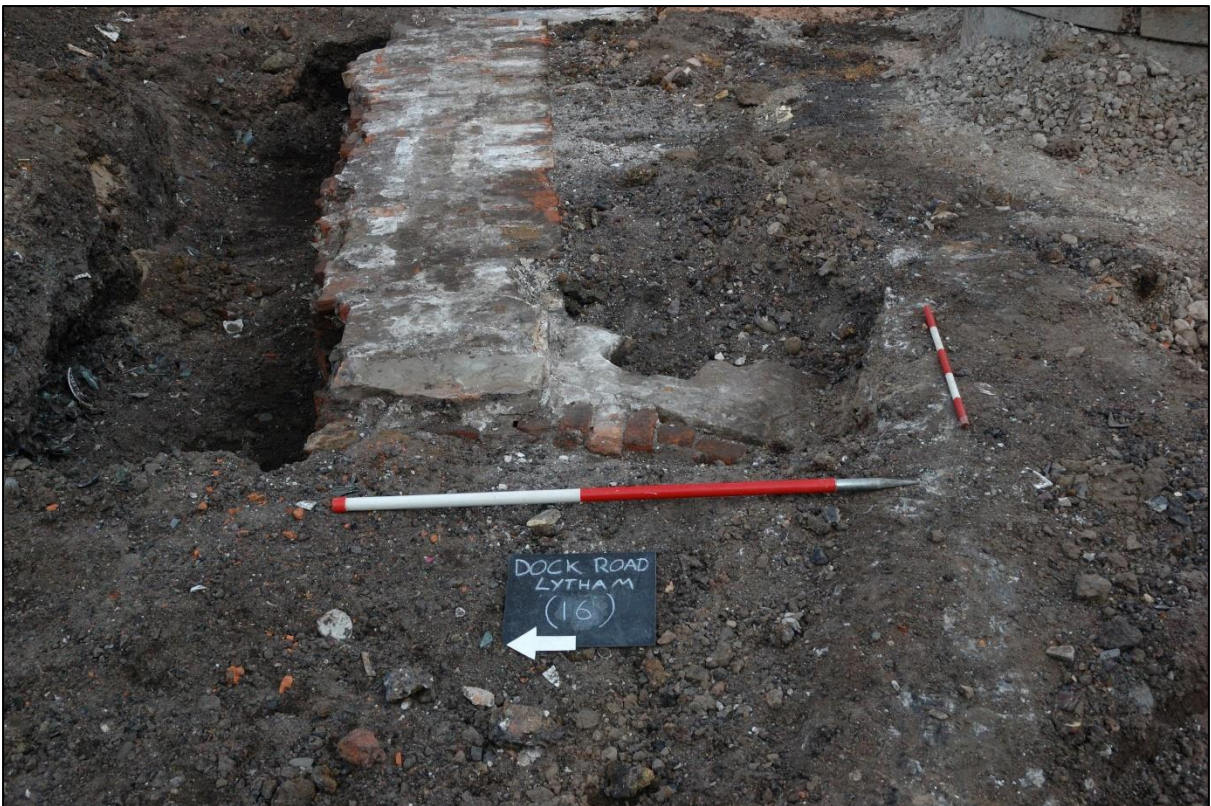
Plate 28: Western wall [16]

[16] The western return elevation associated with wall [15]. A brick and sandstone wall 0.7m long by 0.6m wide heading south. The wall was truncated by a modern manhole. The wall contained a large sandstone block, which was orientated at an angle to the wall. The sandstone block had carved grooves for machine fittings. A similar sandstone block was seen on the eastern elevation [17] associated with wall [15].

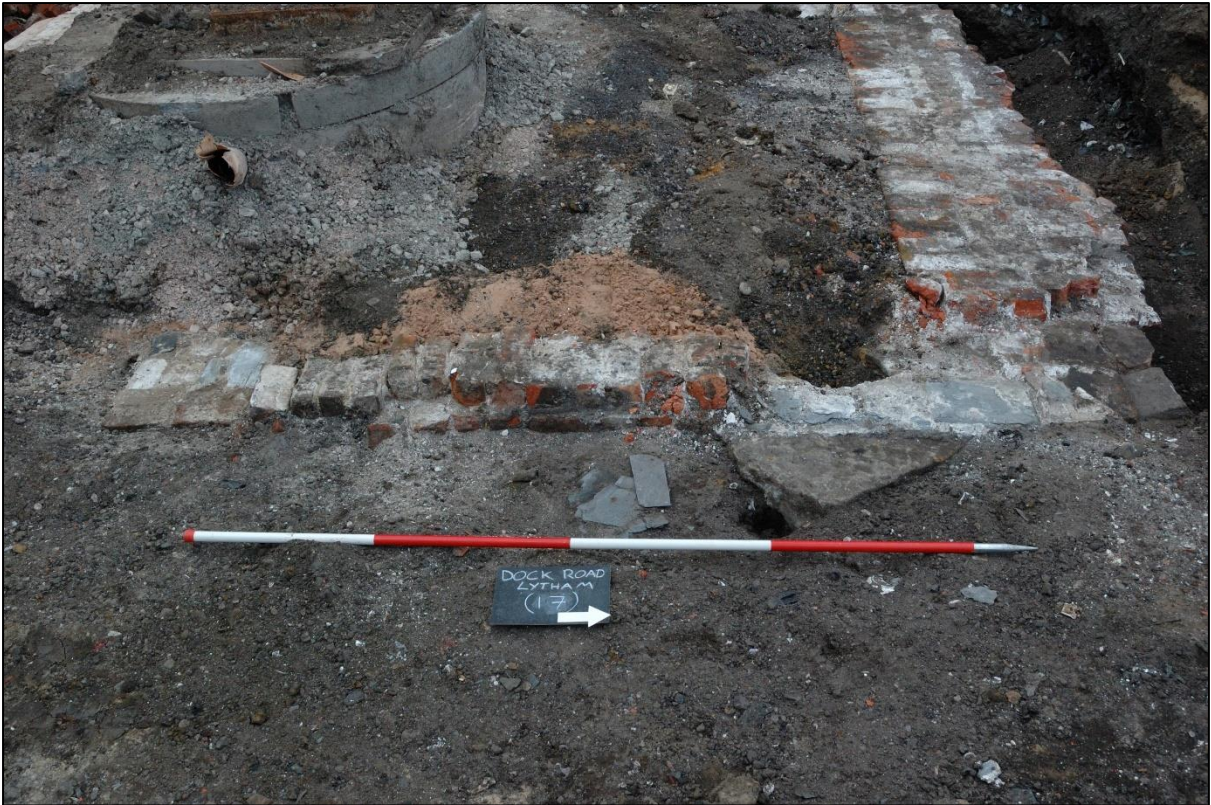
Plate 29: Eastern wall [17]

[17] The eastern elevation associated with wall [15] A brick and sandstone wall 9.3m long 0.35m wide 0.15m high heading south. The wall contained a large sandstone block similar to the one seen in wall [16]. Its location and orientation also matched.

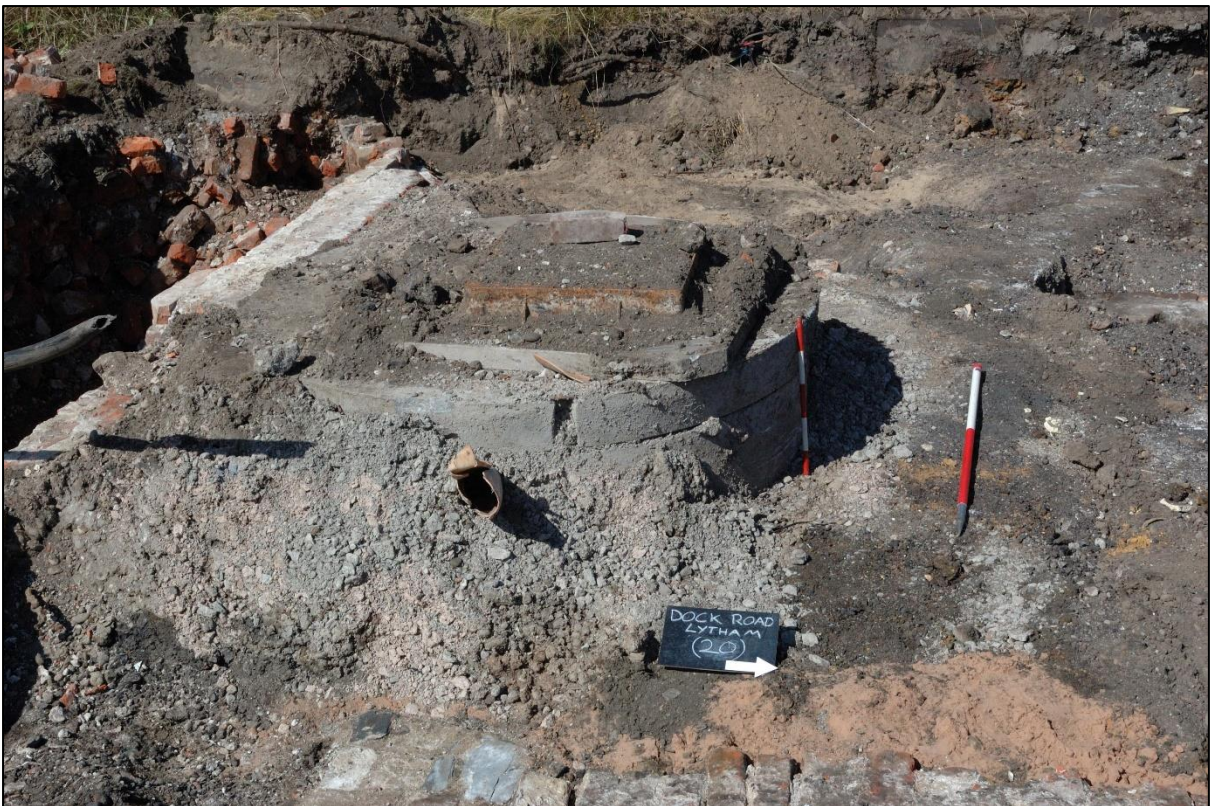
Plate 30: Modern manhole [20]

[20] A modern concrete manhole 1.74m wide by 0.74m high. Located to the south of wall [15] and truncating wall [16].

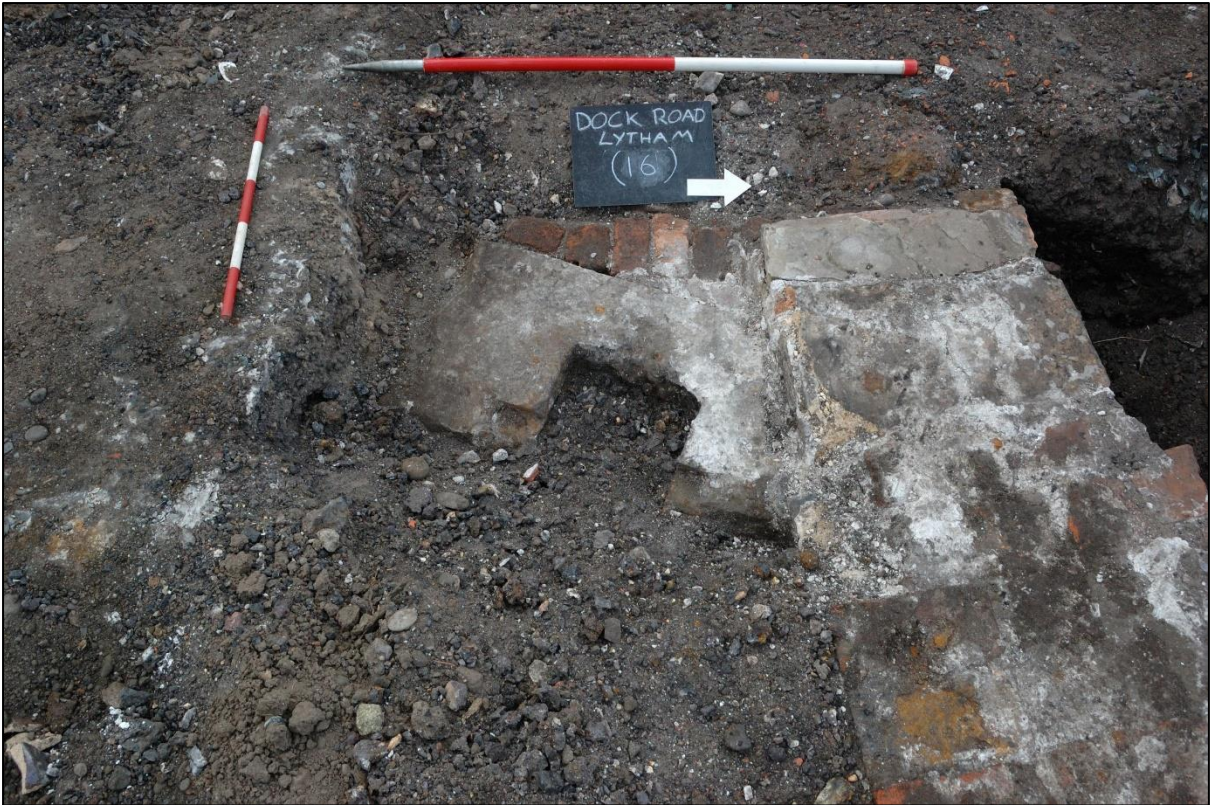
Plate 31: Sandstone block in wall [16]

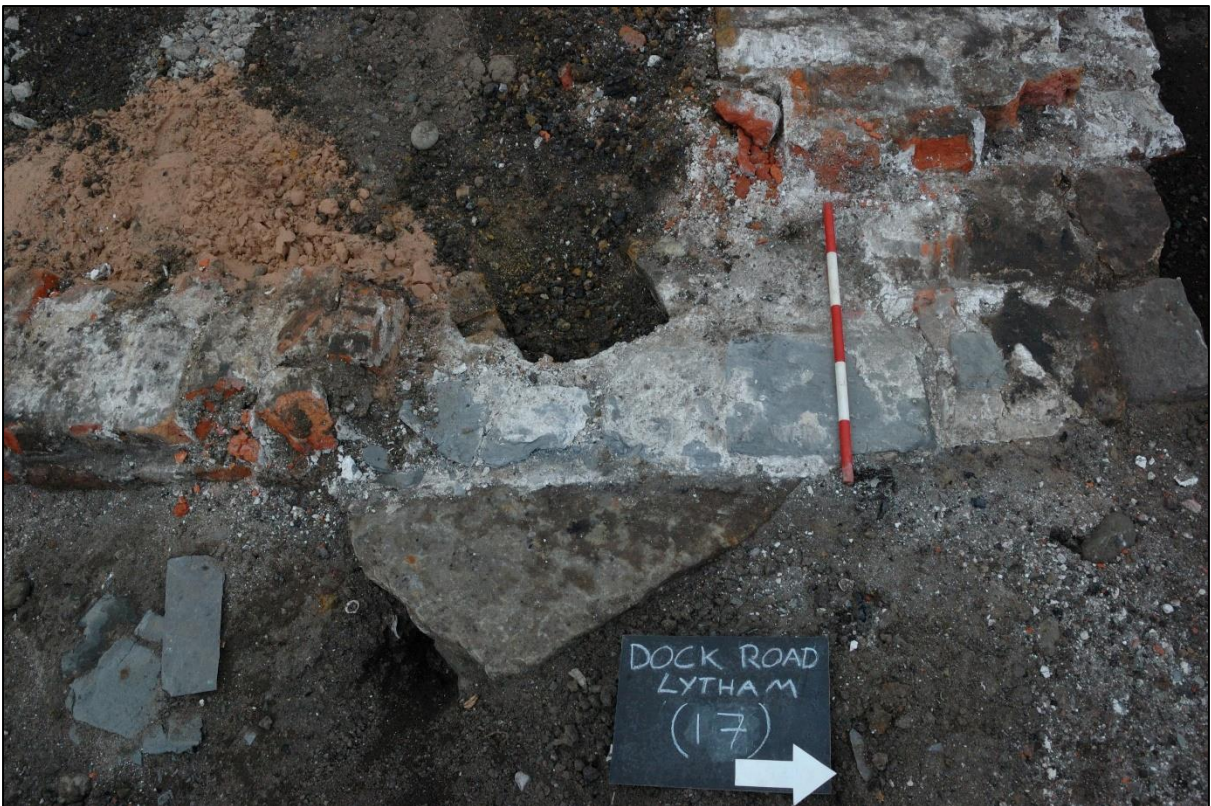
Plate 32: Sandstone block in wall [17]

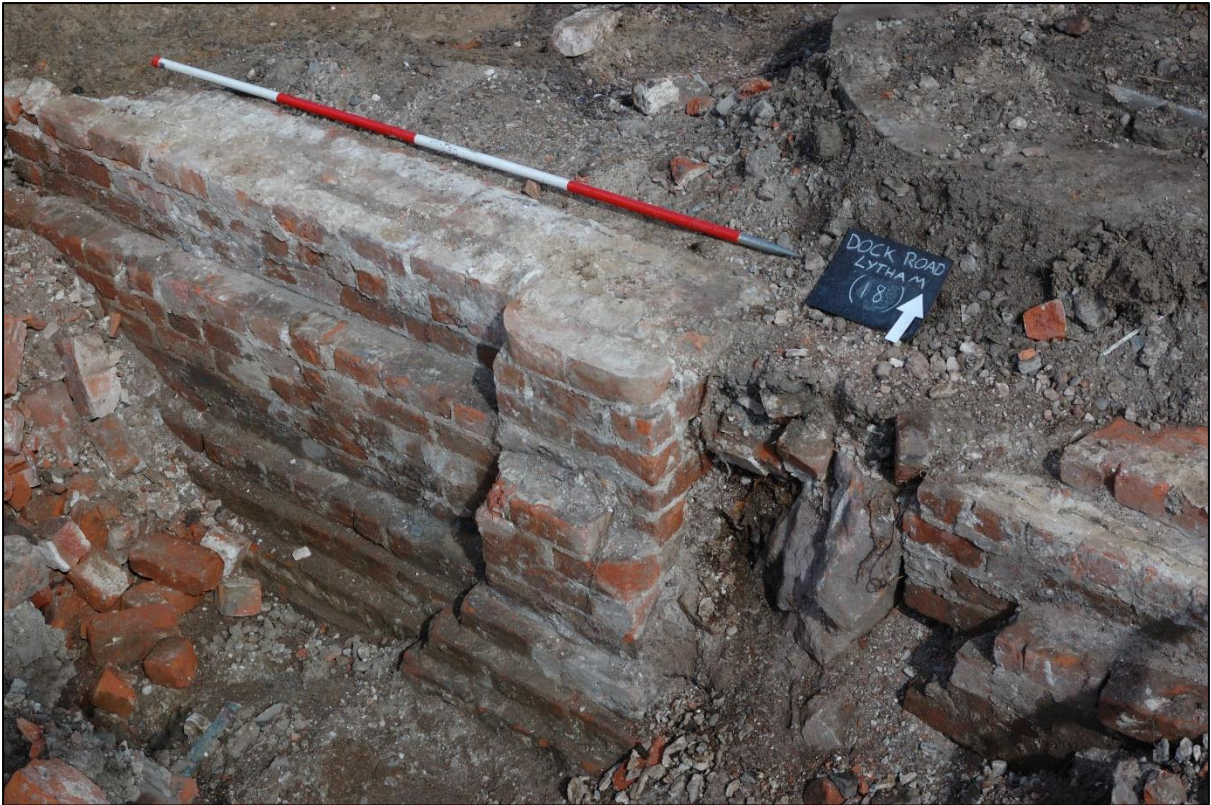
Plate 33: Gap in wall [18]
