St John the Apostle, Sheepscombe, Gloucestershire

An Archaeological Watching Brief Report

Archaeological Watching Brief Report

Client:	Peter Davies, on behalf of Sheepscombe PCC
Diocese:	Gloucester
Faculty date:	14th July 2017
NGR:	SO 8918 1011
Project no:	UA177
Author:	Chiz Harward BA MIfA
Doc Ref:	UA177_wb_WSI_v1
Date:	August 24th 2017
Site Code:	SHE17
OASIS ref:	urbanarc1- 291077

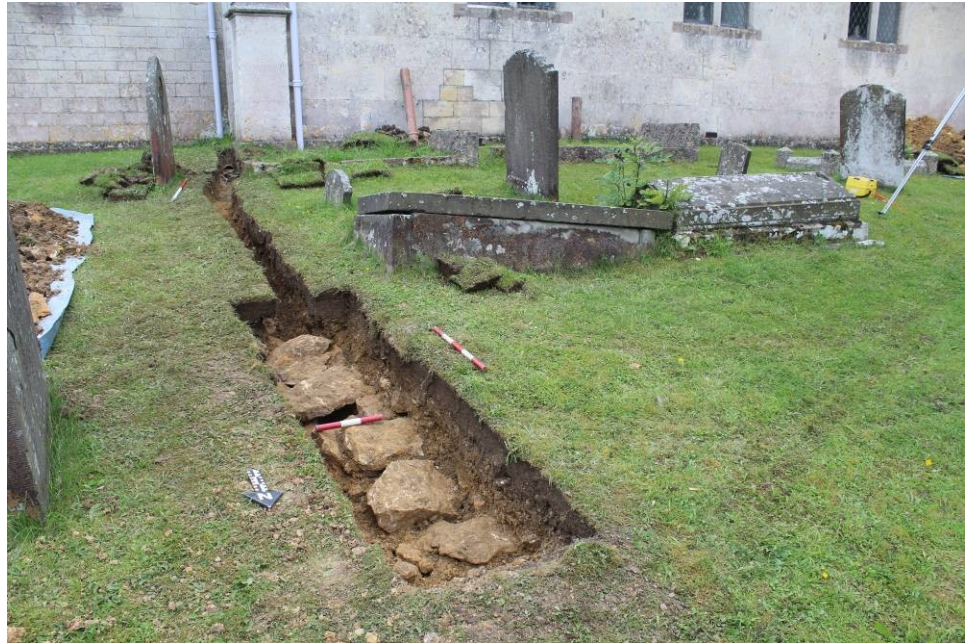
Front cover: View of drain [6] with stone slab roof in situ, looking south; scales 0.3m and 0.5m

- 6.7 Cutting through the natural substrate was a north–south aligned trench [8] containing stone drain [6] (Fig. 5). The drain was built directly on the flat base of the trench, which sloped down to the south from 147.58–147.31m OD. The drain was constructed from un-worked limestone rubble built without any mortar or cement bonding, with two side walls 0.3m high and approximately 150mm apart (Fig. 6). The drain was roofed with large irregular limestone rubble pieces (*front cover*).

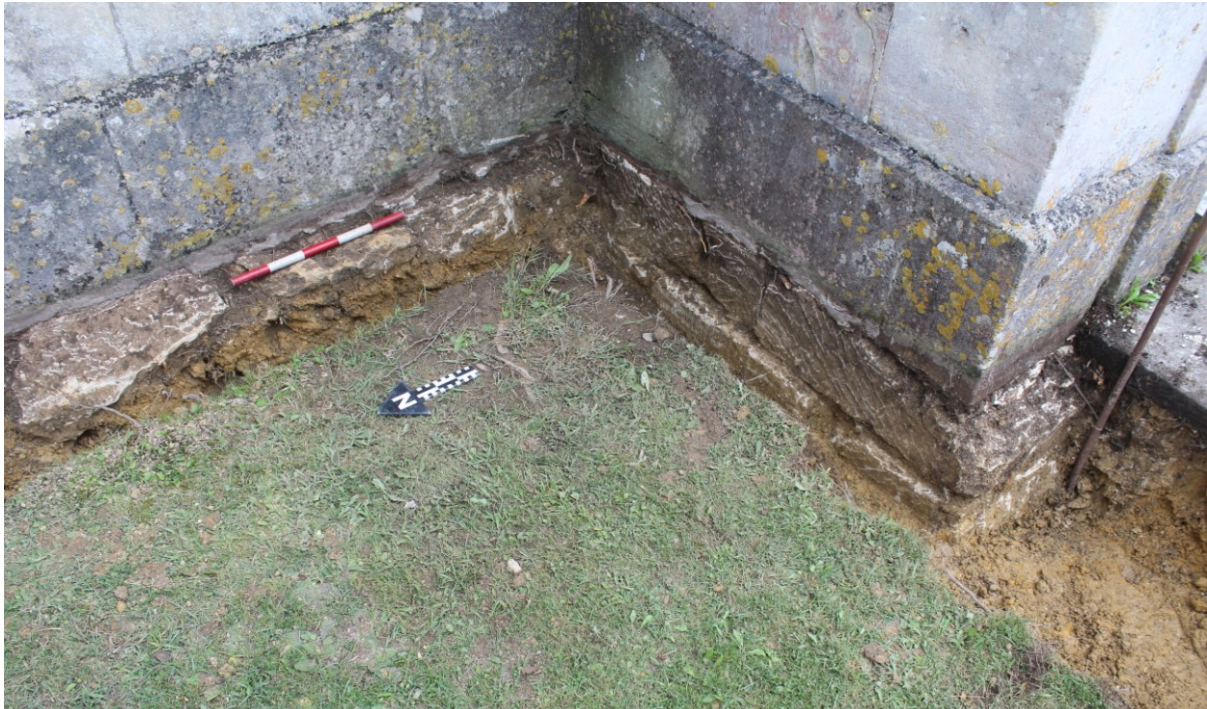
Fig. 3 View of nave [2] and porch foundations [3] looking southwest showing superstructure sitting directly on natural clay; scale 0.5m

- 6.3 The natural substrate had been horizontally truncated prior to the construction of St John the Apostle [6]. The ashlar superstructure of the west wall of the southern part of the nave was founded directly on the truncated surface of the natural substrate at 148.41m OD, with a rubble foundation only at the buttress (base not observed, Fig. 3). The northern nave had a slightly offset course of rubble blocks as a foundation, with the base of the foundation at 148.17m OD, slightly deeper than the south side (Fig. 4). The porch had a deeper foundation of roughly squared blocks (base not observed). The superstructure of nave west wall and porch was all of one build.

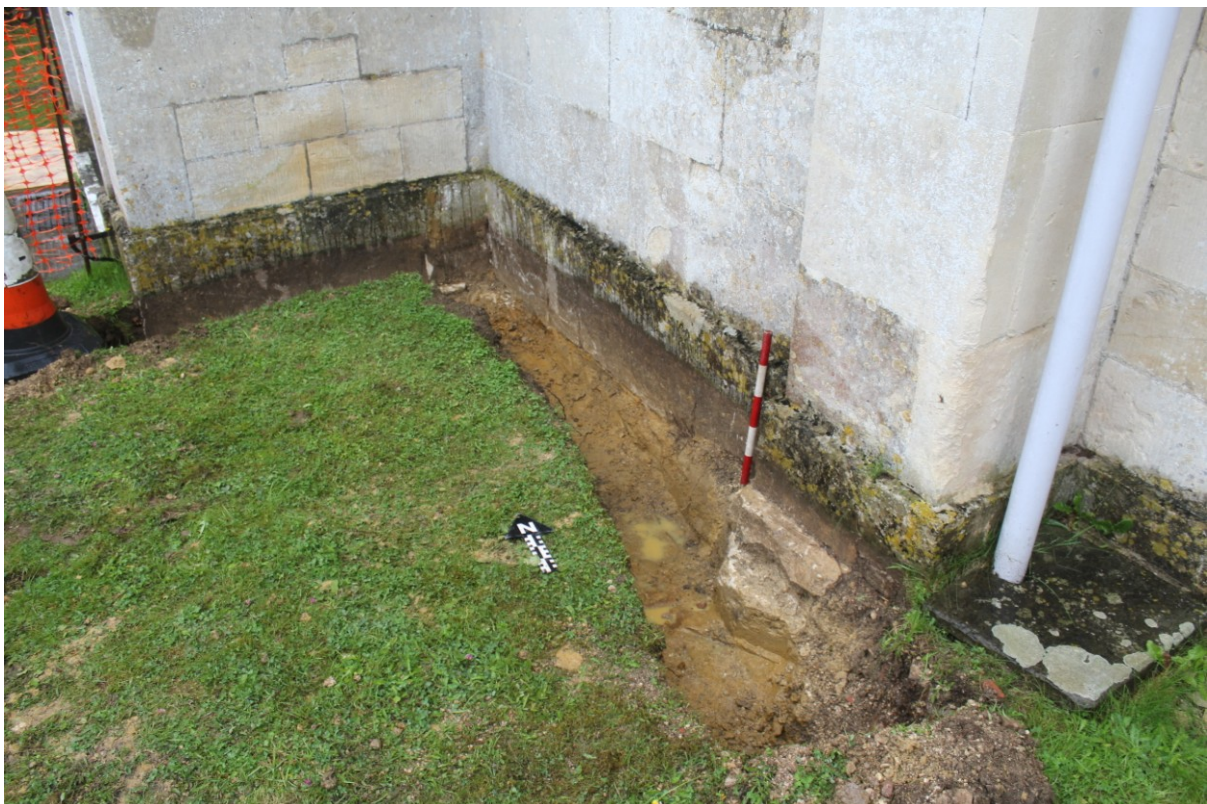
Fig. 4 View of church and porch foundations [2] and [3], looking northeast; scale 0.5m

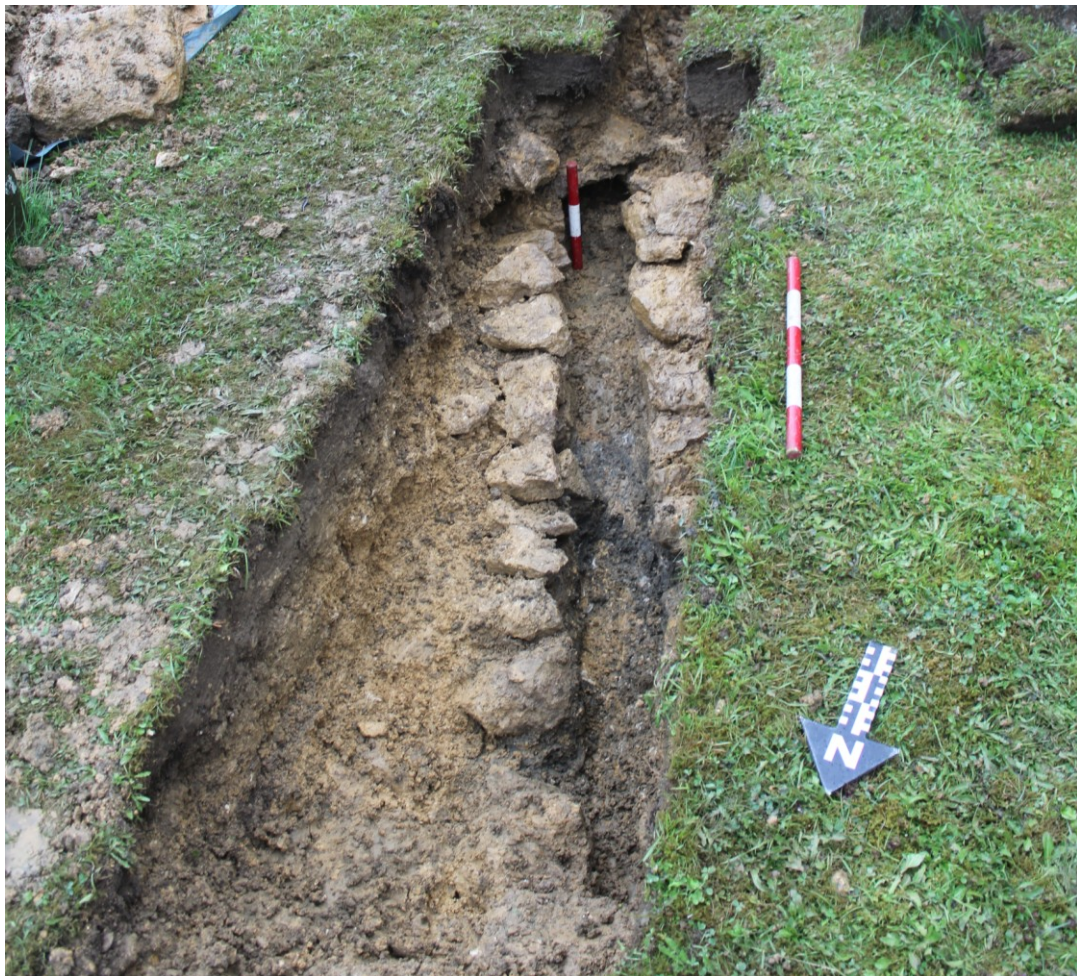
Fig. 6 View of drain [6] with lid removed, looking south; scales 0.3m and 0.5m

- 7.4 The stone drain is constructed in a typical style for the Cotswolds; it is undated, but is likely to date from the construction of the original church, or its 1872 enlargement, and be part of the drainage to take water away from the church to drain, presumably, into the hollow-way to the north.
