## External drainage at Gloucester Cathedral

An Archaeological Watching Brief Report  
for Antony Feltham-King on behalf of  
Dean and Chapter, Gloucester Cathedral

Archaeological Watching Brief Report

Doc Ref: UA182\_wb\_report\_v2

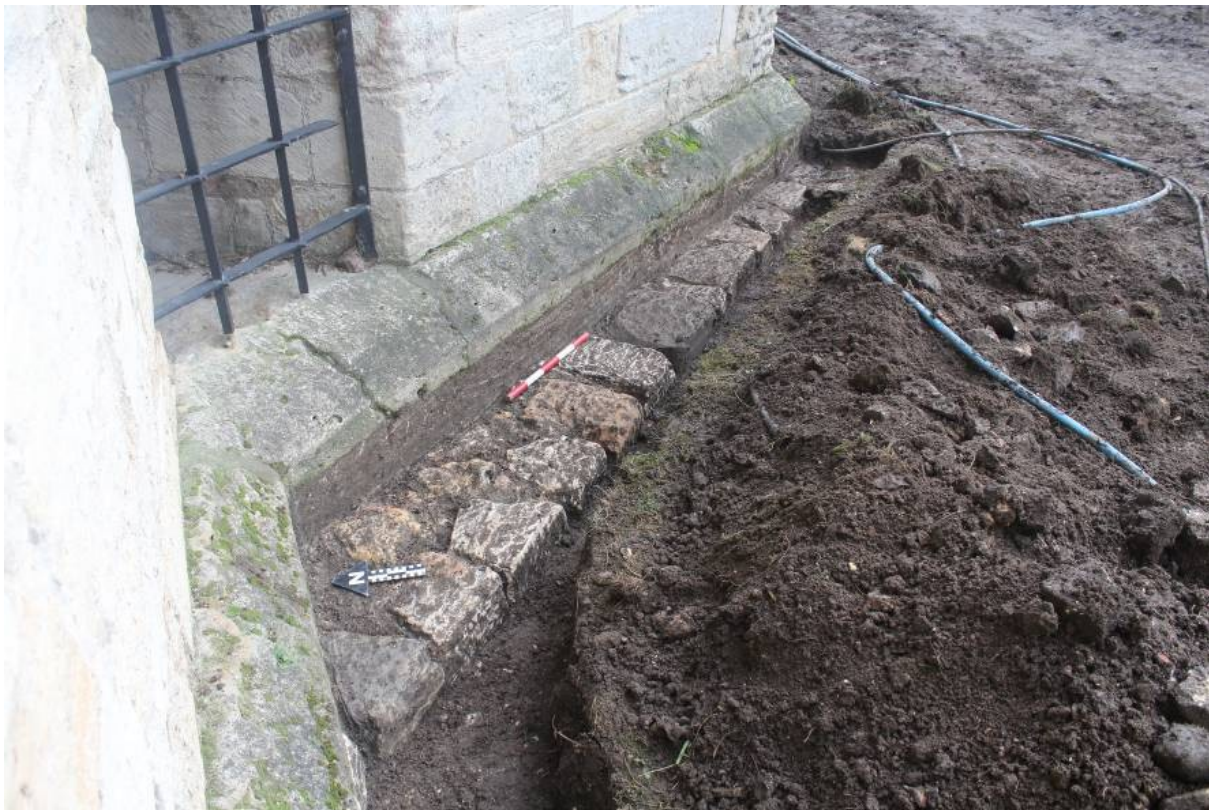
Fig. 4 View looking east showing the southeast Ambulatory chapel foundation [7]; 0.5m scale

- 6.3 The external foundation of the South Ambulatory and its southeast and southwest chapels was exposed in the French Drain trench. The lower foundation [7] of the southeast Ambulatory chapel extends up to 0.46m out beyond the line of the superstructure (Fig. 3, Fig. 4). The top of the foundation lay at 15.36–38m OD. The lower foundation for the southeast Ambulatory chapel [7] consists of large Painswick, Lias, Red Sandstone and Brockhampton Stone blocks bonded with a soft very sandy mid orange-brown lime mortar.

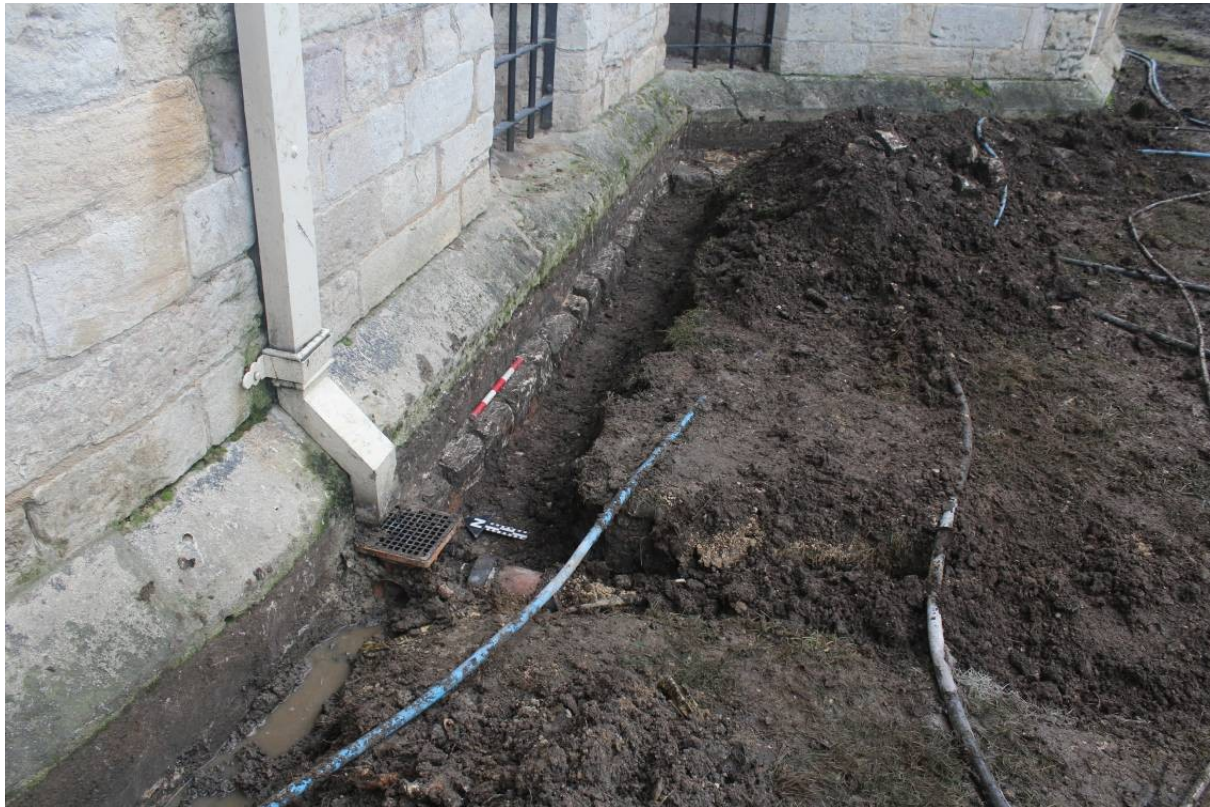
Fig. 5 View looking east along south wall of South ambulatory showing curve of foundation [4] compared to straight line of superstructure; 0.5m scale

- 6.4 The lower foundation [7] is overlain by foundation [4] which extends around the southeast chapel, South Ambulatory and southwest chapel. The foundation to the South Ambulatory was slightly curved, contrasting with the straight lines of the superstructure built on top (Fig. 5). The foundation to the southwestern Ambulatory chapel and the South Ambulatory, [4], is

- 10.3 The foundations of the South Ambulatory, its southeast and southwest chapels were exposed for some distance in Trench 1. The late 11th century ambulatory foundations were clearly distinct from the superstructure, with slight but visible changes in alignment between the foundation and the ashlar superstructure. The foundation represents the lower part of the crypt's southern wall, and the level of the transition from foundation to superstructure suggests that modern ground level remains approximately at the medieval level. The top of the South Ambulatory's foundation was at 15.54m OD, with an impressively small tolerance of just 10mm along the observed entire east–west length of this foundation.

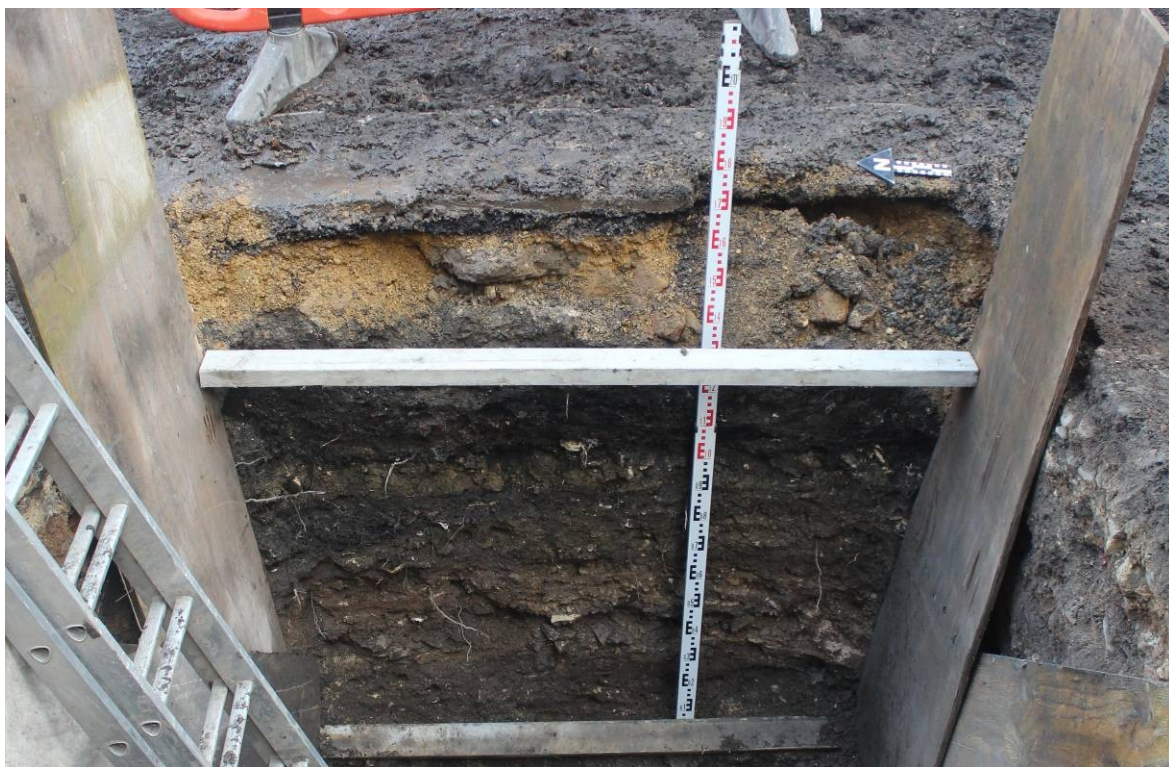
Fig. 8 West facing section Trench 2; 2m scale

- 6.13 Made ground (12) was observed in the trench sections to the full depth of the trench. No buried soil horizons, surfaces or cuts were observed, and the made ground appeared to be fairly homogenous soily dumps (Fig 8–9). No dating material was recovered from the made ground.
