## **Church of St Mary, Aston Somerville, Worcestershire, Diocese of Gloucester**

**An Archaeological Evaluation Report  
for Aston Somerville PCC**

Archaeological Evaluation Report

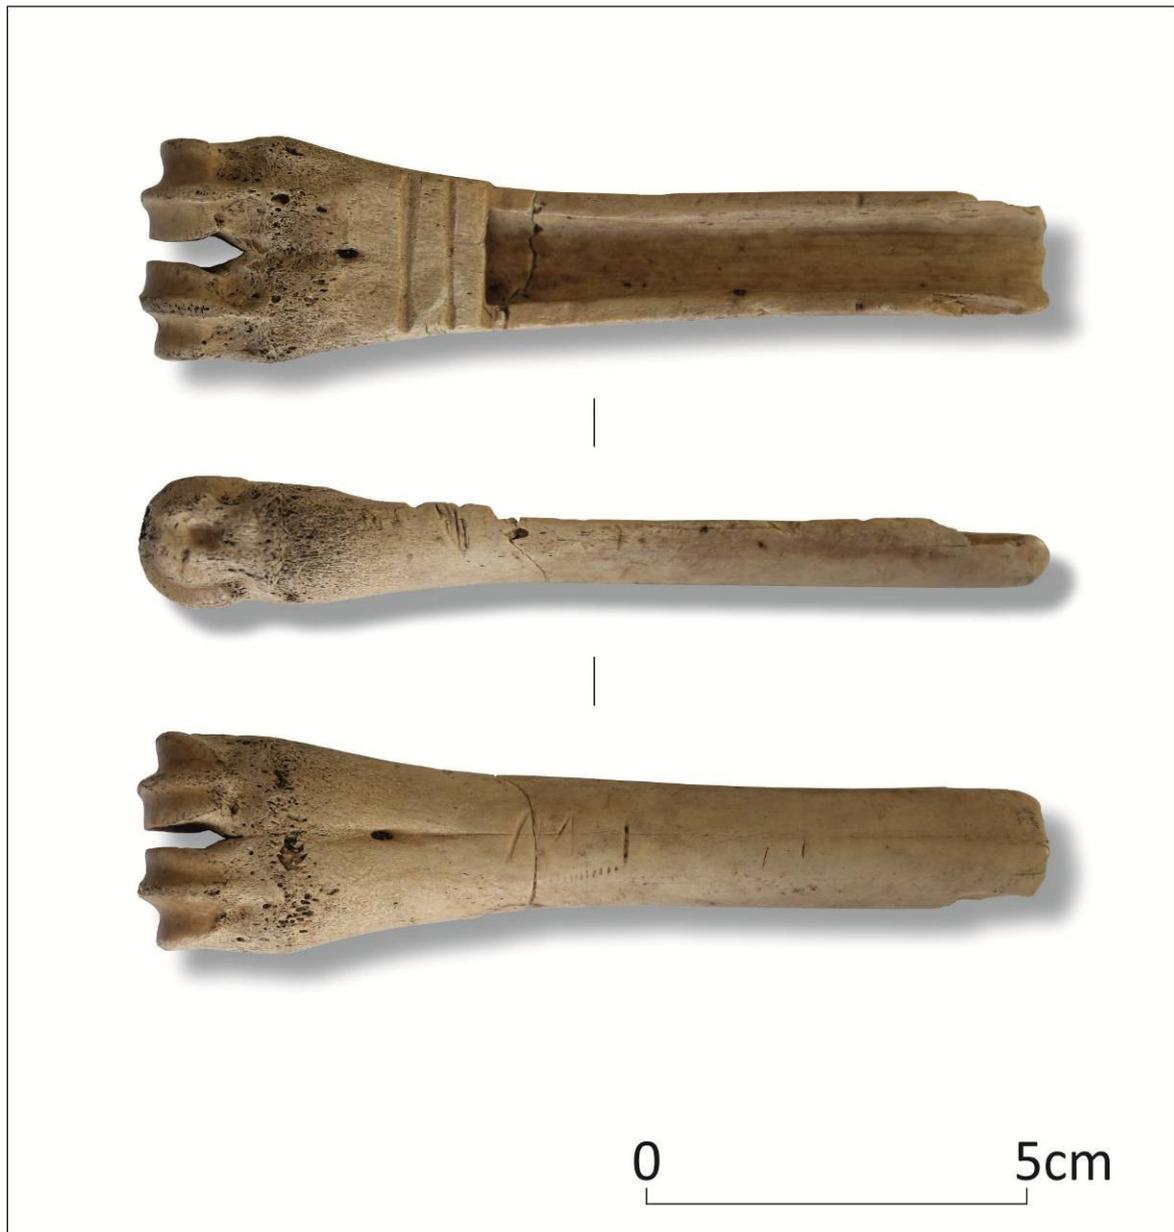
Bone tool from AST18 (8)

7.4 A bone tool from (8) is carved from a sheep's metapodial bone, a bone that was often used for making into simple tools with the articular condyles left intact to form the handle, while the shaft can be cut and shaped into a point or, as here, a scoop.

7.5 In this case the bone has been decorated with three well-defined cut marks on the top of the shaft, the shaft being split from the third cut onwards to form the 'scoop'; there are additional cut marks from a knife on the side and base. The proximal end has been shaped to form a tapered, squared edge, slightly angled and the cut edges are polished and worn from use.

7.6 Similar bone tools have been interpreted as 'fids' or rope-splicers, and as apple or cheese-corers which are often dated to the 18th century although this example is probably medieval. A similar bone scoop is illustrated in MacGregor (1985,180 fig 97) with the following discussion:

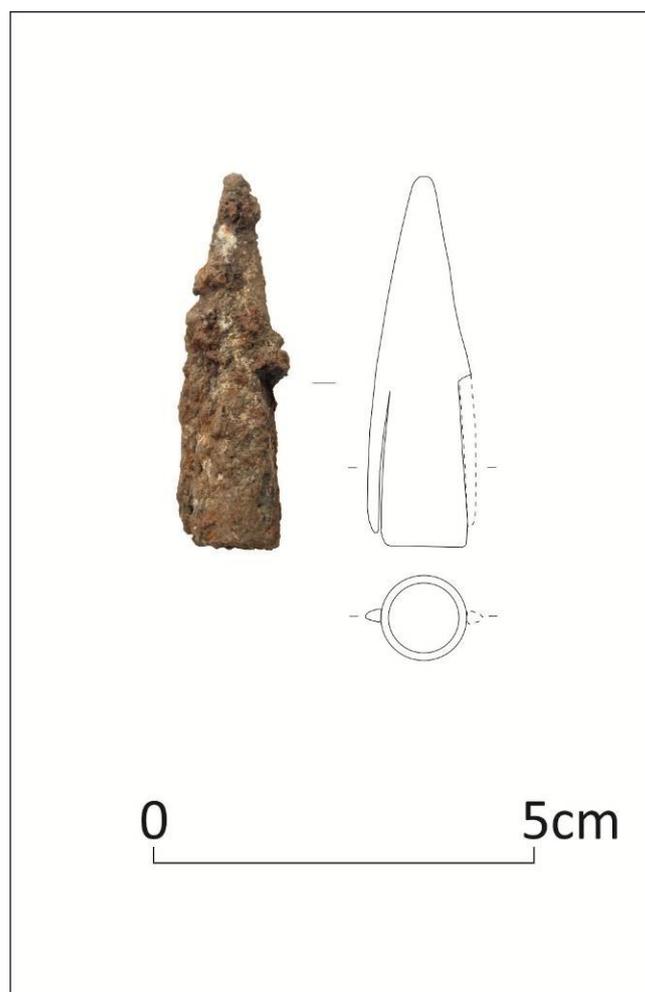
Iron arrowhead from AST18 (8)

- 7.7 A forged medieval iron arrowhead from (8) is complete except for one of the barbs which has broken off. The arrowhead has a circular socket which tapers to the blade. The blade section tapers very gradually from the socket to the point. One barb has lost its point, however the other is complete, lying very flat against the socket and extends over the socketed section. The cross-section of the arrow is diamond shaped, becoming circular at the socket.

- 7.8 This type of arrowhead has been categorised as Type M4 by Jessop and is regarded as being specifically for military use. Type M4 is strong and slender with the compact head and close-fitting barbs able to punch holes through early forms of armour, as opposed to the wider 'broadhead' arrows that were used for hunting (Jessop 1996, Jessop 1997). Jessop's Type M4 equates to the Museum of London Medieval Catalogue Type 16 and is introduced around the 14th century (Ward Perkins 1940).

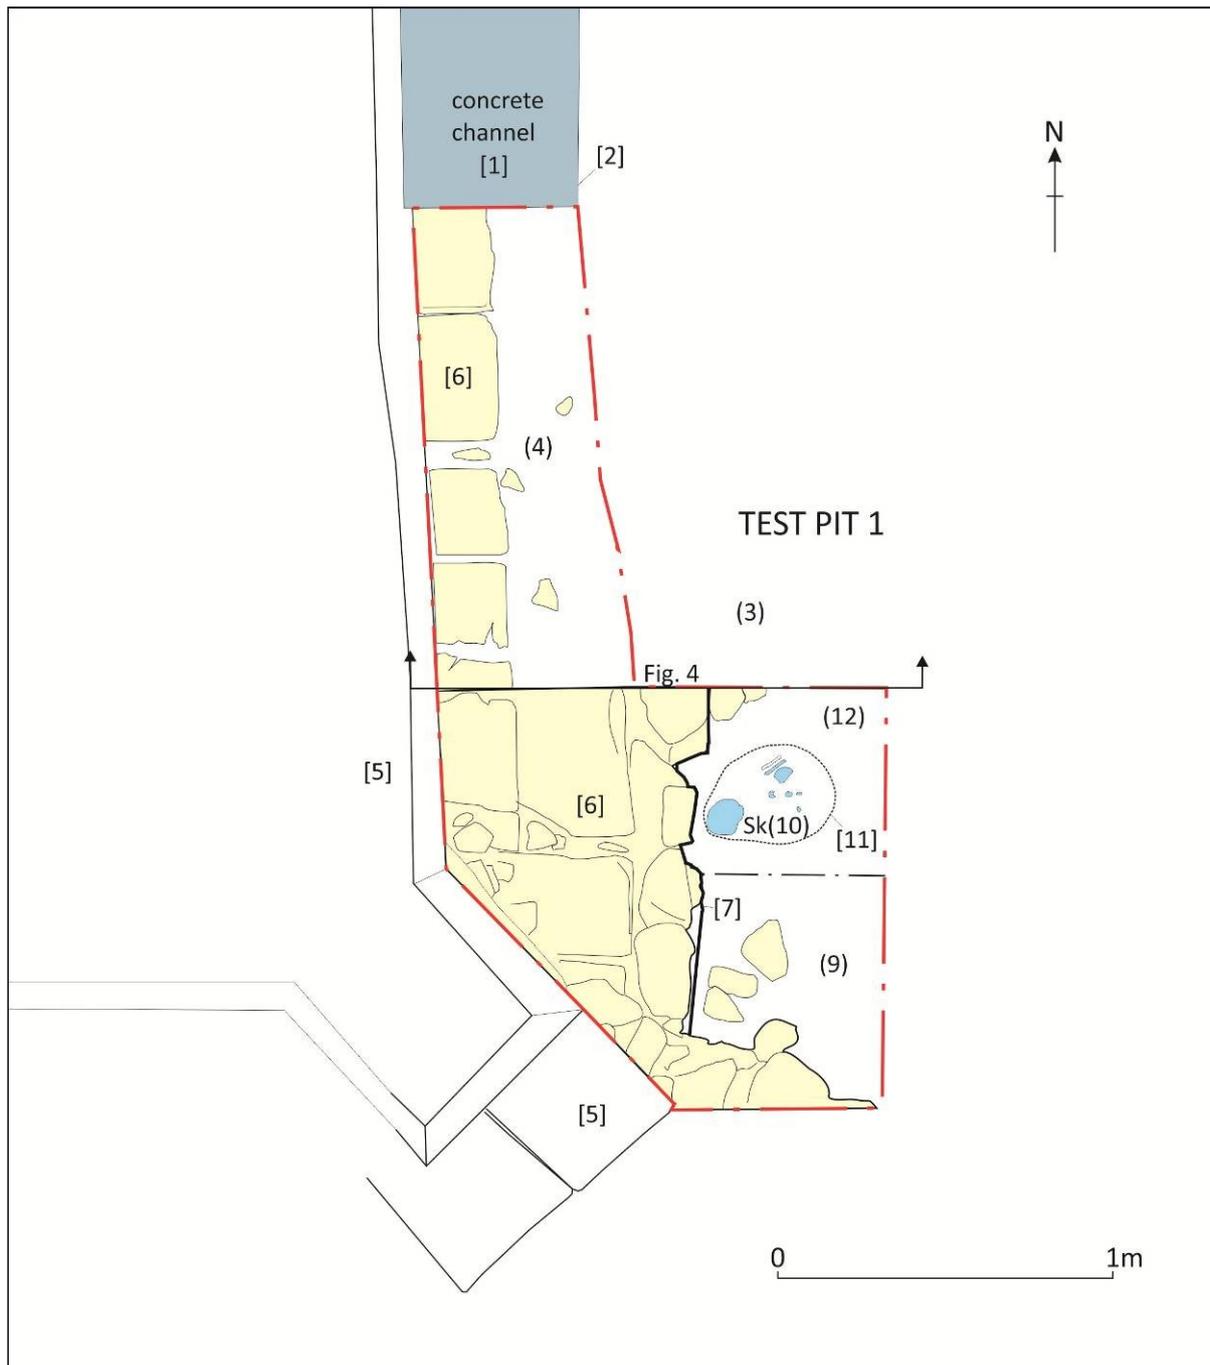
Fig. 3 Plan of Test Pit 1

- 6.2 Test pit 1 was located at the southern end of the east wall of the chancel, between the chancel wall and south-eastern buttress. The test pit was excavated to a maximum depth of 1.03m (50.03m OD), (Fig. 3–6).

- 6.3 An articulated human infant skeleton Sk(10) was partially exposed at the base of the test pit, it was aligned east–west, with the skull at the west end of the burial. A nominal cut [11] was allocated to the burial which was probably cut from higher in the sequence although the cut was only identified at the base of the pit. The burial physically overlay a stiff mid-greeny grey redeposited sandy silt layer (12) which contained occasional charcoal and burnt clay flecks. Above the level of the burial, a very similar stiff mid-greeny grey redeposited sandy silt layer (9) was observed across the test pit and contained pottery with a *terminus post quem* of the late 11th century. This was in turn sealed by a compact mid brown sandy clay layer (8) which contained frequent small limestone fragments and occasional larger fragments of limestone up to 250mm in size. A bone tool and a medieval arrowhead with a *terminus post quem* of the

- 6.4 Cutting through deposit (8) was the foundation trench of the chancel, [7]; the trench is vertically sided, and continued to the base of the trench, although probing suggested it did not continue any deeper. The trench was filled by foundation [6] which was made up of limestone rubble. No mortar bonding was noted, although the foundation may have been clay bonded. The surface of the foundation was made of larger blocks which were laid flat, a single row of limestone blocks formed an offset foundation to the chancel superstructure [5].

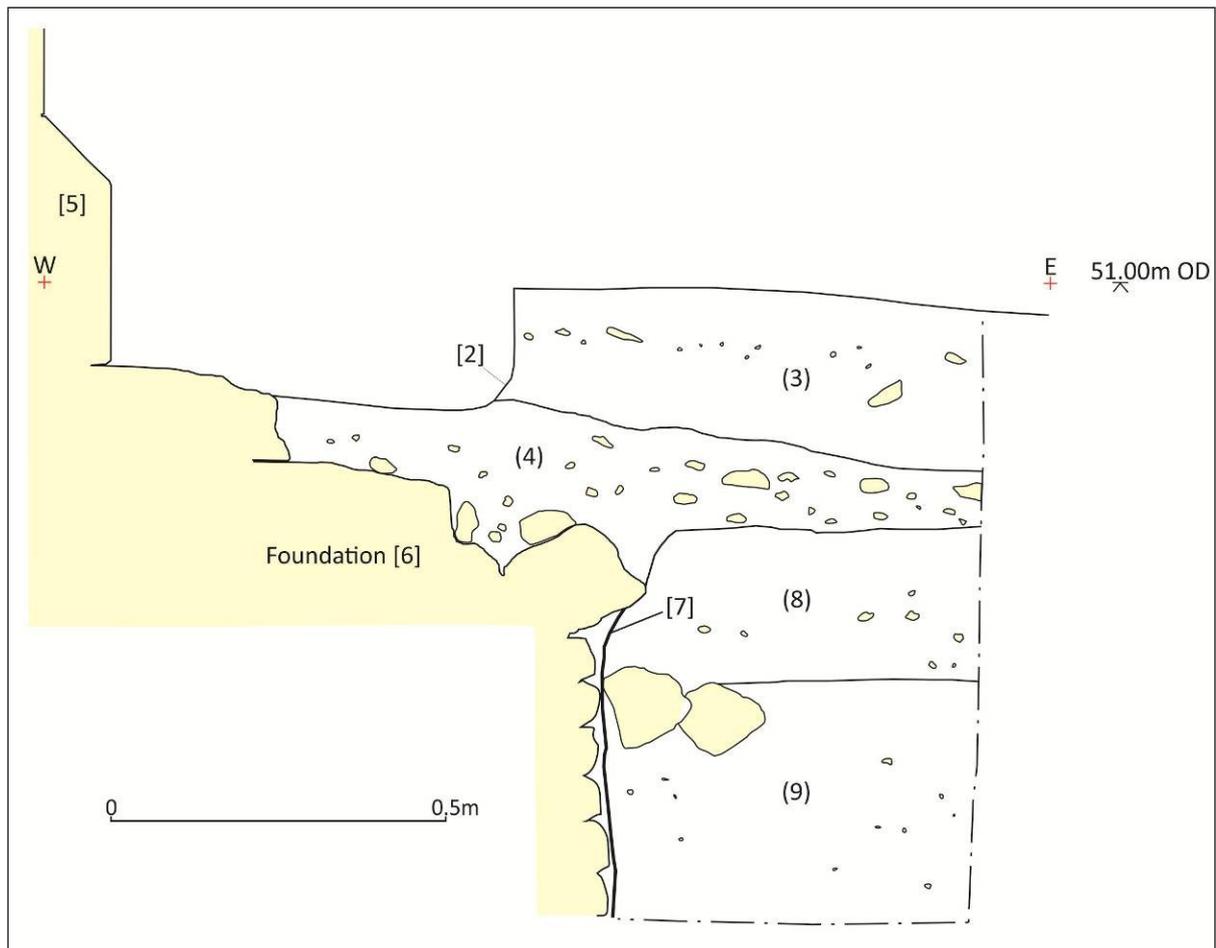
Fig. 4 South facing section of Test Pit 1

- 6.5 The foundation was sealed by a mid-yellow brown sandy clay levelling layer (4) which contained frequent small limestone fragments and pottery with a *terminus post quem* of the late 13th century. The levelling layer was sealed by topsoil and turf (3), which had a surface at 51.00m OD. A concrete drainage channel [1] was cut into the topsoil along the side of the chancel wall.

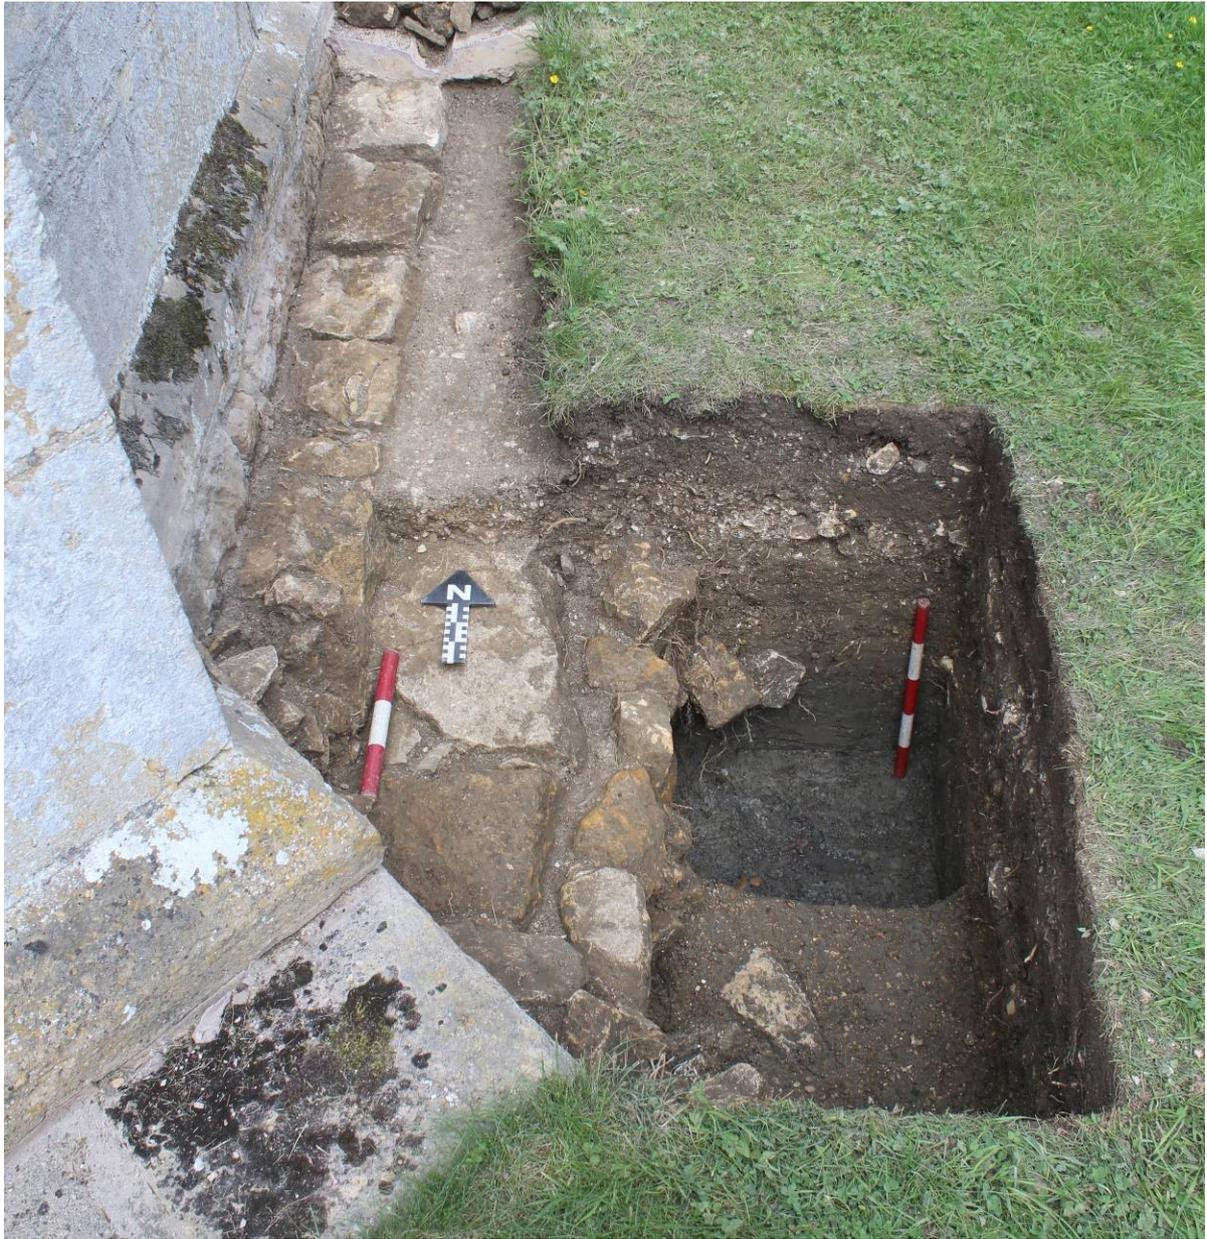
Fig. 5 Test Pit 1 showing foundation [6] sealed by layer (4) looking north; scales 0.3 and 0.5m

- 9.4 A large foundation trench was dug to carry the foundation of the chancel, which is very substantial, extending 0.75m east of the superstructure and to approximately 0.8m depth. Assuming the foundation is symmetrical internally the foundation may be up to approximately 2.5m thick. The foundation was made using blocks of limestone laid in the trench, some attempt at coursing may have been made, but stones along the outer side of the foundation were pitched in. The foundation appears to be bonded using clay/soil, there is no sign of mortar in the exposed foundation, although the core could be bonded with mortar. It is highly likely that the masons building the church knew that the ground under the wall line was poor, and that the substantial footing was designed to circumvent this.

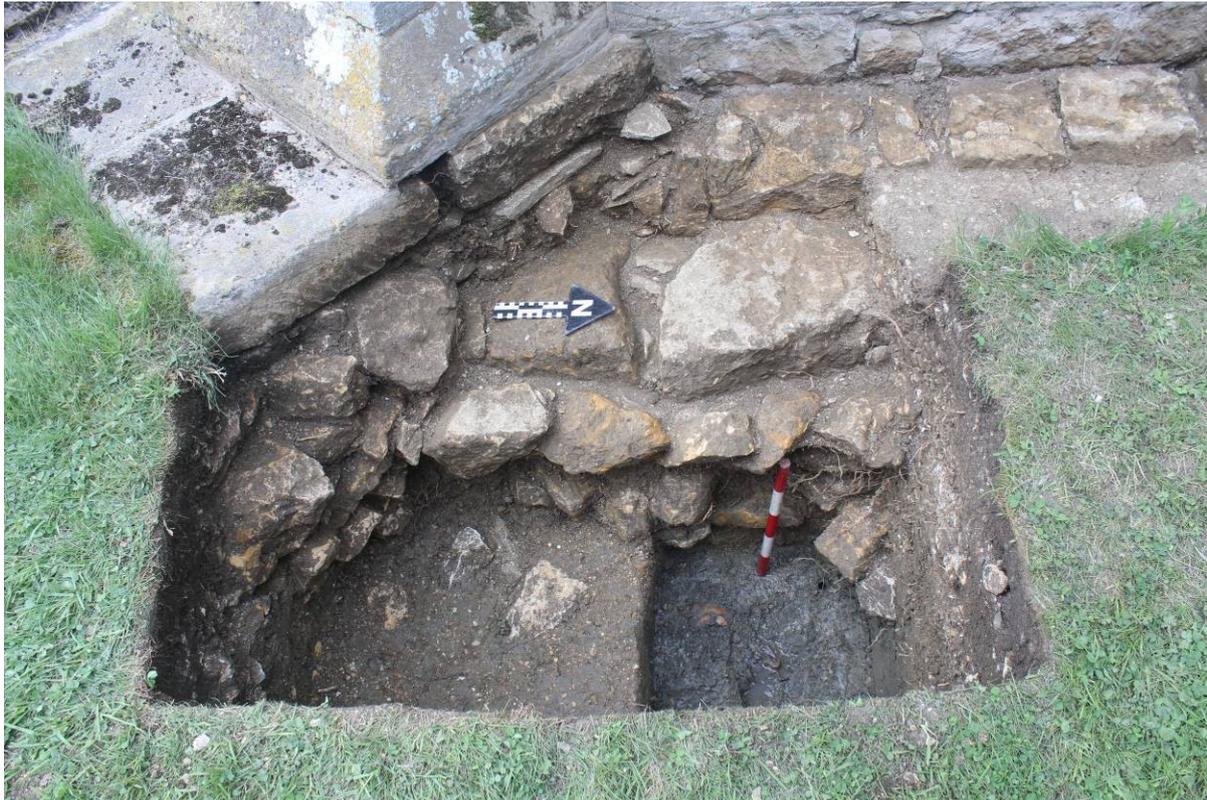
- 9.3 Human infant skeleton (10) was observed lying within, or probably cut into, the redeposited clay layer. The skull and arm bones of the skeleton were exposed, however the burial was not cleaned in order to minimise disturbance. No grave cut or fill was discernible in the layers above the skeleton, but the burial is likely to have been cut from the top of redeposited clay layer (9) or gritty layer (8). The grave cut did not cut through levelling deposit (4) and therefore predates the chancel. The burial itself is undated, however it is mostly likely to be medieval and have a *terminus post quem* of the late 11th century. Given the presence of a church on the site from at least c1200, it seems probable that the burial is part of a churchyard cemetery, extending eastwards of the earliest church.

Fig. 6 Test Pit 1 showing foundation [6] and burial Sk(10) looking west; scale 0.5m

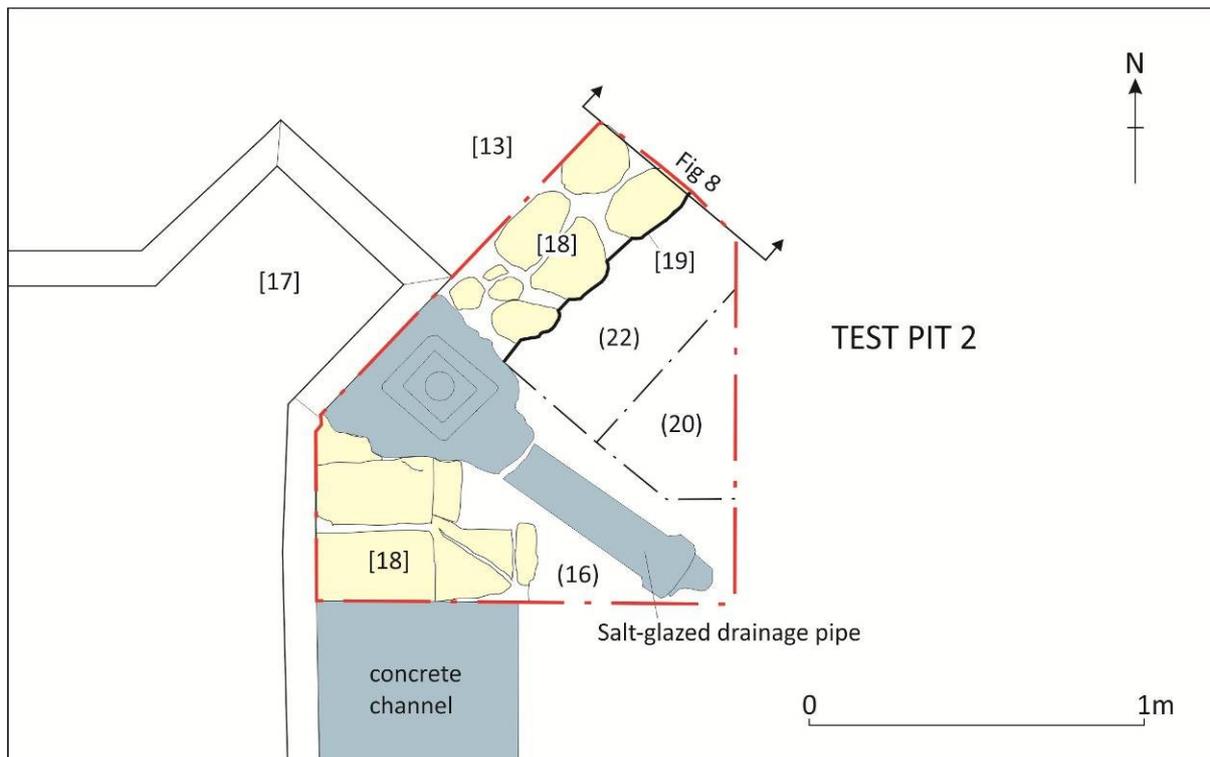
Fig. 7 Plan of Test Pit 2

- 6.6 Test pit 2 was located at the northern end of the east wall of the chancel, between the chancel wall and north-eastern buttress. The test pit was excavated to a maximum depth of 1.05m (49.84m OD), (Fig. 7–9).

- 6.7 A largely similar sequence to that observed in Test Pit 1 was observed in Test Pit 2. At the base of the trench a layer of redeposited brown oxidised clay (22) was sealed by a mid greeny-grey redeposited sandy silt layer (21=9), this in turn was sealed by a gritty mid brown sandy clay layer (20=8) with a surface at 50.58m OD, which was cut by the chancel foundation trench [19=7]. The base of the foundation appeared to be at 50.03m OD. Foundation [18=6] was sealed by a mid-yellow brown sandy clay levelling layer (16=4) which contained a sherd of pottery with a *terminus post quem* of the late 11th century.

- 6.8 The levelling layer was sealed by turf and topsoil (15=3) with a surface at 50.88m OD which was cut by concrete gutter [13=1] which was integral with a concrete and salt glazed gully and drainage pipe; the drainage pipe had snapped at the collar.

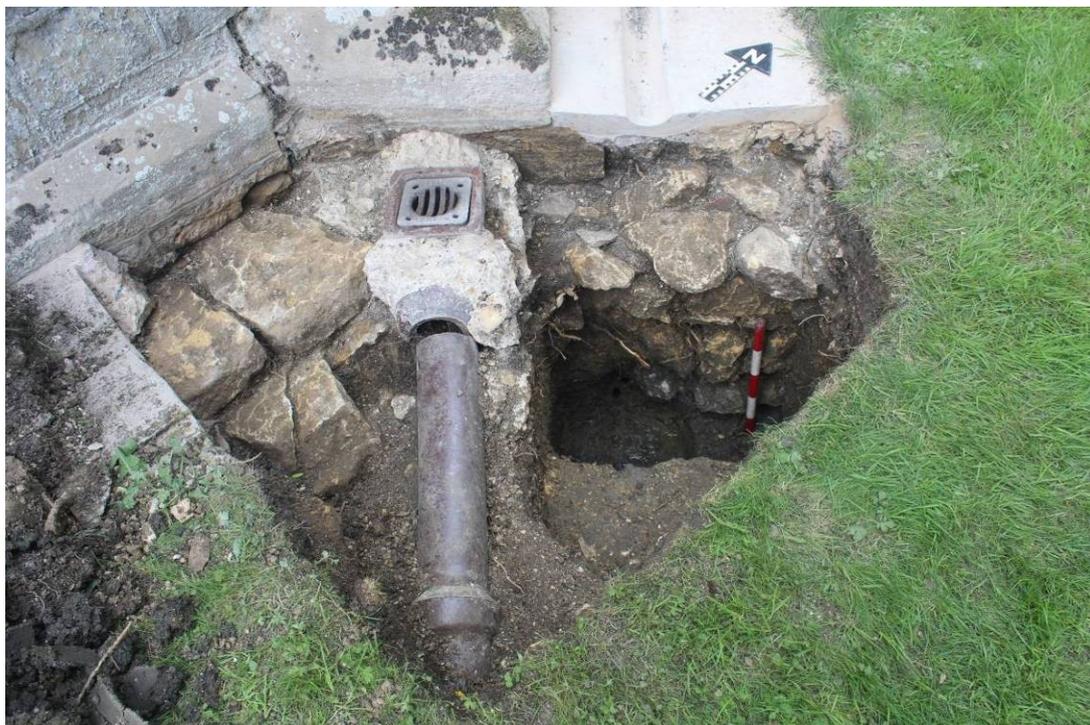
Fig. 9 Test Pit 1 showing foundation [18] looking northwest; scale 0.5m
