St Nicholas' church, Kemerton, Worcestershire, Diocese of Gloucester

An Archaeological Watching Brief Report

Archaeological Watching Brief Report

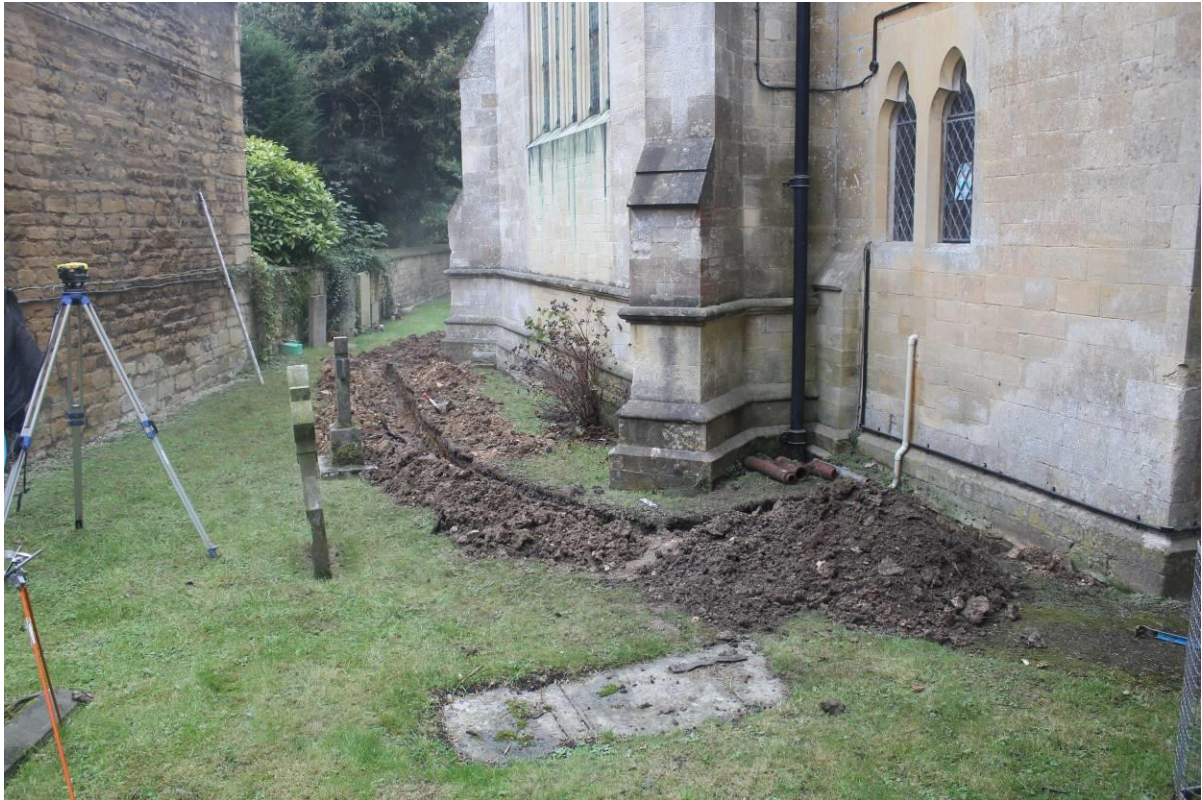
Fig. 3 The trench, looking south; scale 1m

- 6.2 Natural substrate was not reached; the earliest deposit was a friable mid-grey brown sandy clay silt (5) containing occasional human bone fragments and limestone fragments (Figs 3–5). The deposit was observed at a depth of approximately 0.25m below ground level. At the east of the chancel this was sealed by a 20-200mm thick layer of limestone chippings (6); some of the limestone had axed toolmarks and probably relates to the mid-19th century rebuilding of the church. The construction debris was sealed by turf and topsoil (4).
