**Hull College,
Queen's Gardens
Hull
Archaeological Evaluation 2008**

Project No. 1817

By Phil Mann

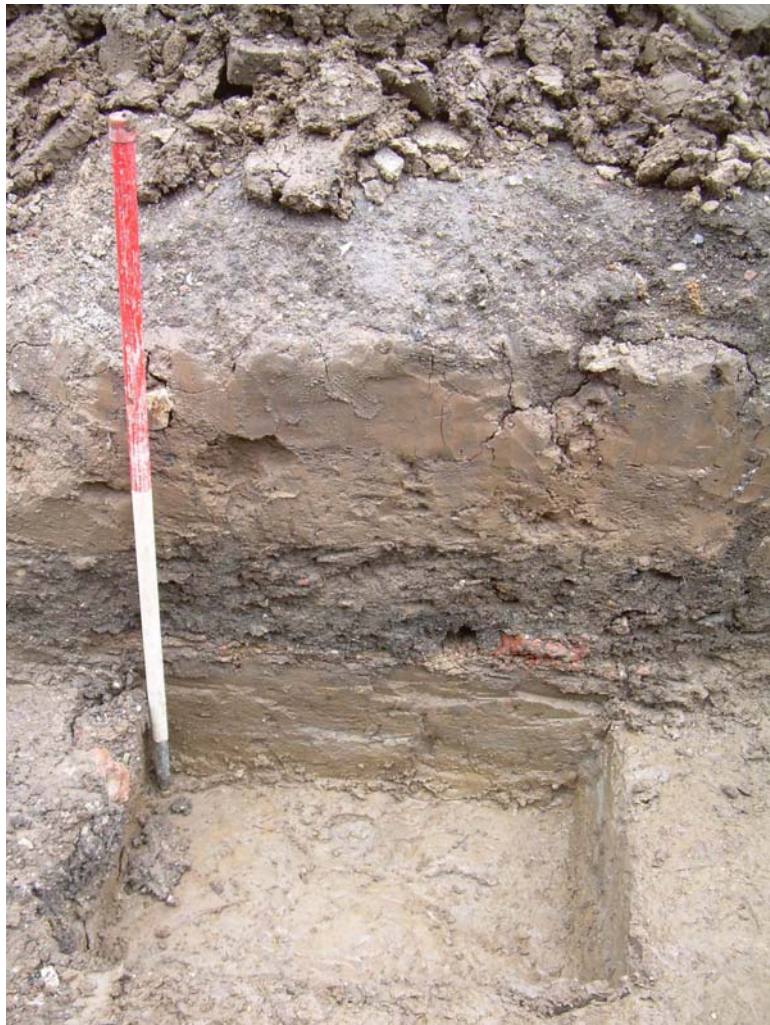
Plate 5

- 5.2.3. Wall 214 (Plate 5) lay approximately 4.2m to the southeast of wall 202 and was constructed of rough coursed grey oolitic limestone. However, lime render had been applied to the outer surface on both northern and southern faces. The wall survived to a height of 0.6m and a width of 0.5m. The base of the southern elevation of the wall showed evidence for an offset to the foundations in the form of a step around 0.05m in width. To the north of wall 214 were the remains of two small stakeholes, with associated wooden stakes W2 and W3.

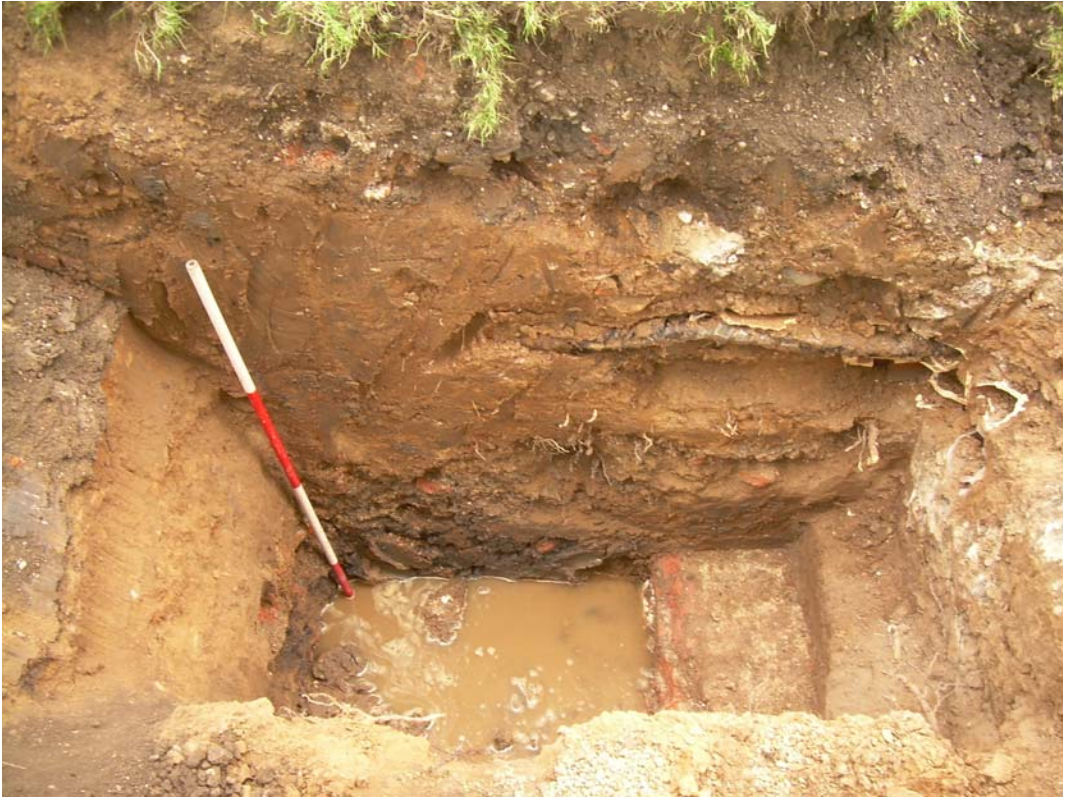
Plate 6

- 5.2.4. Sealing 215 towards the north end of the trench, and between walls 202 and 208, was a layer of black sandy silt (211) 0.22m in thickness and which contained fragments of pottery dating to the 14th century (Plate 6). The layer suggested a former garden/occupation layer. Overlying 211 and the remainder of the trench was a layer of light-brown silty clay (210) 0.55m in depth, which contained occasional fragments of broken brick and which appeared to be a levelling or ground raising layer across the area. Overlying 210 to the northwest and southeast ends of the trench was a layer of black sandy silt (213) c 0.4-0.6m in depth that contained fragments of pottery dating to the 17th century.
