**Chapman's Yard, Scarborough,**

**An archaeological watching  
brief 2003**

Birmingham University Field Archaeology Unit  
**Project No. 977**  
June 2003

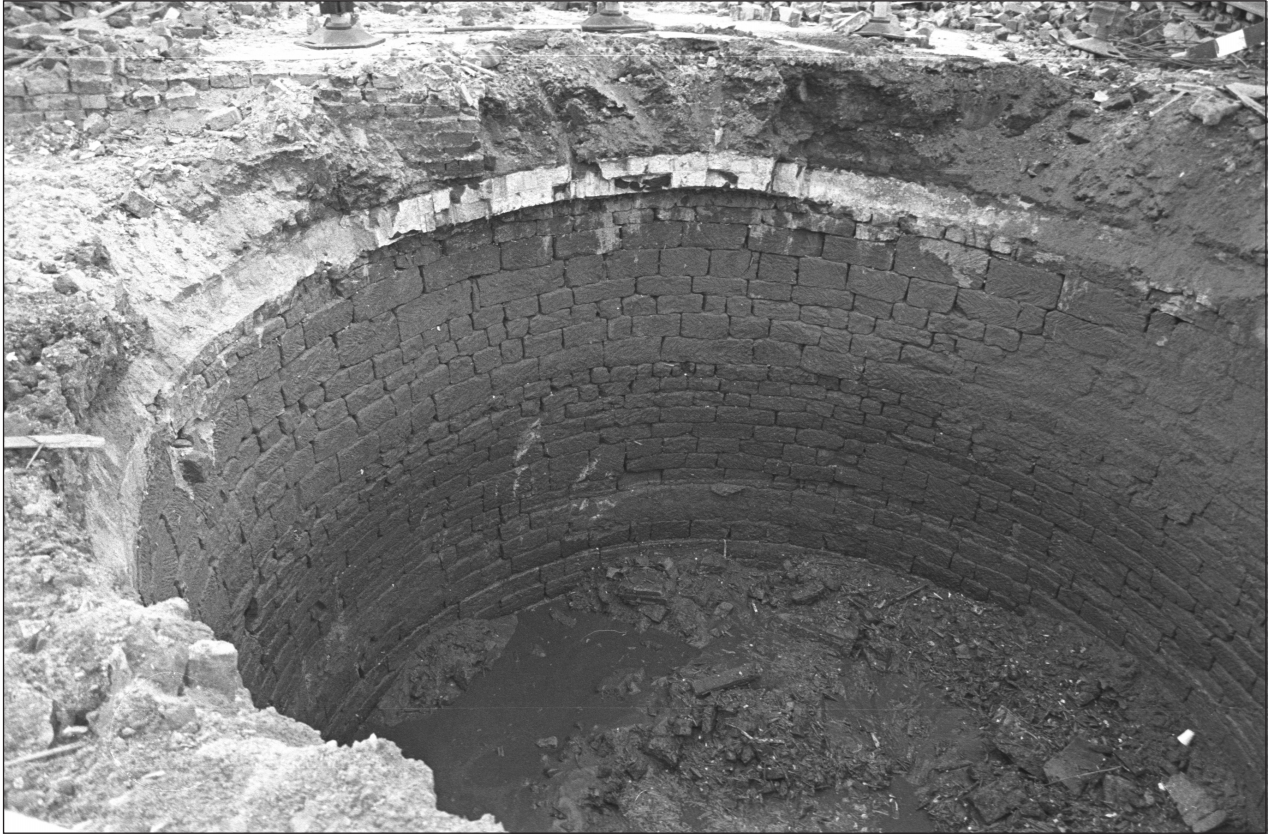
- Plate 1 Sandstone reservoir  
Plate 2 Sandstone reservoir being emptied  
Plate 3 Sandstone reservoir in relation to surrounding buildings Plate 4 Sandstone reservoir detail

Groundworks revealed a large stone built reservoir (F101) towards the southern extent of the Chapman's Yard development area (Fig.3). Due to safety concerns it was not possible to examine structural elements from inside. This was, however, photographed, plotted and significant features recorded. The reservoir measured c.7m in diameter and was constructed using well-dressed sandstone blocks (1002; Plate 1) with clearly visible 'chevron' tooling marks (Fig.4). The structure contained large quantities of waterlogged materials (1003) which were excavated to a depth of over 5m by machine and transported away from the site (Plates 2-3). Fragments of wood and a leather shoe fragment were recovered. The shoe is considered to be relatively recent in date. Two stone inlet or outlet features were recorded in the southern wall of the feature (Plate 4; Figs.3 and 4). The upper outlet/ inlet was two courses of masonry below the surface, the second eight courses below the current surface of the reservoir. The surviving remnants of a slightly domed brick-built capping (1001) were visible above the sandstone masonry.
