Southampton Archaeology Unit

Report 1132

Archaeological Watching Brief on Trial Holes for Works at Central Station North Quarter, Southampton, SOU 1613

Client: Southampton City Council

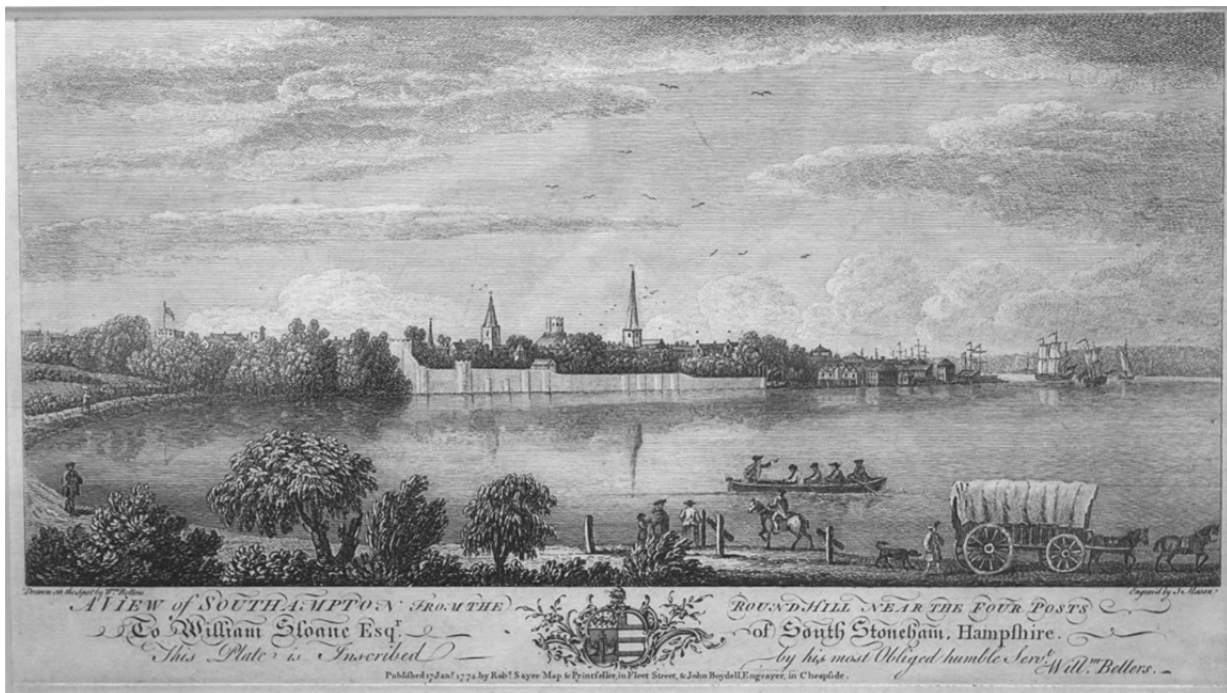
Figure 2. An 18th century view of Southampton from the west showing the Strand route along the shore in the area of the site, and the Four Posts bridge with its vanes.

The bridge carried the main routeway west from Southampton over the Rollesbrook. References to the route by the shoreline exist from at least the mid-13th century when it was referred to as 'vico qui vocatur la Stronde' (Blake 1981, 51) meaning 'the street called the Stronde', 'strand' being the Old English word for 'shore'. In the 1270s it was referred to as 'strata super Strondam' (*ibid*, 159) meaning 'street on the shore'. The earliest map of Southampton, dating from the late 16th century, shows this route with a slight strip of land between it and the waterfront. It remained a routeway well into the 18th century (Fig 2).

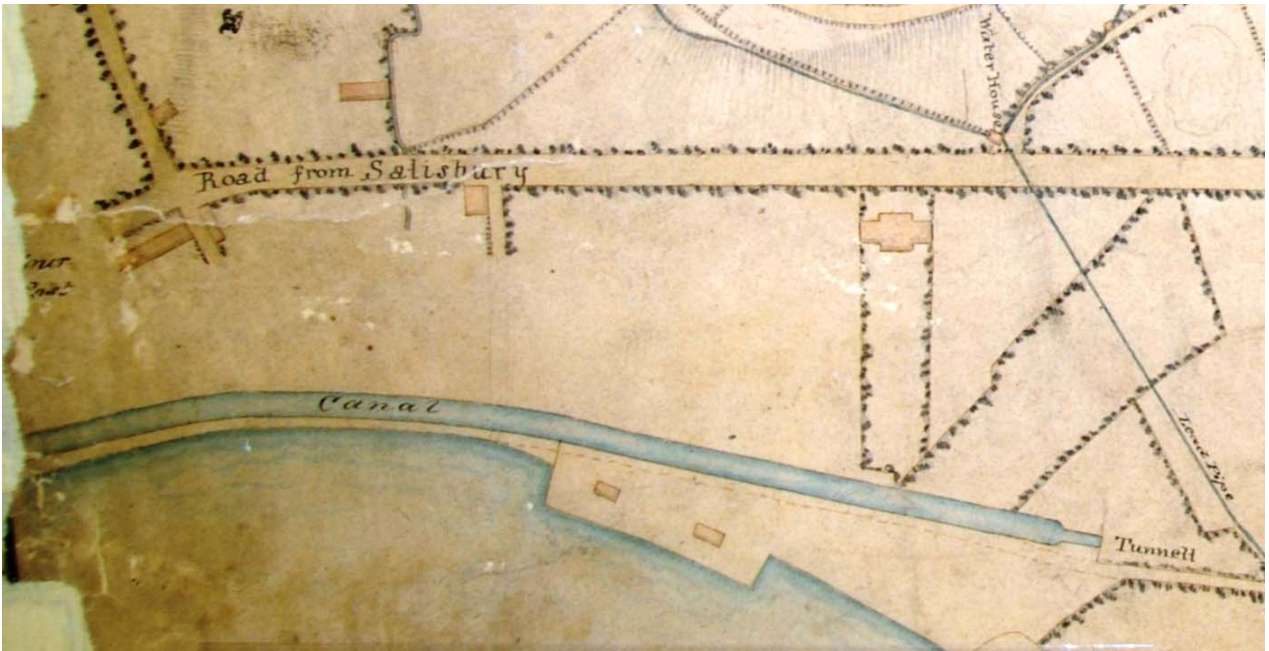
Figure 3. Detail of Doswell's "Water Map" of 1803–1827 showing the Southampton and Salisbury Canal.

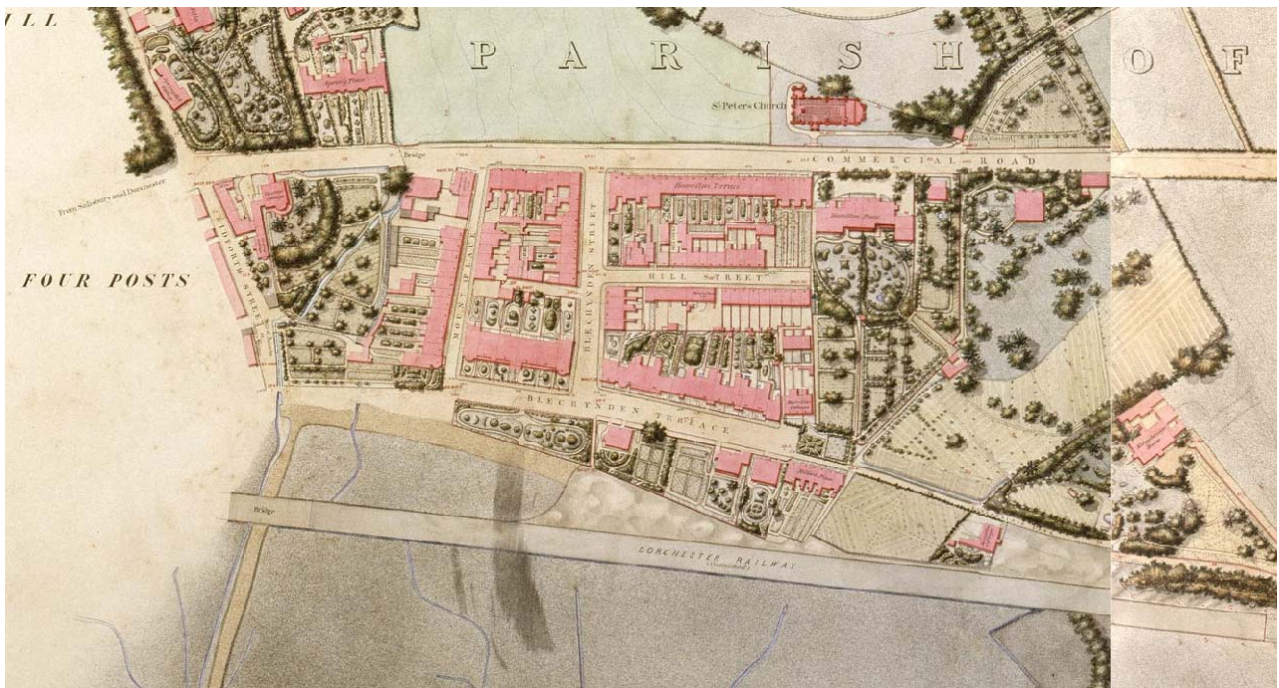
Figure 4. Detail of the Royal Engineers' map of 1846 showing the area of the site.

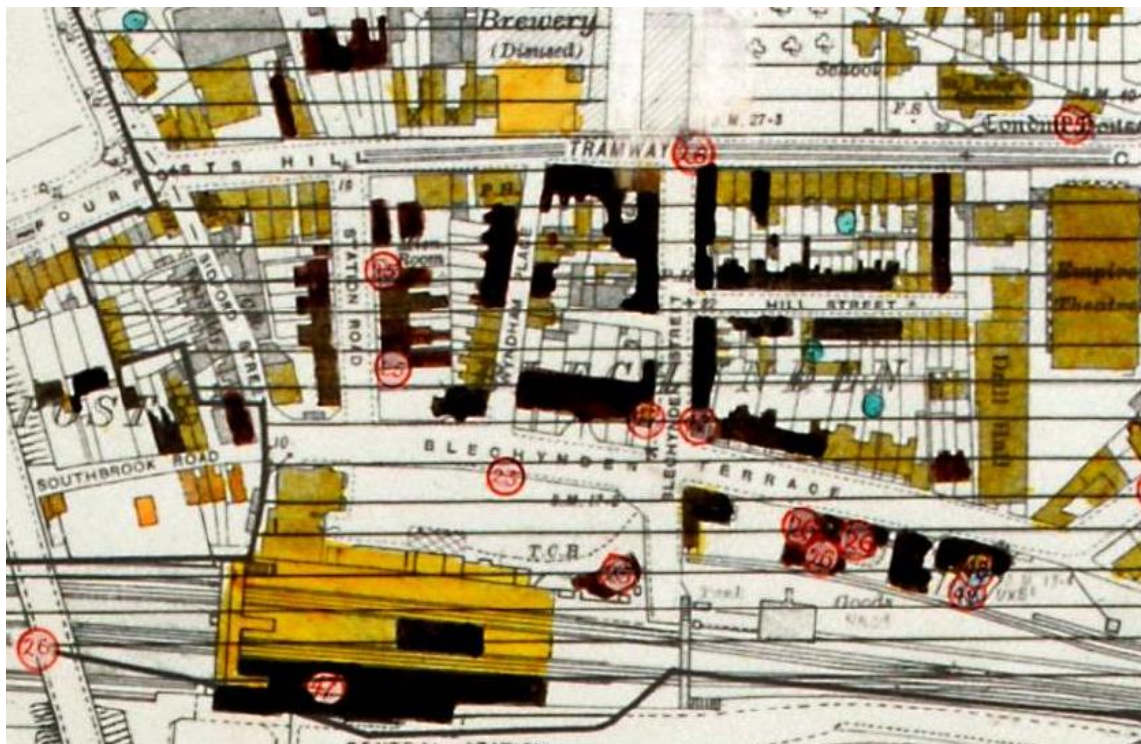
Figure 6. Map showing the extent of bomb damage in the area.

War (Fig 6). The clearance of the terraced houses and other buildings took place in stages until c1970. Wyndham Court was built in the 1960s and was followed in the 1970s by other large developments.

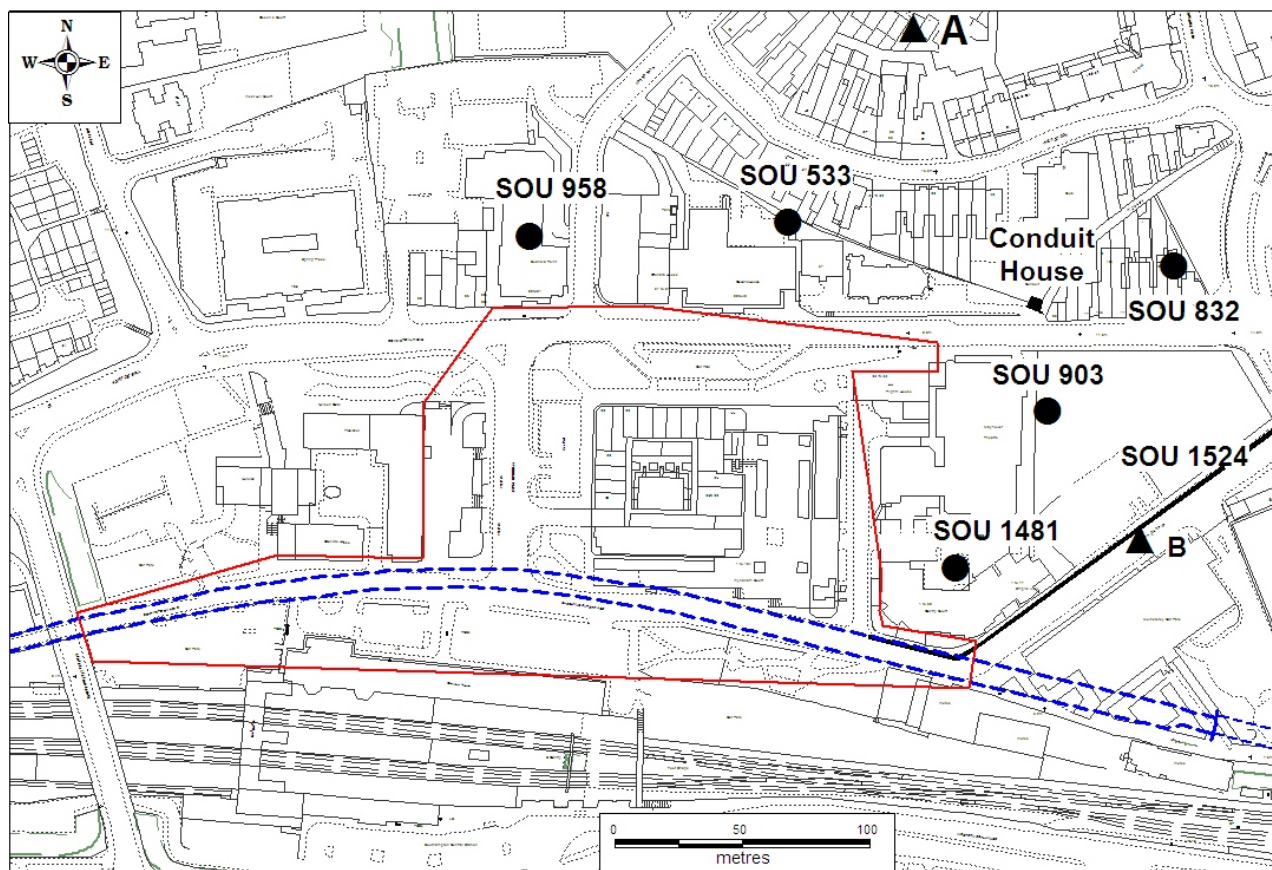
Figure 7. Previous investigations in the area and the estimated line of the Southampton and Salisbury Canal.

The site is in Local Area of Archaeological Potential 7 (Bannister's Park) and there have been several archaeological projects and casual finds in the area (Fig 7). Prehistoric evidence has been recorded across much of the area and Roman occupation evidence has been found in London Road and Archers Road. Palaeolithic hand axes were found before 1919 in The Polygon and West Park Road (Fig 7, A & B).
