## Southampton Archaeology Unit Report 1174

# Archaeological Watching Brief at Brunswick House, Brunswick Place, Southampton SOU 1667

AD Russel BA PhD MIfA 2014

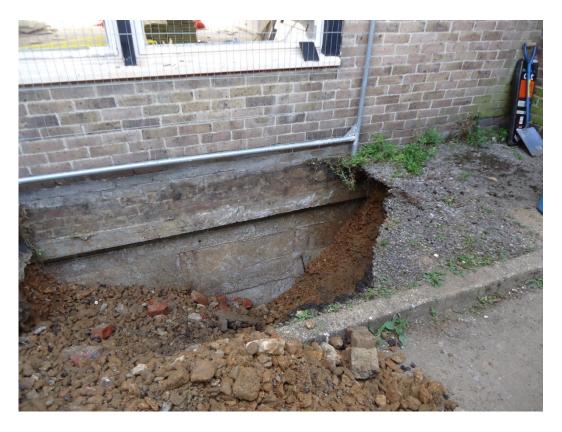
Figure 3. Trial pit A showing foundations of Brunswick House and the gravel fill 3.

Brunswick House was found to sit within a large foundation trench (feature 2) backfilled with coarse gravel with fragments of brick (fill 3) (figs 3 & 4). The fill was very loose and difficult for the machine to dig through cleanly. The base of the feature was not reached, but it was at least 2.5m deep. It was encountered in TP A and TP B. The coarse gravel fill also occurred outside the feature and was found in the upper part of BH1 and BH 2.

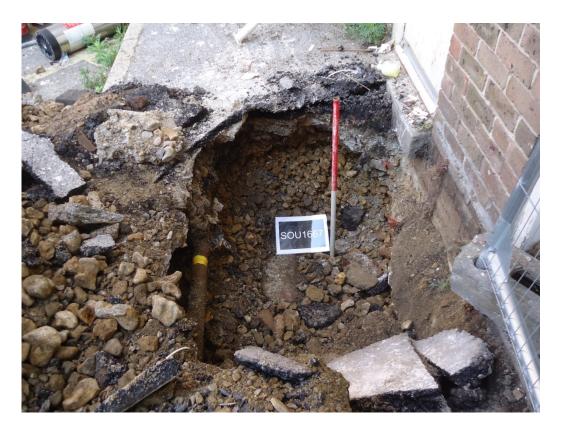
Figure 4.Trial pit B, initial location.

In the event only the two boreholes, and three of the trial pits were carried out. The boreholes were drilled in their intended locations. Trial pit A was dug in its intended location, but could not reach its full depth. Trail pit B was excavated in its intended position but a gas pipe meant excavation had to cease, and it was moved to the

approximate position of Trial pit C, but was still called Trial pit B. The second position encountered two concrete encased drains and excavation ceased.

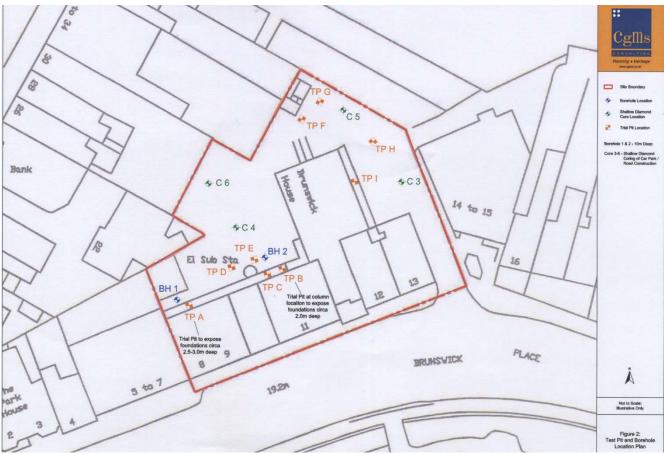
Figure 5. Location of the proposed trial pits, boreholes and cores.

The methodology followed that specified in the Written Scheme of Investigation (CGMS 2014) but the position of some trenches was altered due to the presence of obstructions. Eight trial pits (TP A-H), two boreholes (HB 1-2), and four cores (C3-6) were to be undertaken.
