**Newlands Farmhouse,
Emersons Green, South Gloucestershire
Standing Building Recording**

NGR ST 67112 77647

Avon Archaeology Limited
Bristol: September 2018

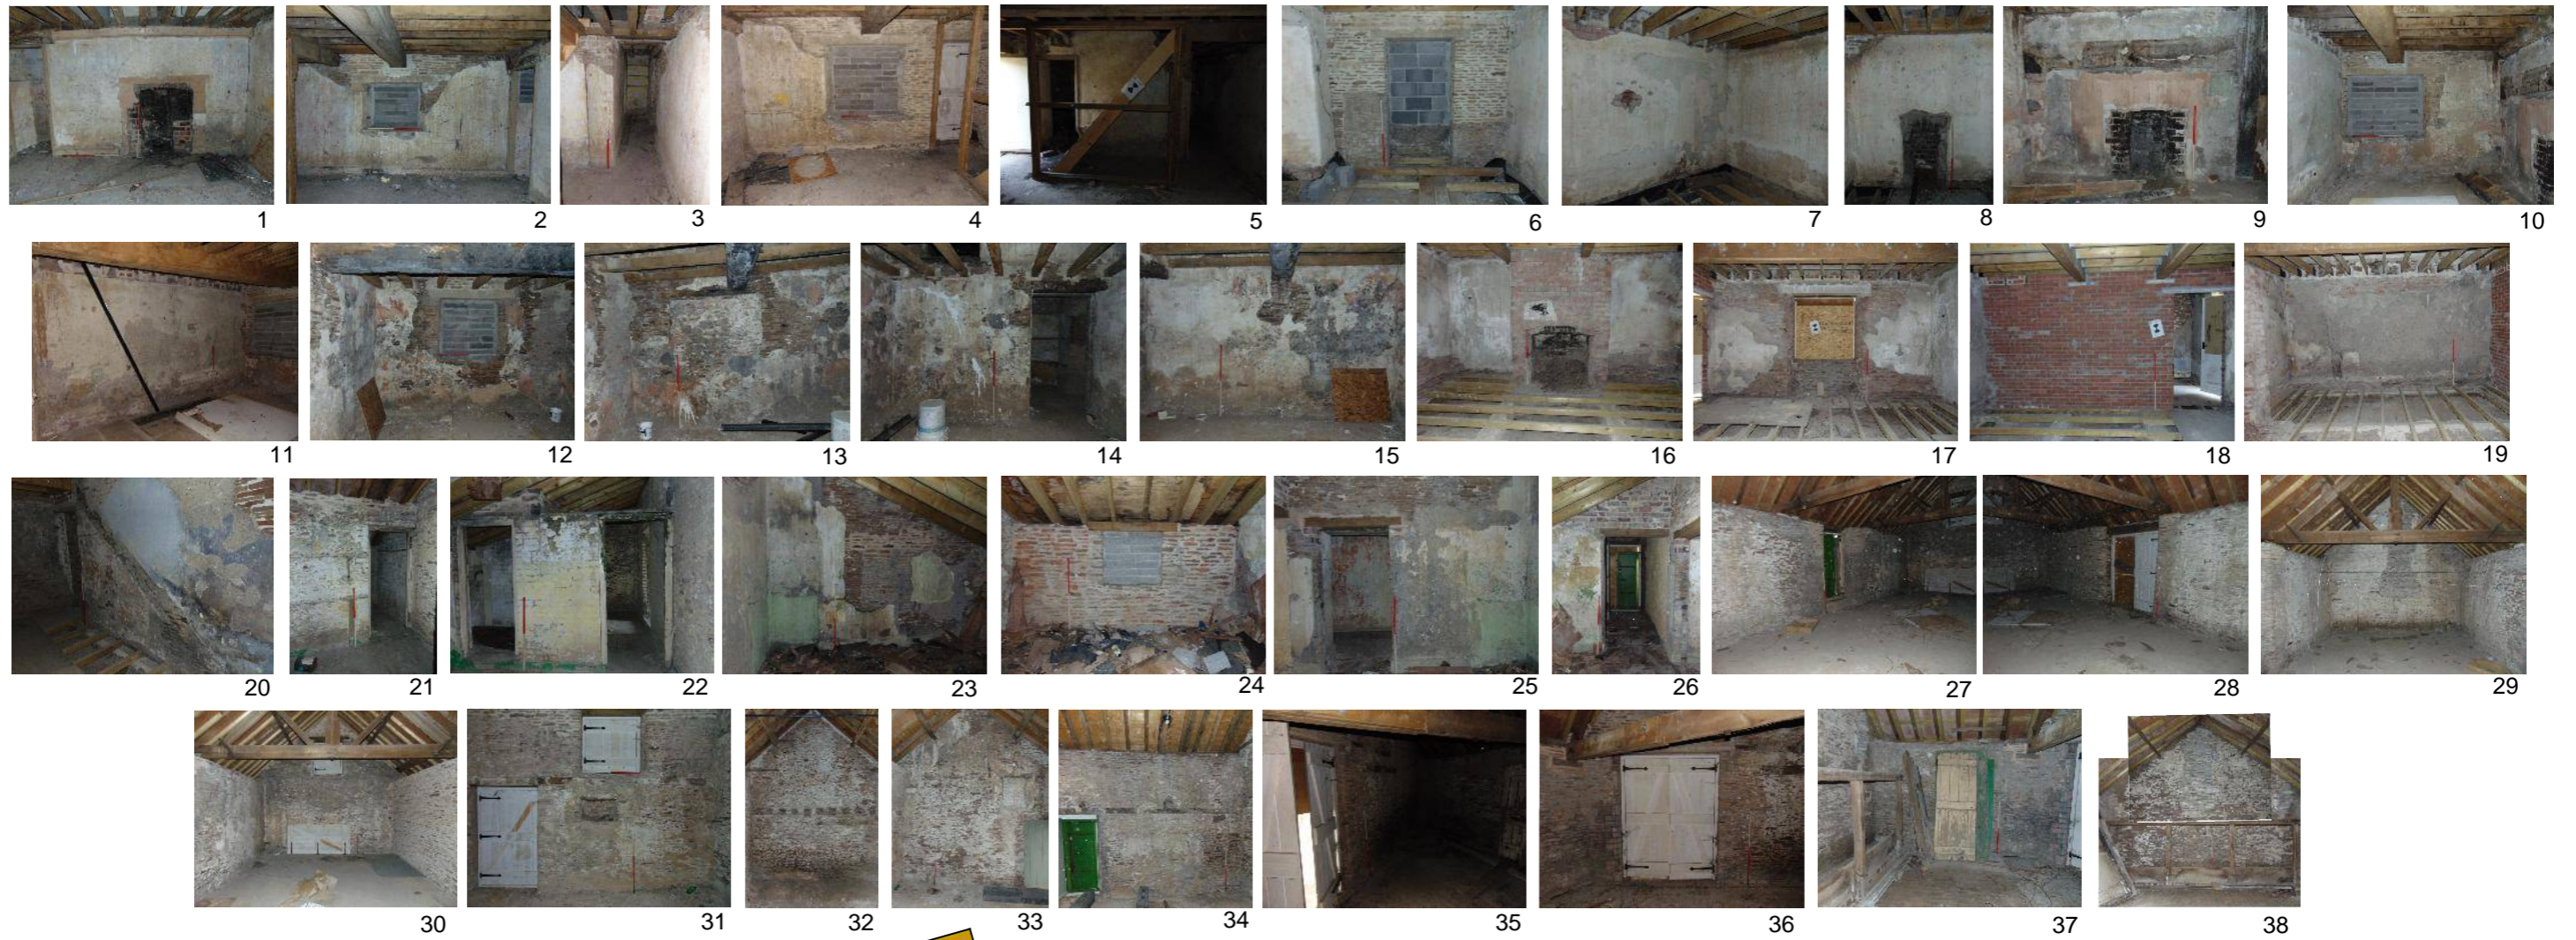
Figure 3

Ground Floor Plan

The 17th century farmhouse is currently divided into four rooms (rooms G5, G6, G9 and G10) with a 20th century lean-to extension to the rear (rooms G7 and G8) (**Figures 3 & 4**). Original inglenook fireplaces were recorded on the northern (room G5) (**Plate 1**) and southern gables (room G10) (**Plate 9**), although both have later brickwork in-fills. Further fireplaces were recorded: on the first floor of the southern gable in room F5 (**Figure 4, Plate 39**); on the ground floor and first floor of partitioned rooms G9/F4 (**Figures 3 & 4, Plate 8**); and on the first floor in room F3 (**Figure 4, Plate 46**), which was topped with a large timber lintel although no chimney could be seen on the outside of the building. The majority of the southern gable was constructed of flat rubble, however some 19th and 20th century brick repairs were also observed (**Plate 39**). The gable in room F2 has a stepped chimney but no fireplace (**Figure 3, Plate 9**).

The original layout of the 19th century extension consists of two rooms in an L-shaped plan (**Figures 3 & 4**). Rooms G1/F1 has a brick chimney with fireplaces on both the ground (**Figure 3, Plate 16**) and first floors (**Figure 4, Plate 48**) of the northern elevation. There is currently no staircase in this side of the building however a wall scar (**Plate 20**) records its previous location in front of the doorway in room G2. The partition between rooms G1 and G2 is constructed of brick and appears to be very modern (**Figure 3, Plate 18**).

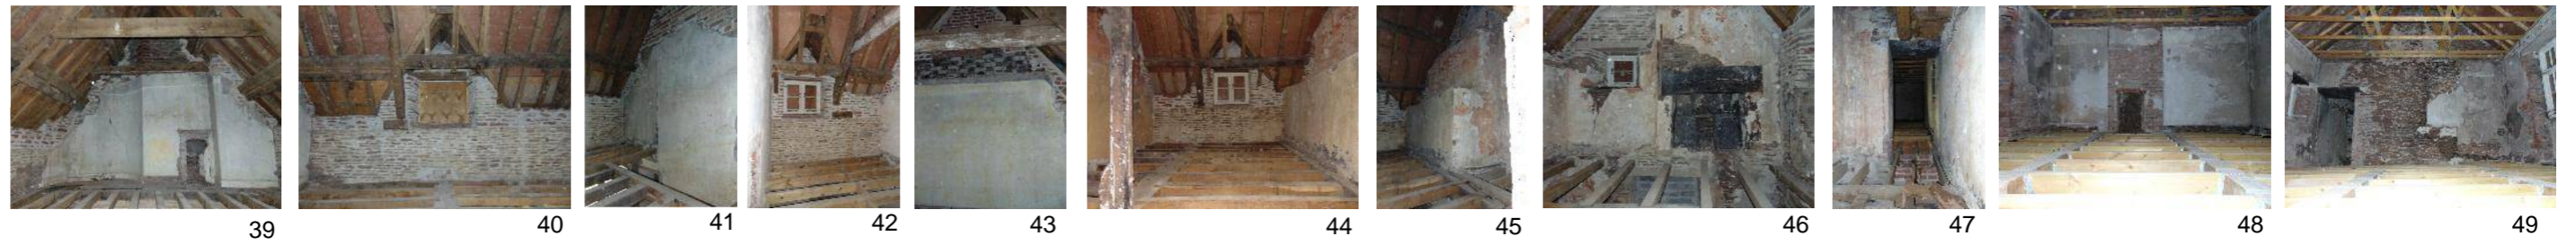
Figure 4

First Floor Plan

Adjacent to the fireplace in room G10 was a small room which undoubtedly previously contained the original staircase (**Figures 3 & 4, Plates 60 & 61**). A lath and plaster ceiling with lime plaster now forms the ceiling of this space, indicating that the staircase removal was not a recent modification. The current staircase, located in room G10 (**Figure 3, Plate 5**), is modern, as are the ceiling joists. In many of the rooms a light grey, ash lime plaster was observed which likely dates to the 19th century.

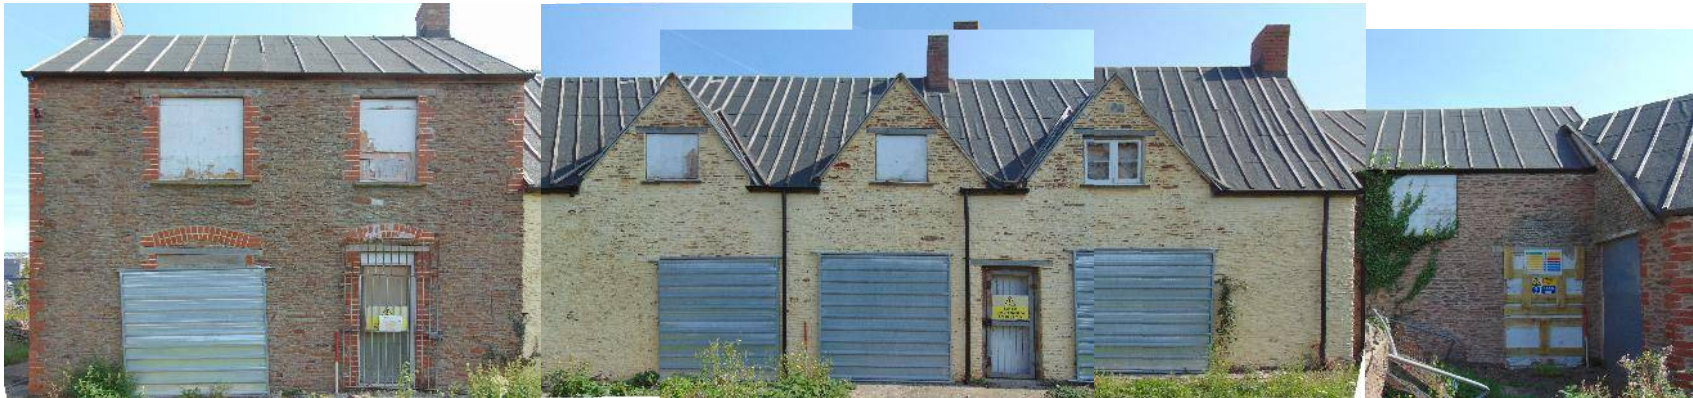
Figure 5

South-west facing elevation of farmhouse frontage (Elevation A)
(composite photograph not to scale)

The 17th century part of the farm has a two storey, L-shaped building with three, unevenly spaced, gabled windows (**Figure 5, Plates 51 & 58**) on the frontage with another gabled window on the south-east facing elevation (room F3) (**Figures 3 & 9, Plate 58**). The entrance is located to the south of the building between the two southernmost gables. The south-east corner of room F3 has been rebuilt in brick (**Figure 6, Plate 52**) Security barriers obscured the view of all but one of the windows, that on the southernmost gable, which appeared to be modern. A stub wall projects off the northern elevation on the frontage of the 17th century building (**Figure 3, Plate 59**). It is assumed to be part of an outbuilding seen on the first edition OS map which was demolished during the extension of the building during the late 19th century. A single storey lean-to extension (rooms G7 & G8), constructed of flat stone rubble and brick, has been added to the rear of the block in the 20th century (**Figures 3, 6 & 8, Plates 52 & 58**). The building has three brick chimneys within the 17th century block, although the northernmost has been incorporated into the later 19th century extension.

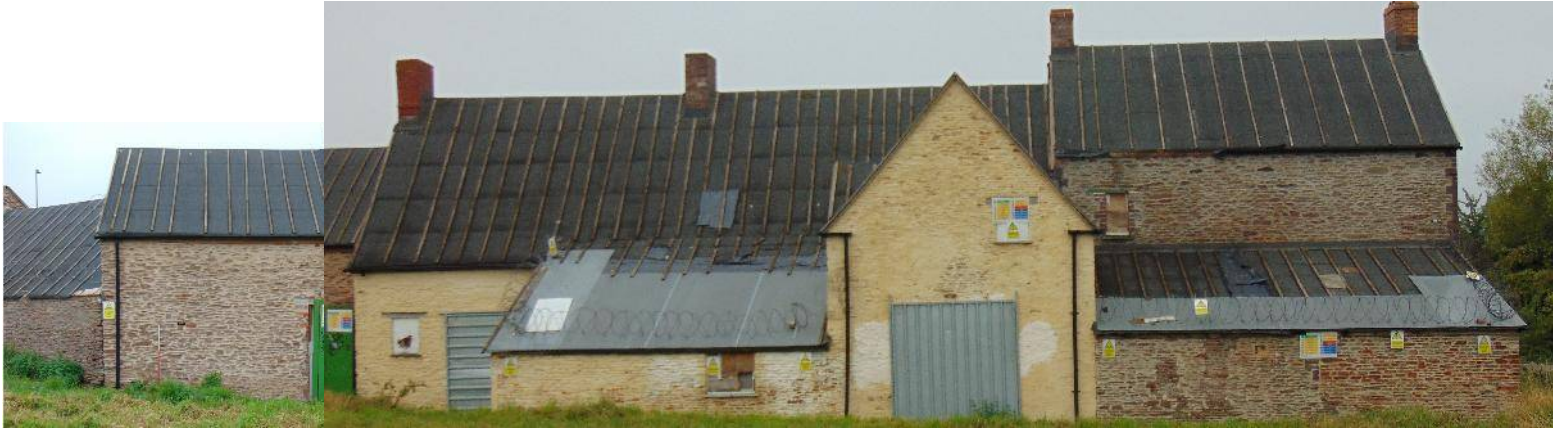
Figure 6

North-east facing elevation of farmhouse rear (Elevation B)
(composite photograph not to scale)

The 19th century extension (**Figures 3, 5 & 6, Plates 51, 52 & 58**) is located to the north of the building with an entrance to the south of the block. The main section of the building is two storey and rectangular with a single storey lean-to at the rear (room G3) (**Figure 6, Plates 52 & 58**). All chimney tops have been rebuilt relatively recently. A later 20th century single storey lean-to of flat stone rubble has been constructed in the north-eastern corner (**Figures 3 & 6, Plates 52**

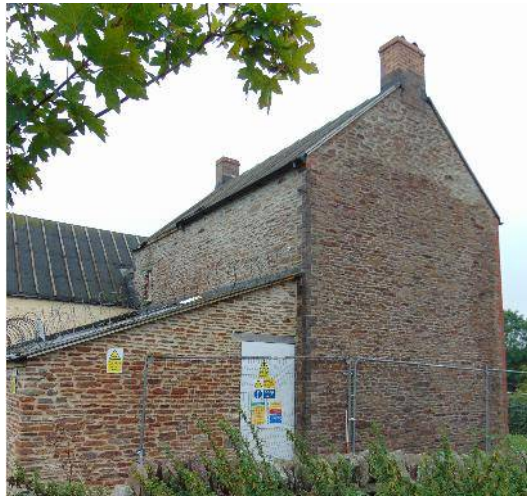
Figure 7

North-west facing elevation of
farmhouse rear (Elevation C)

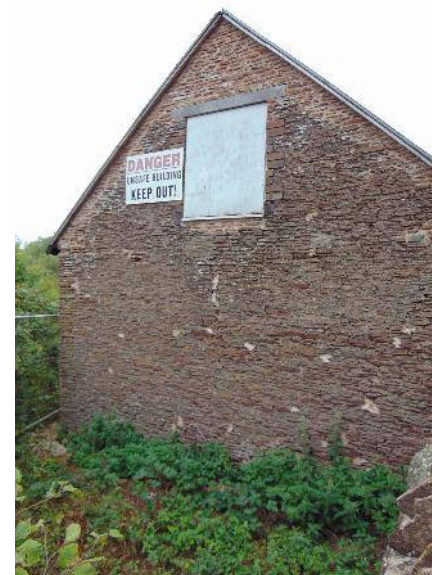
North-west facing elevation of
Barn C (Elevation D)

Barn C (**Figure 3, 7, 8 & 9, Plates 54, 55, 57 & 58**) is a rectangular single storey structure which is assumed to be associated with the 17th century construction phase and would have originally been separate from the main farmhouse. The opposing doorways on the eastern and western elevations suggest the building was originally a threshing barn. Barn A (**Figures 3, 5 & 6, Plates 51, 52, & 58**) and Barn B (**Figures 3, 8 & 9, Plates 55, 57 & 58**) were constructed during Phases 2 and 3 respectively. Barn A is a one and a half storey square plan building constructed off the southern elevation of the 17th century block. It has doorways in the eastern and western elevations and a window/opening on the upper storey of the western elevation, presumably to provide access to a mezzanine/hayloft. Barn B represents an episode of infill between Barns A and C and is assumed to be contemporary with the 19th century extension. It is single storey and has a large doorway on the frontage; a smaller doorway to the rear, although this may have been in-filled to make smaller; and a hayloft door on the southern gable. It also has a wall tie between the eastern and western elevations.

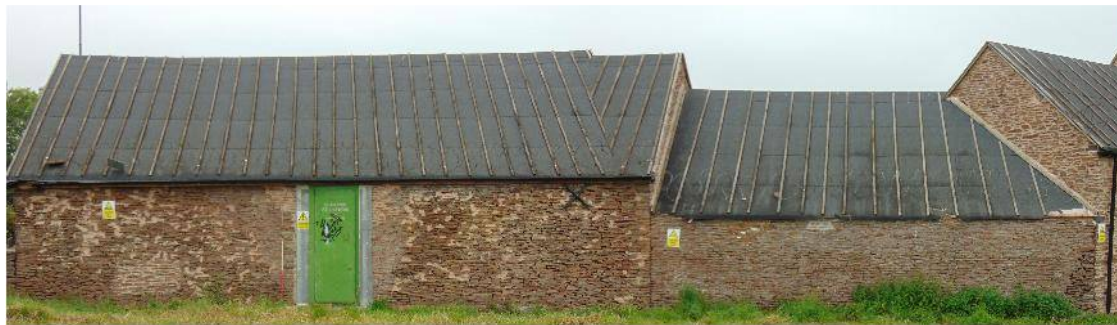
Figure 8

East facing elevation of
Barns B and C (Elevation E)

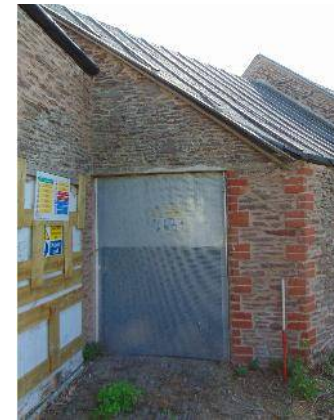
North-west facing elevation of
Barn B (Elevation F)

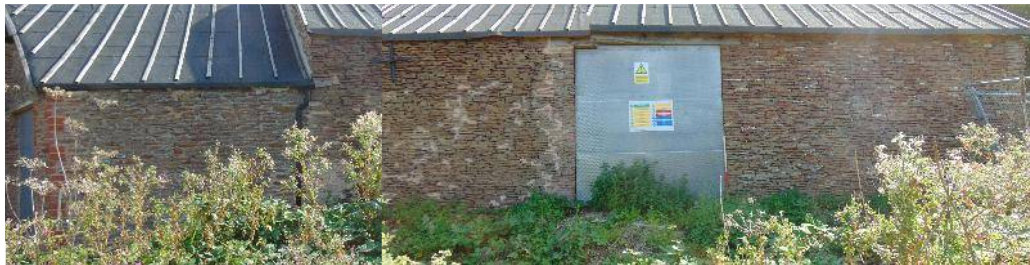
Figure 9

West facing elevation of
Barns B and C (Elevation G)

The external fabric of the barns, 17th century farm building and 19th century extension are all constructed from flat stone rubble. Brick quoins are present on the 19th century extension and Barn B and the south-east facing elevation of lean-to (rooms G7/G8) is constructed entirely of brick (**Figure 9**).

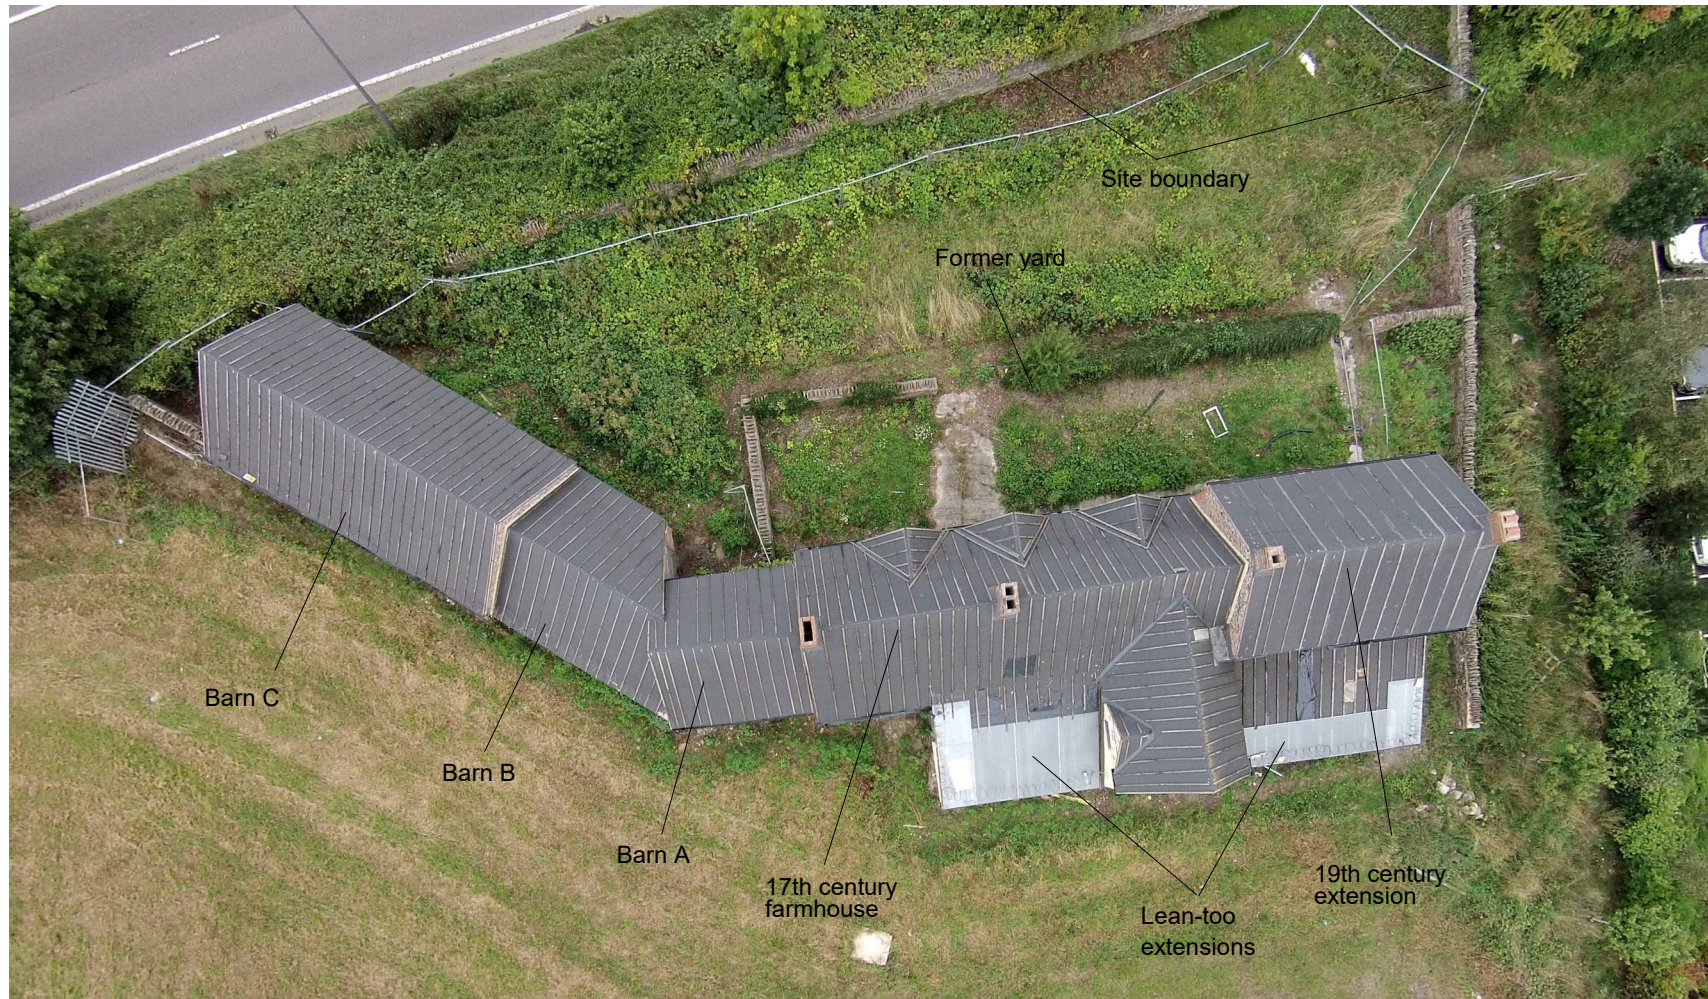
Plate 58: Drone image showing various structural elements of Newlands Farmhouse

The roof is believed to have undergone repair works in 2011/2012 and is currently untiled, covered instead with plywood, polythene and mineral felt (**Plate 58**). Numerous areas of the building also appear to have been repointed and repaired within the last few years.

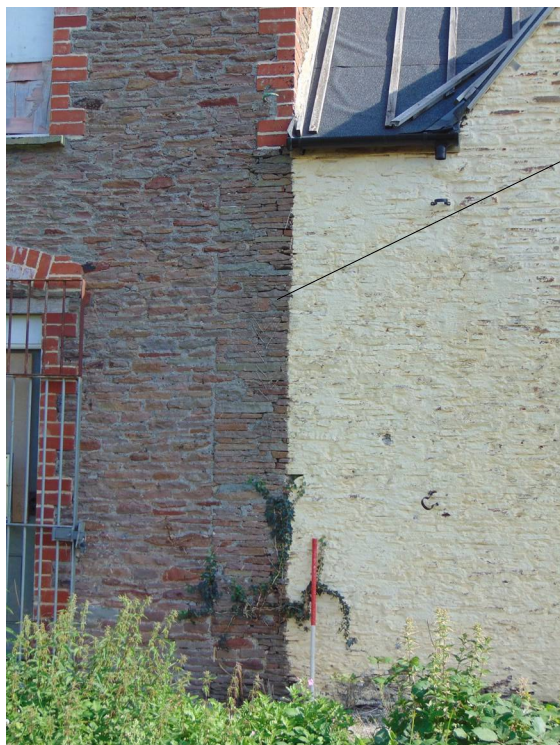
Plate 59: Detail of 17th century stub wall adjoining 19th century extension on south-west facing elevation.

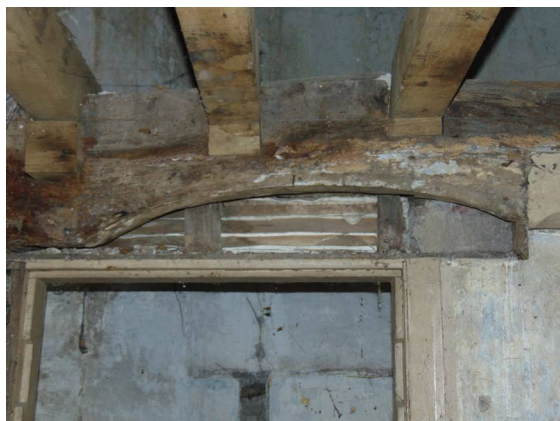
Plate 60: Detail of lintel over former stairway entrance adjacent to the fireplace in room G10.

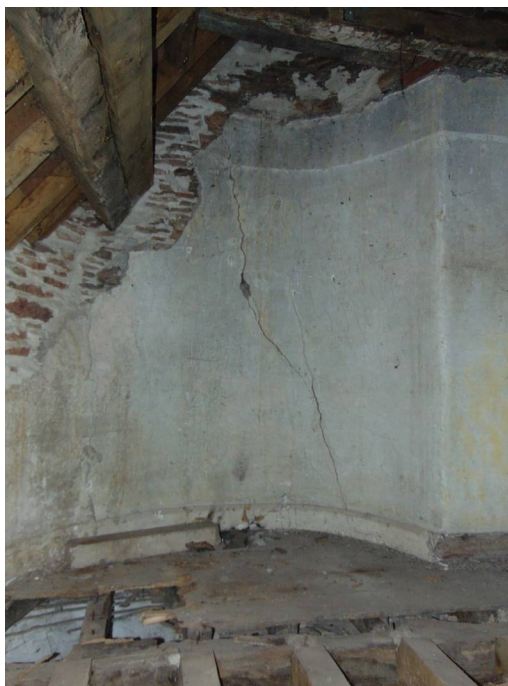
Plate 61: View of curved wall of former staircase in first floor room F5.

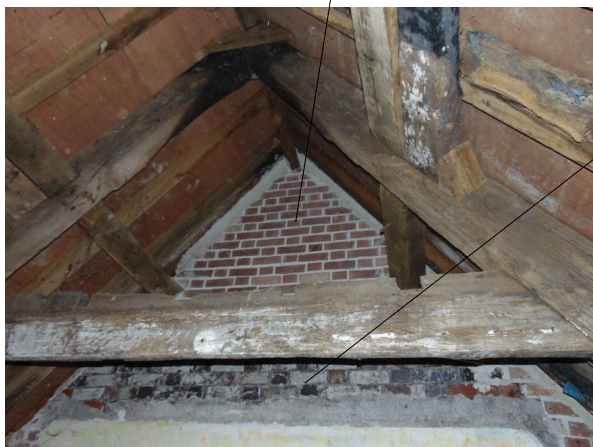
Modern brickwork

19th? Century brickwork

Plate 62: Showing multiple phases of brickwork repair on the partition wall between rooms F4 and F5. Note original beam structure with modern ply roof covering. Looking north-west.

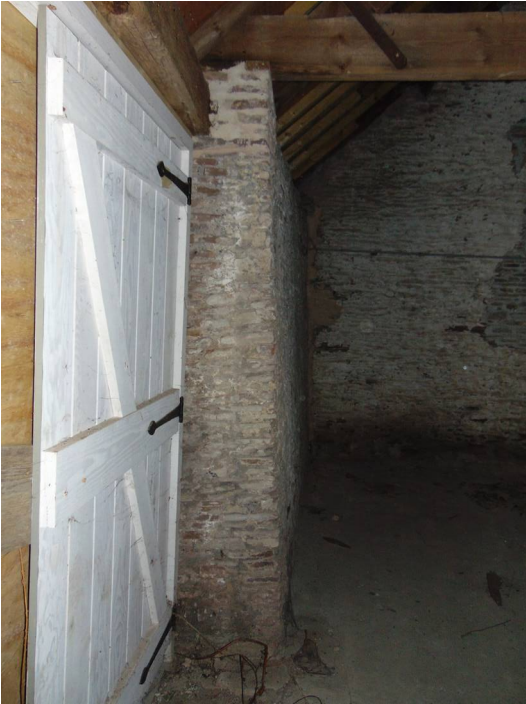
Plate 63: Detail of splayed base in Barn C.
Looking north at western doorway.

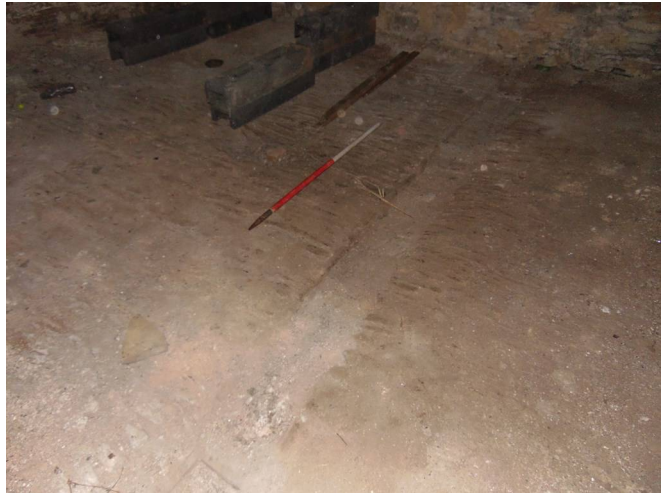
Plate 64: Looking north-east at cobble floor and drain
in Barn A.

Cartographic and structural evidence indicates that Barn A predates Barn B. Internally joist holes for a suspended floor were recorded, although no joists remain, over a horizontal floor beam (**Plates 31 – 34**). On the western elevation a doorway and first storey hayloft opening were recorded (**Plate 31**). On the northern elevation a blocked window, presumably opening onto the original stairway of the 17th century house was seen (**Plate 32**), while on the southern elevation a blocked doorway and window were observed (**Plate 33**). The roof beams appear to be contemporary with the barn however a scar was seen in the northern elevation (**Plate 32**) which presumably indicates that the pitch of the roof was changed at some point. An in-situ cobble floor, with drain (**Plate 64**) was also recorded.

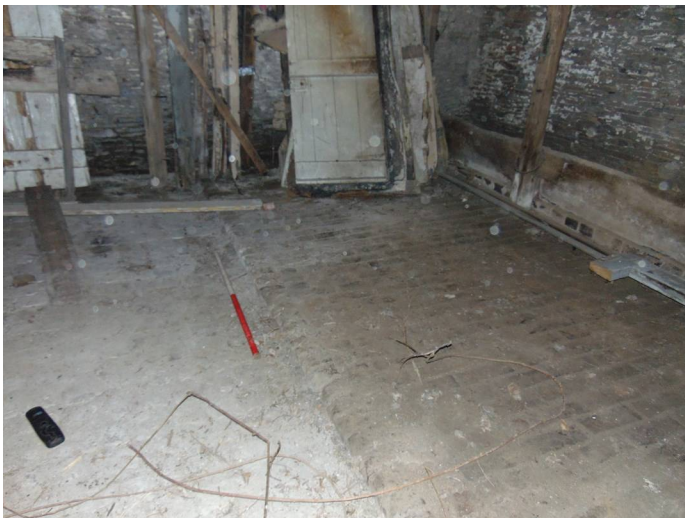
Plate 65: Looking south-west at cobble floor in Barn
B.
