Castle Park Depot, Castle Park, Bristol

Report on Archaeological Evaluation

On Behalf of
Bristol City Council

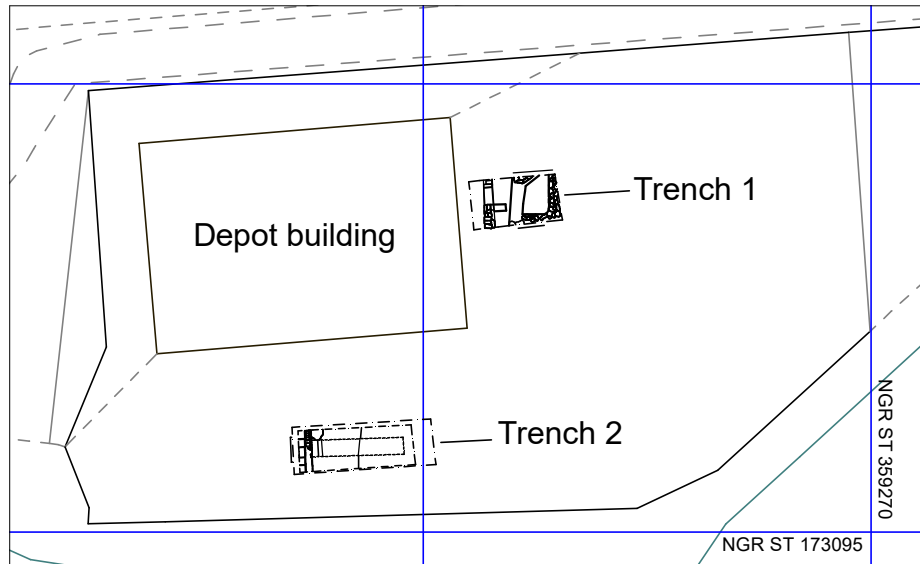
Figure 2

Trench Location Plan. Grid lines at 20m intervals

The aim of the fieldwork was to characterise the buried archaeology of the site, establish its presence or absence, and provide sufficient detail to devise a subsequent mitigation strategy for preserving or recording any significant archaeology that was discovered. The trenches were located around the current depot building, as this is where most of the construction work is planned to take place. Unfortunately, the large number of services in the area prevented the trial trenches from being sited to reflect the location of the planned piles for the development, and instead they were situated where possible between these services. Ultimately, two east-west trenches were excavated, of 4m x 2m and 6m x 2m respectively (**Figure 2; Plates 1 and 2**).

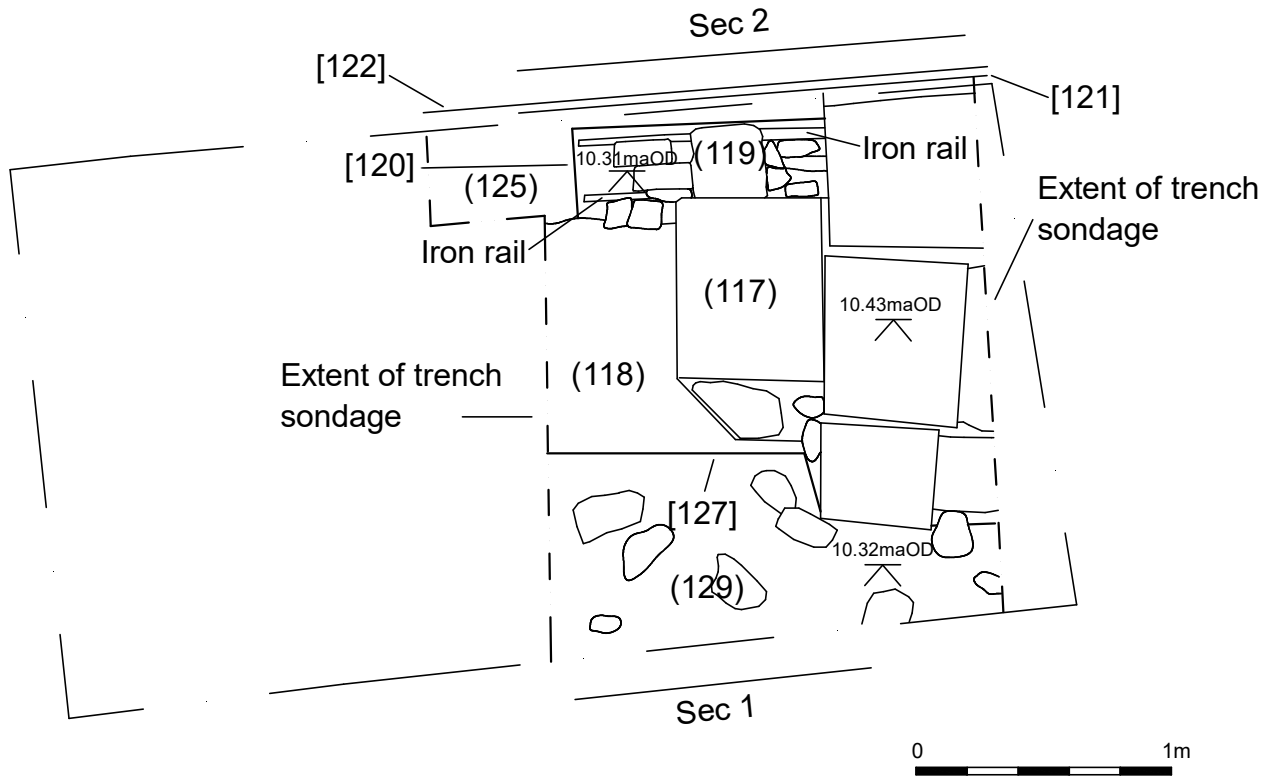
Figure 4

Trench 1. Features recorded in trench sondage

As the archaeological horizon uncovered in Trench 1 clearly dated to the 20th century, it was decided during excavation to dig a large sondage in the eastern half of the trench prior to backfilling, in order to investigate where earlier remains existed below. In so doing, several structural features of 18th – 19th date were uncovered and recorded. Therefore, the Trench 1 plan has been presented in two figures, which mirror the two phases of excavation.

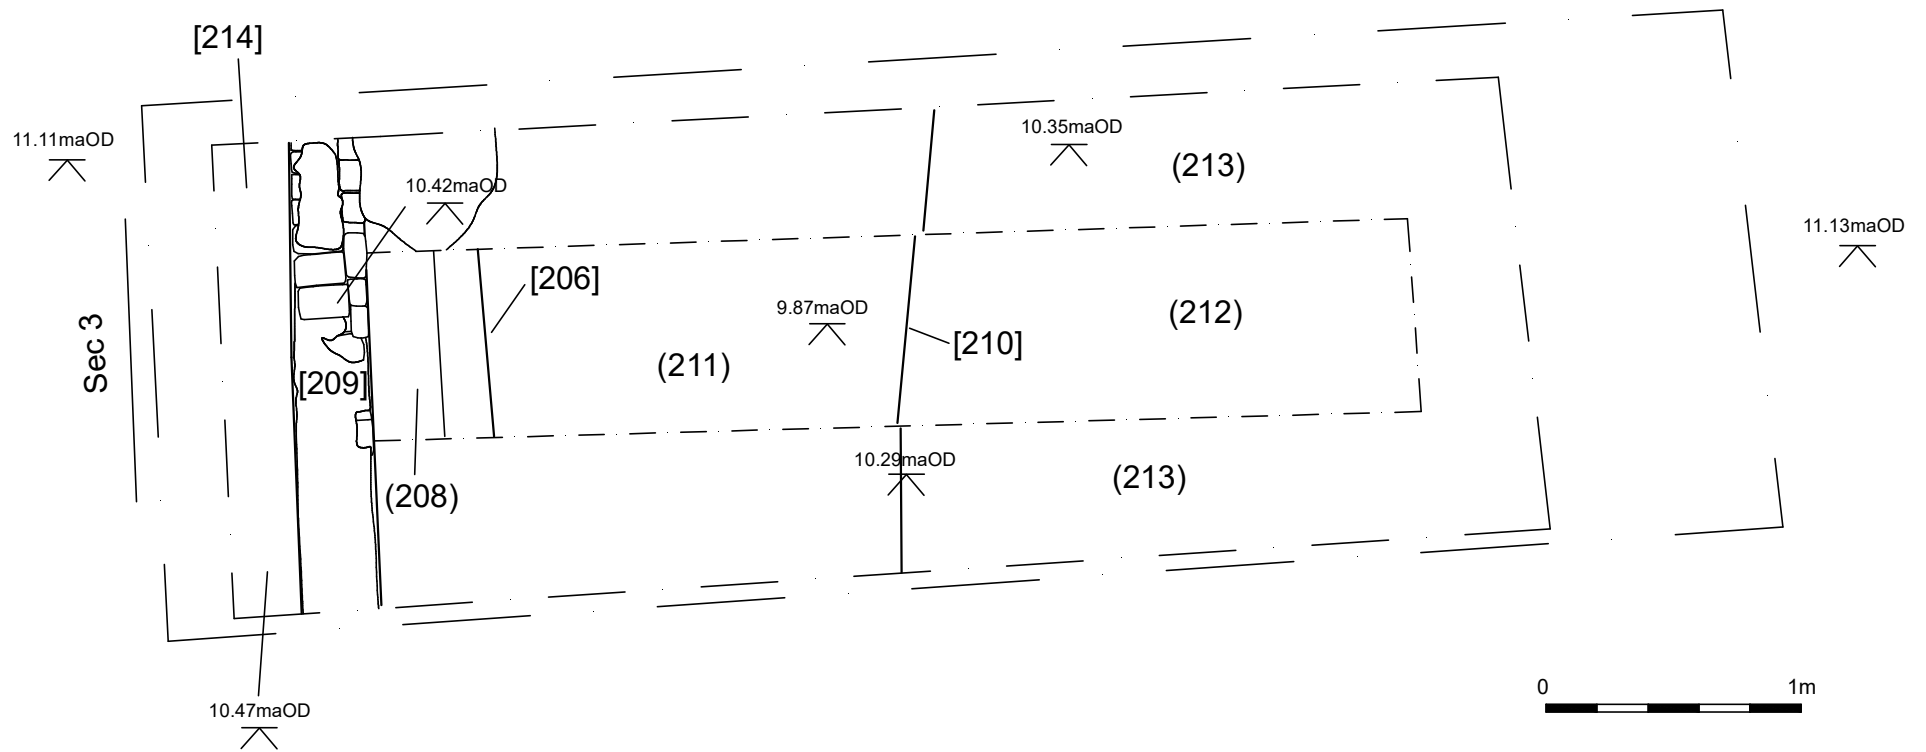
Figure 5
Trench 2

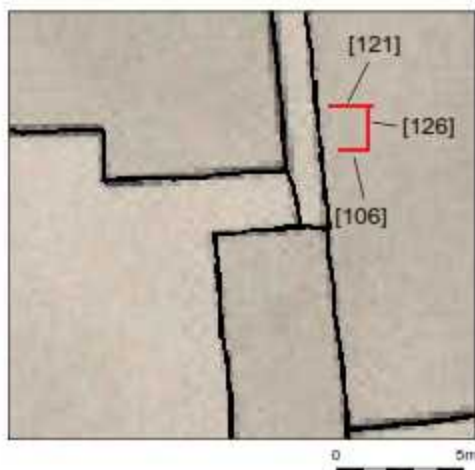
Figure 13

Phase 2 surveyed features overlain onto the 1855 Ashmead map of Bristol, according to the positioning of the map on KYP

Ashmead's 1855 map of Bristol (**Figures 12-14**) suggests that, by this date, [127] had been removed and infilled with (129) in order to make way for a small passageway between nos. 71 and 70. Presumably, this is when [122] was cut by [121], to allow for access to the passageway. In the process, the back yard of the neighbouring no. 70 was extended to the west, whose new boundary wall is probably represented by [126], and a new building was constructed immediately to the south of no. 71; [106] may refer to its northern wall.

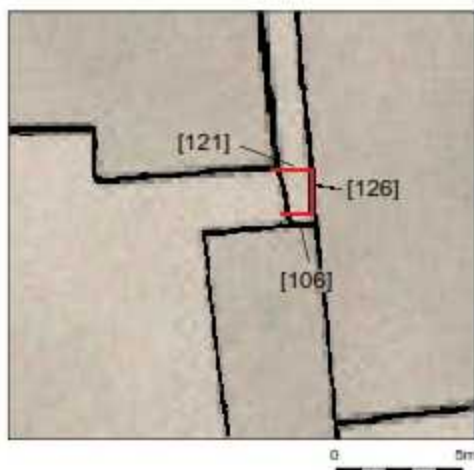
Figure 14

Phase 2 surveyed features overlain onto the 1855 Ashmead map of Bristol, following modifications to the map's positioning

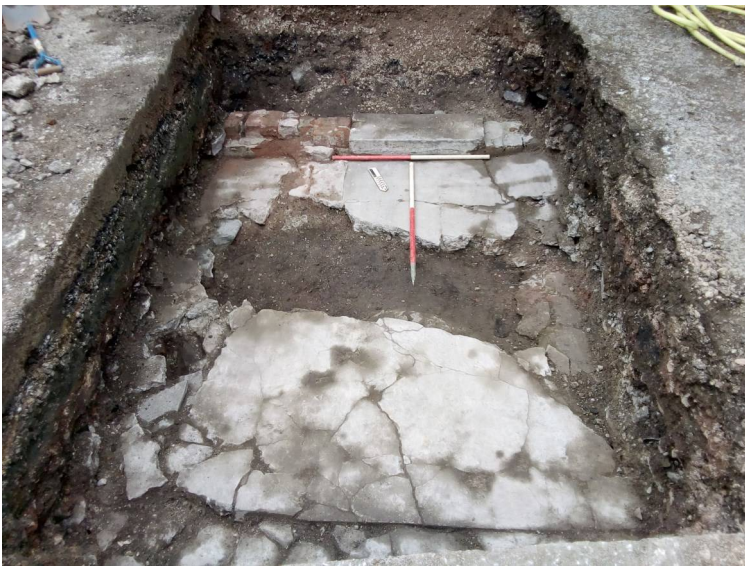
Plate 3. Phase 1 of Trench 1, looking west (north arrow incorrectly placed). 2 x 1m scales

Wall [114] ran north to south and was located at the western end of Trench 1 (**Plates 3** and **4**). It was of modern red brick construction and incorporated large stone or concrete slab (115). This had small squared notches carved at either end, indicating that it formed part of a doorway. It was respected by surface (104).

Cut [109], as stated, was seen as a disturbance in modern surface (104) and was filled with quite loose rubble and demolition material (**Plate 3**). However, once (104) and the made ground it rested on was removed as part of Trench 1's sondage, no cut for [109] could be seen at the reduced ground level. Unlike [106], it did not appear to truncate (118), nor did the sondage's western section show any indication of a structure or a cut. Although the western side of [109] does align nicely with an outhouse wall shown on the 1885 Town Plan, it is believed more likely that it reflects a post-war area of particularly unstable ground. (104)'s collapse into this unstable ground may have created the appearance of a cut, when in fact there never was one.

During excavation, cut [111] was thought to be a possible drainage feature related to surface (104) (**Plate 3**). The evidence now suggests that it was merely another misleading area of (104) collapse and is not a feature at all. [113] may represent a small section of east-west wall which abutted [114] – maybe part of an internal room division – but may also be merely a part of (104)'s construction.

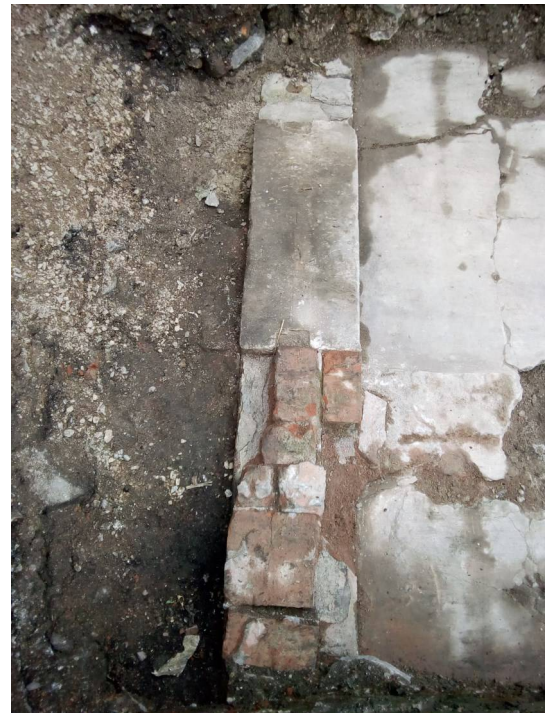
Plate 4. Wall [114], possible door step (115), and concrete floor (104), looking north

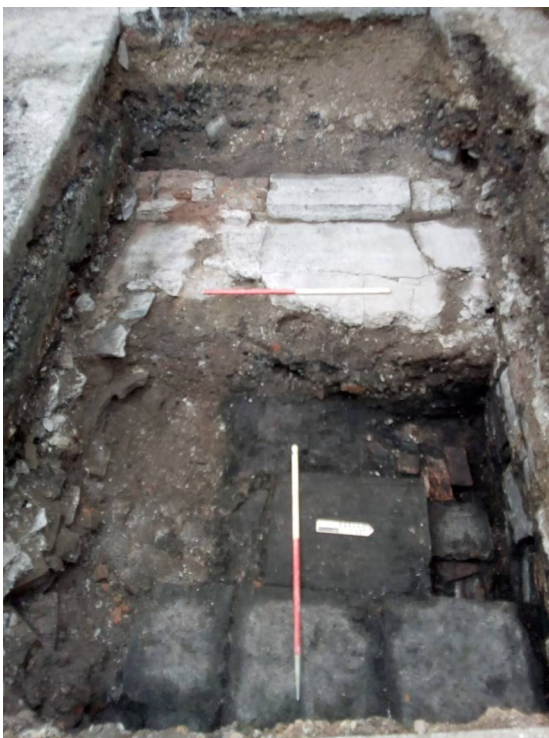
Plate 5. Phase 2 of Trench 1, looking west. 2 x 1m scale

The purpose of [120], running east to west along the northern side of Trench 1, is unclear (**Plates 5** and **6**). It contained a deliberately laid ceramic pipe, capped by red bricks and small stone slabs, and was flanked along its northern and southern sides by what appeared to be iron rails. It terminated at roughly the same point as the western side of [121], appearing to sit directly on top of, or in a very shallow cut truncating, deposit (125), and was overlain by deposit (118). Although

Cut [127] was located along the southern side of the trench and was revealed during the excavation of Trench 1's sondage (**Plate 5**). It ran east to west and was filled with demolition deposits. Survey data demonstrates that it extended further north than [106], being 0.8m wide, whilst [106] was only 0.4m wide at its maximum. It formed an irregular dogleg shape and was probably respected by (118). On site, it was interpreted as a modern truncation by a culvert or similar. However, comparison with historic maps suggest that it is in fact the cut for an 18th century wall, robbed out and infilled to create a passageway during the 19th century.

Flagstone floor (117), uncovered at the eastern end of Trench 1, overlaid deposit (118) and cut [120], and appeared to respect cut [106] and walls [121] and [122] (**Plates 5 and 6**). It probably continued into section to the west.

(125) is thought to represent the earliest archaeological deposit found (**Plates 5, 6, 9 and 10**). It consisted of a fairly plastic, light brown sandy silty clay, and was seen along the northern side of the site, and was truncated by [122]. It contained frequent shell fragments and small stones and occasional charcoal and clinker, and is thought to be post-medieval in date.

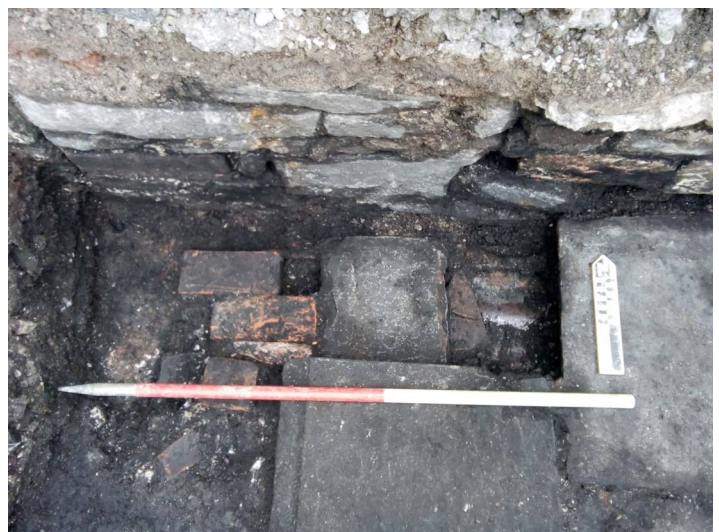
Plate 6. [120], [121] and (117) in plan, looking north. 1 x 1m scale

Wall [121], ran east to west along the northern side of Trench 1 and was also seen only in Section 2 (**Plate 6** and **8-10**). It was ultimately revealed to be a cut through and later infill of earlier boundary wall [122]. Although mostly infilled with neatly-hewn stones, two red bricks were also seen. Its mortar was dark in colour, which, along with cartographic evidence, suggests a 19th century date. It was overlain by a narrow band of made ground, (131), upon which rested modern surface (104).

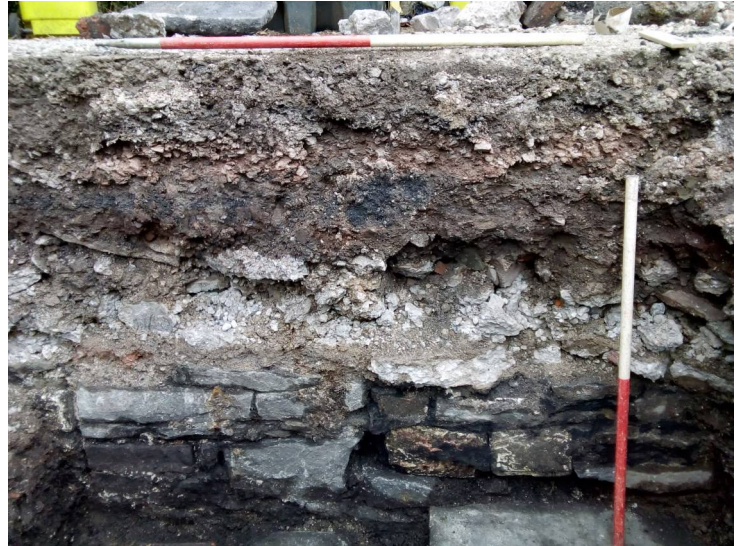
Plate 8. Section 2, looking north. 2 x 1m scales

Wall [122] was an east-west wall, probably of 18th century date, only seen along the northern side of Trench 1, in Section 2 (**Plates 8-10**). It was constructed of large, neatly-hewn stones and white

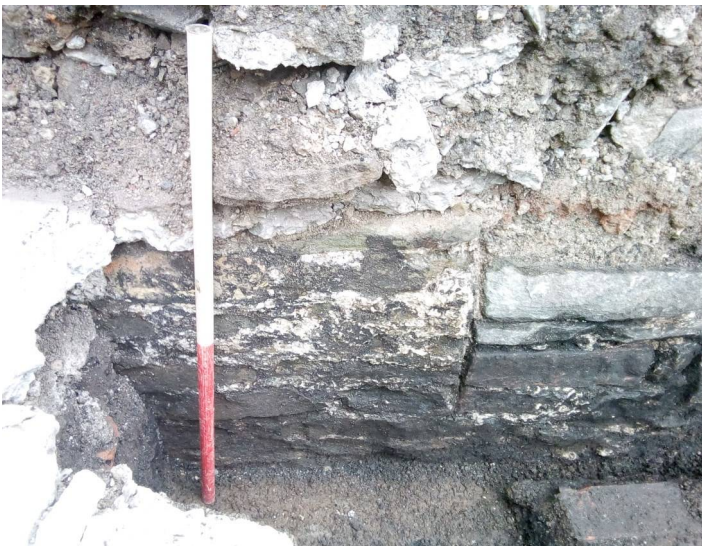
Plate 9. Sondage revealing westerly continuation of wall [122] in Trench 1, looking north. 1m scale

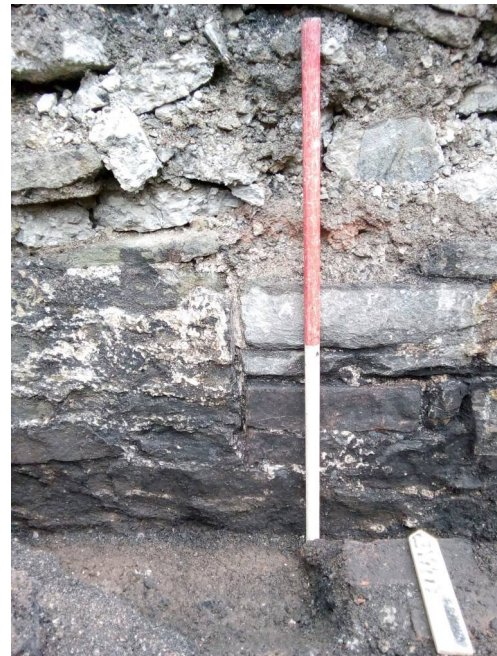
Plate 10. Detail of relationship between walls [121] and [122], looking north. 1m scale

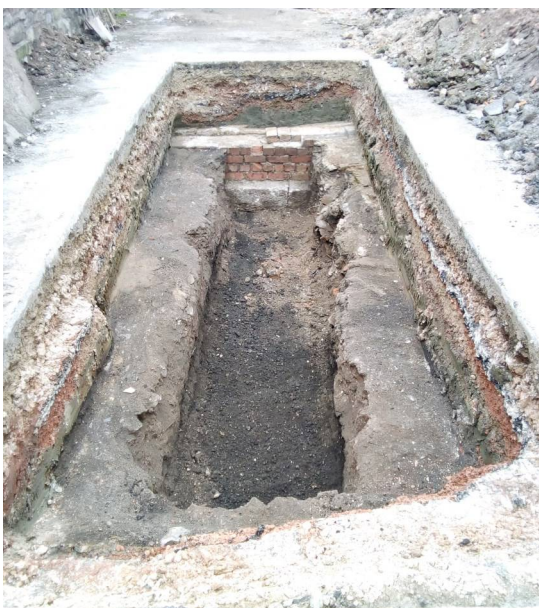
Plate 11. Post-excitation shot of Trench 2, looking west. 2 x 1m scales

Stone wall [214] and red brick wall [209] ran in parallel, from north to south, and abutted one another (**Plates 11-13**). Both are thought to be of 20th century date but [214] is presumed to be earlier, with [209] forming a later supporting wall. Concrete block (208) served as the foundation for this latter wall.

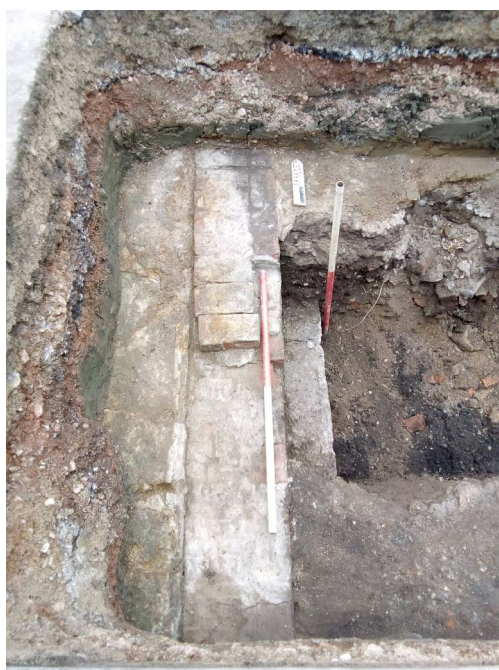
Plate 12. [114] looking north. 2 x 1m scales

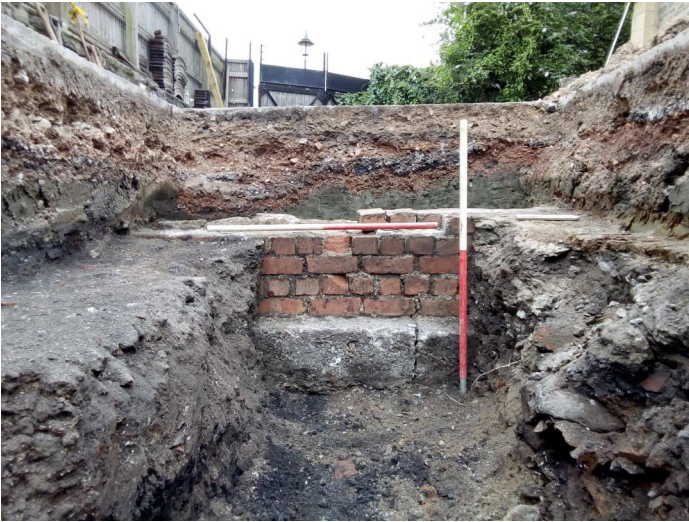
Plate 13. Section 3, looking west. 2 x 1m scales.

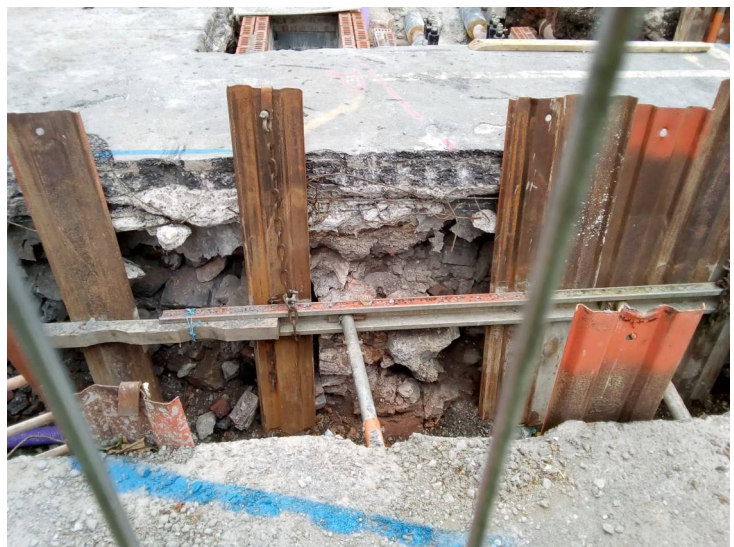
Plate 16. Probable 17th century wall seen in section of Castle Street/Queen Street roadworks, to the east of the study site, looking south
