South Bristol Link Road Project: City of Bristol and North Somerset

Report on Archaeological Watching Brief

Avon Archaeology Limited

Bristol: January 2016

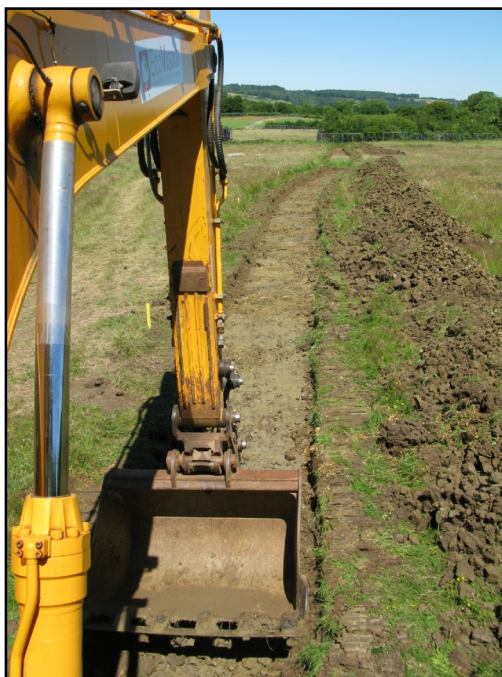
Excavation of hedgerow receptor trench, view to north from its southern termination point at OS NGR ST 56079 68749. This is between chainages 2300 and 2400, in Section 3 of the road corridor, south of the A38.

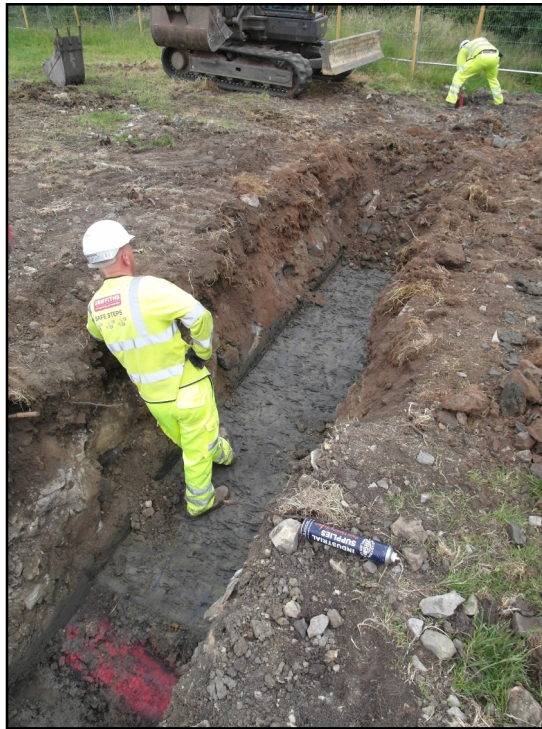
1. View to north-west showing dark grey, natural Lias clay in base of newly-cut service trench, Section 5, chainage 4150.

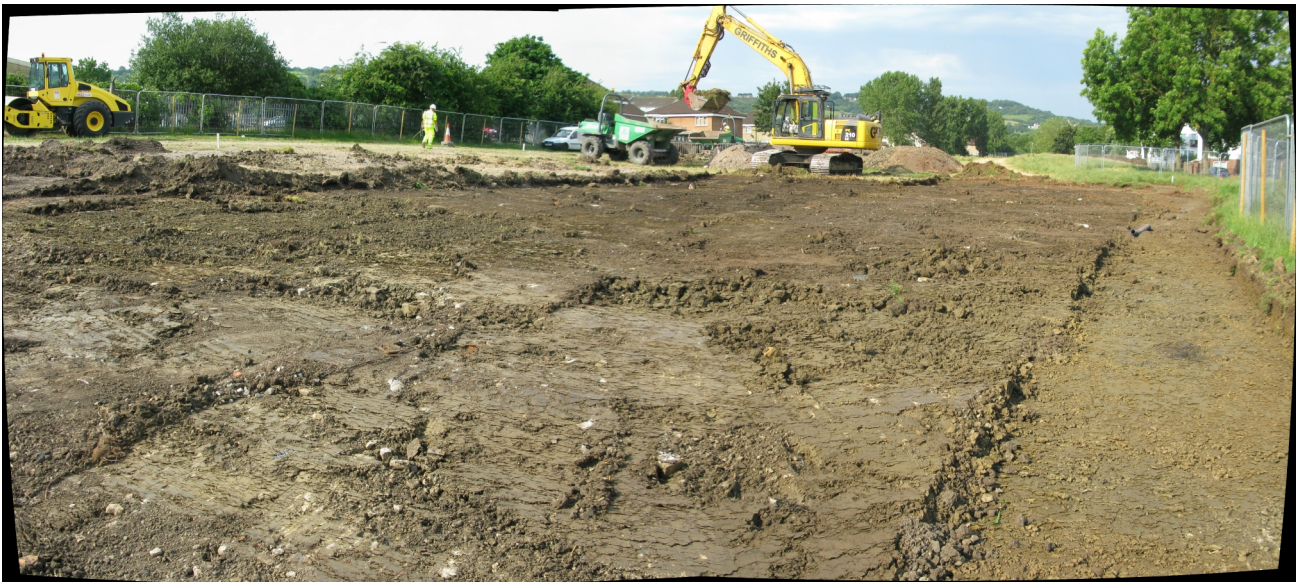
2. Section 5, composite view to south-west from around chainage 4150, west of Hareclive Lane, Bishops-worth. Topsoil stripping in progress.

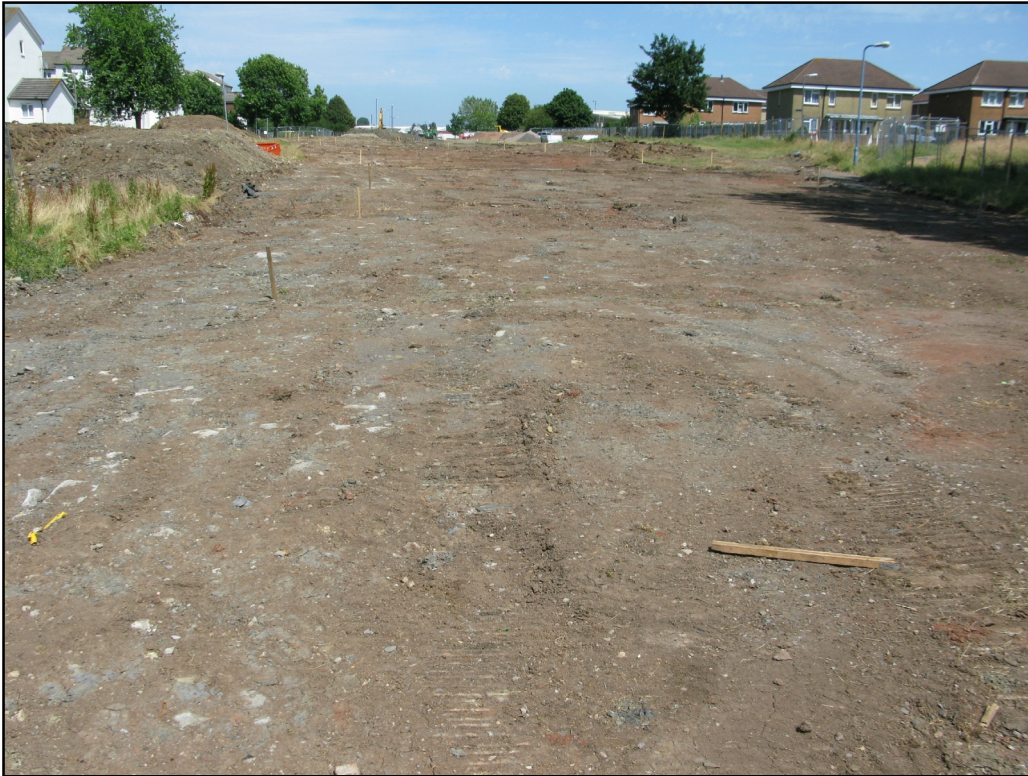
3. View to east-north-east from about chainage 4000, looking back towards Hareclive Road (ST 57346 68309). Showing stripped surface tracked over by vehicles.

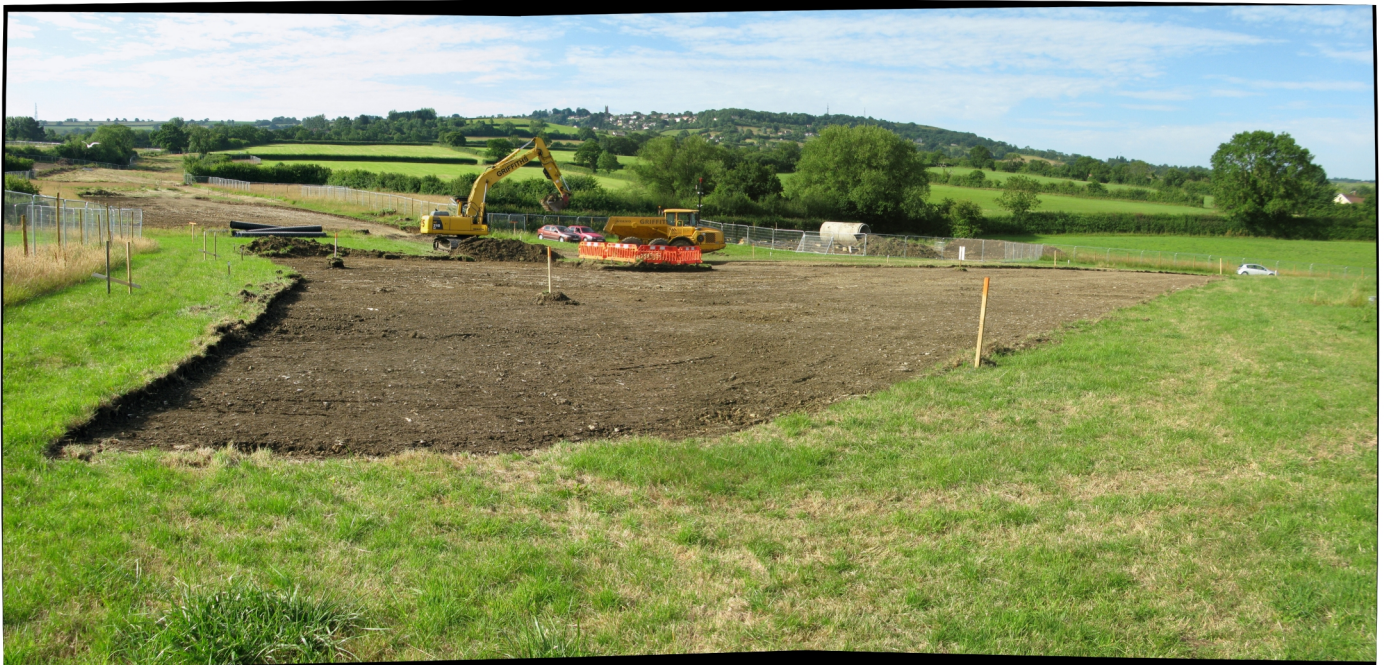
4. Composite image looking south, topsoil stripping of a large area on the south-western side of the new roundabout site, immediately south of the A38, and in the vicinity of chainage 2100. The tower of Dundry church can be seen in the background, and closer to the camera, to the right of the dumper, the site of the new artificial badger sett marked by a section of large-diameter concrete culvert.

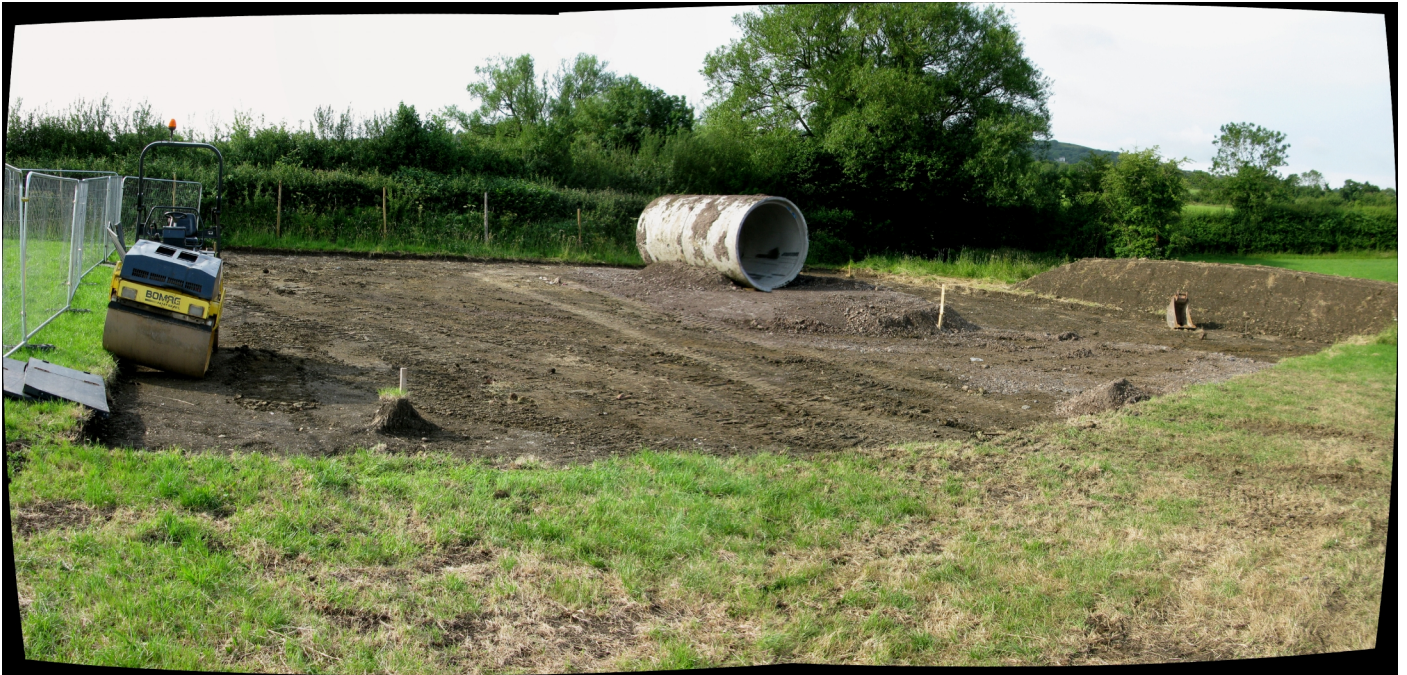
5. Composite detail of the site of the artificial badger sett, following topsoil stripping. View to south. Centred on NGR ST 55913 68922.

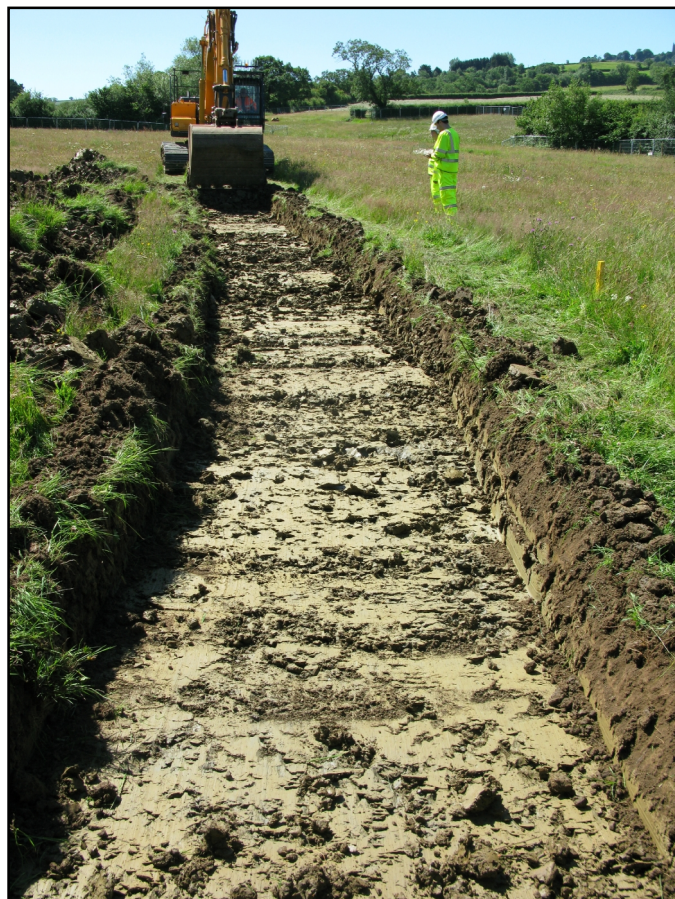
6. Excavation of receptor trench for transplanted historic hedgeline (see also **Plates 7** and **8**). View to south from north end, at NGR ST 56041 68855. Depth from turfline is about 0.45m, exposing the natural Lias clay.

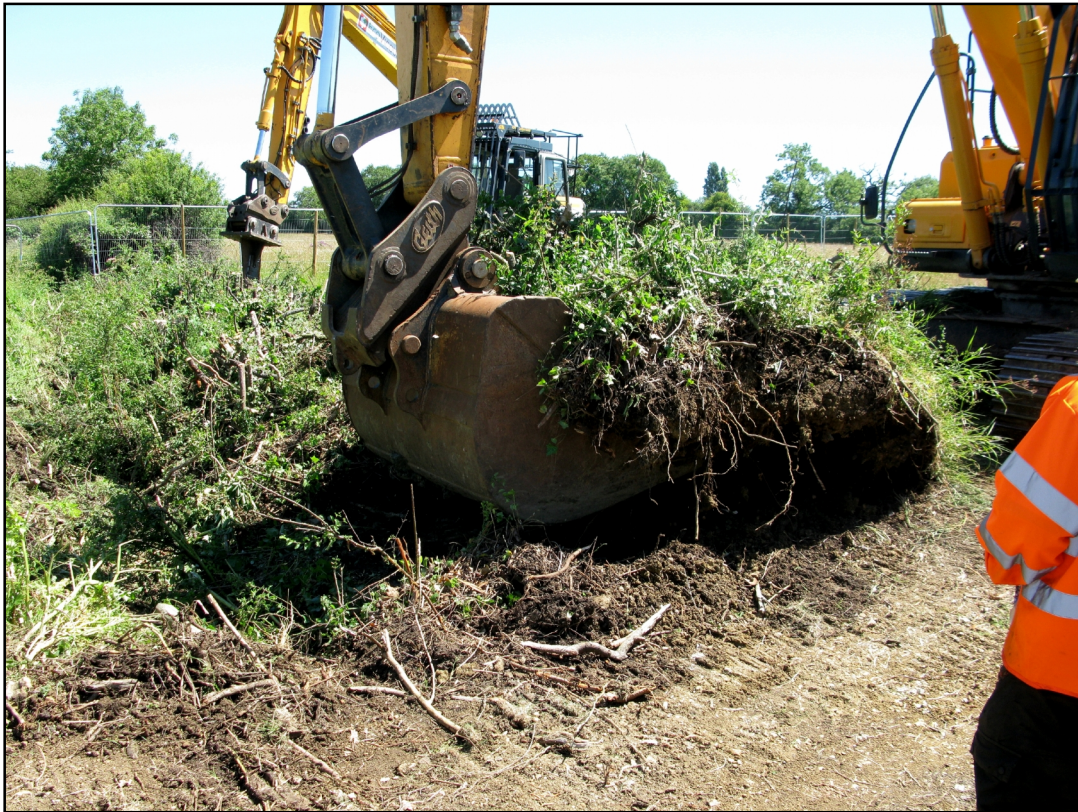
7. Removal of historic hedgeline for transplantation in receptor trench, at NGR ST 55963 68934, close to chainage 2100. View to north-east. See also **Plates 6** and **8**.

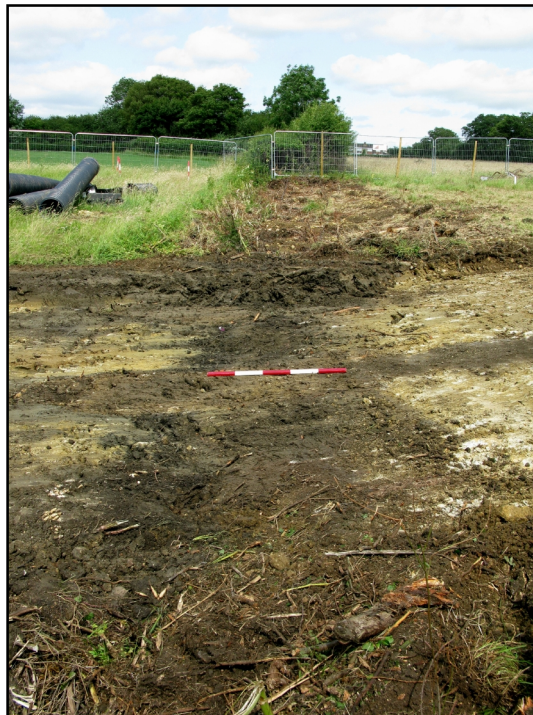
8. Former field boundary following removal of part of historic hedgeline for replanting in receptor trench. Taken from roughly the same position as **Plate 7**. View to north-east. The scale (1m) sits on top of the ditch running parallel to the hedge on its north-western side.

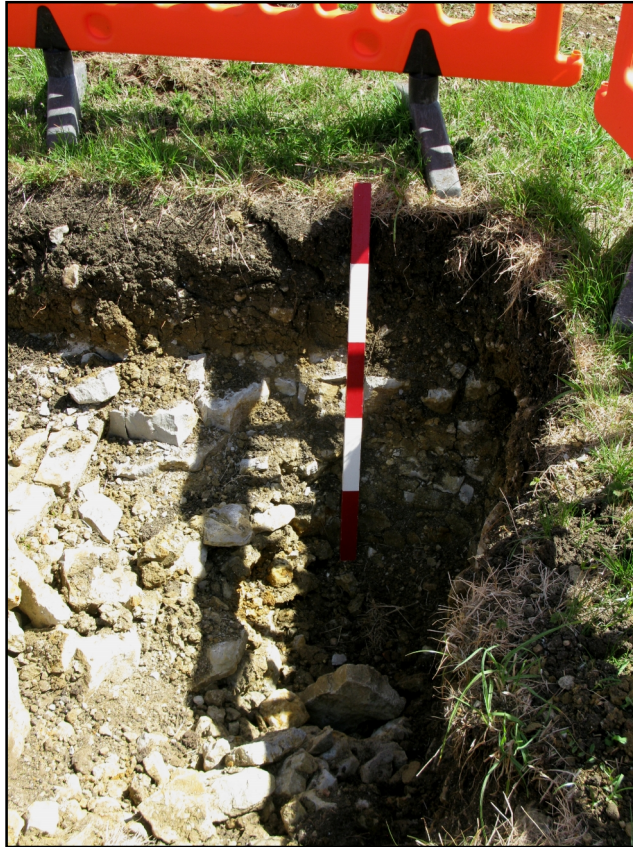
9. South-west facing section in geotechnical test pit close to chainage 2100, at NGR ST 55945 68962. This shows weak or non-existent subsoil formation, the turf/topsoil layer sitting virtually straight on top of the Lias limestone and clay formation. Scale: 1m.

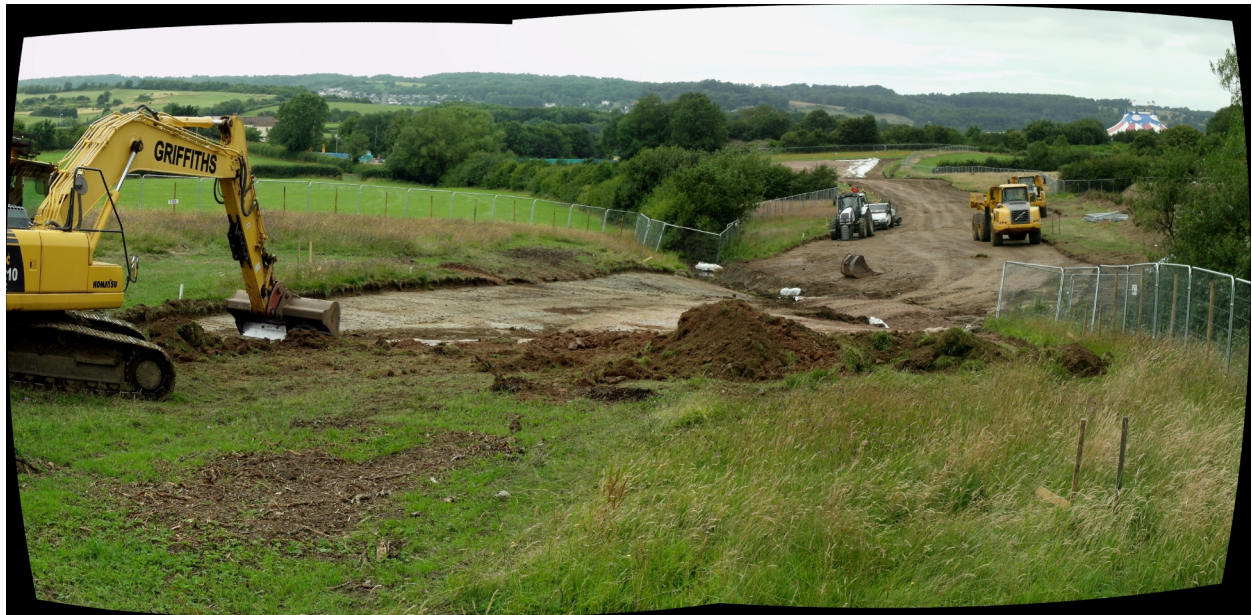
10. Composite view to north-west from close to chainage 2400. The road corridor is seen fully stripped up to this point, and north-westwards back to the A38. The easement breaches a hedgeline, and a small stream, which formerly ran across the middle right of the frame, its course marked by three pieces of white terram. The breach is at NGR ST 56109 68749.

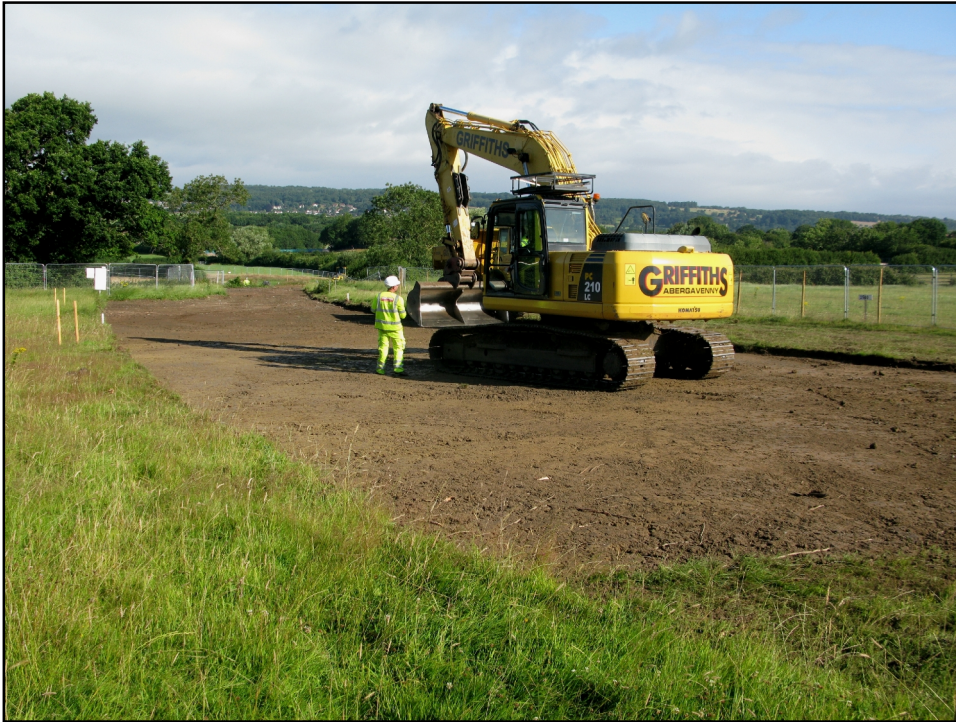
11. View to north-west from close to chainage 2550, NGR ST 56165 68613. This represented the most south-easterly extent of the continuous main road corridor strip that was monitored. There was some subsoil development here, but the turf and topsoil strip barely penetrated the upper surface of it.

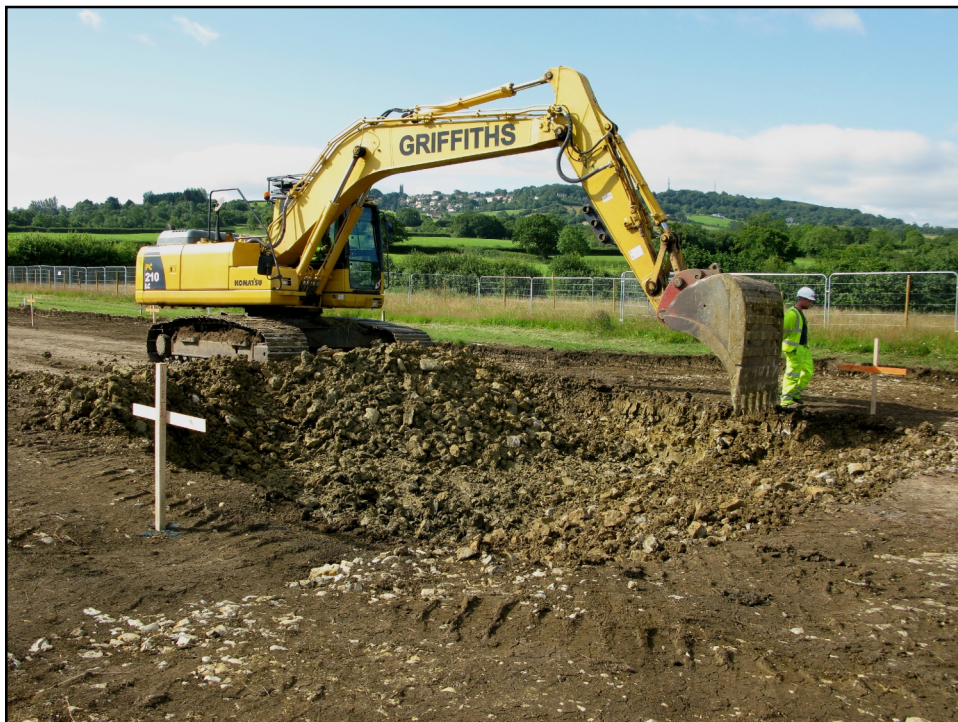
12. View to south-west from just south of chainage 2150, at NGR ST 55981 68914. Showing machine with toothed bucket engaged on level reduction for the road surface itself, and penetrating well into the Lias clay and limestone natural. The tower of Dundry church is visible on the ridge in the background, just below the arm of the machine.

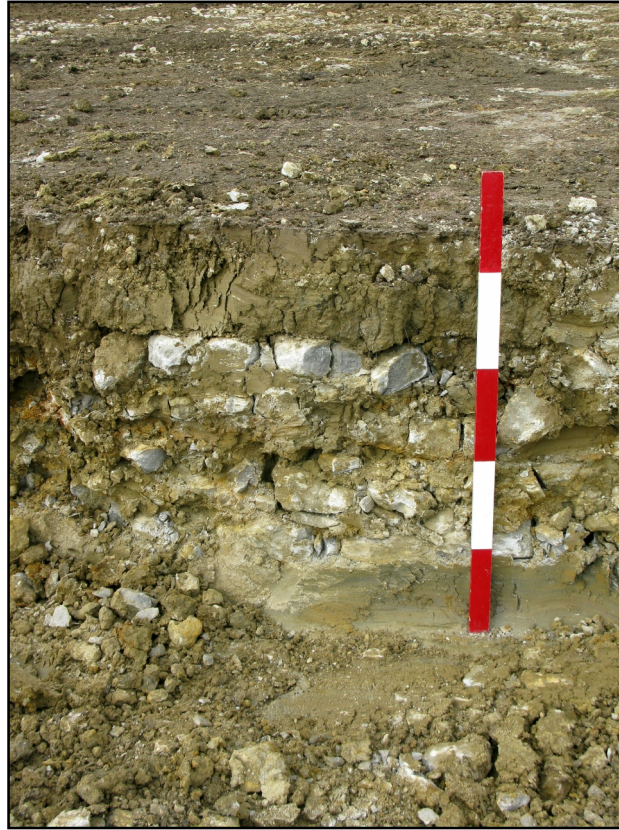
13. East-facing section of full road reduction immediately south of chainage 2150 (see also **Plate 12**). About 20-30cm of turf/topsoil had already been stripped. The repeating sequence of Lias clay and limestone is very clear. Scale: 1m.

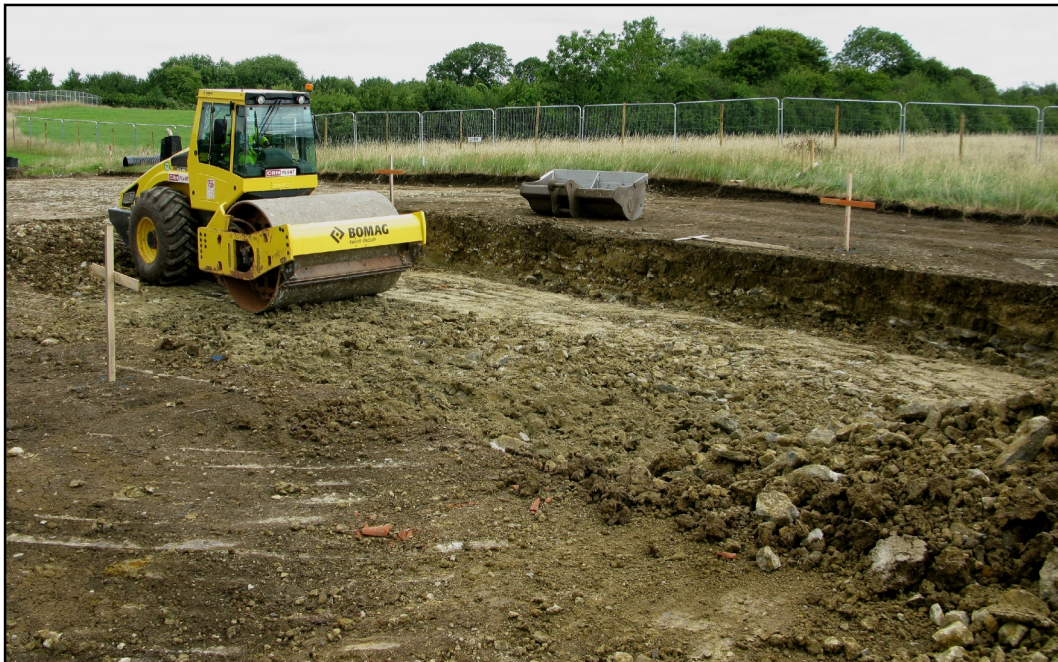
14. View to north-east from close to chainage 2160, showing rolling of dumped aggregate in progress at the road formation level.

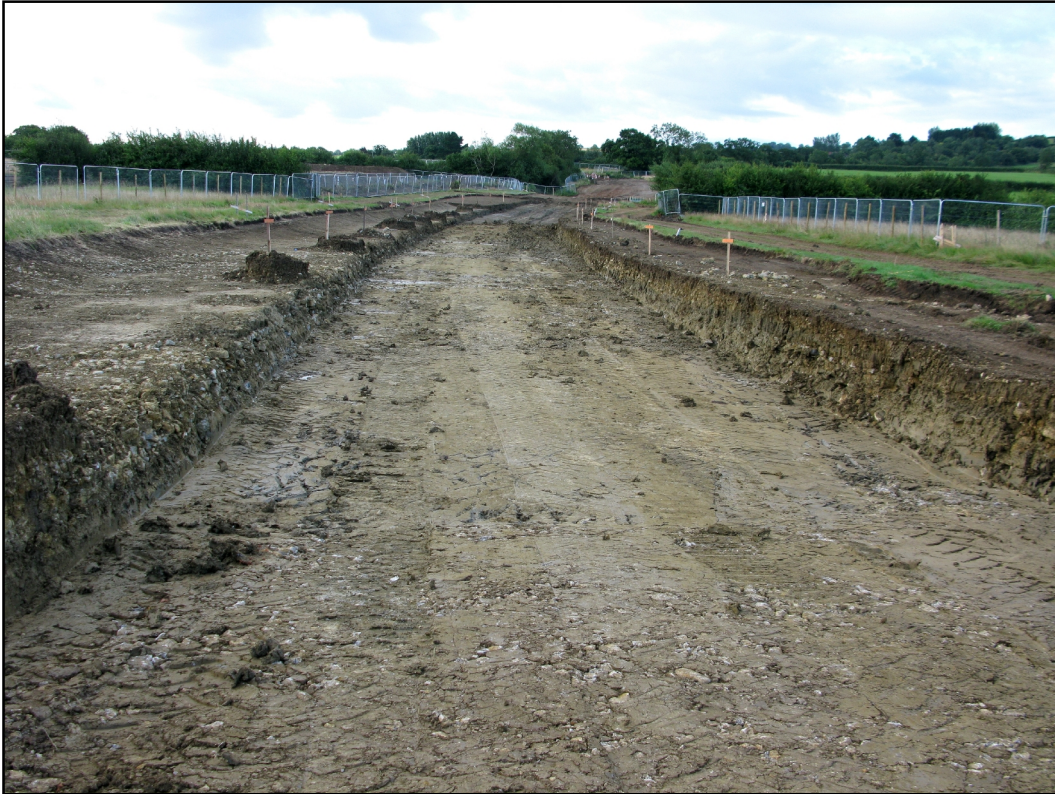
15. Base layer of rolled aggregate completed. View to south from NGR ST 68912.

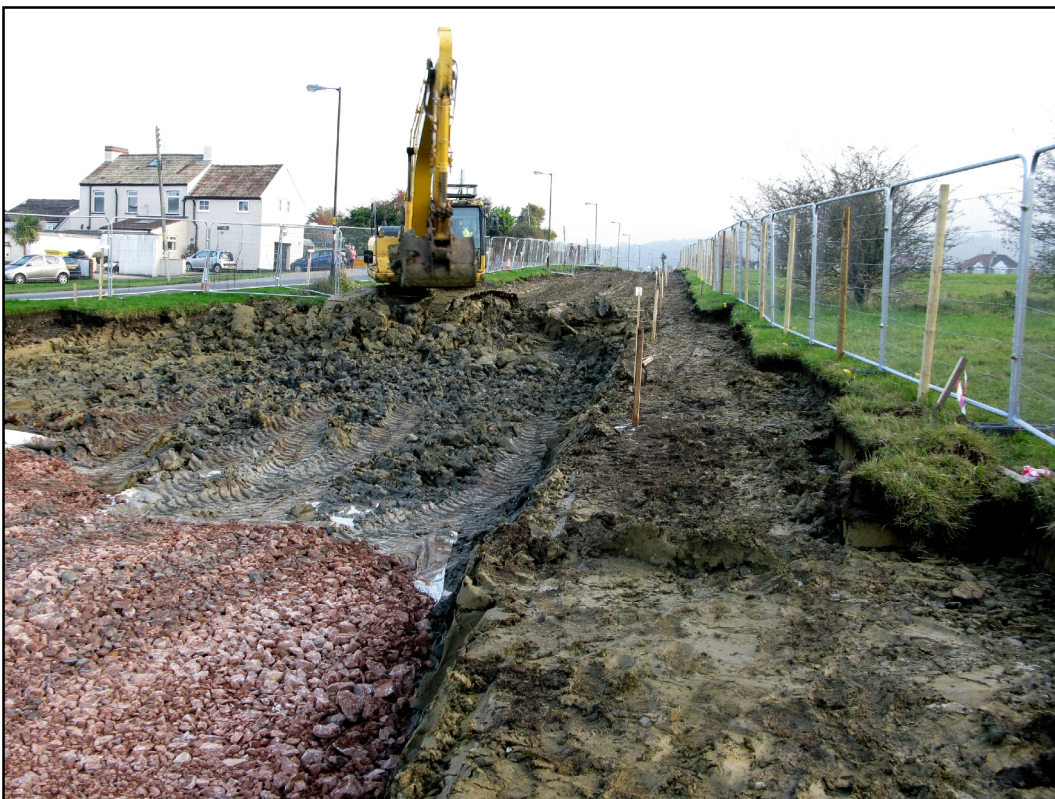
16. View to south-east from NGR ST 56404 68496, close to chainage 2800. Turf and top-soil strip already completed, reduction to the road formation level underway, using a toothed bucket.

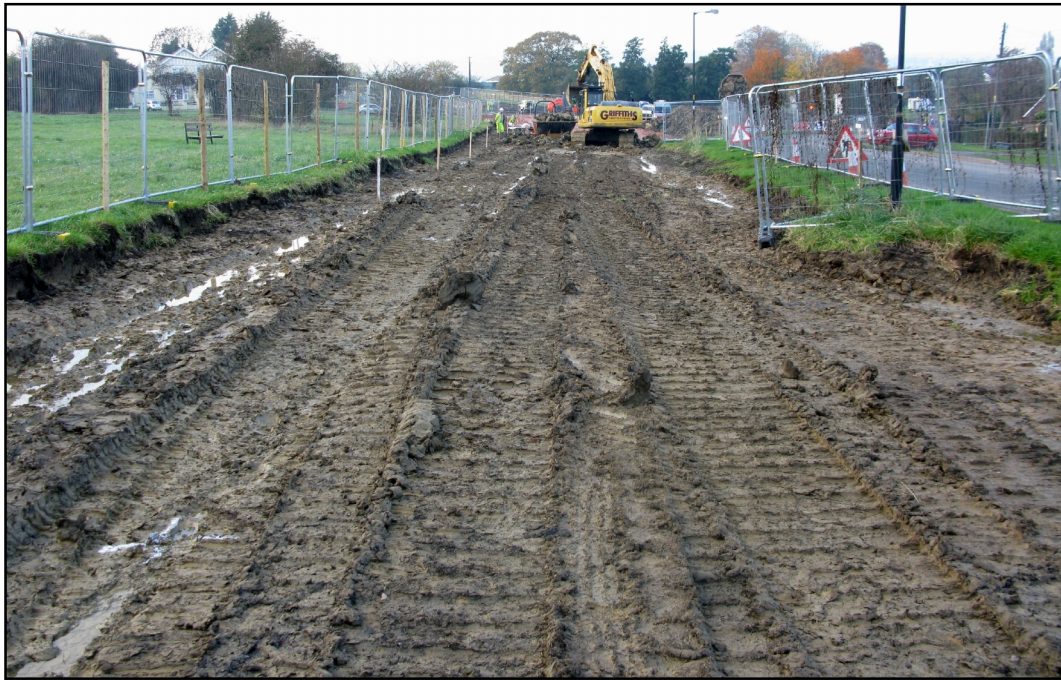
17. View to north-west from close to chainage 3050. The ground can be seen to be heavily tracked by vehicles. The road that can be seen running parallel to this stretch of new easement in the top right of the frame, is Highridge Green.
