Nos. 14-16, Duncombe Road, Speedwell, Bristol

Archaeological Watching Brief

By Sarah Newns

Avon Archaeology Limited

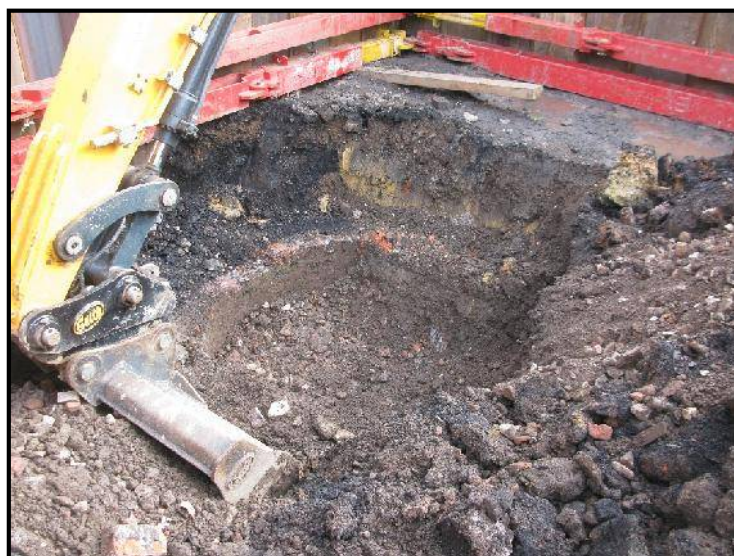
Cover

Top of brick-lined mineshaft (Context 104) at northern edge of site from south-west, showing sheet piling to rear (Trench 1).

The brick-lined mineshaft revealed in the initial groundworks (see **Cover Photo** and **Plate 3**) was encountered at a depth of some 900mm below the current ground surface (at 85.53m aOD, Ground Investigation 2015, figure 1). The shaft was constructed of red bricks, laid side by side, bonded with a light grey lime mortar. The shaft measured some 3m (10') in diameter and was at least 4m deep. The upper part of the shaft was backfilled by modern demolition rubble (Context 106) to a depth of at least 3m. The shaft itself was located within a steep-sided cut (Context 108), which truncated the yellow clay natural substrate. The lower fill of the shaft (Context 110; **Plate 5**), recorded between 3m and 3.7m below the current ground surface, was composed of demolition rubble (ceramic building material), clay and some coal, within a loose silty matrix.

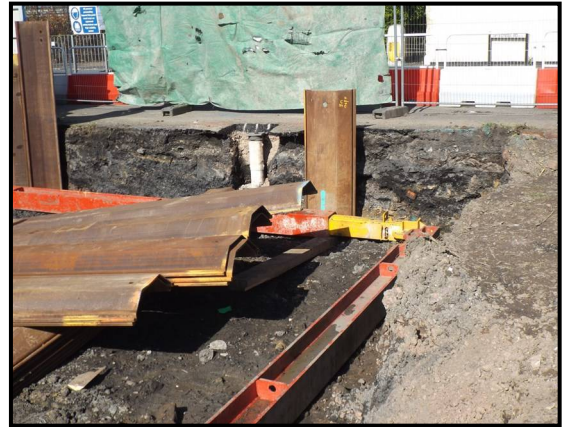
Excavation of Trench 1 revealed a relatively straightforward sequence of deposits, with a modern tarmac/bedding layer (Contexts 100/101) overlying a mixed grey/black deposit of silty clay with frequent ceramic building material fragments and small stones (Context 102), which in turn overlay the natural yellow clay substrate (Context 103), which was encountered at a minimum depth of approximately 1m below the current ground surface. The natural yellowish grey mudstone was revealed at a minimum depth of 2.7m below the current ground surface (between 83m aOD and 84m aOD (**Plate 5**)).

2. Trench 1 during insertion of sheet piles, showing south-facing section, to a depth of 1.2m.

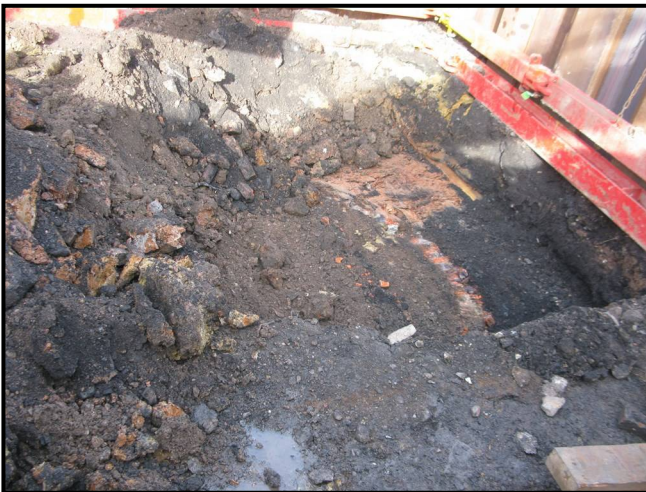
3. Trench 1 during excavation, from south-east, showing Cut [108] with Fill (107) to right of frame, and northern edge of Shaft (104).

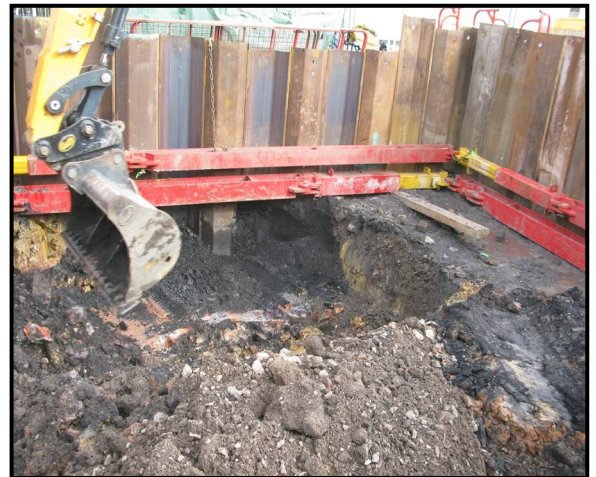
To the north-east of the mineshaft, the backfill of Cut 108 was visible as a loose black deposit (Context 107), consisting largely of coal fragments, coal dust and mudstone fragments. The cut was visible in both the south-facing and the west-facing sections of the trench (**Plates 3 and 4**). Cut 108 measured over 7m east-west when first visible, at a height of 900mm below the current ground surface, tapering to approximately 3m wide at a height of 3.7m below the current ground surface. **Plate 4** shows that the southern edge of the cut bowed out slightly to the south. As recorded, the cut measured over 1m north-south and was over 1.8m deep. It is likely that it represented the cut for mineshaft 104.

4. North-east corner of Trench 1, showing Cut [108] with Fill (107), in south- and west-facing sections.

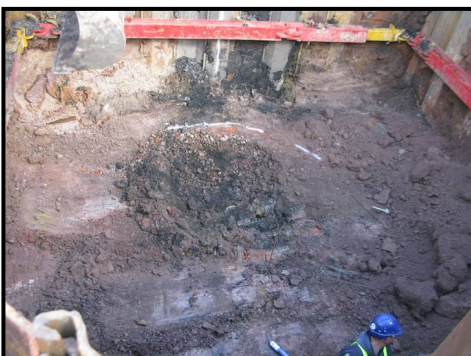
5. Base of Trench 1, showing Fill (110) and Mudstone (109), from south-west.

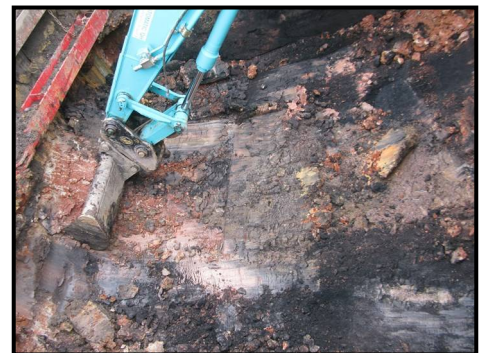
The possible backfilled mineshaft recorded in the Ground Investigation Ltd excavation (GI 2015) was recorded at a depth of some 2m below the current ground surface (approximately 83m aOD). At this depth, the feature (Fill 204, Cut 205) appeared to be an irregular ovoid shape in plan (**Plate 6**), truncating the natural mudstone substrate (Context 203) and was filled with a soft, mixed dark brown/black silt, with orangey clay smears and coal smears and rare medium/large stones. The feature was waterlogged at this depth, and, in fact, the previous GI test pit at this location (TP 1) had had to be abandoned due to water ingress (GI 2015, 8). The dimensions of the feature were extremely difficult to estimate due to ground conditions (**Plate 6**), but it is thought that it measured, in plan, at the base of the trench, some 2-3m east-west by 2m north-south.

6. Base of Trench 2, from north, showing Cut [205], Fill (204), truncating Mudstone (203).

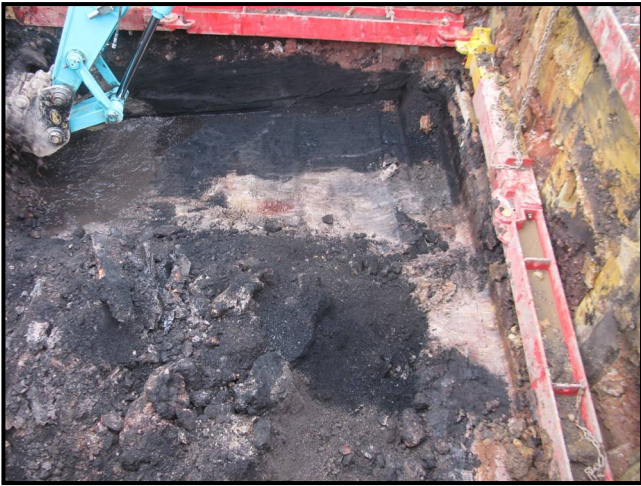
To the north and south of this feature, excavation revealed irregular black coal deposits (Contexts 206 and 208). Context 206, which was visible in the base of the trench and in the north and west-facing sections (**Plate 7**) consisted of a clean black coal-dust deposit, which was waterlogged where it occurred in the base of the trench. Towards the east edge of the trench, excavation of the deposit revealed waterlogged timbers, consisting of both unworked timber uprights and roughly hewn planks (**Plate 8**). Estimated dimensions of these fragments give an approximate maximum length of less than 2m for the timber uprights, and plank fragments of maximum 0.5m long by 0.2m wide. It is likely that Deposit 206 was located within a horizontal cut [Context 207], visible in the north-facing section of Trench 2 (**Plates 7 and 8**), which measured over 6m east-west, by over 1m north-south by over 0.75m high. A further black coal deposit (Context 208) was observed to the north of Cut 205, possibly more ephemeral and irregular, measuring approximately 1.5-2m east-west by 1m north-south and was of unknown depth (**Plate 6**).

7. South-west corner of base of Trench 2, showing black coal deposit (206) within probable Cut [207].

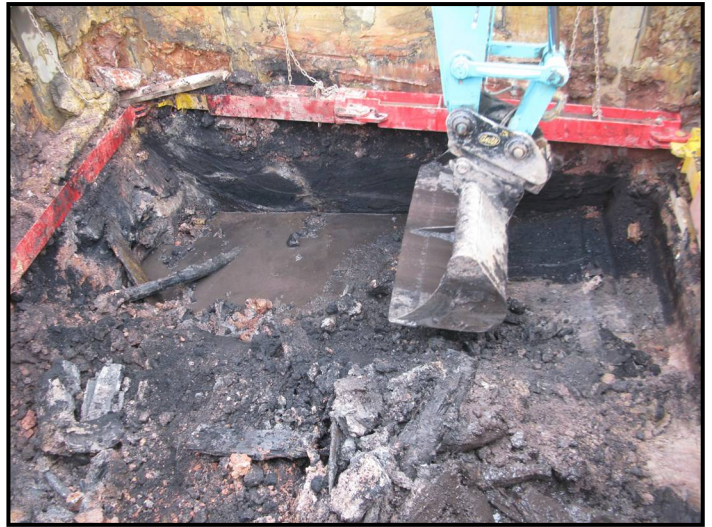
8. Waterlogging within Context (206) in south-east corner of Trench 2, also showing rough-hewn timber planks and wooden uprights.

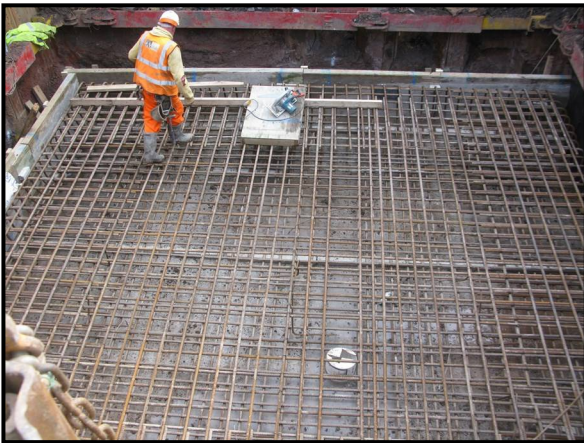
9. Reinforced concrete capping in base of Trench 1, from north.

Trench 1, which measured 8m north-south by 8m east-west, was excavated to a depth of some 3.7m below the present ground surface, (at approximately 83m aOD) at which point deposits of natural mudstone were encountered. Excavation was undertaken by a tracked 360° mechanical excavator, using a grading bucket of 1.5m width. After excavation, a reinforced concrete capping, 8m square, was placed over the area of the mineshaft (**Plate 9**).
