Land at the Former Old Mill Garage, Long Street, Croscombe, Somerset

Mendip D. C. Planning Reference 2015/0463/FUL
Somerset HER 37668
Somerset Museum Accession No. TTNCM 68/2017

Report on an Archaeological Watching Brief NGR ST 58841 44324

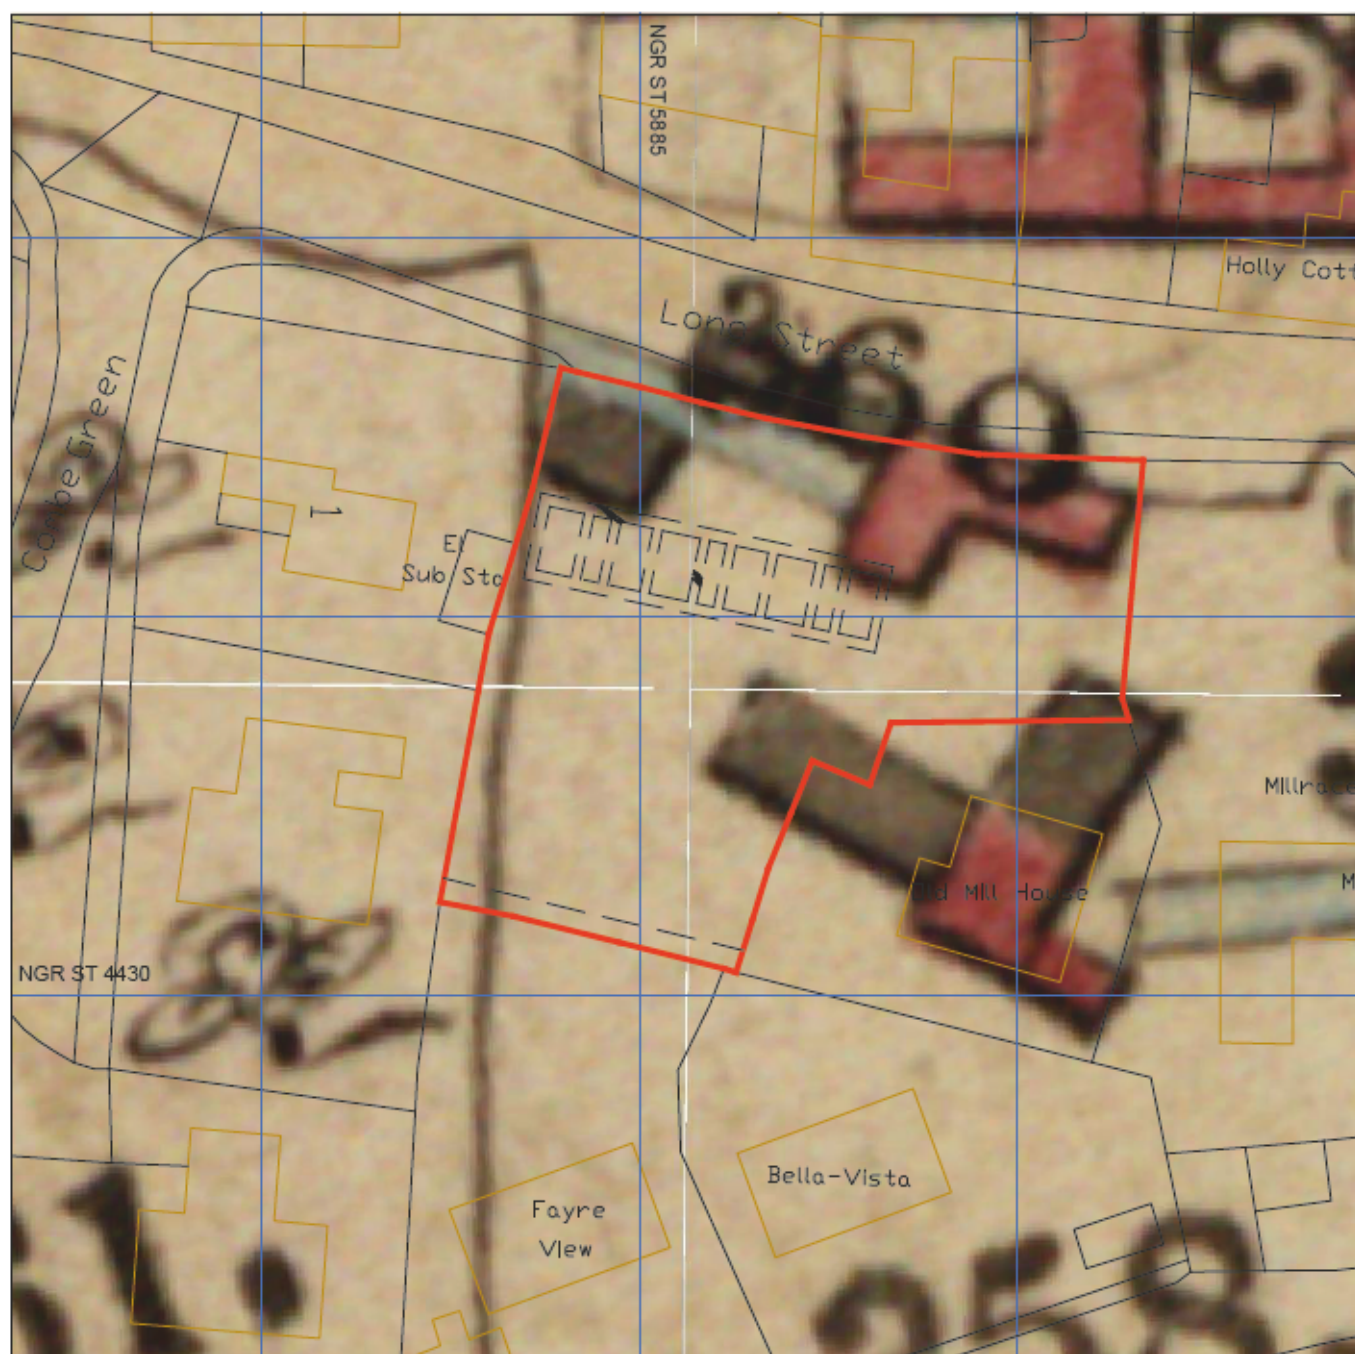
Figure 4

Plan Showing Monitored Trenches Overlain onto the 1840 Croscombe Tithe Map. Source: KnowYourPlace, Somerset

trenches, and it may therefore represent the best explanation for that wall. The function of this long, narrow building, shown also on the tithe map, is unknown, although its position and orientation clearly indicate some function connected with the mill. There is of course always the problem of trying to reconcile differences in the various surveys, and it is impossible to know what the level of error actually is. In terms of surviving structures, the First Edition OS ties in reasonably well with the modern map, upon which both of the main historic maps have been projected here (**Figures 4 and 5**). Note, for example, the long narrow building attached to the western side of the mill house, shown on both the tithe map, and the First Edition OS. The position and size of this structure is very different between the two maps; and in order to accommodate such a difference we must assume either that the tithe survey map is really wildly inaccurate; or, rather more likely, that between the dates of the two maps, something amounting to roughly 40 years, there had been considerable changes on the mill site, including rebuilding and/or extensions to existing structures.

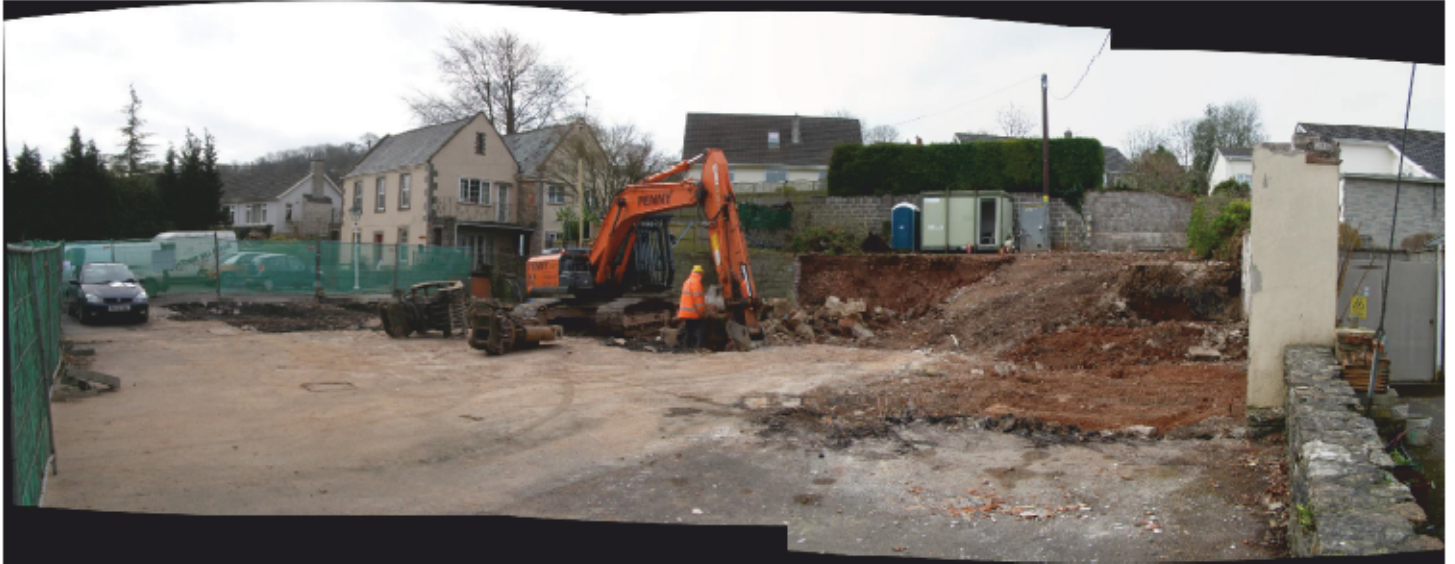
1. Composite panoramic view of the site prior to the commencement of the main phase of work, taken from the north-western corner of the site. The view pans round from east (left-hand side of frame) to south (right-hand side). Removal of main rear breeze block revetment wall in progress just to the right of the arm of the machine.

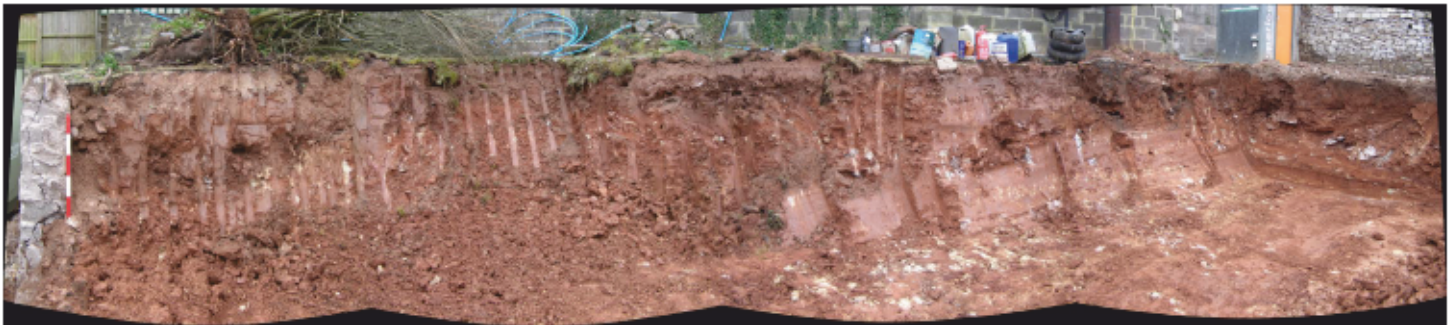
2. View of southern side of site following removal of modern revetment wall, and cutting back into the face of the natural Mercia Mudstone as revealed. The view pans round from east on the left-hand side, to south-west on the right. Note remains of modern revetment wall on left, with backfill of scalplings behind it. Scale: 1m. The site has historically, clearly been terraced back into the natural slope profile, which originally would have dropped down towards the little River Sheppey to the north, behind the photographer.

Prior to the commencement of the groundworks proper, and the excavation of the house footings themselves, it was first necessary to undertake major ground reduction at the southern side of the site. This involved essentially removing a modern breeze block wall, which was effectively acting as a revetment for the material behind it. It seems clear that, probably at the time of the construction of the garage, a deep vertical cut had been made along the entire southern boundary of the site, in effect creating a 'terrace'. This had then been revetted with the breeze block wall, which was 0.45m in width and 2.15m in height, and the space behind the wall backfilled with scalplings. The present project required the removal of this wall, and then cutting back even further into the north-facing elevation of the section (**Plates 1 and 2**). The section consisted almost entirely of the Mercia Mudstone natural, apart from a layer of topsoil. No features or deposits of any archaeological significance were noted during this phase of the work (contexts 100 to 103).

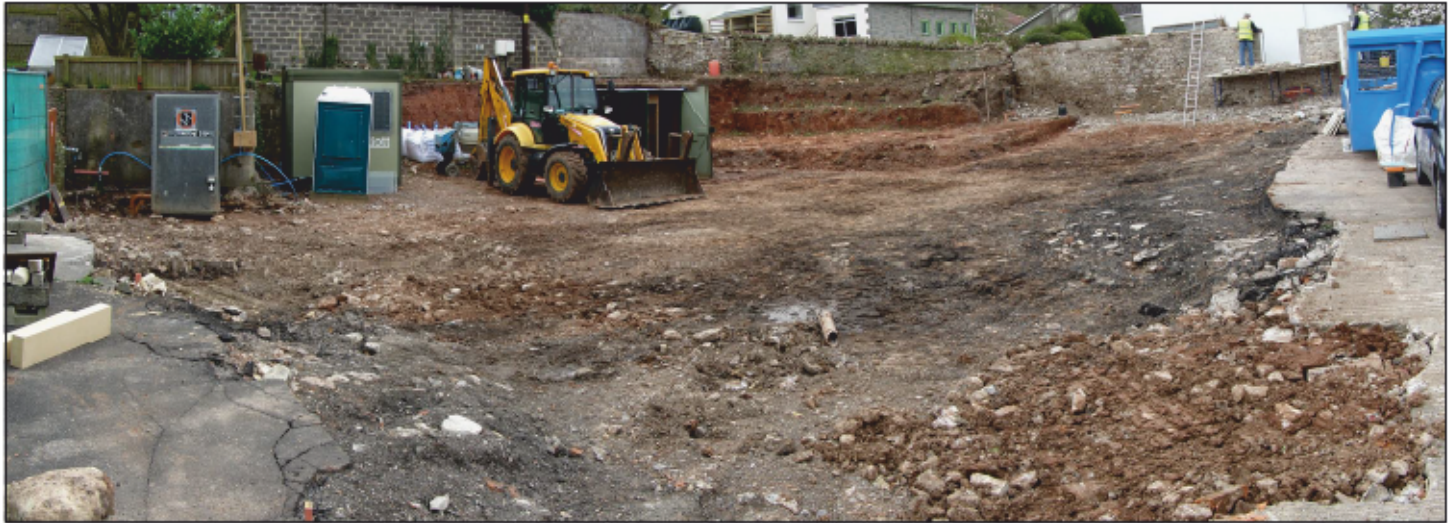
3. Composite panoramic view of the site just prior to the commencement of the main excavation phase for the footing trenches of the three houses, to be built on the part of the site in the foreground. The view pans round from the south (left-hand side) to south-west (right hand side). The masonry wall in the background, marking the site's western boundary, is the only historic structure now standing, and although in its present form it clearly consists of multiple phases, it is probably this wall which was depicted on the tithe map of 1840, and it therefore at the least precedes that date.

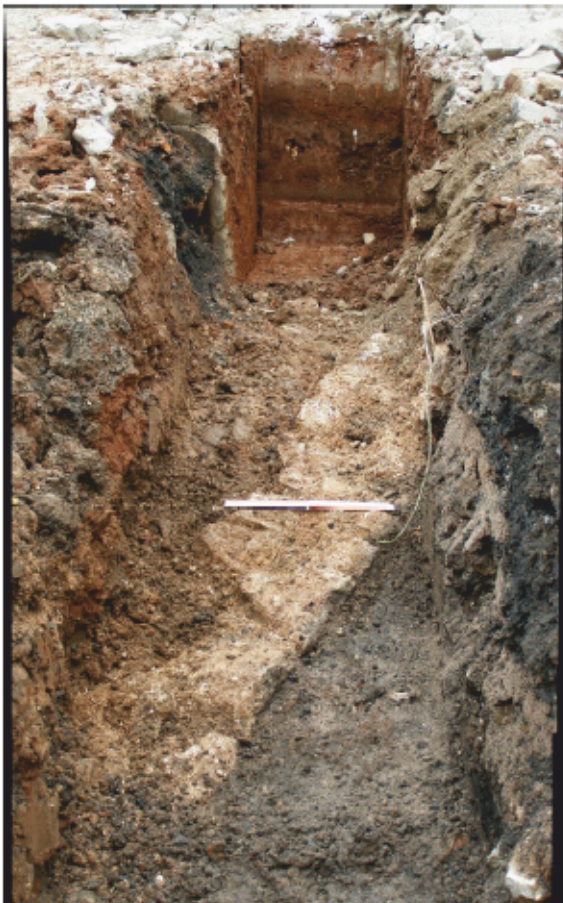
possible truncation of the two historic walls which were recorded in the course of the work (see further below). A backfilled vehicle inspection trench from the former garage, constructed of breeze block walls and cut through the natural, was encountered at the junction of trenches 1 and 2 (**Plate 5**). It was not removed, but was left in situ. Trench 1, marking the front (ie north) common wall of the new terrace, produced the most interest and potentially significant discovery. This was the line of a wall (context 104), clearly heavily truncated in its upper courses, constructed of rubble masonry, probably carboniferous limestone but this is problematic, and bonded with a mid-orangey red, speckly, friable mortar. Its width was 0.52 m, and its surviving upper course, which was the only part of the wall which was seen, lay at about 0.85m below site formation level, so at about 49.15m aOD. It was aligned north-west/south-east (**Plate 4; Figure 3**). No construction cut was observed for this feature although it had clearly been dug through the natural Mercia Mudstone. This wall was observed only in the base of this particular trench and, in this form anyway, was not traced in any of the trenches to the south-east through which it might have passed. It seemed to us that what made this structure especially significant was the fact that to its north was a deposit (105), which was extremely silty, fine-grained, very dark grey or black in colour, and greasy in the hand. This looked very much like a typical drain or culvert deposit redolent of gradual silting in water (**Plate 4**). The southern side of the wall consisted only of the natural Mercia Mudstone. The clear implication was that *outside* the northern trench section, rather further to the north, was the other side of this channel. The function of this structure is unknown, but we do wonder whether it might be a candidate for the putative, and presumed, tailrace from the former mill building immediately to the south-east (but see further below).

4. Wall 104, Trench 1, view to west. Note dark, silty organic deposit 105 to the right (ie north) of the wall. Modern backfilled garage inspection pit, with breeze block walls, in the background on the left (southern) side of the trench. Scale 0.50m.

The most important findings from this project were the three walls, 104, 108 and 601. The problem is in coming to any meaningful judgement about how they may relate to each other, if indeed at all. The dark, silty deposit to the north of wall 104 seemed clearly to indicate that it was only the southern side of a culvert-type structure which had once carried flowing water. Wall 601, while of quite a different nature in terms of its construction, *could* be projected north-westwards from its discovery point in Trench 6, to conjoin with wall 108, and, in turn projecting wall 104 to the south-east, this would produce a 'culvert type feature, with walls on either side of about 1m width. The difference in construction between 104 and 601 could perhaps be put down to rebuilding/repair at some point. Is this, however, wide enough for a mill tailrace? There is also the problem that wall 104 was not traced to the south-east, and 601 was not seen anywhere to the north-west of Trench 6. Again, this might simply have been due to the clear (and probably modern) truncation that we observed in the central area of the site. However, there is further problem in that on site, it certainly *seemed* as though wall 108 was oriented south-west/north-east rather than, if it had indeed been a north-westward extension of 601, south-east/north-west. The former orientation might make it theoretically possible, indeed, that 108 actually formed a return from the south-eastern end of 401; and indeed a projection onto the Croscombe tithe map (**Figure 4**) might well incline one to say that 108 could have represented the eastern wall, and 104 the southern wall, of a non-domestic building which is shown occupying a part of the development site in the mid-19th century. A projection on to the First Edition OS map about 40 years later, however, is less convincing, although at least wall 601 has a pretty close relationship, on this map at least, with the northern corner of one of the former mill buildings which no longer exists (**Figure 5**). Indeed the north-western corner of this building, as mapped by the OS, coincides almost perfectly with wall 601 as it was found in the excavation

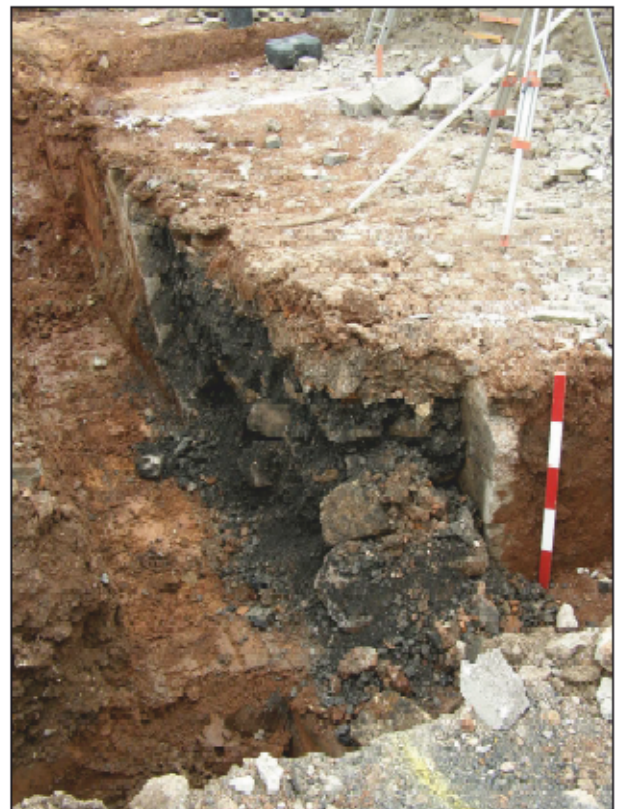
5. Detail of backfilled garage inspection pit, junction of Trench 1 and Trench 2, view to south. Scale: 1m.

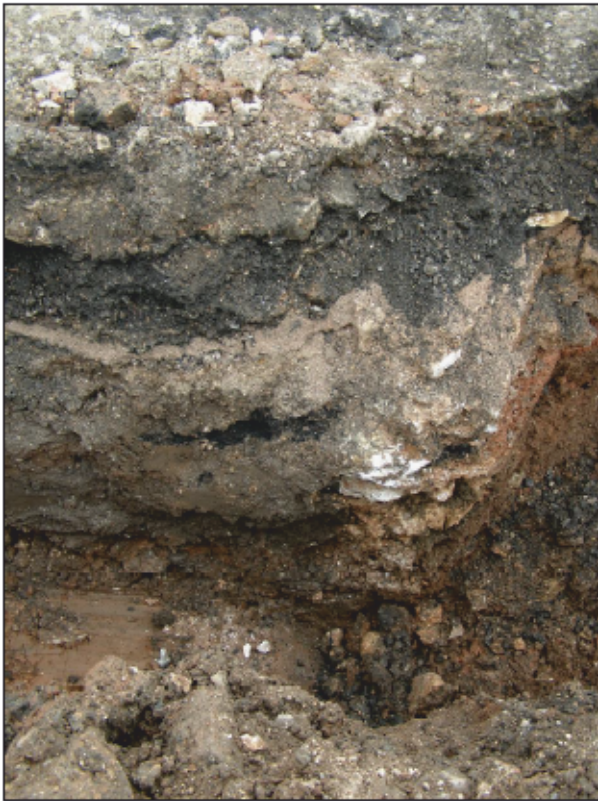
Slightly further to the east, in the northern section of Trench 1, another wall was seen but only in section (108). It *appeared* to be oriented north-east/south-west, but it did not appear in the base of the trench, and did not appear to cross over into the southern section of the trench. Its construction appeared to be of a similar type of rubble build, with a similar type of mortar, as that seen in wall 104 (**Figure 3; Plate 6**). It could not be examined in detail because of the unsafe depth of the trench at this point.

6. Wall 108, seen in section only, in the south-facing section of Trench 1. View to north.

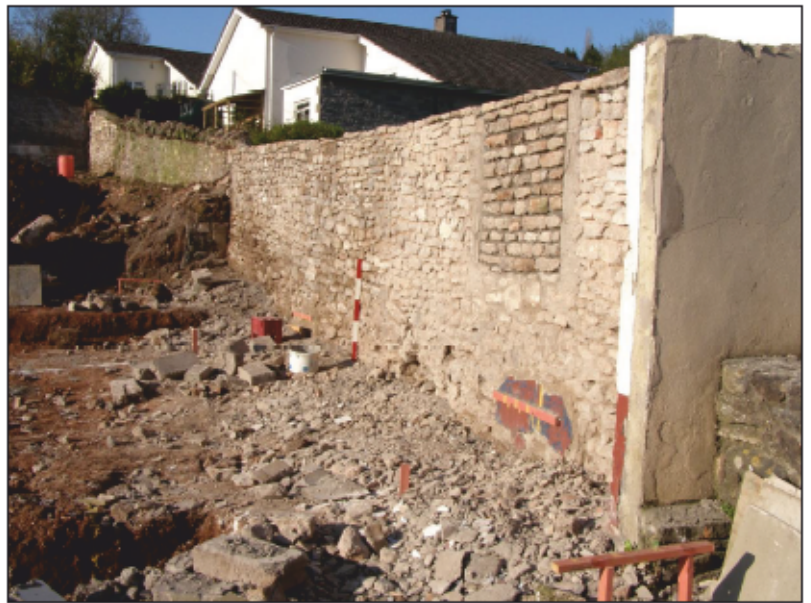
close to each other, not far north of the church, and about 260m to the north-east of the development site. Neither of these projects have any immediate implications for the proposed development site. So far as we could determine, the only historic structure now standing as part of the site was the wall which bounds its western side, and which will be fully restored, including recapping and repointing, as part of the present development project. This wall has been subject to damage in the recent past, as attested by a window at its northern end punched through it, and made good with a makeshift frame formed from concrete breeze blocks (**Plate 7**). This was almost certainly related to the former use of the site as a garage.

7. Detail of historic wall marking the western boundary of the development site, image taken from its northern end. This is the only structure incorporating historic fabric now surviving above ground on the site. Preparation prior to repointing in progress. The blocked up window is modern, its frame being formed of concrete breeze blocks. View to south. Scale: 1m.

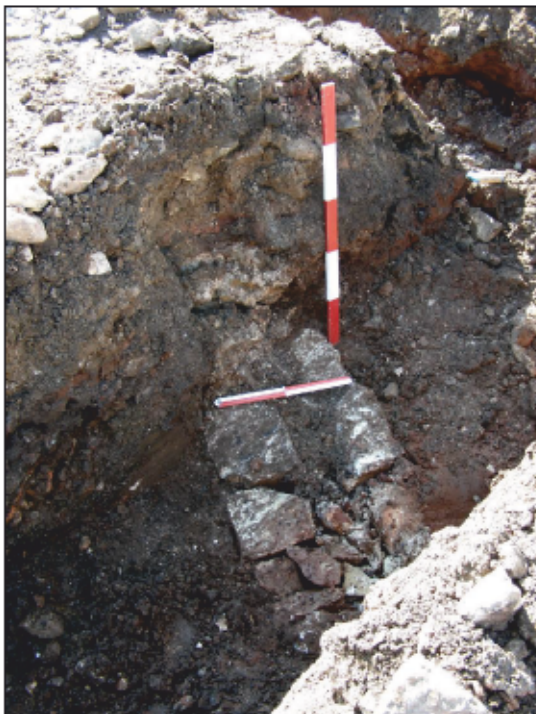
The only other feature of any interest from the monitoring was another wall, identified initially in the western section of Trench 6, but in fact traced from thence south-eastwards, into the northern section of Trench 3, representing the main rear common wall of the terrace of houses. This structure was allocated context 601, and was cut into the natural substrate, although there was no obvious sign of a construction cut. The exaction of the trench cut through this wall, but it was seen in the base of Trench 6, and surviving to almost the full height of the eastern section of the same trench (**Plates 8 and 9**). The wall was aligned south-east/north-west, and was 0.65m in width. It was of rubble limestone construction, with the stone itself being a hard, semi-crystalline, fine-grained, mottled mid to light grey, and it was bonded with a light grey, speckly, friable mortar, quite different in nature from that which was used in the 'culvert' wall 104. It is possible that the stone was a local variety of Lias Limestone, which outcrops locally and is very plentiful, but this is uncertain. **Figure 3** shows the wall and its passage south-eastwards from Trench 6, through Trench 7, and disappearing into the southern baulk of Trench 3.

8. Wall 601 at the southern end of trench 6. View to south east, into the east-facing section of the trench. Scales: 1m and 0.50m.

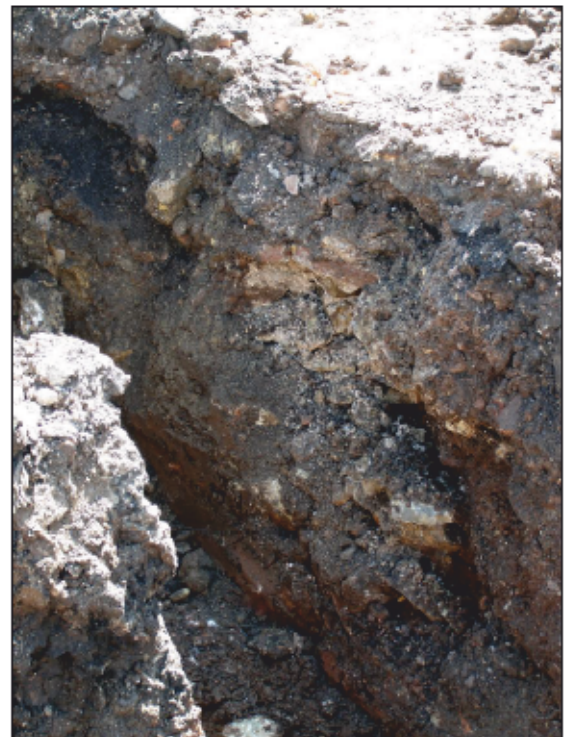
9. Wall 601 exposed in the north-facing section of Trench 3, close to the southern end of Trench 8. View to south-east.

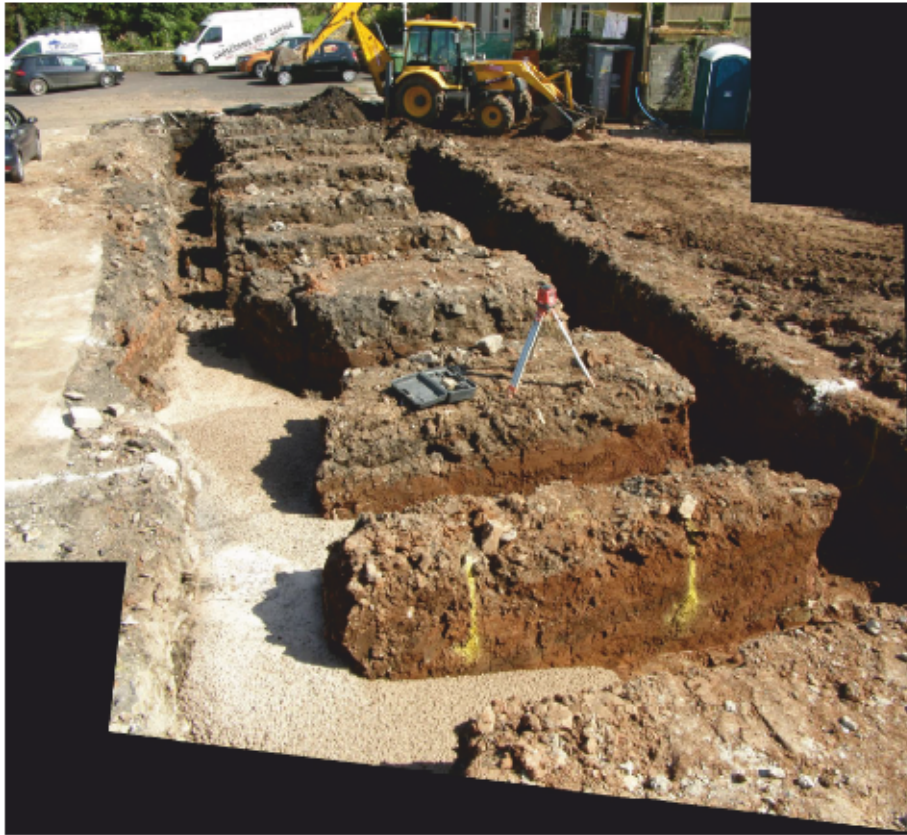
10. Composite panoramic view of the site, with excavation of all trenches completed, save for Trench 12, at the extreme western side of the site, behind the photographer. Pouring of concrete has already begun in the trenches closest to the camera, and proceeded eastwards. View to east.

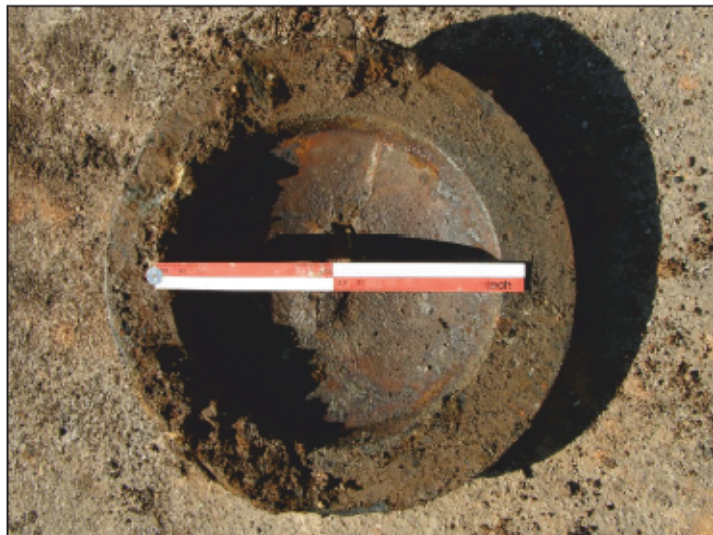
and covered with mortar on what was clearly the lower, flat side. It was made from what was probably cast iron, and appeared to be damaged in the centre of the dished side (**Plate 11**). Its date and purpose is unknown. It *may* relate to the earlier garage on the site, but this is problematic.

11. The circular ?cast iron dished object recovered from modern backfill in Trench 11. Scale: 0.50m.
