# Land at Bellevue Terrace, Totterdown, Bristol

## Archaeological Watching Brief

BHER 25236

Bristol: November 2013

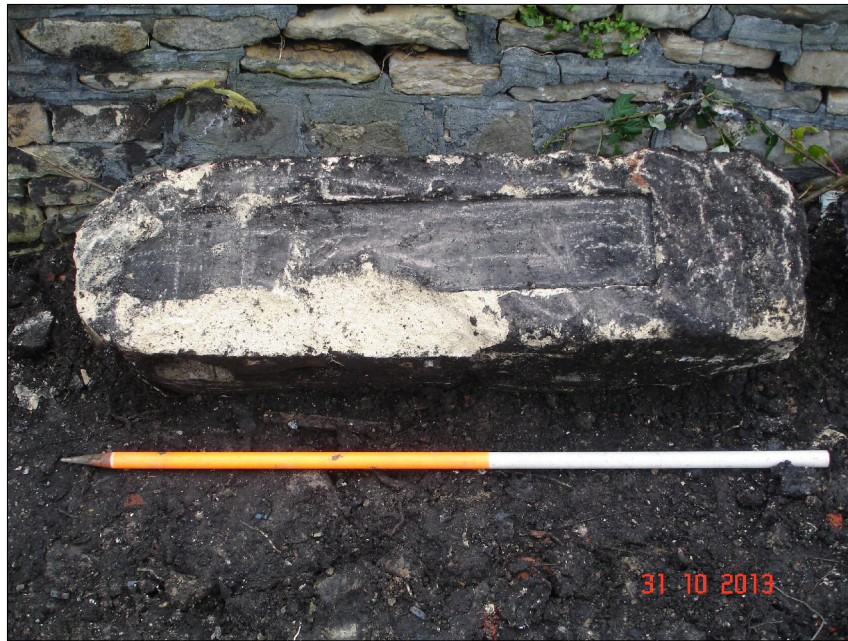
Frontispiece: Probable gatepost of oolitic limestone, possibly Dundry stone, recovered from the topsoil context during machine excavation of house foundation trenches. The quality of workmanship of this object is such that it can only be associated with the two large, 19<sup>th</sup> century villas which formerly occupied the site.

A single feature which is likely to have been associated with the villas was recovered by machine as an unstratified find from the topsoil layer (100), and this was a very fine gatepost made of oolitic limestone, possibly from the quarries at Dundry, and displaying a plain decorative rebate on what was presumably intended to be its front side (Frontispiece).

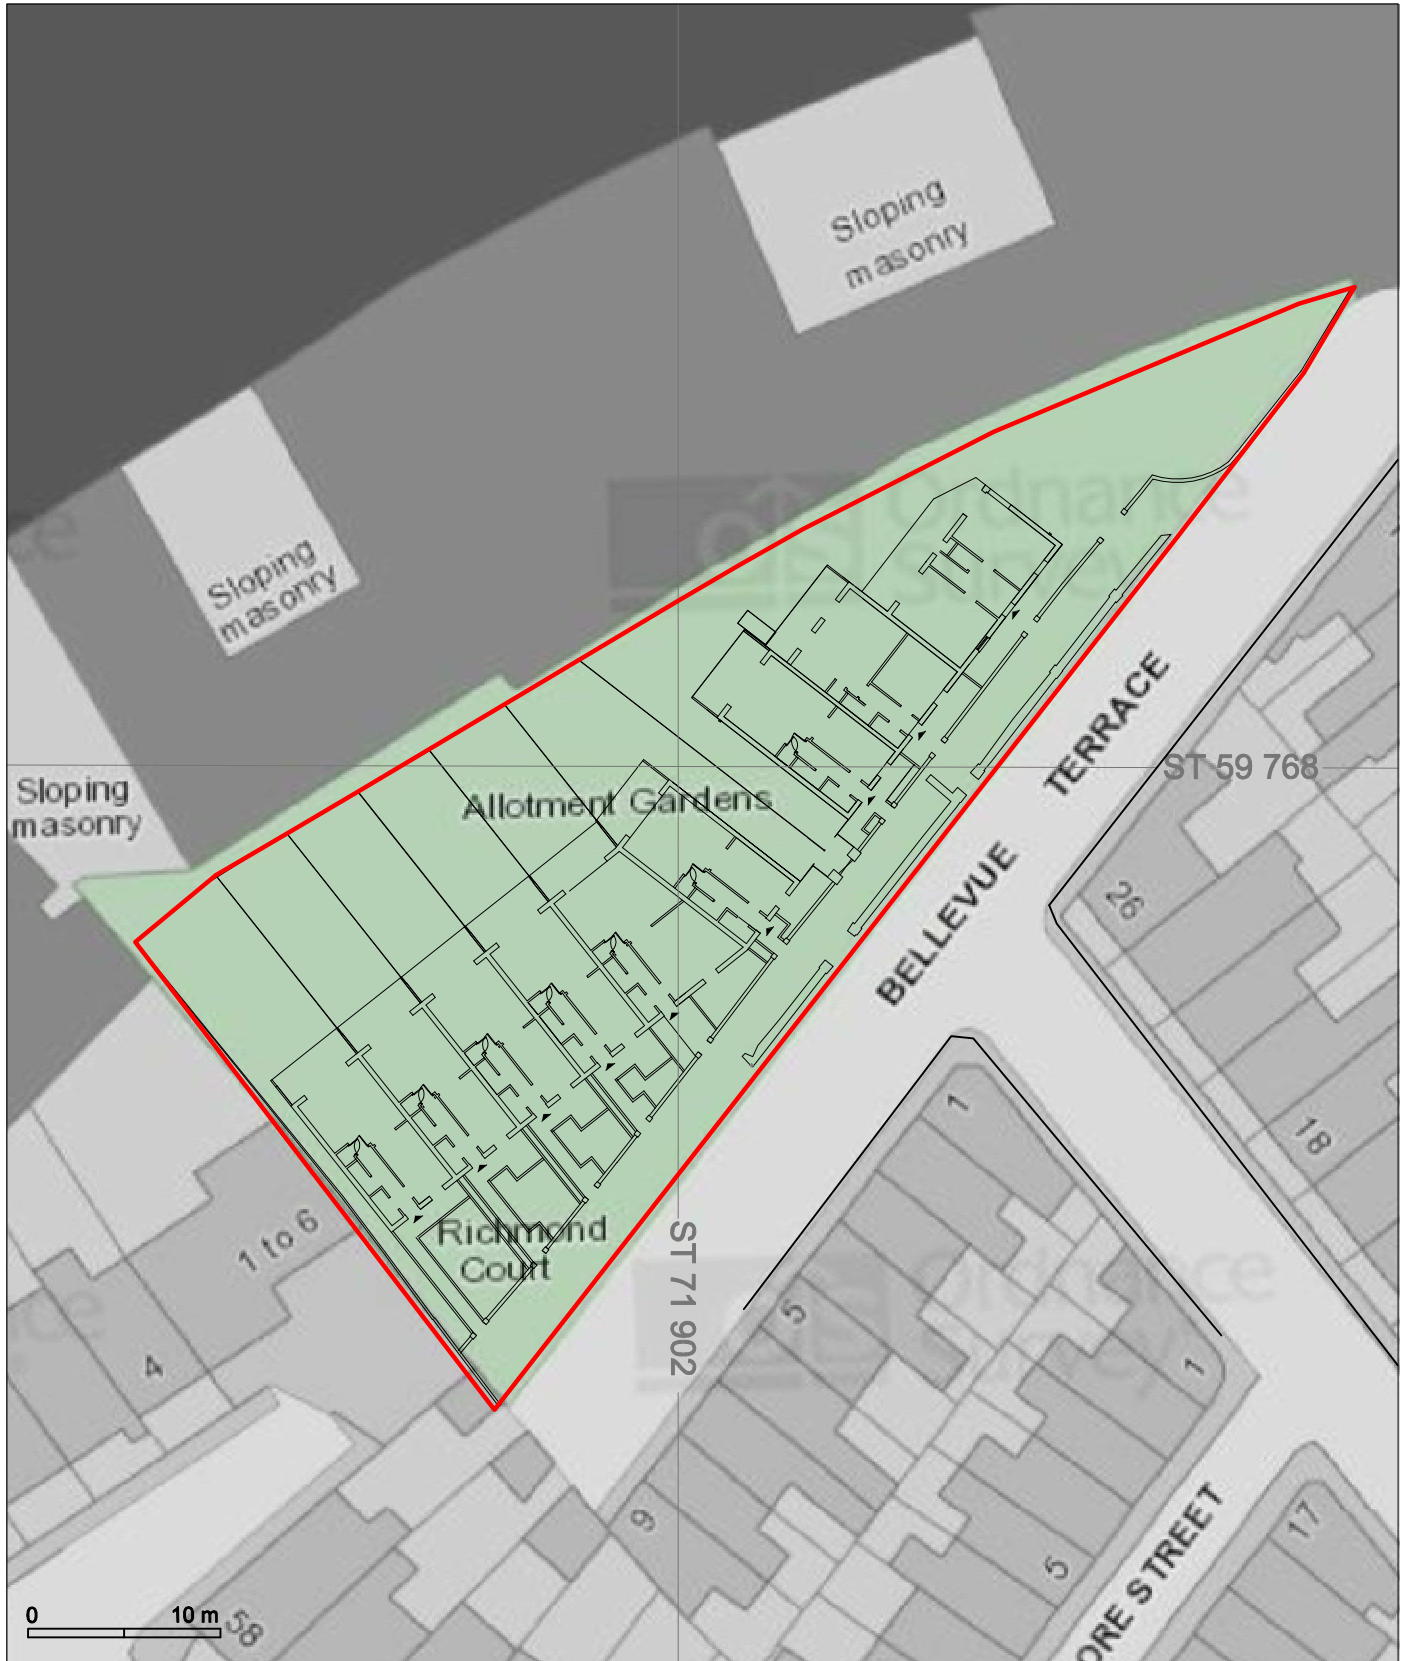
Developer's Ground Plan superimposed on historic OS Plan,  
1883 (Published scale 1:500)

It is, in any event, quite clear that not only was the wall a relatively late feature, its very rough construction indicates that it was not intended to be load-bearing – it is most likely to have been a boundary and/or a garden wall. The composite plan presented here as Figure 3 suggests that the most likely candidate is what appears to be a garden/boundary wall running north-west/south-east a little distance to the south-west of the more south-westerly of the two large 19th century villas. The wall separated this house from a large garden which lay on the other (ie south-west) side of it, but which clearly belonged to the house, as is shown by a gap at its north-western end; this open gateway gave access to the south-western garden via a path which is clearly depicted on the OS plan. However, it will be noted that the alignment of this wall as depicted on the First Edition 1:500 OS plan, and that of Trench 10, are by no means coincident, although it seems unlikely that this can be attributed to significant inaccuracies in either the historic map, or the modern survey plan.

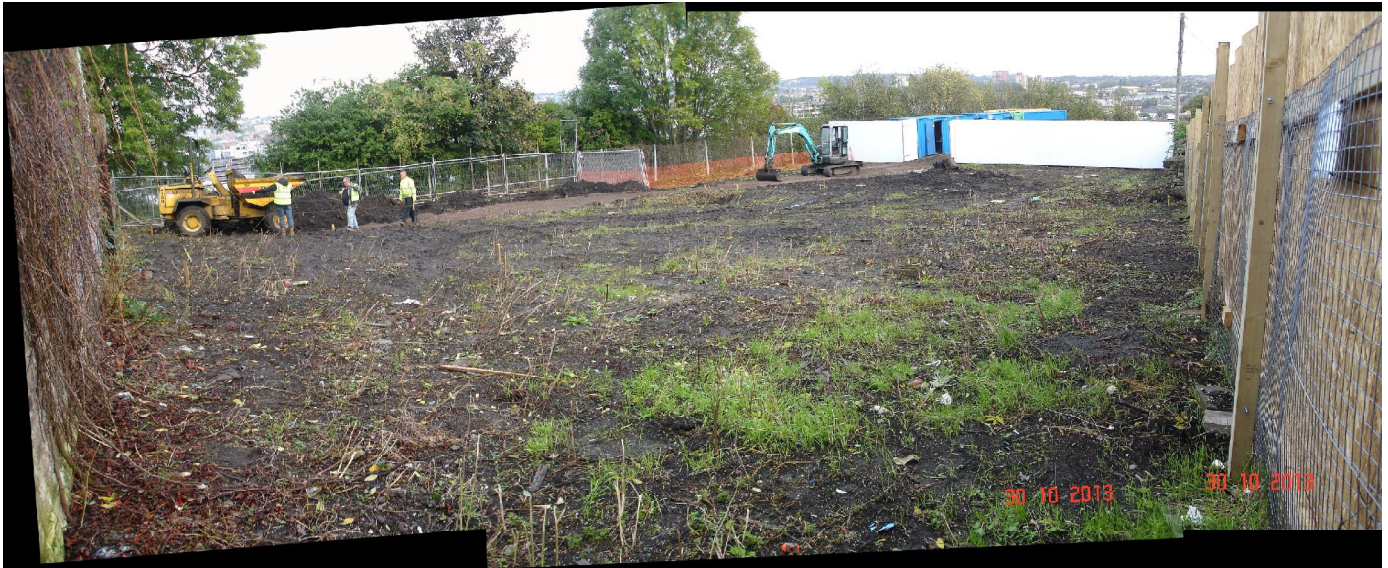
1 Composite panorama showing the Phase 1 site (six houses) prior to commencement of groundworks, taken from the extreme south-western corner. The view pans round from north-west (left) to north-east (right). The Phase 2 site, of the remaining three houses, lies to the north-east beyond the white hoarding in the background.

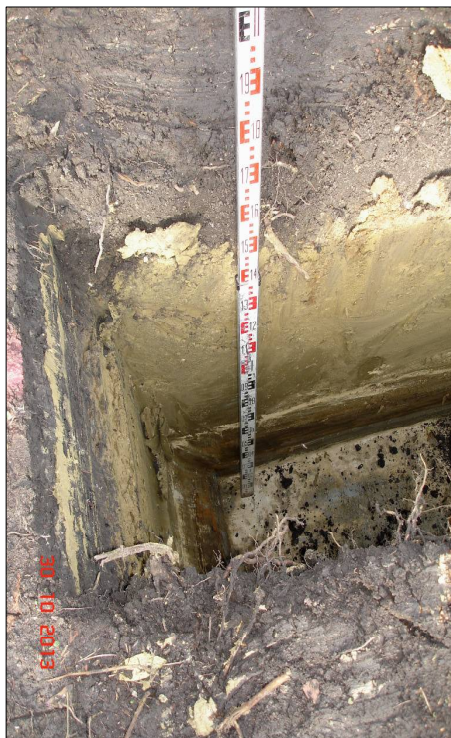
2 Trench 1 at full depth, 1.7m below ground level, at its south-western end. View of south-east facing section.

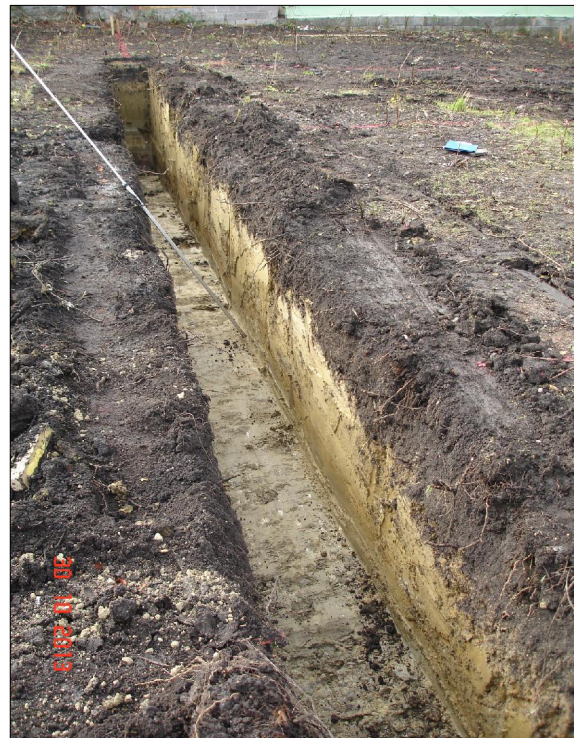
3 South-western section of Trench 1 completed. View to south-west.

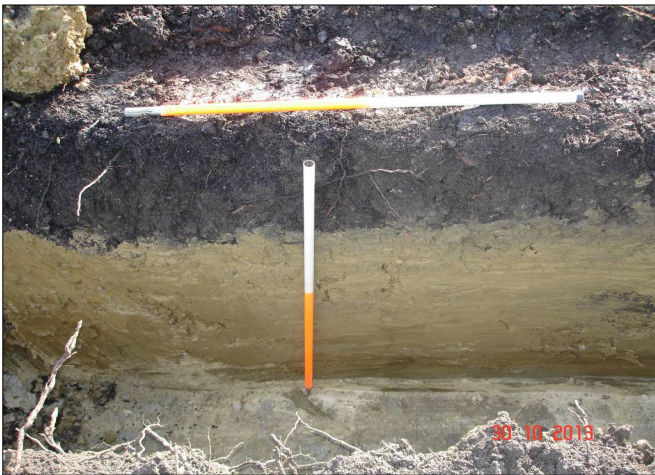
4 North-west facing section in Trench 1, taken 8m from its south-west end, showing the topsoil layer (100) lying directly on top of natural clay (102). Scale 1x1m.

The subsoil layer (101) was developed only towards the north-eastern and north-western sides of the site, and by contrast, in the south-western and south-eastern areas, the topsoil layer could be seen to lie directly on top of the natural (102). Plate 4 shows a typical example. The subsoil, shown clearly in Plate 7, was a mid, greyish-brown silty clay, highly friable and with moderate root activity, with numerous gritty inclusions, numerous flecks and larger fragments of charcoal, and moderate occurrence of white flecks of what was clearly lime mortar. The subsoil layer was typically 0.20m to 0.30m in thickness. Despite much searching, the only find retrieved from this context was a small fragment of fully glazed pottery, a rim sherd of light buff colour, which was certainly no earlier than the 18th century and may well be far more modern. Although not entirely diagnostic in this respect, the find came from a well-sealed part of the context, and it at least demonstrates that the layer has been disturbed in relatively modern times.

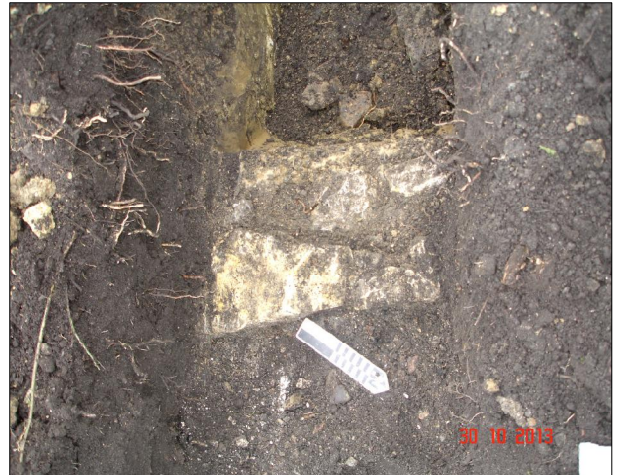
5 Wall (103) in plan, seen towards the north-eastern end of Trench 1.

The work revealed a single feature which might be considered to have any archaeological significance at all, and this was a wall (103) which ran north-west to south-east across pretty much the middle of the site, virtually, and by coincidence, parallel to the excavated foundation trenches also running in that direction. The wall was seen in plan in Trench 1, and in section in Trenches 1, 3 and 9, and its line coincided very closely with that of Trench 10, so that the excavation of that trench also involved effectively the complete removal of the wall along that part of its length. By definition the wall itself could only be examined in section, and at no time was either face visible for inspection. The best view was revealed in the south-east facing section of Trench 3 (Plate 8). Its construction was therefore somewhat problematic, but it was clear that it was, at least, of extremely rough build. A maximum of six surviving courses, to a total height of 0.56m, were seen in the Trench 3 section, and its south-western face appeared intact. Its north-eastern side had,

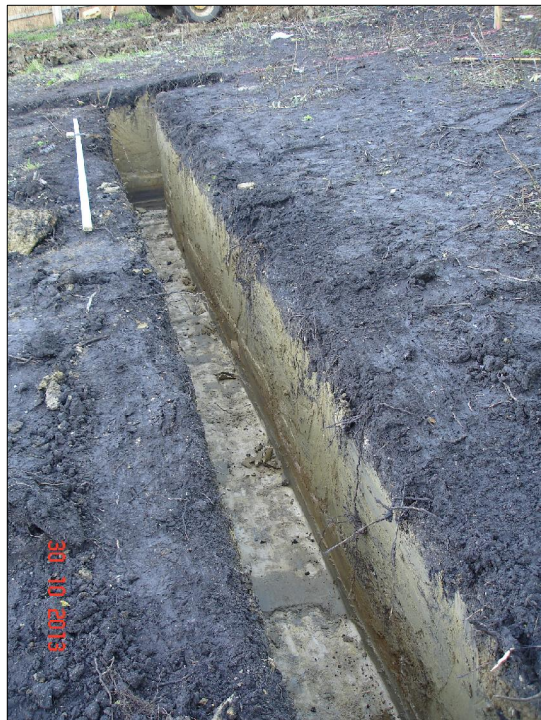
6 Trench 2 completed, view to south-east.

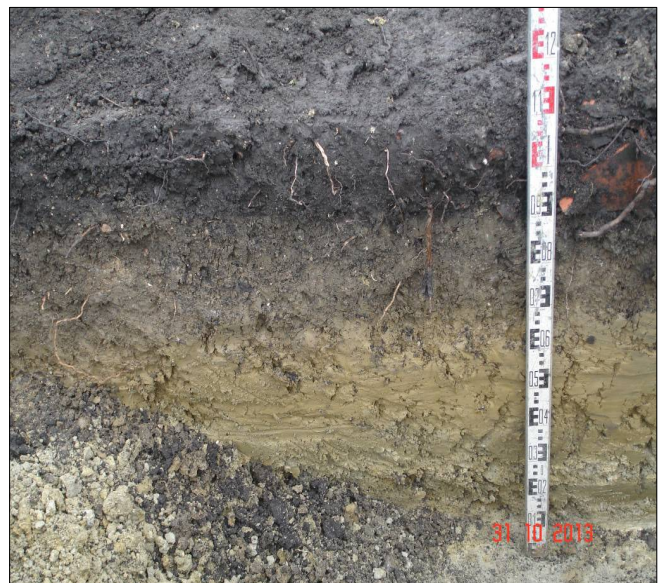
7 South-east facing section in Trench 3 close to its junction with Trench 4, showing topsoil (100), subsoil (101), and natural clay (102).

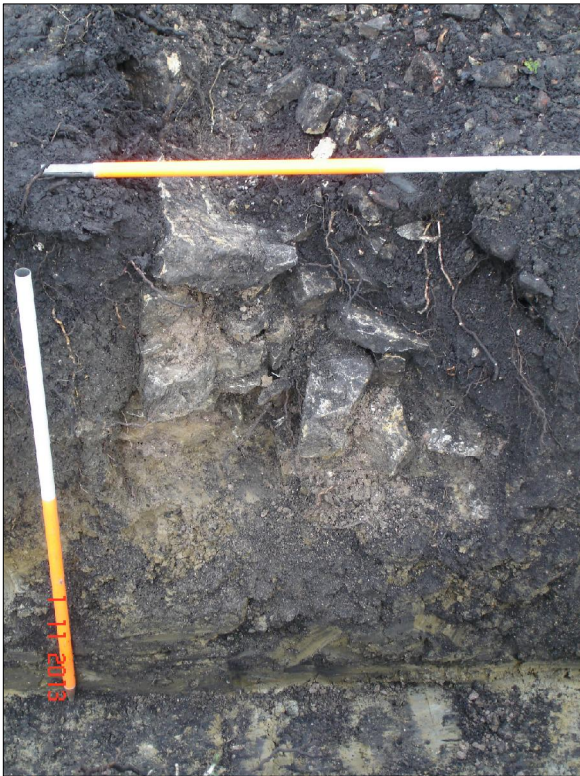
8 South-east facing section in Trench 3 showing section through wall (103). South-western face appears intact. Scales 2x1m

however, tumbled badly, and as a consequence its full width, as built, was difficult to determine. It could have been a minimum of 0.24m in width or a maximum of 0.58m, but is perhaps more likely to have been the latter, and on balance to have been of double skin construction with a mortared rubble core. It should be noted that, as seen in plan at the north-eastern end of Trench 1 (Plate 5), its measured width appeared to be 0.33m, but this was only along a 0.60m length (ie the width of the digger bucket), and it may well be that collapse had resulted in some loss of width here, as well as that seen in the Trench 3 section.

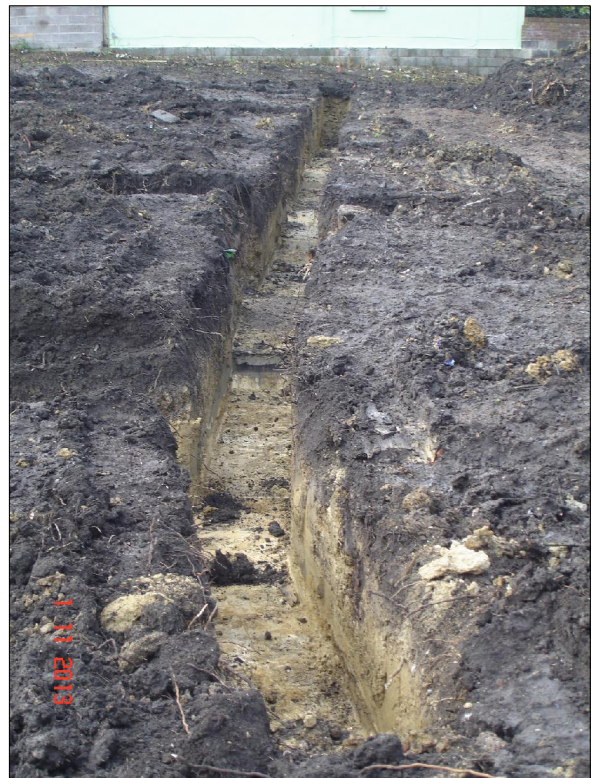
9 Trench 3 completed, view to south-west.

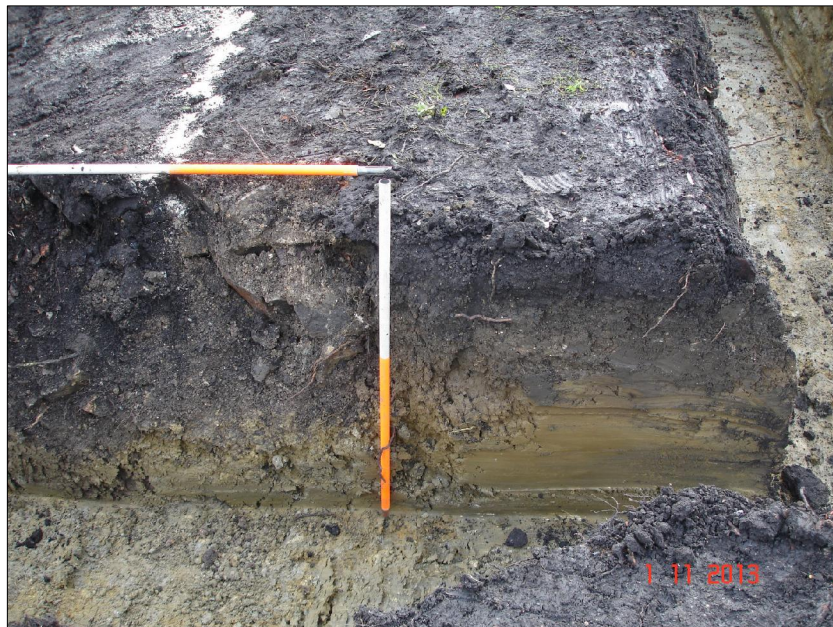
10 North-west facing section at south-western end of Trench 9 showing section through wall (103). The sawdust line running from the horizontal scale marks the intended line of Trench 10, coincidentally taking virtually the same line as the wall. Scales 2 x 1m.

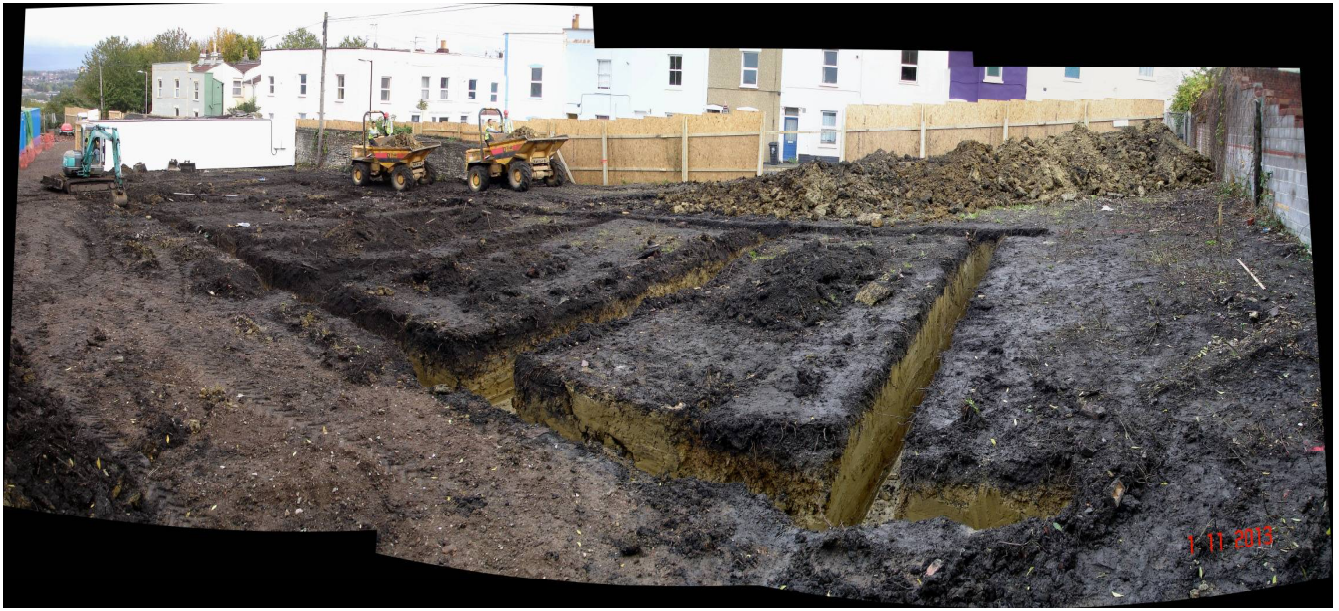
11 Composite panoramic view of the Phase 1 house foundations completed, taken from the extreme north-west corner. The view pans round from north-east (left) to south-east (right).
