Land to the Rear of “Lynton” and “Roman Orchard”, Wells Road, Radstock, Bath and North-East Somerset

Report on Archaeological Watching Brief

B&NES Council Planning Reference 13/05520/FUL

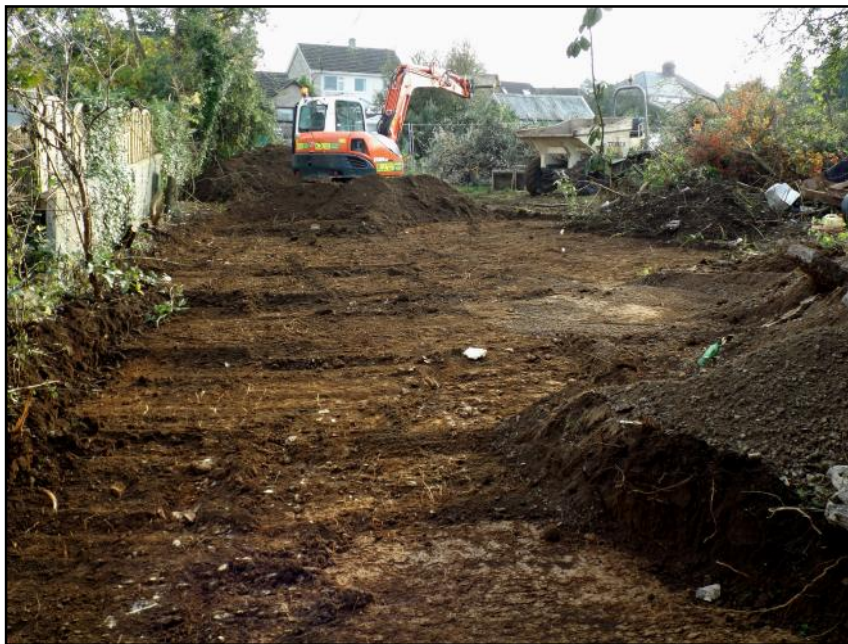
Cover

Topsoil stripping in progress close to the site entrance, at its north-eastern end, view to south.

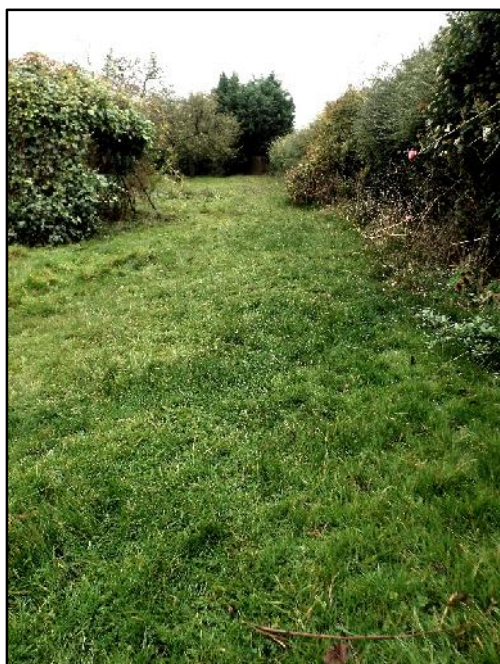
1. The slight ridge running south-west/north-east and marking the site's north-western boundary, prior to topsoil stripping. The boundary hedge can be seen on the r/h side of the frame. View to south-west.

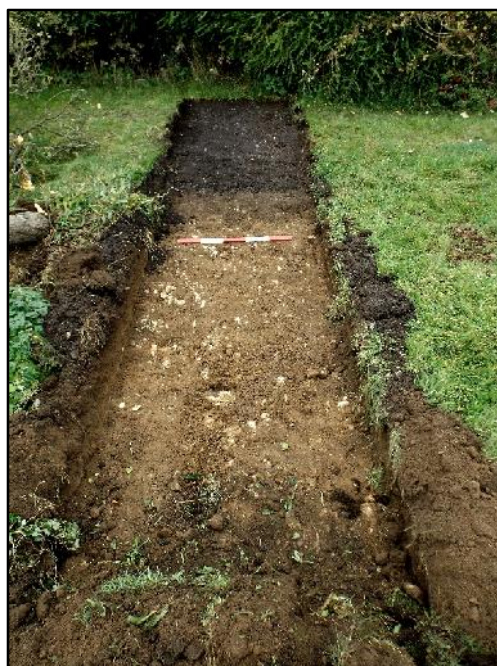
2. Test Trench 3 (see **Figure 3**), view to north-west from south-east end. Note south-eastern side of probably early 20th century cinder trackway at far end of the trench, cut into the top of the mid-brown subsoil layer. The top of the natural Lias limestone and clay has been revealed in the base of the trench beside the scale. Scale: 1m.

While the topsoil strip was underway on the main part of the site, the opportunity was taken to use the machine to cut three small 'test trenches' at right angles across what proved to be the cinder trackway, but also further to the south-east, intruding into the main area of the former gardens of "Roman Orchard". Their locations are shown on **Figure 3**. This gave full sections through both the trackway and the garden material; and this was reinforced when the north-western foundation footing for House 3, and those for its garage, were excavated (**Plate 10**). Where it could be seen in section, the trackway was between 0.15 and 0.20m in thickness, and consisted of highly compacted cinder material that had clearly been deliberately laid for the purpose of forming a resilient, reasonably hard and well-drained running surface.

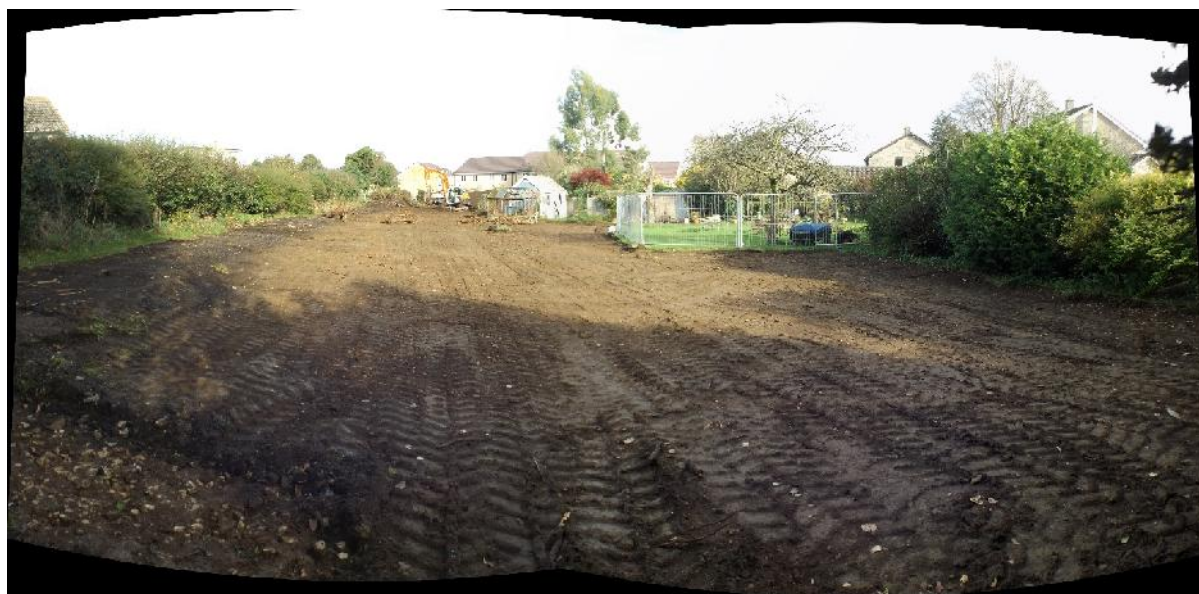
3. Composite panoramic image of the main site, with topsoil stripping complete. The view is from close to the south-west extremity of the site, and pans round from the north-west (l/h side of frame) to north-east (r/h side). Note, on the l/h side, the line of the probably early 20th century cinder trackway running north-east/south-west, along the site's north-western boundary. It would have originally run underneath the boundary hedge on that side.

length of the north-western boundary (**Plate 3**). It can confidently be assigned an early 20th century date.

The topsoil strip over the main part of the site, which is documented on the **Cover** and **Plate 3**, revealed no indication whatsoever of anything of archaeological interest or significance. In terms of actual foundation footings, the first to be excavated, following successful completion of the topsoil strip, was for the wall which was to form a part of the boundary on the south-eastern side of the site. This was carried out using a 0.60m toothless bucket, and the foundation was excavated to a maximum depth of 0.65m below the modern ground level (ie the pre-existing turf surface). **Plate 5** records this work. Nothing of archaeological interest was identified. The foundations for House 3 were then excavated, the deepest point being at the extreme north-west side where the house wall shared a partially-common foundation with the wall of the attached garage (**Figure 3**). Here, trench depth attained 0.96m below modern ground level. All the trenches for House 3 were monitored, but at no point was anything of archaeological significance revealed, and at this point the monitoring exercise was curtailed.

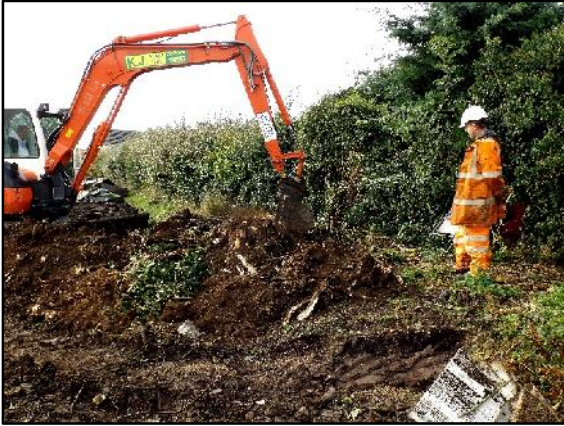
4. Using the machine to remove a large tree stump at the north-eastern end of the site, in the middle of the line of the new access road. View to south-west.

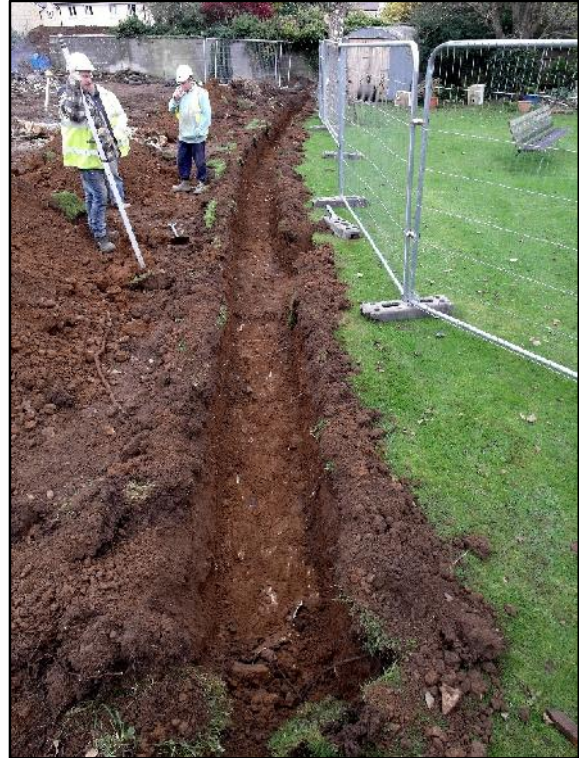
5. Foundation trench for new boundary wall on the south-eastern side of the site nearing completion (see **Figure 3**). View to north-east from close to the south-western end of the trench.

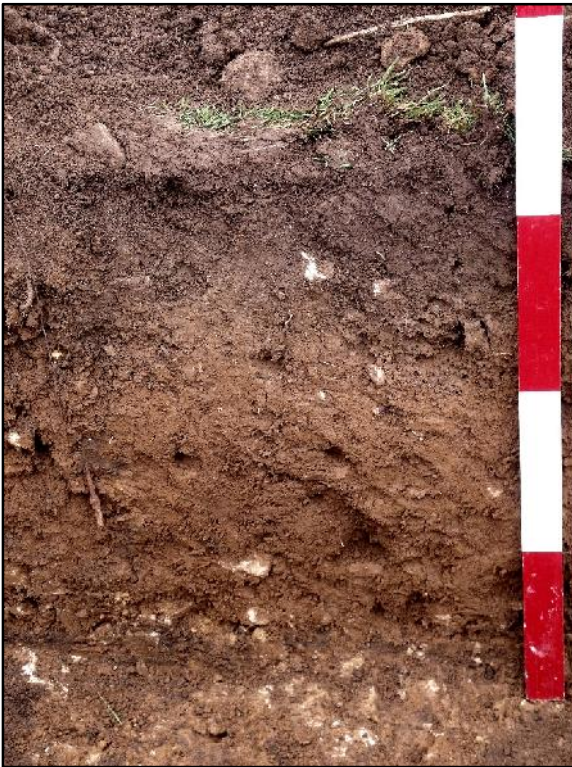
6. North-west facing section in south-eastern boundary wall trench, taken at NGR ST 67665 54404. Trench depth, 0.70m below modern turfline. The section shows turf and topsoil 0.07m thick, subsoil 0.14m thick, and then natural (but weathered) Lias limestone and clay down to the trench base. Scale divisions: 0.20m.

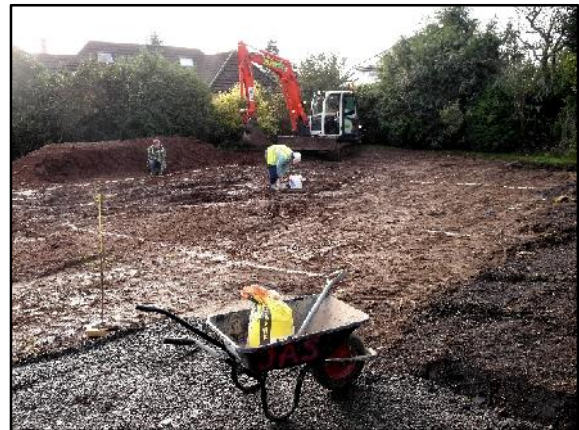
7. Marking out the trench lines for the foundations of House 3, at the extreme south-western end of the site. View to south.

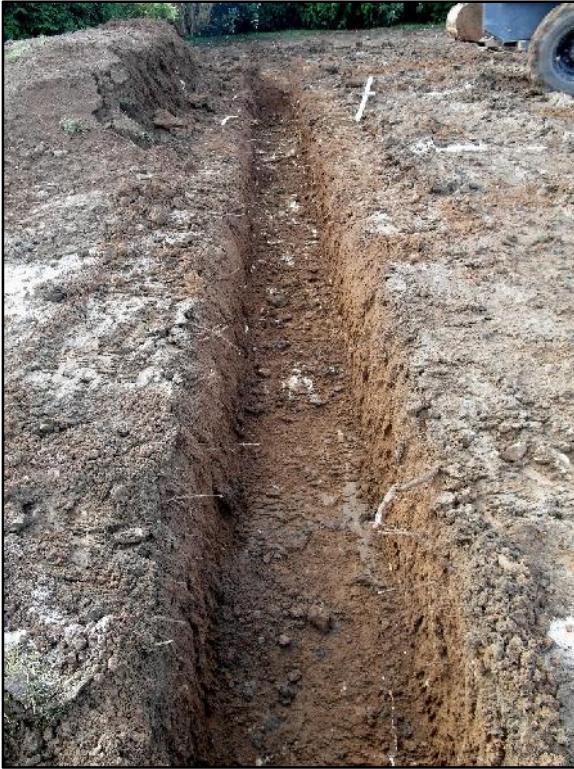
8. Trench 2 of House 3 complete (see **Figure 3**). View to north-west.

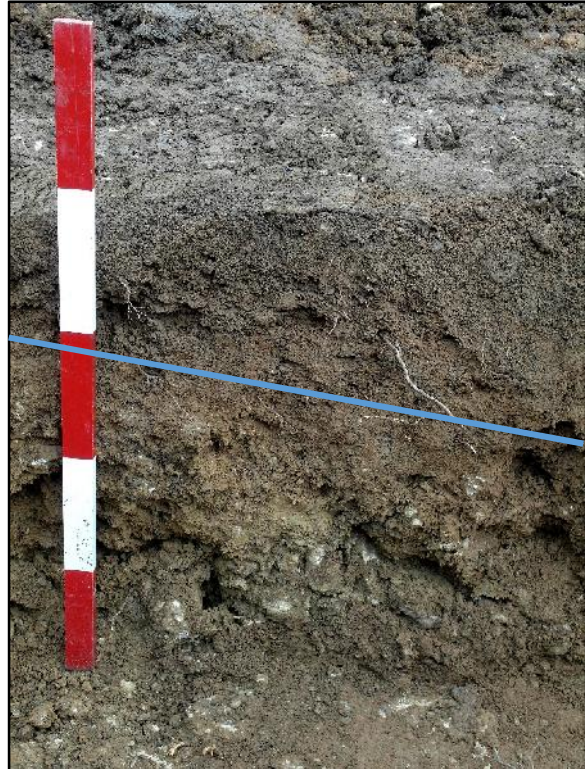
9. South-west facing section of Trench 2, taken at NGR ST 67643 54383. Trench depth 0.74m below stripped level. The blue line indicates roughly the way in which the natural Lias limestone and clay begins to dip away to the south-east at this point, underneath a subsoil layer which increases in thickness in that direction. Scale: 1m.

With the sole exception of the cinder trackway at the north-west side of the site, the sequence of deposits throughout was topsoil and turf, subsoil, and then natural Lias limestone and clay. As already noted, the trackway lay below the modern turf and topsoil, but was cut into the subsoil. Away from the cinder trackway, the House 3 trenches showed that subsoil depth increased markedly from north-west to south-east, and towards the former, there were places where the natural was covered by only a few cm of subsoil following removal of the turf and topsoil, and at the south-eastern ends of trenches 2, 3, 4 and 5, the subsoil extended to virtually the full depth of the trenches, which attained a maximum of 0.80m below the stripped surface of the site, at the south-eastern end of Trench 2. This was the excavation for the south-western end wall of House 3.

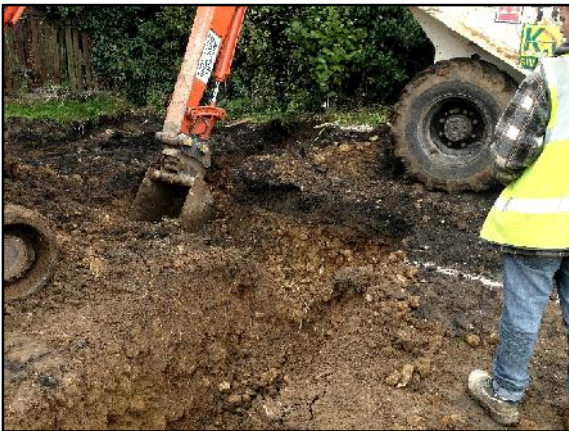
10. Image taken at the point where the south-eastern wall of the garage joins onto the north-western wall of House 3 (see **Figure 3**). View to west. Note the depth of the cinder trackway at this point, and the way that it has almost entirely truncated the subsoil layer in this area, to sit almost directly on top of the heavily weathered natural Lias limestone and

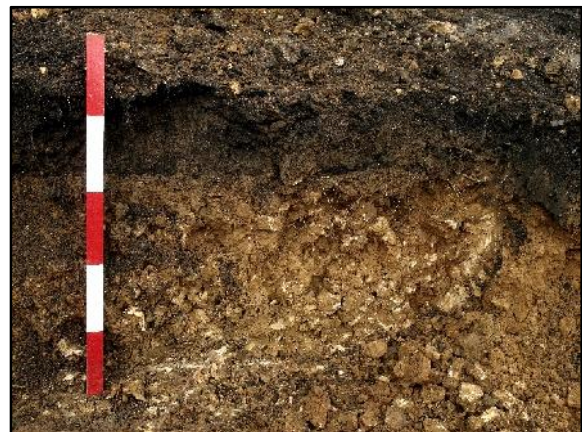
11. Detail of south-east facing section in the north-west foundation trench of the garage attached to House 3. Cinder trackway lying almost directly on top of natural. Scale: 1m.

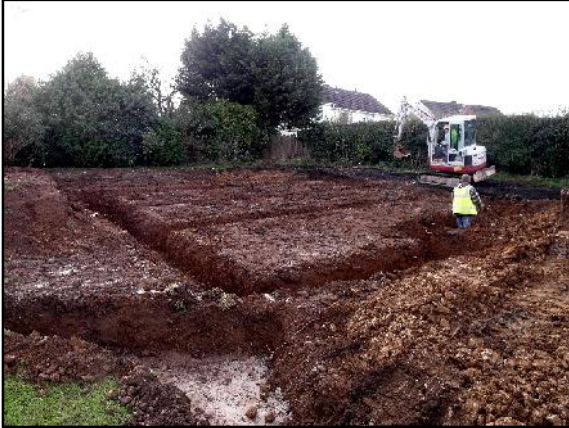
12. House 3 foundation trenches completed. View to west. In the foreground, concrete has been poured into the foundation trench for the south-eastern boundary wall (see **Figure 3**).

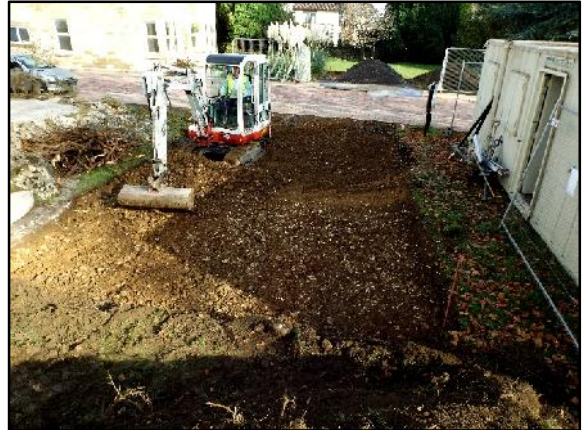
13. Completion of topsoil stripping in the former garden of one of the two pre-existing houses outside the development boundary, at the entrance of the new estate just off Wells Road. The work was carried out to install new driveways in front of both houses, and the image shows that for the westernmost house, shown on **Figure 3** and known as *Towerhurst*. In the background, behind the excavator, the easternmost of the two houses can just be seen, together with the spoilheaps from the stripping of its own garden.

strict limits of the site boundary, close to the entrance into the small cul de sac giving access to the new estate off the Wells Road, two large, detached houses had already been constructed, from historic map evidence at some point before the late 1950s. A small, late addition to the present project involved the stripping of topsoil and some subsoil from limited areas in front (ie immediately to the south-east of) both of these houses for new driveways and parking areas. Following stripping, the exposed surfaces were covered in terram sheeting and then finished off with rolled gravel. The areas involved were 77m² for the house on the north-western side of the access road, and 55m² for the house on its south-western side. Since both of these small areas were strictly *outside* the conditioned, red line boundary area, they are not specifically referred to in the **Figures**. However, both were nonetheless monitored in their entirety. For both areas, the formation level was about 0.30m-0.35m below the modern turf line, and in both, the work removed not only the turf and topsoil, but also the subsoil, revealing the top of the highly weathered and fractured natural Lias limestone clay formation (**Plate 13**). The subsoil on both sides of the access road contained very few finds, but those that did emerge were all modern. At no point during the monitoring of either of these areas were any structures, deposits or features of potential archaeological significance identified.
