**Former Griffin and Fudge Premises,  
Whiteheads Lane, Bradford on Avon,  
Wiltshire**

**Standing Building Recording Project  
NGR ST 82734 61063**

**Avon Archaeology Limited**  
Bristol: September 2017

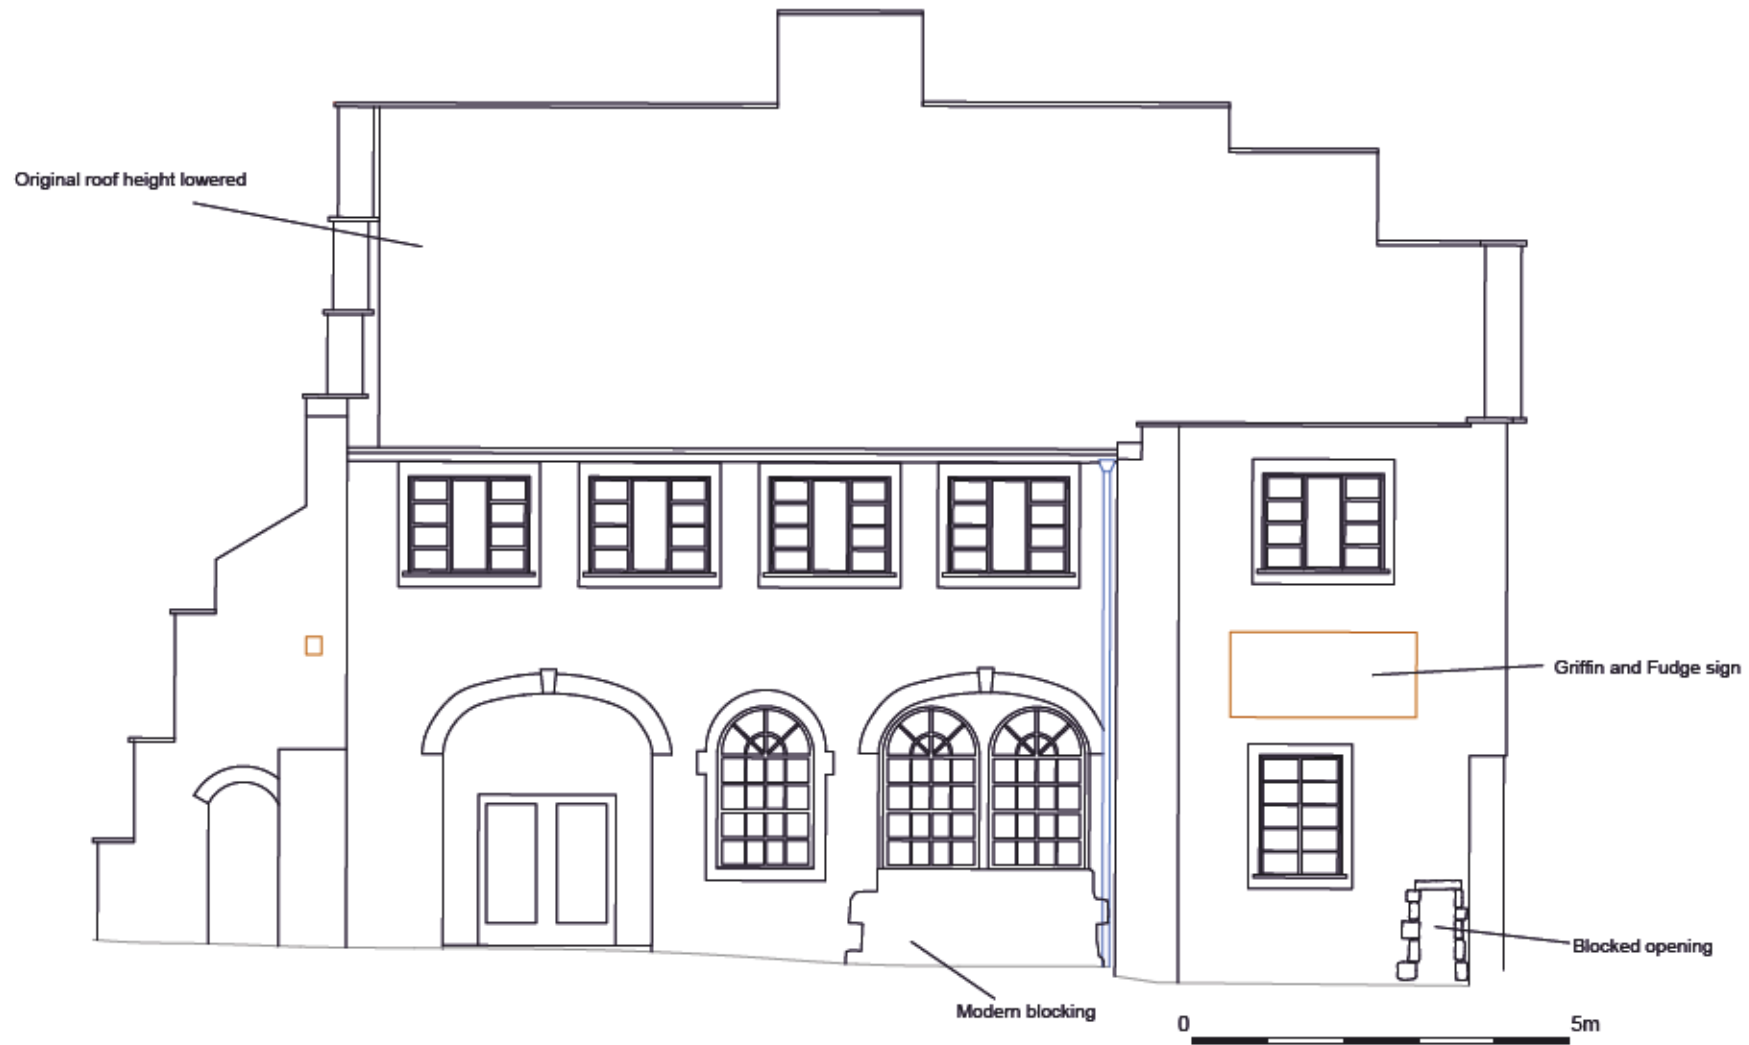
Figure 7

The former Griffin and Fudge office block (**Figures 3 - 4 & 6 - 8, Plates 1 - 4**) was also originally part of the G & T Brewery. Cartographic depictions show that originally it was physically connected to the wider Brewery complex, although the west facing gable end appears to be an original external elevation. Indications that the office was formerly connected to a larger building remain in the presence of a now redundant section of wall, with a vaulted archway, protruding from the south-west corner of the building (**Figure 7, Plate 1**). The Griffin and Fudge office comprises the southern half of a roughly T shaped building, bisected along its central east to west axis. Originally the T shaped building had a cross gabled roof, however the roof of the Griffin and Fudge offices has been reduced and is at the time of writing a flat roof (**Figure 7, Plate 21**).

The construction materials and architectural style of the former Griffin and Fudge office, which is the only building on site with a historically significant character, are consistent with the vernacular tradition of the area, the dominant characteristic being the use of Bath stone. Windows are predominantly metal frame. Those on the first floor are typically three light latch windows, divided into 12 panes. The ground floor is typified by more ornate arch topped one and two light windows, set in stressed Bath stone surrounds with pronounced keystones (**Figure 7**

South Facing Elevation of Office Building

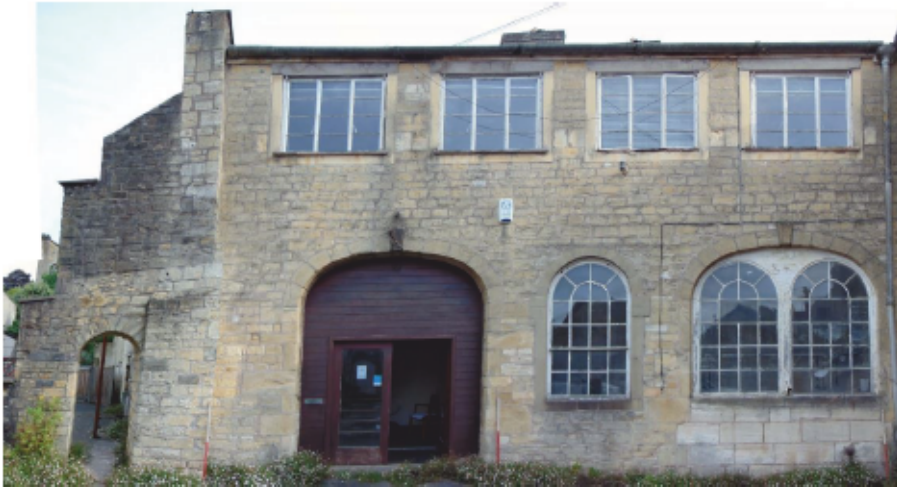
Plate 1: South facing external elevation of office building.

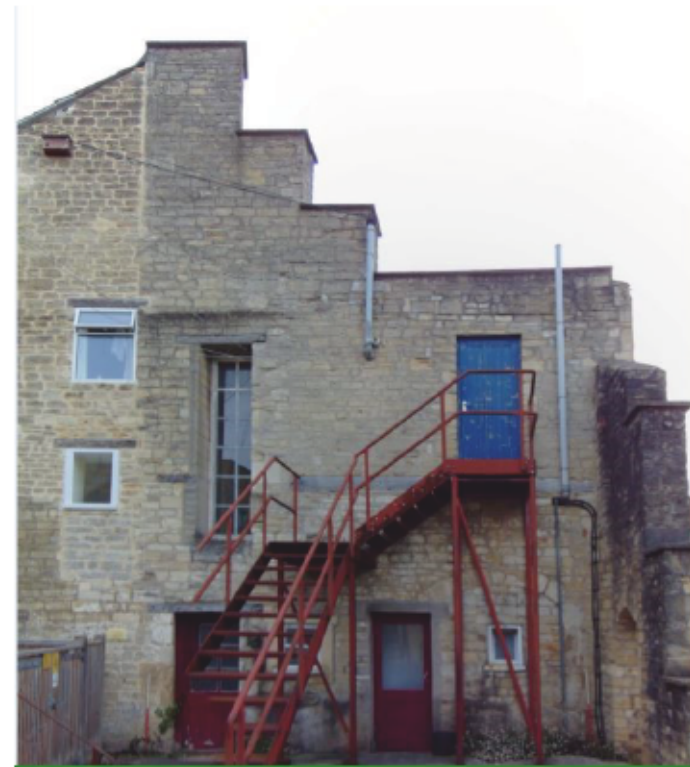
Plate 2: West facing external elevation of office building.

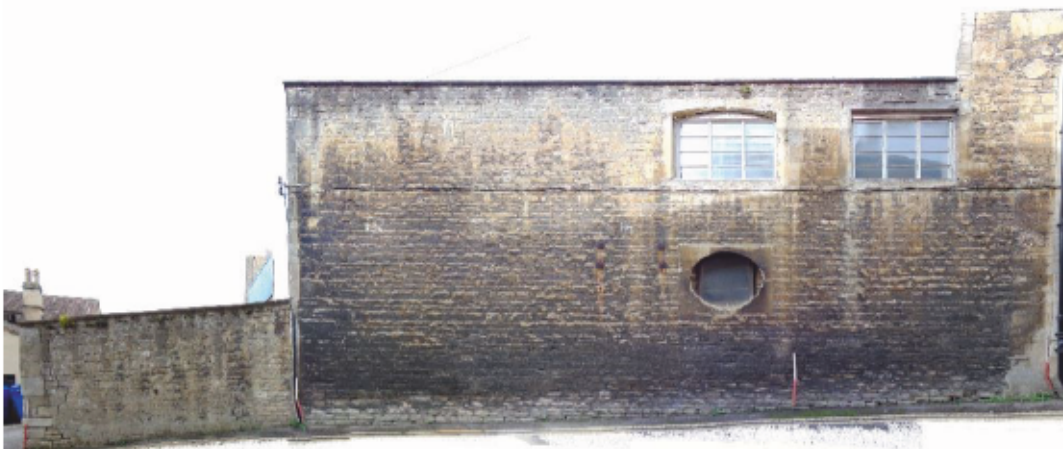
**& Plates 1 & 10**). Of note is a round opening in the east facing façade, which is now blocked but may also have been a window (**Figure 8 & Plate 3**).

Plate 3: East facing external elevation of office building.

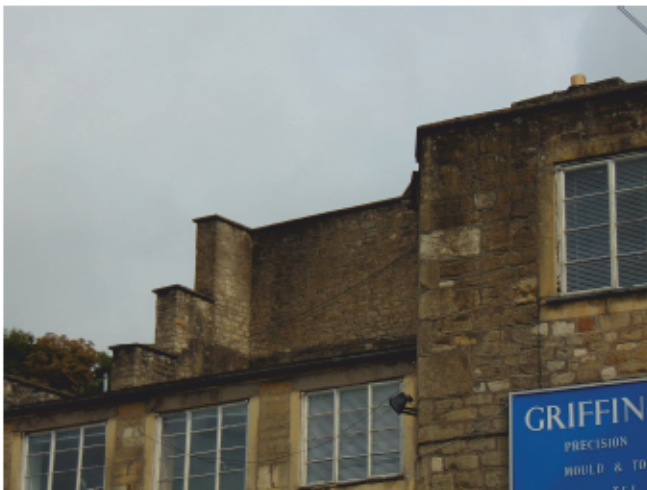
Plate 21: Looking north west at original roof line of office building.

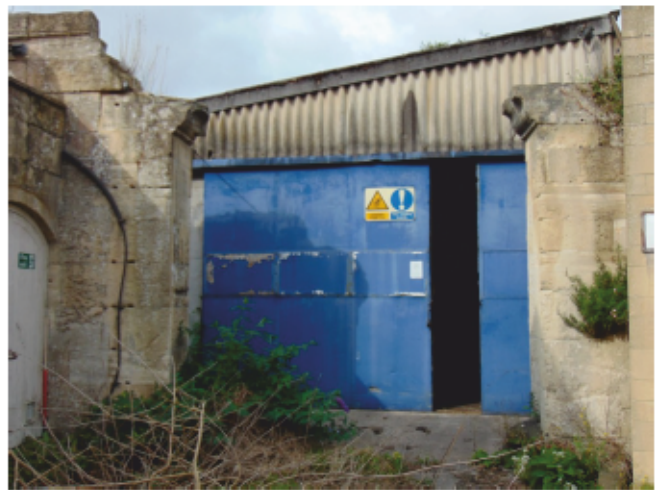
There are three ranges of interconnected workshop units (**Figure 5**). The southern range (**Plates 22 – 23**) is the largest and runs east to west. It is essentially a single hangar with a smaller unit on its southern side, the latter divided into two. The roofs of both sections are pitched and constructed from corrugated metal sheet (**Plate 26**). Access is via two sets of large metal roller doors in the east facing elevation of each unit respectively (**Plates 22 – 23**). The floor is concrete. Of significance is the dividing wall between the two units (**Figure 5 & Plates 24 – 25**). It is constructed from random coursed sandstone blocks and is probably of 19<sup>th</sup> century date, associated with the former Brewery. The eastern end of the wall extends beyond the lean to structure (although not to the front of the hanger). Its ends in a return to the south, where there was an arched opening, which has been removed leaving it an isolated structure, although it was clearly formerly attached to the boundary wall of the site (**Plate 22**).

Plate 22: View through partially demolished 19th century arch to the southern range of the modern workshop building behind. Looking west.

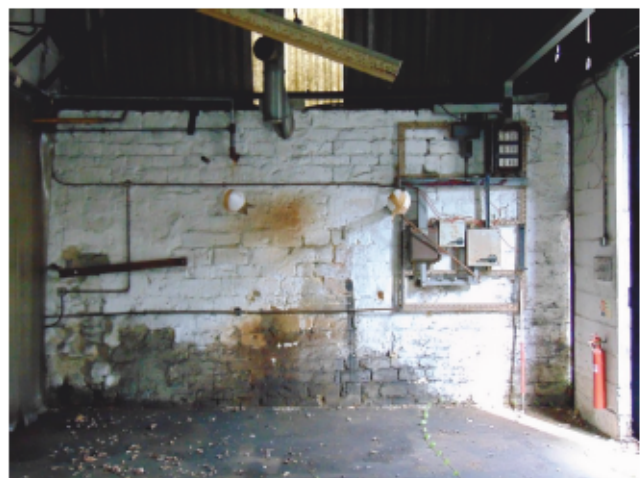
Most of the buildings on the Griffin and Fudge premises are modern industrial workshop units constructed in the 20<sup>th</sup> century. There are three blocks of steel frame buildings, which are interconnected forming a U shape (**Figure 5**). The linking axis of the units runs roughly north-south parallel with, and very close to, the western site boundary. The east facing façade of each of the industrial units is clad with machine cut rectangular blocks of random (but following a regular pattern) coursed sandstone bonded with cement. Behind the façade the units are predominantly built from concrete block. Although remnants of random coursed Bath stone masonry, likely to be surviving elements of the former brewery, were present within some of the modern walls (**Plates 24 - 25**).

Plate 24: Looking north at 19th century wall re-used as partition within the southern range of the modern workshop building (eastern end).

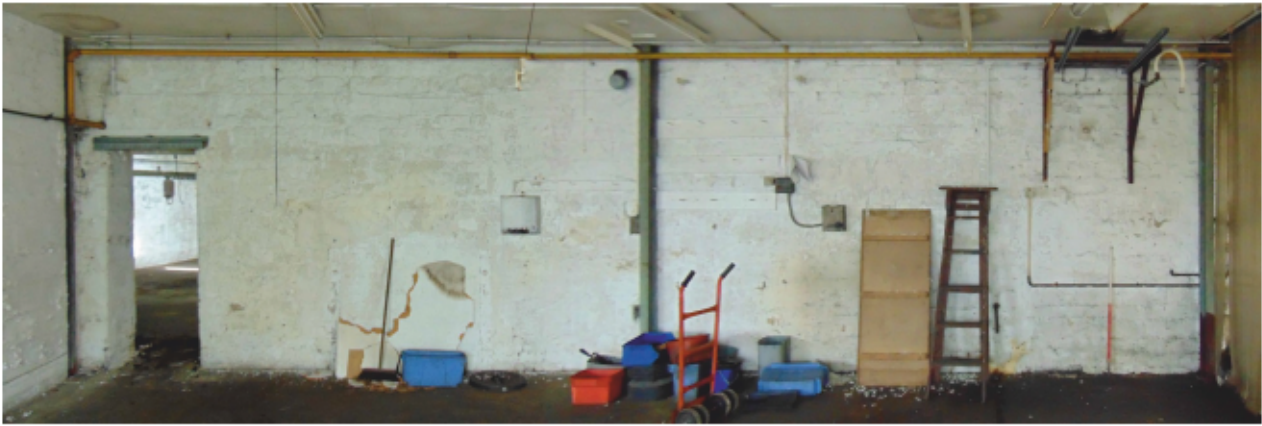
Plate 25: Looking north at 19th century wall reused as partition within the southern range of the modern workshop building (western end).

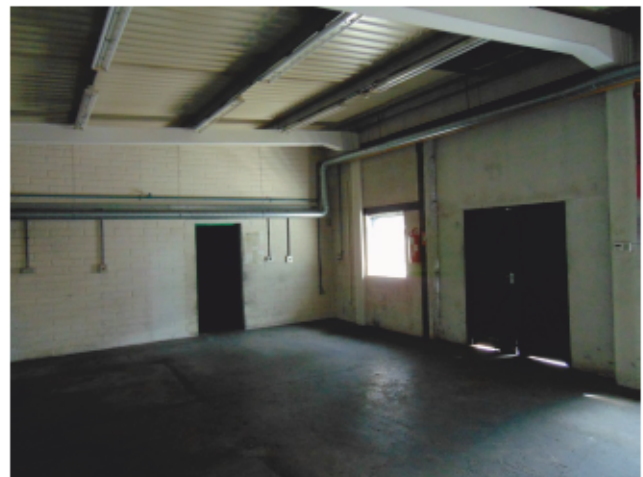
The central range (**Figure 5 & Plates 27**) consists of a single storey structure with a flat corrugated iron roof with a partition wall leading to the northern range. It is primarily constructed in concrete blocks with a Bath stone façade.

Plate 27: Looking north east at internal space of central range of the modern workshop building.

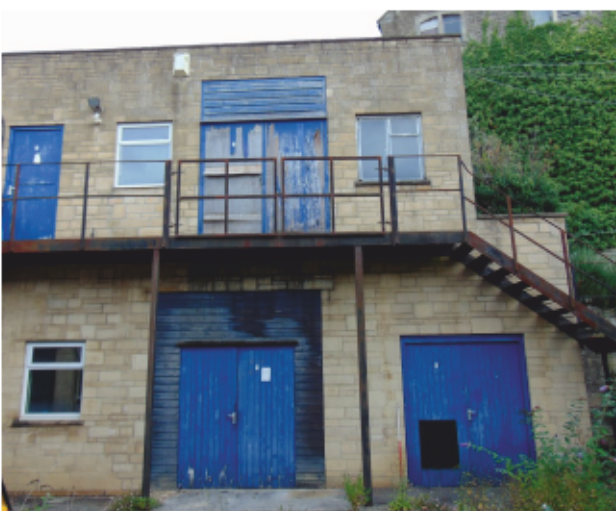
The northern range (**Figure 5, Plates 28 – 29**) is a two storey structure divided into smaller workshop spaces. It is constructed from concrete blocks with a face of Bath Stone on the south facing elevation.

Plate 28: Looking north at south facing external elevation of northern range of the modern workshops.
