# Land at Lansdown Court, Lansdown Road, Charlecombe, Bath

## Report on Archaeological Watching Brief

B&NES Application Ref. 11/00349/FUL

## Avon Archaeology Limited

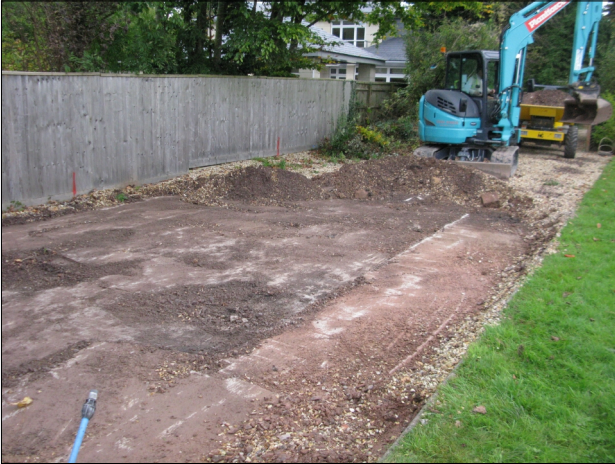
Plate 1. Looking north at the site

The concrete floor of the former barn building, which lay within the area of the new leisure facility, was removed along with topsoil across the entire area of the new building's footprint (**Plate 1**).

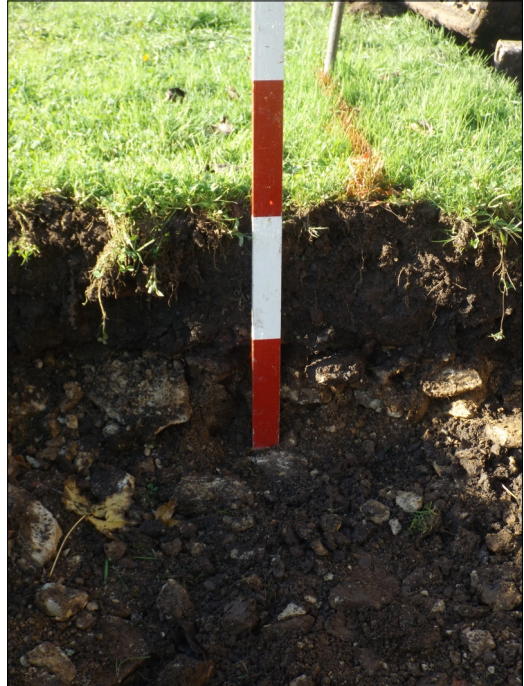
Plate 2. Detail of the excavation in section.  
Scale has 20cm divisions

The topsoil was approximately 0.40m deep (**Plate 2**) and directly over the surface of the underlying natural substrate, which was weathered limestone within a matrix of yellow brown sandy clay. Essentially this meant that there was no potential for buried archaeology within to footprint of the new building, however the excavation of subsequent foundations was monitored in order to confirm this. The foundations were excavated to an average depth of 0.50m below the reduced level, revealing intercolating bands of limestone and clay (**Plate 3**).

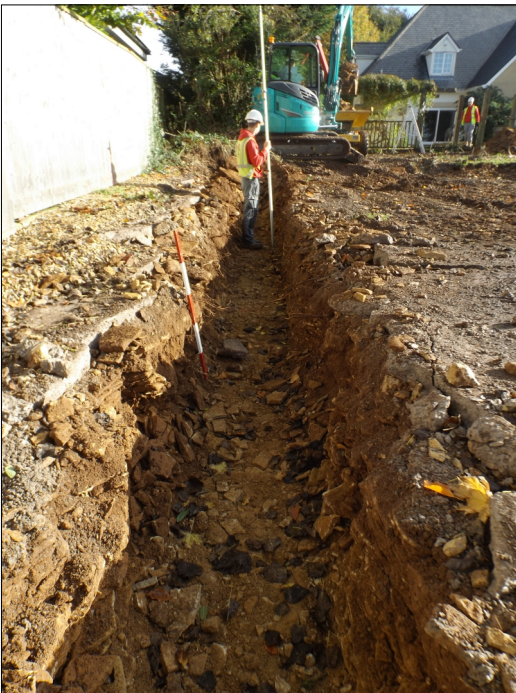
Plate 3. Looking north-east along the north  
foundation trench of the new building
