Castle Park Depot, Castle Park, Bristol

Archaeological Desk-Based Assessment

Avon Archaeology Limited

October 2019

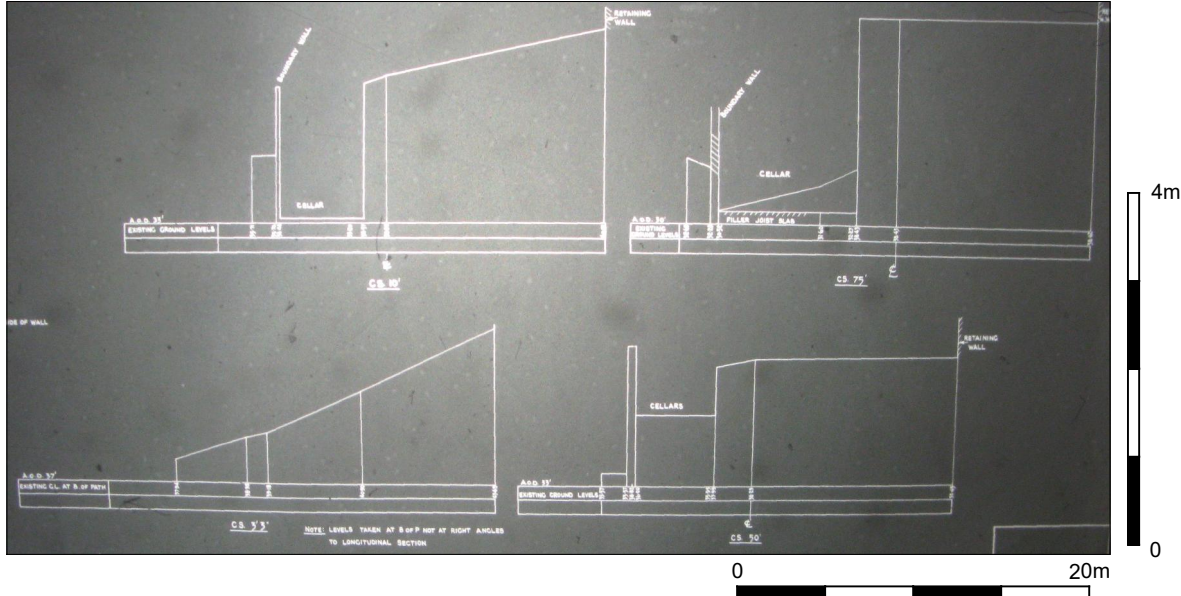
Figure 18

Sections CS 10", CS 50", CS 75" from BCC's Treatment over Castle Ditch (BRO 42054.G. Drawr 2/08793), showing depth of Post-Medieval cellars

The plans and sections suggest several points of relevance to the proposed development. The first is that, at the time of survey, the bases of the post-medieval cellars reached depths of 0.8m to 2.2m below ground level (**Figure 18**). Secondly, the new river wall, for the most part, uses the old river wall, possibly post-medieval in date, as its foundations. The longitudinal section of the proposed new wall (**Figure 20**) shows that, although the existing river wall stood to a maximum height of about 6m, only the lowest 2m to 3m was retained, with the upper portion of that wall dismantled and removed. A typical cross-section of the new river wall is also reproduced here, showing its depth, thickness and construction elements (**Figure 21**).

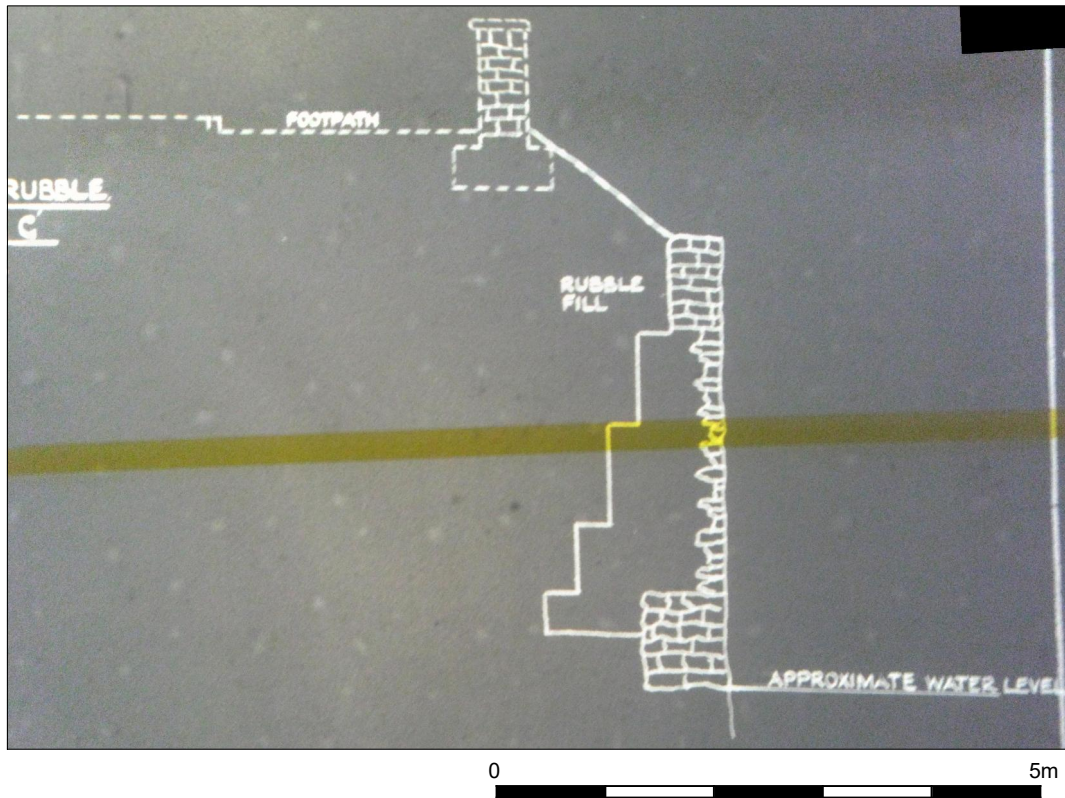
Figure 21

Longitudinal section of proposed River Wall along Castle Ditch
(BRO 42054.G. Drawer 2/06086)

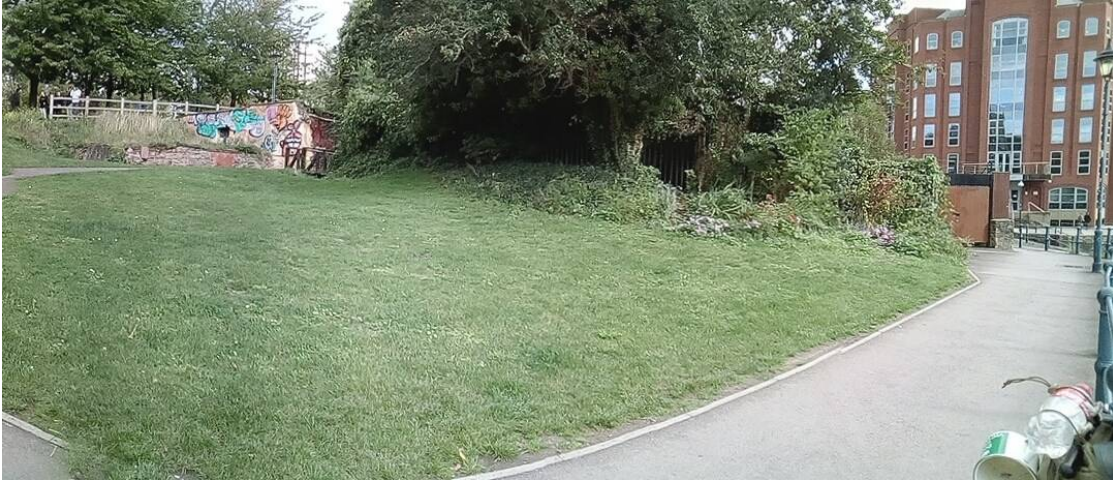
Plate 1. The western side of the site, looking north-east to east, showing slope of ground to the north.

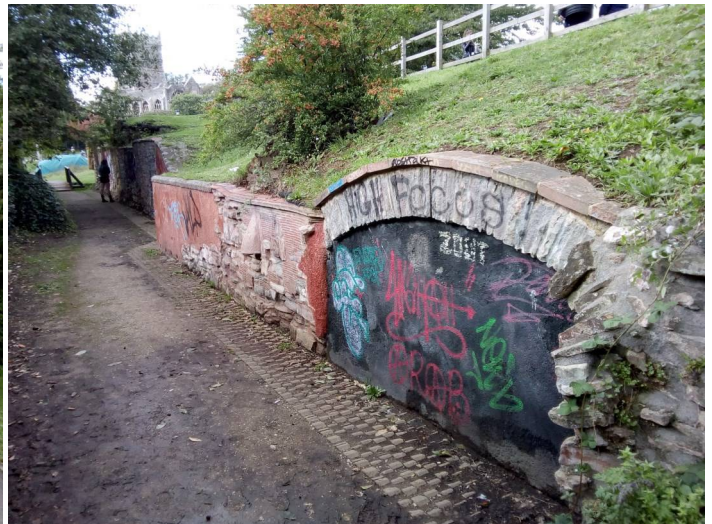
Plate 3. View of the covered western tower and curtain wall which border the northern side of the site, looking west.
