Land at The Car Park, Sadler's Mead, Chippenham, Wiltshire

Wiltshire County Council
Planning Reference 18/10267/FUL

Report on an Archaeological Watching Brief

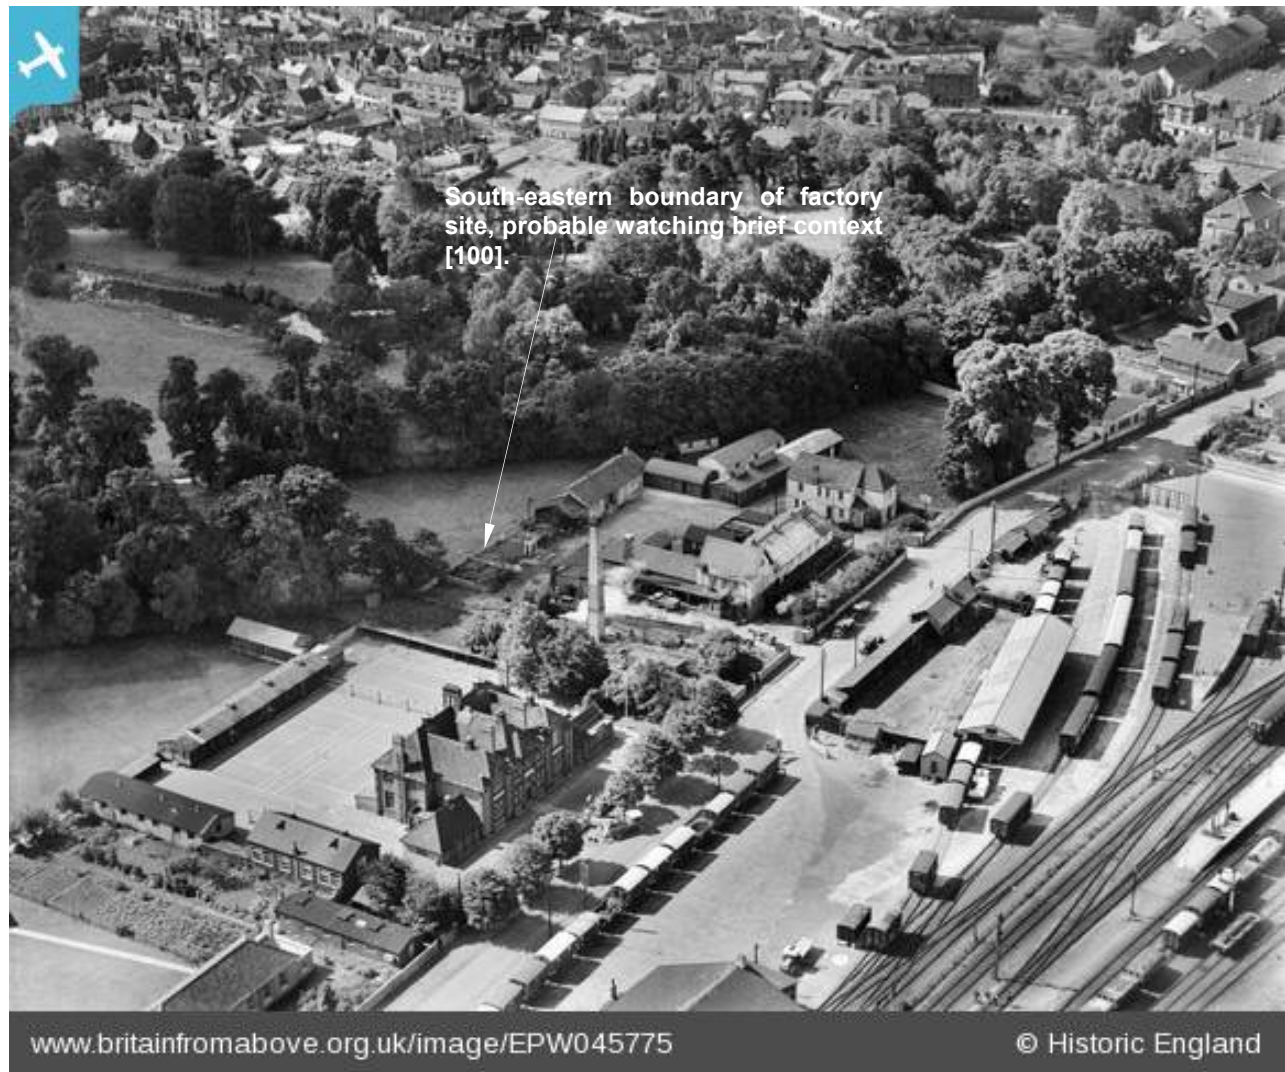
Figure 4

Oblique aerial image of the Wiltshire Creameries factory, on the southern side of Cocklebury Road, 1934. Looking south-west. The building with playing courts to the left of the factory (ie to its north-east) is a school. The south-eastern boundary of the factory site (indicated) is most likely to represent the linear feature identified as [100] in the course of the watching brief, running along the north-western side of the site. The River Avon can just be seen at the very top left corner of the frame. It seems possible, or even likely, that vestiges of the factory may remain underneath the north-western half of the site, which is now earmarked for development with an office block. Source: *Britain from Above* online aerial imagery, Historic England. Full reference as shown on the image.

In reviewing both the nature of the feature itself, its context, and the historic map evidence, it is our view that this feature, on present knowledge, is most likely to represent the grubbed out and backfilled remnant of the south-eastern boundary wall of the Wiltshire Creameries milk 'factory', which dates from the early 1920s (**Cover**). It seems as though the original south-eastern boundary of the milk factory, as indicated in an aerial photograph of 1934 (**Figure 4**), was probably removed at the time of the establishment of the present car parks, and the present low boundary wall was established immediately to the north-west of the original line.

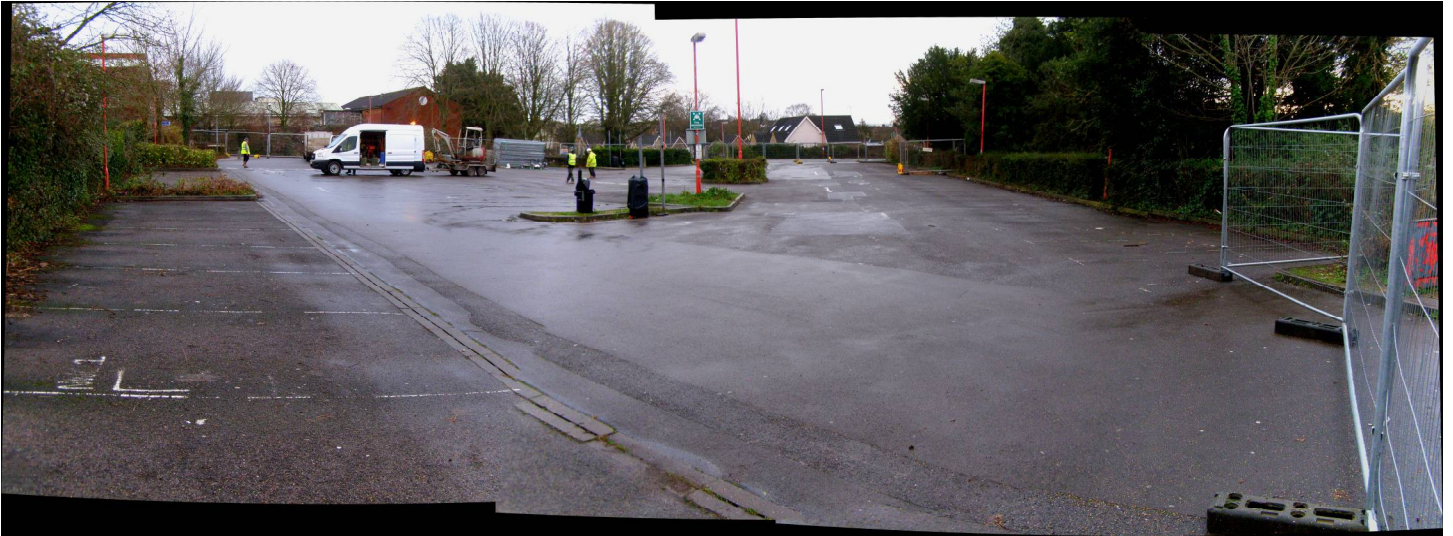
1. Composite panoramic view of the site prior to the commencement of excavation work. Taken from the western corner. The image pans round from north-east (left hand side of frame) to east (right hand side of frame).

The state of the site prior to the commencement of the excavation work is shown on **Plate 1**. All of the low, kerbed 'islands' that can be seen in the image were removed for the work. In terms of actual deposits making up the generality of the site, it became apparent fairly quickly that they consisted almost entirely of various kinds of make-up, directly on top of the natural Cornbrash limestone. This consisted overwhelmingly of the tarmac surface of the car park, laid on top of a make-up and levelling layer consisting of gravel scalplings. **Plates 2 to 14** to provide an idea of typical sections within the interventions that were monitored, with Plate positions identified on **Figure 3**. The plate captions give location and other details. The maximum depth of these interventions was 1.8m below the car park surface, as most typically represented by the eight structural bases on the north-western side of the site, running in a line north-east/south-west (**Plate 4**). These were of slightly varying sizes but the largest, **Bases 3 and 4** on **Figure 3**, measured *about* 4m square. It should also be noted that because of the requirements of spoil management, the bases were actually excavated alternately, so that numbers 1, 3, 5, and 7 were done first, and then numbers 2, 4, 6 and 8. **Bases 6 and 8** were not monitored, but were fully examined after excavation, and **Bases 9 and 10** were fully monitored. Numerous modern services were noted sealed by the car park surface, usually former telecoms or electricity cables. An active fibre optic cable ran very tight along the top of the north-western sections of the bases at the north-western side of the site; and in the northern corner of **Base 6**, a modern plastic drainage pipe, in a concrete casing, was sealed below the car park surface, and running roughly southwards (**Plate 9**). This was pretty much identical in form and construction to the pipe noted running across the width of **Base 20**.

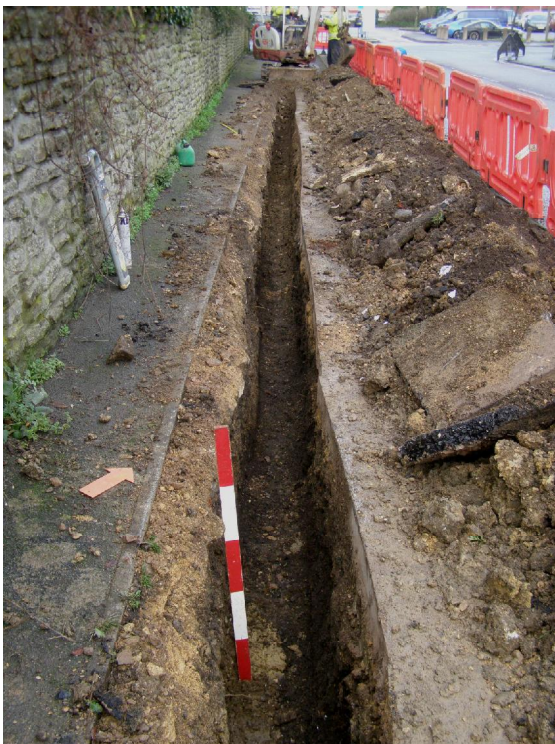
2. Trench for a new EV cable being inserted into an existing service cut in the pavement just outside the north-eastern side of the site, on the western side of Sadler's Mead. Scale: 1m

set of bases was at about 57m aOD. For example the bottom of **Base 6**, after a thin skim of concrete had been poured to provide a dead level surface, was measured at 57.20m aOD by the client's site surveyor using a Leica robotic total station. On the north-eastern side of the site, the south-west facing section of **Base 19** (depth 1.80m, level of base, 56.64m aOD) *appeared* to display what looked like a remnant subsoil (**Plate 11**), but in view of the findings over the remainder of the monitored interventions, it now seems more likely to have represented a part of the backfill of the original service trench in the pavement very close by just outside the site, on the western side of Sadler's Mead, which was, as already noted, recut during the present project for a new EV cable. This deposit, 0.38m thick, was entirely devoid of cultural material of any kind. This trench consisted entirely of the pavement surface and modern make up deposits, just intruding onto the top of the weathered natural substrate (**Plates 2 and 3**).

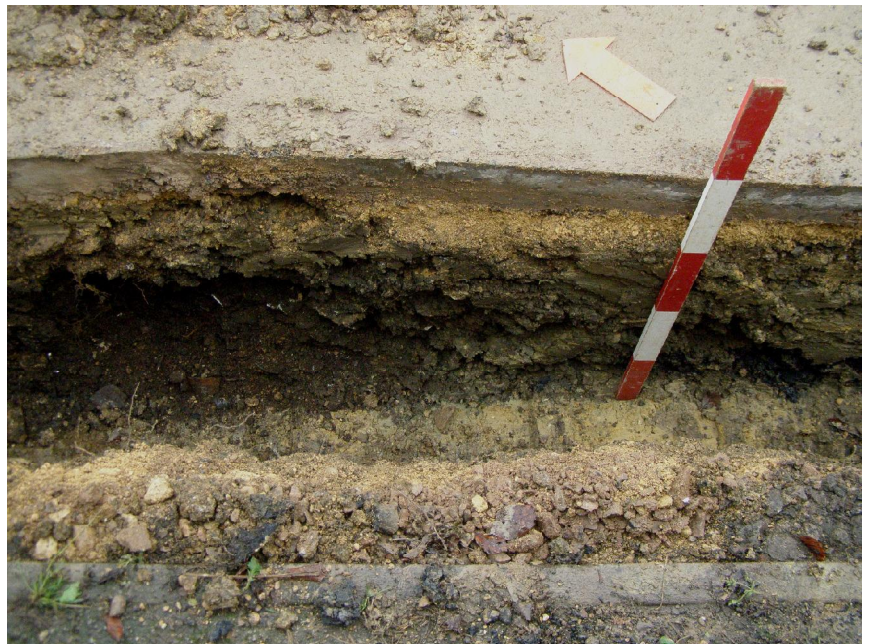
3. Detail of cable trench section showing modern make up on top of the natural Cornbrash bedrock, just showing up at the base of the trench. Scale: 1m

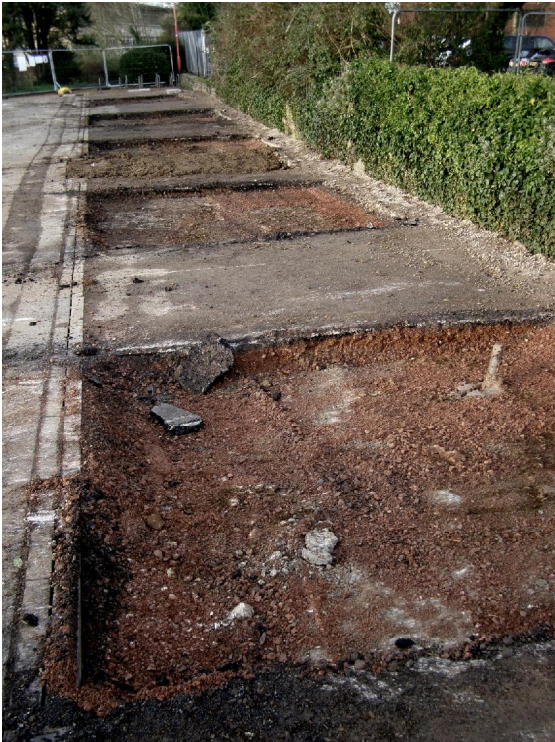
4. General view of structural column bases on the north-western side of the site, prior to excavation. Base 1 in the background, Base 5 closest to the camera. View to south-west.

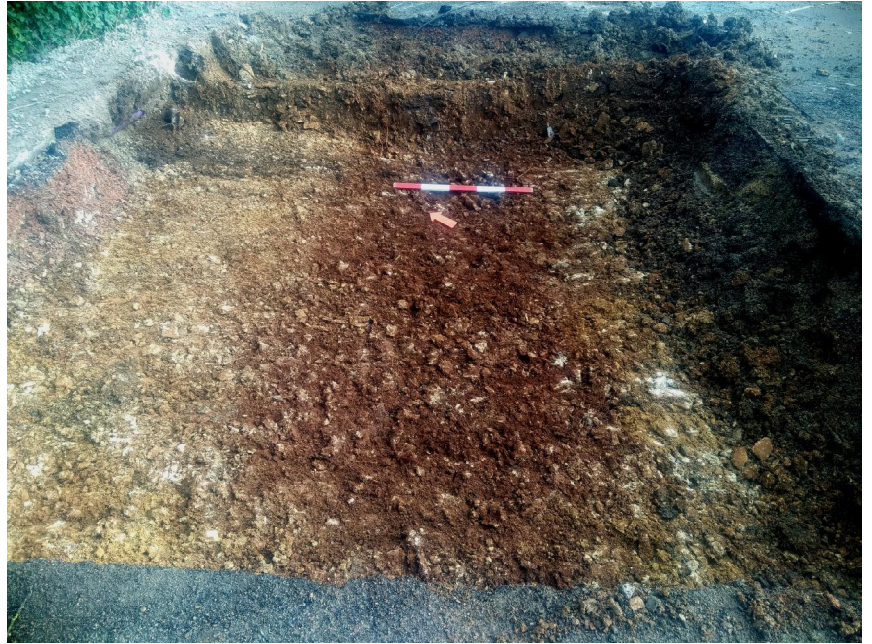
5. Base 1 under excavation, showing linear cut [100]. View to north-east. Scale: 1m.

The sole feature that could in any way be described as of minimal archaeological interest, was a linear cut found to be running south-west/north-east, observed in the sections, albeit intermittently, in all of the square bases which ran along the site's north-western boundary, ie **Bases 1-8 (Figure 3)**. The feature seemed to run apparently exactly parallel with, and very close to the south-east of, the low wall which currently separates the site from the two car parks on its north-western side – one belonging to Openreach, and the one to its north-east a former public car park, but now closed for use. The feature was first identified in plan during the stripping of **Base 1 (Plate 5)**. It was then traced in section through the other bases. It was perhaps best expressed, however, in the north-east facing section of **Base 3 (Figure 3, Plate 8)**. Because it was so obviously the same feature throughout this set of bases, this cut was given a group number of [100]. As expressed on **Plate 8**, it seemed clearly to have been cut from high up, and then sealed by the car park surface. There were occasional modern services cut into its fill, as witness the plastic pipe shown on **Plates 6 and 8**. At its widest point, it measured 1.70m, and depth as found in **Base 3** was just over 1m. The sides were steep, and the base concave. The profile appeared pretty symmetrical, but this did vary somewhat throughout the various bases on this side of the site, probably because of differential damage done when what it originally contained was removed (see further below). The fill of the feature as recorded from **Base 3** (101), was a mid-brown silty clay, of soft compaction and rather friable in the hand, acting as a matrix for numerous pebble-size sub-angular stones, clearly derived from the natural Cornbrash. This means that, while the *matrix* was not compact, the deposit as a whole could be described as firm to hard in places. There were no inclusions evident, and it was noted especially that there was an absence of charcoal, and of any finds at all. The deposit as a whole seemed no less compact than the surrounding material, and certainly did not have the nature of a 'typical' ditch fill. This may also explain why, while there was a low degree of root activity, it was not as great as might have been expected had the material been rather less compact. It seemed to us, therefore, that whatever this

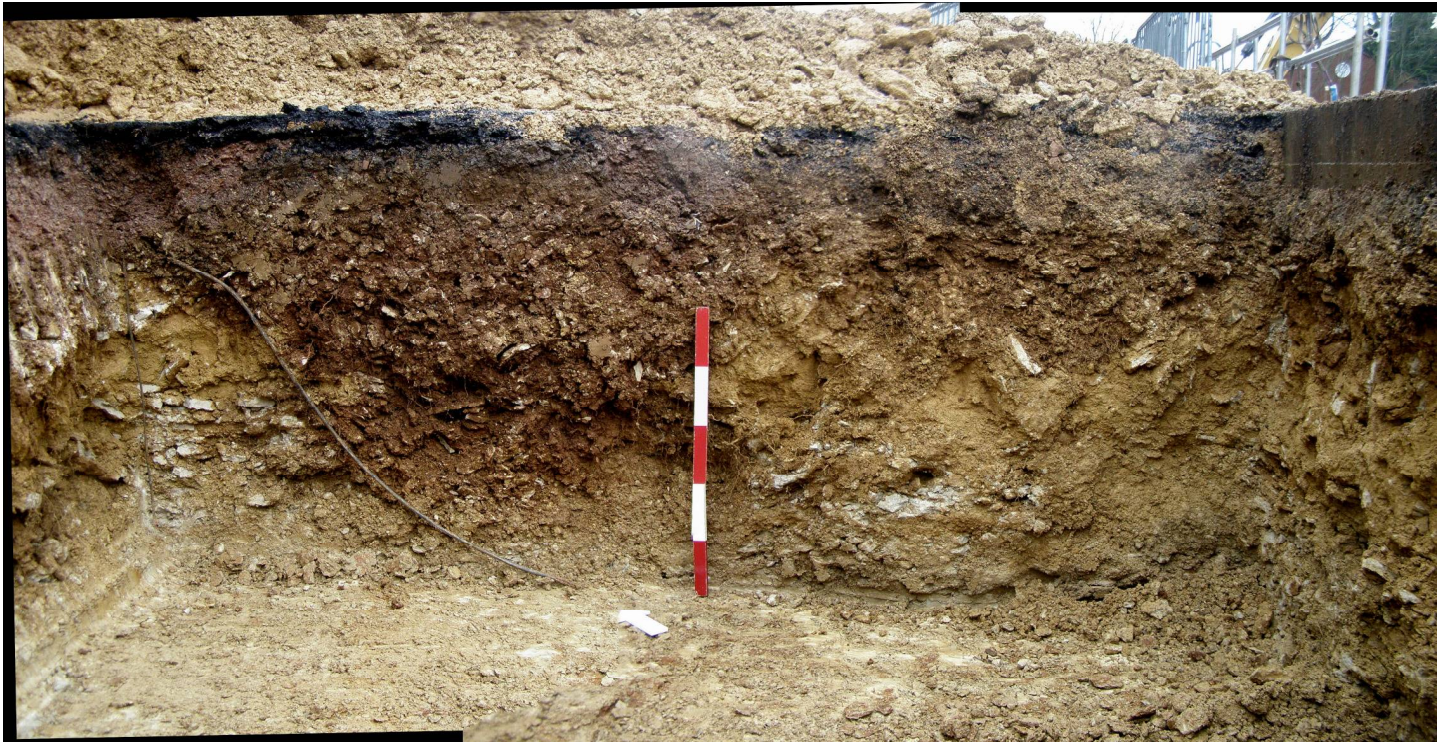
7. Base 2, south-west facing section, prior to pouring of concrete skim in the base. Note cut and fill of north-east/south-west linear, shown in plan in **Plate 5**. Scale: 1m.

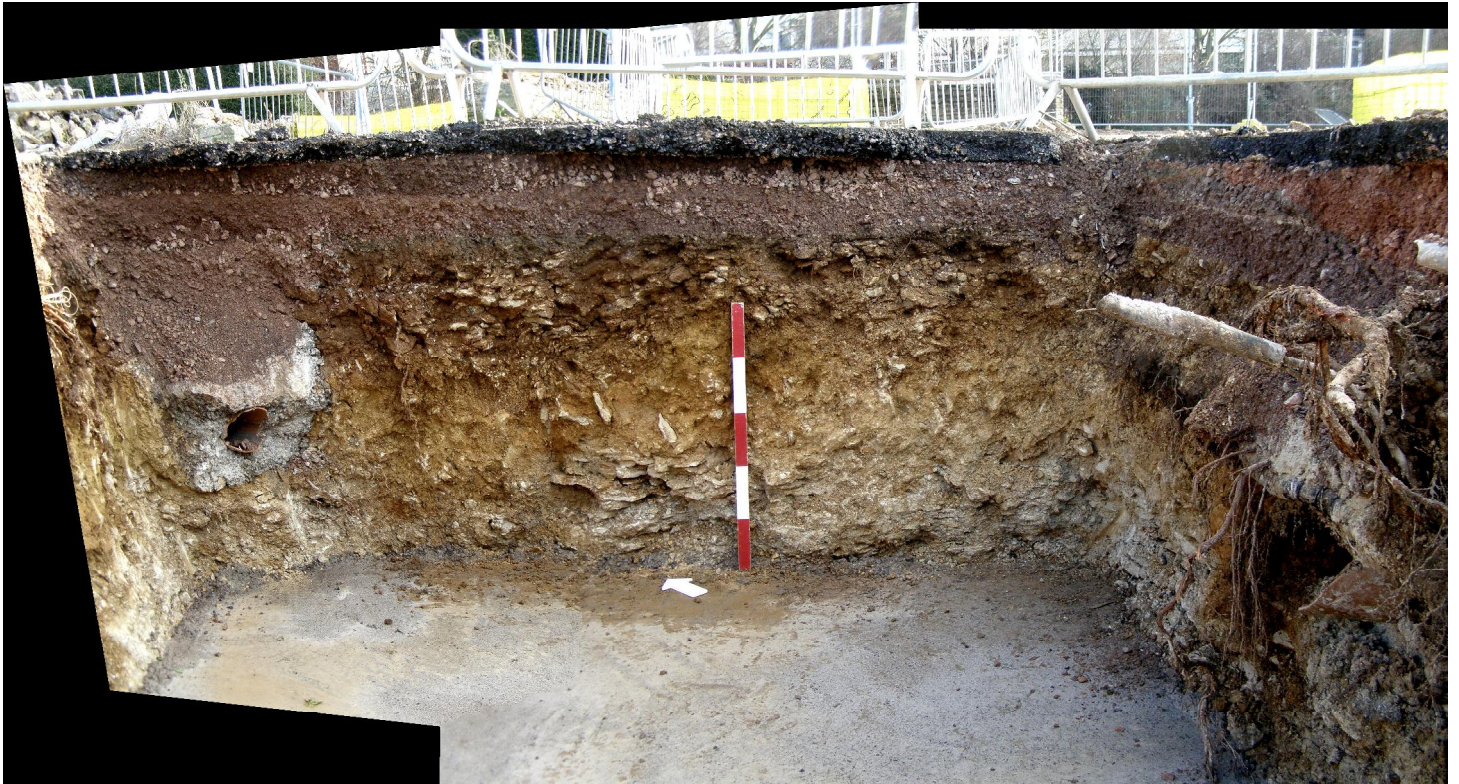
9. Base 6, south-west facing section. Modern concrete encased plastic pipe in the northern corner of the section, with vestige of cut [100] to the right. Scale: 1m.

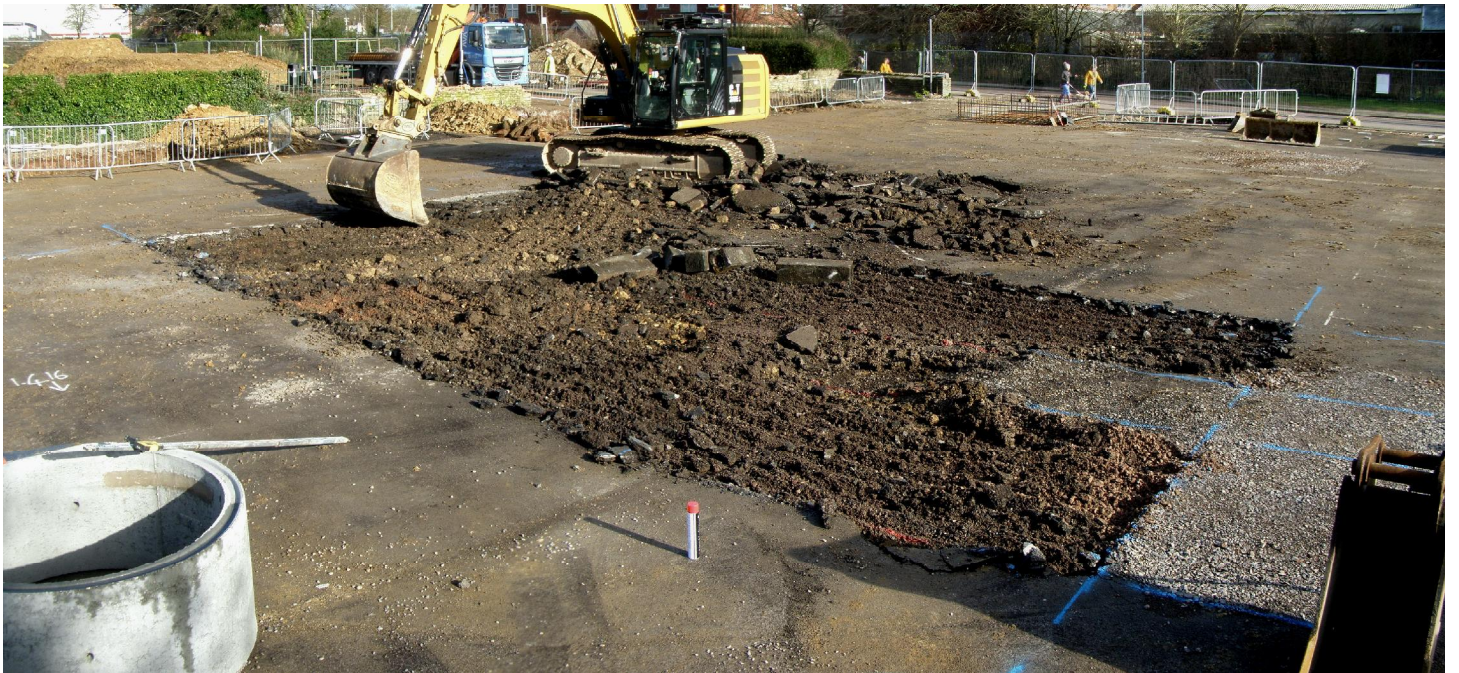
10. Starting excavation of Bases 20 and 21, following stripping of tarmac surface of former car park. View to north.

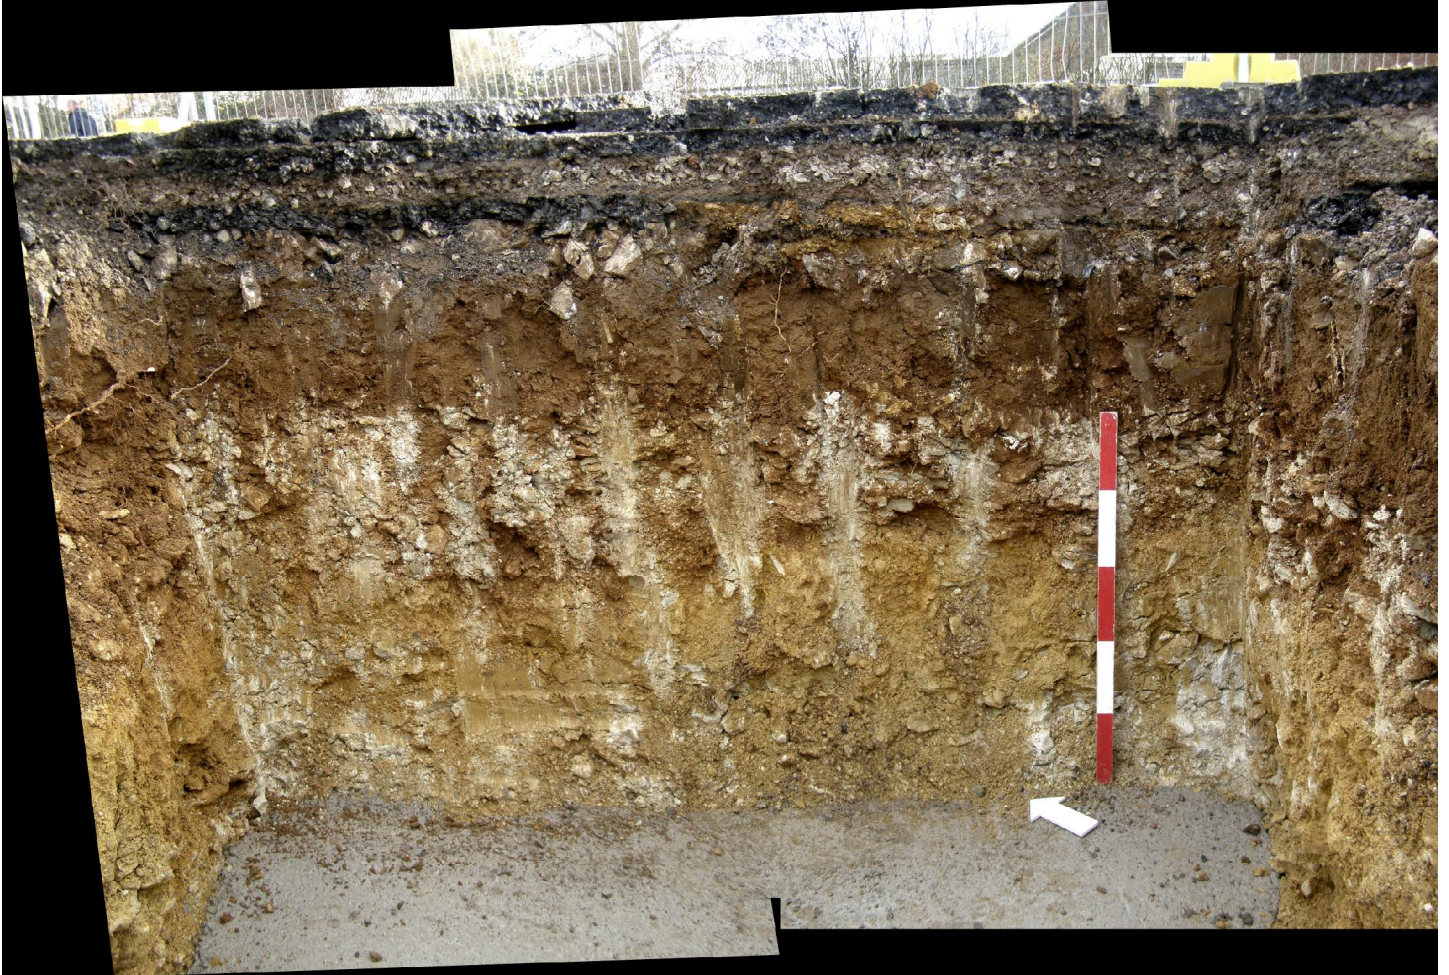
11. Base 19, south-west facing section. The car park make up lies on top of what initially appeared to be a remnant cultivation subsoil, but which on closer inspection was probably part of the backfill of a modern service (probably EV) trench in the pavement immediately outside the site to the north-east. The site boundary fencing can be seen at the very top of the image. Scale: 1m.

Throughout the course of the work, however, what was most striking, however, was the total absence of anything that could be described remotely as a cultivation or agricultural deposit, underneath the car park make up layers, and, as already noted for Base 19, the apparent complete absence of any cultural material whatsoever, of any date, in any of the deposits from the monitored interventions. It is clear from the historic map evidence that this area remained as open and undeveloped land well into the 20th century, and although it was a part of the formal parkland attached to Monkton House, we learn from the mid-19th century tithe survey that much of the parkland was used for pasture at that date. And indeed, post-war aerial photography shows the survival up to at least the early 1950s of a large area of ridge and furrow immediately to the east of the site, on the north-eastern side of Sadler's Mead and occupying an area in the angle between it and Cocklebury Road; and indeed remnants of it are still clearly visible on LiDAR images of the extensive playing fields attached to the Wiltshire College campus. As observed in virtually all of the monitored sections however (see **Plates**), the stratigraphy consisted of modern car park make-up lying directly on top of the natural substrate, quite often with cuts for a variety of modern services, whether drainage, telecoms or electricity. At least some of these were clearly related to the large BT Openreach building, immediately outside the site to the north-west.

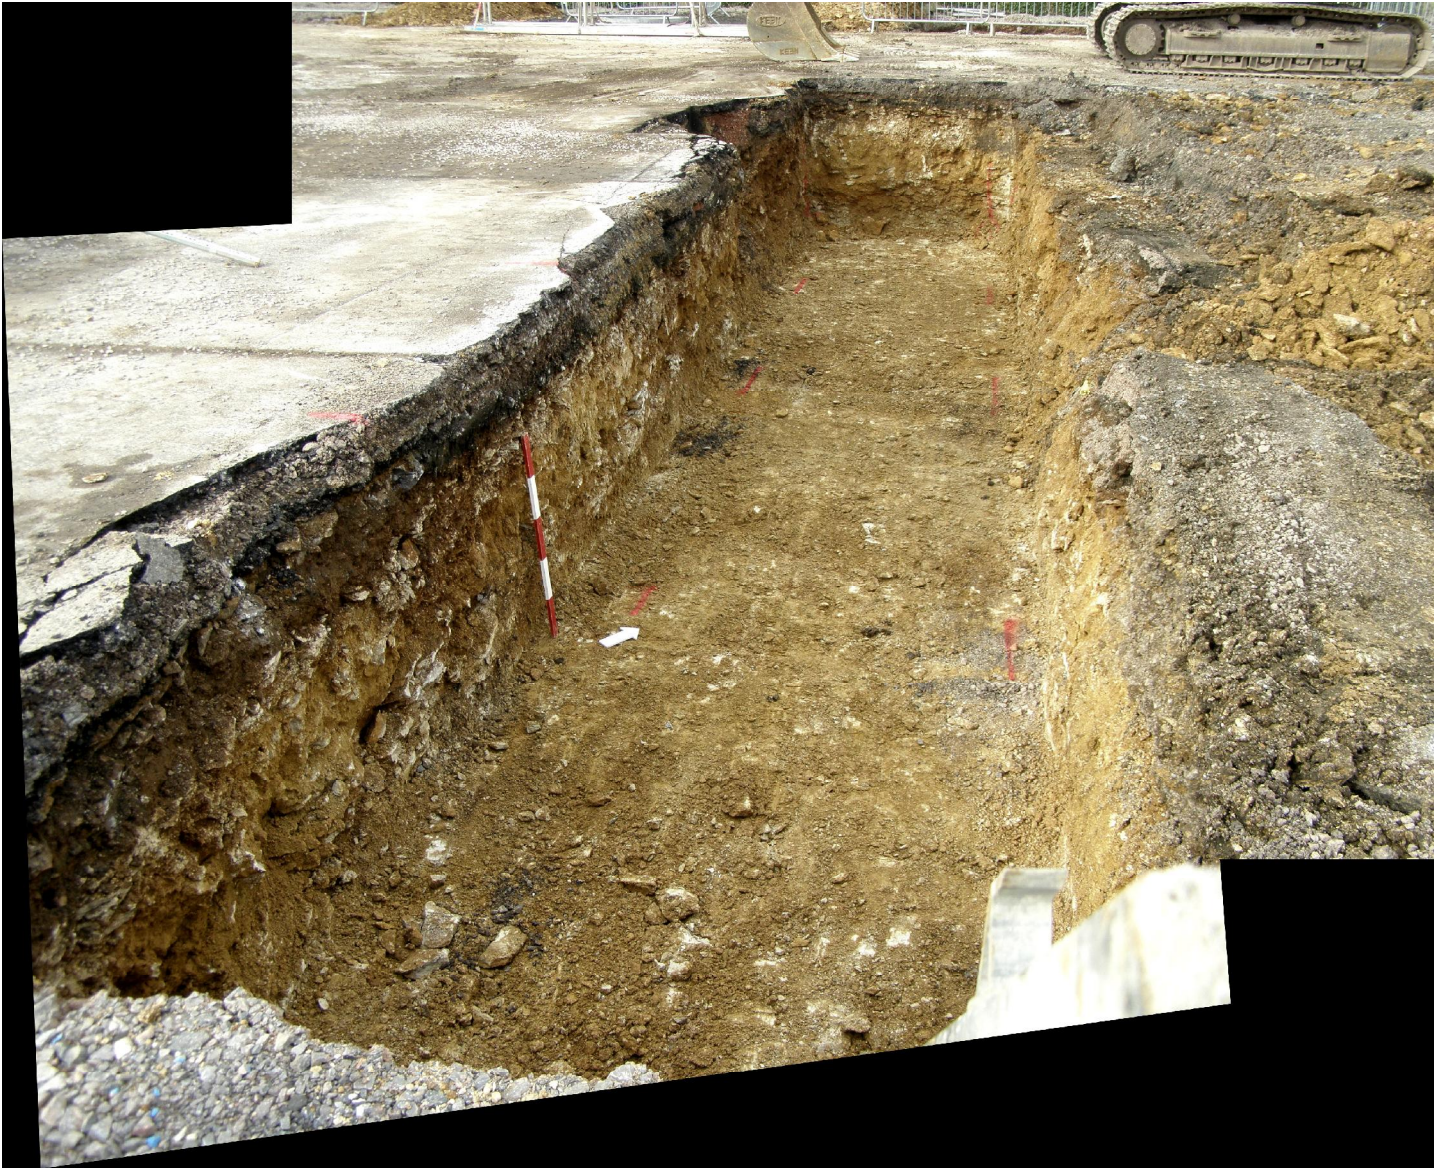
12. Base 20, fully excavated, but prior to pouring of concrete skim. View to north-north-west. Note collapse of the car park surface at the far end, on the left-hand side, which is where a major modern drain crosses the line of the trench. Scale: 1m.

The intervention for **Bases 20 and 21** together formed the largest single excavation that was monitored, and provided a very useful window for examination virtually in the middle of the site (**Figure 3, Plates 12 and 13**). **Base 20** was fully monitored, and **Base 21** was partially monitored. At 1.50m below the current car park surface, the depth of **Base 20** was rather less than that for the other interventions up to that point, to take account of the general southerly downward slope of the site. The north-east facing section of **Base 20**, however, revealed the same narrative of, essentially, modern car park make-up layers above fractured and weathered, but in situ, natural Cornbrash, in turn sitting on top of the unweathered natural. At the north-western end of this intervention, a modern drain consisting of a plastic insert in a concrete casing, and running roughly east-west, had been cut into the natural and then sealed by the car park surface.

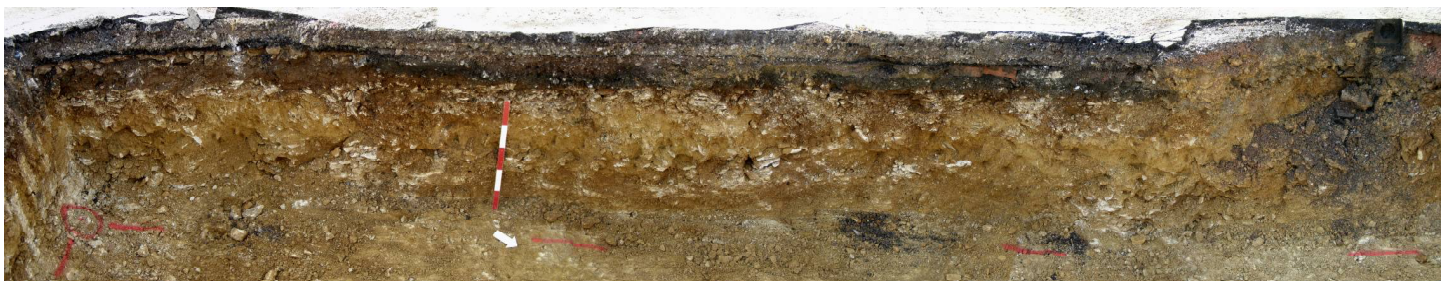
13. Base 20, north-east facing section. The stratigraphy here, right in the middle of the site, consists of various types of levelling and make up for the car park surface, resting on fractured and weathered, but in situ, natural Cornbrash limestone. Scale: 1m.

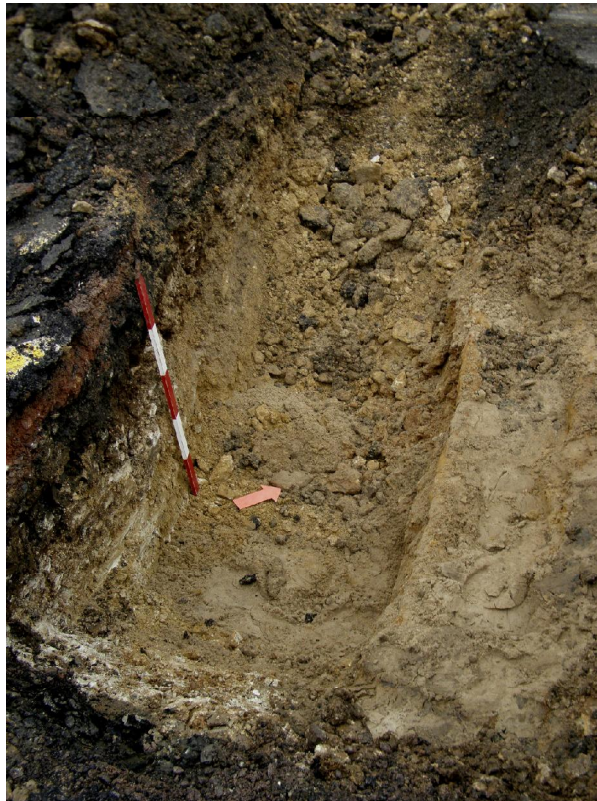
14. Image of the non-structural intervention on the south-eastern side of the site, related to the installation of the new EV cable which runs north-south from the site, out into the pavement on the western side of Sadler's Mead. North as indicated. Scale: 1m.

intervention was entirely negative archeologically, consisting only of the car park surface and make-up lying on top of the natural Cornbrash substrate (**Plate 14**).
