Land at Combe St Nicholas Primary School, New Road, Combe St Nicholas, Somerset

South Somerset District Council Planning Reference 20/01129/LBC
Somerset HER PRN 42561
Somerset Museums Accession Number TTNCM 61/2020

Report on an Archaeological Watching Brief

Avon Archaeology Limited

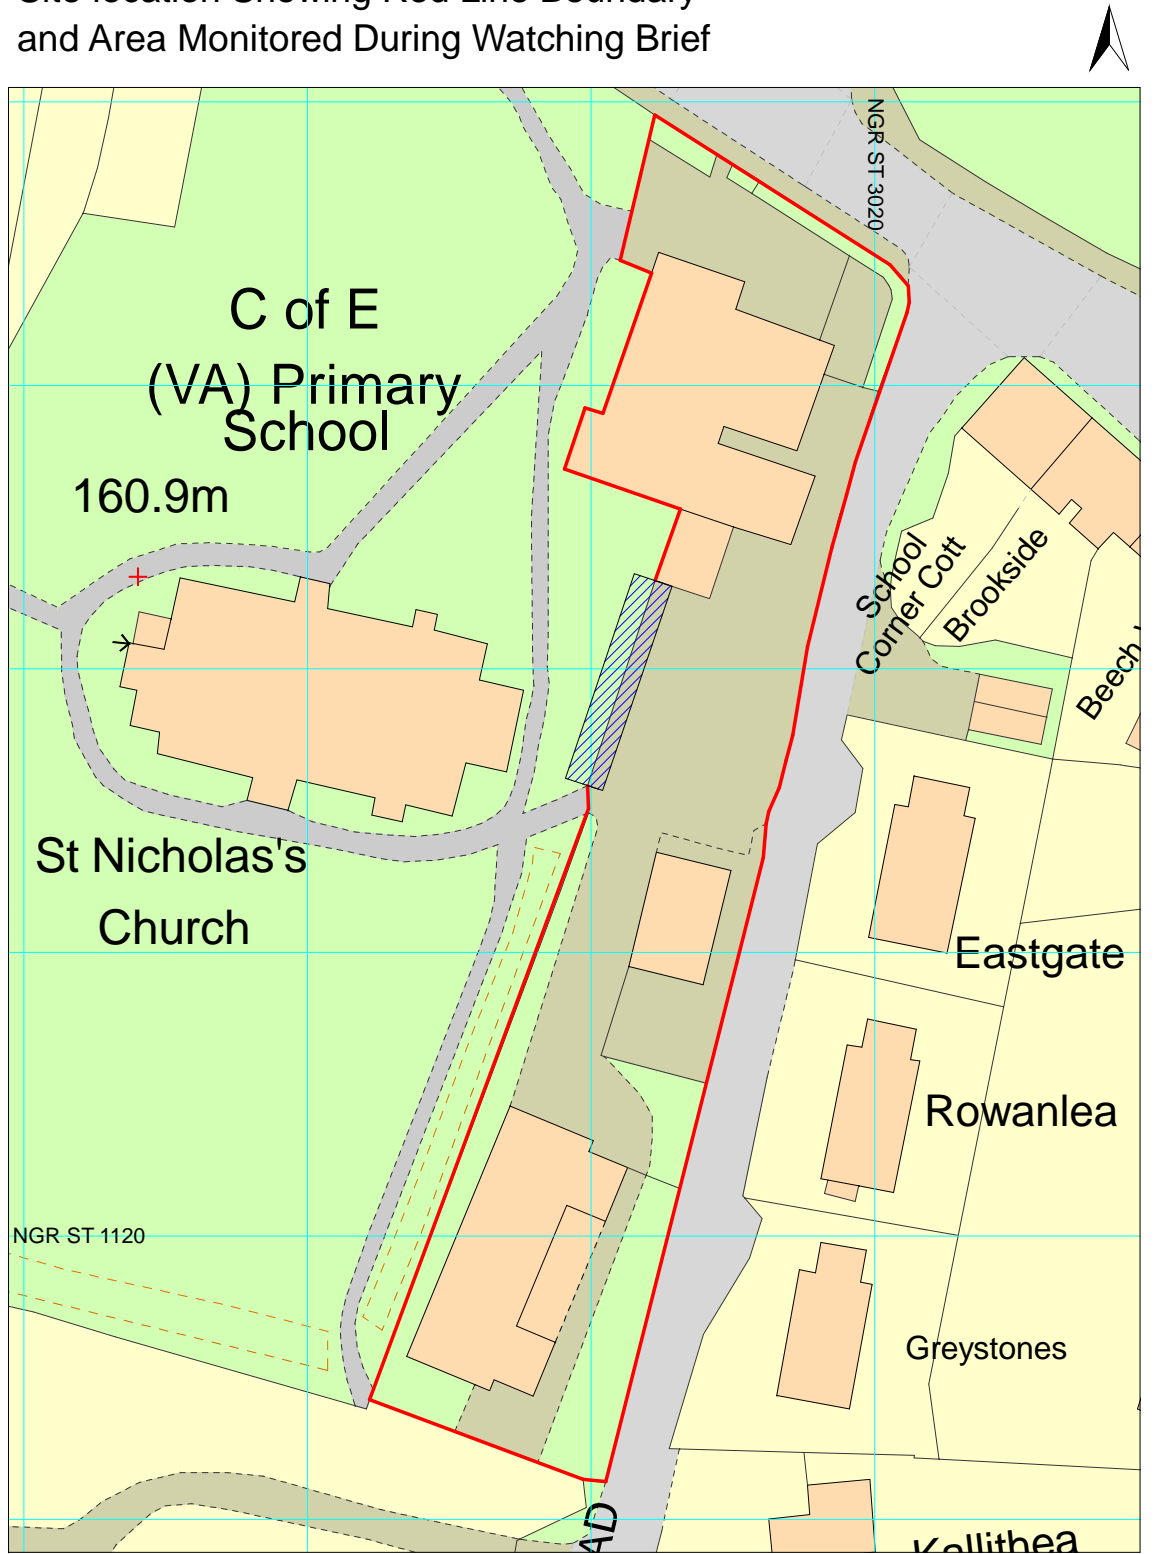
Site location Showing Red Line Boundary
and Area Monitored During Watching Brief

Area Monitored During Watching Brief

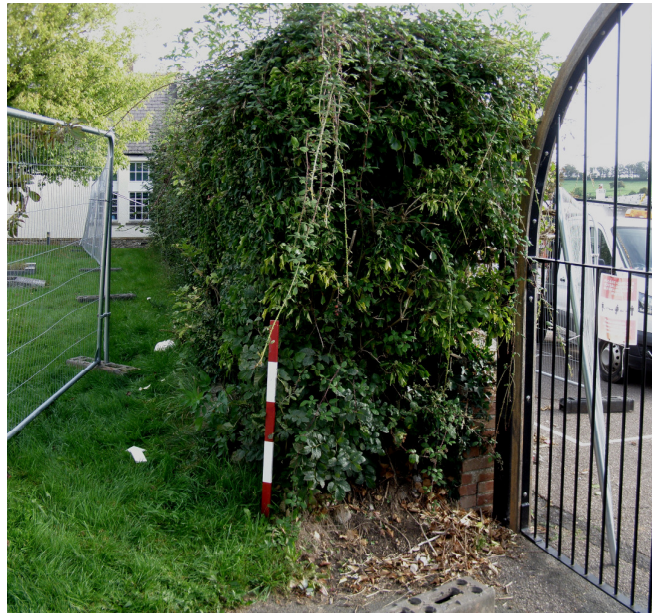
1. View along the hedgeline from its southern end, looking north, prior to the commencement of the work to remove it. The historic stone boundary wall within it is almost completely invisible, apart from a section of a later brick extension, acting as the northern jamb of the gate which leads from the school playground into the churchyard. Scale: 1m, view to north.

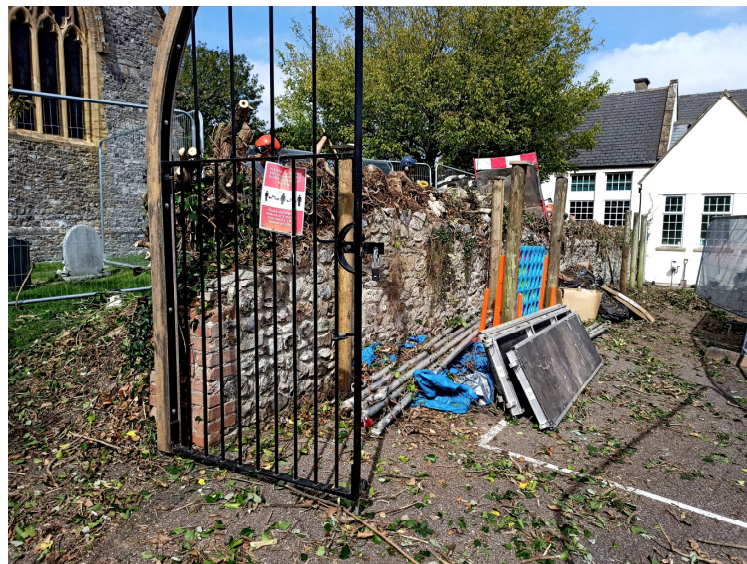
2. The main bulk of the hedgeline foliage removed, view to north-west from the eastern side of the boundary wall, in the school playground.

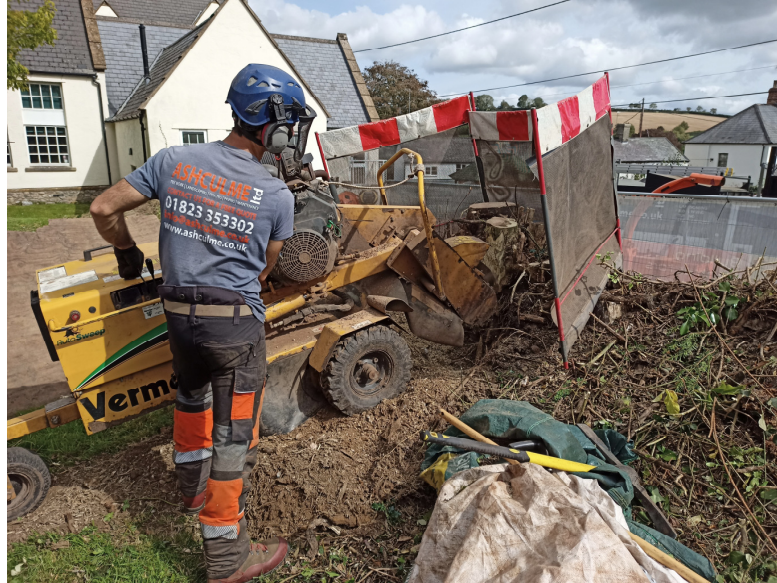
3. The larger remaining stumps were removed with a combination of a mechanical grinding machine (as here) and a mini-digger with a toothed bucket.

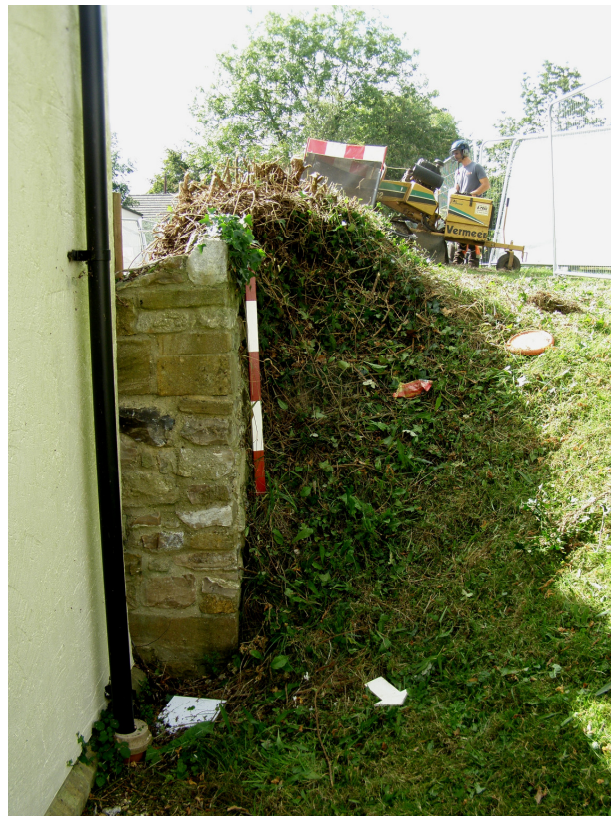
4. View to south from the northern end of the boundary wall, showing the bank established against the western elevation of the wall. Scale: 1m.

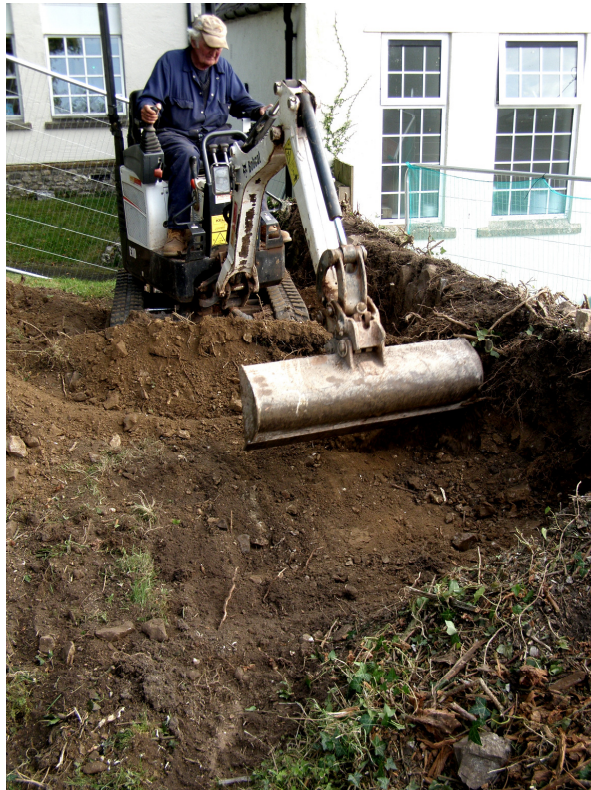
5. Following removal of the hedge, the bank which had supported it was levelled by machine.

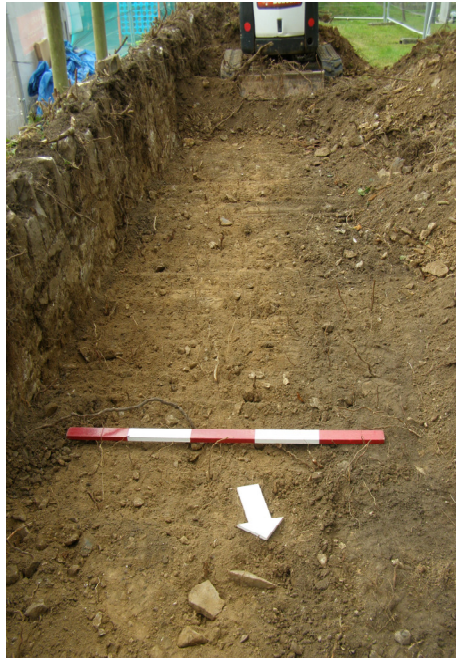
As the removal of the bank material from against the western side of the wall, progressed, it became clear that there was a very distinct change of material in an almost dead straight line north-south a short distance from its western elevation (**Plate 6**). The darker, *in situ* churchyard material (105) gave way close to the wall to a far lighter, sandy, stony material (104). It seemed clear to us, therefore, that this was in fact a construction cut for the wall. What is likely to have happened is that a vertical cut was made through the *in situ* churchyard material, wall (100) was constructed, presumably in a further cut in a conventional foundation trench, and then the space behind it was backfilled with (104), which is likely to have been imported from elsewhere. Wall (100) is acting effectively as a revetment for the churchyard material behind it. It is therefore highly likely that in terms of the installation of the posts for the railings, there will be no archaeological implications because the post shafts will be dug into (104), which we consider, from the levels taken both on the churchyard (western) and on the playground (eastern) side of wall (100), ought to be at least 0.80m in depth. The client has advised (*pers comm*) that the contractors who will be installing the railing fence will not need to excavate any deeper than 0.80m, and it may be less. Any additional support required can be addressed through the use of brackets attached to the wall itself. The post shafts will therefore not penetrate into whatever material it is which underlies context (104).

6. This work revealed what appeared to be a clear linear cut [103], in the darker churchyard material (105) to the right of the frame, (ie west), filled with a much lighter deposit (104) on the left (ie east). This is almost certainly a construction cut for the boundary wall (100), on the left of the frame. Scale: 1m.

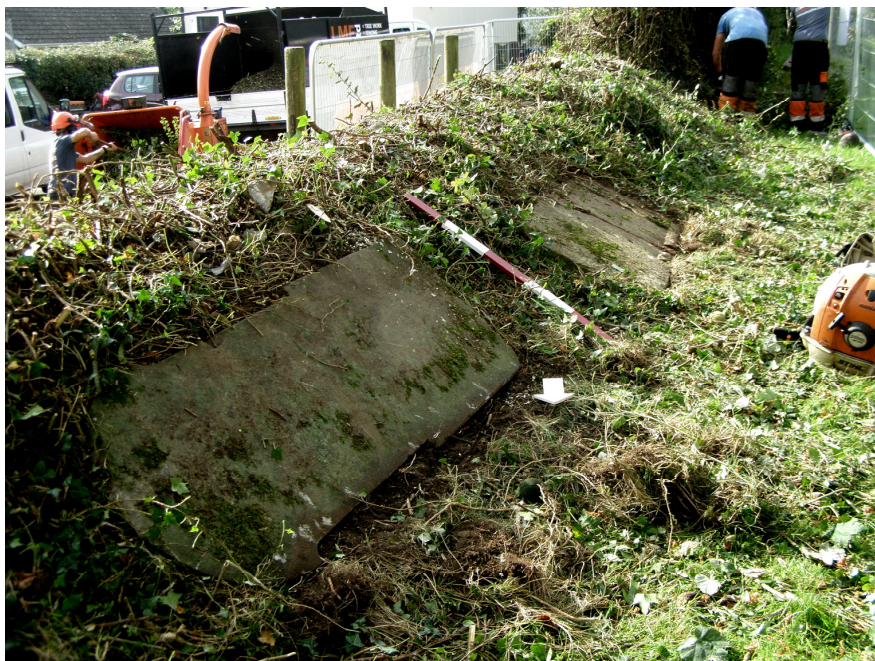
The major discovery during the clearance phase of the hedgeline were two previously unknown and unrecorded ledger slabs which had been dumped on the bank, at its northern end, and the hedge had then clearly just grown up around them (**Plate 7**). We cannot see how they could have been dumped into anything like the *existing* hedge, *unless* it was at that (unknown) time only in the very earliest stages of becoming established. They were, anyway, obviously not *in situ*, and their original locations are entirely unknown, as likewise the reason why they were removed from the churchyard and relocated, with apparently scant ceremony, in the location in which they found. The ledgers were surveyed in with the GPS unit, and a basic level of recording was undertaken on them so far as was possible. **Figure 3** shows their position in relation to the wall. They were given the context numbers (101) and (102). The latter was the southernmost one of the two, but as it had been left, however, it was at least face up, and although in pretty bad condition, its inscription was partly legible. From both the design of the decoration, which was fairly elaborate, and from the inscription, it was clear that this slab was of 18th century date (**Plates 12 to 15**). This stone was, unfortunately, broken. The northernmost ledger (101), as found, lay face down and so its inscription could not be read, but it was clearly in far better condition, being made from quite a different type of stone. The fine state of preservation of (101) was confirmed when both slabs were moved away from wall (100), to a safe position on the south side of the chancel of St Nicholas's church, and the inscription, once brushed off, was completely intact and could be easily read (**Plates 8 to 11**). The slabs are noted in the Table of Contexts (**Table 1**), but are described in rather more detail in the **Appendix**. Exactly *when* the slabs were moved from their *in situ* location in the churchyard, to the position in which they found, is entirely problematic. All we can say with certainty is that it must have been *after* the date of the latest interment recorded on the late 19th century slab (102), ie 1888; and although of course we cannot be certain, it seems to us most likely that, although separated by over a century in terms of their respective dates, they were moved to

7. The two ledger slabs as found, dumped on the bank on the western side of the boundary wall, where clearly the hedge had grown up around them. (101), the 19th century example, in the foreground, with the inscription side downwards, (102), of the 18th century, further away from the camera, with the inscription and decorated side uppermost. See **Figure 3**. North as indicated, scale: 1m

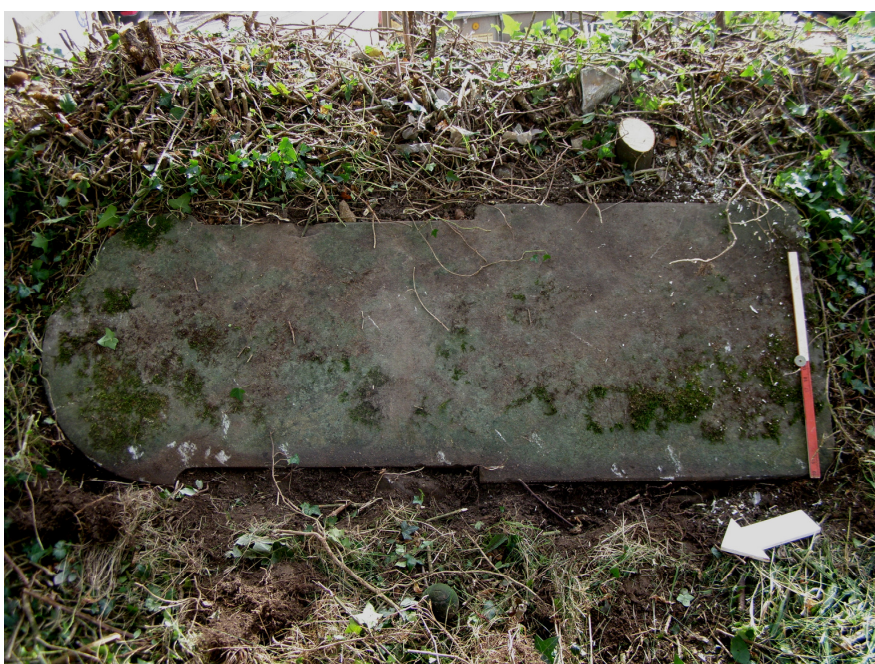
Material: unknown, but looked on close inspection very similar to Pennant Sandstone. This is a hard, brittle, crystalline material, difficult to carve finely and not generally considered a freestone. The right-angled shoulders at the base of this ledger appeared unusual – an inspection of very similar memorials still standing in the graveyard found exclusively only sloping shoulders. But that comparison also showed that, unlike for the 18th century ledger (below), it is very unlikely that the entire base of the slab *below* the shoulder was intended to be beneath the ground; rather, ground level was probably about $\frac{1}{2}$ or $\frac{2}{3}$ of the way up the base of the slab.

8. Detail of 19th century ledger slab (101) *in situ*, as found. Note right-angled shoulders demarcating the lower from the upper part of the slab. No exact match could be made between this slab and examples still standing upright in the churchyard, all of which appeared to have had sloping shoulders in this position (see **Plate 9**). Scale: 0.50m

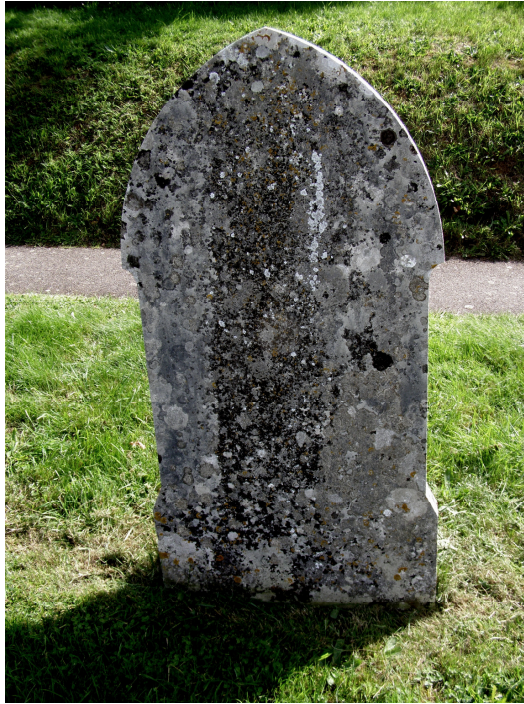
9. Rear face of a standing ledger slab of 1924, very similar to (101) but with sloping lower shoulders.

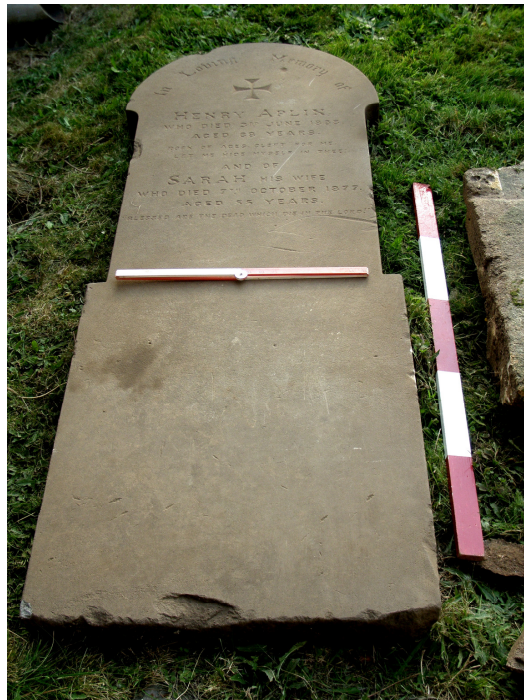
10. The 19th century ledger slab (101), having been moved from where it was found, and sited in its new temporary location with the inscription uppermost. Scales: 0.50m and 1m.

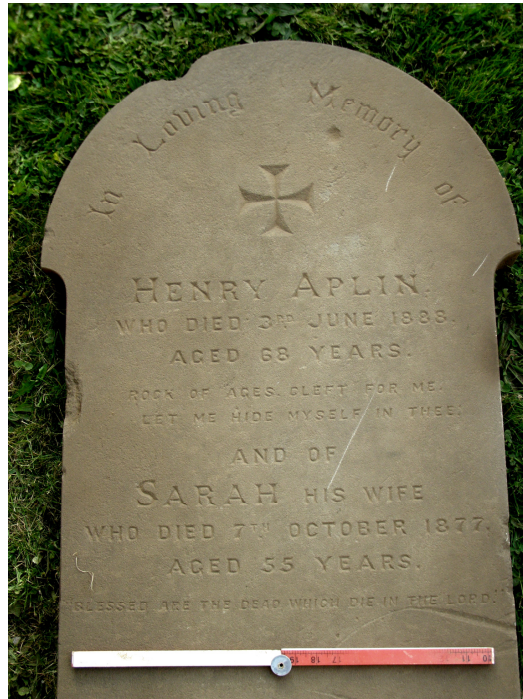
In Loving Memory Of
Henry Aplin
who died 3rd June 1888
Aged 68 years
Rock of Ages Cleft for Me
Let Me Hide Myself in Thee
And Of
Sarah His Wife
Who Died 7th October 1877
Aged 55 Years
“Blessed Are the Dead Which Die in the Lord”

11. The 19th century ledger slab (101), showing detail of inscription. Scale: 0.50m.

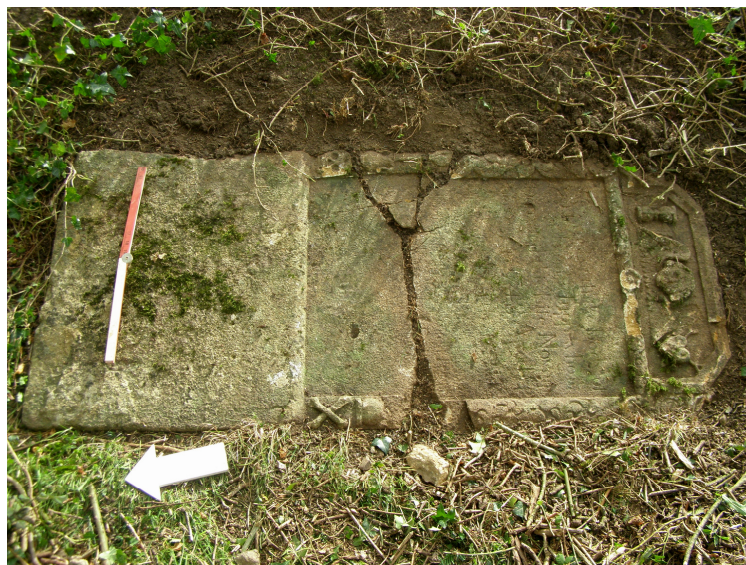
This ledger was badly damaged, having split in two across almost the middle of its width, and with several smaller pieces having broken off from its left-hand long side as viewed from the front (ie the side containing the inscription).

12. 18th century ledger slab (102). Note complete fracture across the width of the slab, resulting in extensive damage in the middle of the left-hand border. North as indicated, scale: 0.50m.

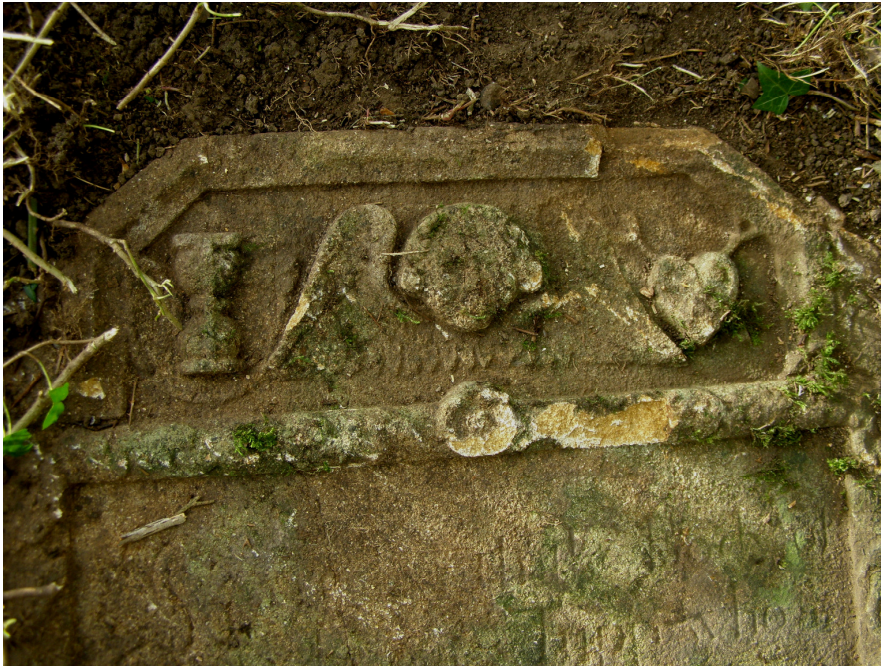
Description: Completely blank on the rear face, but with fine and elaborate carving on the front face. In the upper section of the slab, decoration includes a winged angel (left wing damaged), an hourglass, and a heart pierced by two arrows, all these elements being contained within a bordered cartouche, the upper part of which is a plain but chamfered border, the lower part a floral linear carving broken in the middle by a carved flower (possibly a rose). Below this is the inscription, with what was clearly, as originally executed, very finely carved lettering; the left lower border has a jug and, below it, a skull; and the right lower border has cross bones (exactly in line with the skull on the opposite border) and, above those, an object which we cannot identify, and which seems to have suffered some damage. All of the borders

13. The 18th century ledger slab - detail of upper cartouche and part of the inscription.

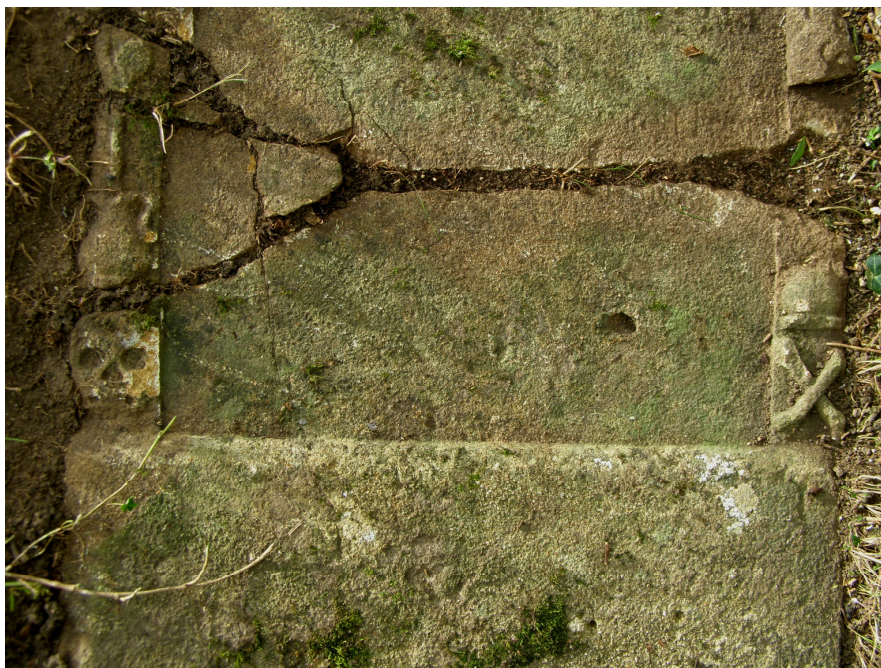
above the lower, stabilizing section, which do not contain carved objects, are nonetheless elaborately carved with scroll/vine leaf/acanthus designs.

14. Detail of lower border decoration, central fracture, and damage to left-hand border.

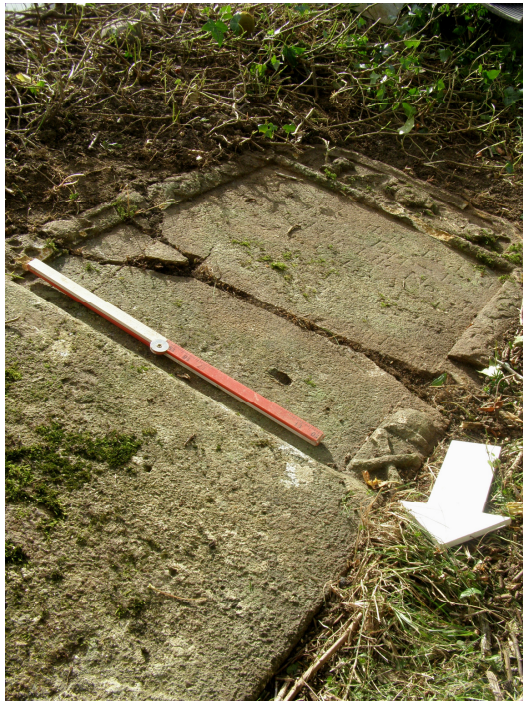
Inscription: Badly damaged but potentially recoverable by either laser scanning or high resolution photography in sharply slanting bright light:

Here Lyeth the Body of.....[Tripp or Fripp?], who departed this
Life Nov[ember].....[1743 or 1748?].

15. The 18th century ledger slab prior to moving, attempting to catch glancing light to show the fairly worn and only semi-legible inscription. The inscription does not seem to extend below the line of the major fracture across the width of the slab. Scale: 0.50m, north as indicated.

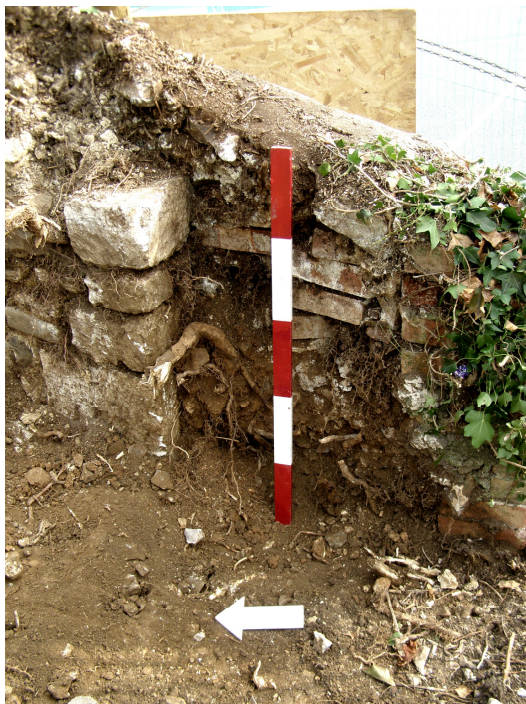
As the clearance of the hedge vegetation progressed, it was also clear that, at its southern end, wall (100) had in fact been extended, by some 0.93m, to the south, by the addition of a brick stub, butted against neatly laid, squared stones which clearly formed the original southern terminus of the wall, and probably the northern jamb of an original gateway into the churchyard ((106); **Plate 16**). Although damaged by the incursion of roots from the former hedge, it still seemed as though this structure had been pretty crudely built in the first place. We guess that this was done to narrow the gateway through the eastern boundary of the churchyard at this point, and to accommodate a new gate which is the one still in use today. From the form of the bricks used, this is likely to have been a relatively very modern development. This

16. Probably modern brick extension at the southern end of masonry boundary wall (100). Note semi-ashlared stone blocks denoting the original southern end of the wall, probably acting as the northern jamb of an original gateway through it into the churchyard. Scale: 1m, north as indicated.

feature has now been removed, and wall (100) has been rebuilt and conserved, to what was presumably its full, original height, entirely in masonry, and fully repointed.
