CENTRAL SECTION PROJECT

INTERIM STATEMENT Archaeological Evaluation & Boreholes 91 to 109 Moorgate – XSP10

Document Number: C257-MLA-X-RGN-CRG02-50051

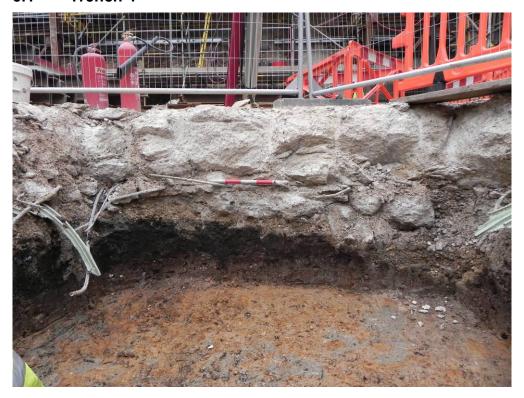
Photo 1 Trench 4 looking north. Section showing gravelly brickearth natural overlain by marsh deposits.

The gravely brickearth layer [15] could potentially be re-deposited given its position immediately below layer [14]. The absence of any man-made material does not support or disprove this. The cleaner brickearth layer [16] can confidently be identified as natural.

Layer [14] is likely to be Roman in date, and is comparable with layer [10] from Trench 5 and layer [3] from Trench 6 (see C257 ARCHAEOLOGY CENTRAL Interim Statement Archaeological Evaluation (C136 Moorgate Shaft) 91 to 109 Moorgate - XSP10, Document No. C257-MLA-X-RGN-CRG02-50028) both of which produced Roman pottery. This layer can be interpreted as either a dumping or levelling layer, or as a proto-marsh deposit within which Roman finds accumulated. The geo-archaeological samples should help to refine this interpretation.

Layer [13] is almost certainly representative of the formation of the marsh in this area and is, therefore, likely to be late Roman or medieval in date.

The small pit [18] in the south-western corner is currently undated. It could be modern as it is immediately below the concrete in the sequence and cuts layers [13] and [14]. However no modern remains were found in the fill and as such it may also be of medieval or post-medieval date.

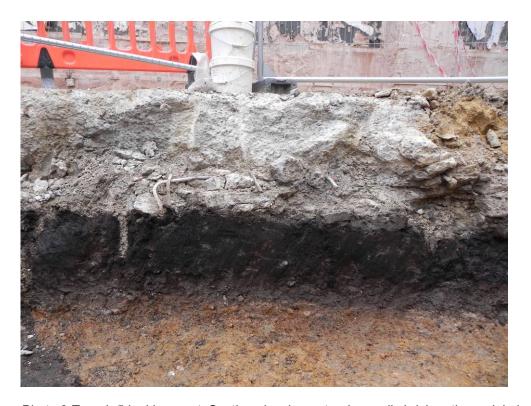
Photo 2 Trench 5 looking west. Section showing natural gravelly brickearth overlain by clay and marsh deposits

The gravelly brickearth layer [11] could potentially be re-deposited given its position immediately below layer [10]. However the absence of any man made material does not support or disprove this. The cleaner Brickearth layer [12] can confidently be identified as natural.

Layer [10] is likely to be Roman in date as it contained Roman pottery and other evidence of Roman activity such as CBM. This layer can be interpreted as either a dumping or levelling layer, or as a proto-marsh deposit within which Roman finds accumulated. The geo-archaeological samples may be able to refine this interpretation.

Layer [9] is almost certainly representative of the formation of the marsh in this area and is likely to be late Roman or Medieval in date.

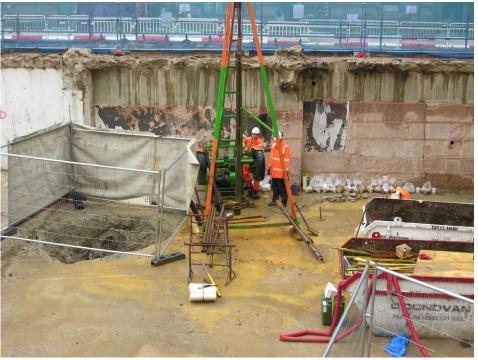
Photo 3 Borehole 1. Looking east. During drilling

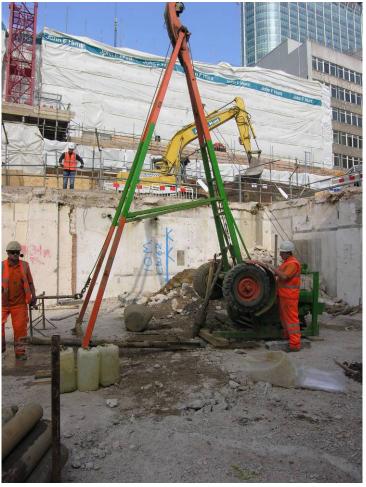
Photo 4 Looking north-west. Borehole 3 during drilling
