Report for
91 Town Green Street, Rothley, Leicestershire

Site Code: ROT-D

The Medieval Peasant House in Midland England

ROT-D: 91 TOWN GREEN STREET, ROTHLEY, LEICESTERSHIRE

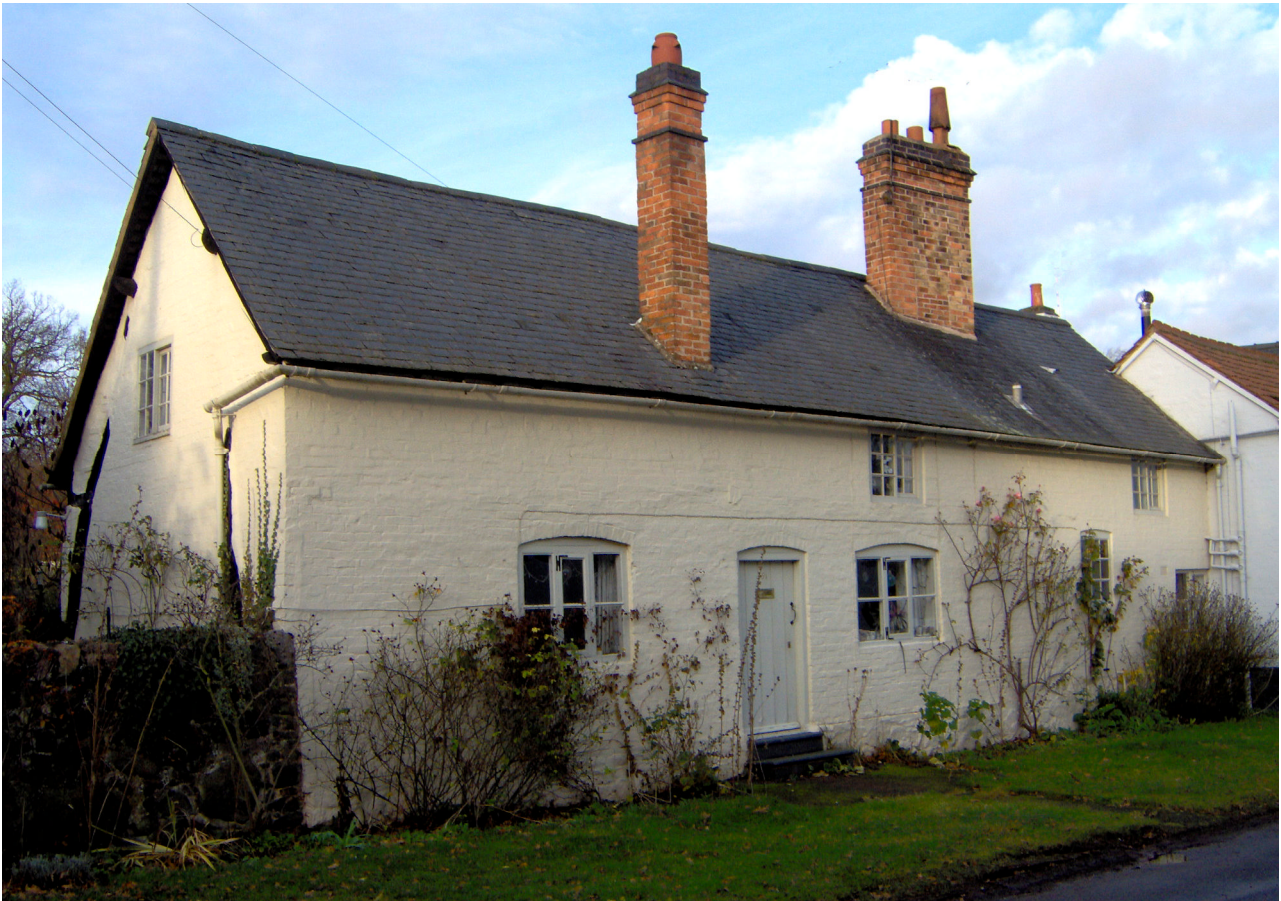
Fig. 1. View from the south-west (Photo: Neil Finn).

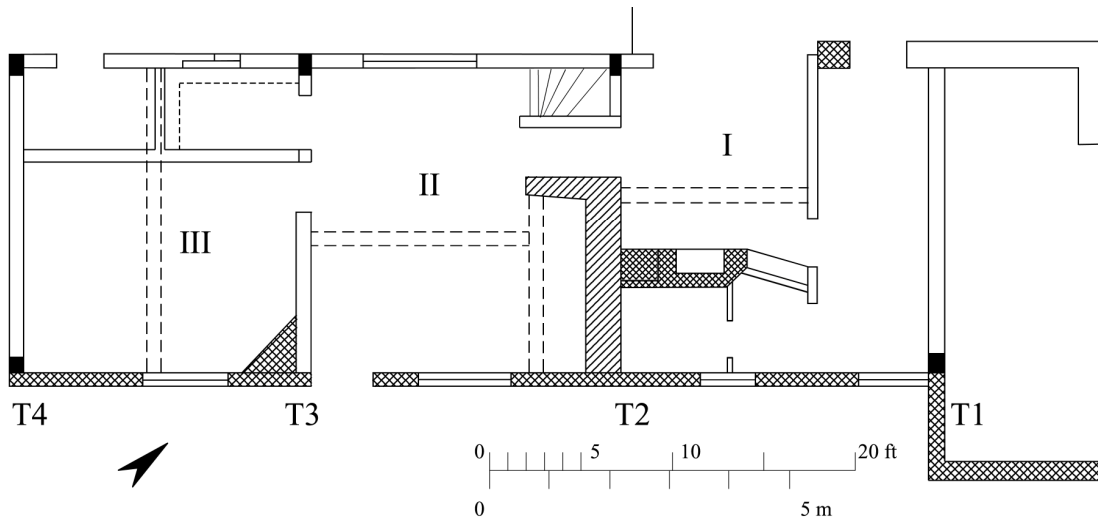
Fig. 2. Plan (prior to 1980s alterations) showing truss and bay numbering.

PHASE 1: No. 91 Town Green Street Rothley is a three-bay cruck house of one main constructional phase. In the original house, bay III was probably the chamber, and the middle bay (II) served as the hall, partially divided from the service area in the east bay (I). Further study of the soot distribution is needed to confirm this interpretation. However, it appears that the hall and service bays were open to the roof, whilst the chamber end may have been floored originally; its floor is carried on a heavy transverse beam rather than the axial beams of bays I and II. Two cruck trusses (T2 and T3) are complete to the apex, one carrying a king post with braces on the collar (apex type 'F3') and the other having a saddle apex (type 'C'). Both the other cruck trusses survive but are incomplete. A tree-ring felling date range of **1492-9** has been obtained.

LATER PHASES: In the seventeenth/eighteenth century, the hall and service bays were floored over with axial beams and joists, over which a lime-ash floor was constructed. A ceiling was inserted upstairs and the inside of the rafters lined with plaster supported on reeds. In the nineteenth century, the front wall was rebuilt in brick, the level of the eaves raised, and the front wall plate and purlin removed. A dairy with thralls and a coal-hole were cut off from the inner room.

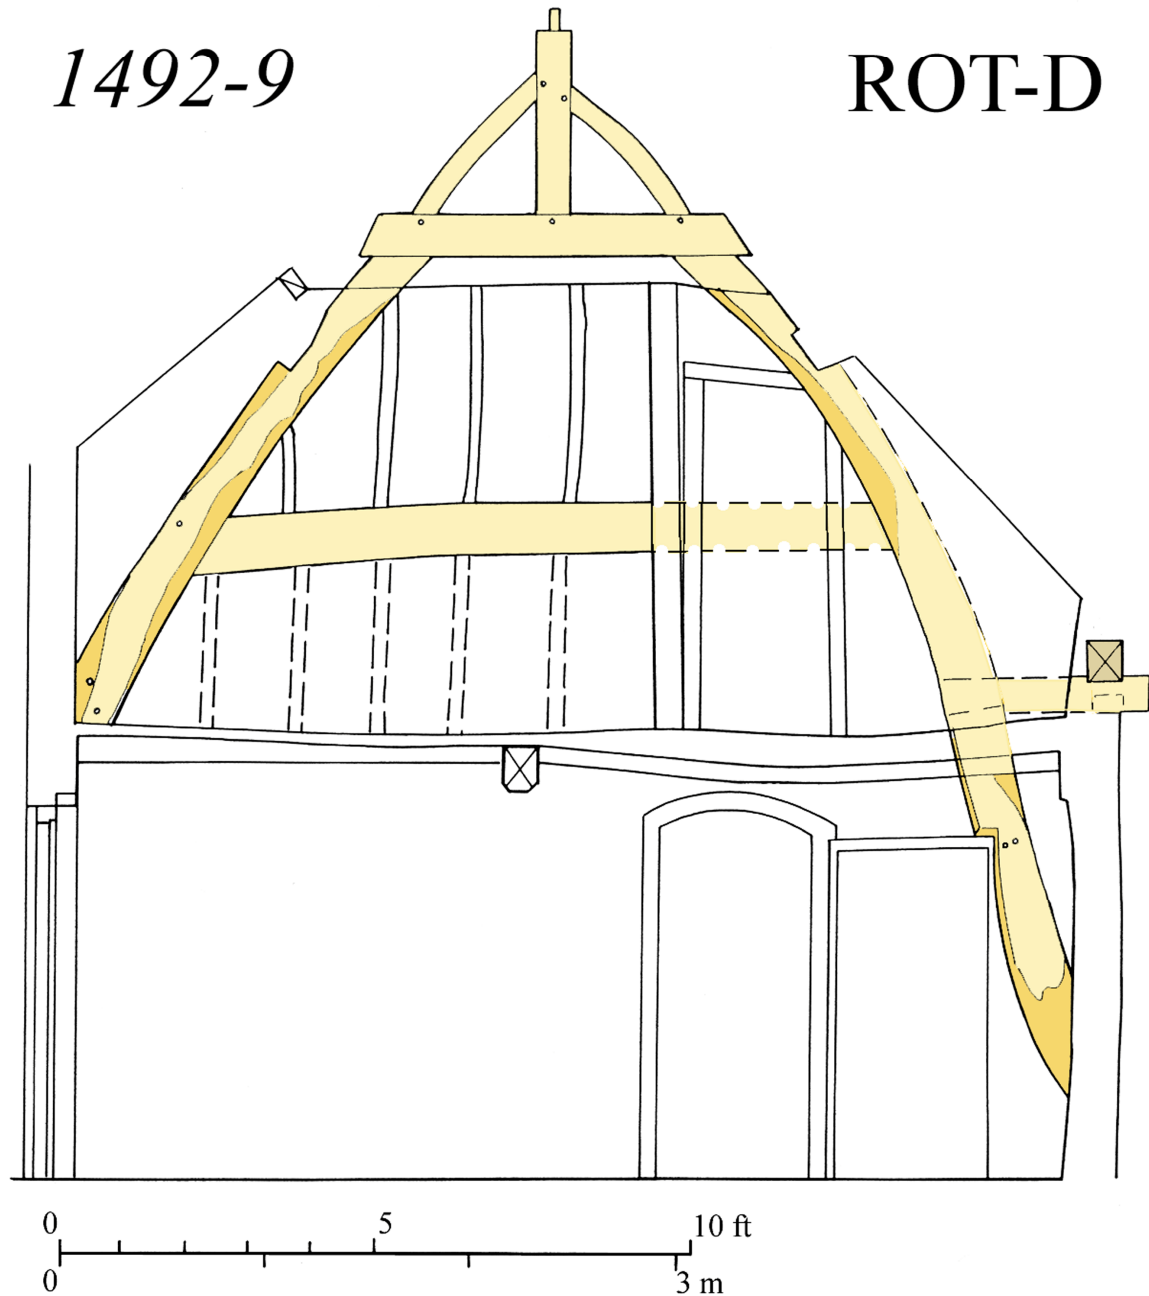
Fig. 3. Section of truss T3.

PHASE 1: Truss T3 is the best preserved of the internal trusses. The cruck blades are joined by a long saddle with a superstructure comprising a king post and two curving braces carrying a square set ridge piece (removed) (type 'F3' apex). The collar has been cut through by an inserted doorway. Evidence for the tiebeam is hidden behind plaster, but two pegholes by the side of the door to the dairy indicate its probable position. The truss is been infilled with studs or staves and reed lath fixed to the south-west side

and plastered. It was not possible to inspect the underside of the saddle or collar to check for the existence of stave holes.

The purlins are trenched into the back of the cruck blades, and no evidence was visible for windbraces. The front purlin has been removed. The wall plates are carried on cruck spurs which are fixed to the south-west side of the truss with bare-faced dovetail halvings. The outer end of the rear spur was originally supported by a cruck stud, as indicated by an empty mortice just visible under the wall plate; this shows clearly that the outer walls were originally timber-framed. On truss T2, the apex is missing, but it has both a collar and a tiebeam, the latter extending to support the wallplates. The pegs to the joints in this truss are strongly skewed, each being driven in at 45 degrees to the surface of the truss. Relatively little of truss T4 is visible. Its cruck blades are longer and carry a saddle which supported the ridge directly. It has a collar and cruck spurs, set about five feet below the collar. Of truss T1, only the front foot of the cruck remains.

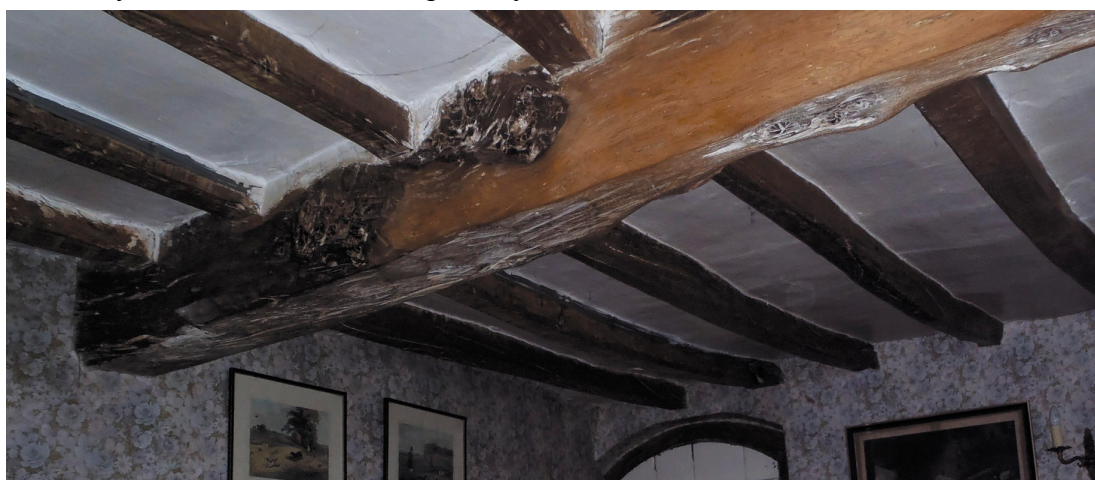
Fig. 4. The ceiling beam in bay III, showing the transition from the regular chamfered part to the waney end (Photo: Neil Finn).

The transverse ceiling beam in bay III (Fig. 4) is notable for having one extremely waney end (south), although the north end is neatly squared and chamfered with run-out stops; it is probably of elm. The joists are light, with small chamfers and run-out stops. It is clear that this bay was floored before the others, but the presence of a mortice on the underside of the south end of the beam suggests that it may have been an early insertion rather than a primary feature.
