Report and Documentary History for  
**Quaintree House, Braunston, Rutland**

*Site Code:* BRN-H

# BRN-H: QUAINTREE HOUSE, BRAUNSTON, RUTLAND

Grid reference: SK 8328 0676      Survey Dates: 1981; 1982; 2011      By: A Gibson; C. Hewett; N. Hill

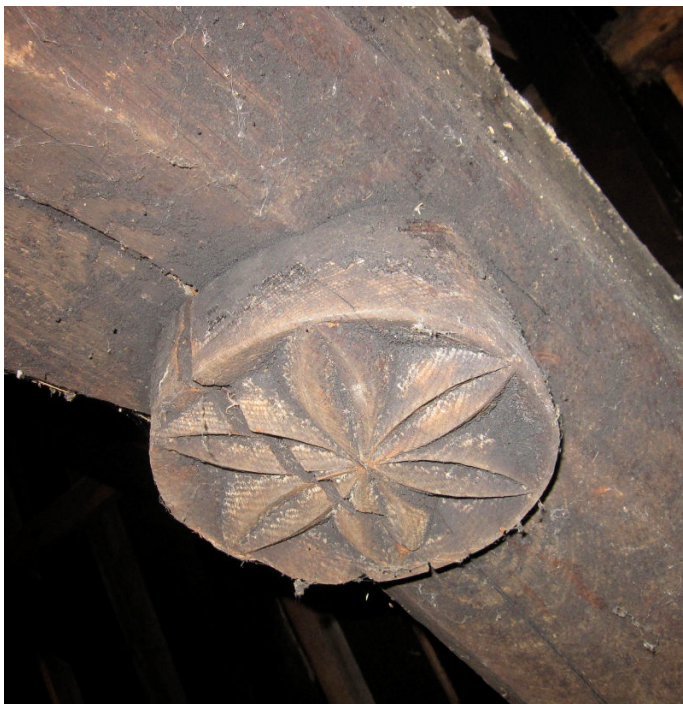
Fig.5. Daisywheel decoration on truss T1 (Photo Nick Hill).

The upper roof structures of both trusses are similar, with collars, passing braces and short cross-braces from the tiebeams to the rafters. The underside of the spere-truss tiebeam carries a sharply carved hexagonal rosette boss (Fig. 5), and it seems highly likely that the base-cruck tiebeam also had one, though this part of the truss is concealed.
