55-56 Church Street,
Tamworth

**ARCHAEOLOGICAL
WATCHING BRIEF**

PN 14-20

Archaeological Watching Brief, [10/2014]

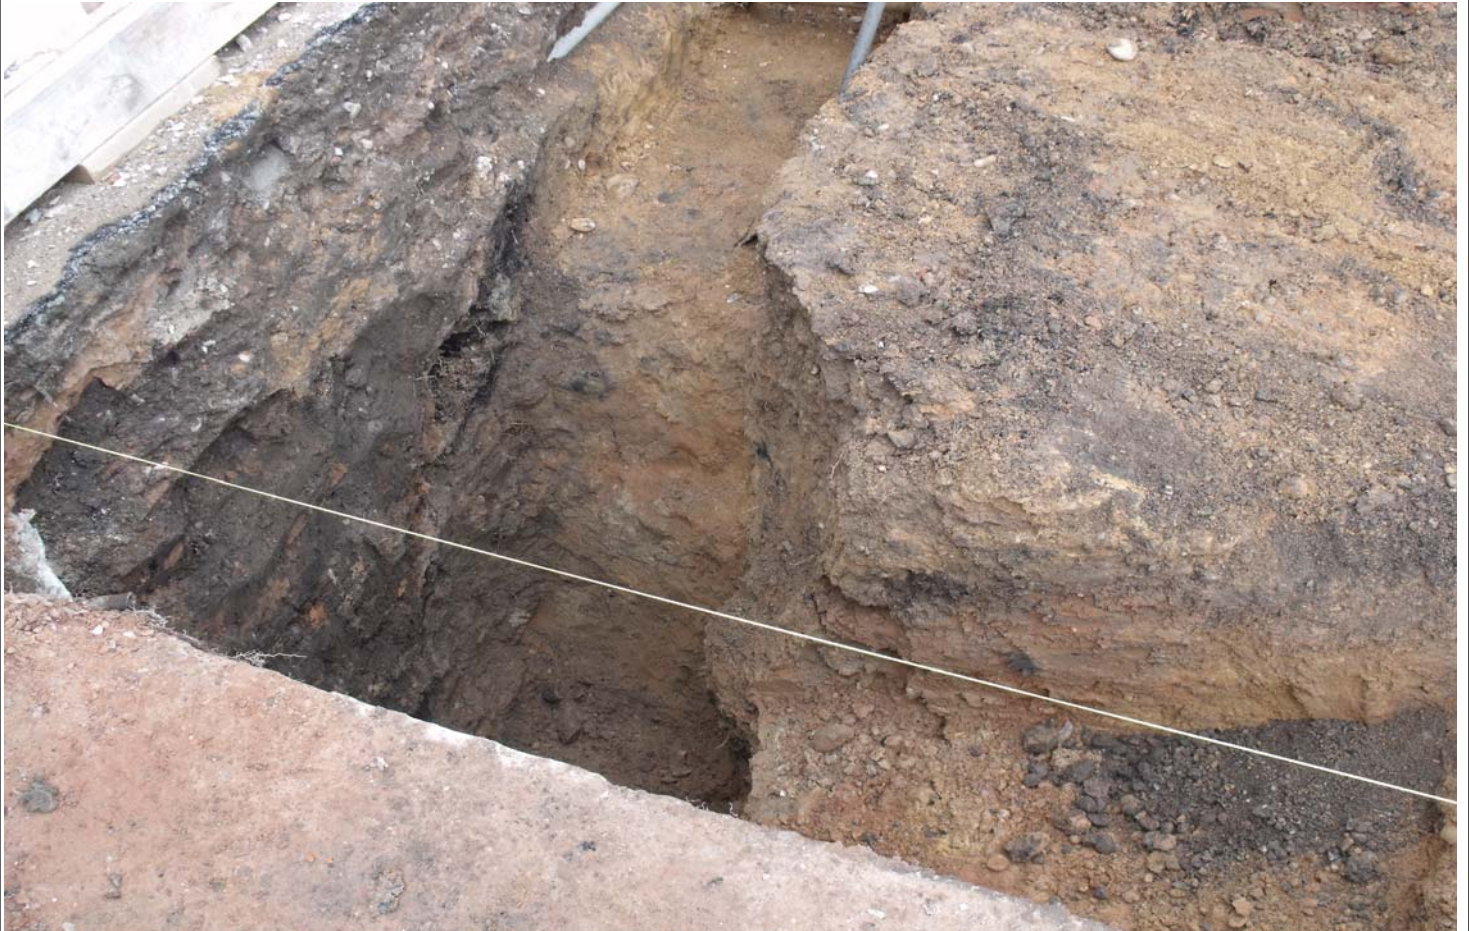
- 6.1.1. The natural deposit **1004** was identified across the site and comprised of mid yellowish-orange sand with 30% sandstone inclusions.
- 6.1.2. Pit feature **1005** was identified in the south-western corner of the site (in the same location as the first piling point) cutting through natural **1004** (Figure 3). Owing to the position of the feature and the limited extent of excavation, the shape and type of feature could not fully be established. The sides of the pit were vertical. The total length of the feature measured 3.00m and at least 1.00m wide with a depth of 1.27m (Figure 4). The feature contained only one fill (1006) which comprised of a very dark blackish-brown silty loam with infrequent (10%) very small (<2mm) stone inclusions. An animal bone (mandible with two teeth) was recovered close to the base of the pit. The date of **1005** and **1006** is unknown due to a lack of dating evidence. The function of pit feature **1005** is unknown but may have served as a rubbish pit based on the animal mandible recovered from **1006**.

- 7.1.1. Animal bone. A total of nine animal bone fragments were recovered during the watching brief. A fragmented sheep mandible and several other long bone fragments were recovered from fill **1006** of pit **1005**. The bones were in a good state of preservation with no identifiable butchery marks.

Plate 3 - Photograph of pit [1005] looking north

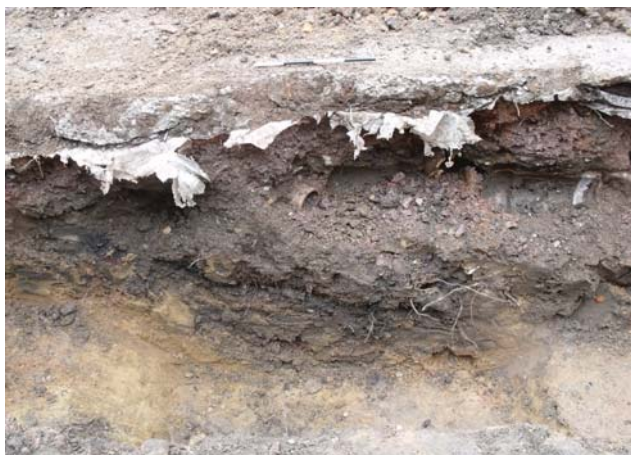
- 6.1.3. A north-south aligned linear scoop **1007** was identified immediately to the north of the southern section of the site (Figure 3) cutting through natural **1004**. The scoop was U-shaped in profile with shallow sides. The length of this feature measured at least 1.44m with a width of 0.25m (although the feature continued outside of the excavated area). Deposit **1009** filled **1007** and was composed of very dark blackish-brown silty loam with infrequent (10%) very small (<2mm) stone inclusions. Deposit **1009** is similar in consistency, colour and composition to fill **1006** of pit **1005**. Animal bone was found towards the middle and bottom of this feature as well as a number of pottery sherds dating to the 19th century.

- 7.1.2. Metallurgy. One fragment of unidentifiable iron working slag was recovered from fill **1009** of feature **1007**.
- 7.1.3. Pottery and tile. A total of ten pottery sherds and larger fragments were recovered from fill **1009** of feature **1007**. These include fragment of Midlands Purple and Yellow Ware and fragments of ceramic drains. One patterned chinaware fragment was also identified. All of the pottery suggests a date of deposition in the 19th century. Two large tile fragments, one stone (slate) and one red ceramic, were also recovered from **1009**.

Plate 4 - Photograph of pit [1007] looking south
