ST GILES CHURCHYARD

**ARCHAEOLOGICAL
INVESTIGATION 2016**

PN16-06

ARCHAEOLOGICAL INVESTIGATION**By****William Mitchell**

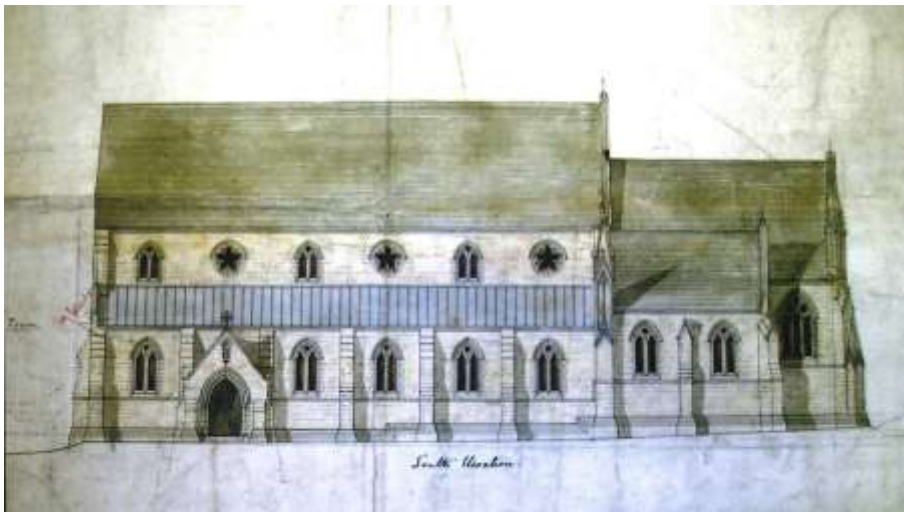
Plate 14: Sir Gilbert Scott's original design for the southern elevation of the Church.

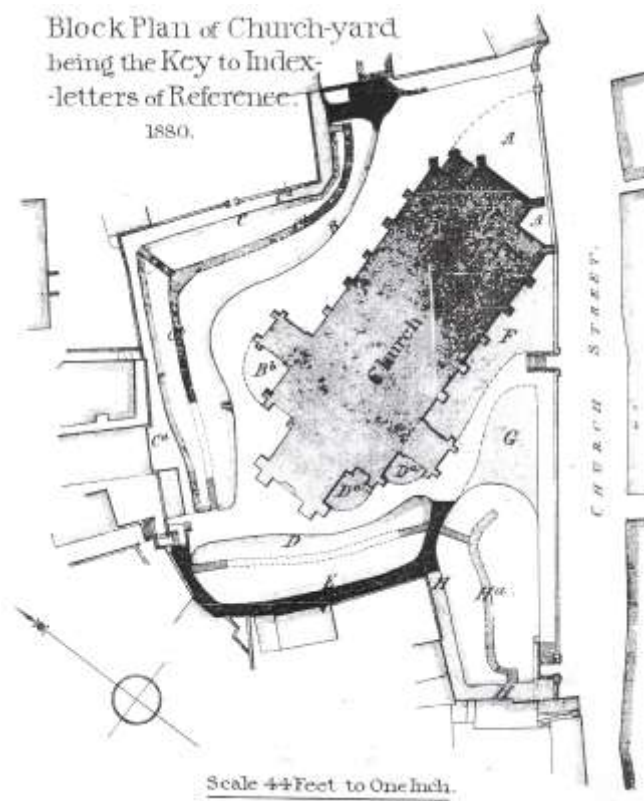
Plate 16: Plan of the church and Churchyard. John Blood 1880.

- 3.2.3. A further plan was compiled in 1880 (Plate 16) which show in detail the redeveloped church and the resulting spoil mounds. This plan also contains an index of names in alphabetical order on memorial stones to show the new positions within the churchyard (by index letter). Their old positions in the churchyard are also noted, as it is indexed using the numbering system from the 1873 plan. The ordnance survey plans from 1889 onwards show the redeveloped church and newly laid out churchyard boundaries. The plan of the church which is recognisable to that of today's church, clearly differs from that of the previous church (Plates 5 & 6). In 1898 the churchyard was redeveloped further. Portions of land to the north and west of the site were acquired and became part of the churchyard (Plate 17).

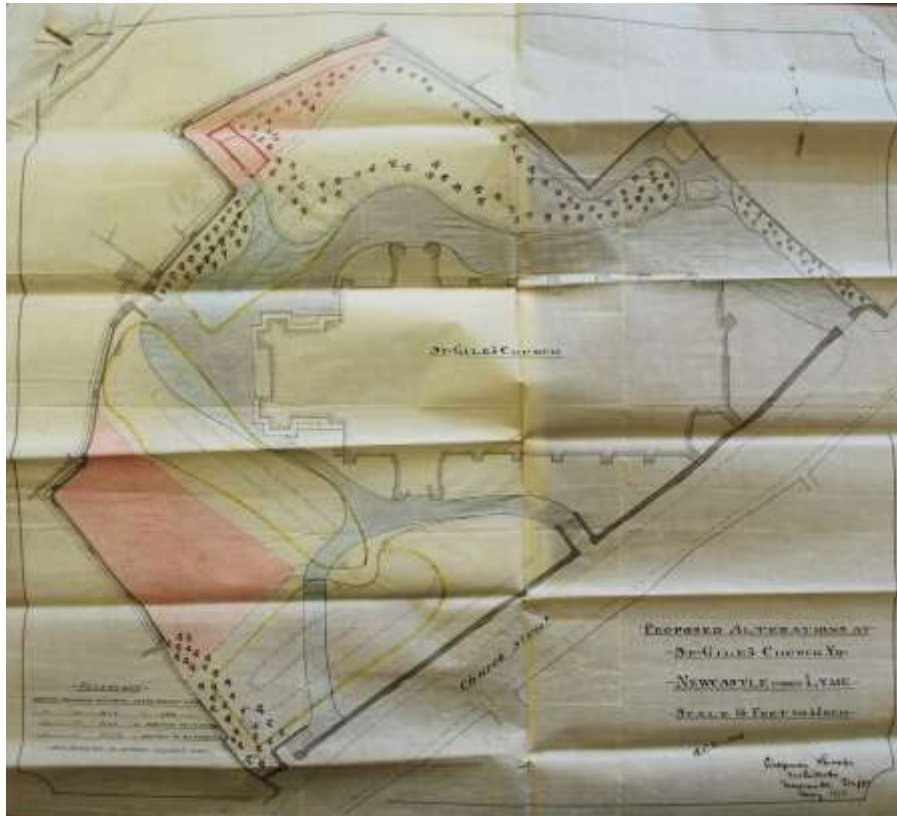
Plate 17: Plan of proposed alterations to the churchyard 1898. Mounds to be removed are coloured in yellow and were to be deposited on the portion coloured pink, which was an addition to the churchyard purchased in the same year.

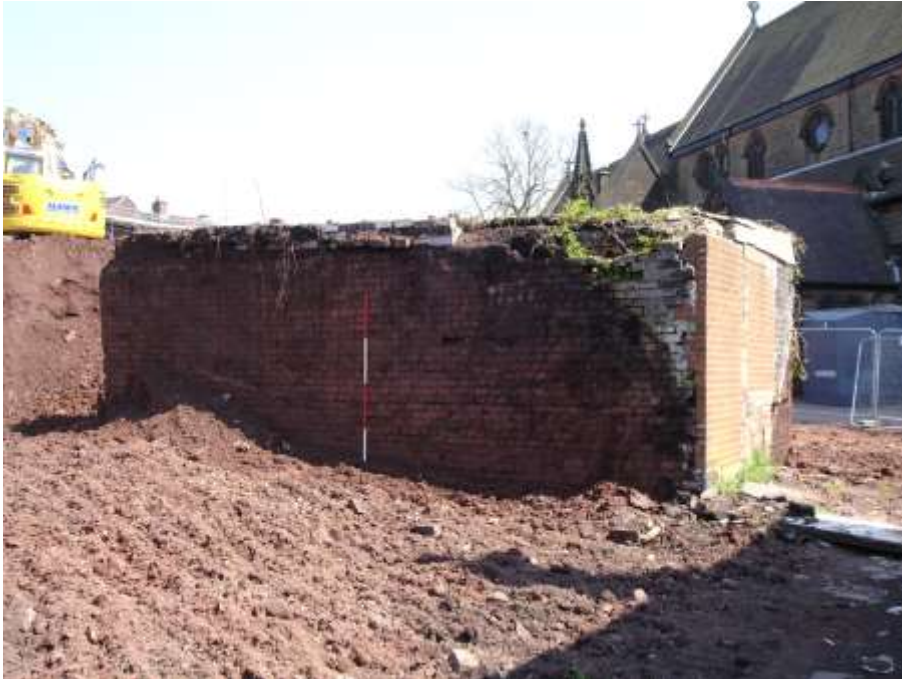
Plate 23: Brick memorial storage building 1045, facing south east.

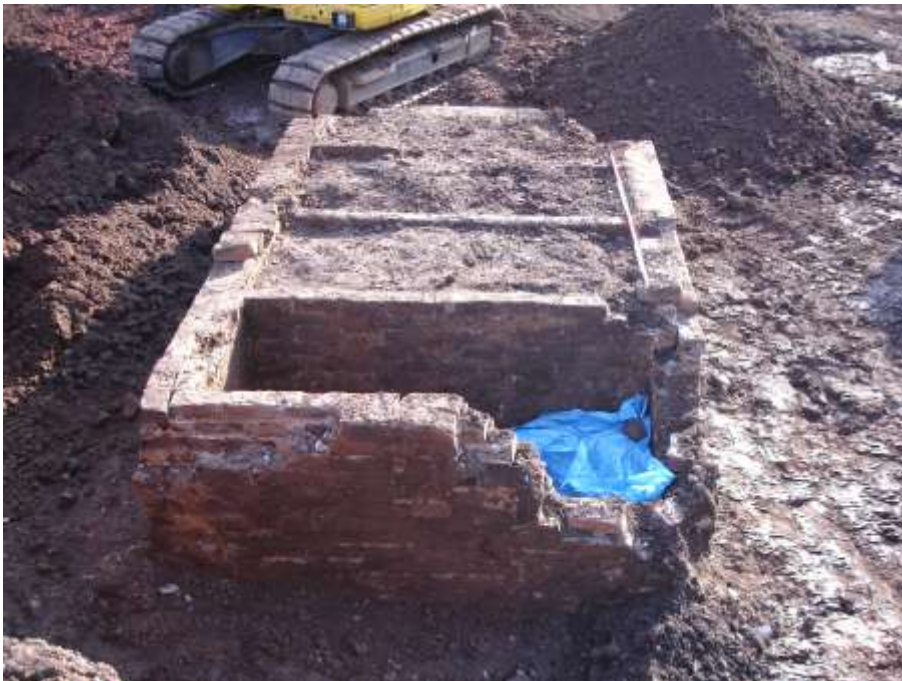
Plate 24: Brick crypt structure 1043 pre-excavation, facing east.

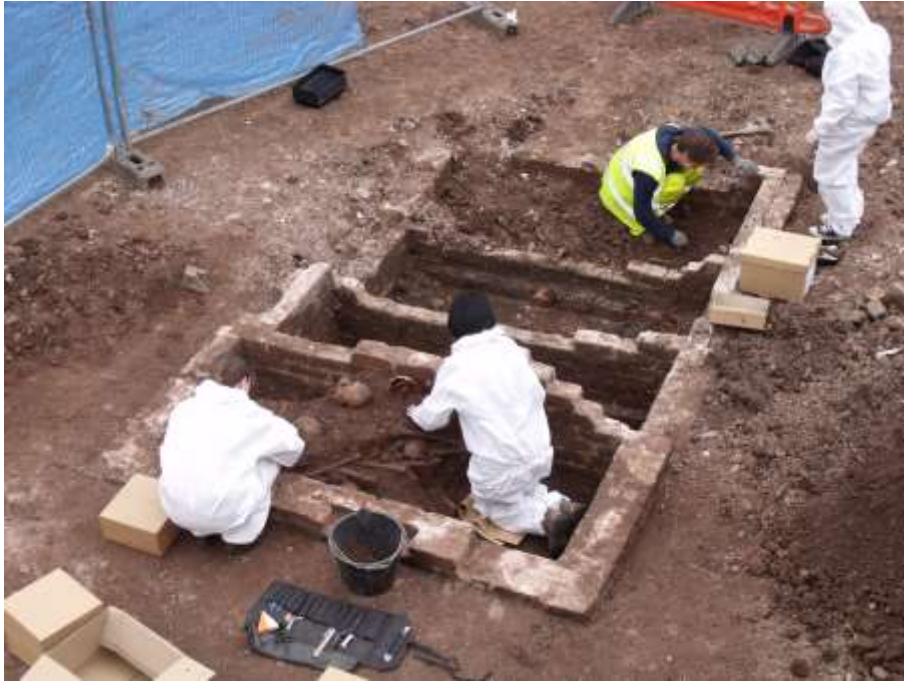
Plate 25: Brick crypt structure 1043 during excavation, facing west

- 6.2.16. The greatest quantity of human remains were in the easternmost chamber (chamber 1), where it was filled almost entirely from its base to the top. It was also observed that each chamber contained a greater quantity in the southern half of the chamber. Lesser amounts were identified in chambers 2, 3 and 4. Chamber 4 held the smallest quantity. The majority of the bones were large bones (long bones- femur, fibula, tibia, radius, ulna, humerus, skull and pelvic bones). The possible reason for this was that these were the sorts of bones most easily recoverable by the Victorian workmen and the types of bones most likely to have been preserved in the slightly acidic soil. The assemblage represented a range of individuals of mixed age and sex whom were buried at various periods in the churches long history. The chambers were excavated in spits but no specific burial trend was observed. It appeared that re-deposition had occurred quickly, with the human remains perhaps being tipped by wheelbarrow into the southern end of the chambers. Being that the greatest quantity was contained within the easternmost chamber, it appears that this was filled first until full, then the remaining bones were spread relatively evenly across the other chambers. There was no evidence of complete coffins, however fragments of coffin timbers

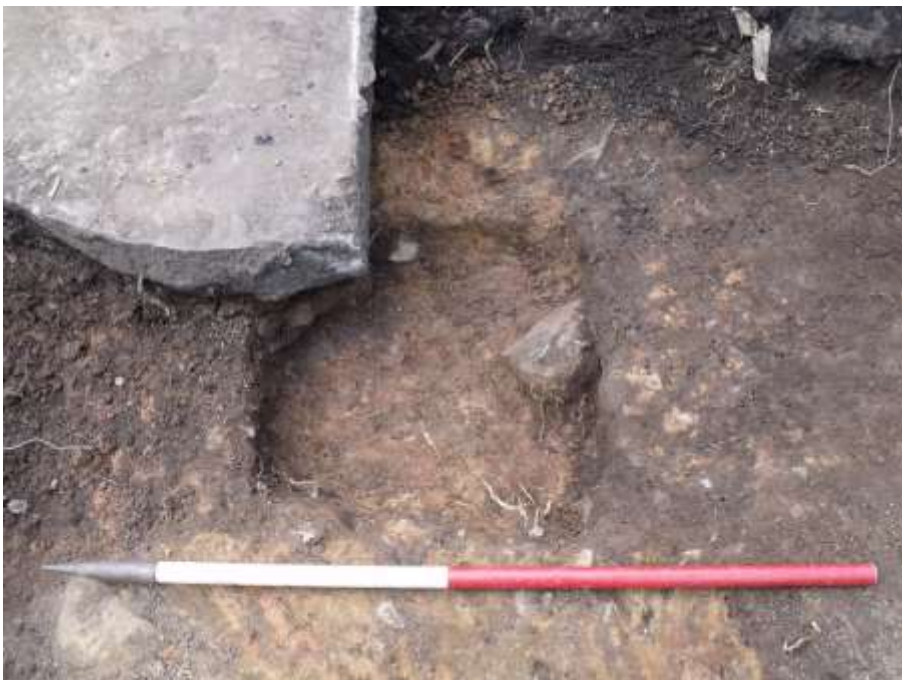
Plate 28: Part of a later 17th to 18th century foundation trench (1023), facing north.

- 6.2.4. Evidence for a robbed out foundation trench (**1023** and **1029**) was identified at the easternmost extent of site, within the area of the discrete graves. At least two of these graves, which were of an unknown burial date, had truncated this foundation trench. Two test slots were excavated through this foundation trench. Evidence of a sandy mortar was identified on the base of the trench and at various locations, dressed red sandstone was still in situ. A fragment of pottery was recovered from within this sandy basal fill (**1024**) providing a securely stratified date of construction. This sherd has been dated to the later 17th to 18th century. Overall the exposed section of the foundation trench was approximately 7m in length with a 2m break part way along it. It continued into the trench edges outside of the excavation edge. It was approximately 0.5m in width and it survived to a depth of 0.14m. It appeared to have a right angle return at the eastern end, the break in the trench may have been the location of a doorway. It is thought that this represented the remains of the foundations of a building associated with either the early church in its final years or a building constructed around the same time as the Georgian church. It was constructed on the same orientation, but was likely to have been a separate building located away from the main church complex (Plate 28). Buildings have been excavated in other churchyard, showing that they were much used places where other activities took place not simply the burial of the dead. Some of the buildings were thought to have had religious functions, others may have housed activities associated with the ecclesiastical functions (Hadley; 2001, 176).

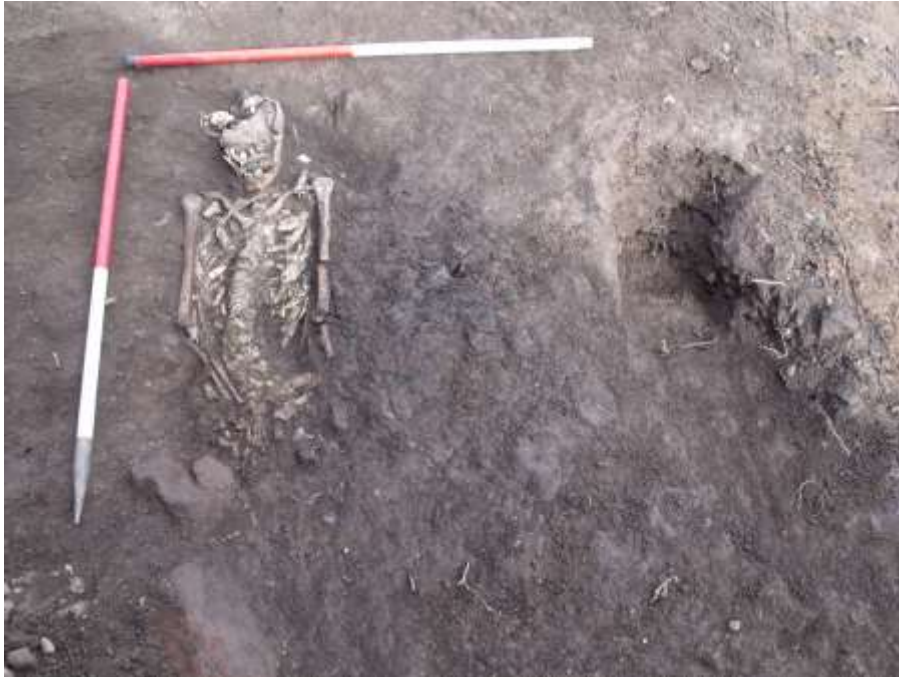
Plate 29: SK 102 and grave cut 1036 (SK101), facing north.

- 6.2.8. Five of these burials were excavated (**SK101- 1036**, **SK102- 1034**, **SK103- 1038**, **SK104- 1041** and **SK105- 1046**). This was because they were most at risk from the development, as parts of the skeleton were observed close to, or at the surface. Detailed analysis of these individuals has been undertaken and is recorded in Section 7. The ceramic assemblages recovered from within each of these grave cuts was similar. The ceramics recovered included 19th century blue and white Staffordshire white ware, backwares and slipwares. The location of these burials along with the associated ceramics and documentary sources makes it highly likely that these were some of the final burials interred in the churchyard in the 1850's and 60's. A further exposed inhumation burial (**SK106- 1048**) was exposed at the north end of the west facing boundary wall (**1050**), it was decided to leave this in situ as it would not be disturbed by the developments. Each of these burials had become disturbed through continued use of the cemetery and the passage of time. In

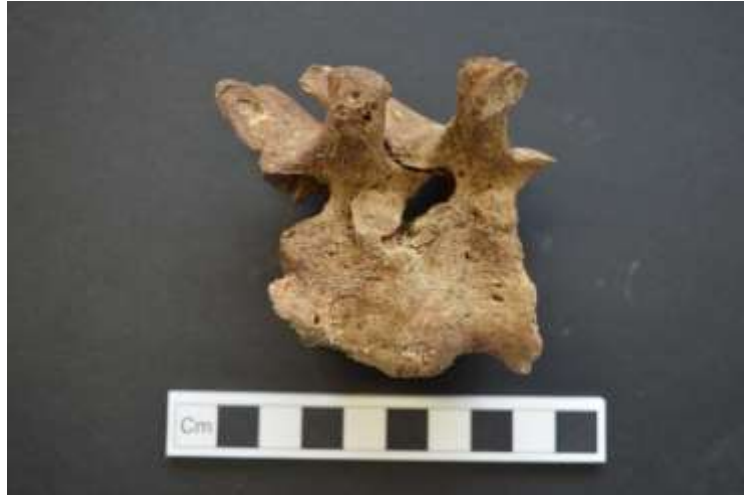
Plate 33: (1): Evidence of ankylosing spondylitis in SK103

- 7.1.15. SDJD affected thoracic vertebrae nine, ten, eleven, and twelve of SK103. Thoracic vertebrae eleven and twelve exhibited signs of ankylosing spondylitis based on the fusion of the right side of the vertebral bodies (Plate 33). This condition is typically identified in adult males, with an initial onset between 15-35 years, though the initial etiology is unknown but may be linked to genetics (Aufderheide and Rodríguez-Martin, 2006). ADJD of the left acetabulum of the os coxa and the left proximal ulna was observed. Slight osteoperiostitis of the anterior surface of the distal third of the left femur was also recorded in this individual.

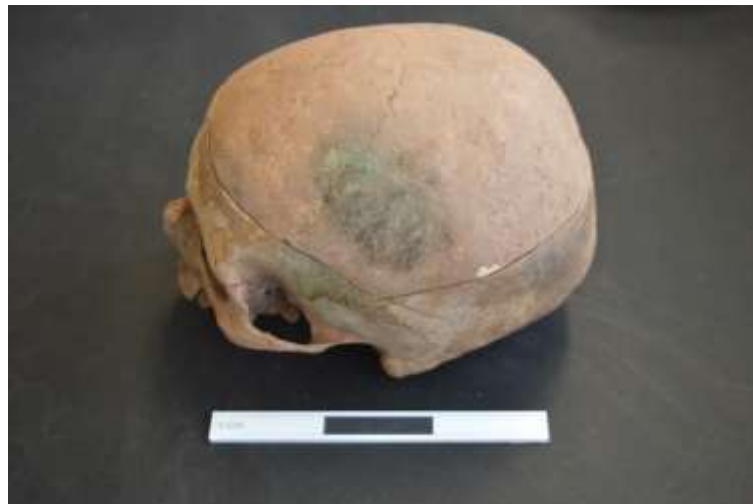
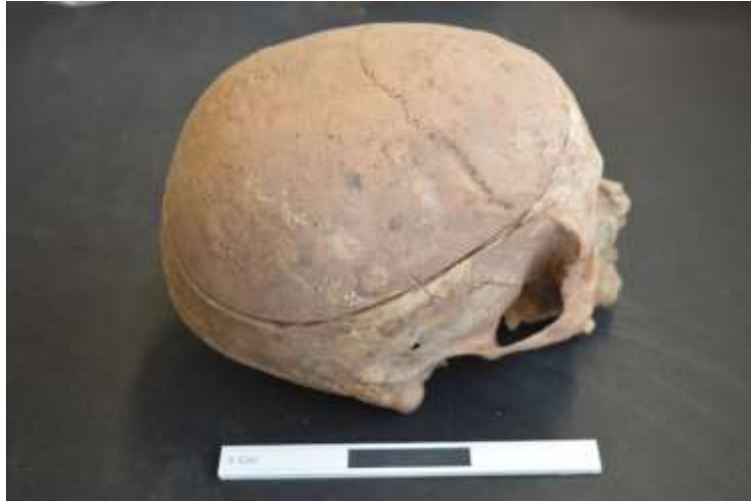
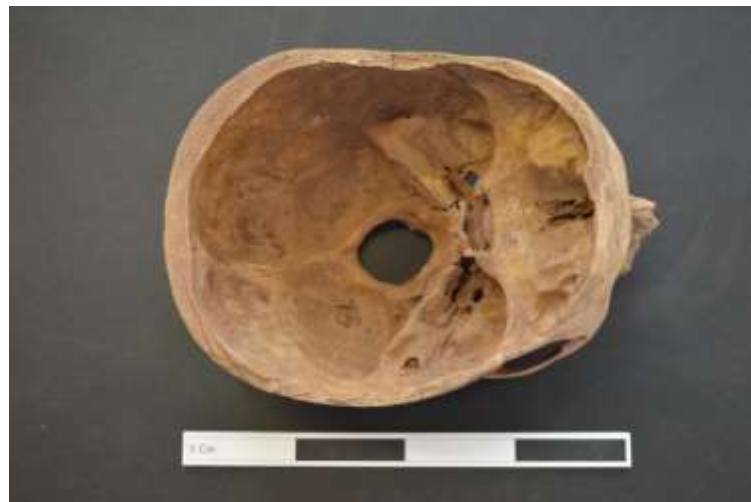
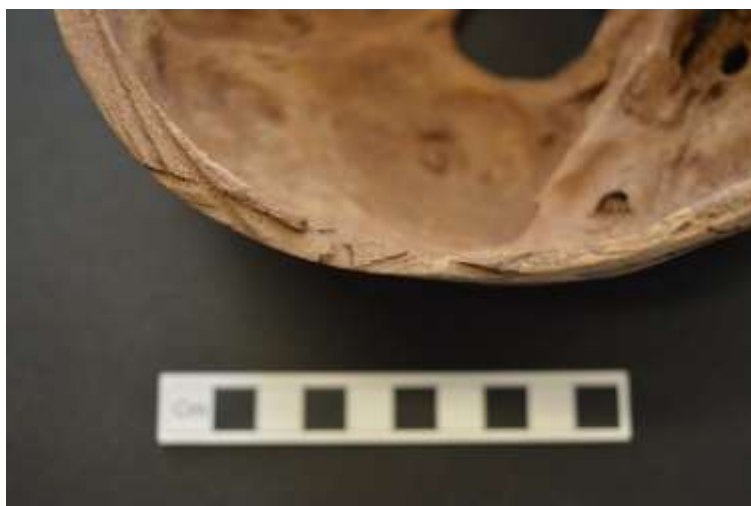
Plate 36: (4): Left lateral side of cranium from (1044-1) BS1 showing signs of a craniotomy

Plate 37: (5): Right lateral side of cranium from (1044-1) BS1 showing signs of a craniotomy

Plate 38: (6): Inferior view of cranium from (1044-1) BS1 that was subjected to a craniotomy

Plate 39: (7): Details of cut marks on the cranium from (1044-1) BS1 that was subjected to a craniotomy

- 7.1.28. Trauma. The skull of an adult male recovered from (1044-1) BS1 indicated that a craniotomy had been carried out as part of a post-mortem examination (Plates 36-39). Extensive dental disease was recorded in this individual and included dental caries, dental calculus, periodontal disease, AMTL, and dental enamel hypoplasia (Plate 40). Based on an examination of these skeletal remains, it is not possible to identify the cause of death. It is possible that the individual died of an acute infectious disease, such as smallpox or cholera as these conditions were rife in Newcastle-under-Lyme in the late and post-medieval periods. It is possible that the craniotomy took place at a local hospital, such as the one dedicated to St. John the Baptist, which was closely situated to the church and operated until the end of the 16th century (British History Online, 2016). Given the fact the grave of this individual was probably one of the older burials in the churchyard,

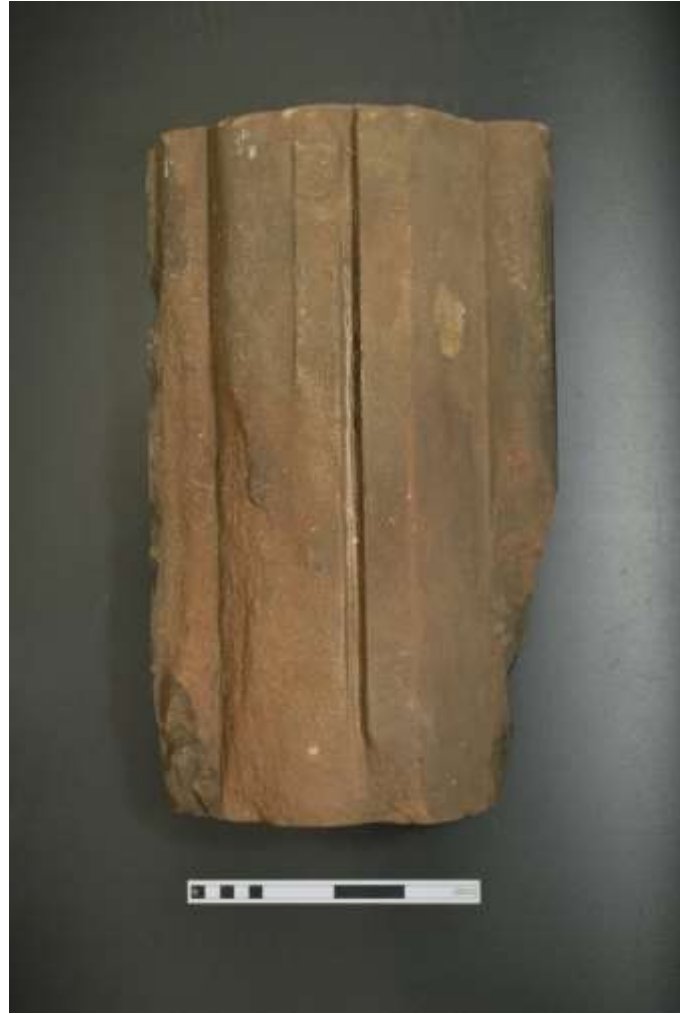
Plate 47: Red sandstone church window mullion, from the medieval church, recovered from the spoil mound (1000).

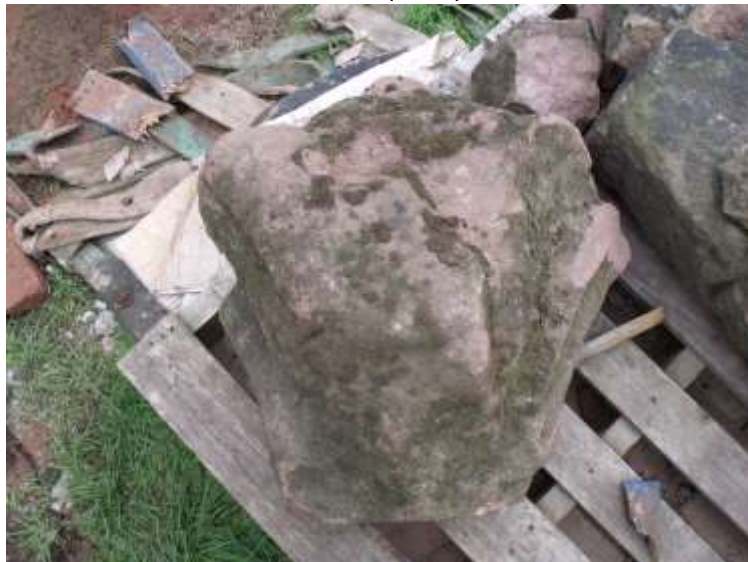
Plate 48: Red sandstone. Part of a split arch or window tracery from the medieval church. Recovered from site.
