St Lawrence Church, Bramshall
ARCHAEOLOGICAL WATCHING BRIEF

Project No.17-04

St Lawrence Church,
Bramshall,
Staffordshire,
ST14 5BQ.

ARCHAEOLOGICAL WATCHING BRIEF

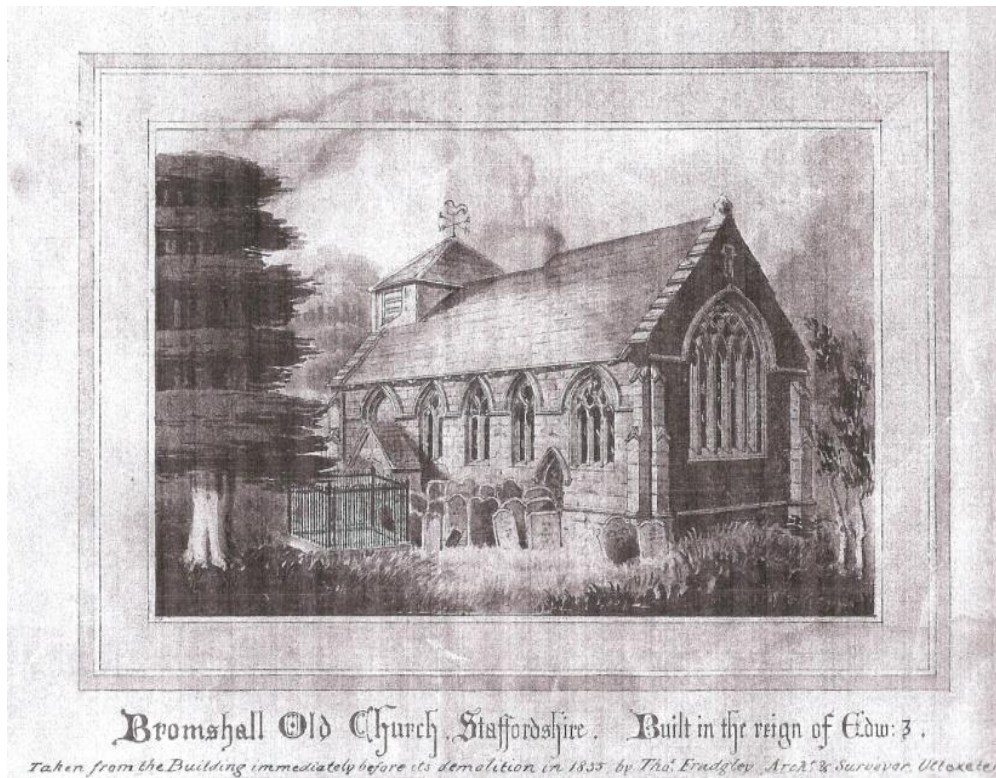
Plate 1: Bramshall old church just before its demolition in 1835, by Thomas Fradgley (Bramshall Collection File 45).

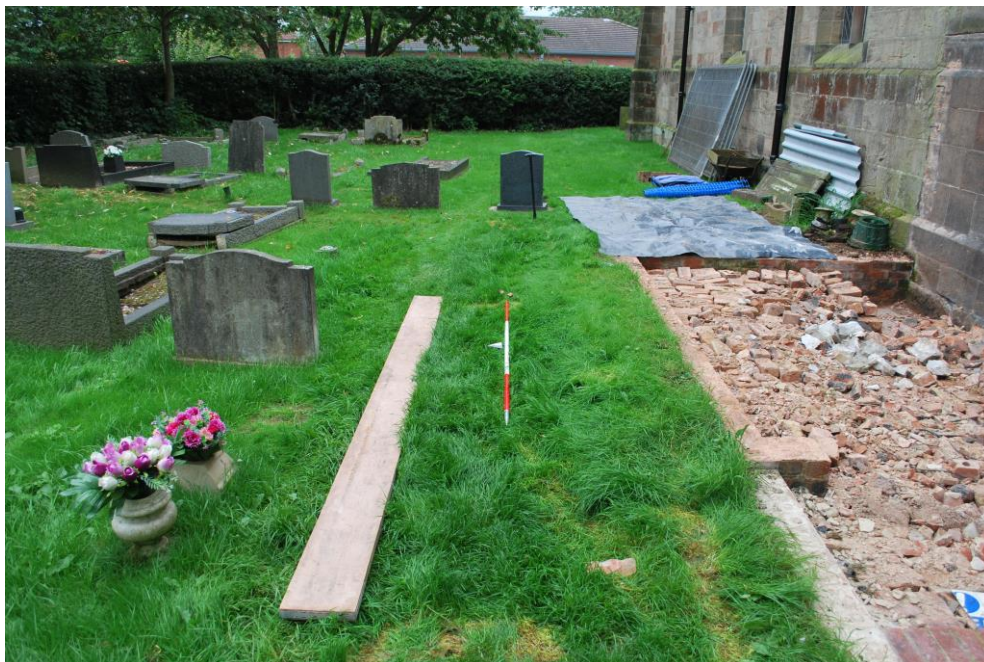
Plate 2. Site pre-excitation facing east. The demolished former oil tank enclosure building is visible in the right of the picture.

7.2. The foul water trench (Plates 2 & 3, Figures 2 & 3) (7m x 0.9m)

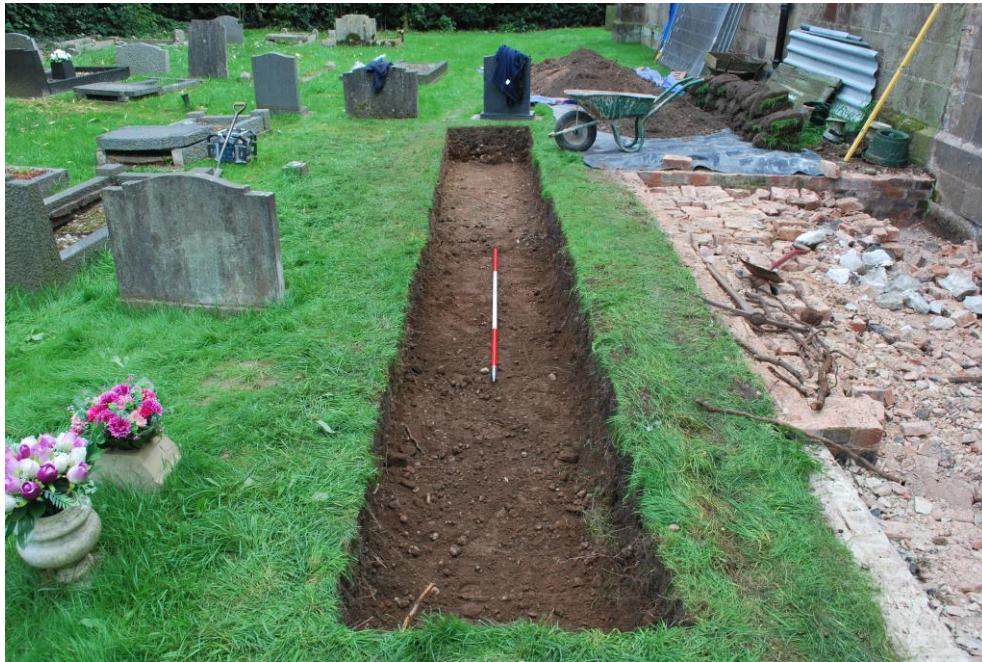
Plate 3. Foul water trench after excavation facing east

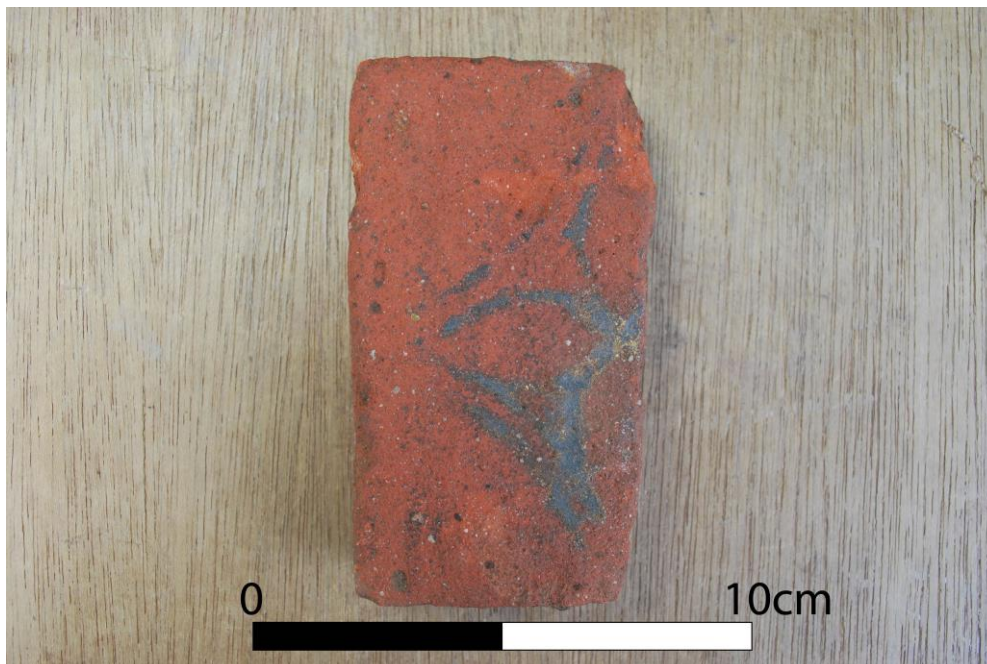
8.1 **Medieval floor tile.** One example of a moulded medieval floor tile fragment was recovered from the overburden layer (002). This tile was hand-made and originally square in form. It has a red coloured ceramic fabric and there was evidence of a brown glaze (Plate 4). It was approximately $\frac{3}{4}$ of an inch thick and 4 inches along its length. The tile is extremely worn but was once line impressed, the design consists of a central flower with four lozenge shaped petals possibly bordered by a quarter circle in each corner. The tile probably dates to the 15th century. This counter relief tile was produced by pressing a carved wooden stamp into the wet clay then the design was the glazed over prior to firing. This is known as the line impressed technique.

Plate 4. 15th century line impressed floor tile fragment from layer 002.

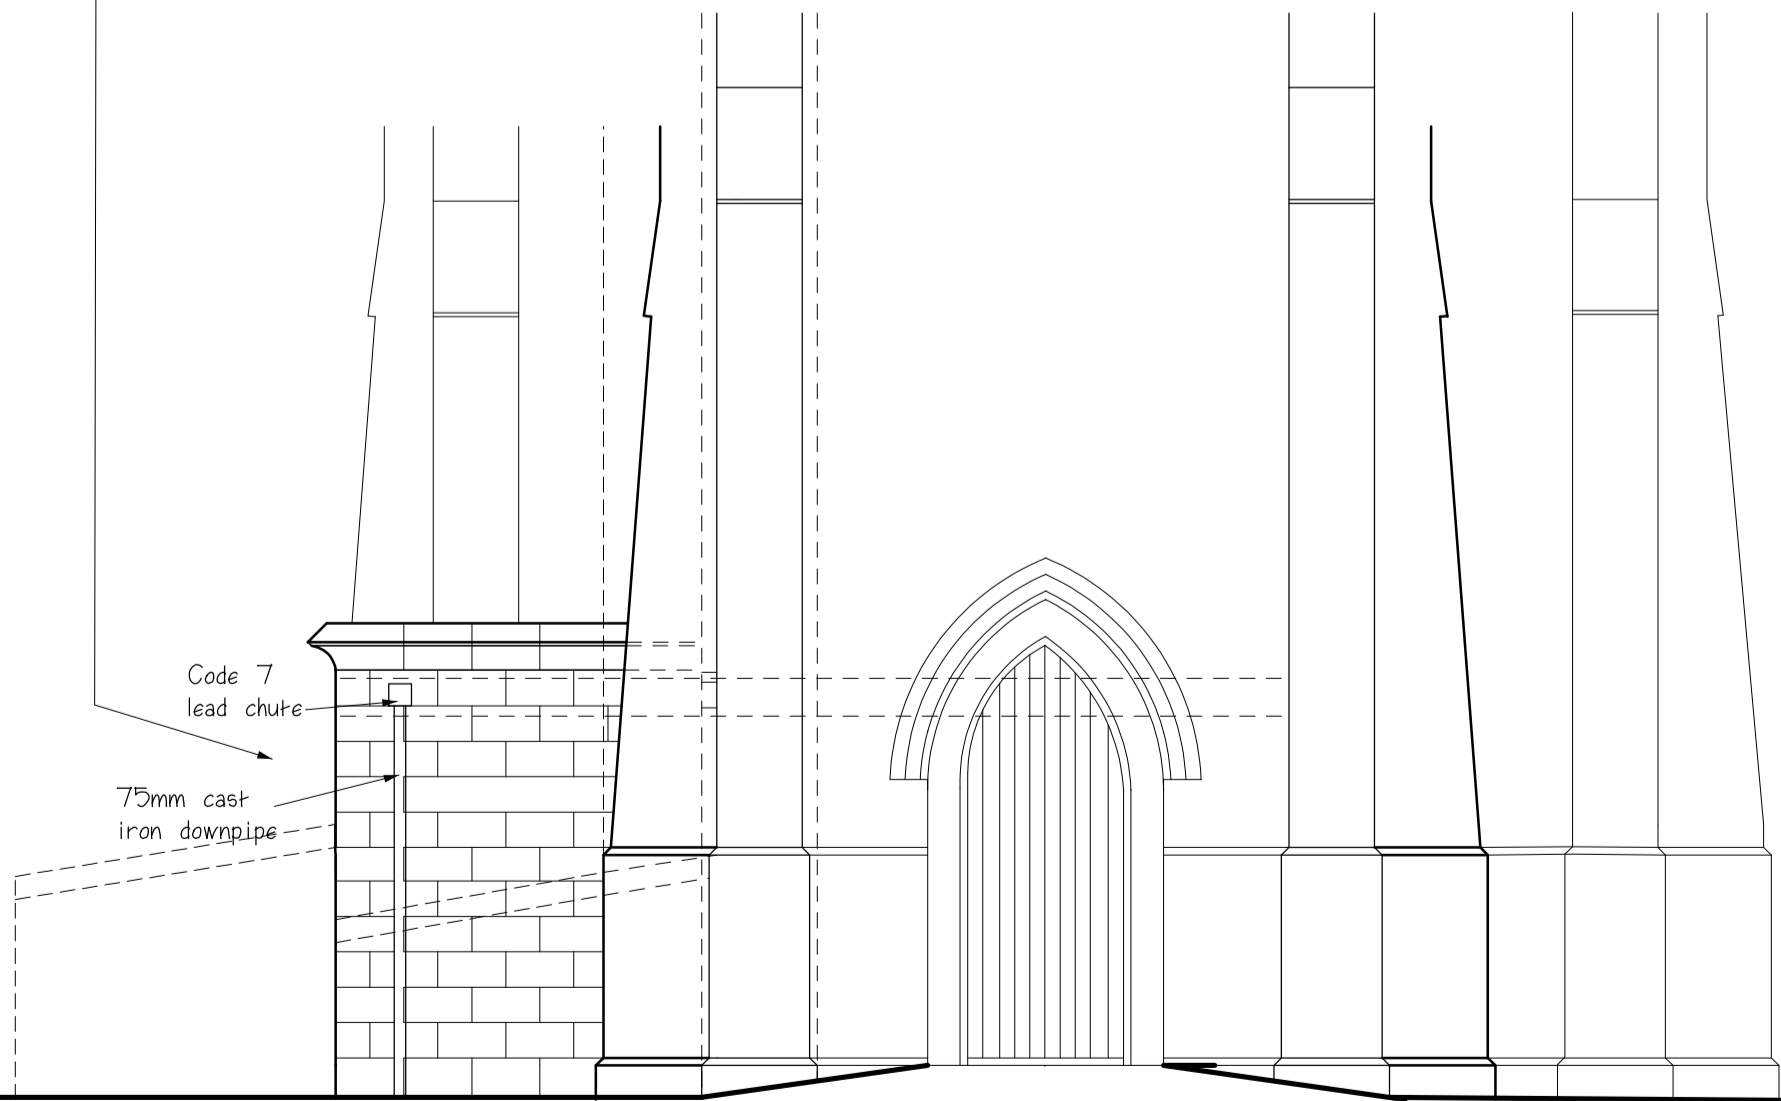
ELEVATION OF FRONT ENTRANCE AND LOWER TOWER

PROPOSED MATCHING STONE ACCESS WC BABY CHANGE AND UTILITY KITCHEN EXTENSION
