Hall's Croft, Old Town, Stratford-upon-Avon, Warwickshire.
Archaeological Desk Based Assessment and Evaluation 2012

Job no. 6245

Museum Code SBT2012-1

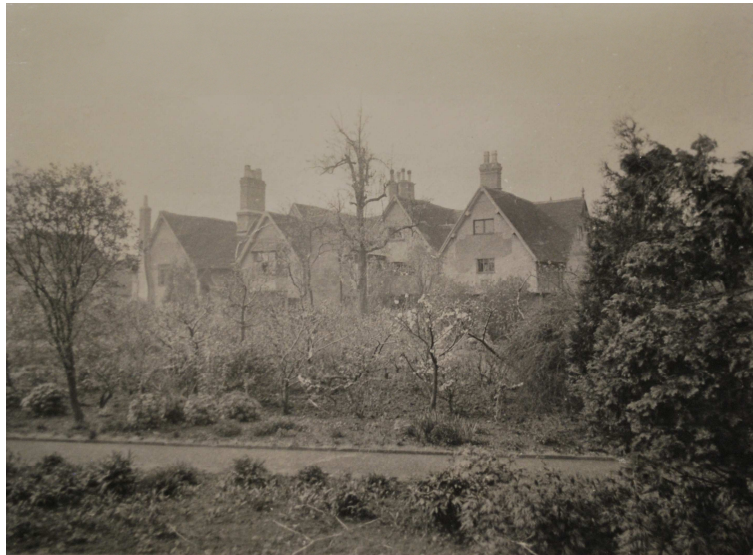
Plate 4: Hall's Croft Garden. Photograph, 1900

The earliest photograph surviving of the garden and rear of the property is from 1900, this clearly shows a garden covered by a miscellany of vegetation (**Plate 4**), paintings from the late 19th and early 20th century support this (**Plates 5 & 6**).

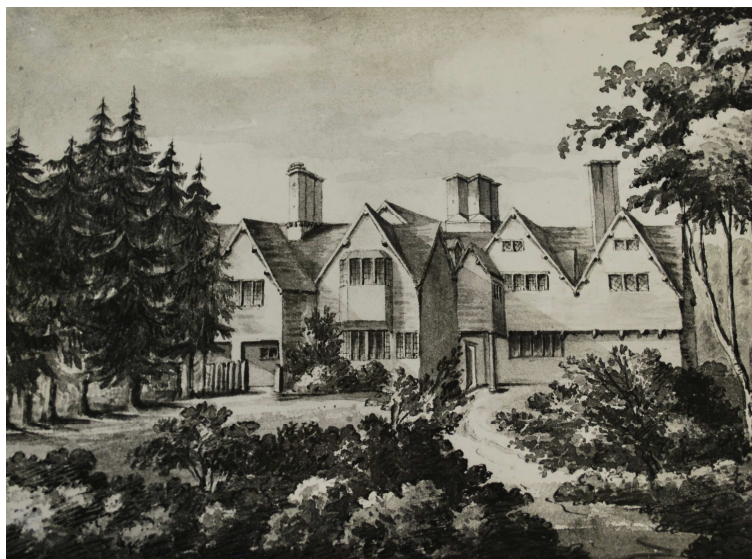
Plate 7: Hall's Croft. R B Wheeler, c 1800-20

Many of the later alterations were taken away and the house was restored back as closely as possible to its original late 17th century state. A comparison of the earliest known photograph of the house (c. 1864) (**Plate 7**) and the house after its restoration in 1951 (**Plate 8**) reveal the extent of the alterations, which were comprehensively researched before restoration commenced. These restorations are well documented (SBT archives, Fox 1997).

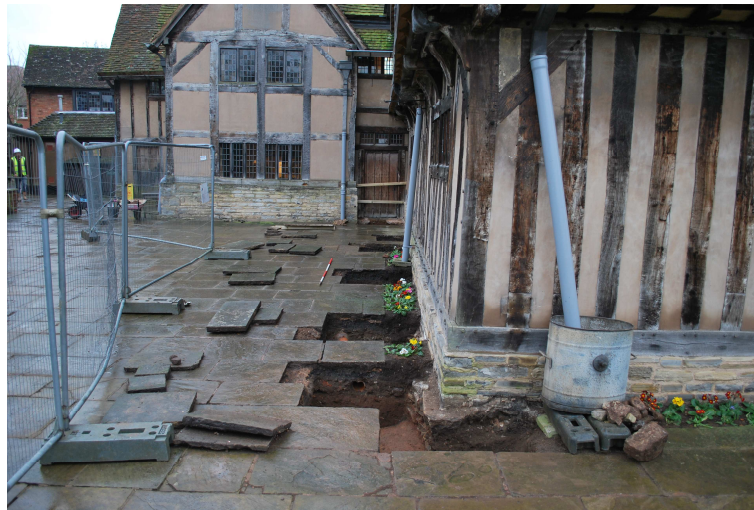
Plate 9: Location of the Test Pits

Seven test pits were excavated at the rear of the property. These were located beneath the east facing jetty within the paved garden area (**Plate 9**).

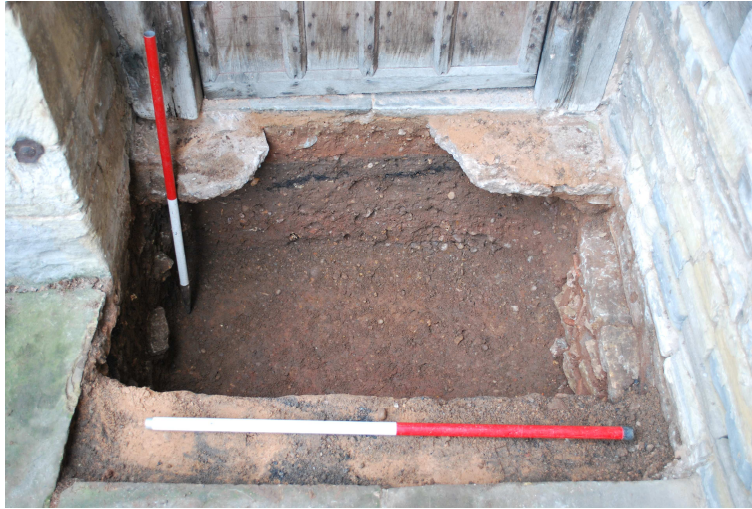
The base of the trench contained a 0.25m thick layer (or undefined pit) **104**, this mid brown sandy silt deposit continued beneath building units IV and V and contained pottery dated to the late 16th – early 17th century. Also recovered from this layer was a large group of horn cores, a small assemblage of animal bones and a dress pin. This deposit could not have been laid down any later than c.1631 when building unit V was constructed. It is contemporary with the occupants of the primary construction phase.

Overlying this deposit was a mixed mid brown sandy silt layer (103) which originated in the 1950's. Compacted red sand, provided an additional bedding layer (101) for the paving slabs which made up the doorway thoroughfare.

Plate 10: Test Pit 1. Looking South

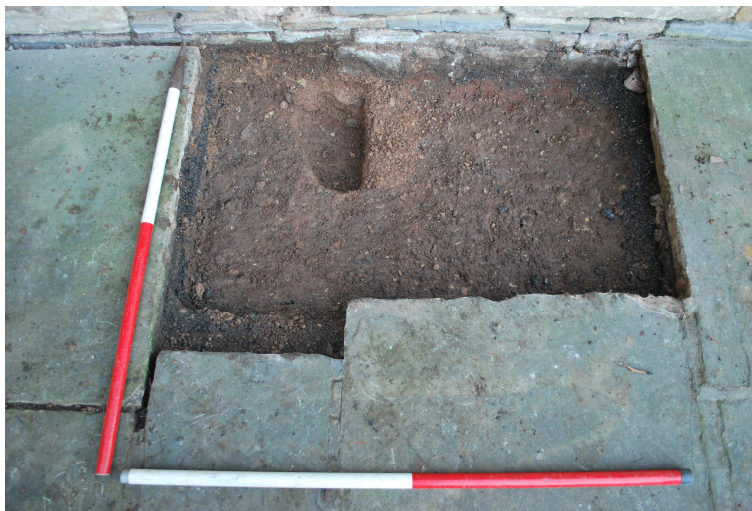
Test Pit 2 was located against the east facing elevation of unit II. It was 0.64m x 1.10m x 0.55m (Plate 11).

The base of the test pit contained a mixed dark brown-red, clay-silt levelling layer (205), containing cultural inclusions (charcoal). This lay directly above the natural gravels (206). A brownish red clay-gravel deposit (202) containing 17th century pottery overlay 205 and was the layer associated with the construction of the cellar in 1614. This layer was also exposed in test-pits 3 and 4. Cut into the top of this layer was a shallow squared post-hole (203) filled with a compact gravel/ hardcore mix (202). This lay beneath the stone slabs laid in the 1950s and was therefore associated with an early 20th century post.

Plate 11: Test Pit 2. Post hole [203]. Looking West.

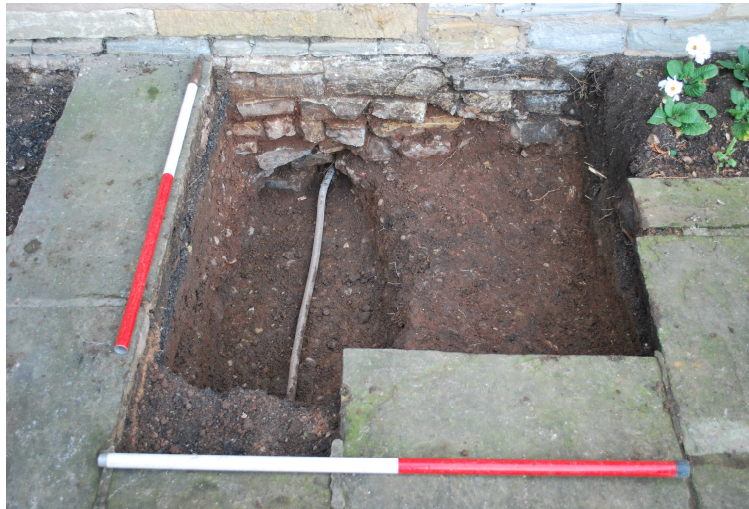
Test Pit 3 was located against the east facing elevation of unit II. It was 1m x 1m x 0.6m (**Plate 12**).

The base of the test pit contained a mixed dark brown-red, clay-silt levelling layer (**306**), containing cultural inclusions (charcoal). This lay directly above the natural gravels (**307**). A brownish red clay-gravel deposit (**302**) containing 17th century pottery overlay **306** and was the layer associated with the construction of the cellar in 1614. A steep linear trench cut through this layer (**303**). This was for a late 18th century lead water pipe (**304**) which fed into the Hall's Croft cellar. The pipe trench had been backfilled with mid brown/red silty-clay/sand (**305**).

Plate 12: Test Pit 3. Pipe trench [303]. Looking West.

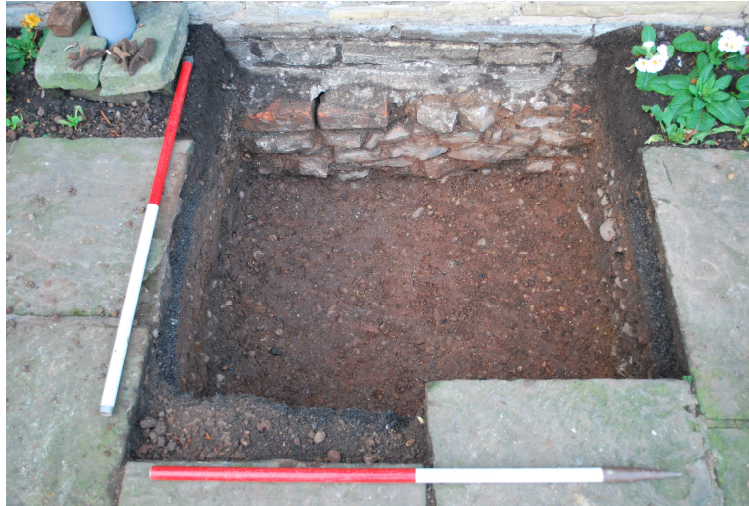
Test Pit 4 was located against the east facing elevation of unit II. It was 1m x 1.04m x 0.6m (**Plate 13**).

The base of the test pit contained a mixed dark brown-red, clay-silt levelling layer (**405**), containing cultural inclusions (charcoal). This lay directly above the natural gravels (**406**). A brownish red clay-gravel deposit (**404**) containing 17th century pottery overlay **405** and was the layer associated with the construction of the cellar in 1614. A large amount of worked stone lay towards the base of this deposit (**407**) some of which appear to have been deliberately laid. It is possible that these worked stones may have been the remains of a truncated structure.

Plate 13: Test Pit 4. Looking West

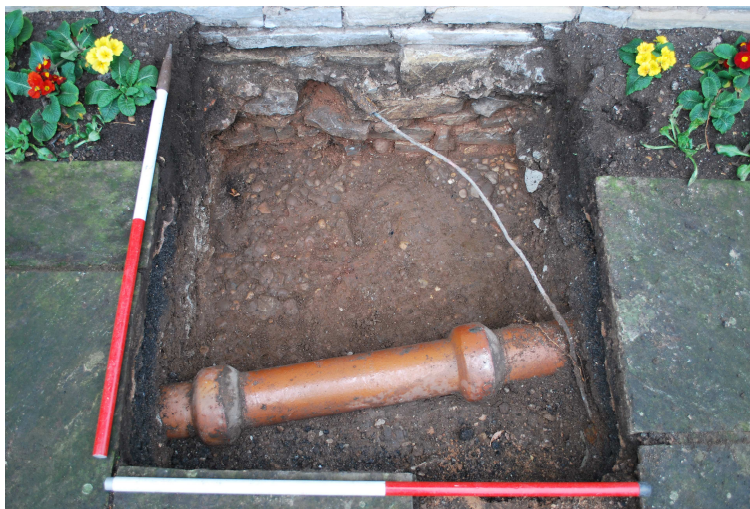
Test Pit 5 was located against the east facing elevation of unit II. It was 1m x 1.4m x 0.8m (**Plate 14, Figure 4**).

The base of the test pit contained a thick (0.4m) mid brown sandy-silt deposit (**509**). The base of the deposit was loose and it was more compacted towards the top, upon which was set a metallised surface (**508**). This surface was made up of small (20-30mm) rounded river pebbles. This surface (**508**) and underlying deposit (**509**) contained 13th century pottery and had been truncated (**510**) by the construction of Hall's Croft cellar. Sealing this surface was a stone rubble deposit (**507**). This contained frequent inclusions of broken limestone and cobbles packed up against the foundations of Hall's Croft. A moderately steep linear trench (**505**) cut through this layer and the layer beneath. This was for a salt-glazed foul-water pipe (**506**) laid as part of the restorations in 1950-51. The pipe trench had been backfilled with a mid-brown mixed sandy-silt deposit (**504**).

Plate 14: Test Pit 5. Metallised Surface 508. Looking West

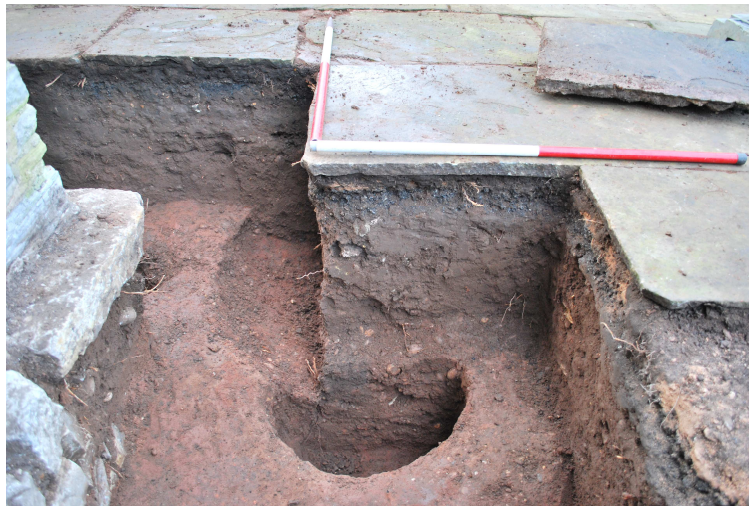
Several *in situ* archaeological features were present with this test pit. The base of the test pit contained a compact mid brown-red, sandy-clay deposit (**615**), the upper part of which contained cultural inclusions (charcoal). This layer immediately overlay the natural gravels (**619**) and was a mixed interface deposit, all the archaeological features had cut through these layers.

A steep sided pit (**610**) was identified in the south-eastern corner of the trench. Its full dimensions were unclear. This was filled with a mid brown sandy-silt deposit (**617**). No artefacts were recovered from this fill. This was the same deposit encountered within the northern part of test pit 5 (**509**), dated to the 13th century. A further shallow pit (**614**) was cut at this level. This was rounded at the southern end and may represent a beam slot foundation. The feature had been backfilled with a dark brown silt deposit (**613**). A steep circular post-hole (**612**) cut through the southern end of the feature. A dark brown silty/organic deposit (**609**) marked the location of a rotted timber post (**608**). Fragmented stone, cobbles and a dark brown, sandy- silt (**611**) had been used as packing material around this post. These features (**610, 612** and **614**) were sealed by a thick (0.35m-0.4m) dark brown organic sandy-silt buried soil layer (**607**) containing 13th century pottery and animal bone. A moderately steep linear trench (**605**) cut through this layer and the layer beneath. This was for a salt-glazed foul-water pipe (**604**) laid as part of the restorations in 1950-51. The pipe trench had been backfilled with a mid-brown mixed sandy-silt deposit (**606**).

Plate 15: Test Pits 6 & 7. Post hole [612] and pit [614]. Looking North.

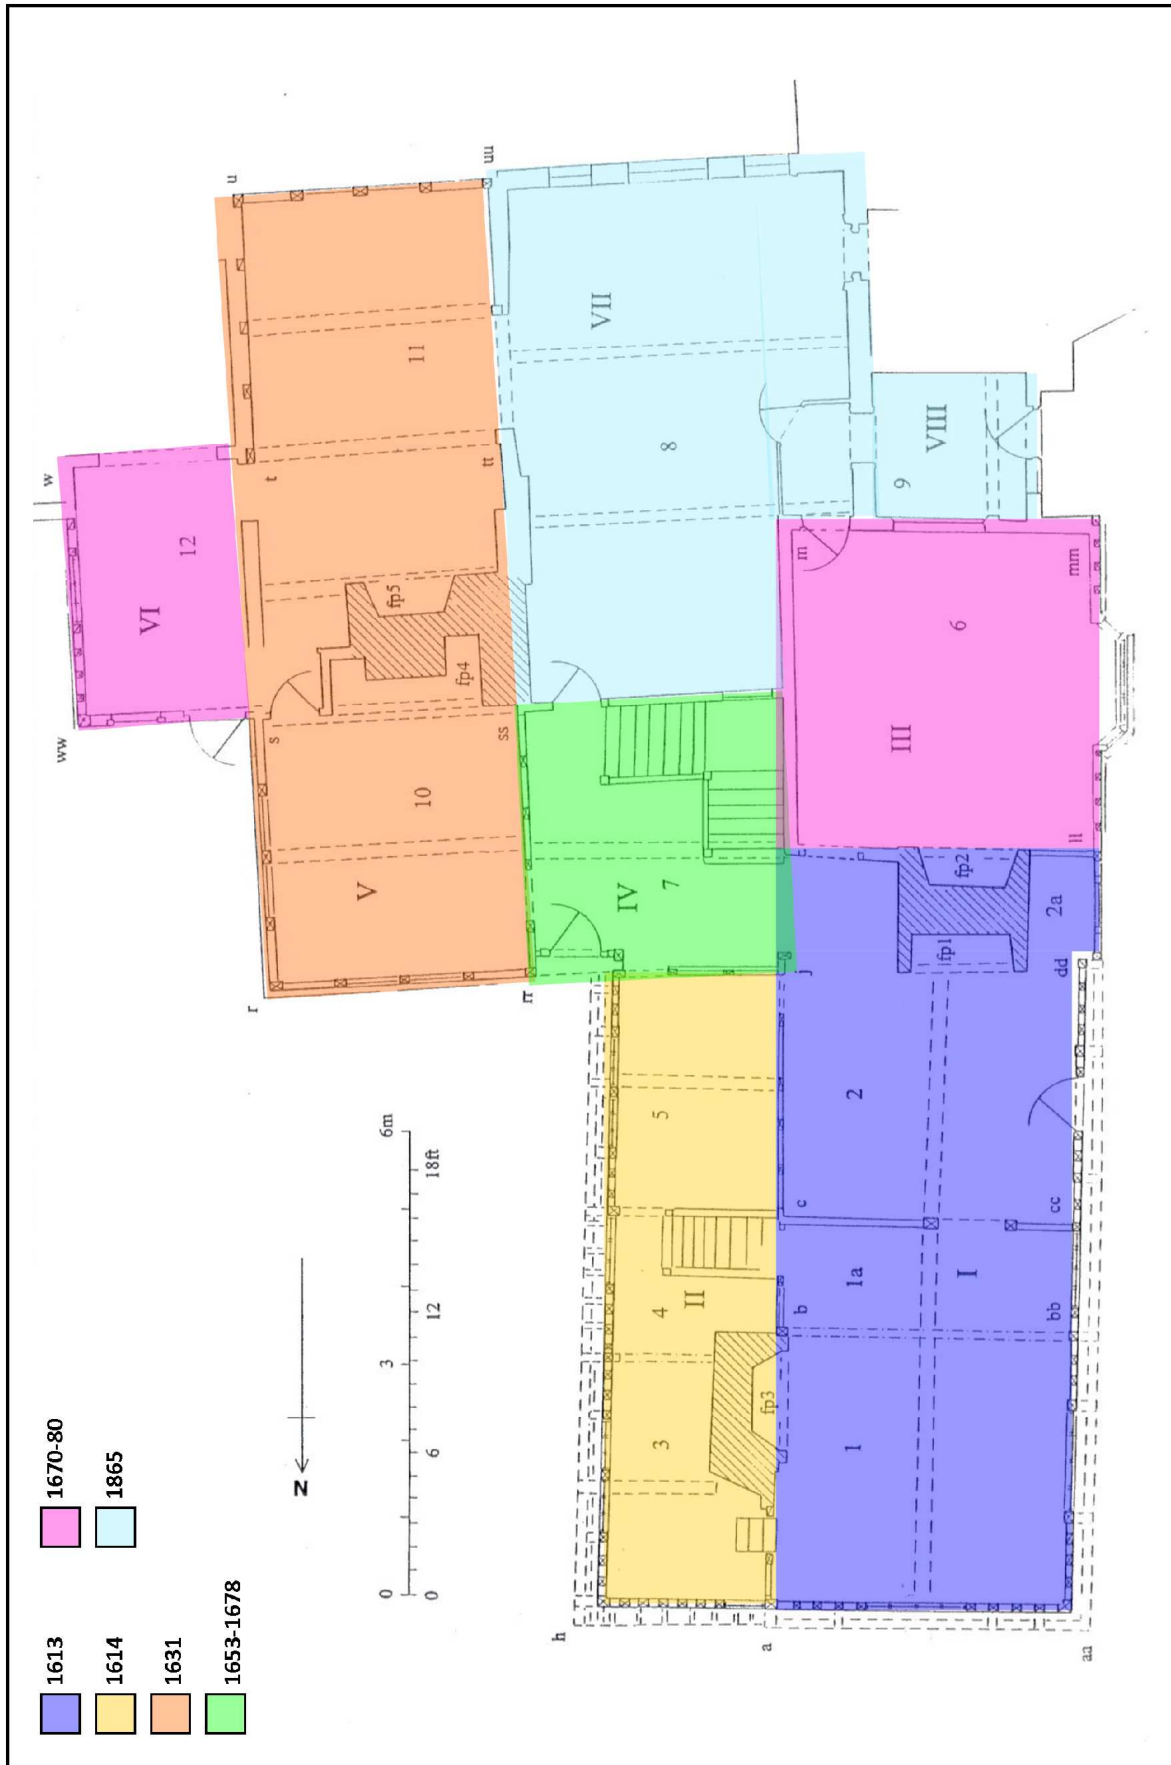
Please refer to **Figure 3** for the location and phasing of the units.

STAGE	DATE	CONSTRUCTION
A	1613 (Tree Ring Date)	Unit I including central stair and fireplace(s): adjoins earlier structure on site of Unit III. Possibly also unit II or a structure on its site. <i>Primary phase of construction. 'Fourteen precise felling dates all for the same felling period of winter 1612/13 suggests the timbers were cut specifically for the construction of the building....during the summer and autumn of 1613' (Miles 1999)</i>
B	1614 (Tree Ring Date)	Unit II with stair and chimneys (fireplaces F1-F8). May be virtually the same date as phase A. (Felling date of a single joist - winter 1613/14).
C	1620's (Approx Date)	New roof; Small stair adjoining F6 inserted.
D	1631 (Tree Ring Date)	Unit V: Detached single storey kitchen, stable and hayloft.
E	1653-1678 (Tree-Ring Date)	Unit IV added for main stair; Unit V reconstructed for ground floor kitchen and service; first floor chambers and fireplace (F9).

F	1670-80 (Approx Date)	Unit III reconstructed. New staircase in unit IV. Addition of Unit VI providing further service and an extra chamber. Corridor adjoining room 22 constructed. Gable added to room 21.
G	1700-20 (Approx Date)	Addition of bay windows to units I,III and V; Unit IVa added.
H	1865 (Documentary Date)	Addition of School Room and Ante Room. (Units VII and VIII)

Figure 3: Building Phase Plan (after Alcock and Meeson 1998)

The earliest phase was the construction of the main building (Unit I) in 1613. This was followed soon after (1614) by the addition of a second range of rooms (Unit II). It is likely that this addition was always intended and construction occurred at the next most convenient time (Nb. An earlier building which originally attached to the main building, stood on the site of Unit III until its reconstruction in 1670-80). A new roof constructed over Units I and III created an enlarged attic space. The attic would have been large enough for the storage of goods making its building by a merchant likely. The construction in 1631 of a detached single storey kitchen, stable and hayloft (Unit V) was next in the sequence. Later in the century this became two stories. Between 1653-1678 the main staircase hall (Unit IV) was constructed to amalgamate the ranges (I,II and V) and provide easier access to the new floor in Unit V. The next major construction phase occurred in approximately 1670-80 when Unit III was reconstructed and Unit VI was

added providing more service spaces and chambers above. Later reconstructions in 1700-1720 consisted of the addition of bay windows and arched ceiling in Unit III. Several of the outbuildings date to the later 18th century. Around 1868 a room built for the purpose of being a schoolroom (Unit VII) and anteroom were constructed (Unit VIII). Further alterations, too numerous to mention, occurred in the later 19th and 20th centuries (**Figure 3**).
