The Boat House, Bitterne Park Triangle, Cobden Avenue, Southampton

Historic Building Record

SOU1608

Report reference: 75990.02

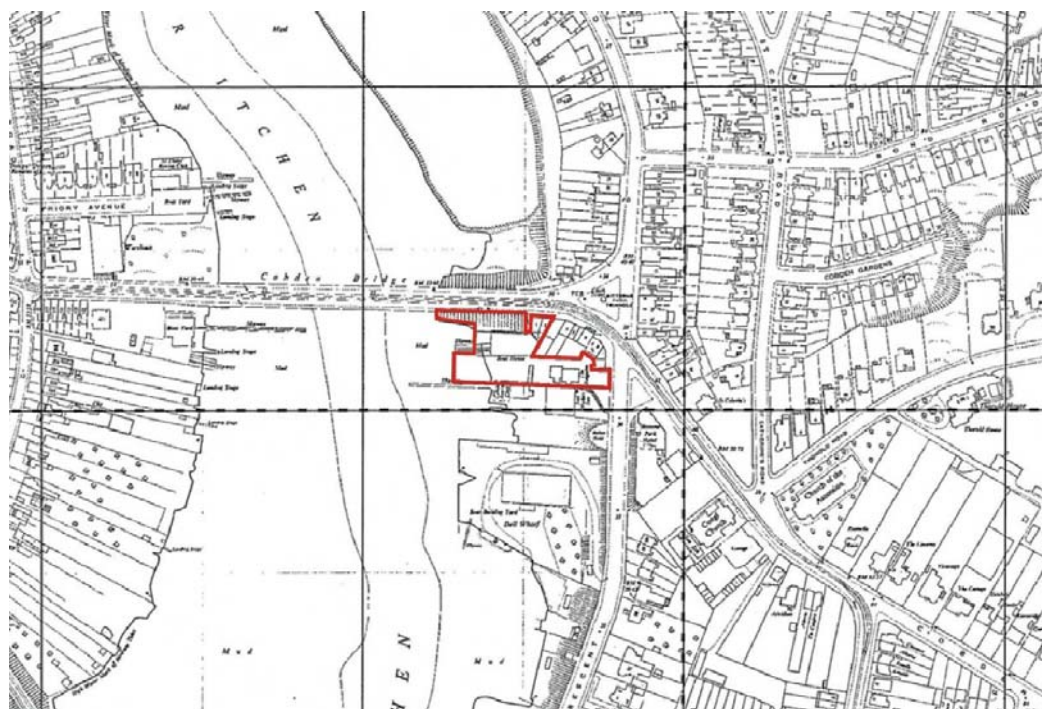
- 3.1.3 Ordnance Survey mapping dating from 1933-1944 shows that the Site had been reclaimed and the Boat House constructed at the northern extent of the Site. A smaller rectangular building is situated at the eastern end of the Site with two small terraced houses (numbers 1 and 2 Whitworth Crescent) constructed to the north (**Figure 2**).

- 3.1.6 The 1950 Ordnance Survey map shows that the eastern end of the building has been slightly extended by this time so that it now occupied the whole footprint of the building (**Figure 2**). Subsequent historic mapping reveals no apparent change to the building.

1933-46 Ordnance Survey map 25" : 1 mile

1950 Ordnance Survey map 25" : 1 mile

- 3.1.5 Around the same time as the Boat House was being constructed there appears to have been an expansion in the boat building industry in the vicinity of Cobden Bridge with a larger boat house depicted to the south of the Site in the 1933-1946 map (**Figure 2**). This was followed by two more boat houses on the west side of the river along with numerous landing stages and slipways by the time of the 1950 map (**Figure 2**).

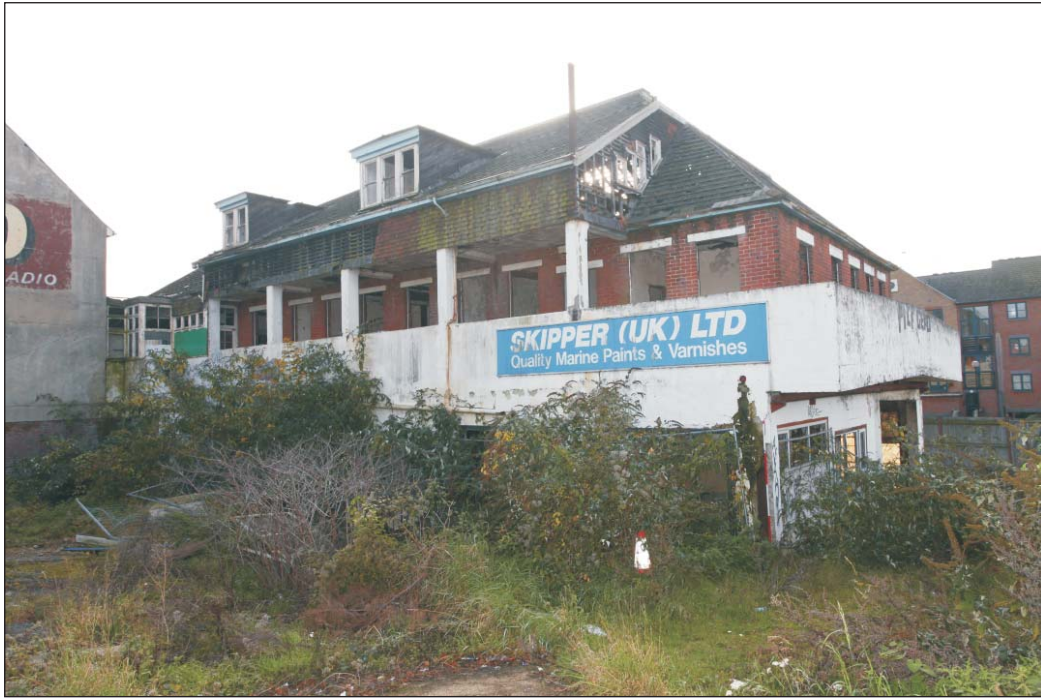
- 4.2.1 The Boat House comprises a large roughly rectilinear structure orientated east-west along its long axis (**Figure 3**). The building consists of three floors, although due to the steeply sloping nature of the embankment upon which the building sits, the building is divided into an Upper and Lower Ground floor with Loft floor above. The Upper Ground floor roughly corresponds with street level and is occupied by former offices (**Plate 1**). A large open workshop is situated at Lower Ground floor level (**Plate 2**).

Plate 1: The Boat House viewed from the north-west

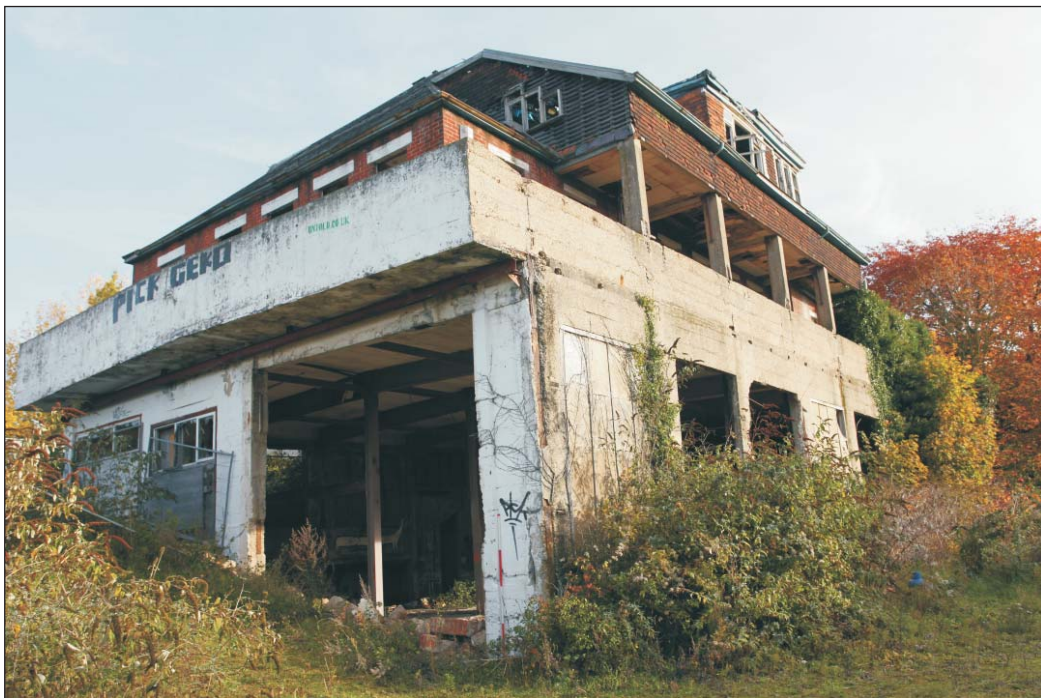
Plate 2: The Boat House viewed from the south-west

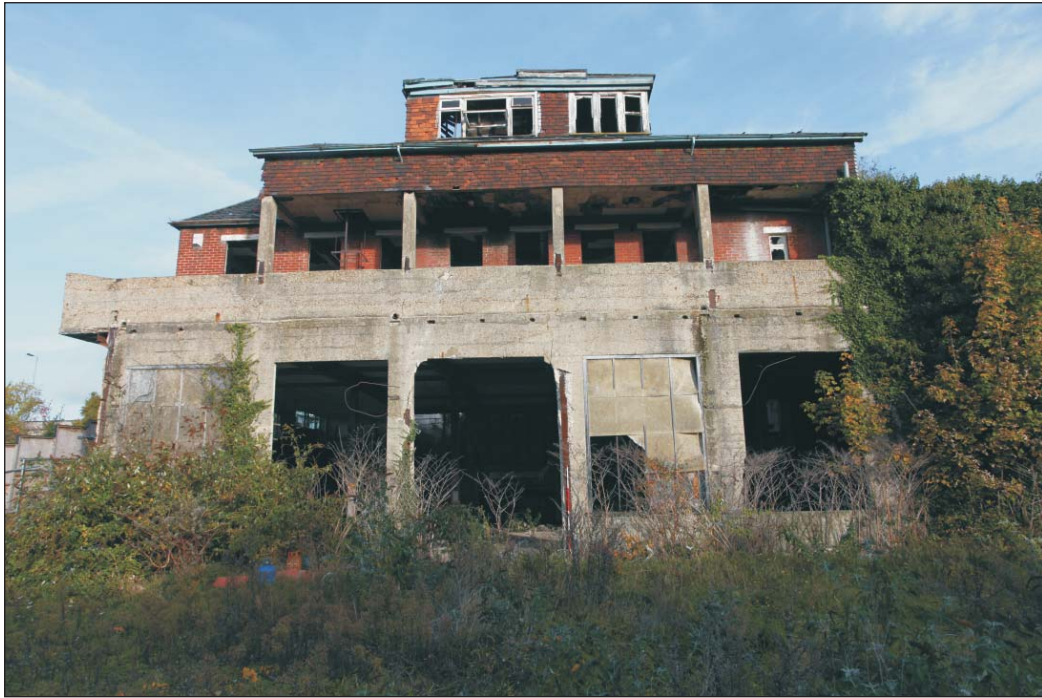
Plate 3: The Boat House viewed from the south

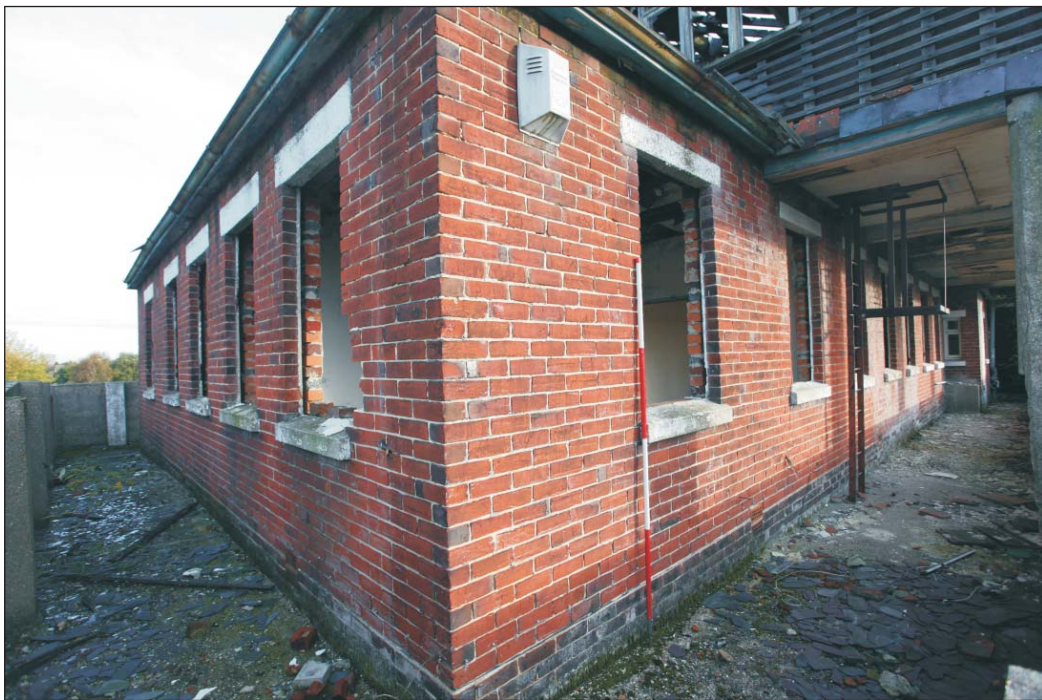
- 4.2.4 Above the level of the boat shed, the Upper Ground floor is constructed from red brick in stretcher bond comprising a 13" cavity wall pierced by numerous rectangular window openings with moulded concrete sills and lintels on the north, south and west elevations (**Plate 4**). The offices are surrounded on the north, south and west sides by a wide concrete walkway comprising the roof deck of the workshop below, which is protected by reinforced concrete walls (**Plate 5**). Access out onto the walkway is via an entrance on the north elevation.

Plate 4: Exterior of the Upper Ground Floor

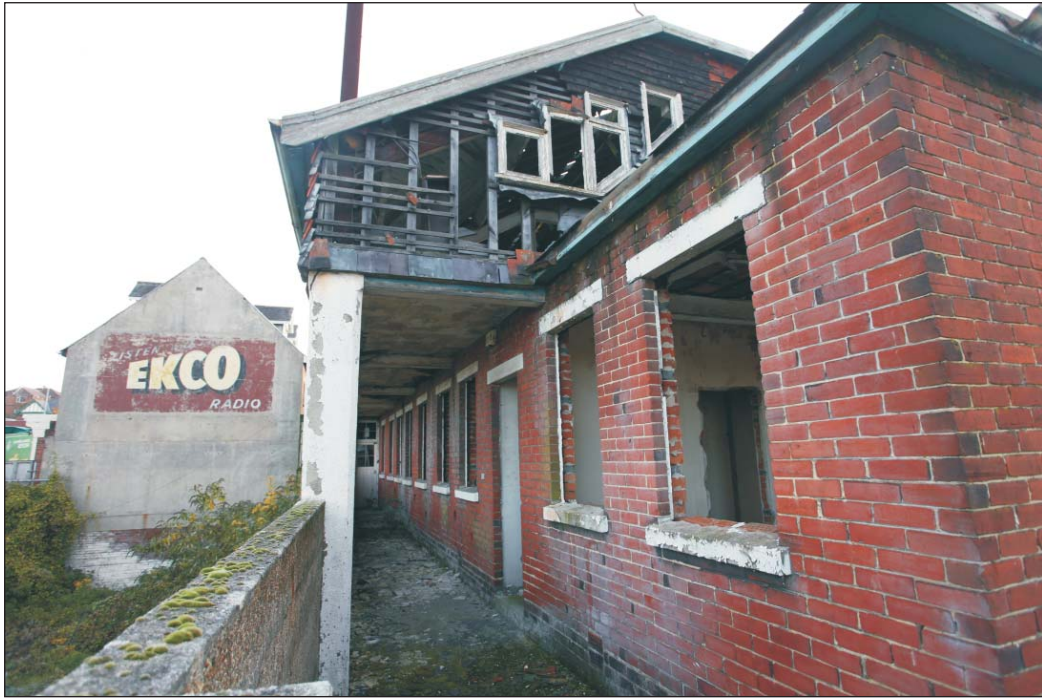
Plate 5: Exterior walkway on the Upper Ground Floor

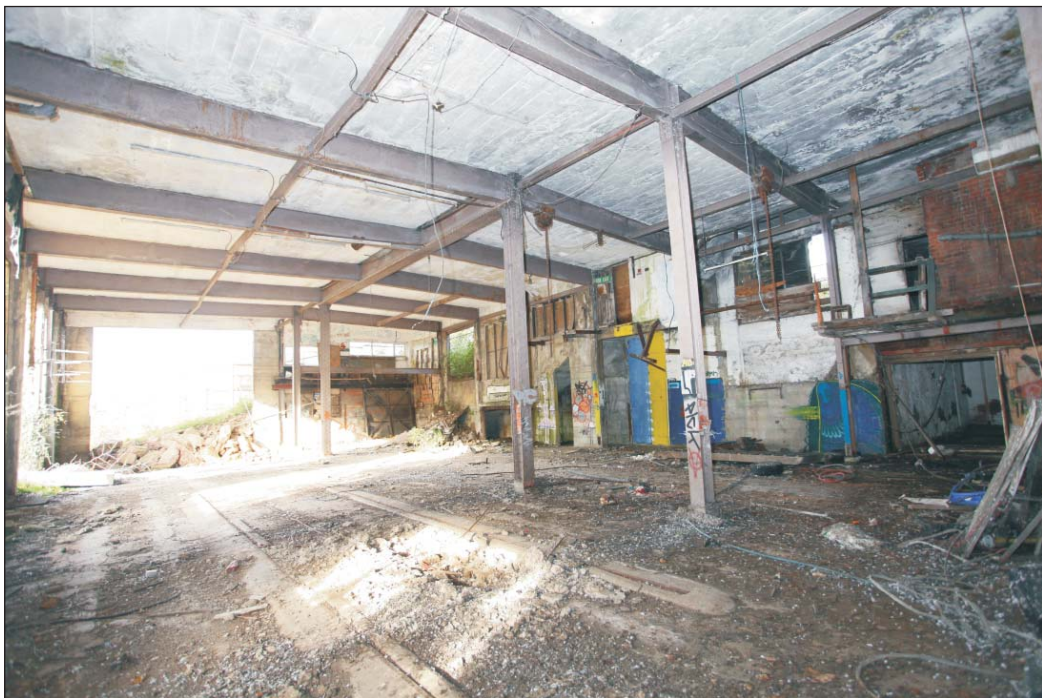
- 4.3.1 The Lower Ground floor essentially consists of a large open space of eight bays constructed from a simple rectangular steel frame of I-profile posts and girders supporting a concrete roof deck with concrete floor below (**Plate 6**). Evidence for former boat building activity can be seen from the steel running rails embedded within the floor on the southern side of the workshop with the south-western corner of the building sloping down towards the former slipway (**Plate 7**). In addition, two remnant 'MORRIS' hand chain hoists are still *in situ* fastened to existing girders (**Plate 8**).
- 4.3.2 Two rectangular stores are situated at the eastern end of the Lower Ground floor running under the adjacent terraced properties of numbers 1 and 2 Whitworth Crescent and connected via a central passageway. The rooms

Plate 6: Lower Ground Floor workshop

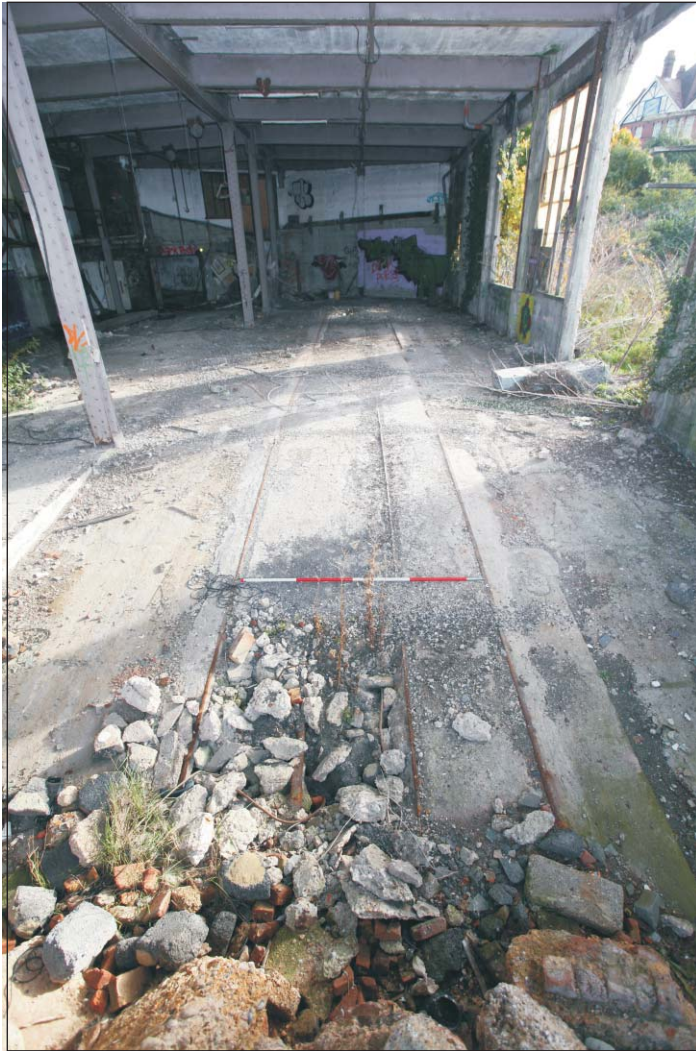
Plate 7: Steel running rails leading down towards the former slipway

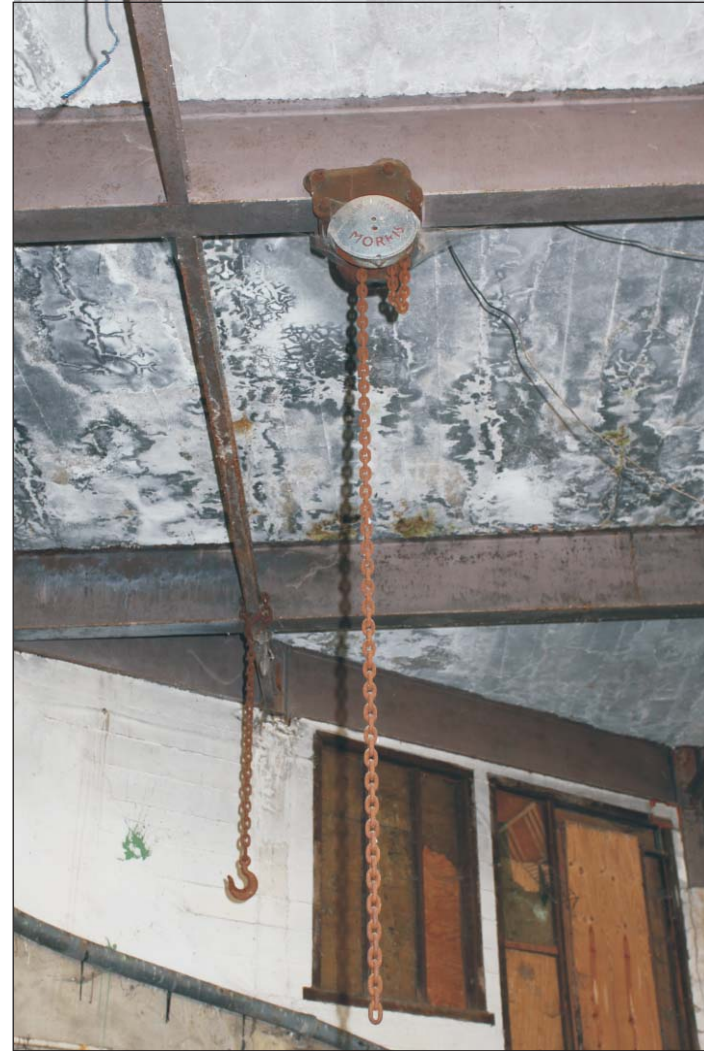
Plate 8: Remnant hand chain hoist

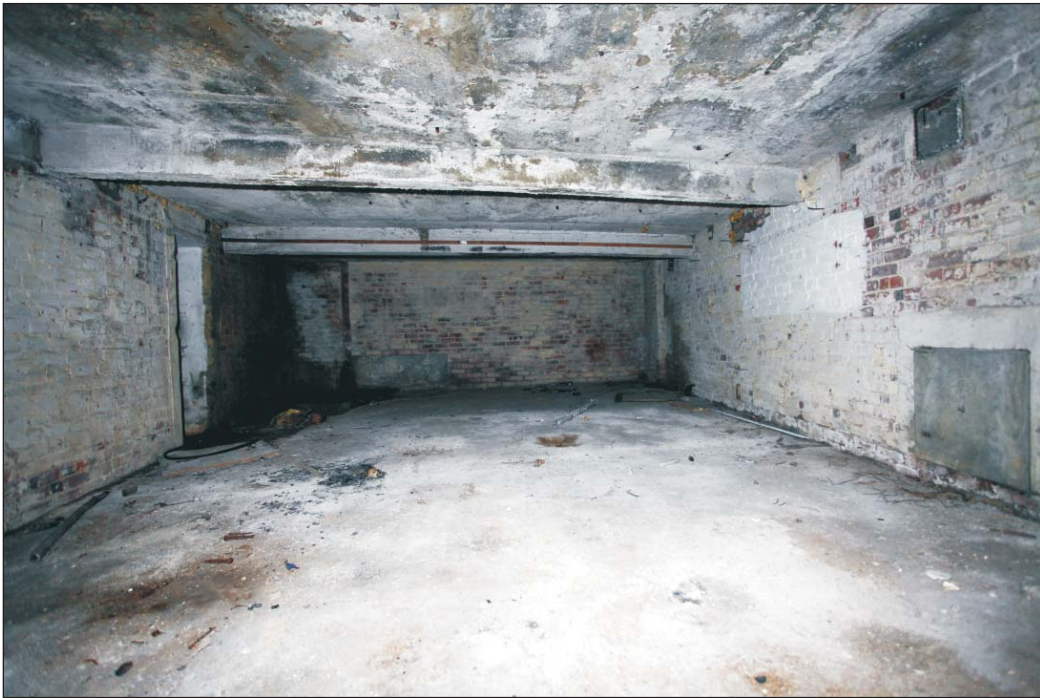
are plain comprising painted brickwork and concrete floors (**Plate 9**). In addition, a single brick toilet cubicle is situated at the eastern end of the workshop adjacent to the remains of a straight flight staircase on the northern wall which formerly provided access to the Upper Ground floor.

Plate 9: Subterranean store situated at the eastern end of the workshop

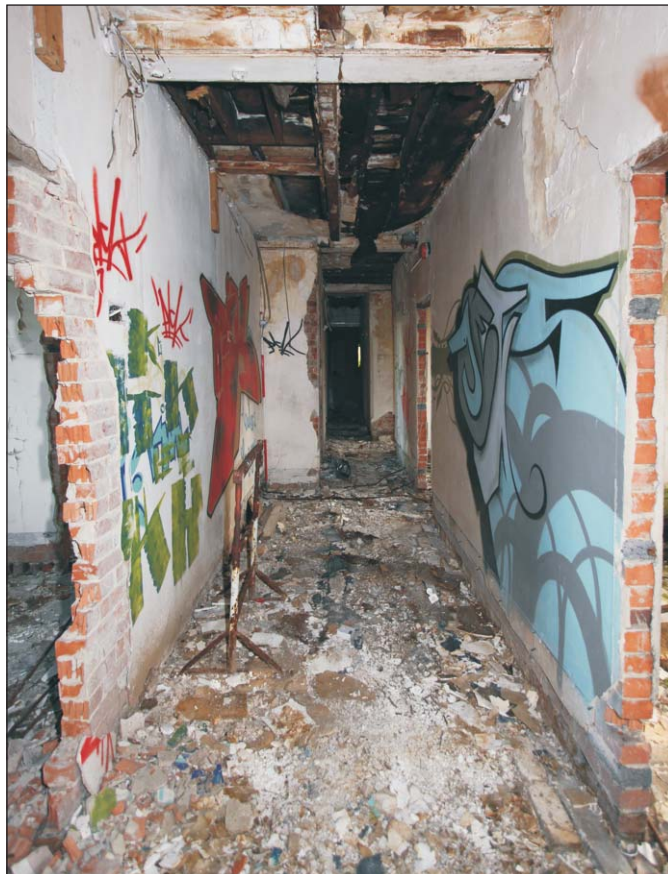
- 4.3.3 The interior of the Upper Ground floor is simple with the main part of the building divided up into offices situated either side of a central east-west orientated corridor with small northern spur leading to a doorway situated on the north elevation (**Plate 10**). Little can be said of the decoration within the Upper Ground floor as the building has been soft-stripped some time ago (**Plate 11**). Low brick sleeper walls topped with slate damp-proofing are set on the concrete deck which would have originally supported timber floor joists. Where the building has been derelict for some time, water penetration has caused the gypsum board ceilings to come down revealing softwood timber joists, boxed in steel girders and the floorboards of the Loft above.

Plate 10: Central corridor viewed from the west

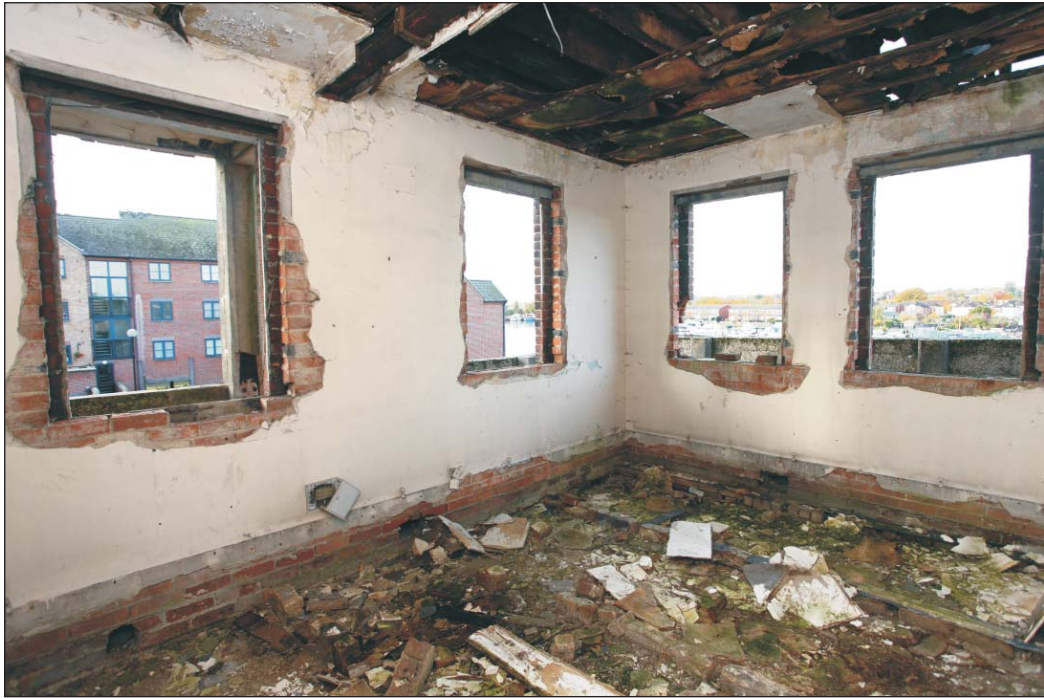
Plate 11: Typical office viewed from the south-west

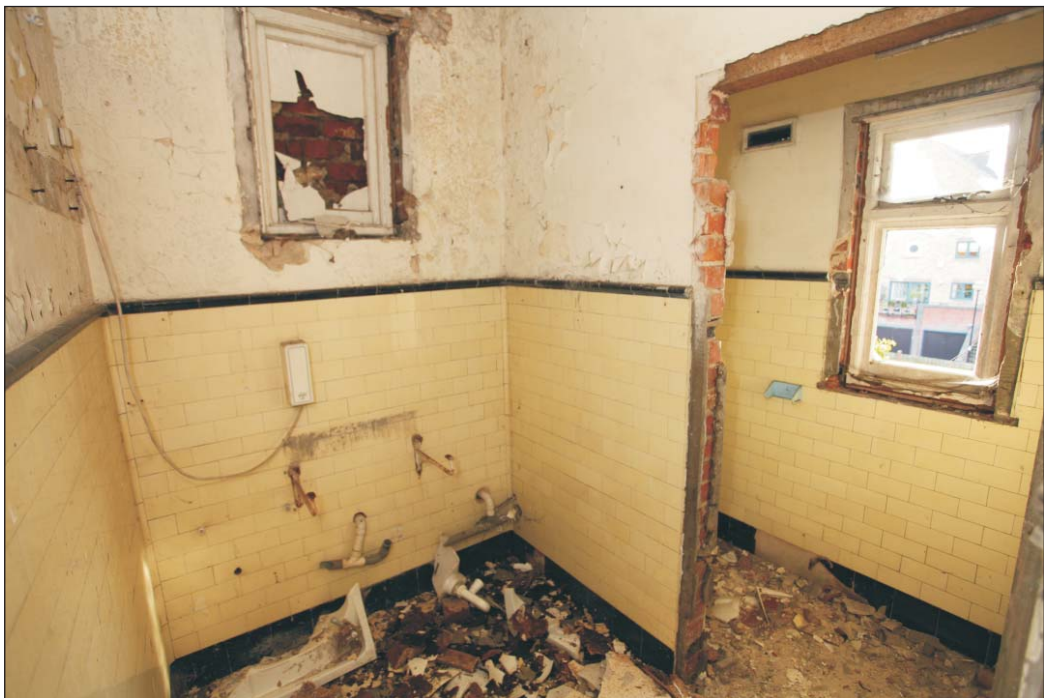
- 4.3.4 The individual rooms are almost identically plain and uninteresting with the exception of the Toilets which feature two-tone enamel tiled walls to 1.4m in height (**Plate 12**).

Plate 12: Toilets viewed from the north

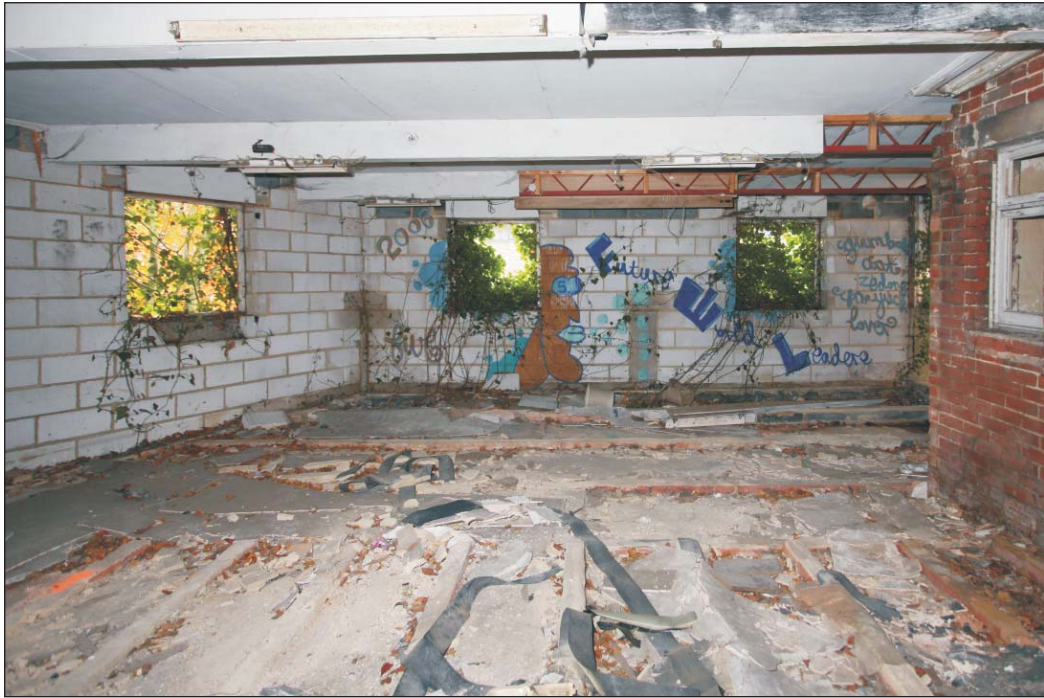
- 4.3.5 At the eastern end of the building is the mid-20th century extension, which extended the Upper Ground floor over an area which is shown as 'Open Yard' in the 1937 proposed plans for the building (**Figure 4**). Initially this yard comprised the concrete roof deck of the Lower Ground floor workshop. This extension comprises a large open space with walls constructed from concrete blockwork (**Plate 13**). Here also low brick sleeper walls are present topped with a damp-proof membrane set on the concrete deck. The flat roof above is supported by boxed-in lightweight steel girders. To the north of the extension is the main entrance vestibule accessed via the covered way on Whitworth Crescent with double-door entrance situated on the north wall (**Plate 14**). Adjacent to the entrance is a straight flight staircase which provides access to the Loft floor replacing the original staircase shown in the 1937 proposed Loft floor plan (**Figure 5**).

Plate 13: Mid 20th century extension

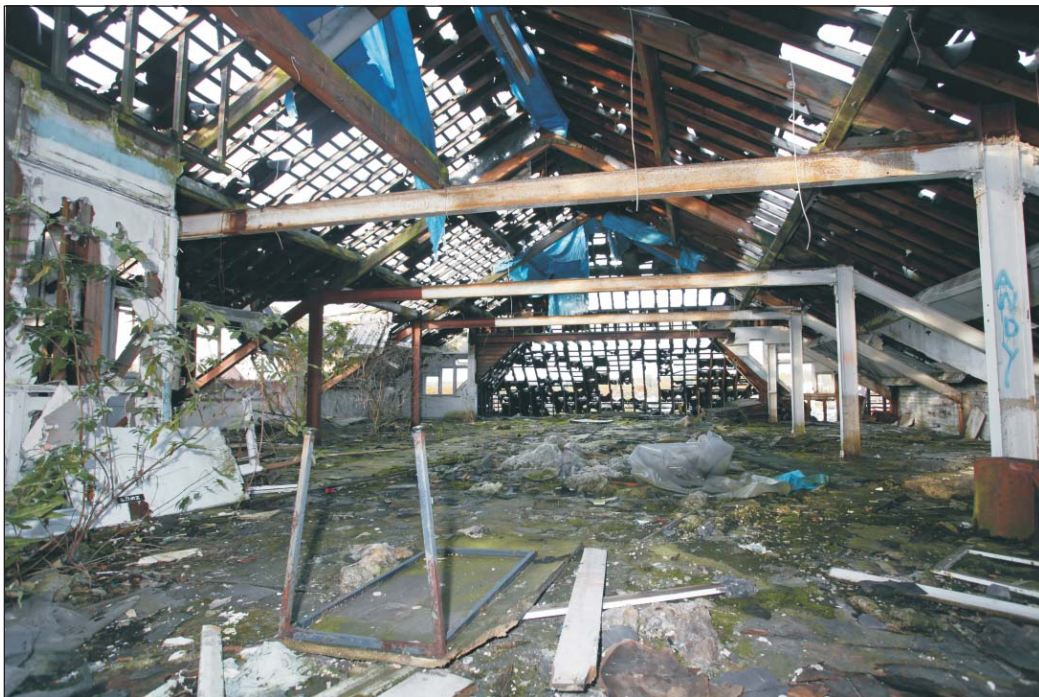
- 4.3.6 Due to health and safety concerns access to the Loft floor was not possible during the Site visit. The poor condition of the building meant that the structural integrity of the floor joists could not be assured.
- 4.3.7 Despite this, a brief examination of the floor was possible from the top of the straight flight staircase leading up from the Upper Ground floor. This showed a single large open space made up of series of regularly spaced trusses comprising bolted steel frames to collar height with a softwood timber roof frame above (**Plate 15**).

Plate 15: Loft floor viewed from the west
