Archaeological Monitoring and Recording Report: Fleet to Camberley 132kV Gas Compression Cable Replacement

Report By: Andrew Brown MSc BA (Hons) ACIfA
Issued by: Diarmuid O'Seaneachain PhD BA MCIfA
Date: February 2020

Submitted to:	Prepared by:
Scottish and Southern Energy Networks	RSK ADAS Limited 11D Park House Milton Park Abingdon OX14 4RS Tel. no: 01235 355638

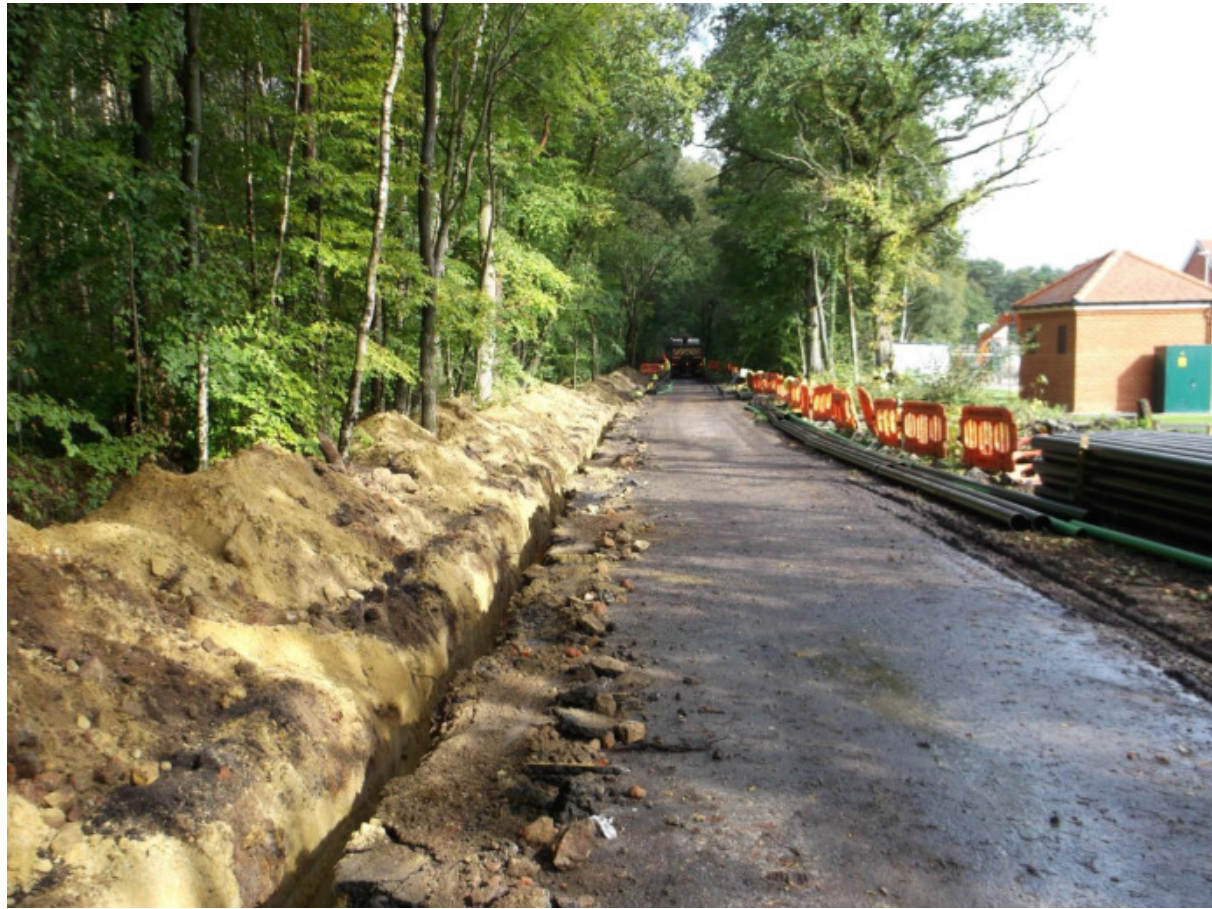
Plate 1: General view of Area 1, looking north-east

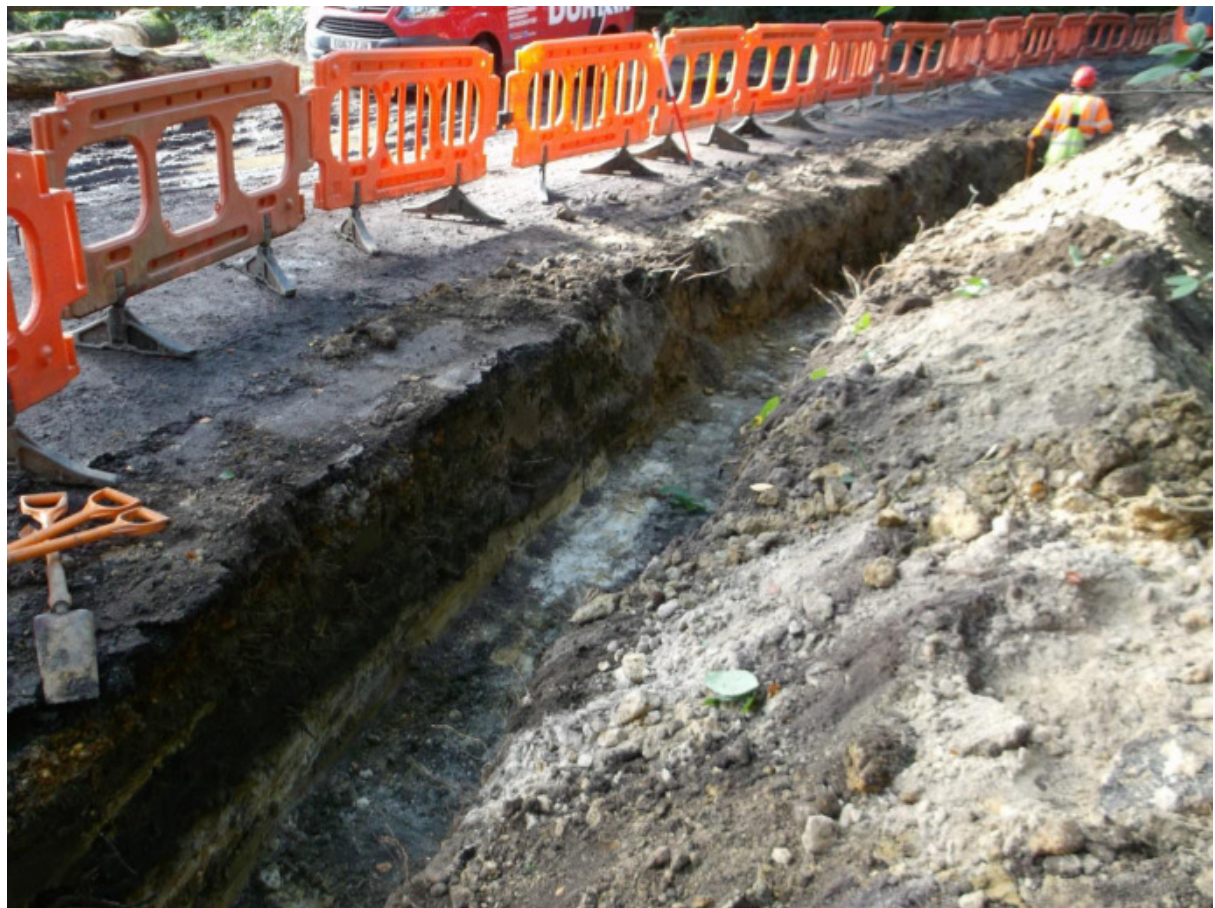
- 6.1.5 Area 1 was located along an existing tarmac footpath (Old Minley Road) just outside the southern edge of the Grade II Registered Park and Garden and measured approximately 415 m in length (Figure 2). The new cable route in places followed the route of the previous 132 kV cable route that is due to be replaced and exposed the modern electricity cables. For simplicity the previous cable trench, cables and modern backfill were designated the context number (105) (Plates 1 and 2).

Plate 2: General view of stratigraphy in Area 1 showing modern backfill (105) relating to the existing 132 kV cable trench, looking south

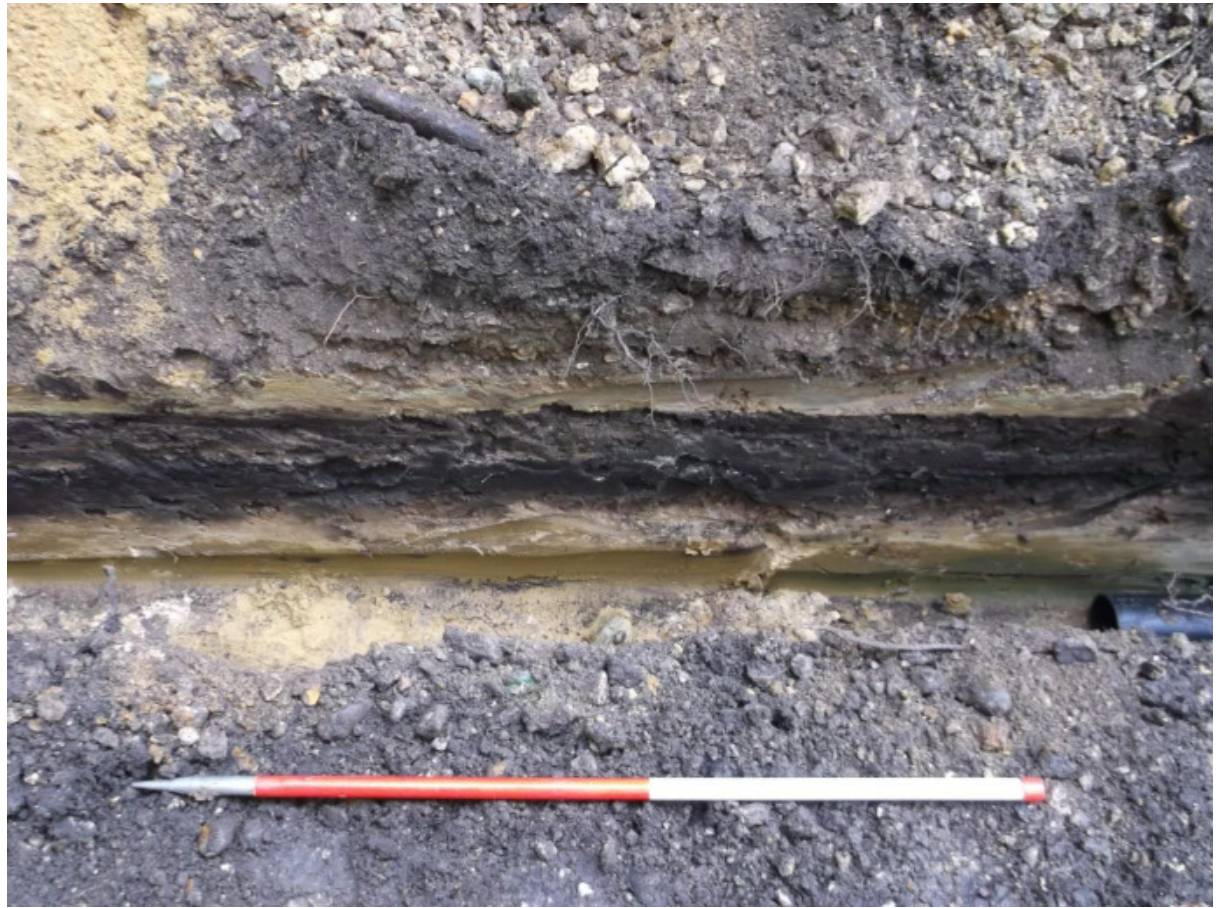
- 6.1.6 The trench followed the existing tarmac path and was partially within a previously excavated underground cable route. The basic stratigraphic sequence of the new replacement cable trench through Area 1 was tarmac (100) sealing 0.20 m of modern imported made ground of red brick fragments, concrete, and limestone fragments (109) were observed. This imported layer sealed a buried topsoil horizon (101) of a mottled grey-brown loam approximately 0.14 m thick, overlying 0.65 m of natural mottled yellowish grey sand (102) (Plates 2-4).

Plate 3: South-east facing representative section of stratigraphy in Area 1, looking north-west

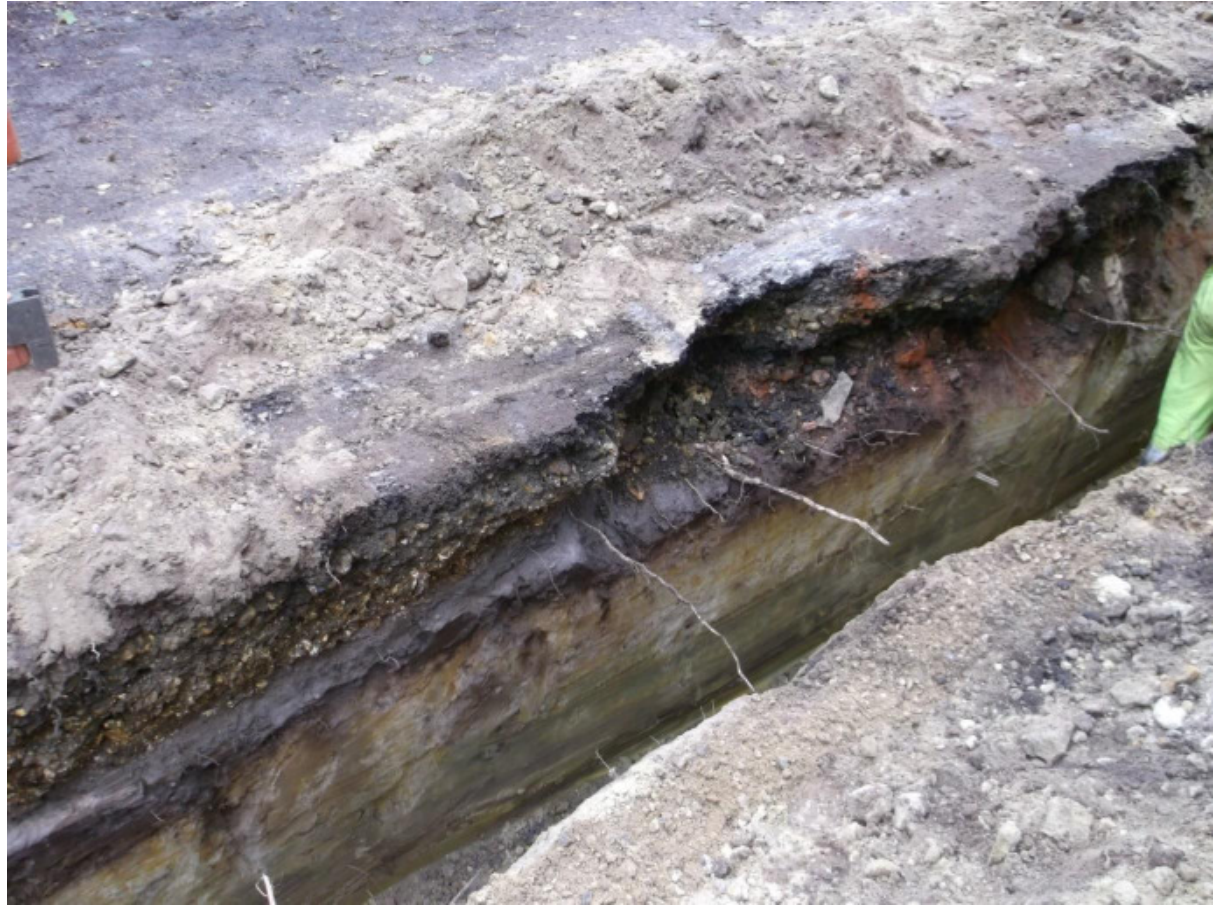
Plate 4: General view of stratigraphy in Area 1, looking south

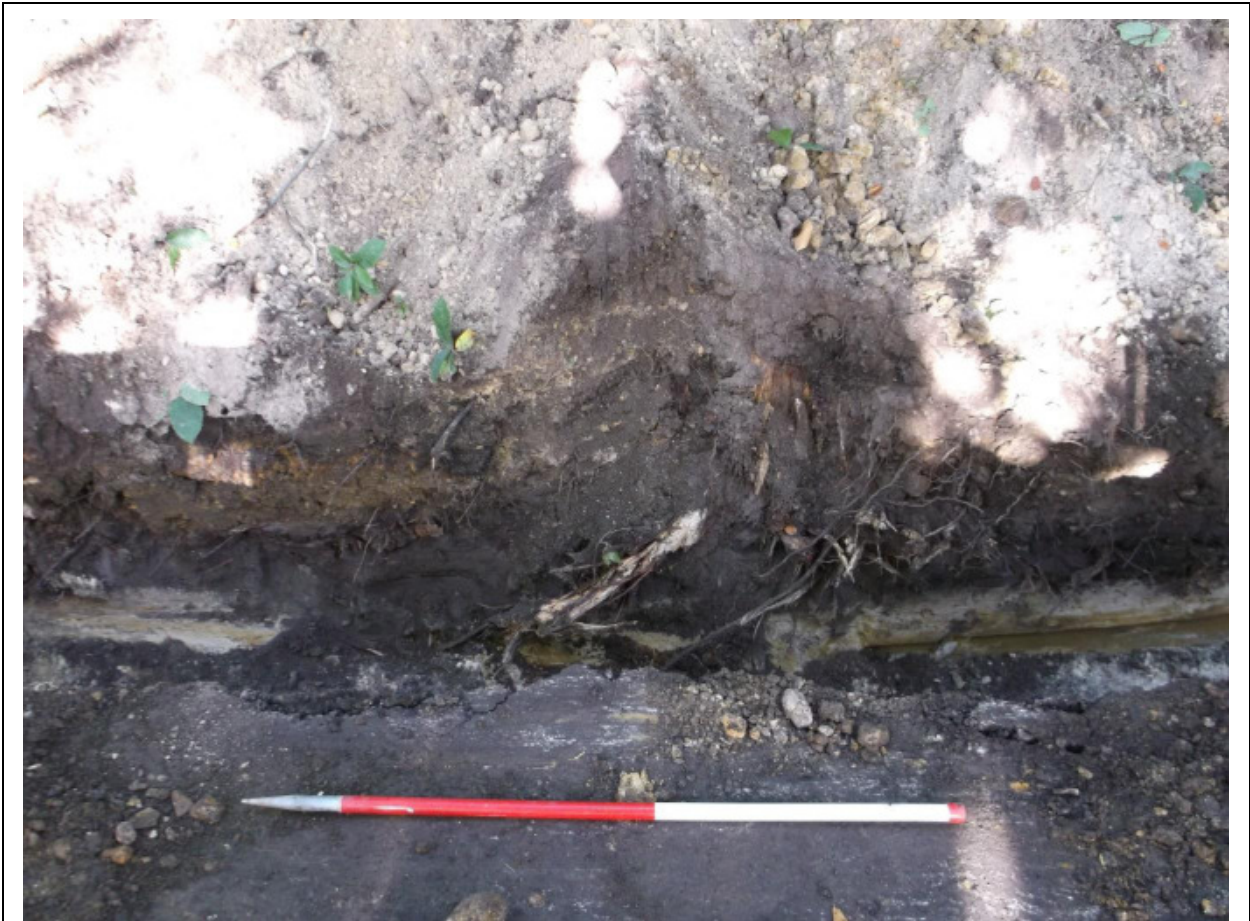
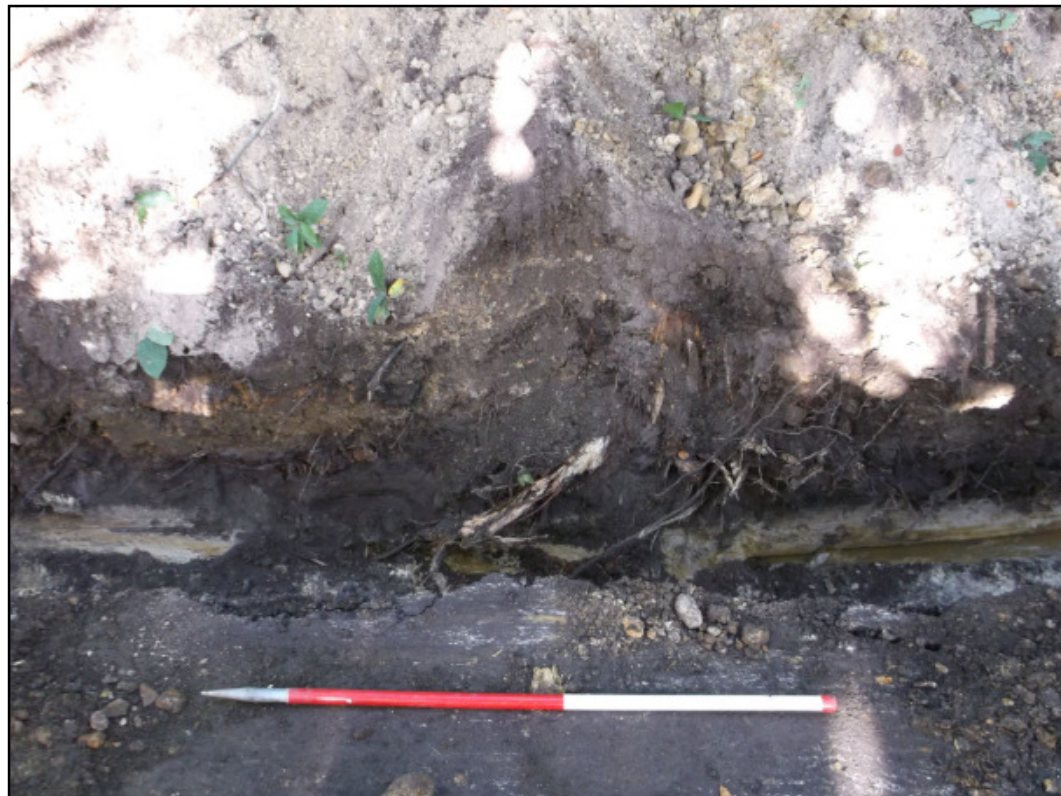
- 6.1.7 A ditch [104] was observed in section at the north-eastern extent of Area 1 and measured approximately 3.20 m wide by 0.34 m deep. This feature contained a single fill consisting of a soft mid-grey fine grained silty sand with occasional stones. Extensive root activity was observed at the top of the fill. This feature was observed to cut through the buried topsoil horizon (101) and was sealed by the modern tarmac surface (100) (Figure 3; Plates 5 and 6).

Plate 5: South-east facing section of Ditch 104, looking north-west

7.1.1 The ditch [104] identified in Area 1 was undated, although it was observed on the same alignment as an open boundary ditch and bank to the north-west of the cable trench. The Ordnance Survey (OS) County Series map of Surrey from 1872 shows a corresponding boundary feature along the southern extent of Hawley Common and immediately south of Hawley Pond. The ditch [104] was interpreted as an extension of this boundary ditch and bank and is likely a field boundary dating to the late 19th century.

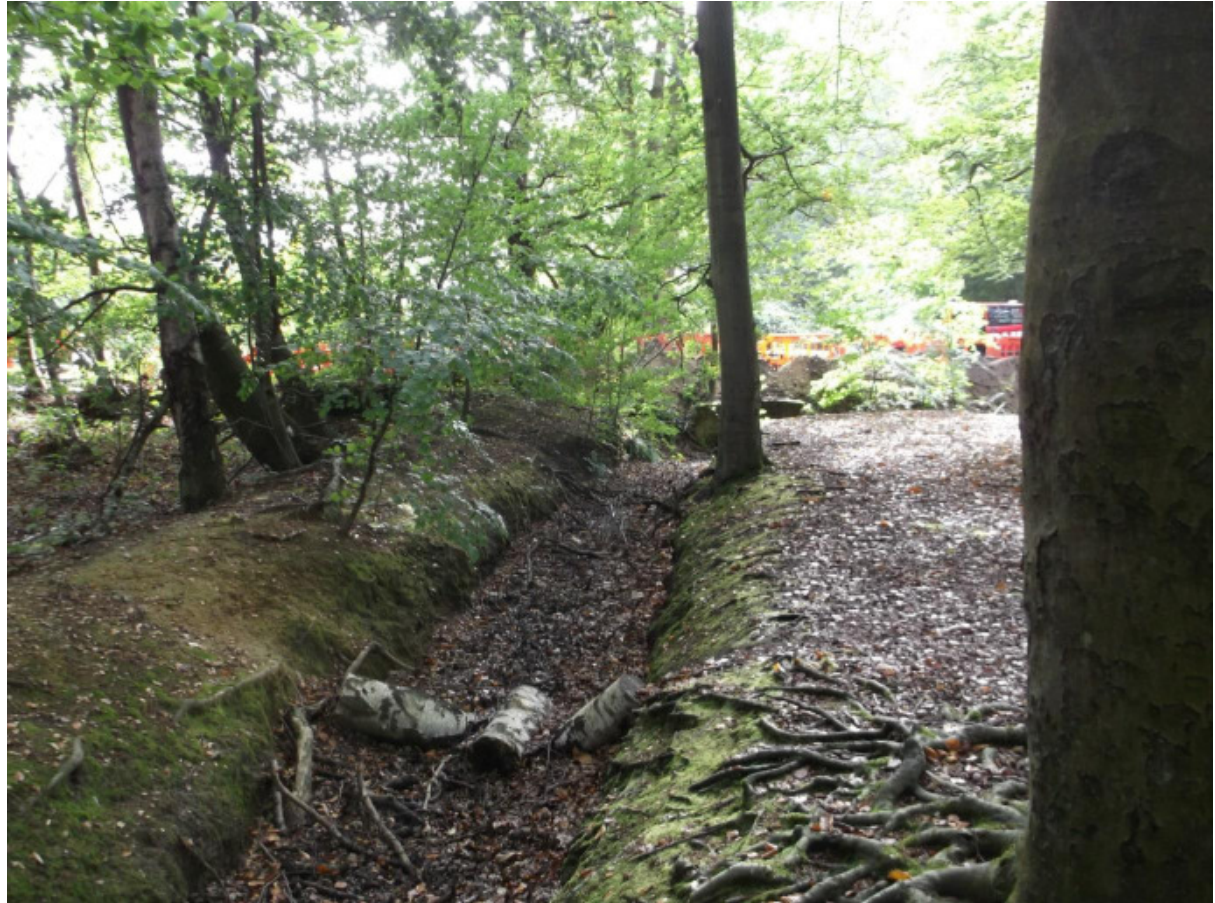
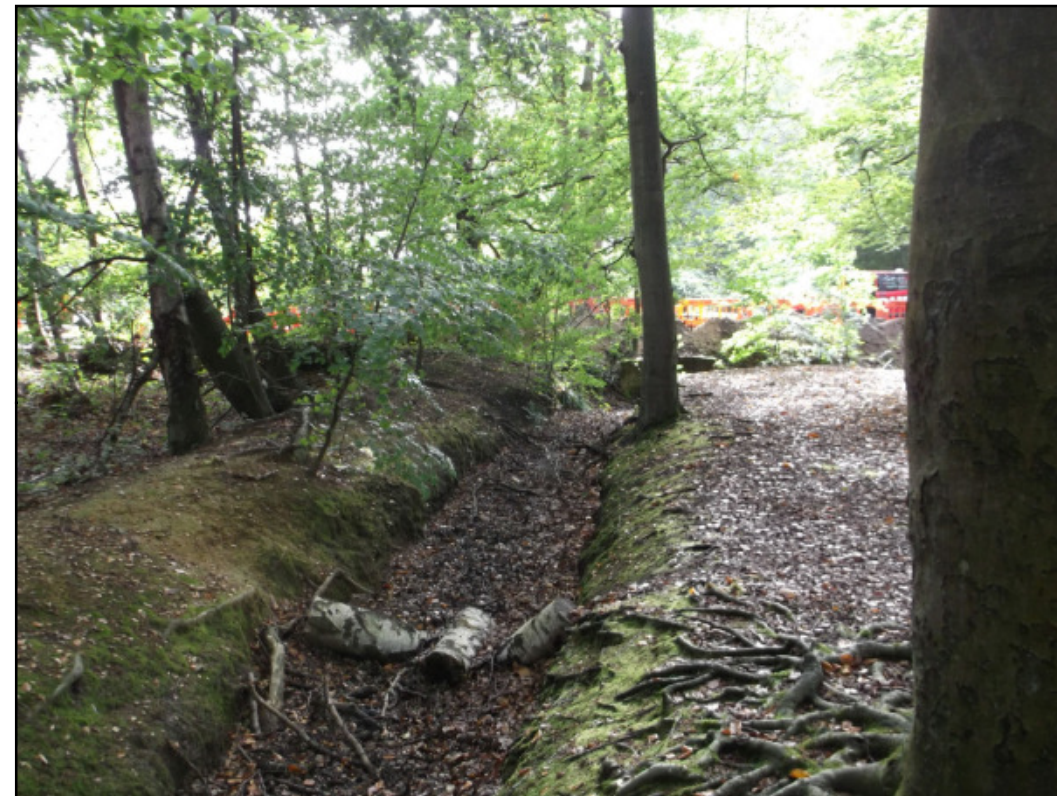
Plate 6: View showing continuation of Ditch 104 as an open ditch and bank to the north-west of the cable trench, looking south-east

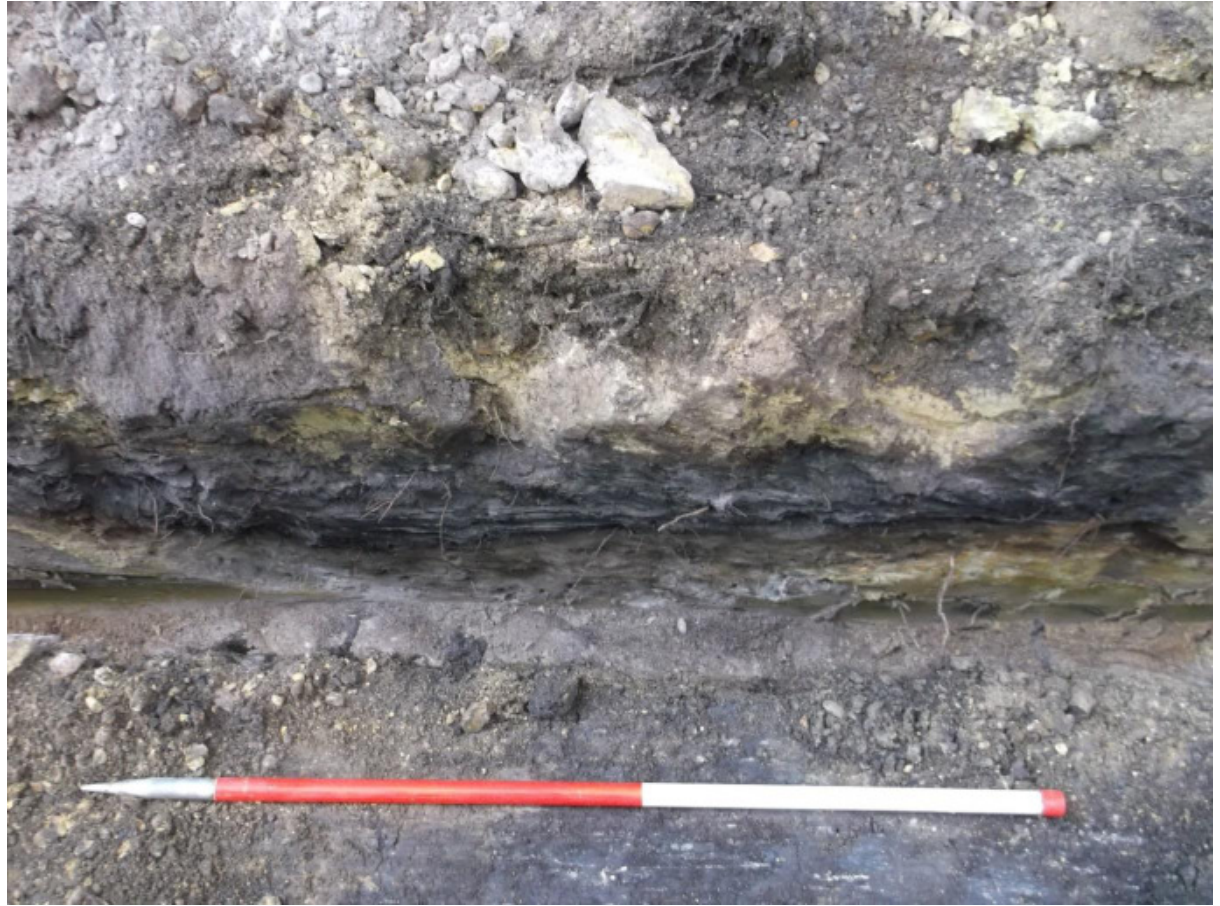
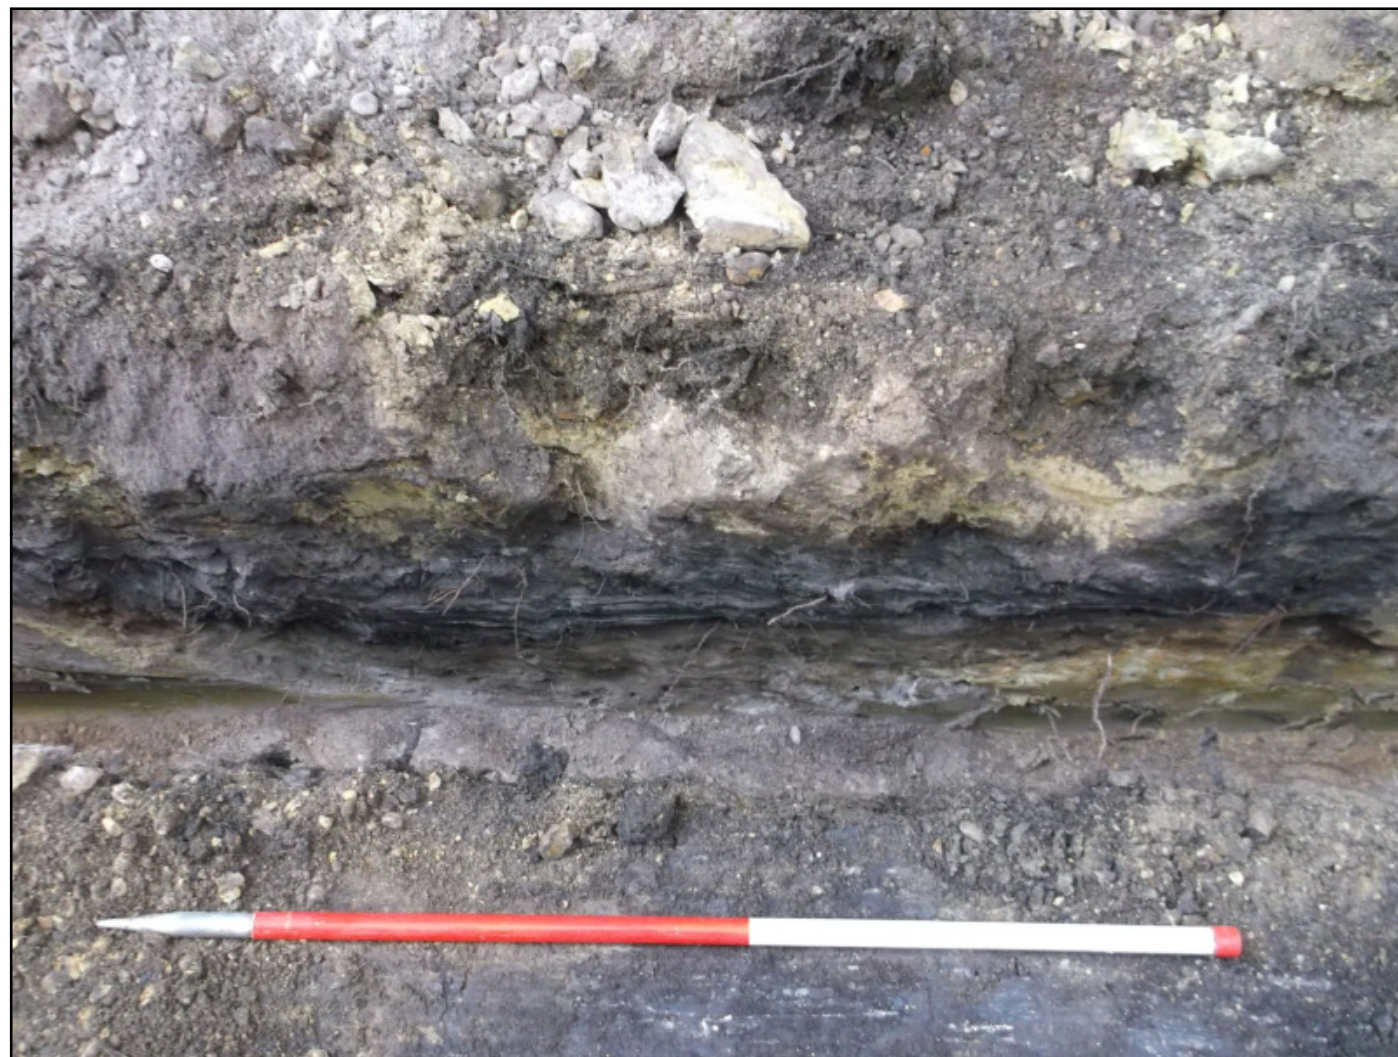
- 6.1.8 A possible pit or tree bowl [108] with a gradual break of slope, shallow sloping sides and a concave base was recorded in section within the cable trench. The possible pit measured approximately 1.90 m long by 0.47 m deep and contained a 0.33 m thick lower fill of soft mixed light grey brown silty sand (107) with occasional stone inclusions. This was overlain by 0.14 m of laminated lenses of alternating light grey and black silty sand (106) (Figure 4; Plate 7).

Plate 7: South-east facing section of Pit/Tree Throw 108, looking north-west

7.1.2 The post hole [112] and the possible pit or tree bowl [108] from Area 1 were also undated. However, the regular rectangular profile of the post hole could indicate a relatively recent feature.

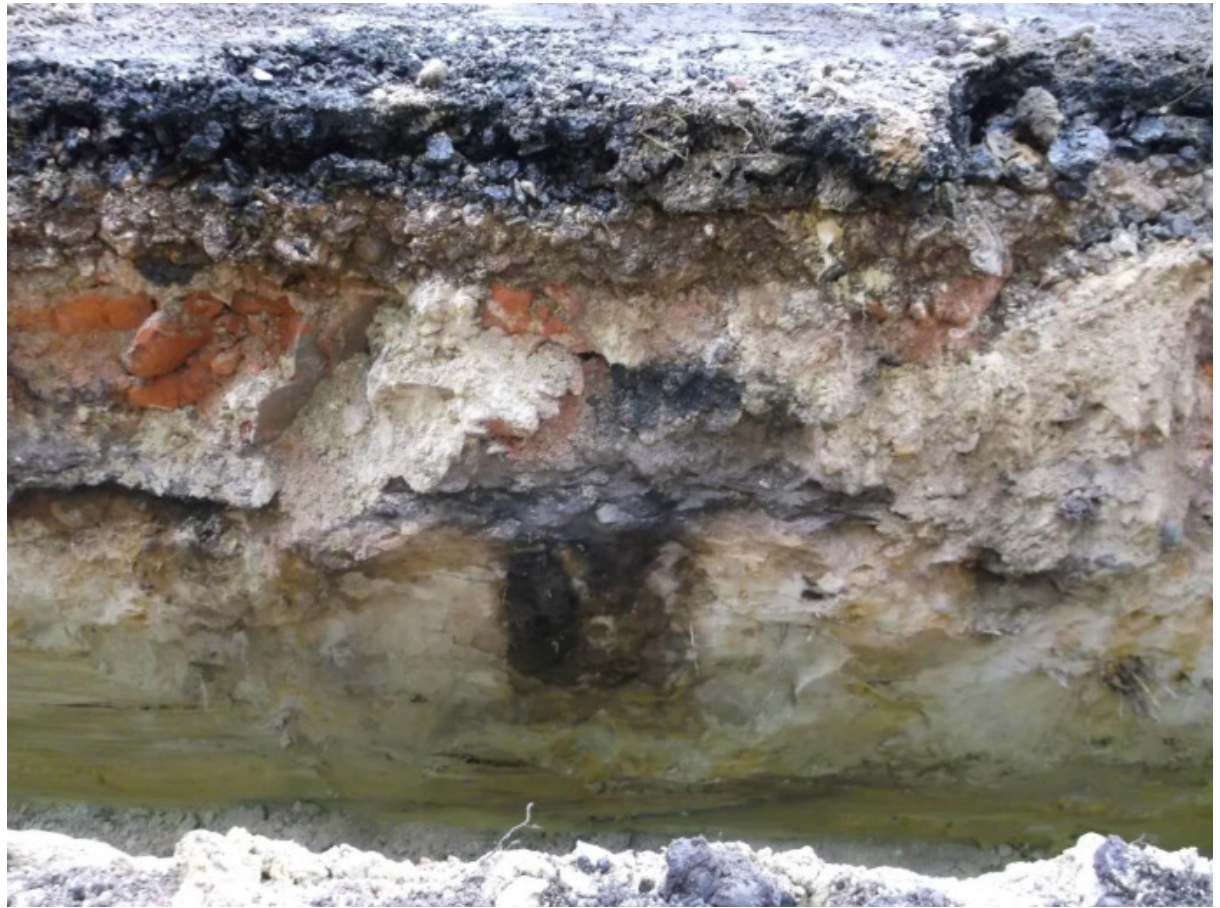
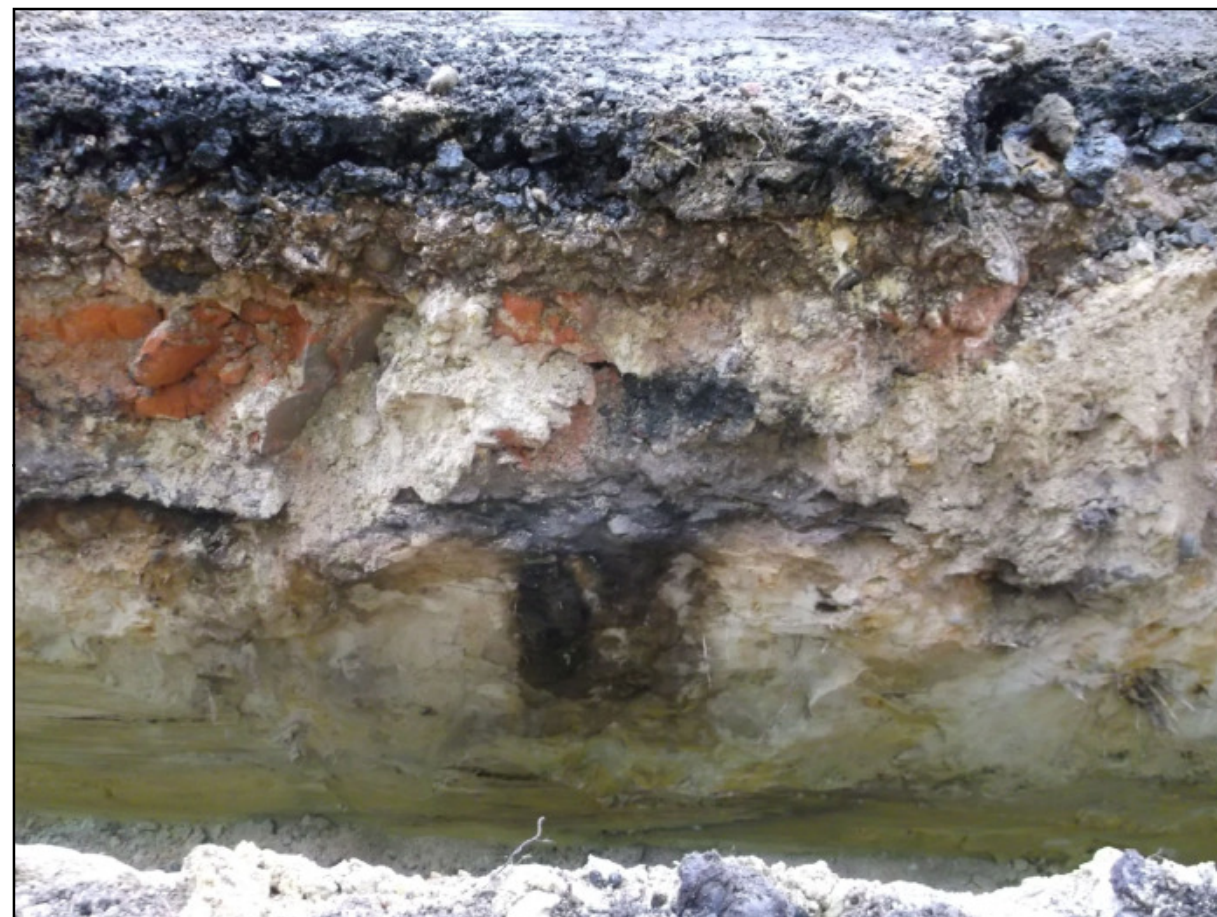
top and base of the cut with near vertical straight sides and a flat base. It measured 0.26 m wide by 0.41 m in depth. The post hole contained two fills with the lowermost consisting of a soft mixed light brownish orange grey silty sand (111) 0.41 m thick which was interpreted as packing around a wooden post that had been removed. Stratigraphically above this was the uppermost fill consisting of soft mixed orange grey silty sand (110) which was interpreted as natural silting of a 'post pipe' formed from the removal of a post from the feature (Figure 5; Plate 8).

Plate 8: North-west facing section of Post Hole 112, looking south-east

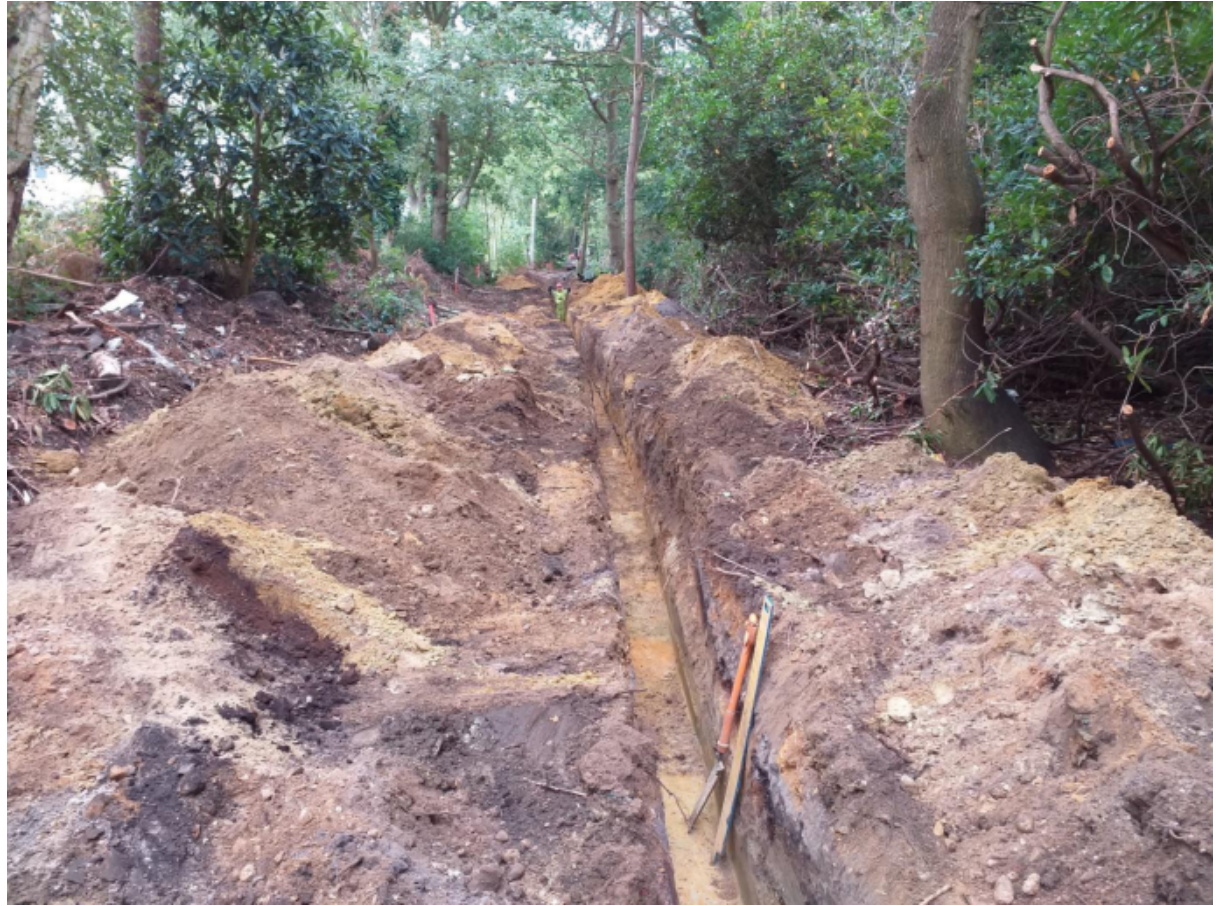
6.1.11 Area 2 was situated to the north-east of Area 1 where the Route entered the south-western extent of the Grade II Registered Park. The area ended where the Route left the park and entered Woodland Road. This section measured approximately 1,089 m in length (Plates 9 and 10).

Plate 9: General view of Area 2, looking south-west

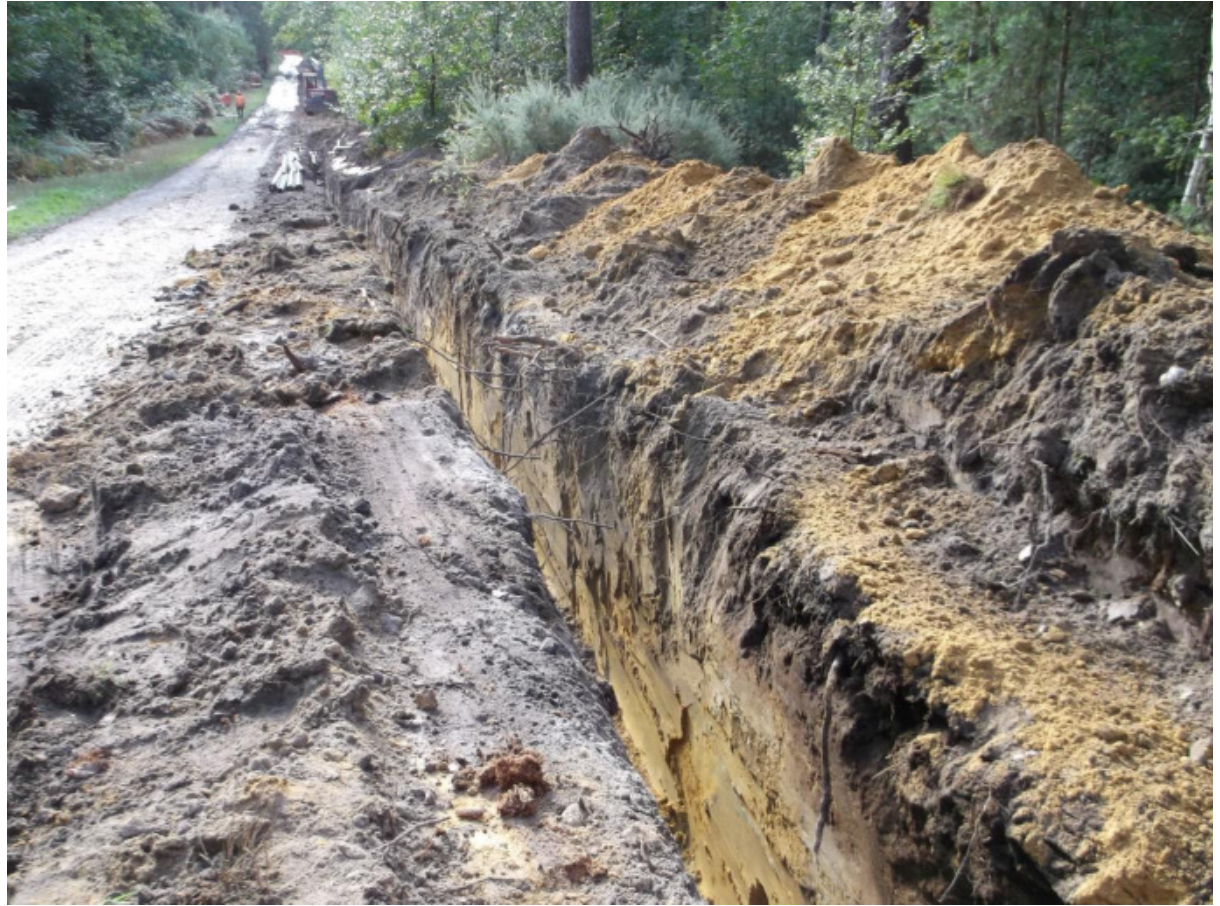
Plate 10: General view of Area 2, looking south-west

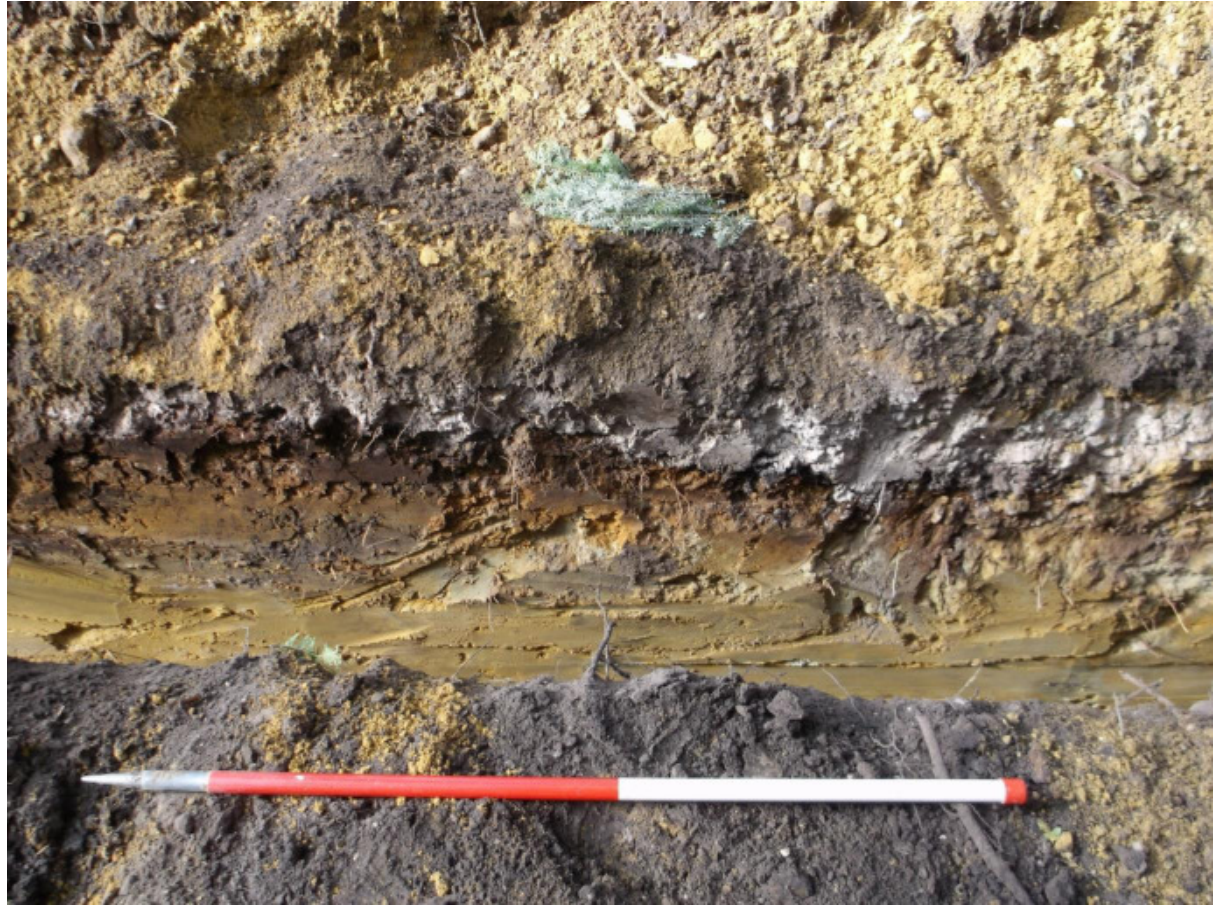
6.1.12 The topsoil was a fine grained, soft sand with no inclusions. It varied from 0.15 m thick throughout the trench and was mid-dark brown in colour. This overlay a made ground layer consisting of red brick fragments, limestone and concrete approximately 0.10-0.20 m in depth. Below this was up to approximately 0.95 m of mottled light brownish sand. This was interpreted as the natural substrate and continued to the bottom of the trench (Plate 11).

Plate 11: South-east facing representative section of stratigraphy in Area 2, looking north-west

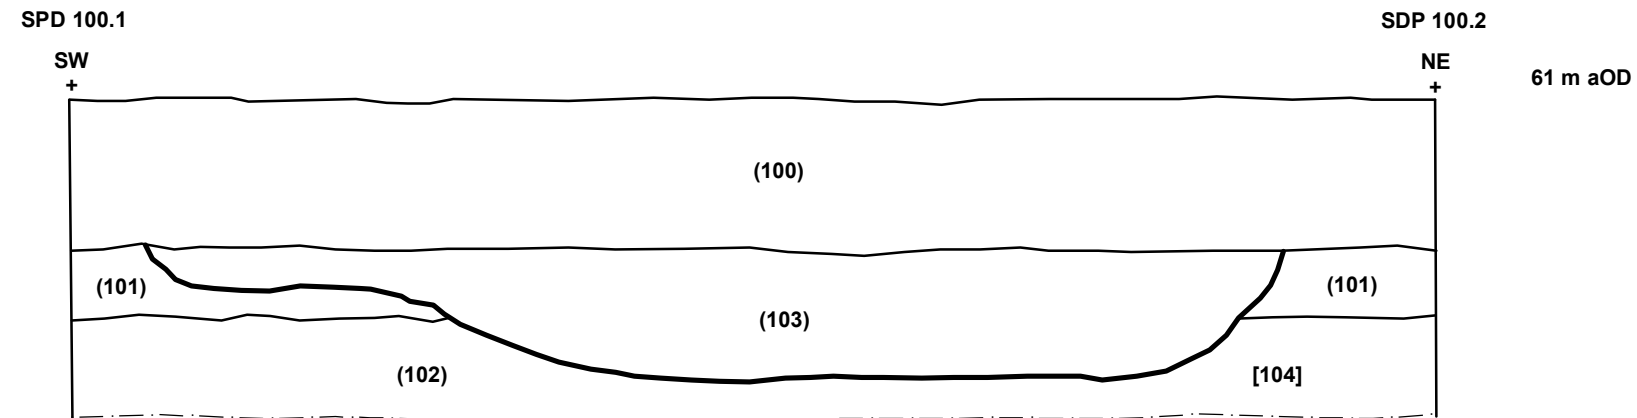
Figure 3. South-East Facing Section 100 through Ditch [104]

South-east facing Section 100 through Ditch 104

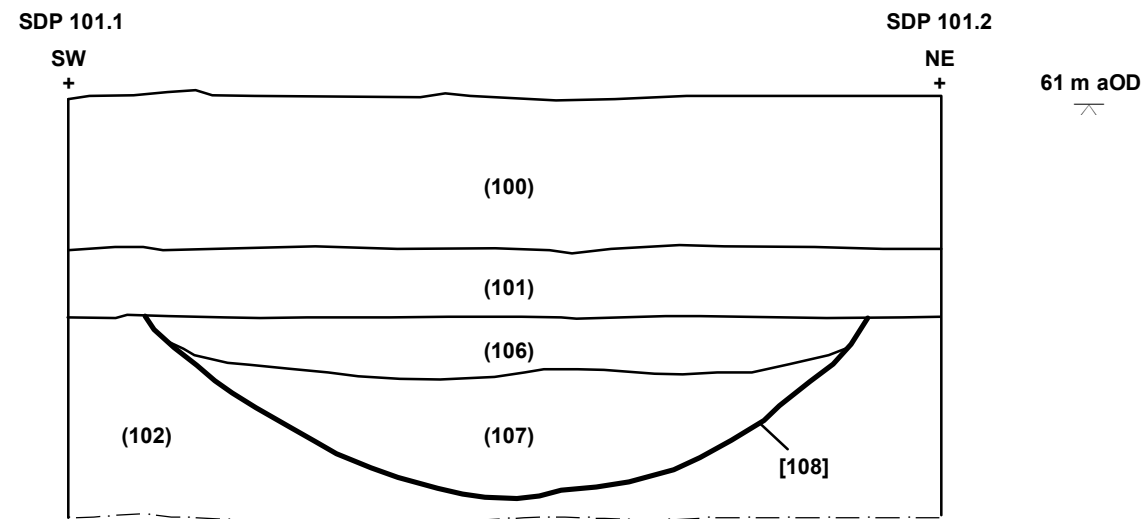
Figure 4: South-East Facing Section 101 through Pit/Tree Throw 108

South-East Facing Section 101 through Pit/Tree Throw 108

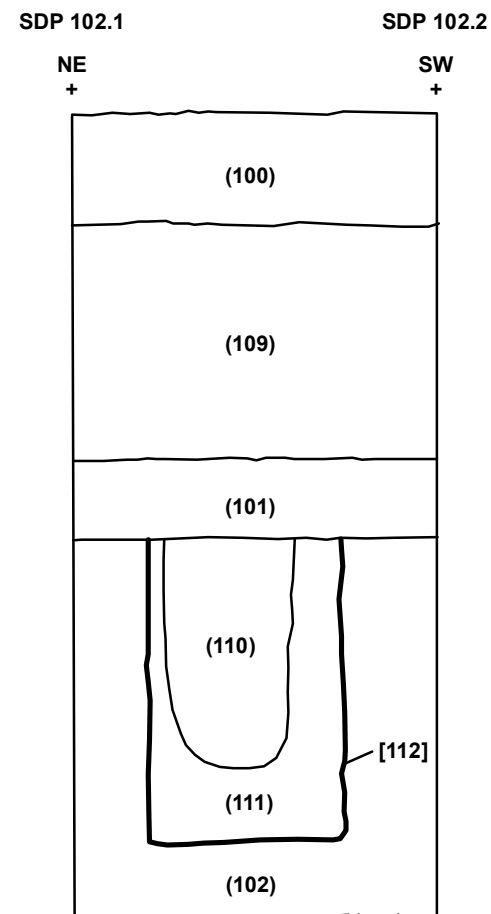
Figure 5: North-West Facing Section 102 through Post Hole 112

- 6.1.9 A post hole [112] was recorded in the north-west facing section of the cable trench at the south-western extent of Area 1 (SU 84073 56996). The post hole had a sharp break of slope at both the

**North-west facing section through
Post Hole 112**
