Archaeological Monitoring and Recording Report: Green Farm, South Gloucestershire

Report By: Charlotte Barley BSc (Hons) PCIfA
Issued by: James McNicoll-Norbury BA MA MCIfA
Date: September 2021
Submitted to: Western Power Distribution
Prepared by: RSK ADAS Limited
11D Park House
Milton Park
Abingdon
OX14 4RS
Tel. no: 01235 355638

In August 2021, RSK ADAS Ltd carried out an archaeological watching brief on land at Green Farm, South Gloucestershire during groundworks for a new permitted development underground cable.

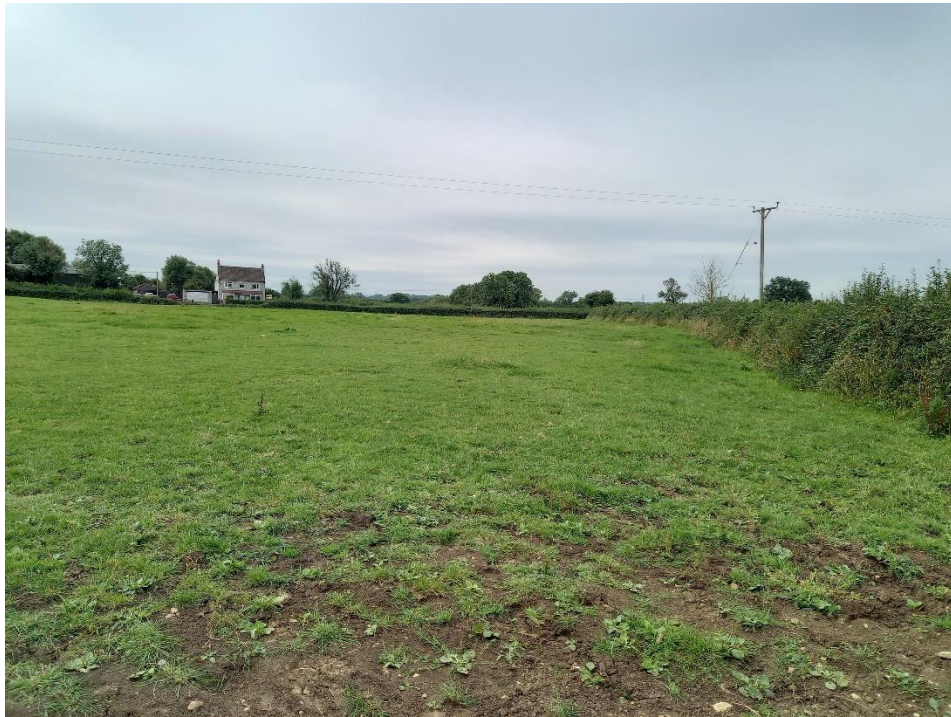
Plate 1: South facing view from Trench 1 looking towards the deserted medieval settlement (HER no. 2781).

8.4 The absence of archaeological features recorded during the archaeological monitoring may be attributed to the relatively limited ground impact of the cable trench and due to the impact of agricultural activity in these fields. However, the results might suggest that significant buried archaeological deposits associated with the Deserted Medieval Village (HER NO 2781) do not extend in this direction.

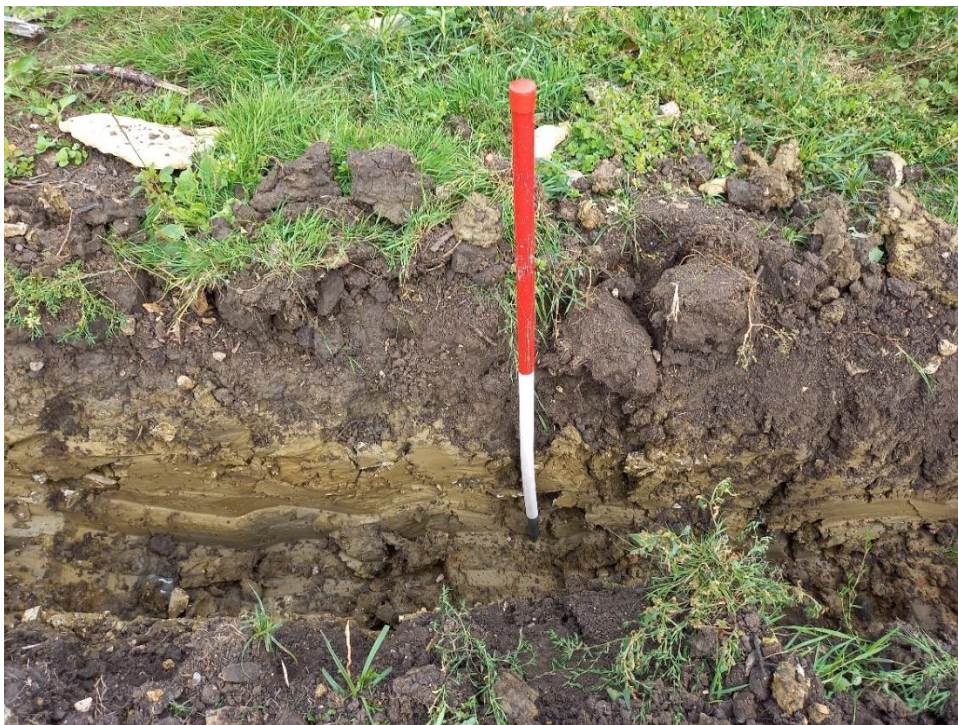
Plate 2: West facing view of Trench 1.

- 7.3 Trench 1 measured 22 m in length by 0.55 m in width and was 0.8 m deep. The topsoil (1001) was approximately 0.4m deep and consisted of dark brown sandy clay. This overlay the undisturbed natural substrate (1002), which was a mid-yellow/brown clay.
- 7.4 No archaeologically significant features or artefacts were observed or recovered from the trench.

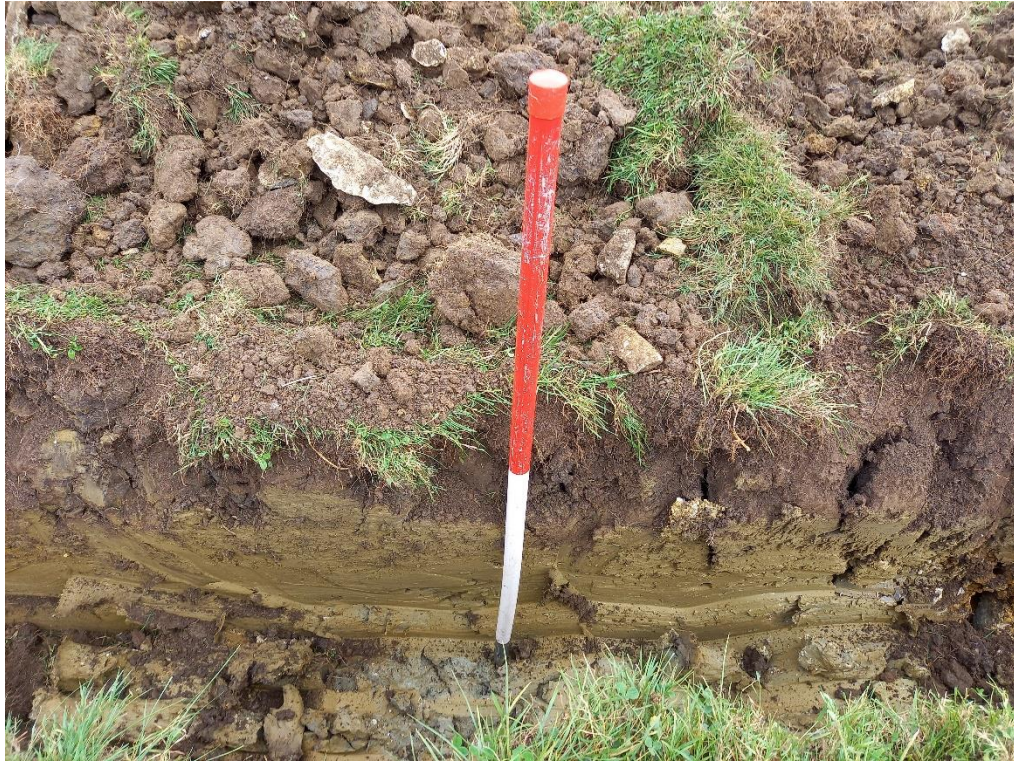
Plate 3: North-east facing view of Trench 2.

7.5 Trench 2 measured 85 m in length by 0.55 m in width and was 0.8 m deep. The topsoil (2001) was approximately 0.4 m deep and consisted of dark brown sandy clay. This overlay the undisturbed natural substrate (2002), which was a mid-yellow/brown clay.

7.6 No archaeologically significant features or artefacts were observed or recovered from the trench.

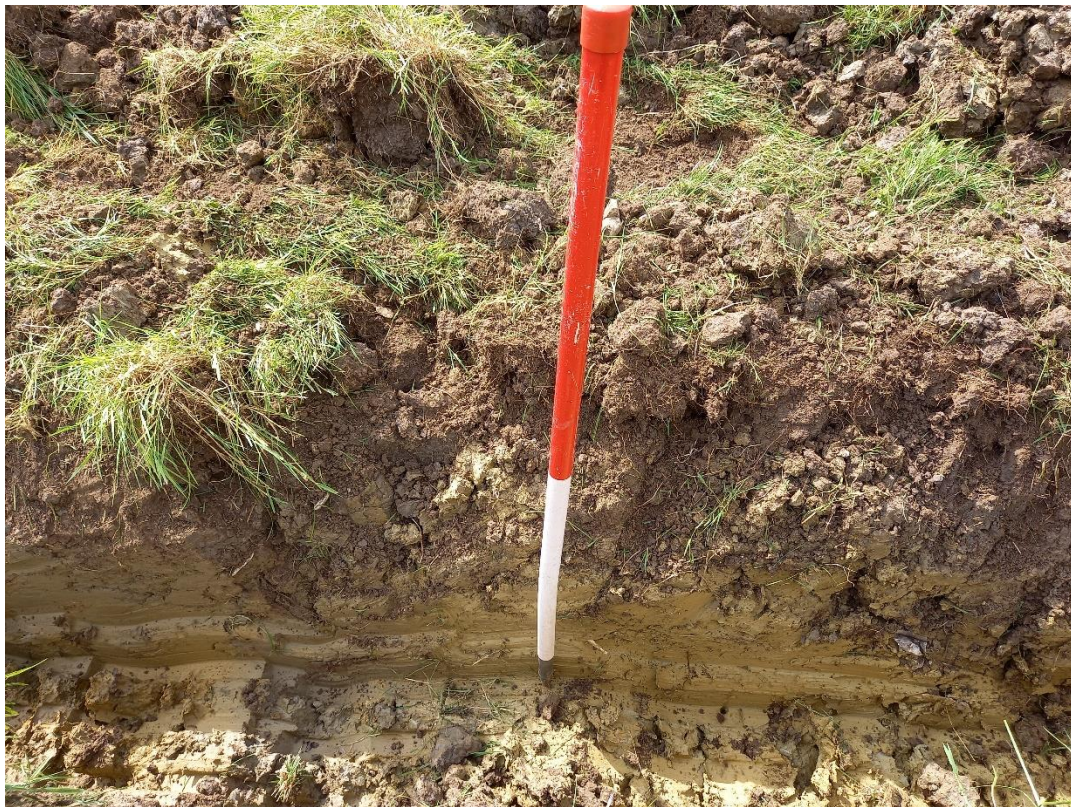
Plate 4: East facing view of Trench 3.

7.7 Trench 3 measured 110 m in length by 0.55 m in width and was 0.8 m deep. The topsoil (3001) was approximately 0.4 m deep and consisted of dark brown sandy clay. This overlay the undisturbed natural substrate (3002), which was a mid-yellow/brown clay.

7.8 No archaeologically significant features or artefacts were observed or recovered from the trench.

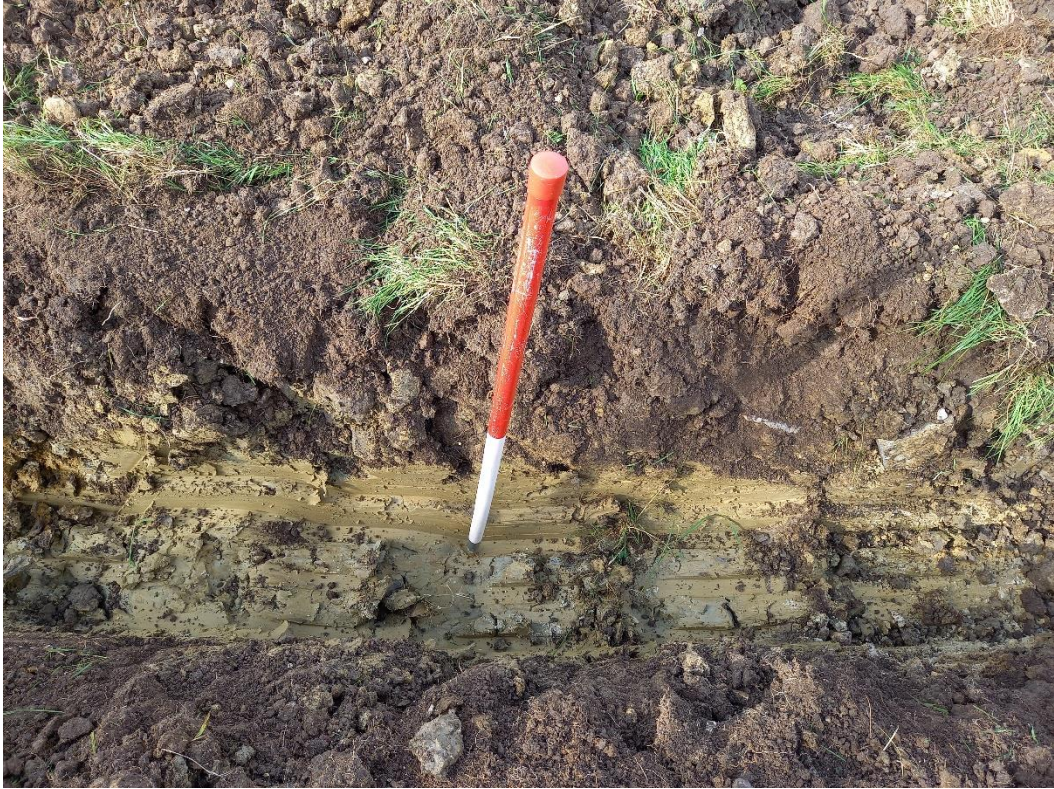
Plate 5: North-east facing view of Trench 4.

7.9 Trench 4 measured 60 m in length by 0.55 m in width and was 0.8 m deep. The topsoil (4001) was approximately 0.4 m deep and consisted of dark brown sandy clay. This overlay the undisturbed natural substrate (4002), which was a mid-yellow/brown clay.

7.10 No archaeologically significant features or artefacts were observed or recovered from the trench.

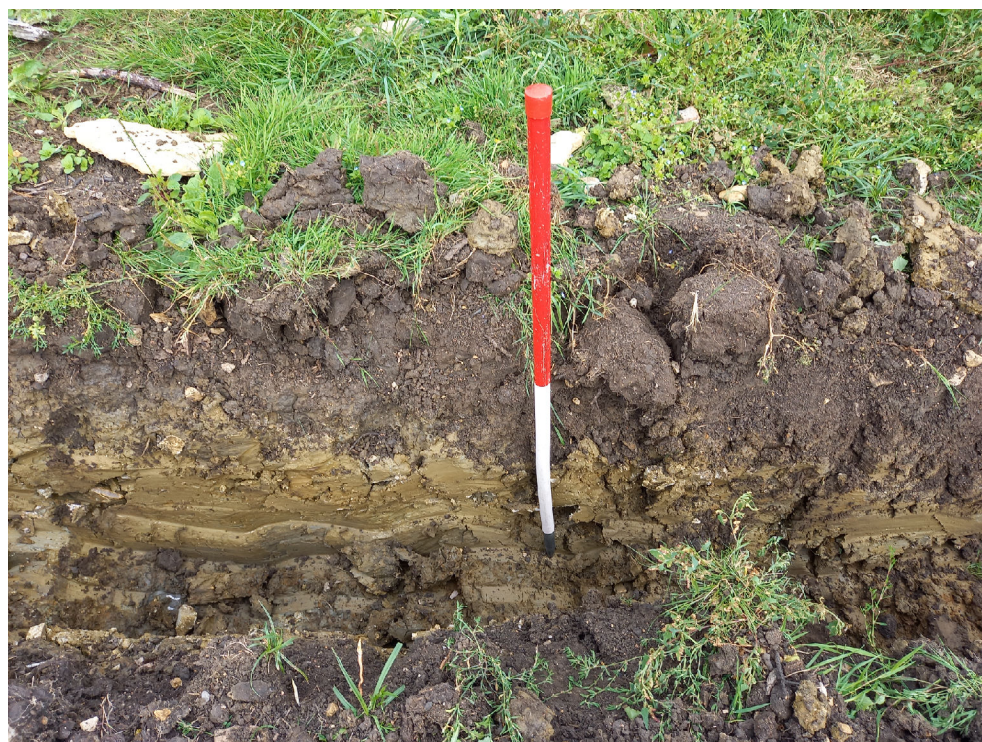
**Figure 3. Representative Section of
Trench 1**

Section 1: West facing section of Trench 1

Plate 2: North-east facing view of Foundation Trench 1
