Archaeological Watching Brief Report: Innovations Project Site 10: Woodford, Wiltshire

Report by: Andrew Brown BA MSc PCIfA
Issued by: Diarmuid O Seaneachain BA PhD MCIfA
Date: March 2016

SSE Power Distribution Ltd
55 Vastern Road
Reading
Berkshire
RG1 8BU

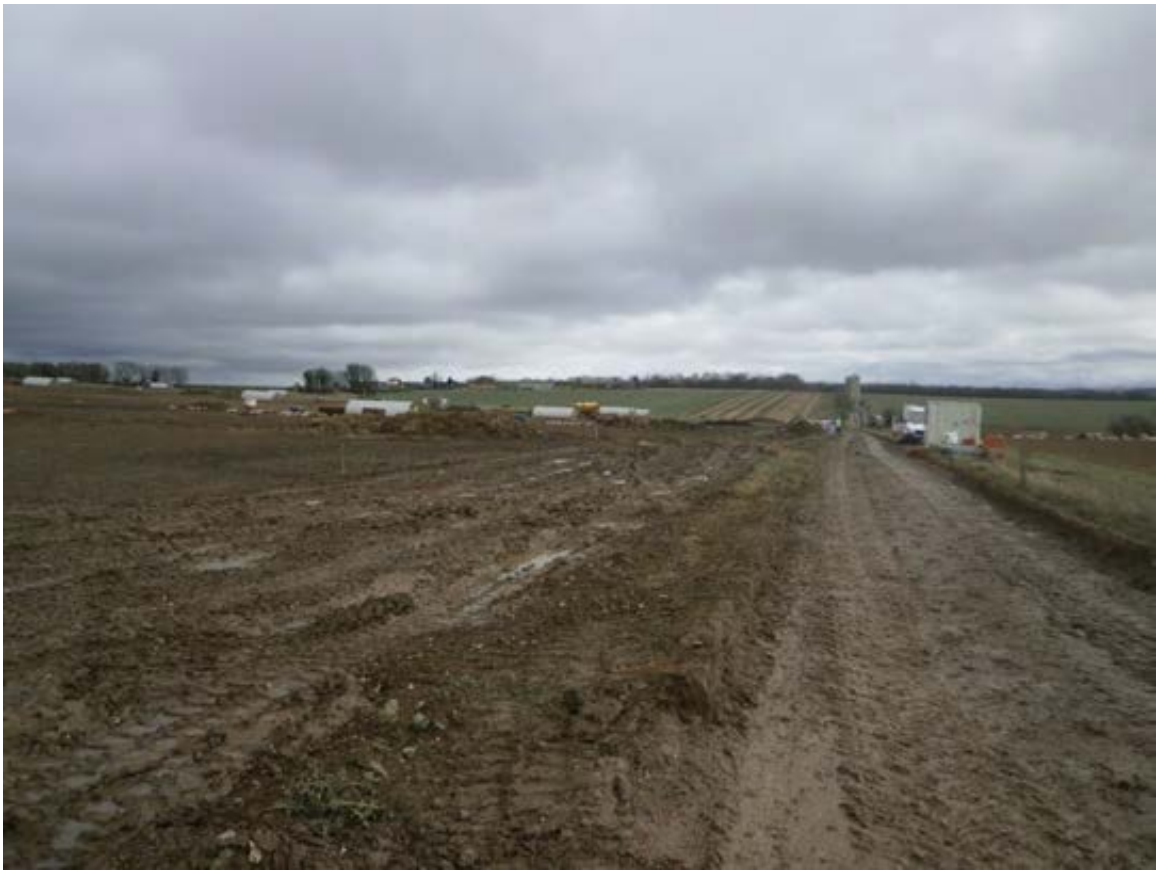
Plate 1: General shot of the cable route, looking east along the farm trackway.

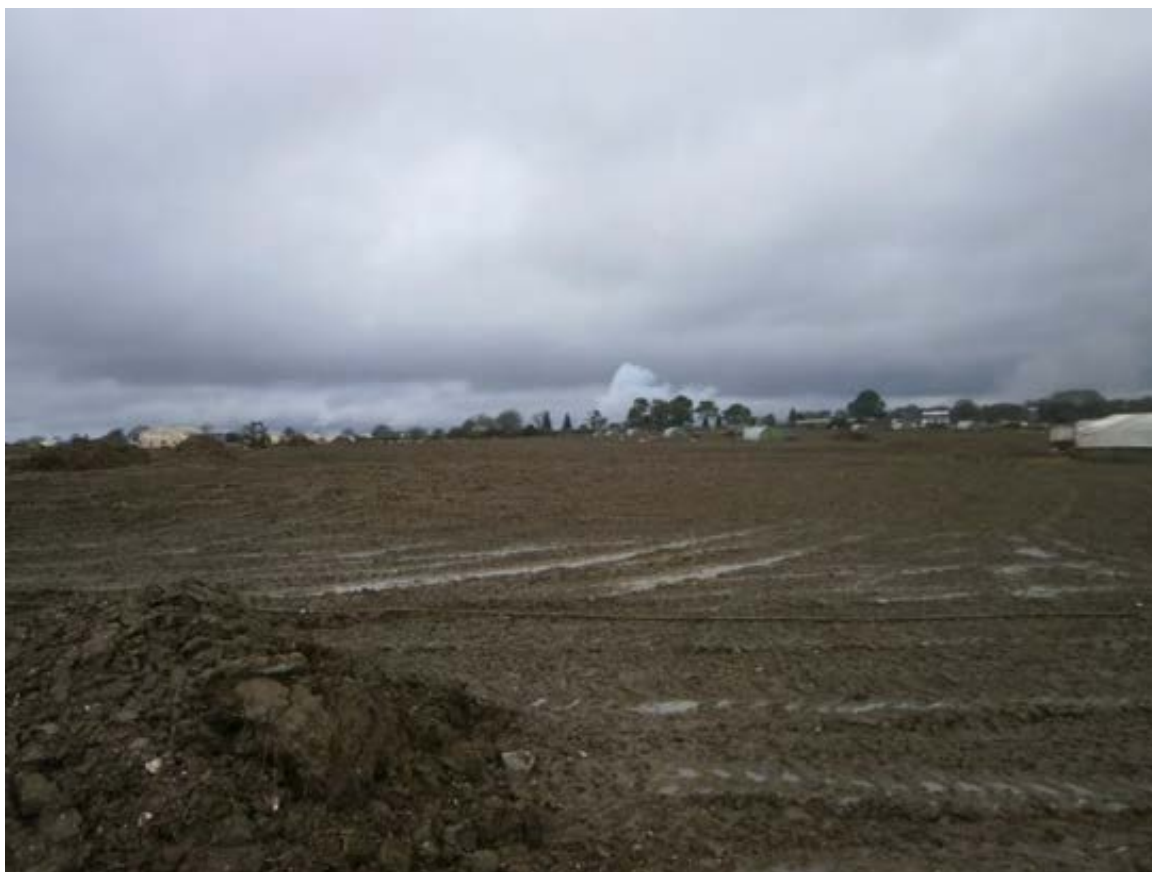
Plate 2: General shot of the watching brief area looking north-west.

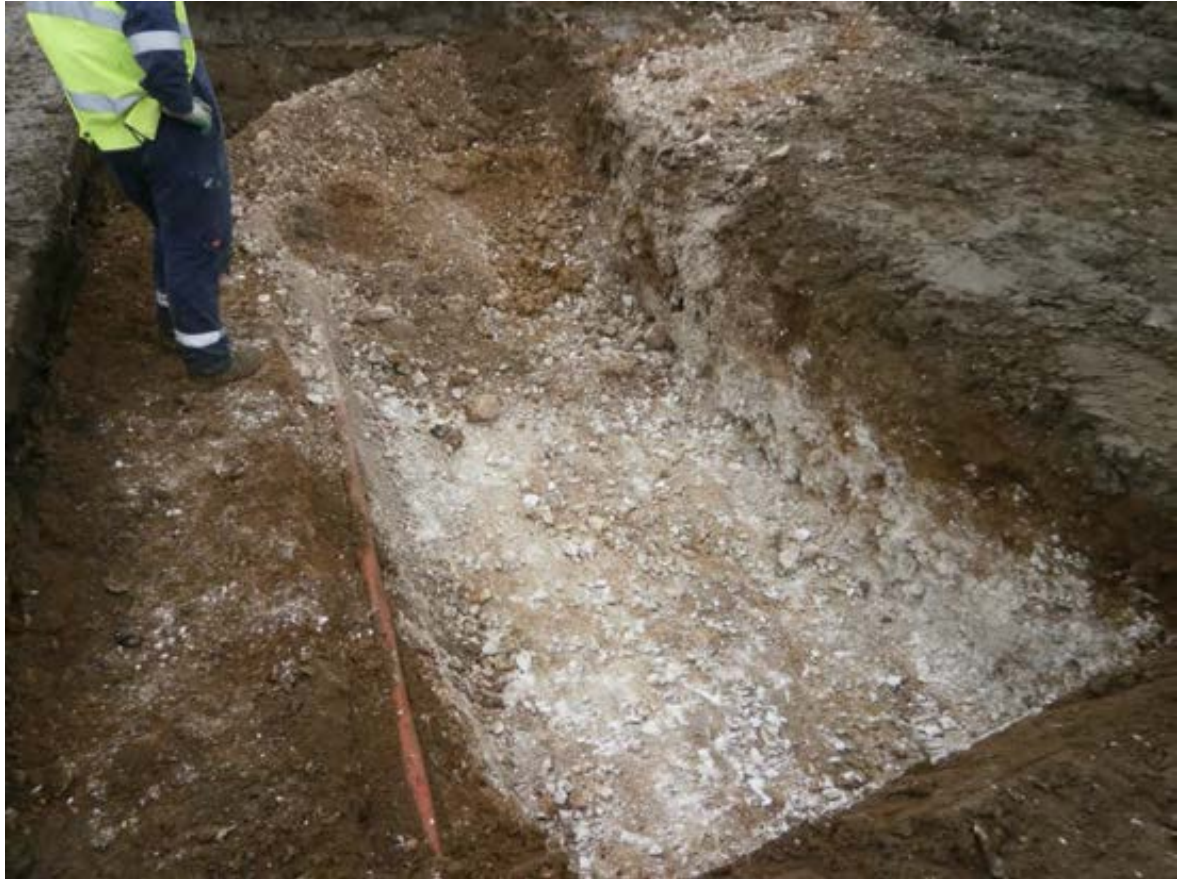
- 6.1.3 Trial Pit 1 was located at the eastern extent of the watching brief area (Figure 2). The trial pit measured 4.5m in length, 2.6m in width and 0.85m deep immediately adjacent to the existing farm trackway (Plate 3). The trial pit was orientated approximately east/west. The topsoil

(1001) was approximately 0.5m thick and consisted of a dark reddish brown clayey silt with 50% inclusions of sub-angular pebbles throughout. The backfill of the construction trench for the existing cable (1003) was indistinguishable from the topsoil layer. The construction trench for the cable [1004] was cut into a possible subsoil horizon (1002) approximately 0.35m thick, which consisted of white chalky clay with large flint nodules throughout. This layer became steadily stiffer towards the base of the trial pit to become chalk bedrock, which was interpreted as the natural substrate (1005). No archaeological features or artefacts were observed or recovered from this trial pit.

Plate 3: View of Trial Pit 1 during excavation, looking west.

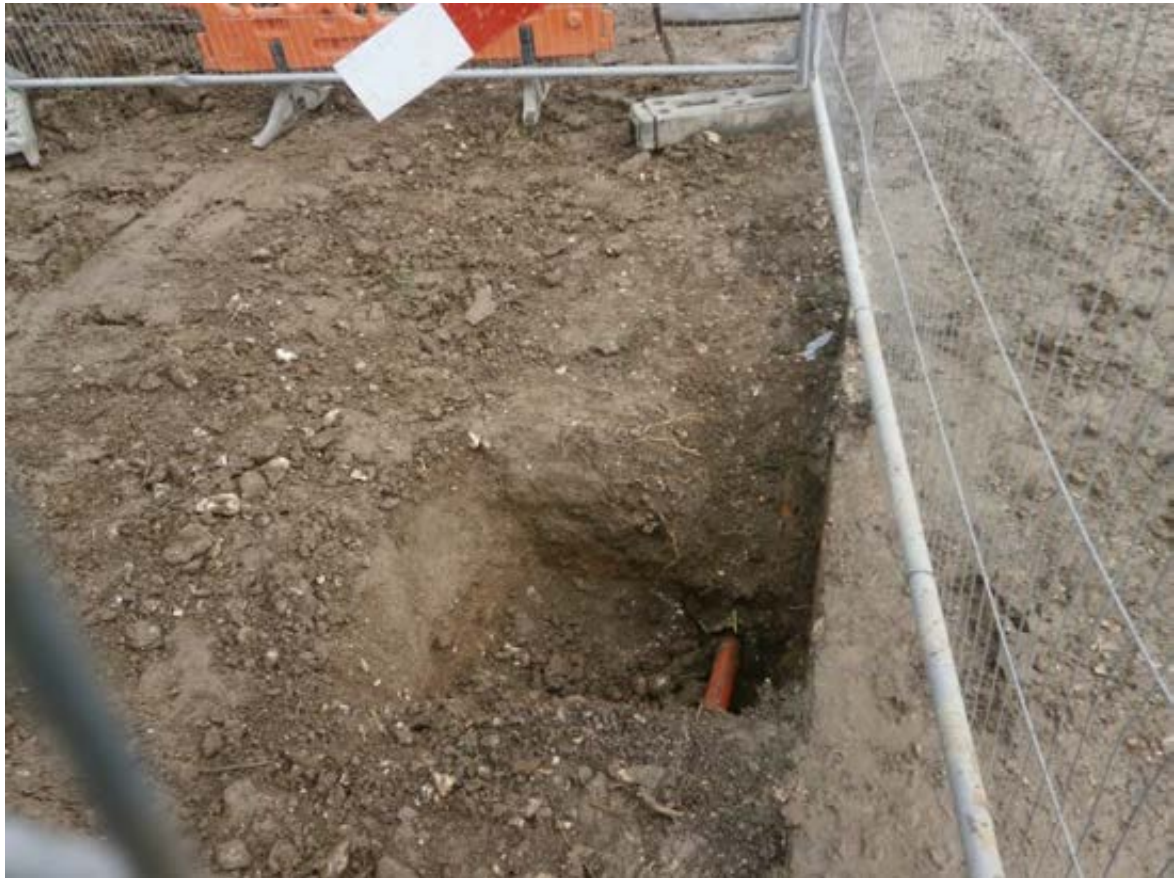
- 6.1.4 Trial Pit 2 was located at the western extent of the watching brief area (Figure 2). The trial pit measured approximately 0.6m long by 0.5m wide and was 0.4m deep (Plate 4). The backfill (2002) of the construction trench for the existing cable (2003) was indistinguishable from the topsoil layer (2001). The natural substrate was not observed in this trial pit. No archaeological features or artefacts were recorded from this trial pit.

Plate 4: View of Trial Pit 2, looking east.

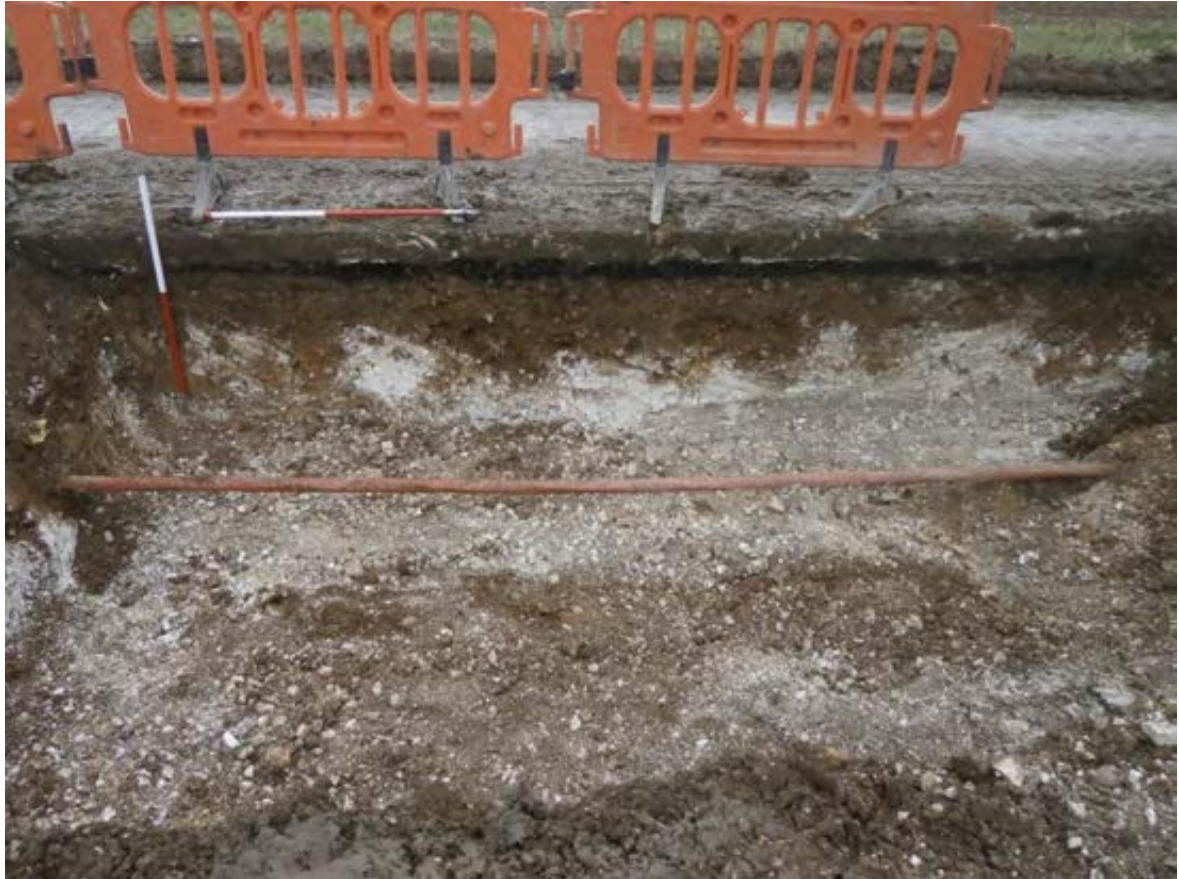
- 6.1.5 Trial Pit 3 was located approximately 35m to the east of Trial Pit 2 along the cable route (Figure 2). The trial pit measured 4.6m long by 2.6m wide and was 0.9m deep and was located immediately adjacent to the existing farm trackway (Plate 5). The backfill of the construction trench for the existing cable (3003) was indistinguishable from the topsoil layer. The construction trench for the cable [3004] was cut into a possible subsoil (3002) approximately 0.35m thick, which consisted of white chalky clay with large flint nodules throughout. This layer became steadily stiffer towards the base of the trial pit to become chalk bedrock, which was interpreted as the natural substrate (3005). No archaeological features or artefacts were observed within this trial pit.

Plate 5: North facing section photo of Trial Pit 3, looking south.

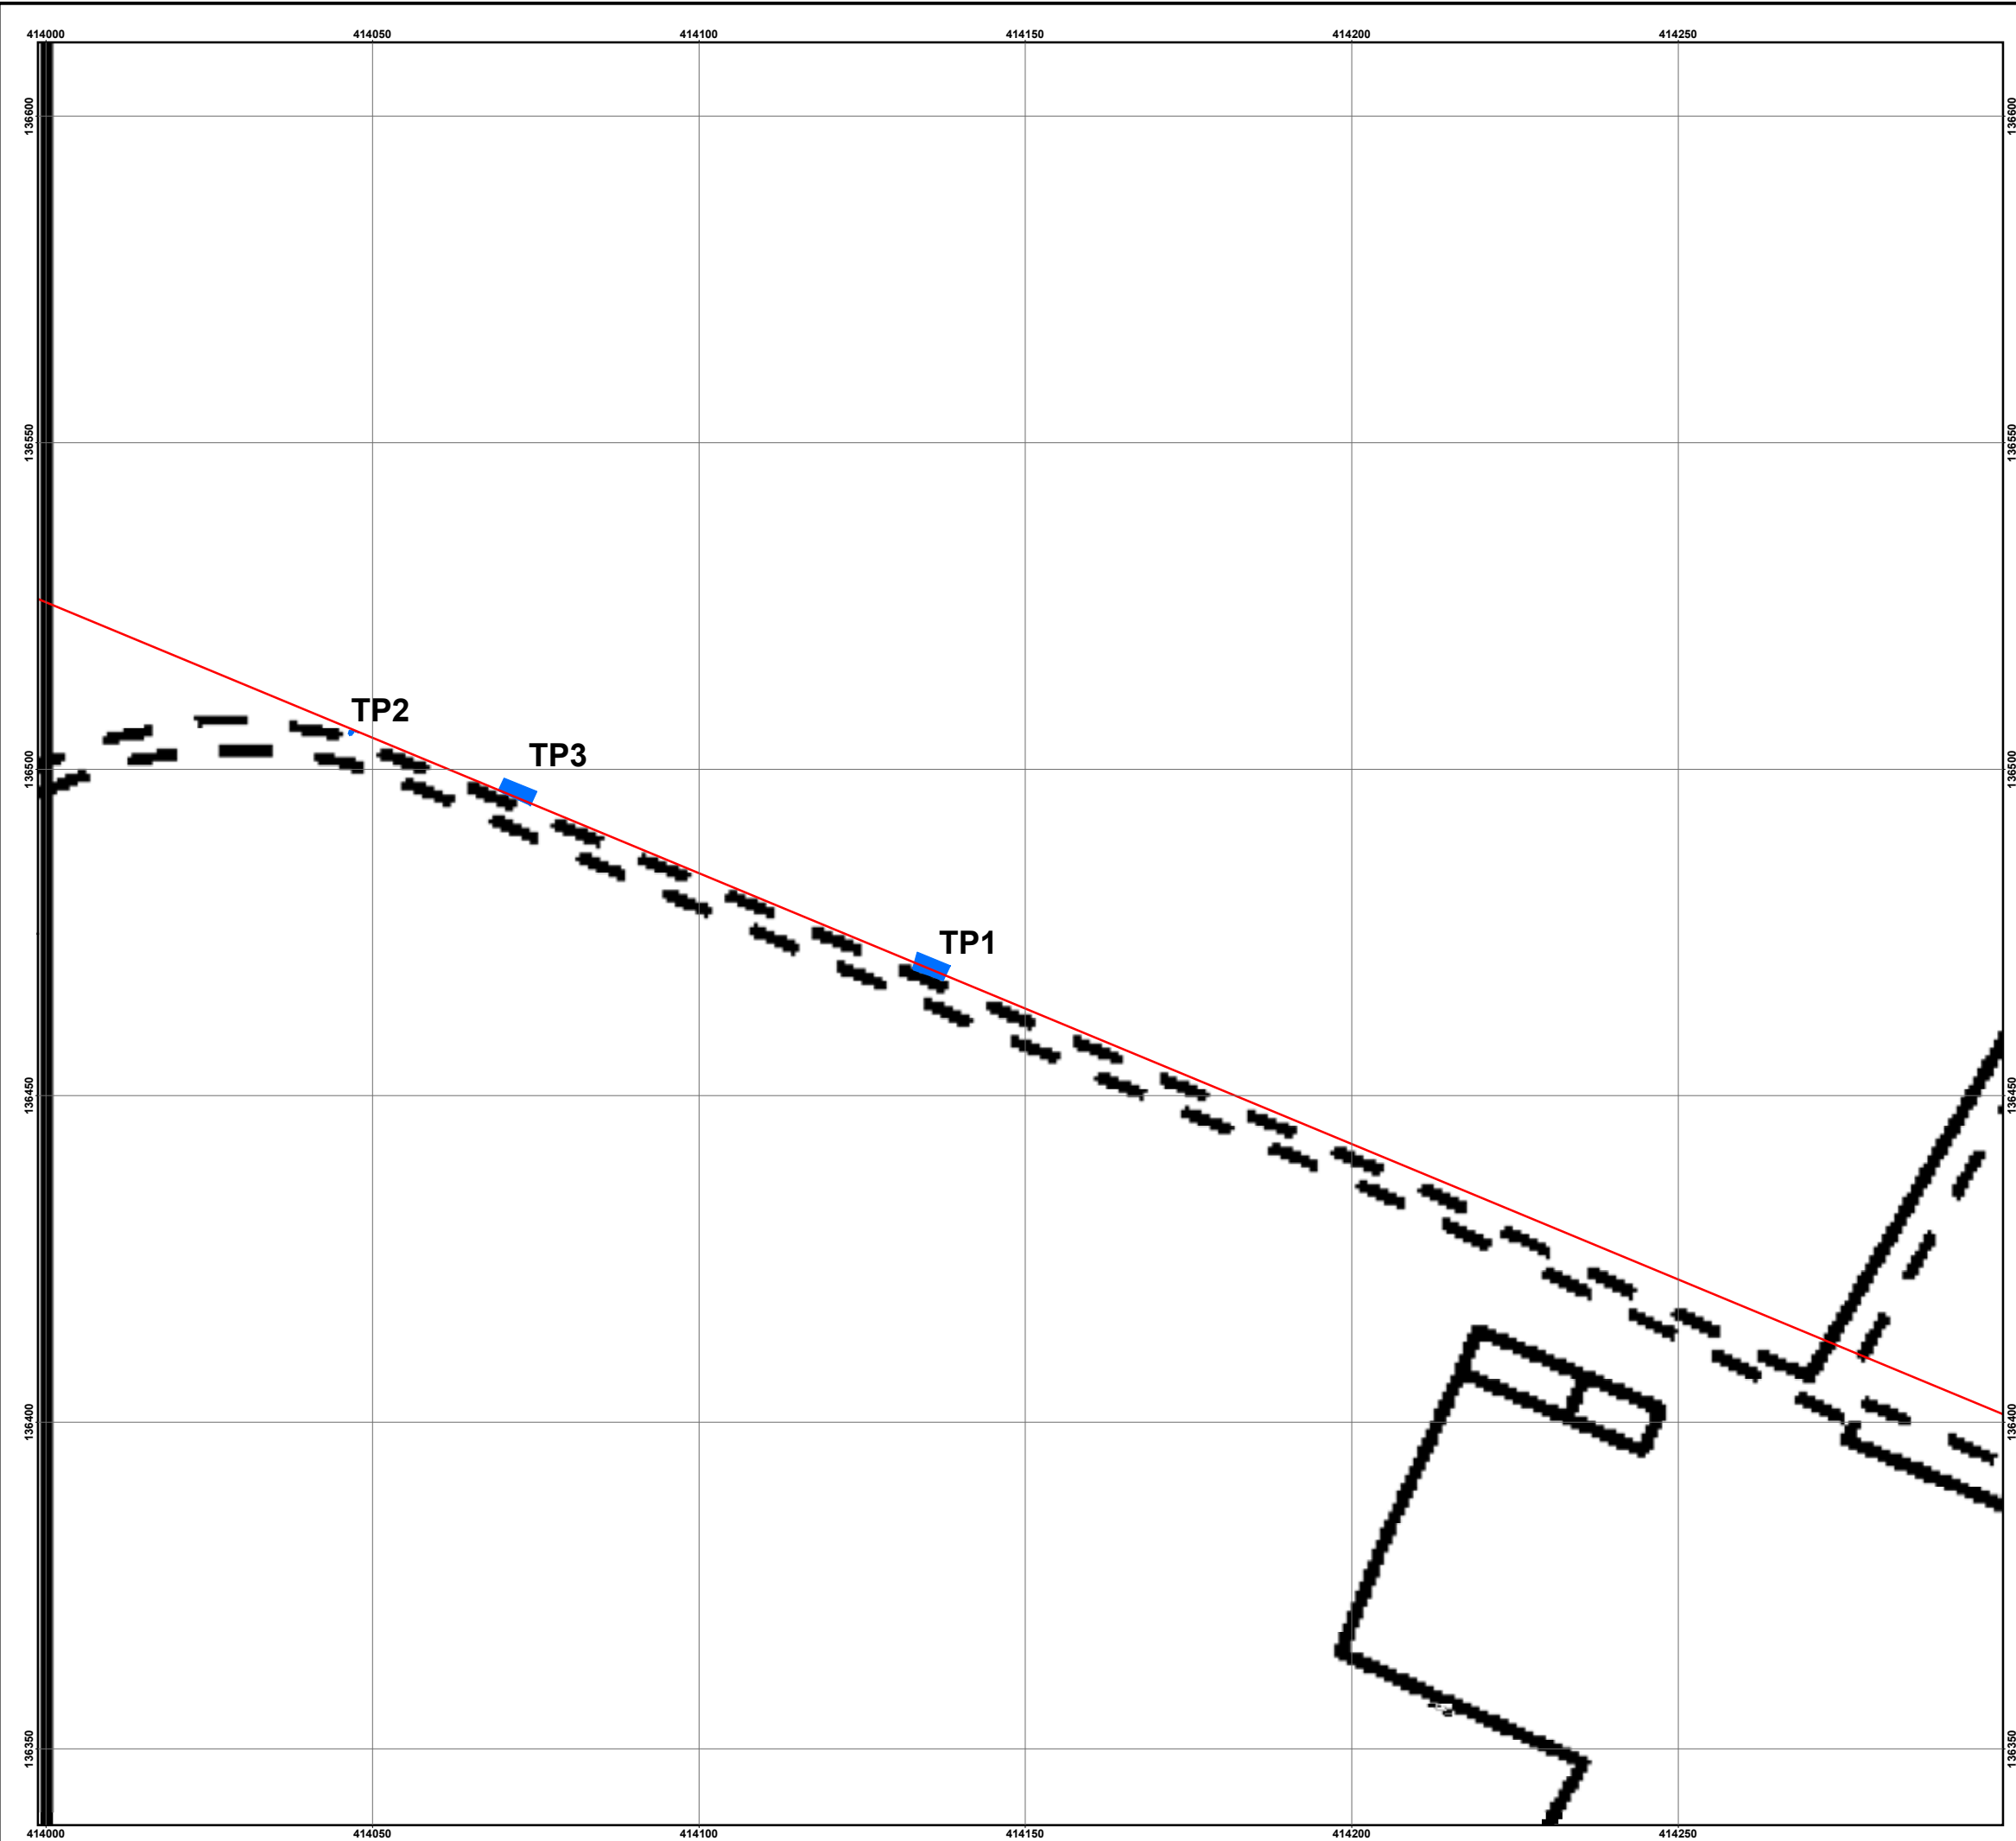
Figure 2: Plan of the
Groundworks

- Existing Cable Route
- Trial Pits
