Archaeological Monitoring and Recording Report: Holland Estate 132kV Cable Diversion

Report By: Andrew Brown BA (Hons) MSc ACIfA
Issued by: Diarmuid O Seaneachain BA PhD MCIfA
Date: November 2017

UK Power Networks Ltd

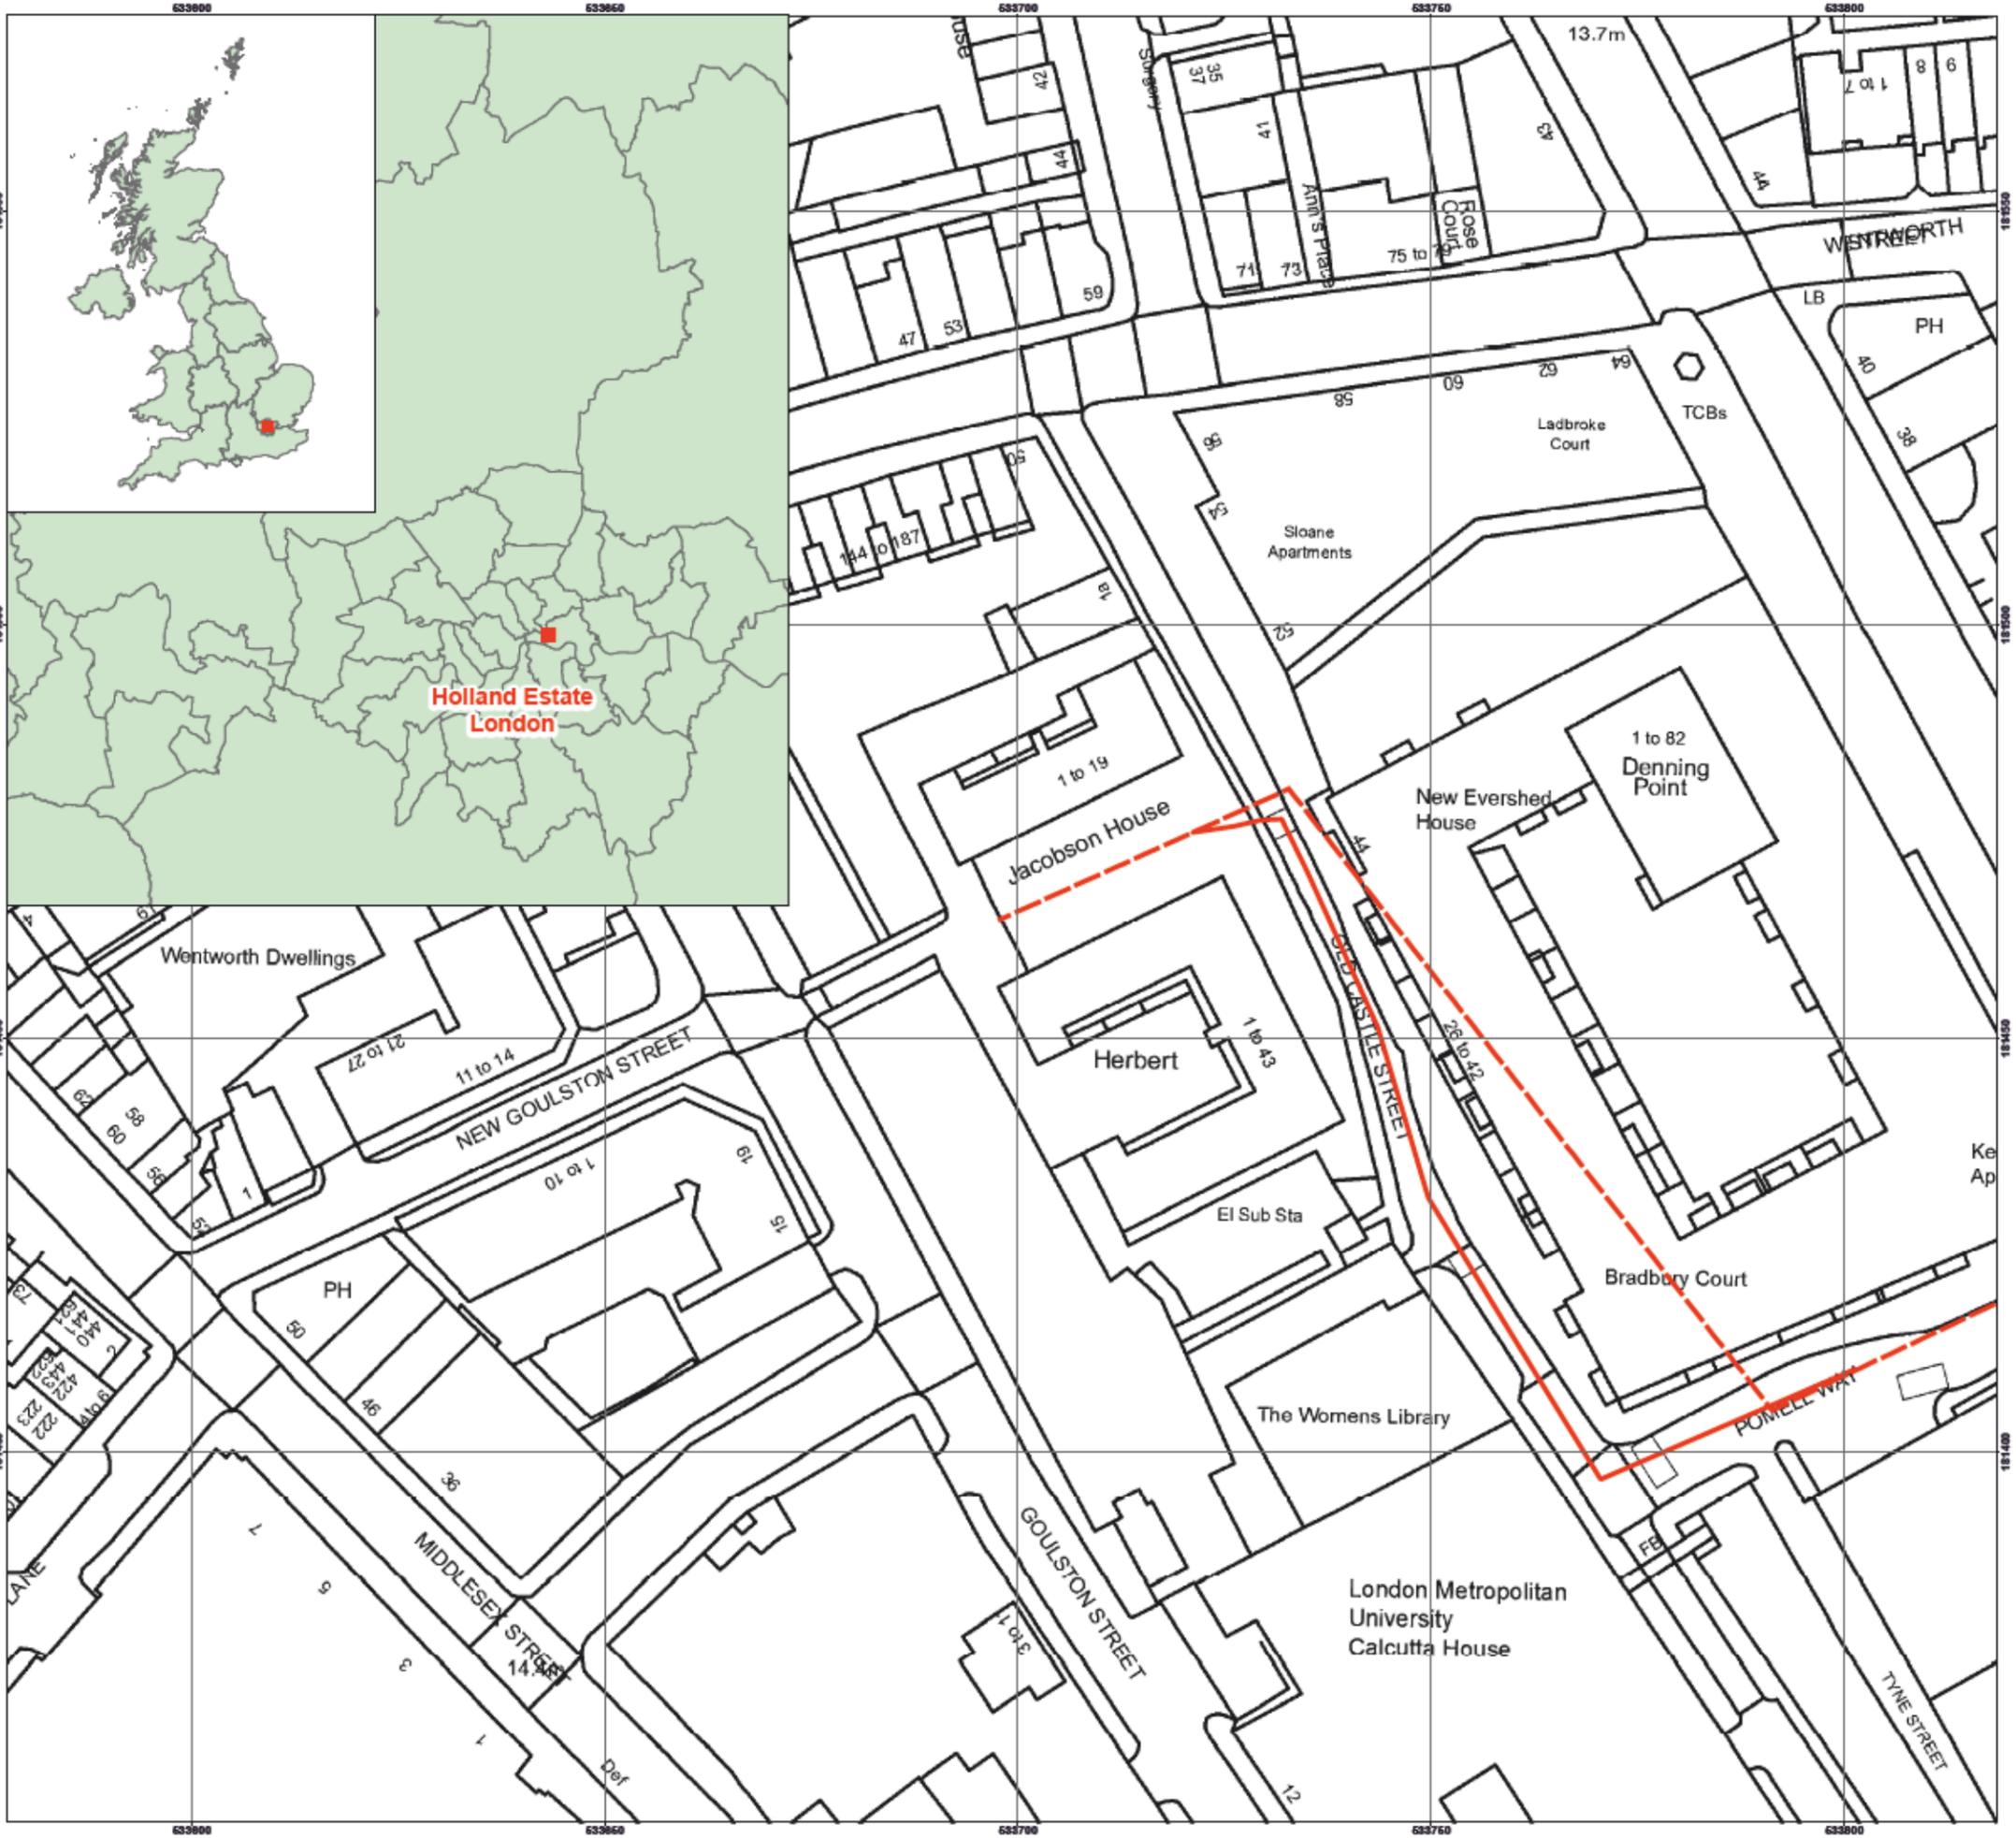
Figure 1: Site Location

- Proposed Cable Route
- - - Existing Cable Route

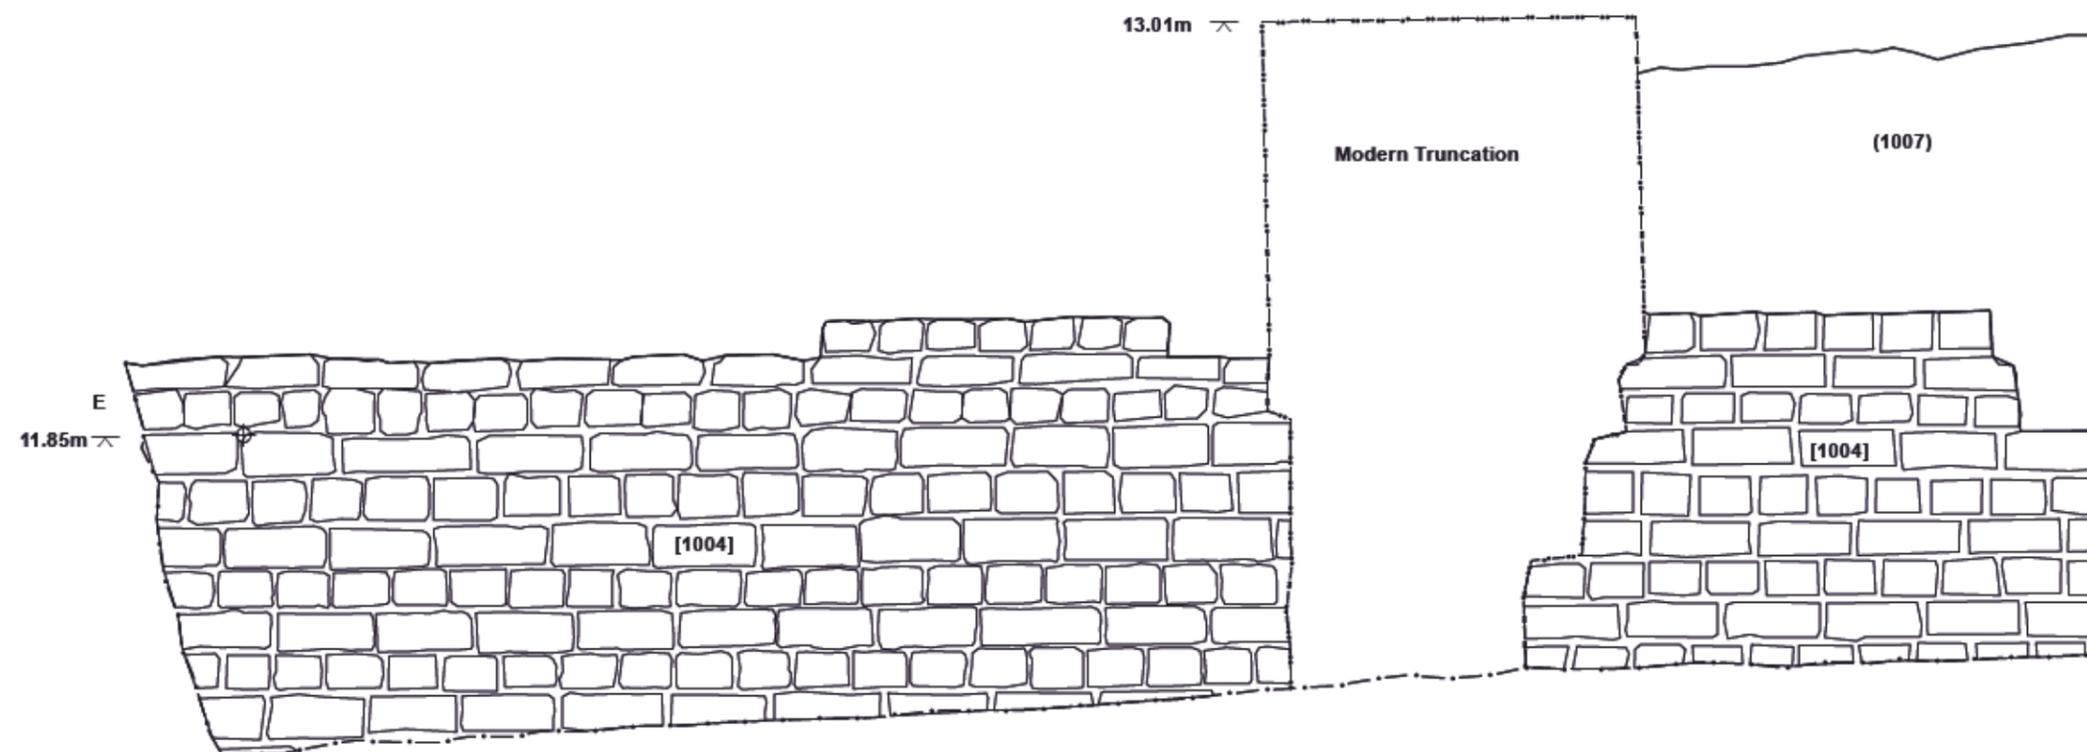
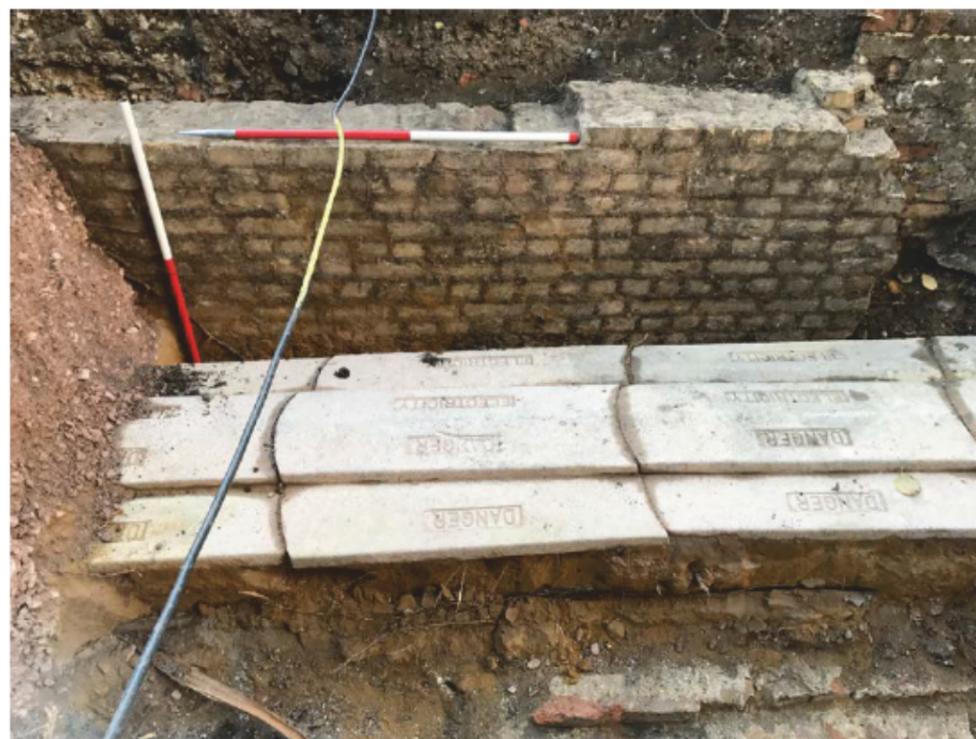
**Figure 6a: North-west facing
Elevation of Wall [1004]**

Plate 4: North-West Elevation of Wall [1004]

- 6.1.5 An extant buried brick wall [1004] measuring at least 7 m in length by 0.35 m in width and at least 1 m in height was exposed on an approximate north-east by south-west orientation along the south-eastern side of Trench 1. The wall was of yellow brick construction with each brick measuring 220 mm x 70 mm x 110 mm in size. The coursing was English or English Cross and bonded with a light grey cement. This wall had been truncated and partially destroyed by a modern service (Figure 5; Plates 7 and 8).

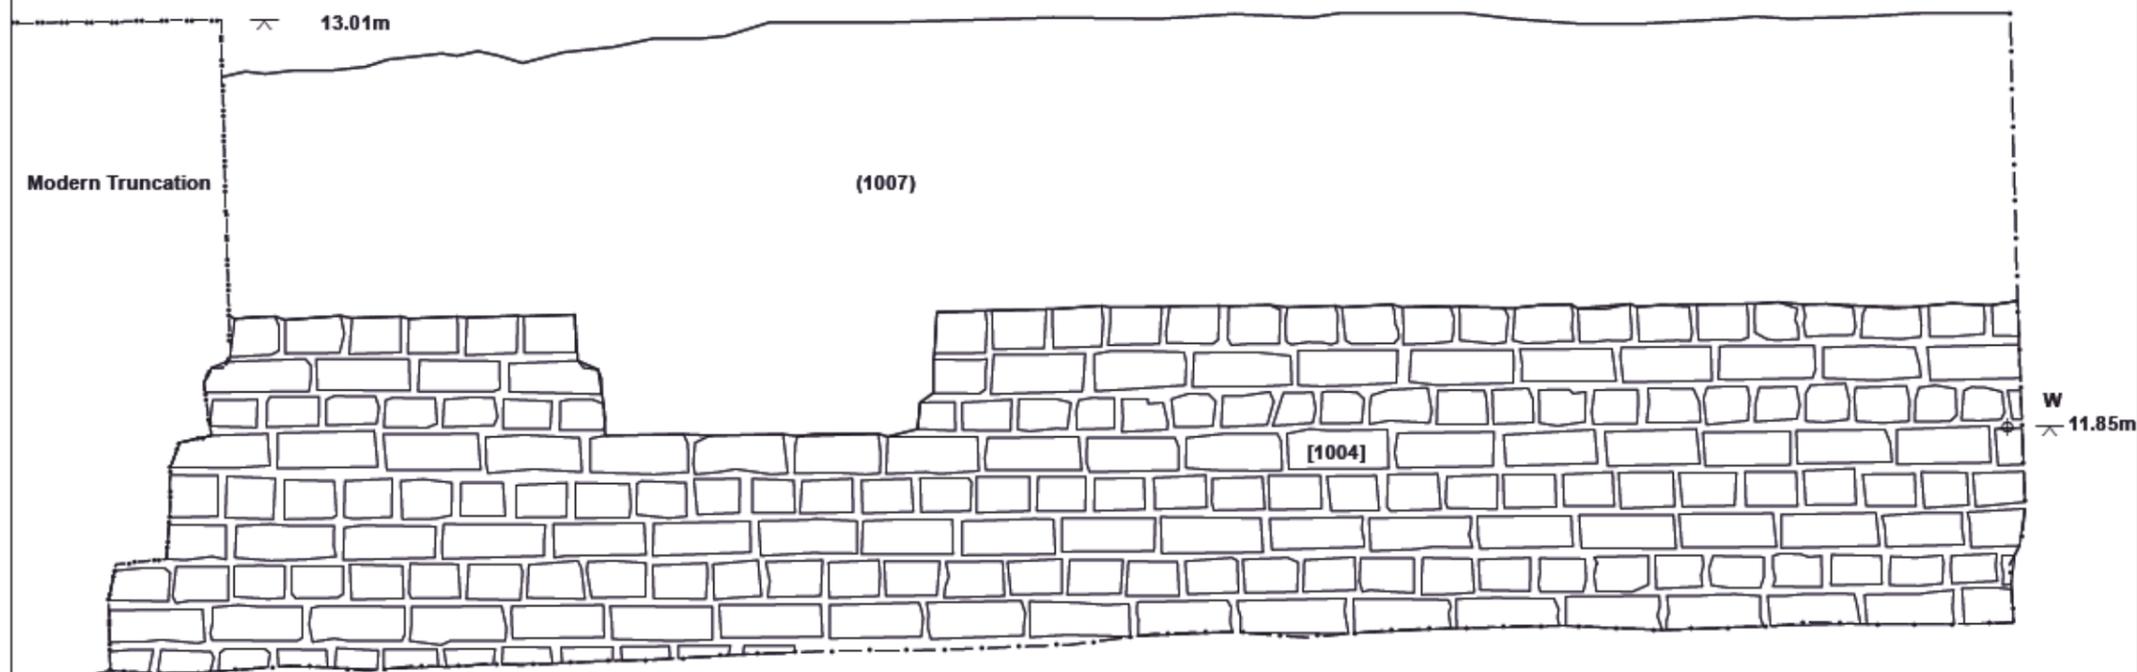
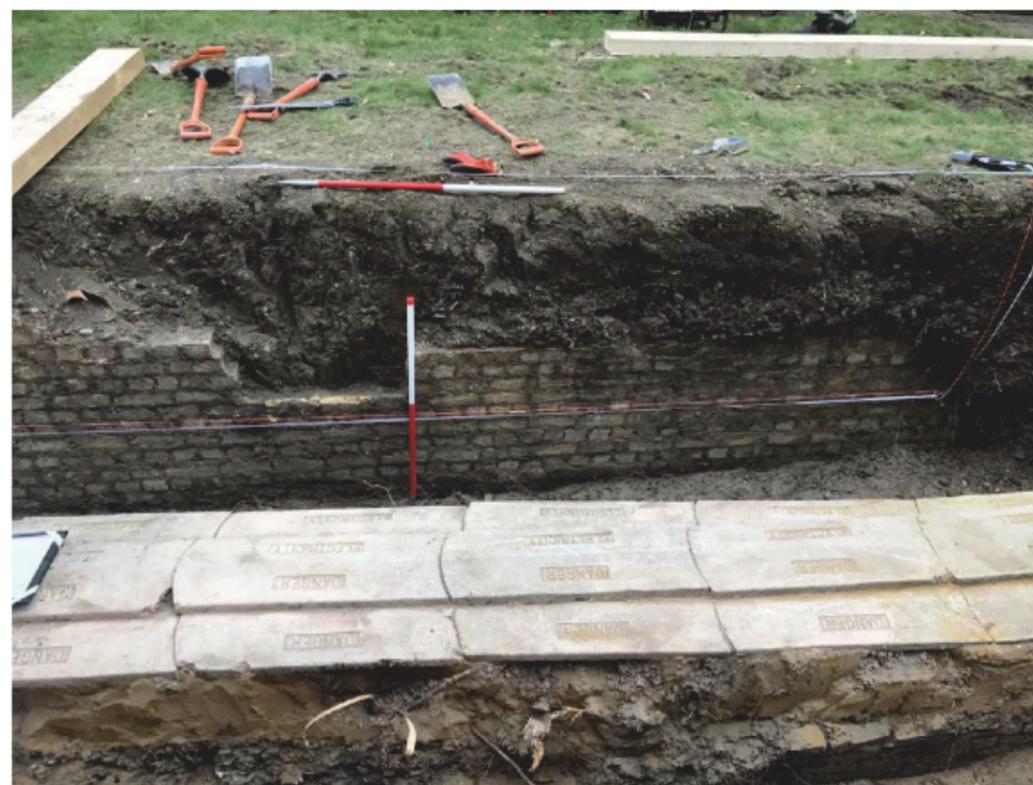
**Figure 6b: North-west facing
Elevation of Wall [1004]**

Plate 4: North-West Elevation of Wall [1004]

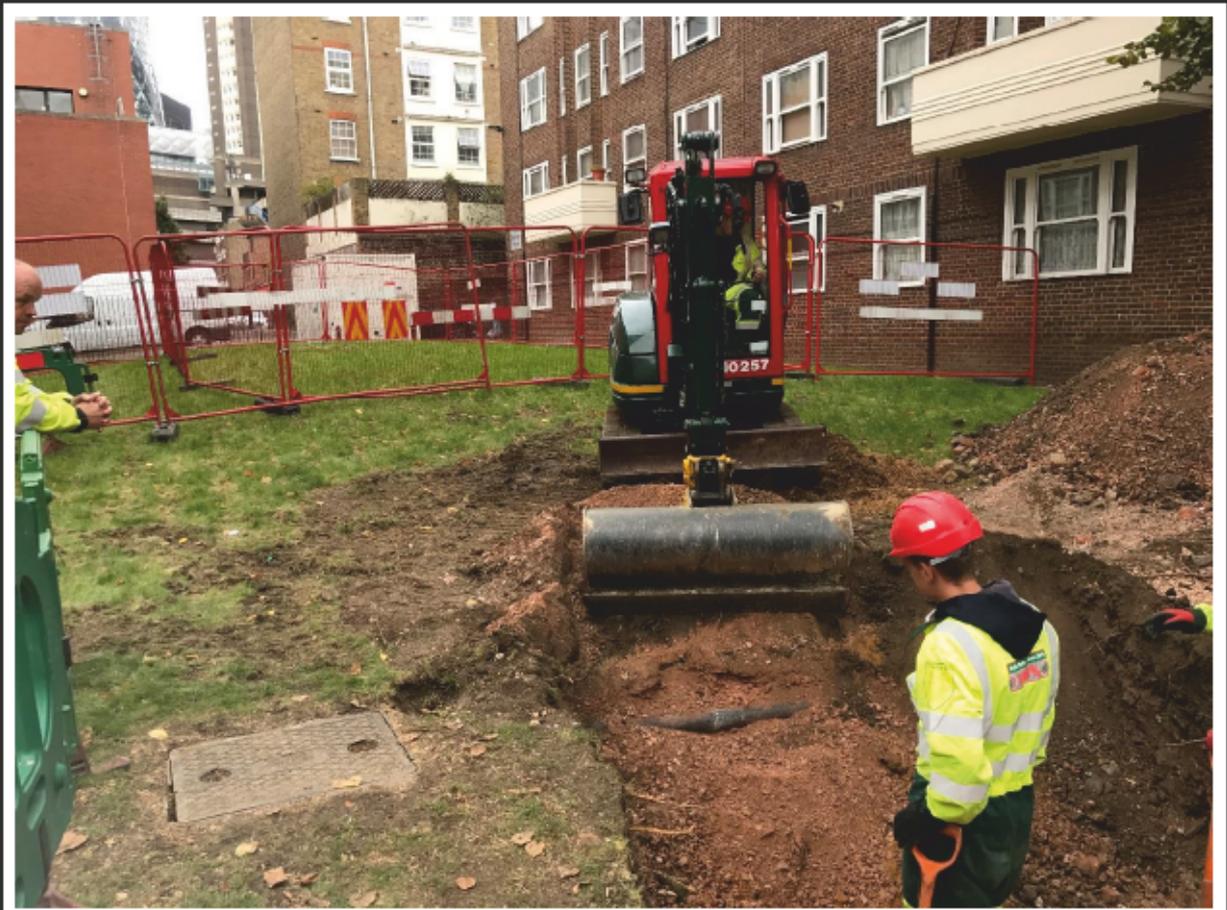
Plate 1: General shot of the excavation of Trench 1, looking south-west with Jacobson House in the background.

- 6.1.1 This section provides an overview of the monitoring results; detailed summaries of the recorded contexts and finds are to be found in Appendices A and B respectively.
- 6.1.2 The watching brief area comprised an area of land used as a small garden for the residents of Jacobson House and Herbert House which was entered into via a gate which opened onto Goulston Street to the west and bound by Old Castle Street to the east (Plates 1 and 2).

- 6.1.3 Trench 1 was rectangular in plan and measured 10 m in length by 3 m in width and was approximately 1.50 m deep. The trench was orientated approximately north-east to south-west (Figures 1 and 2).

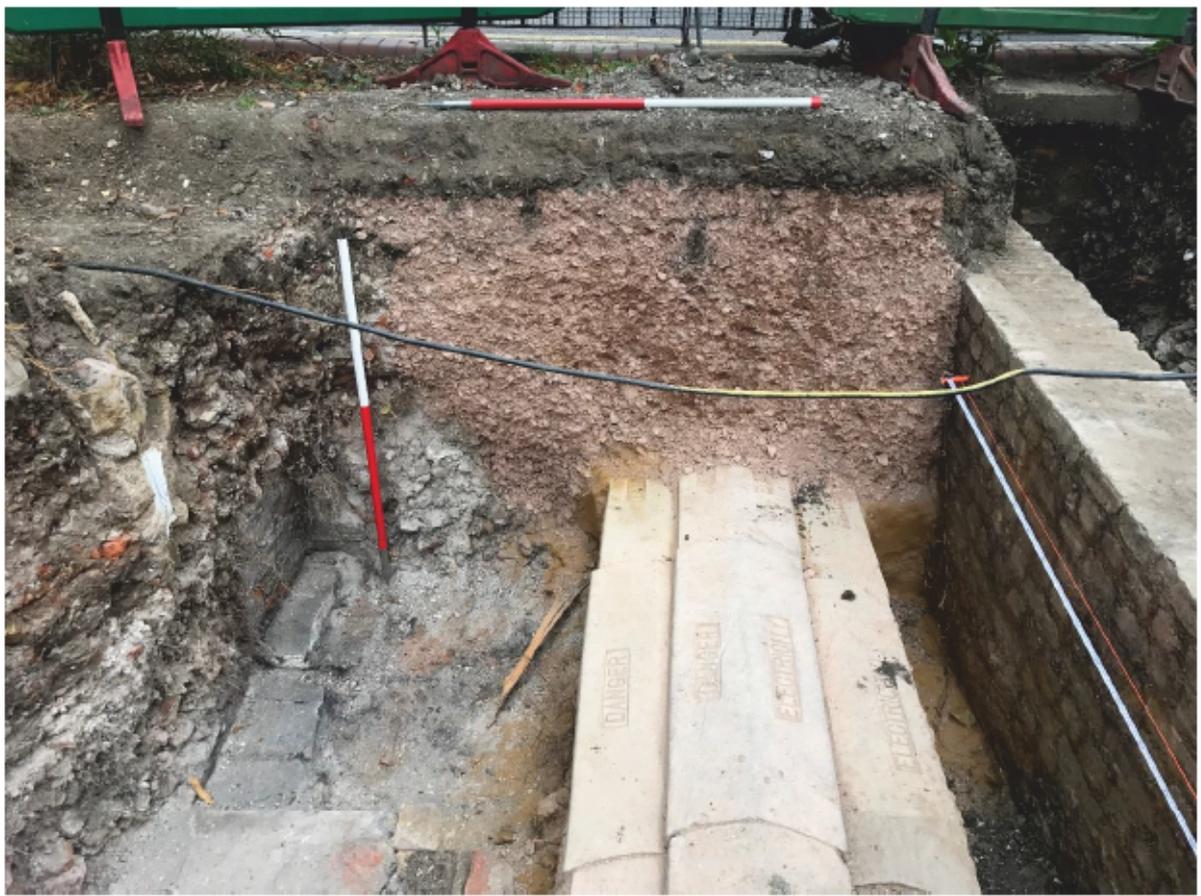
Plate 3: South-west facing section of cut [1001] containing fills (1002) [1006] and (1003), looking north-east.

- 6.1.11 The made ground (1005) was cut by the modern 132kV cable trench [1001]. The cable trench was a linear cut with a north-east to south-west orientation approximately 1.80 m wide at the north-east end, becoming narrower to 1 m wide at the south-west end. The trench was approximately 1.20 m deep with moderate straight sides at the north-east end and vertical sides at the south-west end with a flat base. The cable trench was filled 0.40 m of loose orange red sand (1002) which contained the 132kV cable itself. The 132kV cable was overlain by modern concrete capping tiles [1006] which followed the length of the cable trench. Each

capping tile measured 1.4 m by 0.75 m and were 0.05 m thick. These capping tiles [1006] were overlain by 0.80 m of modern Type 1 hardcore crush (1003) (Plates 3 and 4).

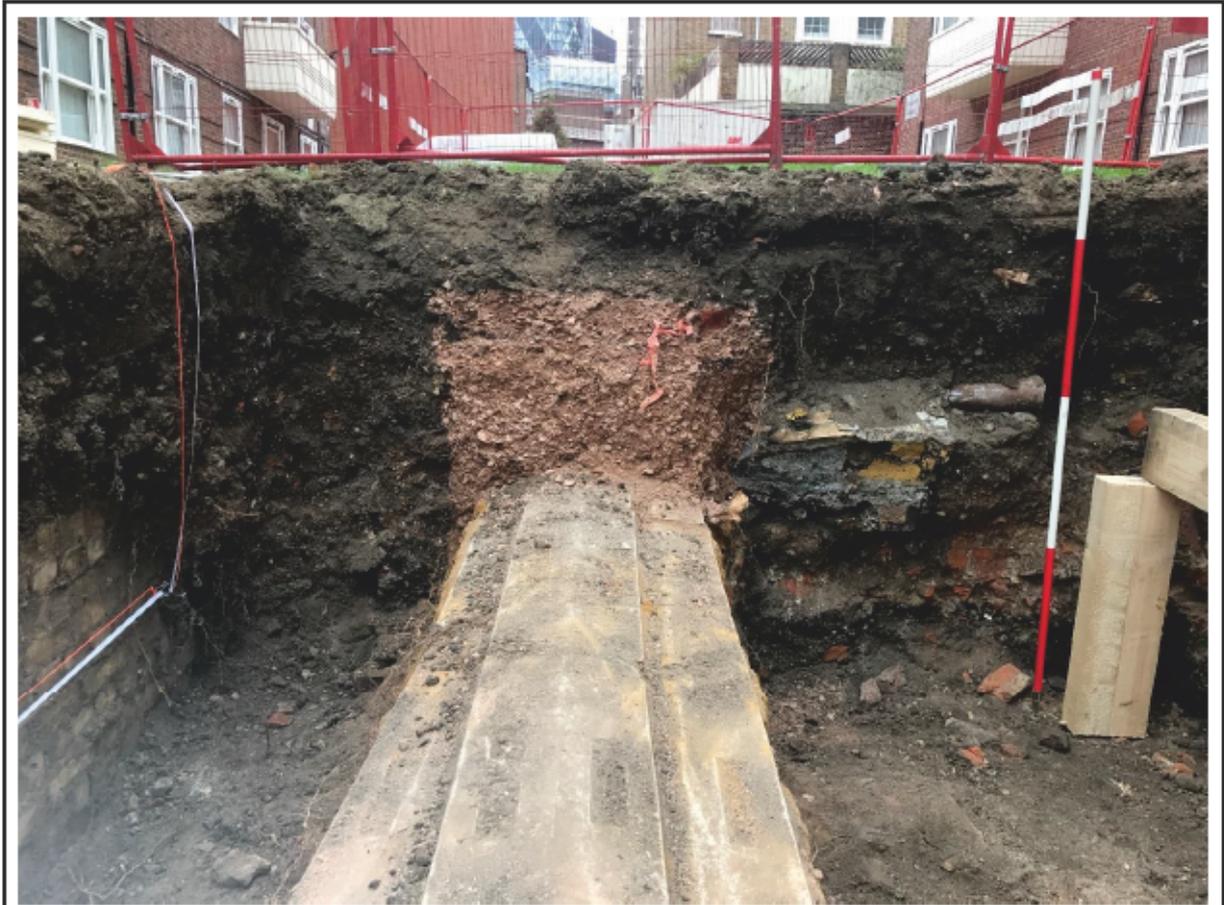
Plate 4: North-east facing section of Trench 1 showing cut [1001] containing fills (1002) [1006] and (1003), looking south-west.

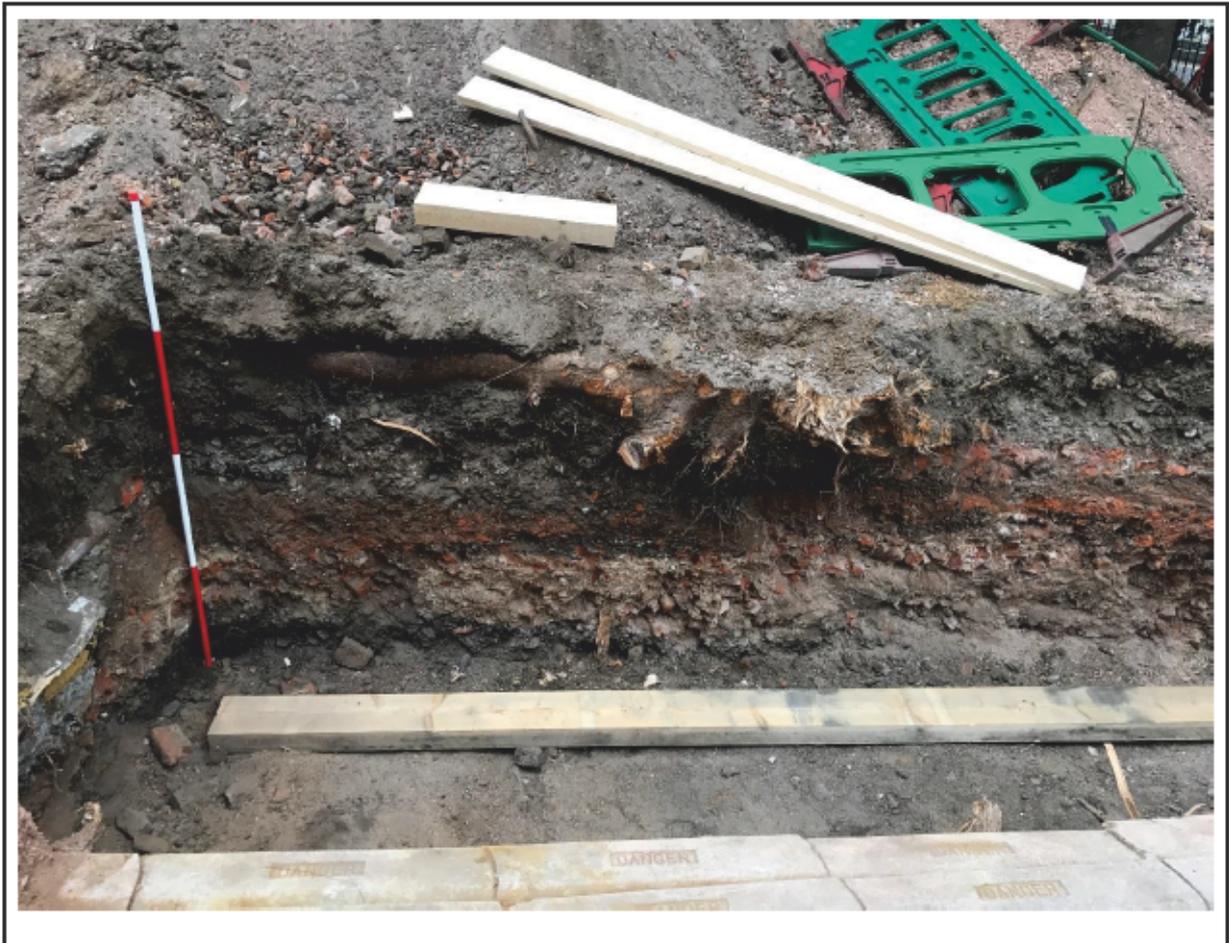
Plate 5: View of the south-eastern facing section of the northern side of Trench 1.

- 6.1.10 This deposit (1005) was made up of multiple lenses of modern material which was interpreted as modern made ground comprised of compacted dump material at least 1.20 m thick. The groundworks for the joint bay impacted approximately 1.5 m below the present ground surface. Therefore the full depth of this made ground layer was not exposed within Trench 1 (Plates 5 and 6).

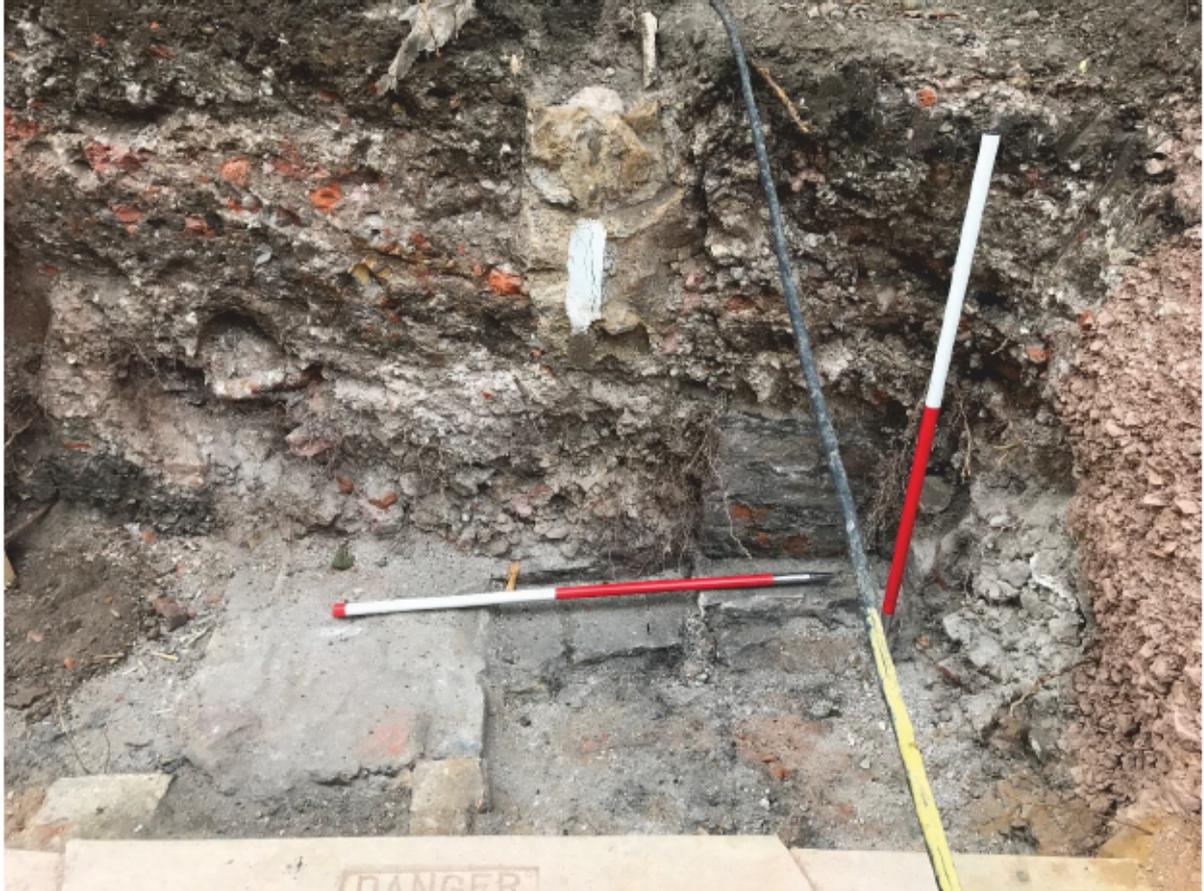
Plate 6: View of the south-east facing section of the northern side of Trench 1, showing structures [1007], [1012], [1013], [1014] and [1015].

- 6.1.4 At the base of Trench 1 excavations revealed only the uppermost section of brickwork for a structure on an approximate north-west to south-east orientation [1007]. The overall size of the remains measured 1 m x 0.60 m in size. The structure was made of yellow bricks, each measuring 220 mm x 70 mm x 110 mm in size. This brick structure appeared to have been truncated by the modern 132kV cable trench [1001] (Plate 6).

- 6.1.8 A small end of a brick structure [1013] was exposed in the north-east section of Trench 1. The overall visible size of this structure was 0.40 m x 0.45 m and was made up of brickwork. Each brick measured 220 mm x 110 mm in size and bonded with grey cement. These remains appear to have been an end of wall overlaying possible floor slabs [1014]. These floor slabs overall measured 0.90 m x 0.25 m in size and appeared to have been made of either Yorkstone or Kentish Ragstone. These slabs were heavily truncated by the modern 132kV cable trench [1001]. The floor slabs overlay a dark grey sandy loam (1020) containing Ceramic Building Material (CBM) fragments and clay pipe stems. The top of this deposit was the base for Trench 1 and so its full depth was not exposed (Plate 6).

6.1.14 A concrete fragment [1015] was revealed in the north-east section of Trench 1 (Plate 6). This structure was contained within a separate cut [1016], the fill (1017) of which stratigraphically cuts into the modern dump layer (1005). The structure and cut measures 0.35 m wide by 0.53 m deep. There was a semi-circular groove with what appeared to be white paint visible in the facing section. This may be a footing to a later structure, however as this does not appear to be associated with any other structures e.g. floors or walls.

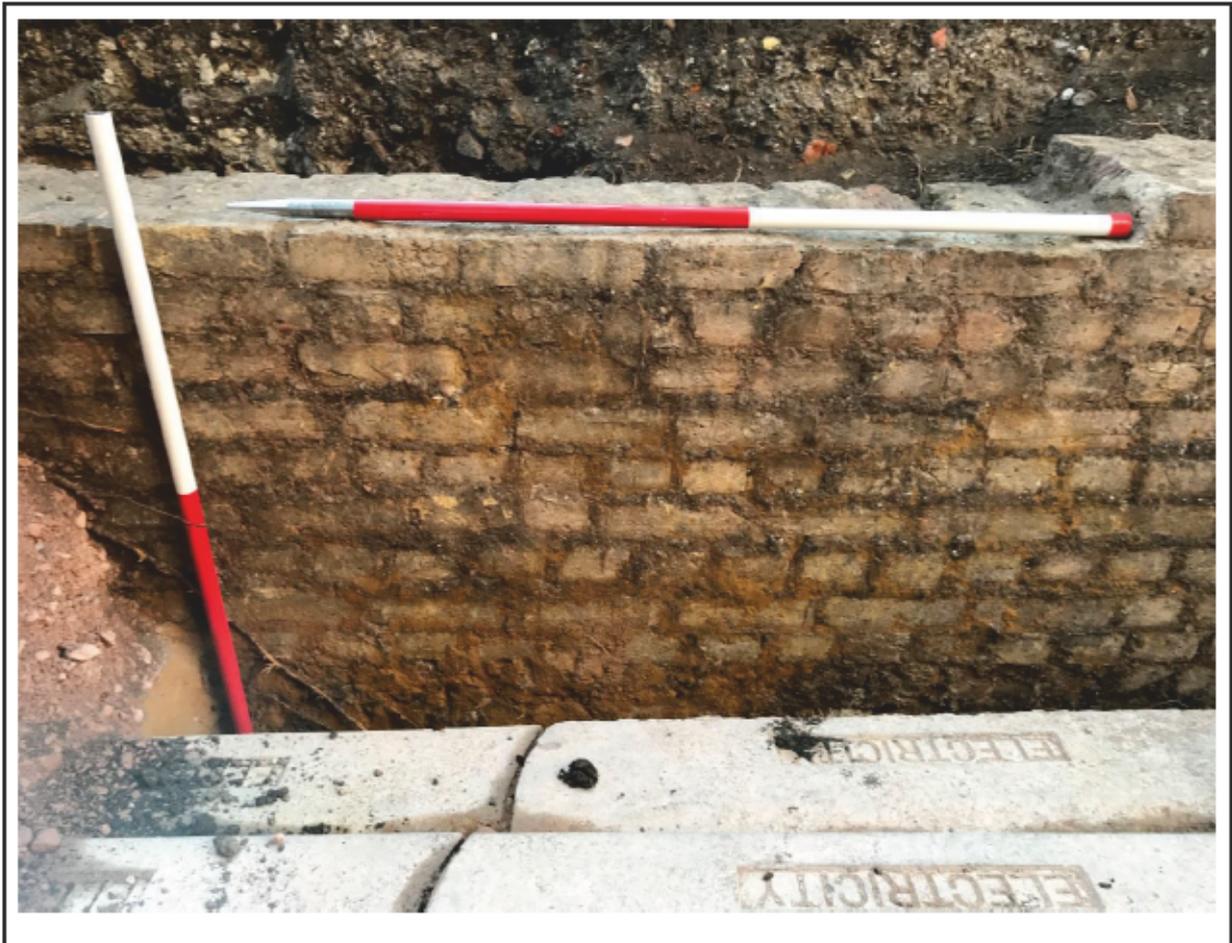
Plate 7: North-west facing elevation of wall [1004].

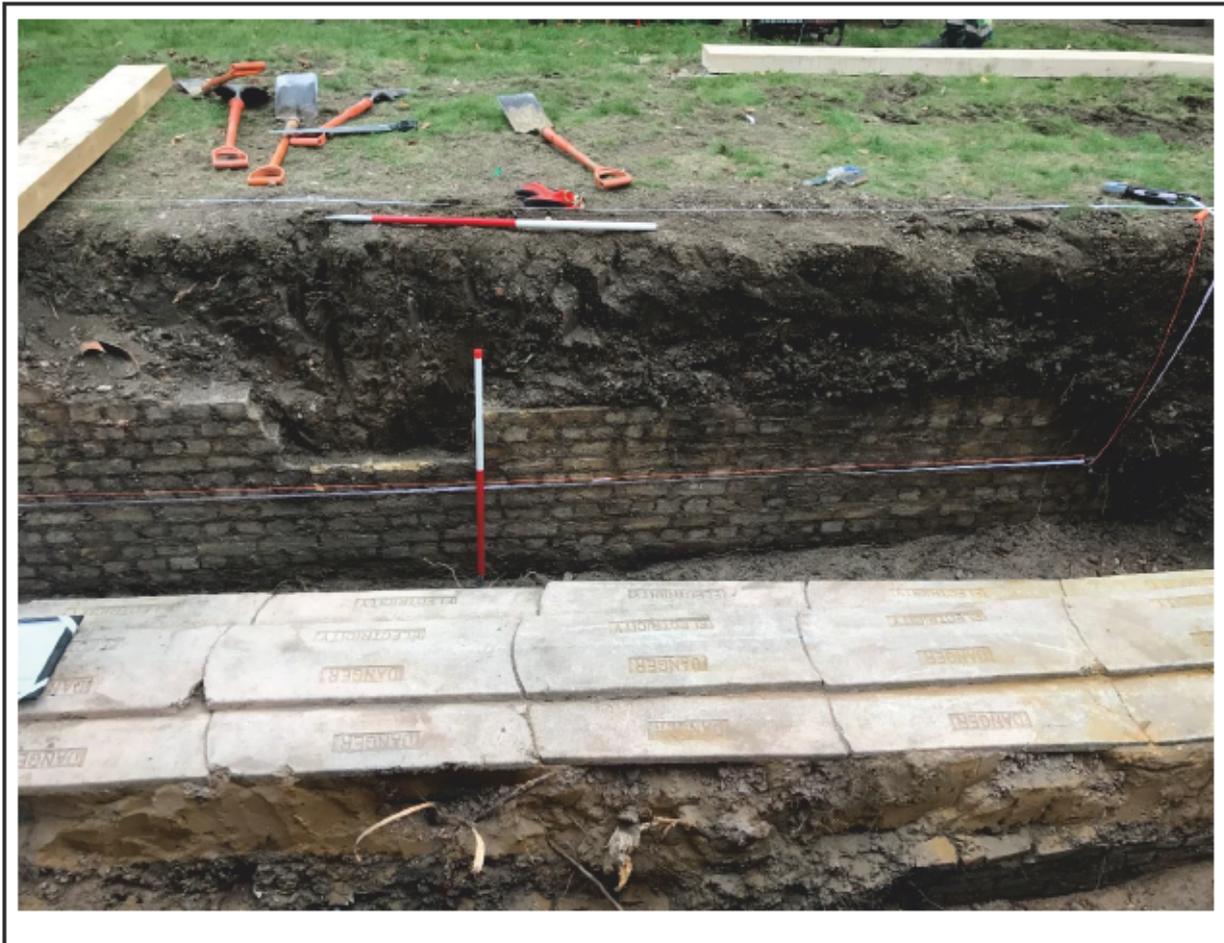
Plate 8: North-west facing elevation of wall [1004], south-eastern end.

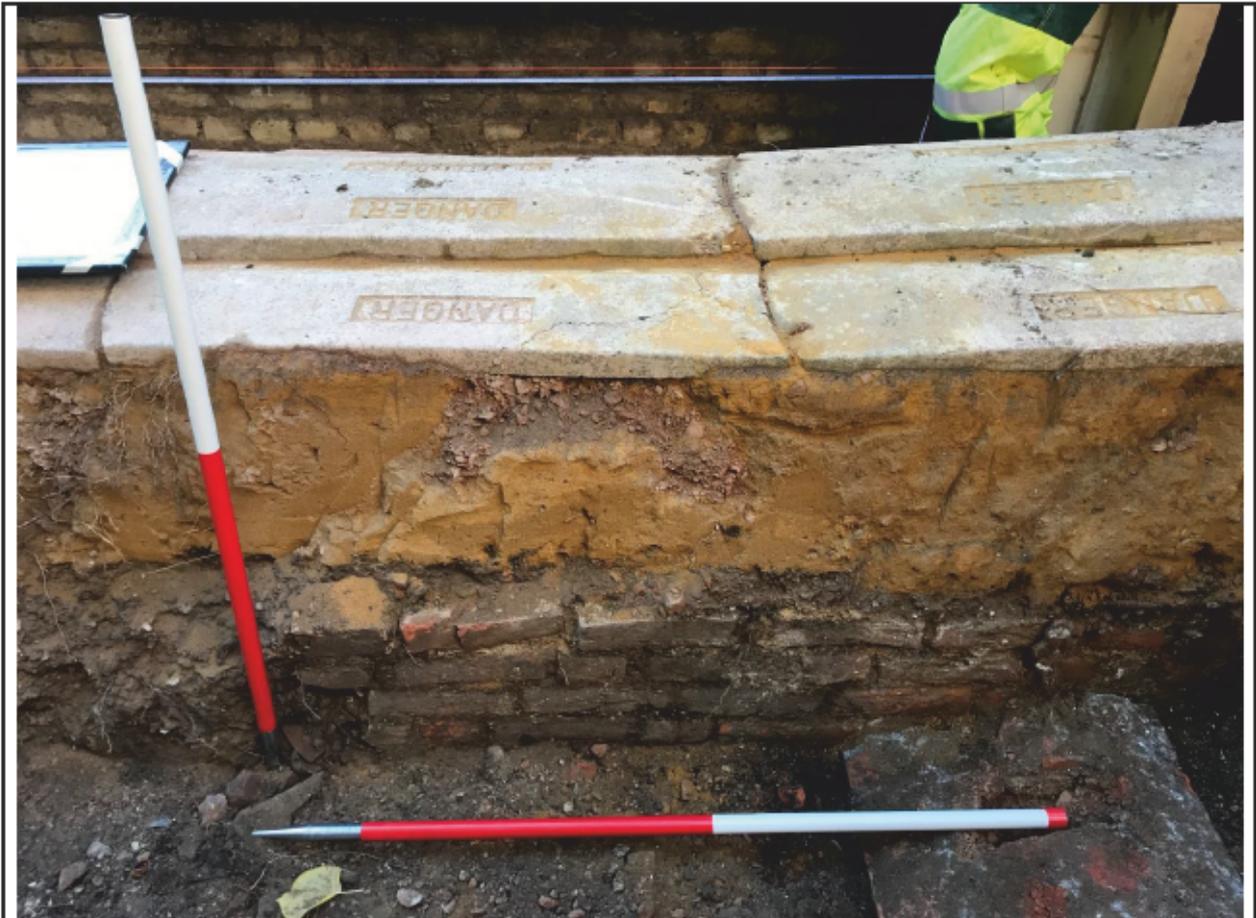
Plate 9: North-west facing elevation of wall [1009].

- 6.1.6 Towards the western end of Trench 1 a small section of brick wall survived [1009] which was on the same alignment as wall [1004] and wall [1012]. This structure was built of yellow brick, each brick measuring 220 mm x 70 mm x 110 mm in size. The overall size of this wall was 1 m

in length x 0.11 m in width x 0.25 m in height. This section of wall appears to have been largely destroyed by the modern 132kV cable trench [1001] (Plate 9).

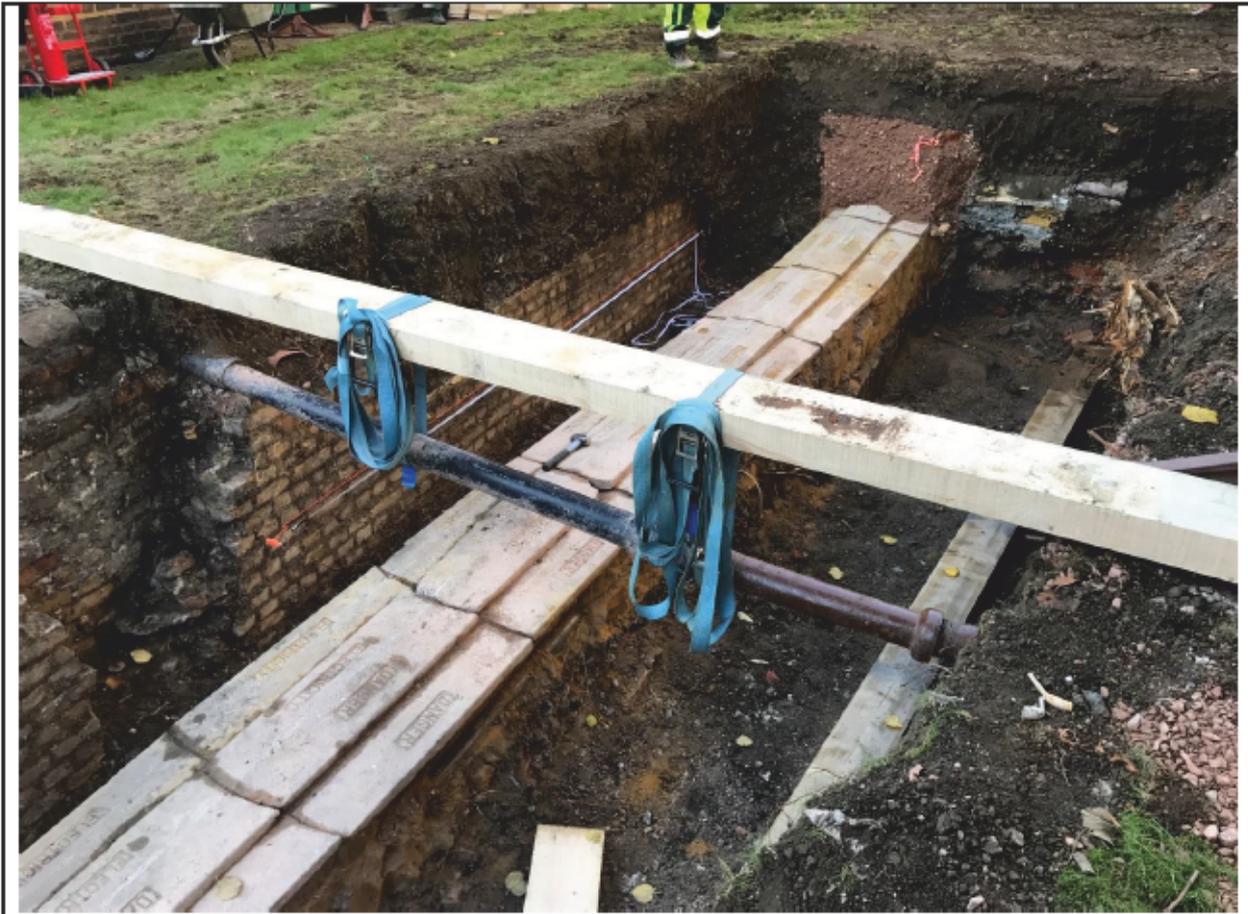
Plate 10: General shot of Trench 1 showing the existing 132kV electricity cable, looking south-west.

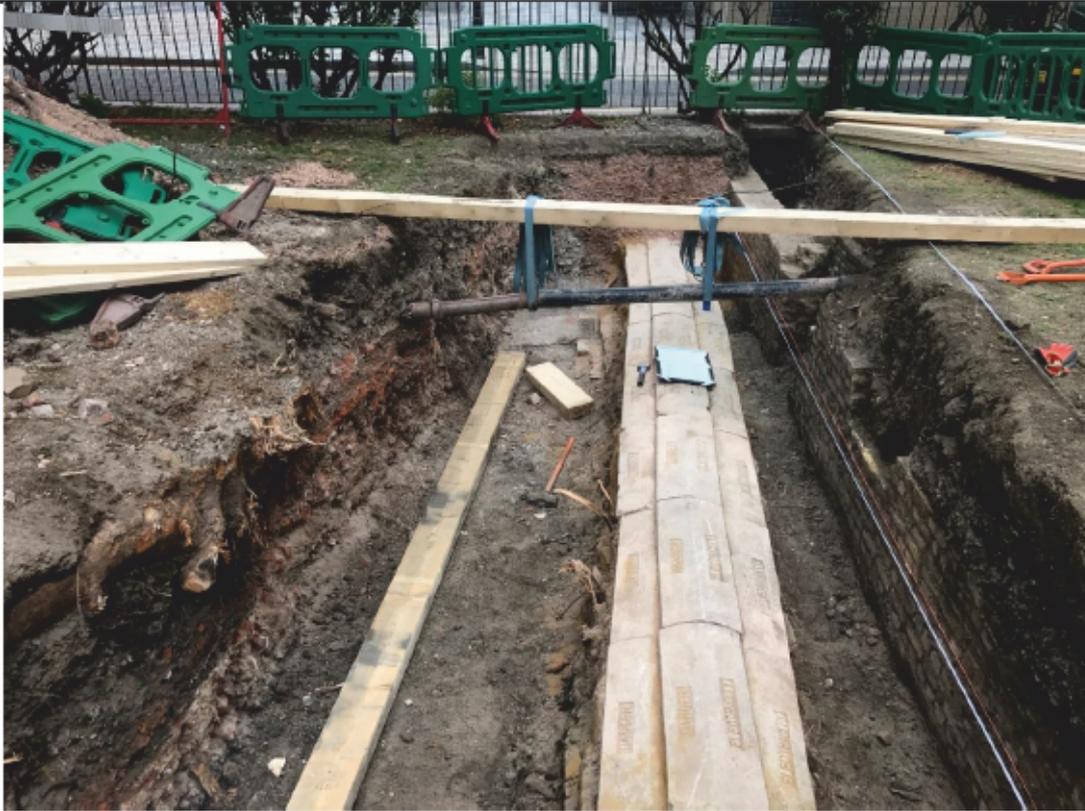
Plate 11: General shot of Trench 1, looking north-east.

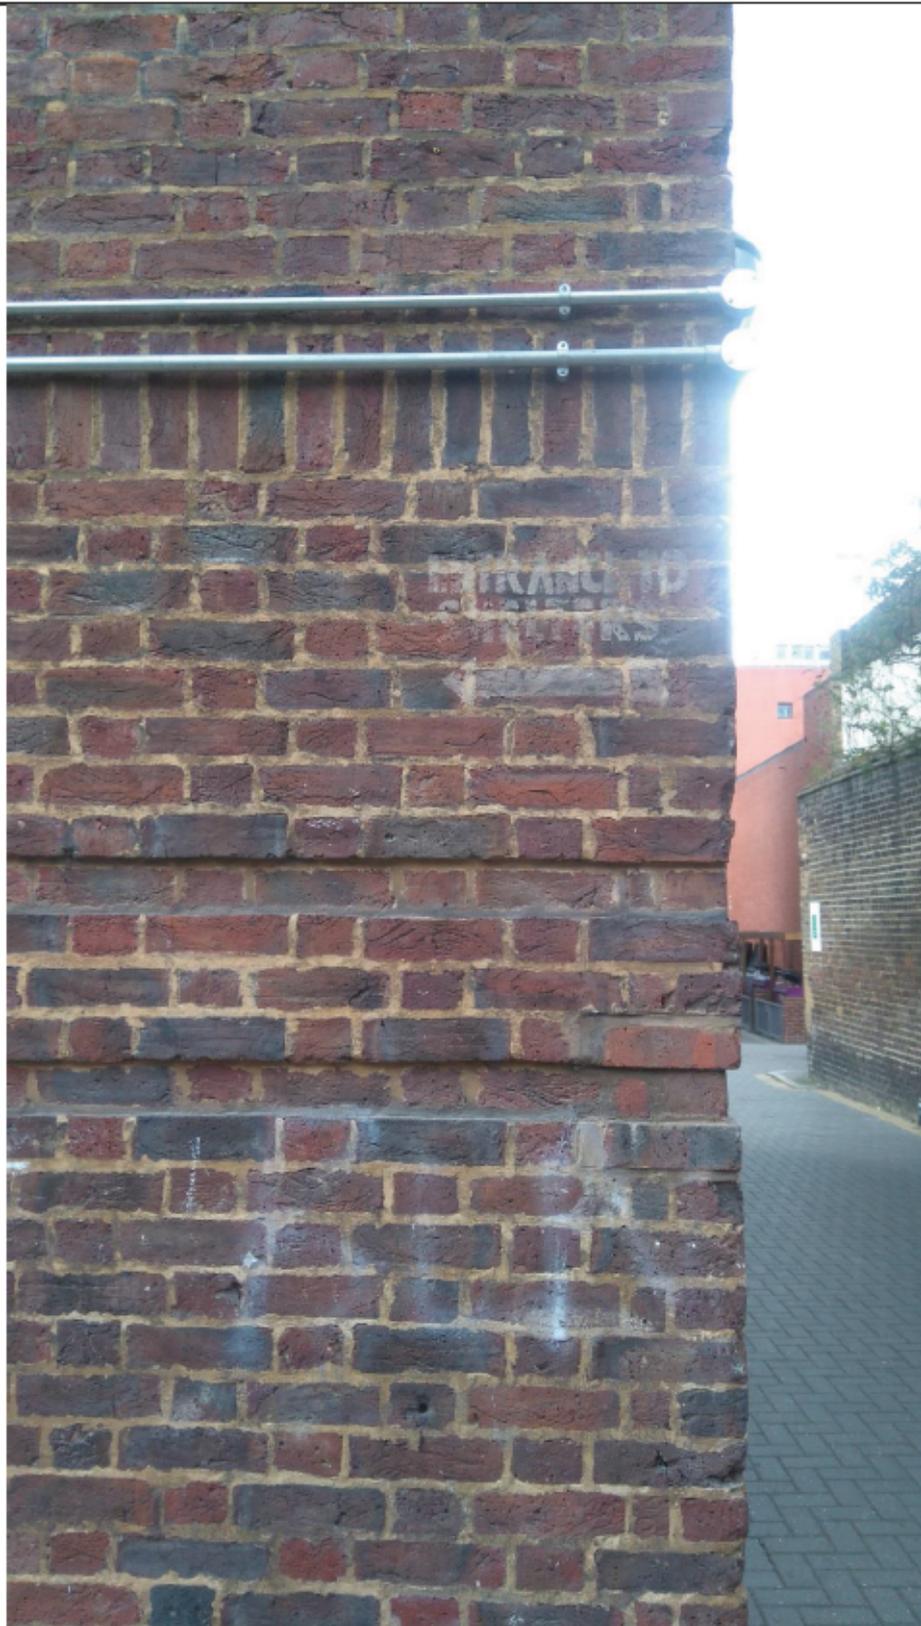
Plate 12: View of a faded sign pointing towards World War II air raid shelter entrances. The sign is located on the north-west facing corner of Jacobson House pointing towards Old Castle Street.

- 4.1.8 During a site visit a large grass-covered mound was observed between Jacobson House and Herbert House. Close inspection of the north-west facing wall on Jacobson House adjacent to the mound revealed a faded sign and arrow pointing to the entrance to a shelter (Plate 12).
