Archaeological Monitoring and Recording Report: Holland Estate 132kV Cable Diversion

Report By: Andrew Brown BA (Hons) MSc ACIfA
Issued by: Diarmuid O Seaneachain BA PhD MCIfA
Date: November 2017

UK Power Networks Ltd

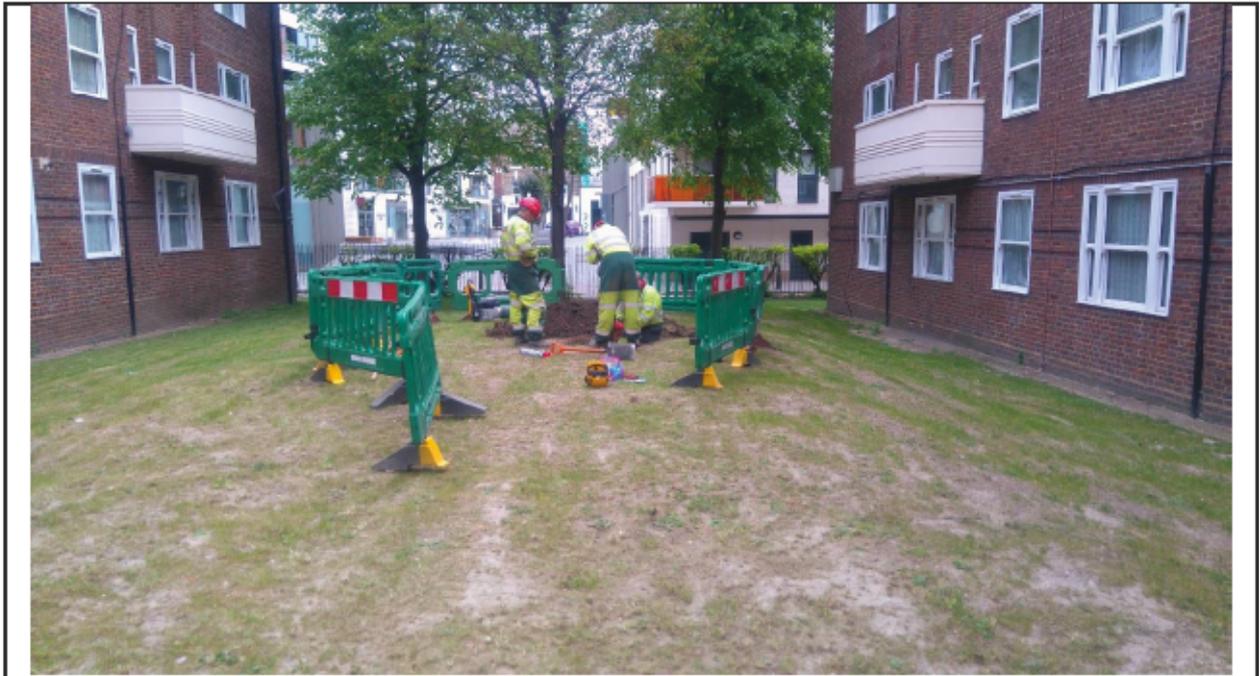
Plate 13: Excavation of Test Pit 2 between Herbert House and Jacobson House looking north-east towards Old Castle Street.

- 4.1.11 One test pit (Test Pit 2) measuring 1 m X 1.2 m revealed the cable cutting through the reinforced concrete roof under the mound and part of the brick walls of the shelter, giving a view into the interior of the shelter (Figure 2; Plates 13-16). The test pitting confirmed that the air raid shelter itself had brick walls c. 0.3m thick with a reinforced concrete roof, which was also c. 0.3m thick. It appears to be internally divided into two chambers by brick piers. There was a considerable amount of collapsed material visible inside the structure and the structure itself must be considered unstable.

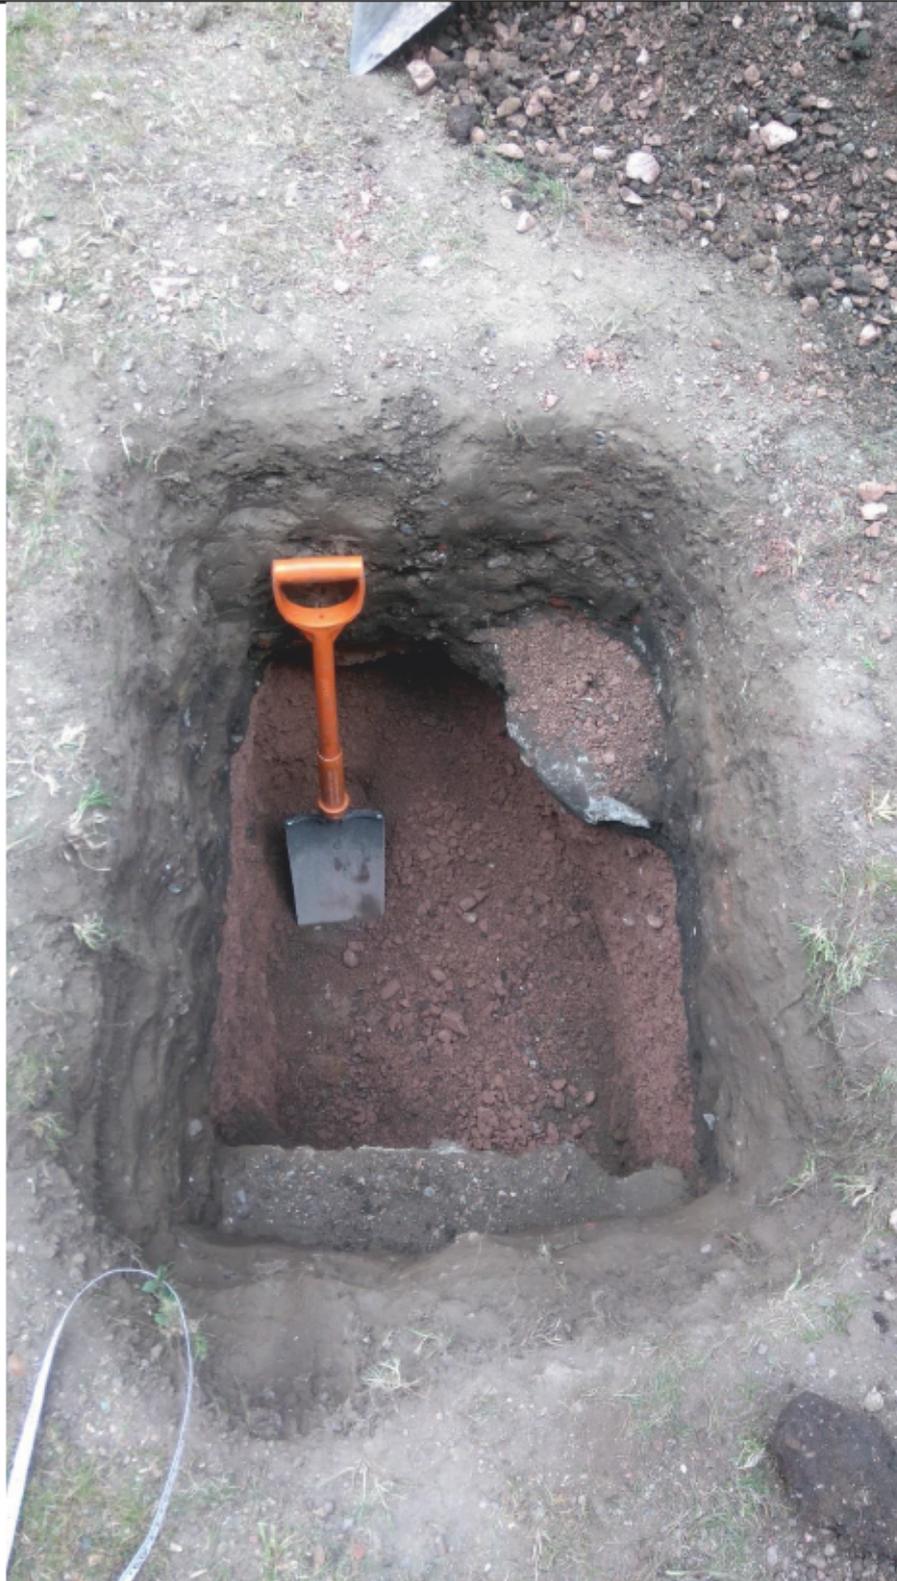
Plate 14: Shot of Test Pit 2 looking north-west showing the cut for the 132kV cable [2003] and Type 1 backfill (2004).

6.1.15 Test Pit 2 was dug in order to located the existing 132kV cable through the grassed area between Herbert House and Jacobson House. The test pit measured approximately 1 m by 1.2 m and was approximately 0.60 m deep. The stratigraphic sequence consisted of 0.20 m of topsoil (2001) which overlay the bomb shelter [2002]. The cable trench [2003] cut into the bomb shelter and was filled by at least 0.40 m of Type 1 backfill (2004).

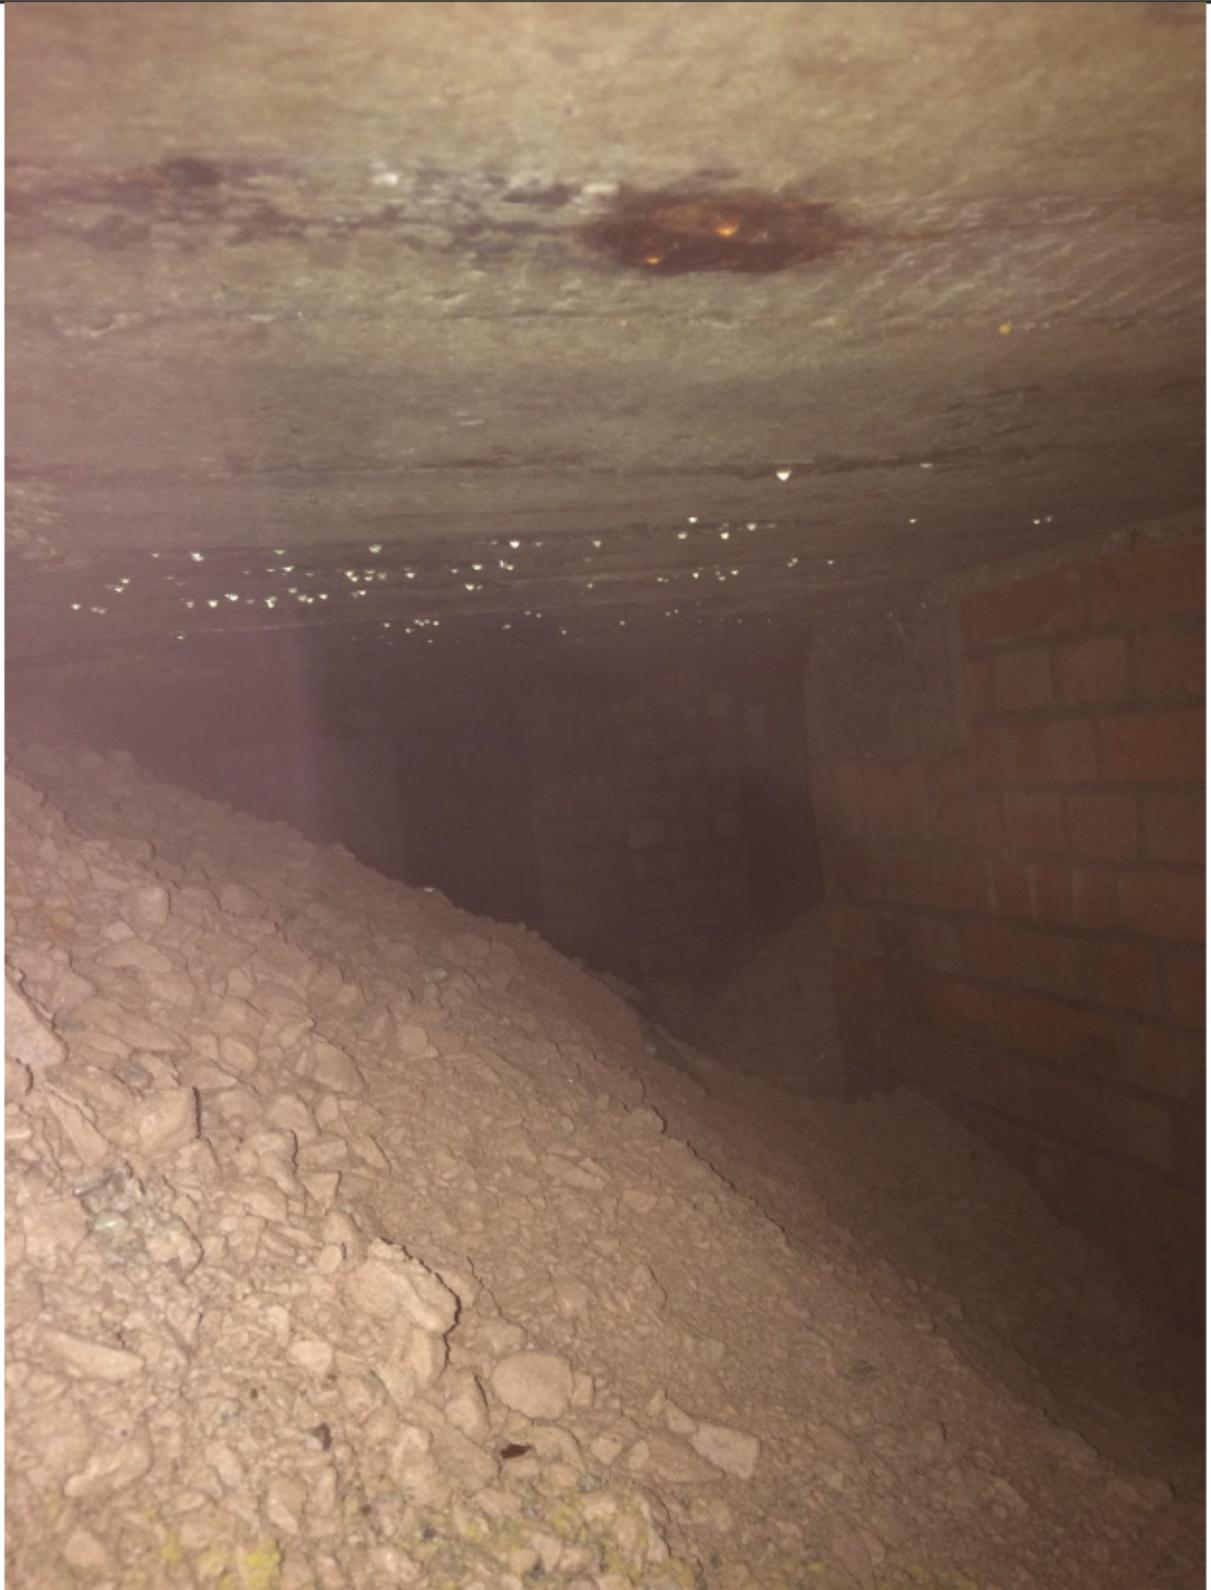
Plate 15: Shot of the interior of the bomb shelter (2002) looking south-west.

6.1.16 Photographs of the interior of the bomb shelter show that it has been largely filled with this Type 1 backfill (2004). The bomb shelter was constructed from brick walls approximately 0.3m

thick with a reinforced concrete roof, which was also approximately 0.3m thick. It appears to be internally divided into two chambers by brick piers (Plates 13-16).

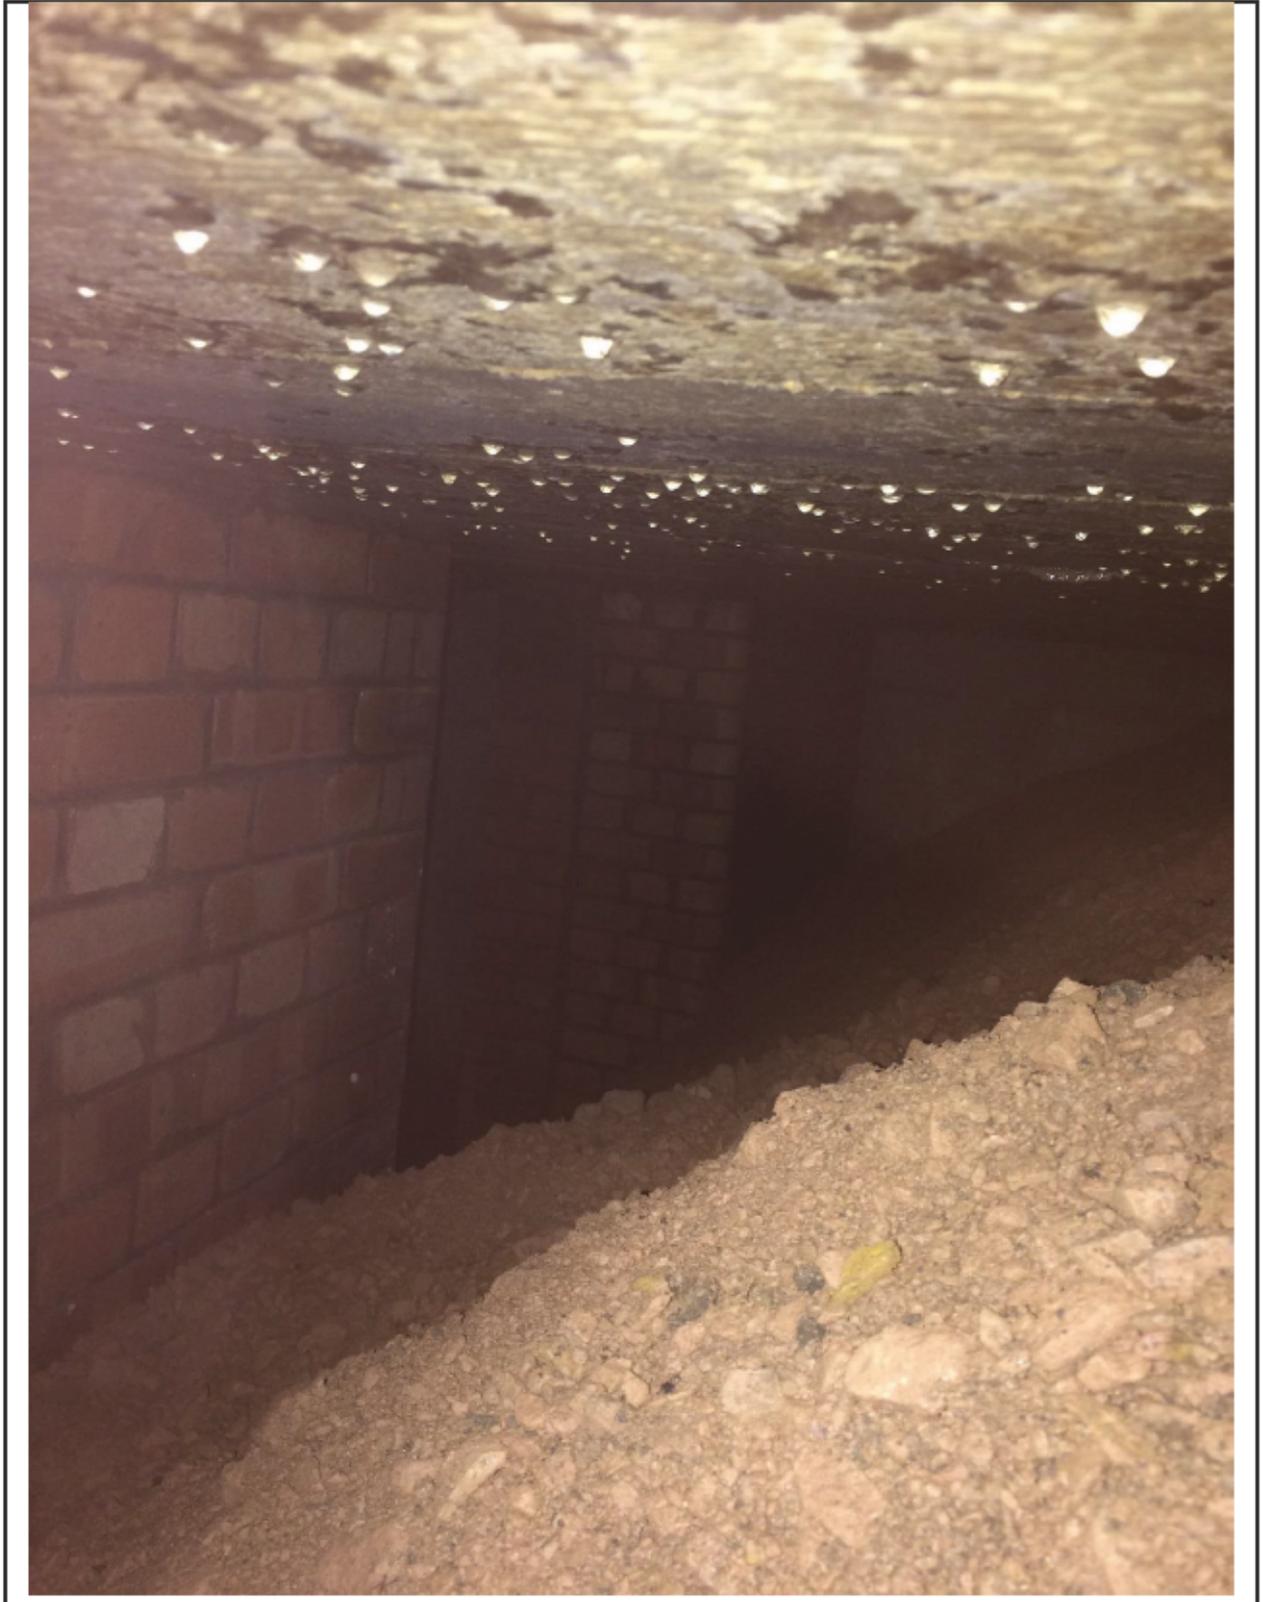
Plate 16: Shot of the interior of the bomb shelter (2002) looking north-east.

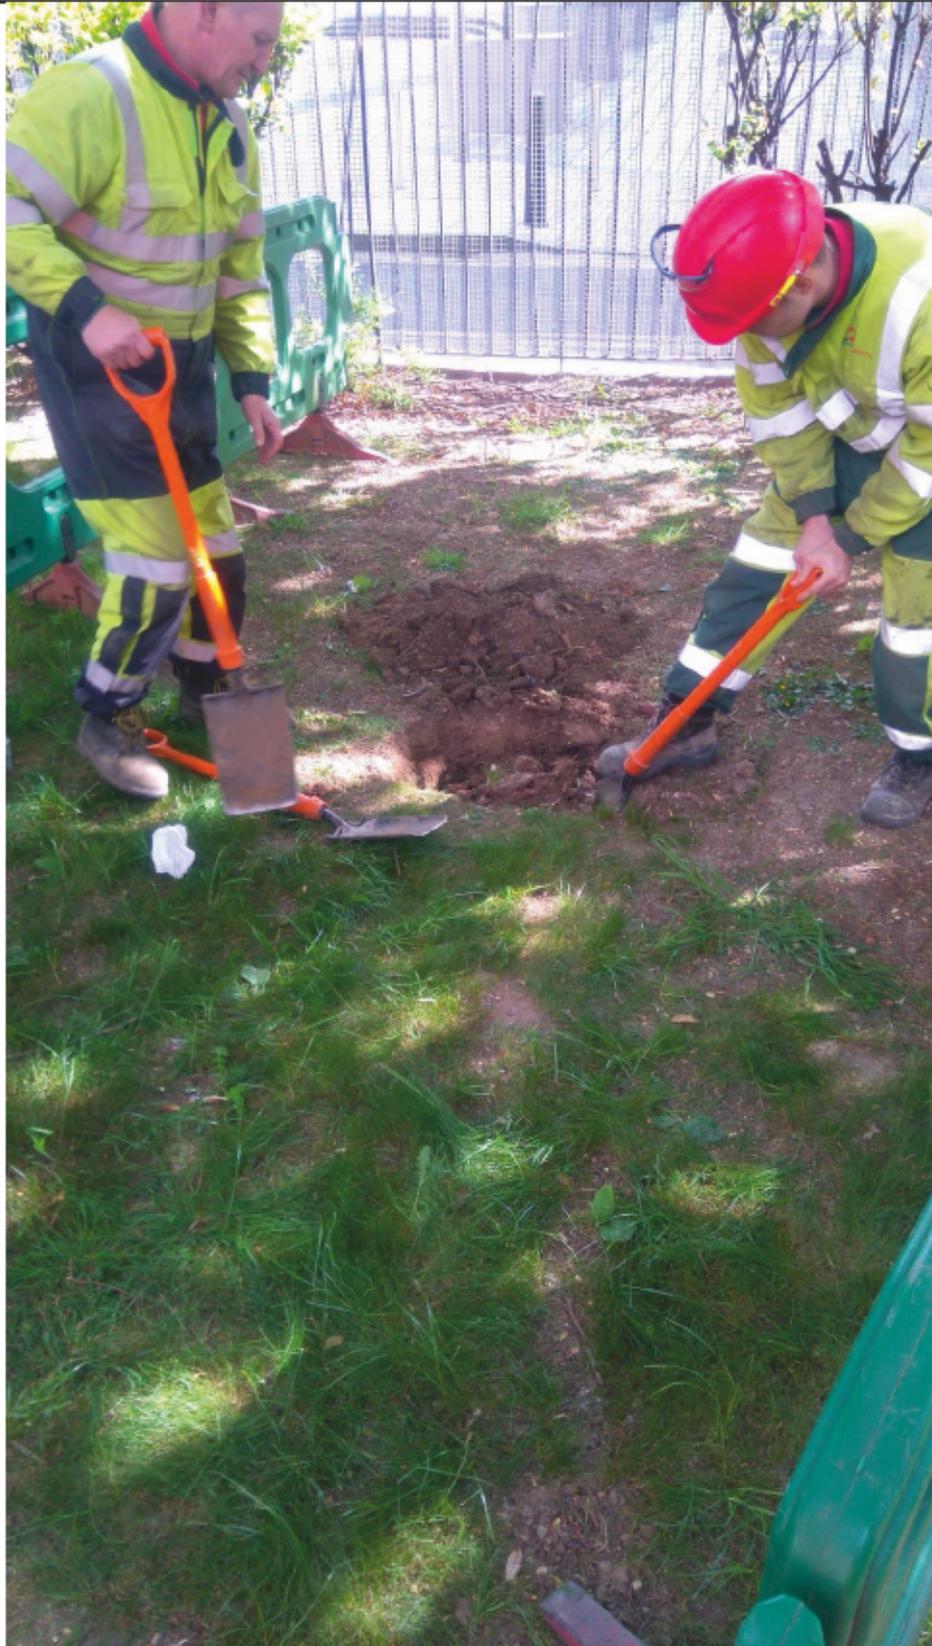
Plate 17: Excavation of Test Pit 3 looking north-east.

- 4.1.12 The second test pit (Test Pit 3) measuring 1m by 0.5 m dug in order to locate the existing 132kV cable and identify the extent of any tree rooting near some trees along Old Castle Street to the east of the structure. This revealed the cable trench and backfilling of the cut with Type 1 gravel and concrete capping tiles over the 132kV cable (Figure 2; Plates 17-18).

- 6.1.17 Test Pit 3 was dug in order to locate the existing 132kV cable and identify the extent of any tree rooting near some trees along Old Castle Street and the grassed area between Herbert House and Jacobson House. The test pit measured approximately 1 m by 0.5 m and was approximately 1 m deep. The stratigraphic sequence consisted of 0.40 m of topsoil (3001) which overlies the modern 132kV cable trench [3002]. The cable trench [3002] cut into the bomb shelter and was filled by at least 1 m of Type 1 backfill (3003) which overlies concrete capping plates [3004] (Plates 17 and 18).

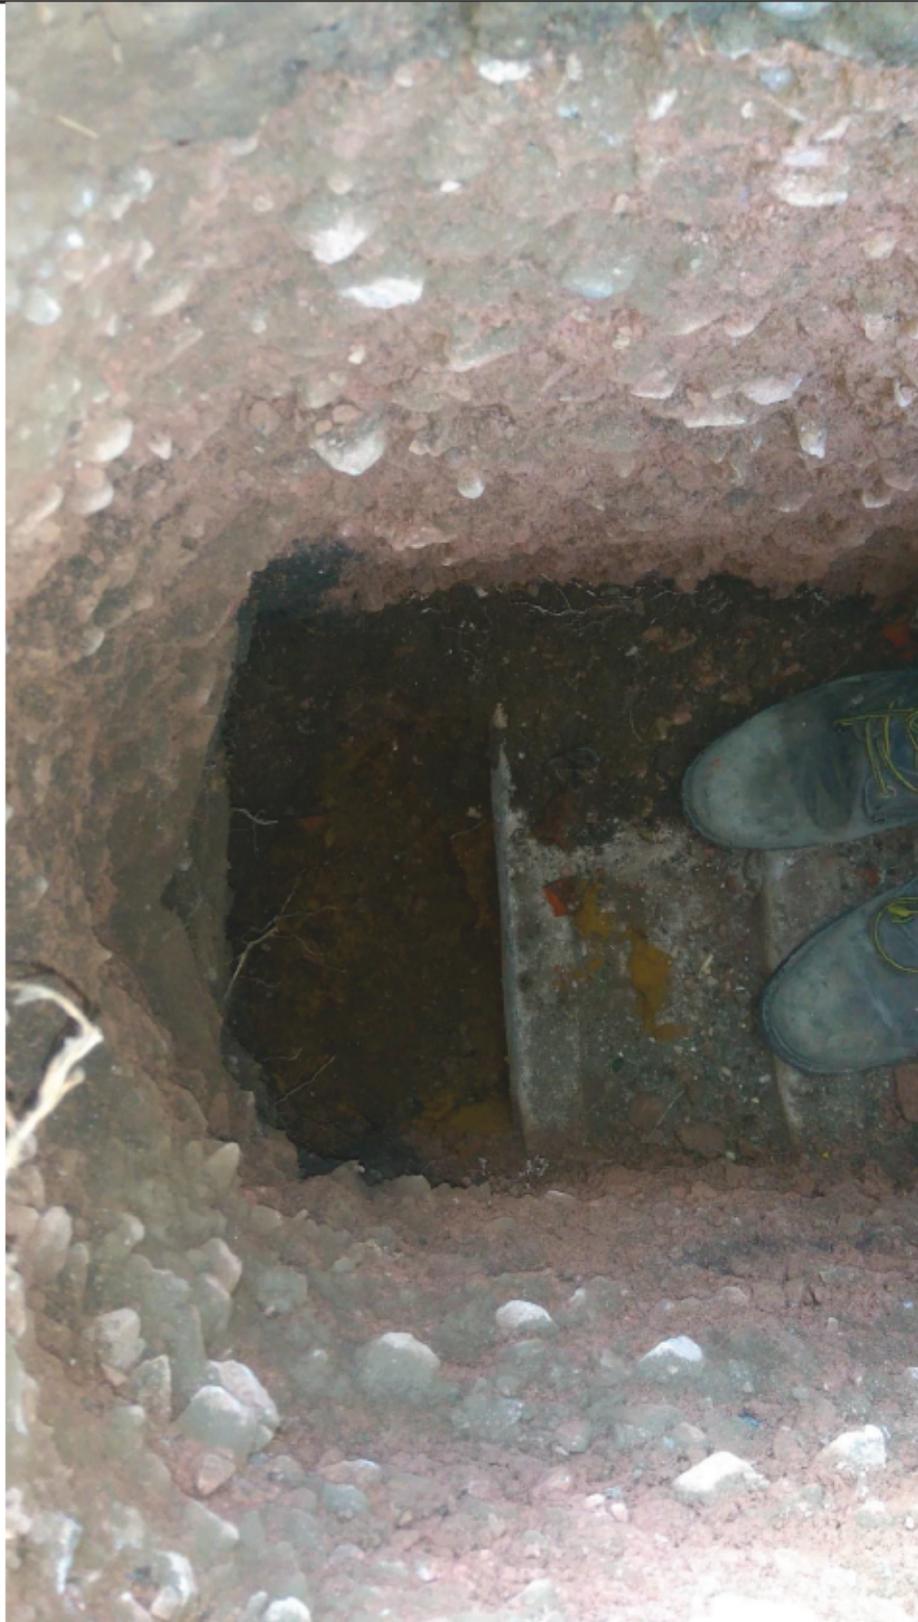
Plate 18: Shot of the visible concrete capping plates [3004] within Test Pit 3.
