Archaeological Monitoring and Recording Report: Bicester North Substation, Land off A4421 Skimmingdish Lane, Bicester, Oxfordshire

Date: December 2018

Submitted to:	Prepared by:
Scottish & Southern Energy Networks No 1 Forbury Place 43 Forbury Road Reading	RSK ADAS Limited 11D Park House Milton Park Abingdon OX14 4RS

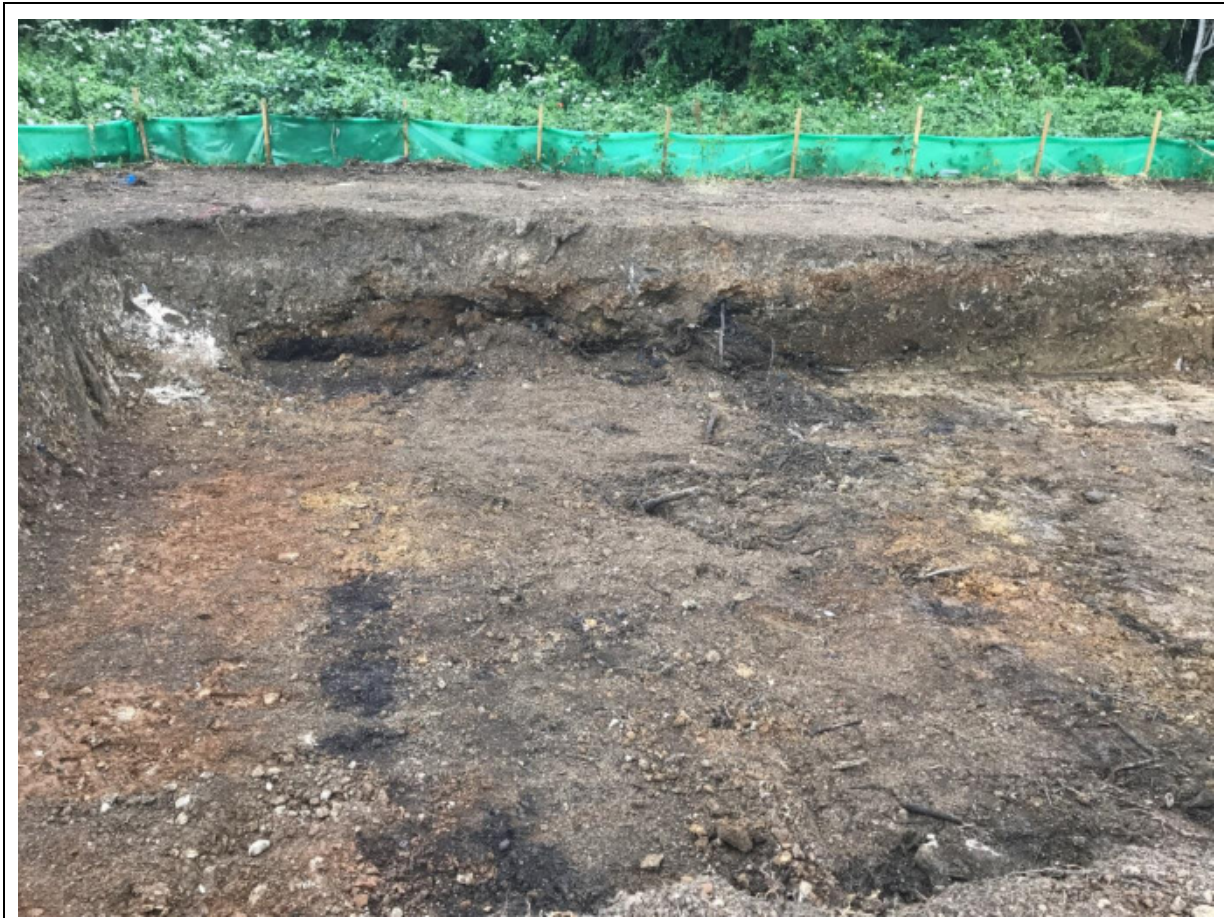
Plate 1: General shot of Modern Ditch 108 in Trench 1, looking south-east.

- 6.1.8 Ditch (108) was aligned north-west to south-east and measured 4.0 m wide and had an overall depth of 1.4 m. It was filled with a loose brown grey silt (107) and contained fragments of wood and barbwire. The ditch was recorded to further truncate a modern disturbance (106) which measured up to 11.0 m in width and over 1.00 m deep within the trench. This was filled with

layers of redeposited chalk and brown silt with modern inclusions including brick, glass and metal (102-105).

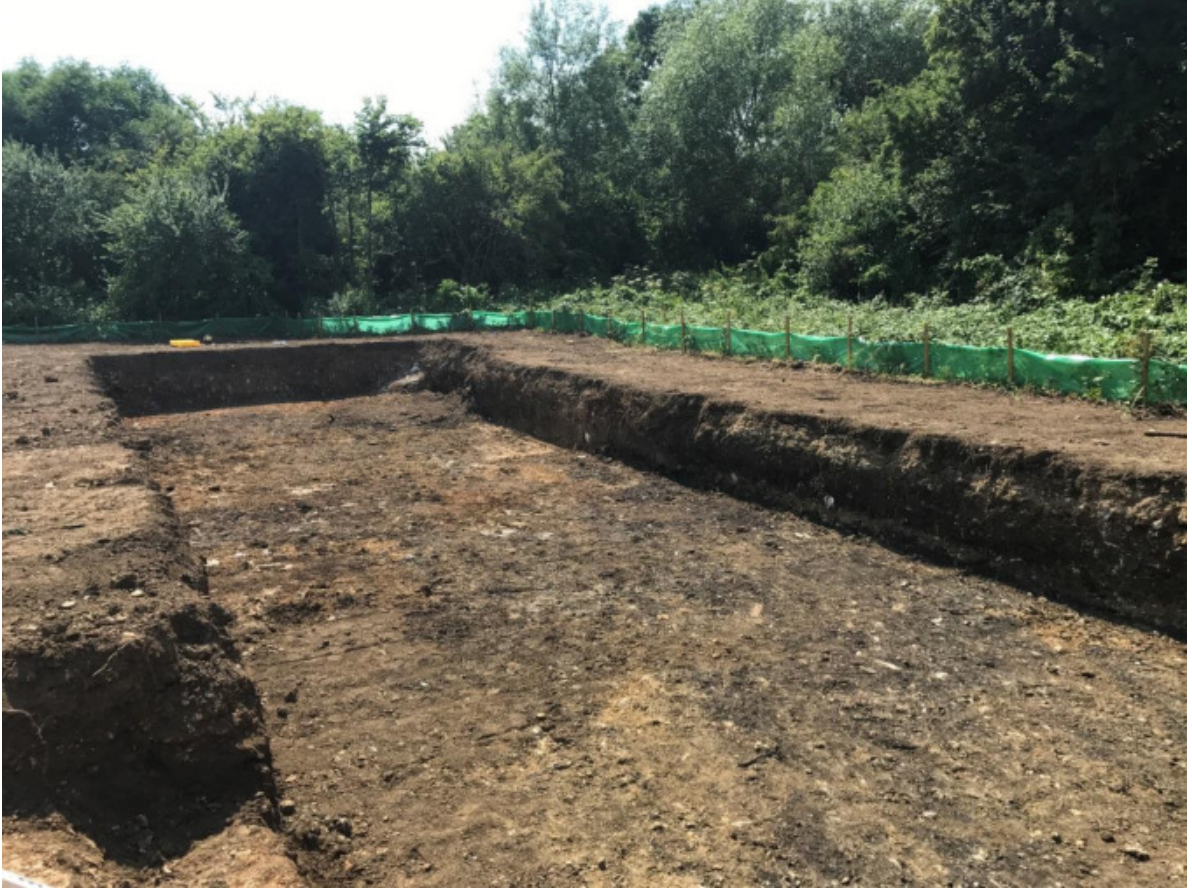
Plate 2: View of Trench 1 (the Switch House), looking south-east.

- 6.1.6 The excavation for Trench 1 (the Switch house) measured 35.0 m in length, 7.0 m wide and 1.3 m deep. The old topsoil (100) horizon within the trench was approximately 0.3 m deep and consisted of mid grey brown clayey silt with modern inclusions. A layer of subsoil (101) was recorded at the north-west corner of the trench which measured 0.20 m thick.

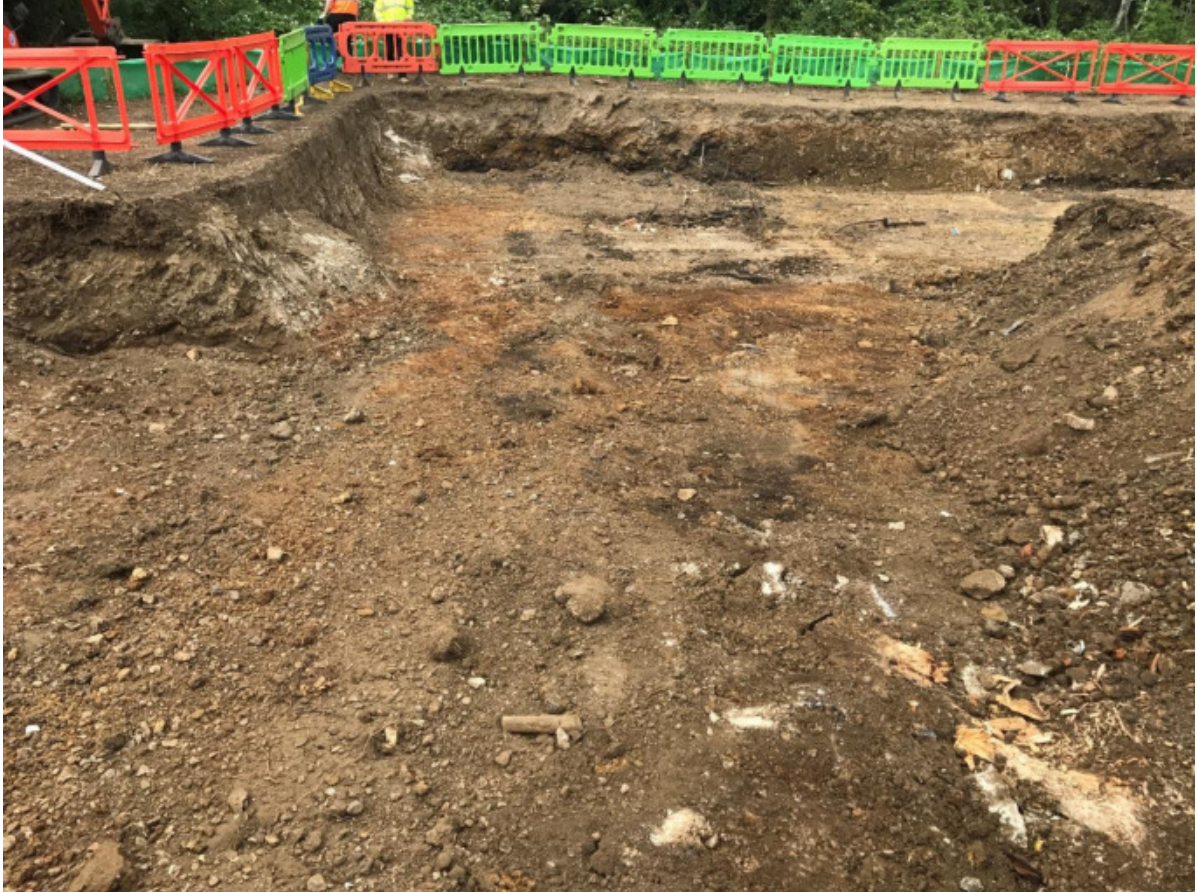
Plate 3: View of the Ditch 108 continuing into Trench 2 (the access road), looking east.

- 6.1.10 The section of Trench 2 (access road) monitored measured 14.5 m in length with a width up to 7.2 m and a depth of 1.3 m.
- 6.1.11 The stratigraphic sequence in this trench comprised 0.30 m topsoil (200) which sealed 1.0 m of made ground deposits consisting of mottled grey brown silt (201) with modern inclusions. The made ground (201) in turn sealed ditch (204) and its fill of grey brown silt (203) which was a continuation of Ditch (108) recorded in trench 1. Ditch (204) in turn was recorded to cut a layer of yellow- brown gravels and silt (202), from which fragments of modern brick were identified.

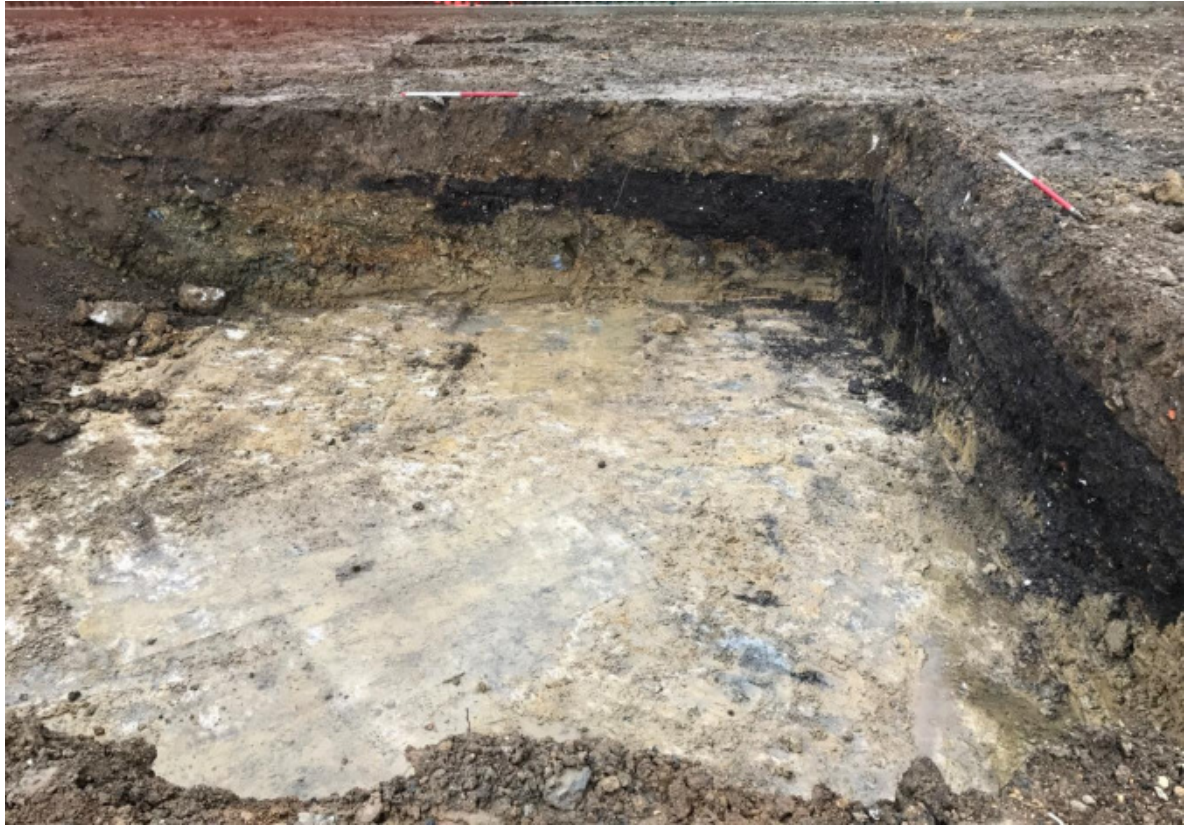
Plate 4: View of the north-east facing section in Trench 4 (Transformer C1MT), looking south-west.

- 6.1.15 Trench 4 (transformer base C1MT) measured 7.0 by 9.0 m with an overall depth of 1.60 m. The stratigraphic sequence in this trench comprised 0.30m Topsoil (400) and 0.4 m of made ground consisting of grey brown silt and gravels (401). This layer sealed a large modern truncation (403) which was filled with a deposit of black silt containing modern debris (402). This modern feature in turn truncated a layer of natural yellow brown clay up to 0.60 m thick (404). This in turn overlay natural bedrock (405) at the base of the trench.
- 6.1.16 No archaeological deposits or finds were identified.

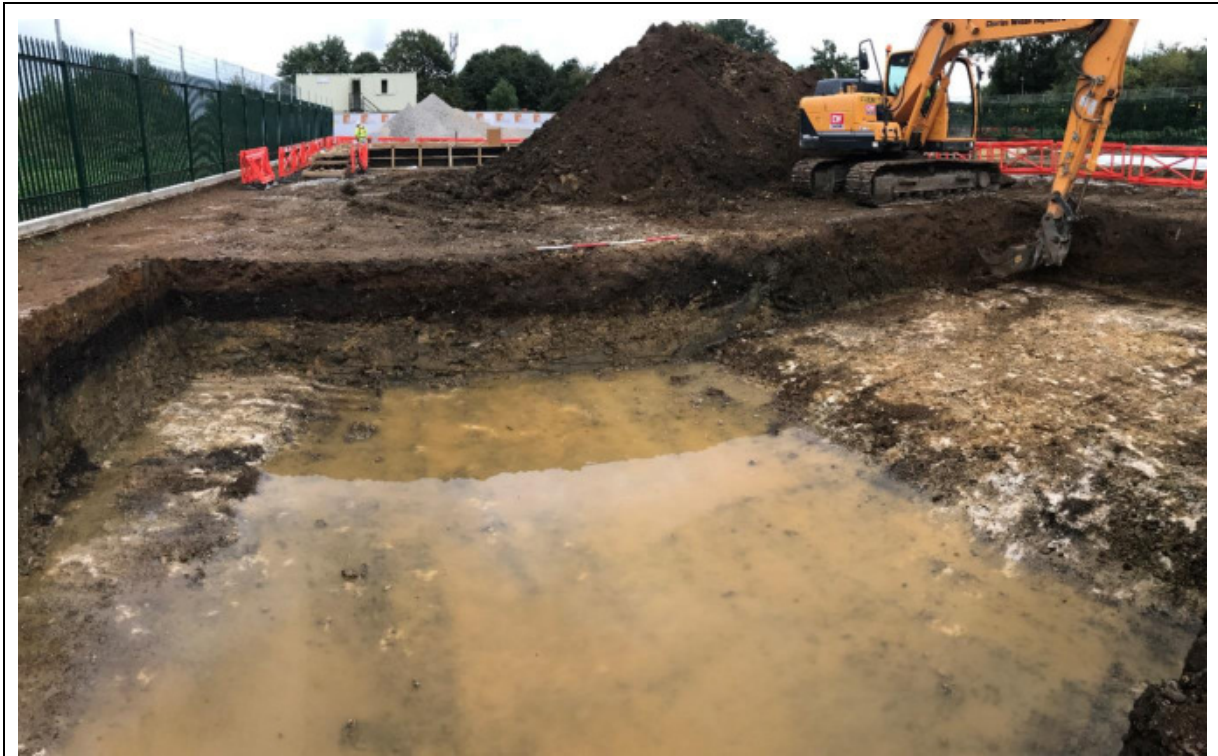
Plate 5: View of excavated Trench 5 (Transformer A1MT), looking east.

- 6.1.17 Trench 5 (transformer base A1MT) measured 15.0 by 7.0 m with a maximum depth of 1.55 m. At the northern end of the trench the stratigraphic sequence comprised 0.35 m of brown silt (topsoil) (500) and 0.20 m black silt (501), both of which contained modern brick, metal and rolls of camera film (Plate 6). The black silt deposit (501) sealed a 1.00 m thick deposit of mottled yellow, blue and grey clays (502) which contained fragments of brick. This mottled yellow, blue and grey clay in turn overlay natural bedrock (505).

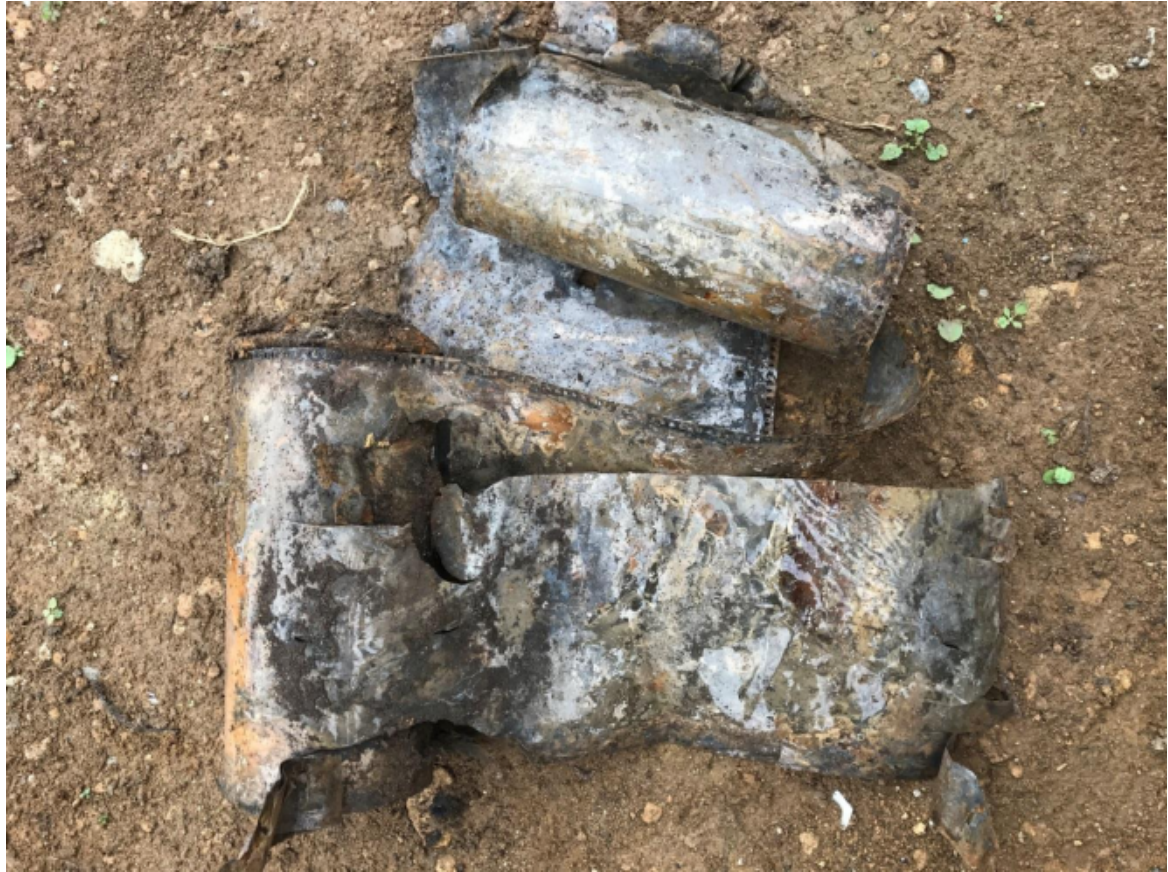
Plate 6: Rolls of aerial photographic film recovered during excavation of Trench 5 (Transformer A1MT).

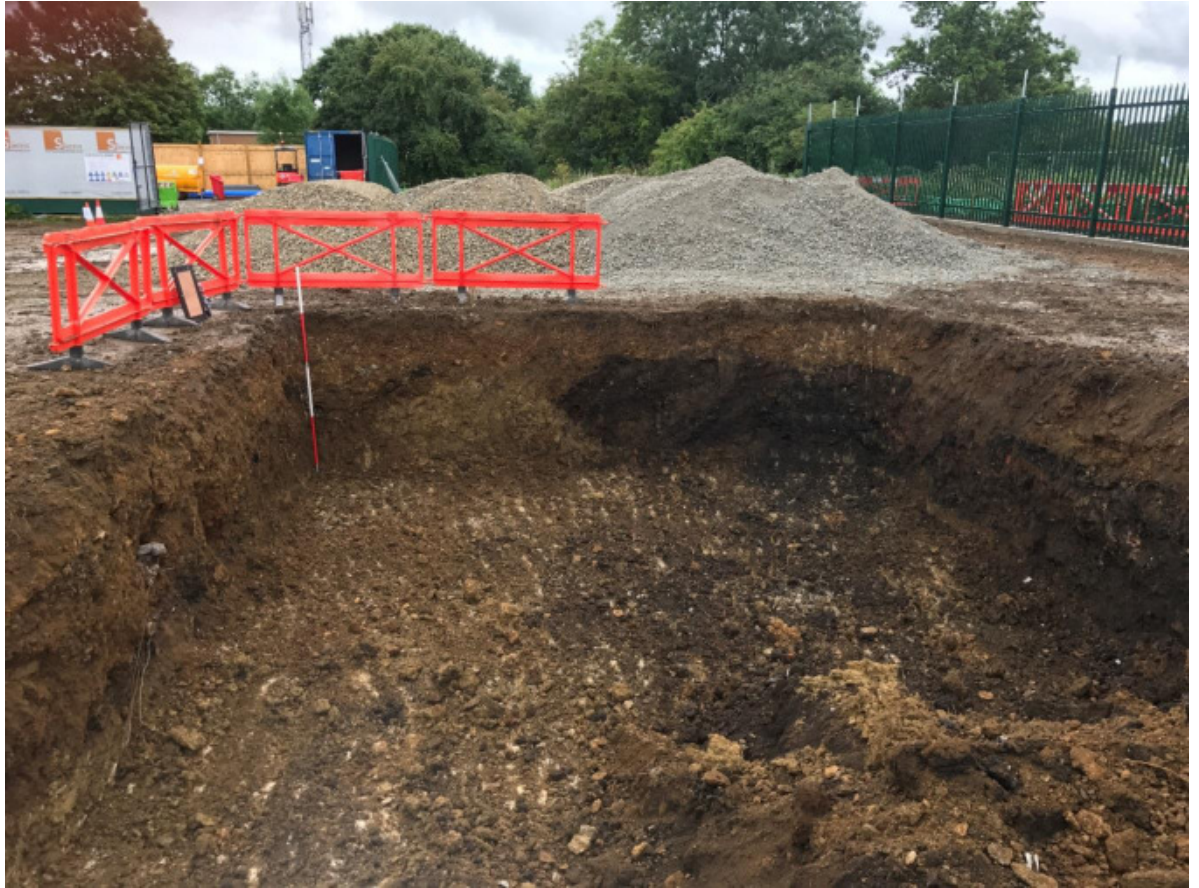
Plate 7: North-west facing section of Trench 6 (Transformer C2MT), looking south-east.

- 6.1.20 Trench 6 (transformer base C2MT) measured 7.0 by 9.0 m with an overall depth of 1.60 m. The stratigraphic sequence within the trench comprised 0.1 m topsoil (600) overlaying 0.4 m brown silt subsoil (601). The subsoil layer sealed a large modern feature (603) which measured up to 9.0 m in width and was 1.0 m deep and filled with a black silt (602). The subsoil also sealed another large truncation (605) which measured 8.5 m in width and was 1.0 m deep and filled with mottled brown and yellow silt and gravels (604).
- 6.1.21 A small section of undisturbed natural geology (606) was recorded to have been cut by features (603) and (605) however no relationship could be identified between these two features.

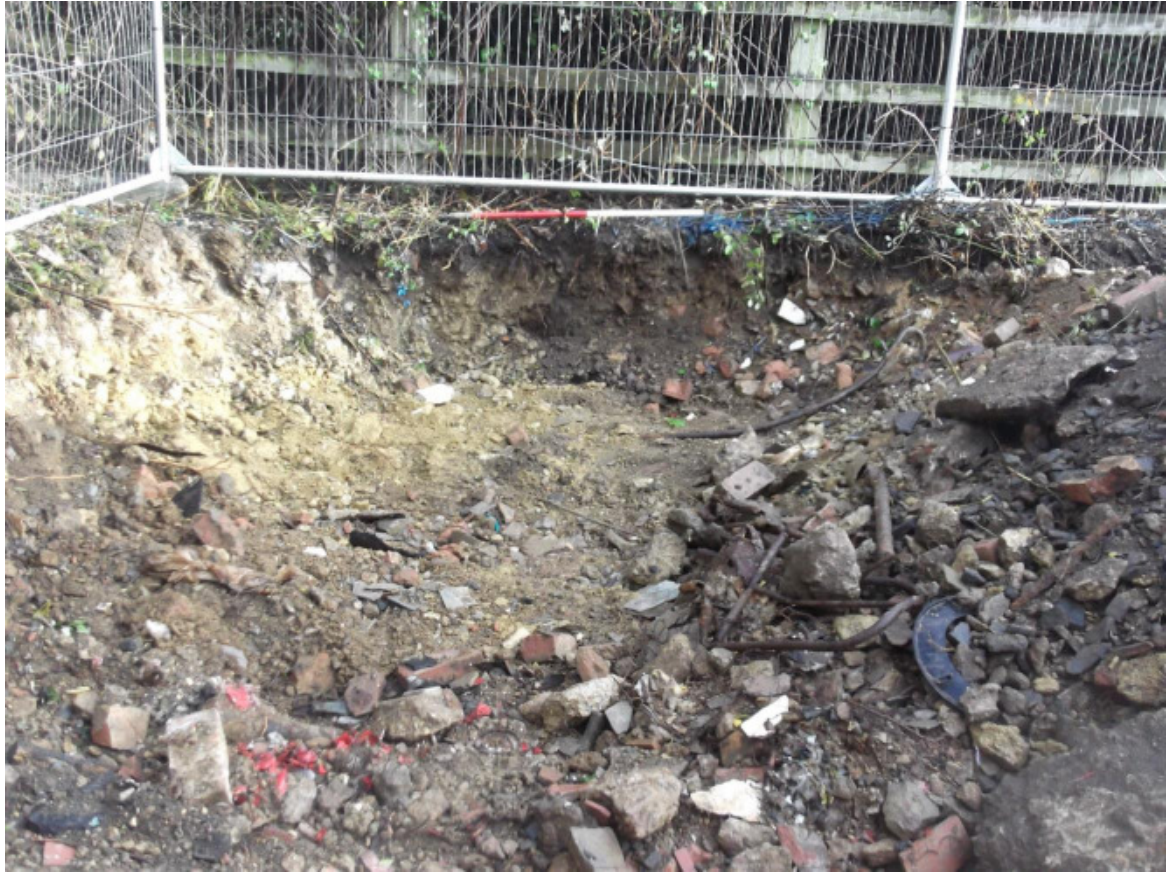
Plate 8: South-west facing section of Trench 7 (Cess Pit North-West of Access Road), looking north-east.

- 6.1.22 Trench 7 (cess pit located north-west of access road) measured 6.60 m by 2.80 m with an overall depth of 0.60 m. The stratigraphic sequence within the trench comprised 0.08 m of topsoil (700)

overlying a substantial mixed deposit of made ground (701) measuring at least 0.52 m thick. Excavation of Trench 7 was abandoned when asbestos containing materials were identified within the made ground (701).

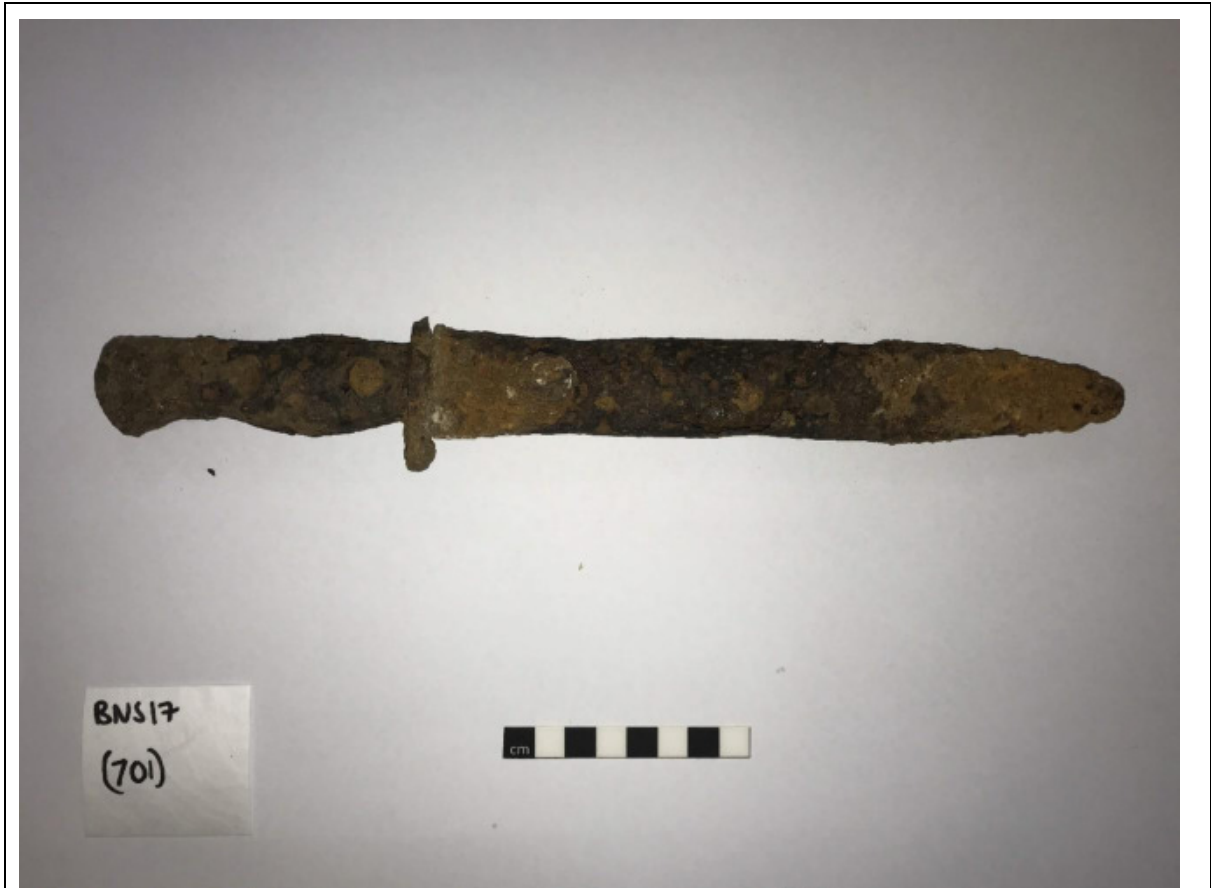
Plate 9: Bayonet recovered during excavation of Trench 7 (Cess Pit North-West of Access Road).

- 6.1.23 A bayonet was recovered from the made ground (701) in this trench. A detailed summary of this artefact can be found in Appendix B.

The bayonet is set in a 0.22 m long sheath and measures 0.32 m from handle to the tip of the sheath and weighs 400 g. The handle is set with two screws and the guard of the bayonet is broken on one side. All aspects of the bayonet including the blade, sheath and handle are heavily corroded. There is damage to the centre portion on one side of the sheath and the barrel ring has broken off, but both elements are otherwise in a good overall condition. The blade cannot be fully removed from the sheath due to corrosion resulting in difficulty identifying the date and type of the bayonet.

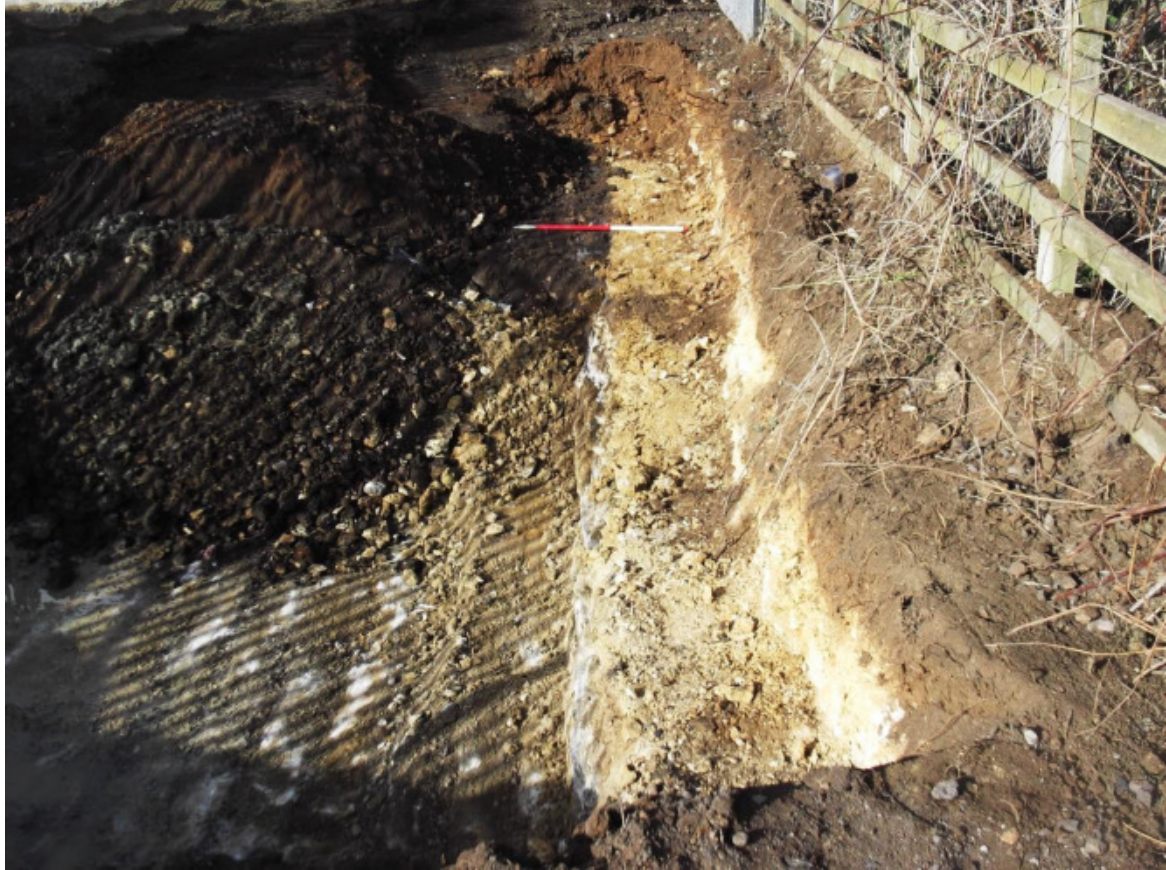
Plate 10: View of Trench 8 (Cess Pit South-East of Access Road) showing partial machine excavation of Modern truncation 802, looking north-west.

- 6.1.24 Trench 8 (cess pit located south-east of access road) measured 9.90 m by 6.60 m with an overall monitored depth of 2.08 m. The trench was excavated to a maximum depth of 3-3.50 m, although archaeological monitoring was stopped once bedrock was exposed at 1.63 m below ground level. The stratigraphic sequence within the trench comprised a substantial modern truncation (802) cutting undisturbed subsoil (800). This truncation measured 5.84 m wide and 1.63 m deep and was filled with a mixed deposit of made ground (801), the full extent of the truncation was not observed. A narrow band of undisturbed subsoil (800) overlying natural geology (803) was observed along the north-east extent of the trench.
