Archaeological Monitoring and Recording Report: Repair and Maintenance Works: 34 Burge Court and Hanover Court, Cirencester

Date: February 2018

RSK ADAS Limited
11D Park House
Milton Park
Abingdon
OX14 4RS
Tel. no: 01235 355638

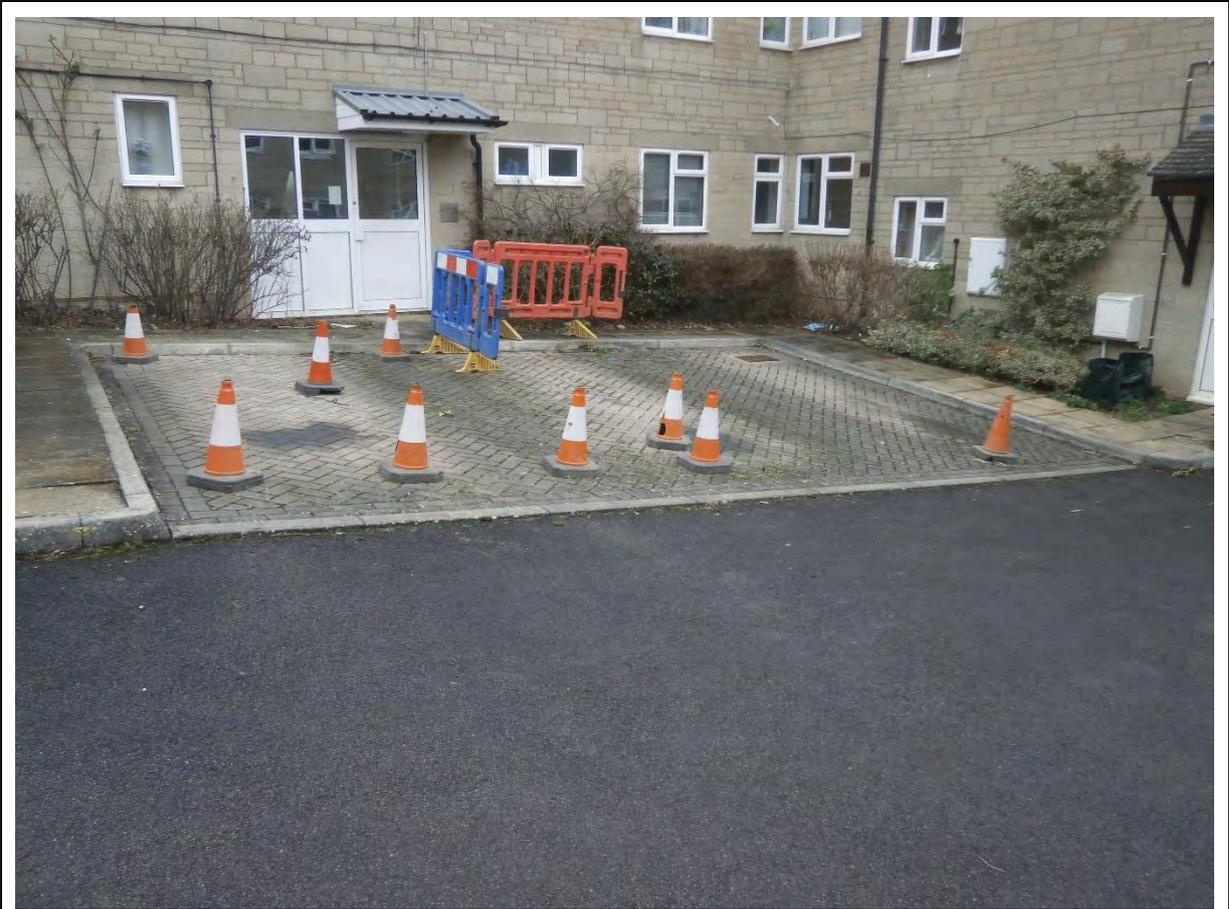
6.1.3 Trench 1 was an irregularly shaped hexagonal trench measuring approximately 1.60 m by 1.20 m across. Each side measured 0.60 m by 1 m by 0.90 m by 0.70 m by 1.10 m and was located within the residential car park of modern flats (See Plate 1).

Plate 1: General view of No. 34 Burge Court prior to excavation looking north.

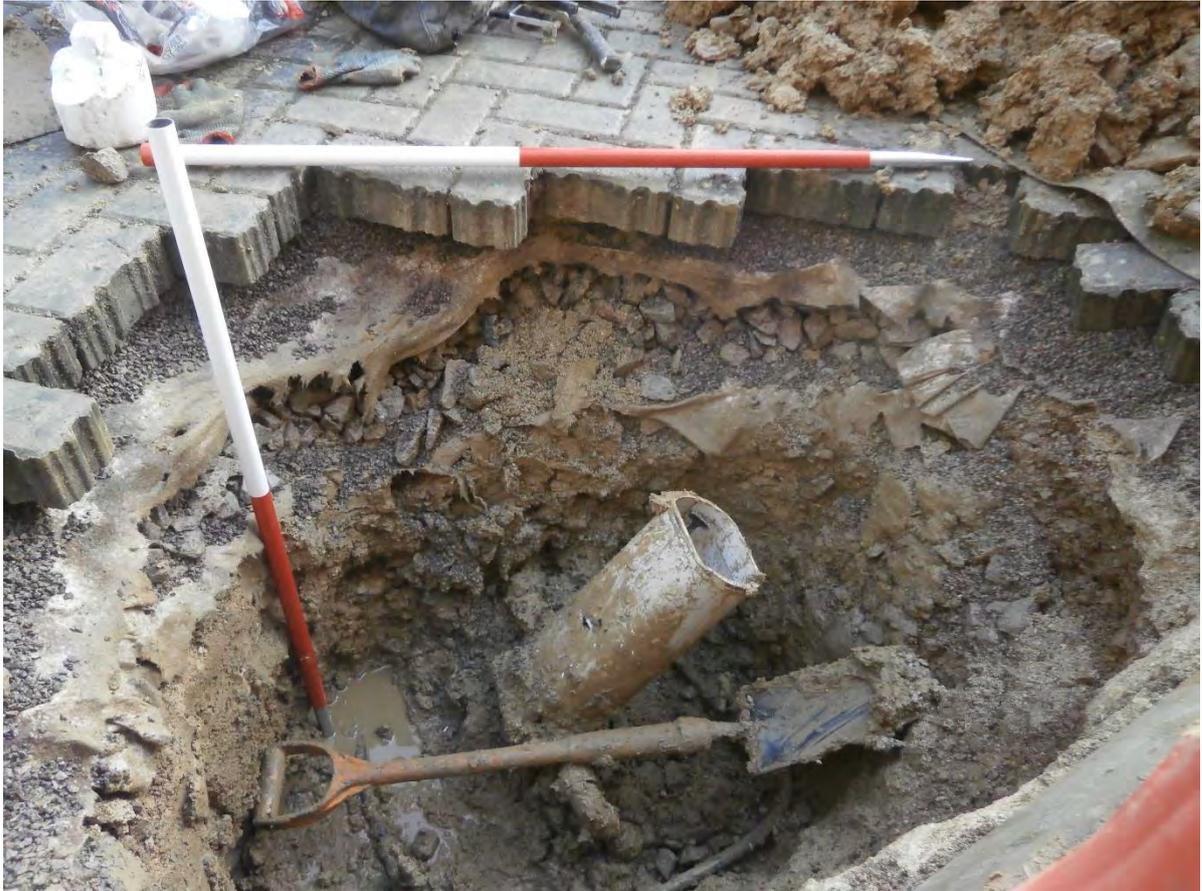
6.1.4 The modern car park surface consisted of modern inter-locking bricks (1001) 70 mm thick which overlay 60 mm of grey pea-gravel (1002). A layer of felt matting (1003) had then been laid down over 160 mm of Type 1 hardcore crush (1004). A second layer of felt matting (1005) had been laid down separating layer (1004) from 700 mm plus of reddish brown silty clay gravels with Type 1 stones mixed in throughout (1006) and contained modern plastic pipework and three stop taps (Plate 2).

6.1.5 This layer was interpreted as redeposited natural gravels described in borehole data (SP00SW39/D- Cotswold DC Offices BH1) mixed with Type 1 hardcore. This deposit would have filled a construction cut [1007] for the modern water service which was not visible in any side of Trench 1.

Plate 2: View of Trench 1 at No. 34 Burge Court showing made ground layers and existing stop tap looking south.

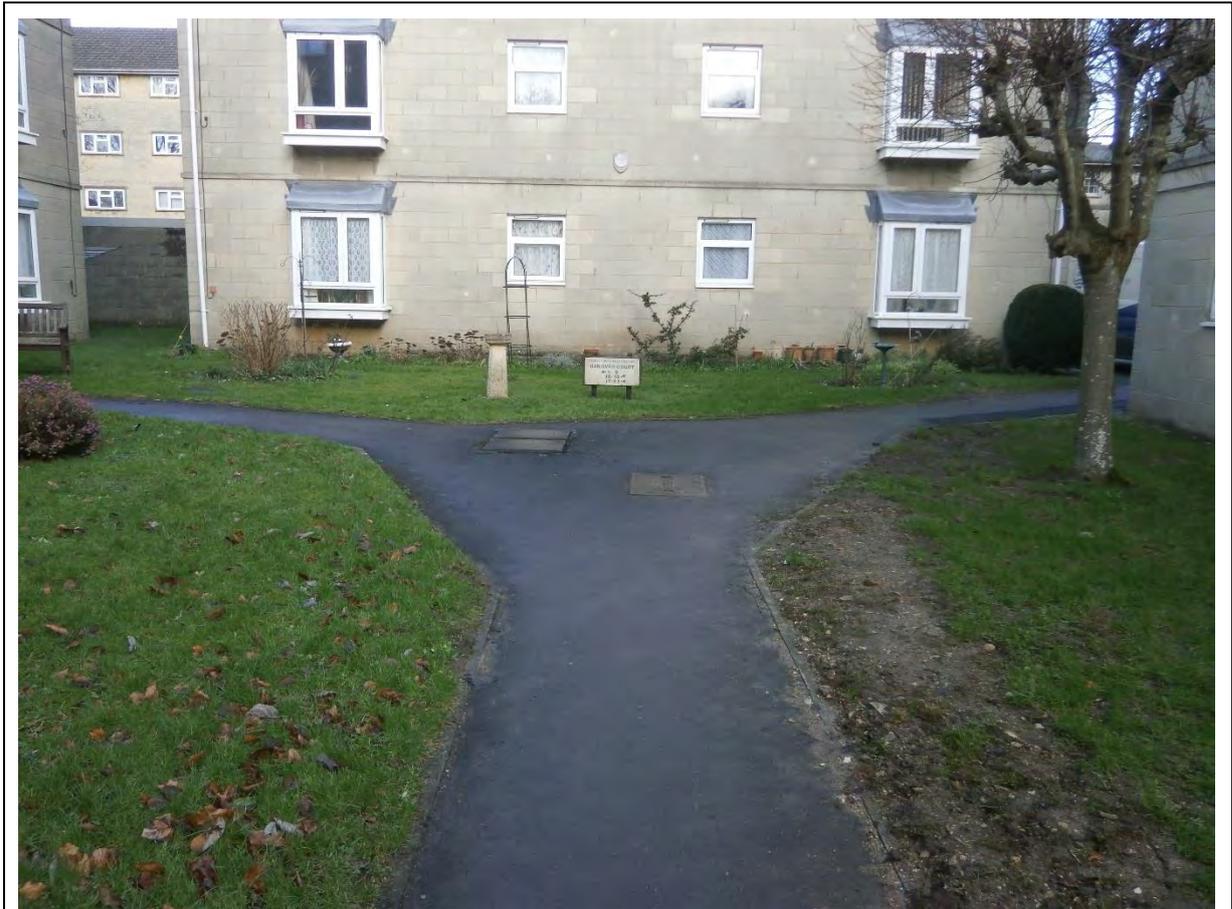
6.1.7 Trench 2 was rectangular in plan and measured 1.50 m by 1 m in size. The trench was located at the meeting point of three pedestrian walkways within the Hanover Court residential complex (Plate 3).

Plate 3: View looking north at Hanover Court prior to excavation.

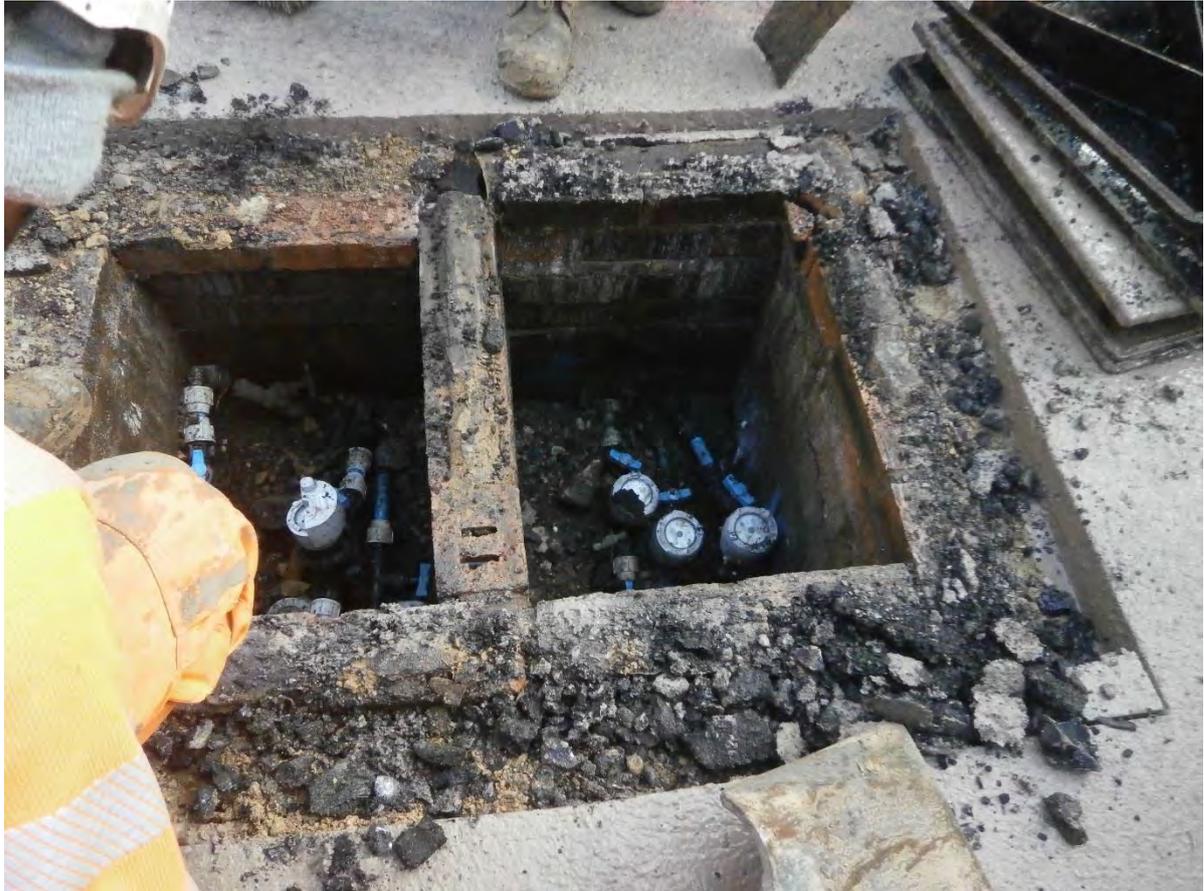
6.1.8 The groundworks consisted of cutting and removing the modern tarmac (2001) which was 0.10 m deep exposing a twin chambered brick built inspection pit (2002) containing two water meters. Each chamber measured 0.60 m by 0.45 m and was 0.60 m deep. The inspection pit sat within cut [2004] which, although it could not be clearly seen in plan, cut into made ground (2003) (Plates 4 and 5).

Plate 4: View of Trench 2 during the removal of the modern tarmac (2001) exposing the modern brick built twin chambered inspection pit (2002) looking west.

6.1.9 The existing steel inspection plates and the upper most course of bricks from the inspection pit were removed and replaced with two new steel inspection plates. No further works were carried out at that location.

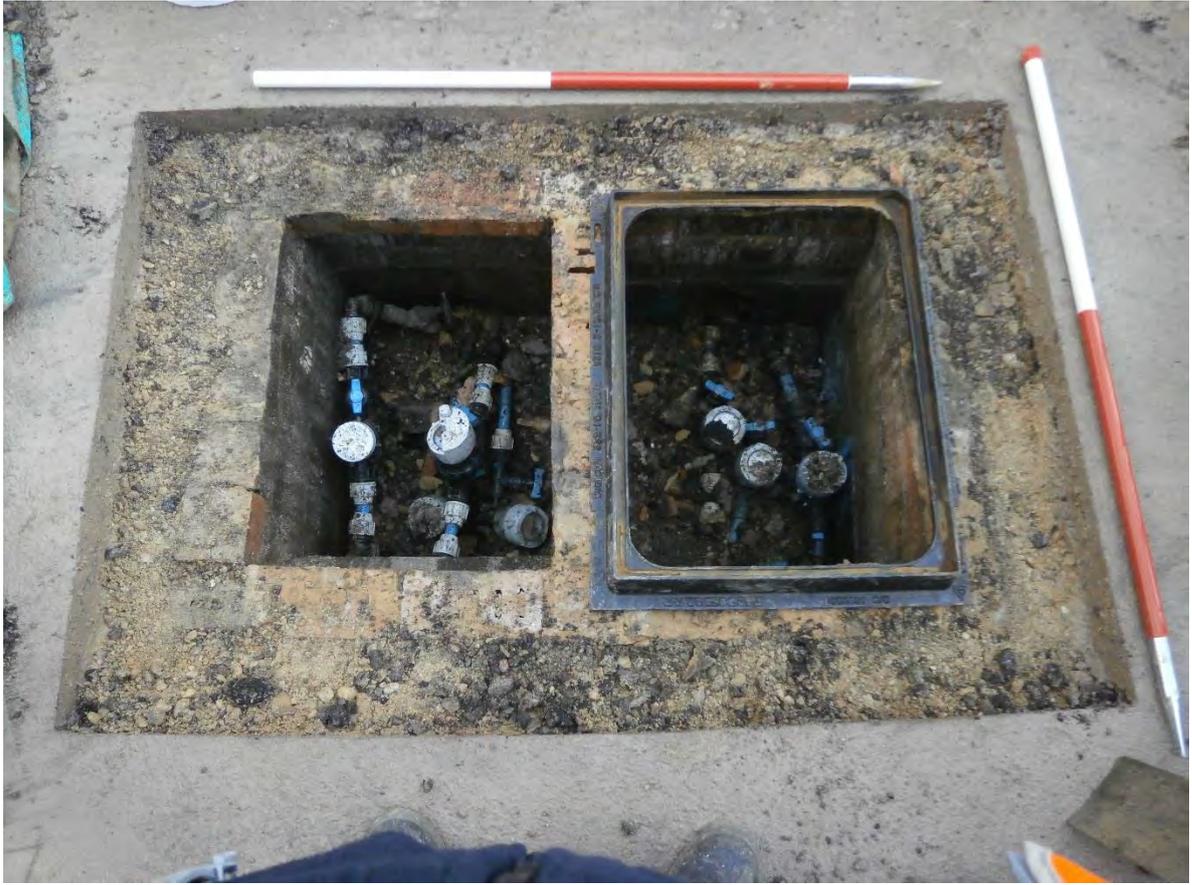
Plate 5: View of Trench 2 showing the modern brick inspection chamber (2002) and surrounding made ground (2003) following removal of the tarmac surface (2001).

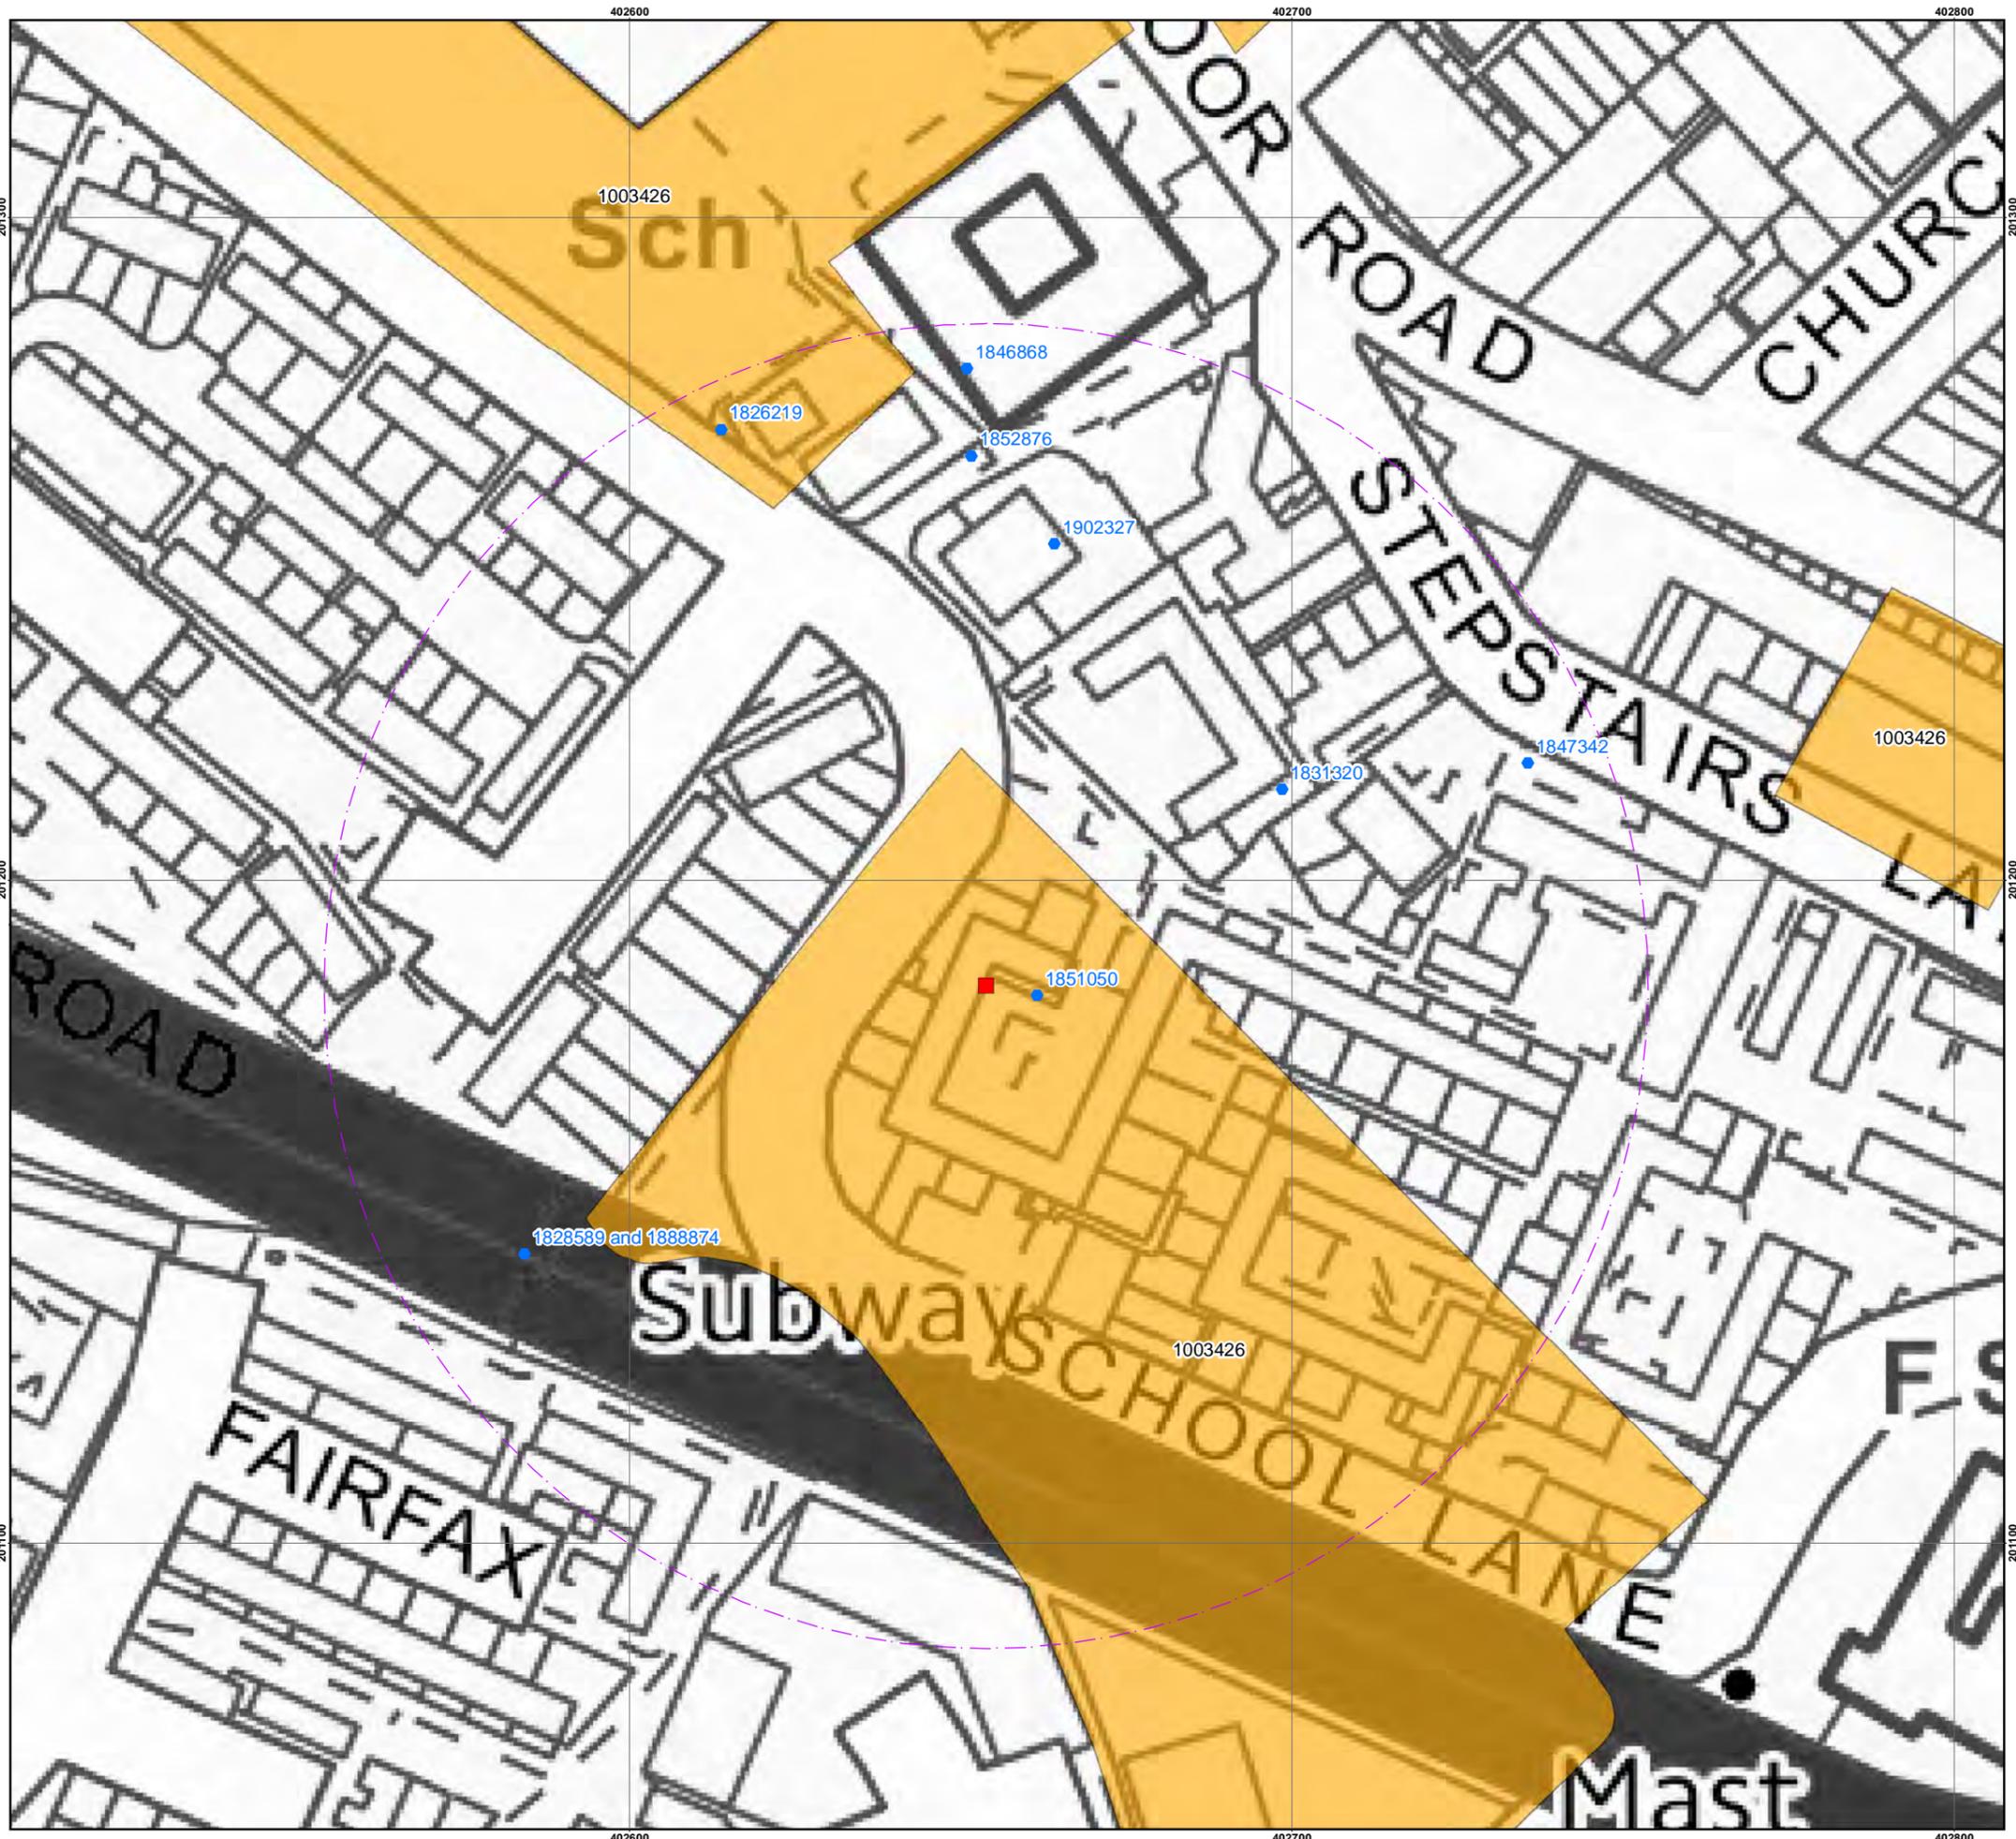
Figure 2: Recorded Heritage Assets and Previous Archaeological Investigations in the Burge Court Study Area

- Location of Trench 1 at 34 Burge Court
- Study Area
- Corinium Roman Town Scheduled Monument
- Burge Court NMR Excavations

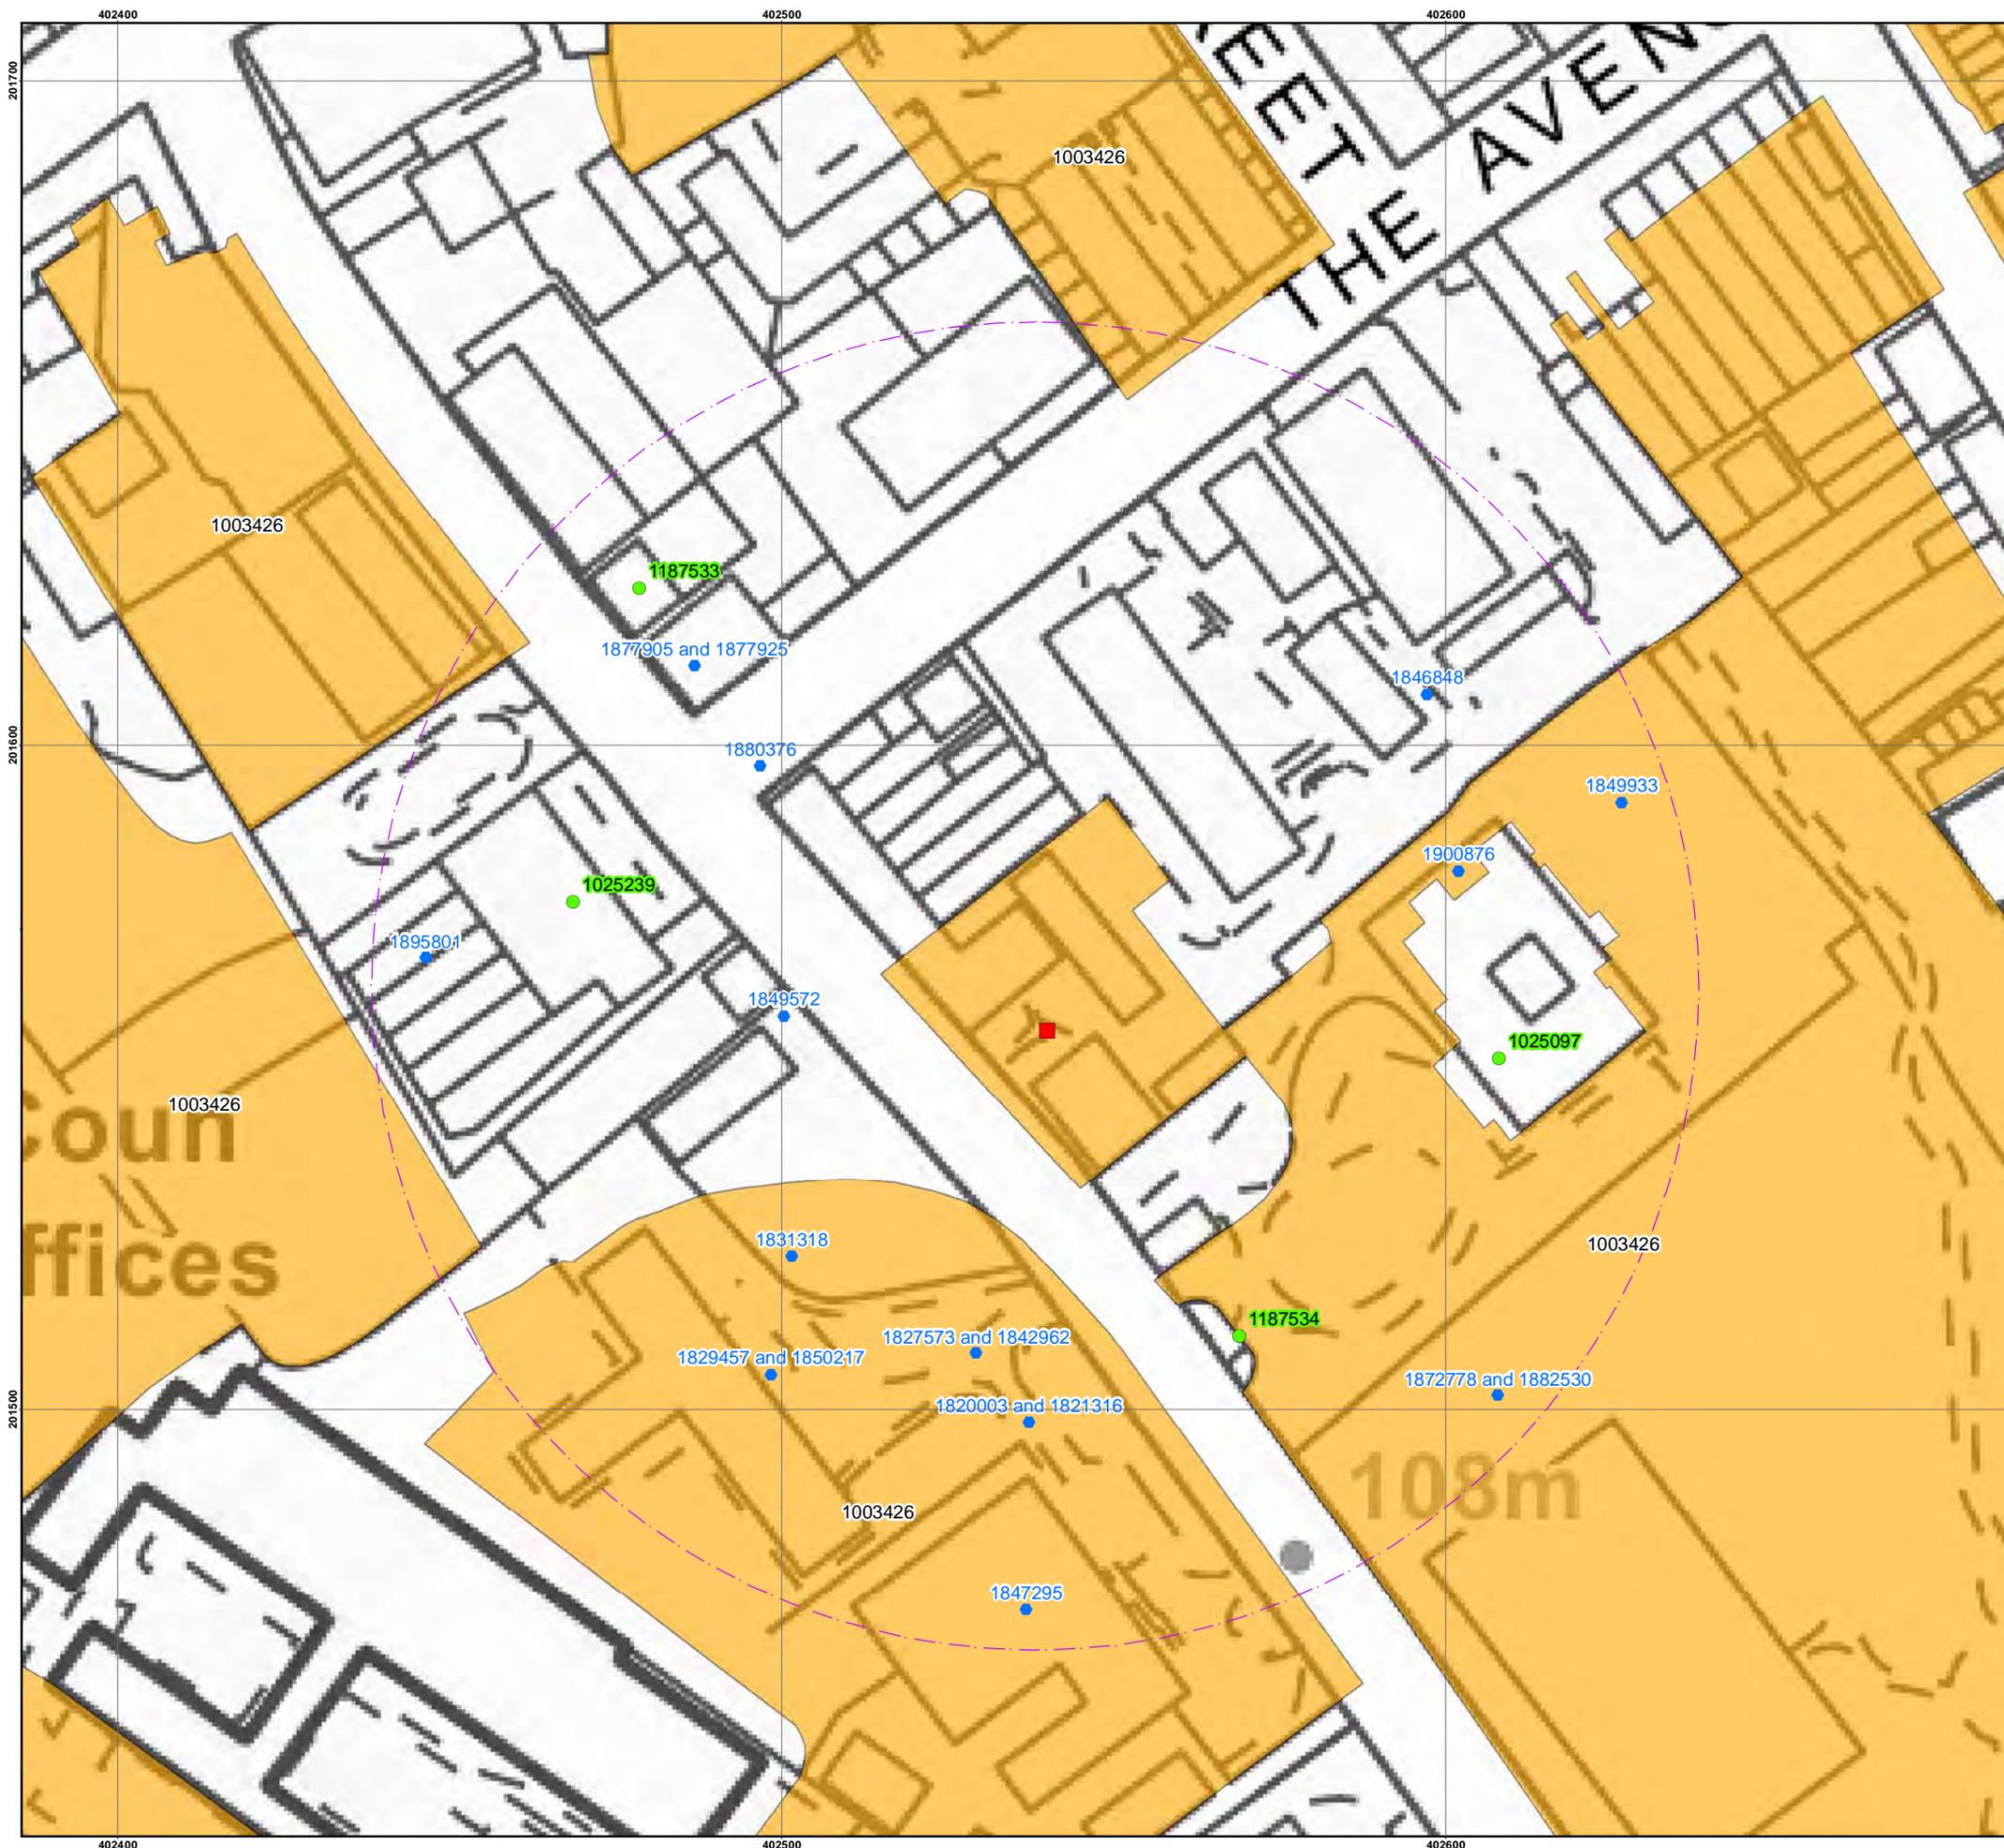
Figure 3: Recorded Heritage Assets and Previous Archaeological Investigations in the Hanover Court Study Area

- Location of Trench 2 at Hanover Court
- Study Area
- Corinium Roman Town Scheduled Monument
- Grade II Listed Buildings
- Hannover Court NMR Excavations
