Report

Archaeological Monitoring and Recording Report: Repair and Maintenance Works: No 113 High Street, Avebury, Wiltshire

Date: April 2018

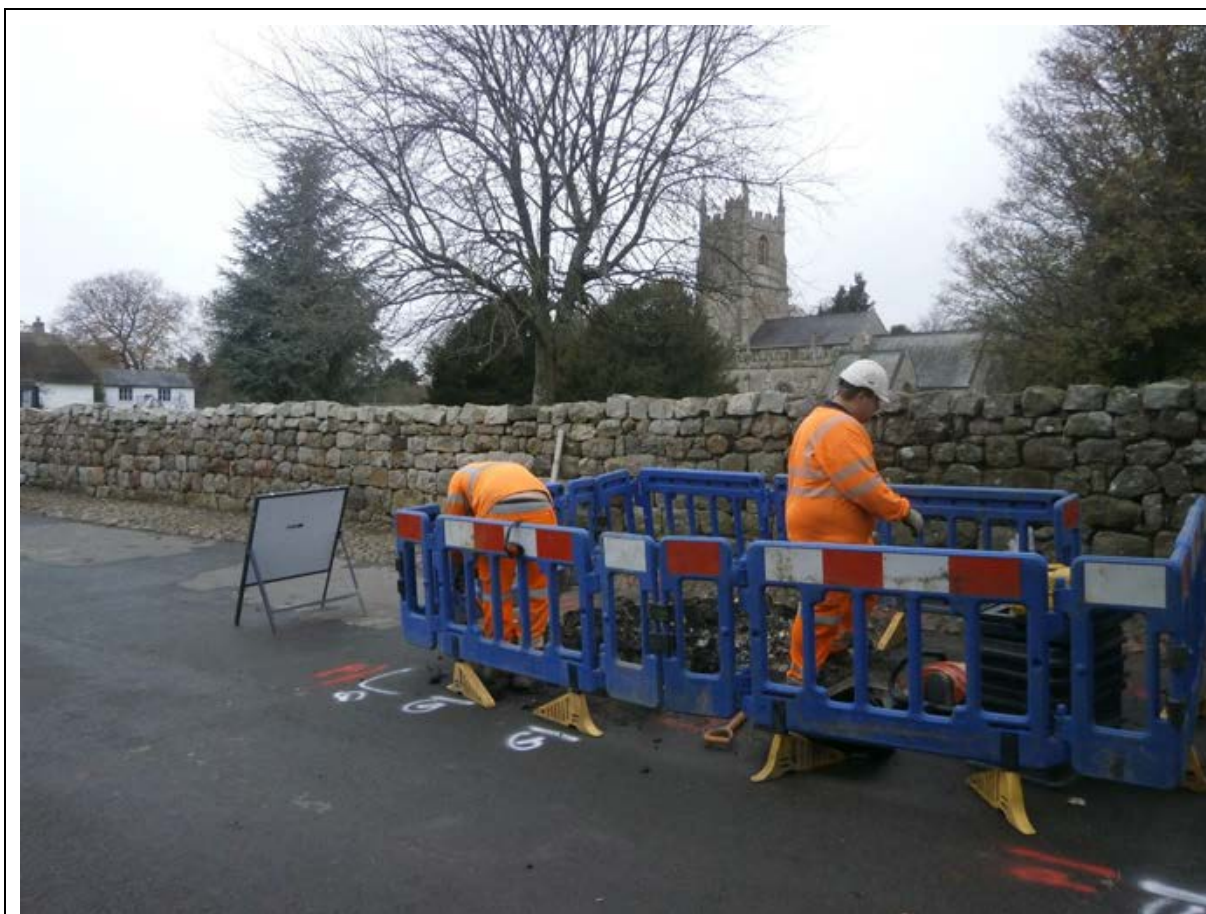
Plate 1: General view of the location of Trench 1 outside St James' Churchyard prior to excavation, looking north-west.

- 6.1.3 Trench 1 was a rectangular trench measuring approximately 1.50 m by 0.9 m and was approximately 0.90 m deep. The trench was located within the existing carriageway of High Street, Avebury between the Grade II Listed Lychgate for St James' Churchyard (1033764) and the Grade II Listed Gates and Gate Posts for Avebury Manor (1286327) (See Plate 1).

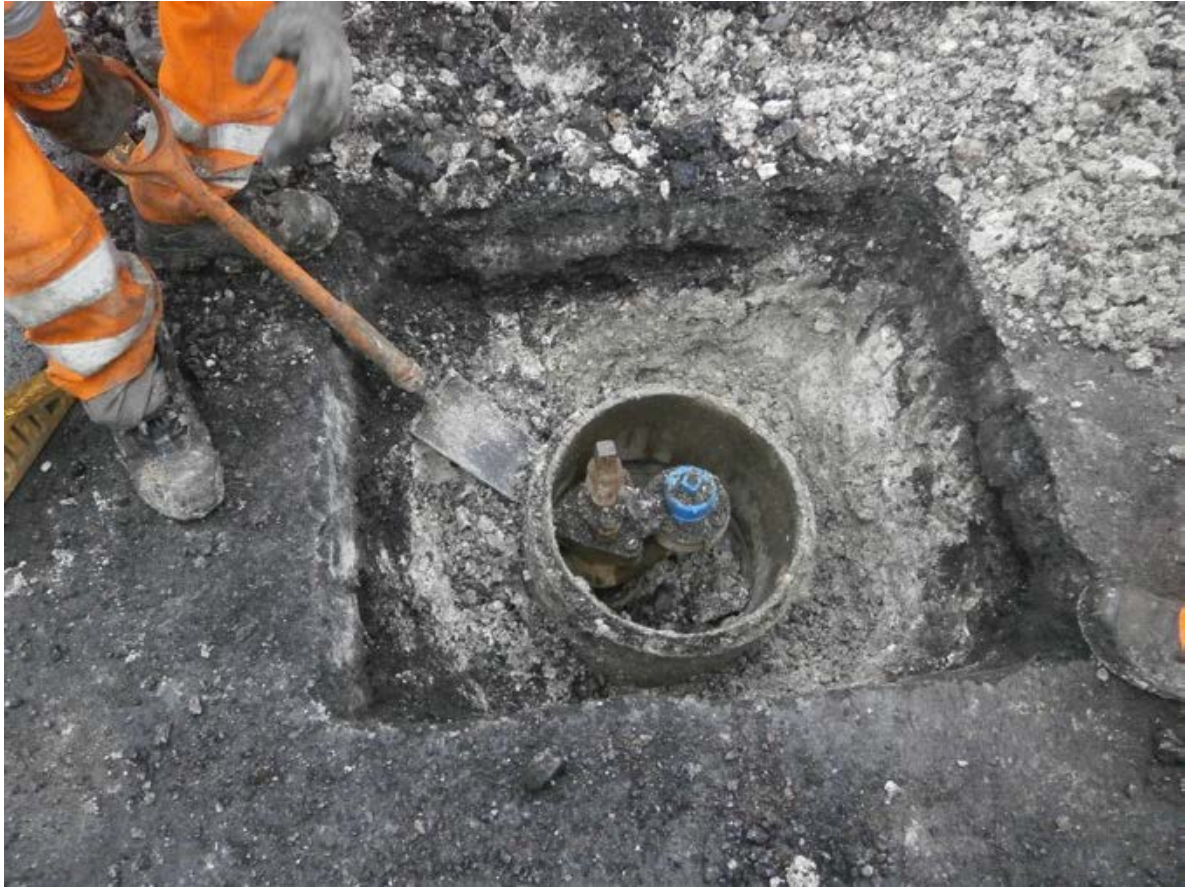
- 6.1.4 The modern road surface consisted of modern tarmac (1001) 0.14 m thick which overlay another 0.14 m of dark grey stone crush (1002). This overlay 0.9 m of compact mixed whitish grey re-deposited chalk and soil (1003) which contained a modern concrete chamber (1004). This chamber enclosed the modern water hydrant (1005) (Plate 2).

Plate 2: View of Trench 1 showing the modern concrete chamber (1004) and existing water hydrant (1005).

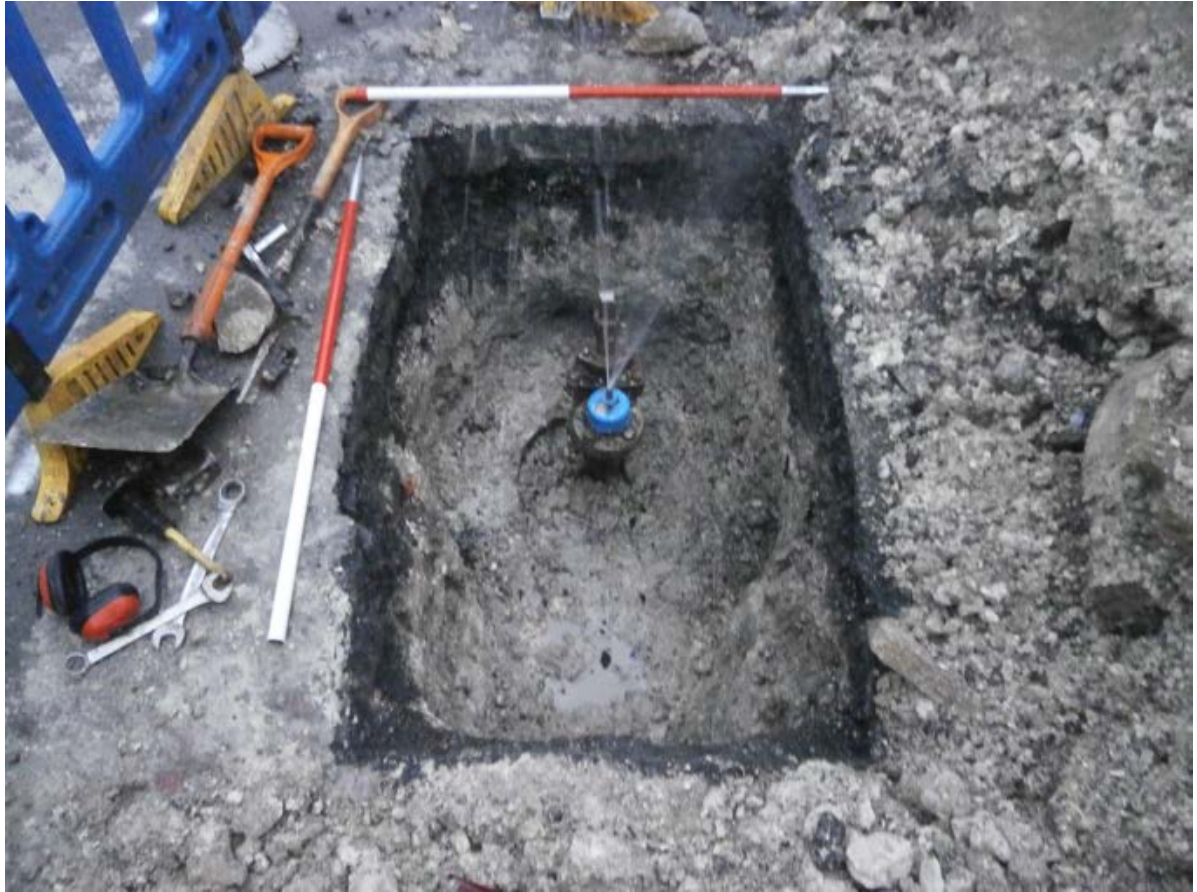
- 6.1.5 This chalk fill (1003) was interpreted as redeposited chalk. This deposit would have filled a construction cut [1006] for the modern water service cutting into the natural chalk (1007) which was not visible in any side of Trench 1 (Plate 3).

Plate 3: View of Trench 1 showing the existing water hydrant (1005), looking west.

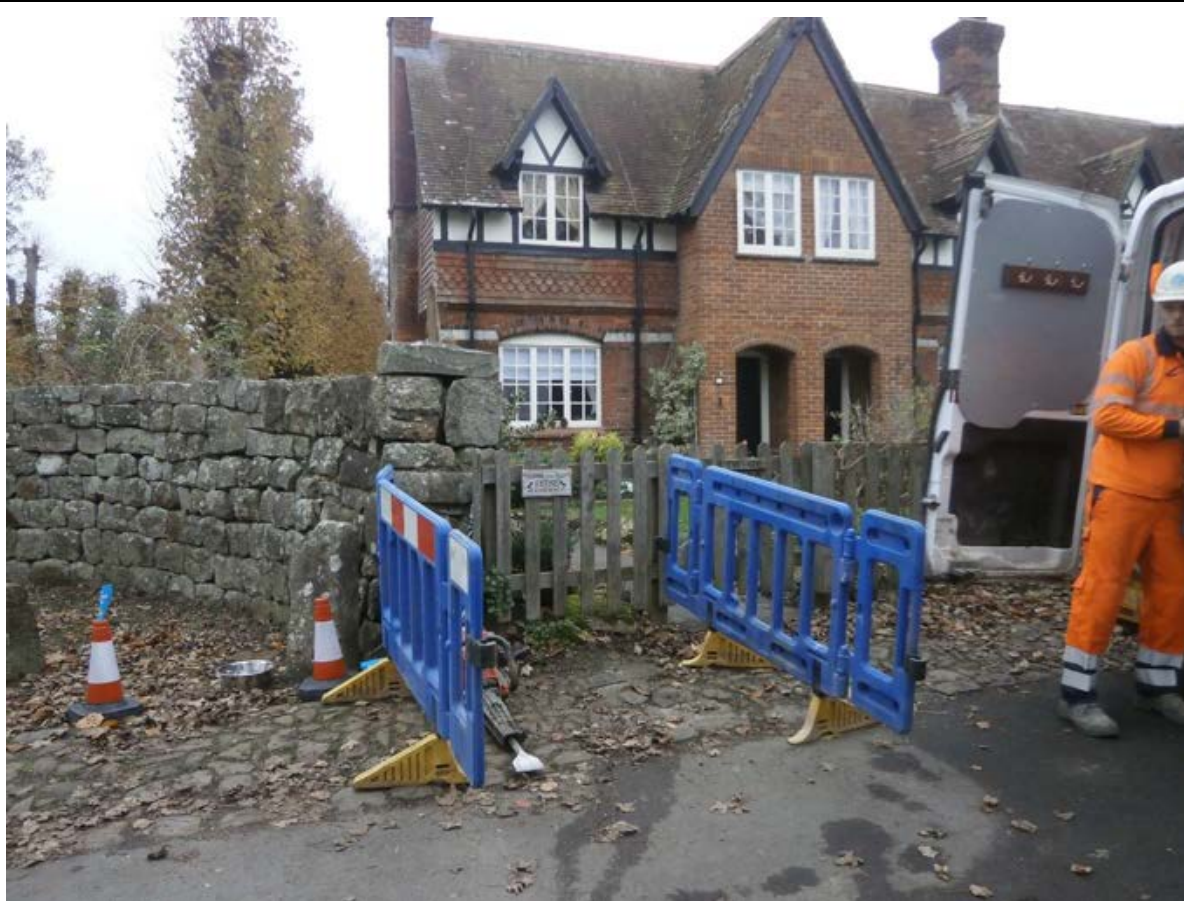
- 6.1.8 The groundworks consisted of cutting and removing the modern cobbled surface (2001) which was approximately 0.05 m deep and sealed a layer 0.15 m thick which consisted of a mid-brownish grey silty, sandy gravel (2002). This layer was interpreted as modern made ground forming a base layer for the modern footpath (Plates 4 and 5).

Plate 4: View of the location of Trench 2 outside No. 113 High Street prior to excavation, looking north.

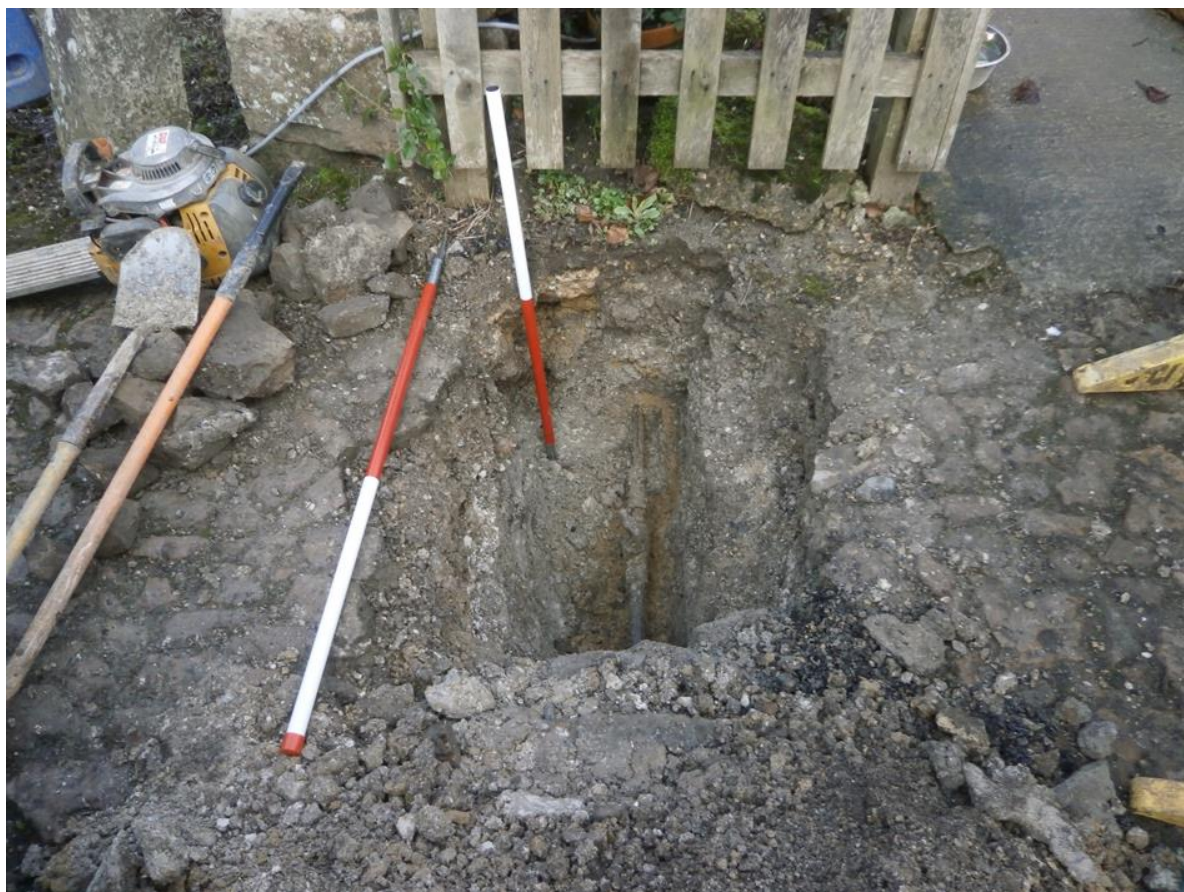
- 6.1.9 This make-up layer sealed a cut [2003] which, although not clearly visible, contained a modern water pipe (2004) and BT telecommunications pipe (2005). This was filled by a mixed dark brownish-grey silt and re-deposited chalk fill (2006). This water pipe cut into re-deposited chalk (2007).

Plate 5: South-facing section of Trench 2 showing cut [1005], water pipe (1004) and fill (1003).
