Archaeological Monitoring and Recording Report: Clean Water Connection at Southway House, South Way Cirencester

Date: June 2018

In May 2018 ADAS carried out an archaeological watching brief for Kier Integrated Services and Clancy Docwra (KCD) of groundworks for a planned clean water connection works to an existing water main located outside Southway House, South Way, Cirencester (NGR: SP 02464 01841) (Figure 1).

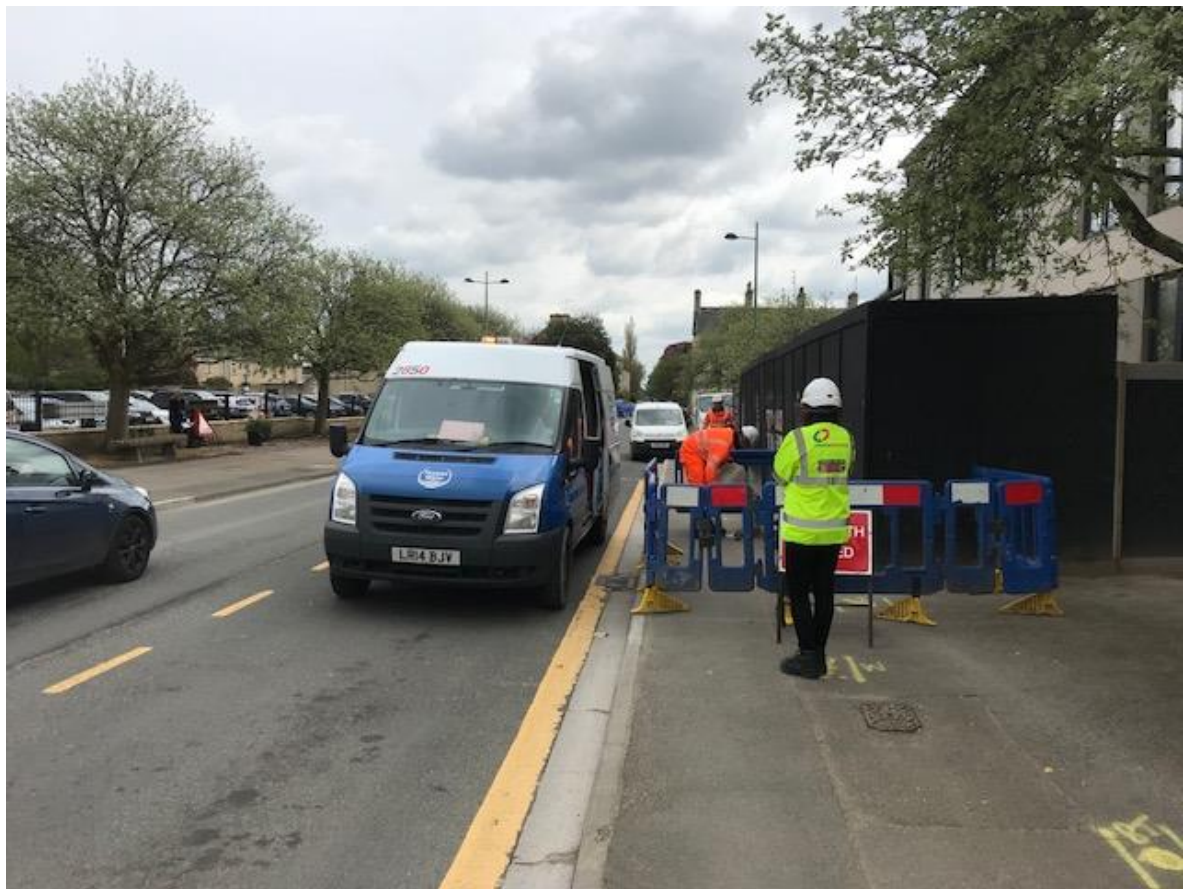
Plate 1: General view of Southway looking, south-east towards the proposed works.

- 6.1.3 Trench 1 measured approximately 6.20 m by 0.40 m wide with a joint bay at each end. It was located on the existing pedestrian footpath along South Way directly outside Southway House (See Plate 1 and 5). The joint bay at the south-western end measured 1.50 m by 1 m and the joint bay at the north-western end measure 1.30 m by 1 m. The whole trench was approximately 0.80 m deep.

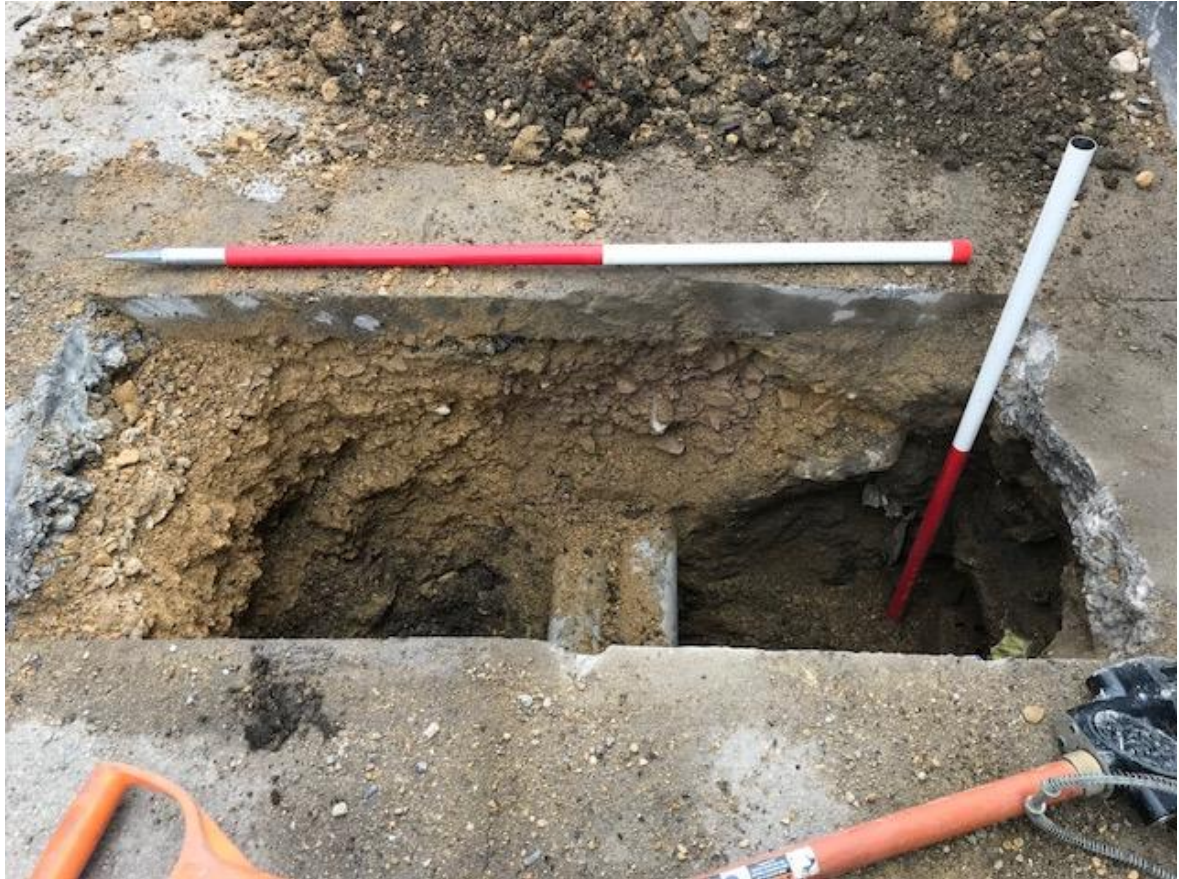
- 6.1.4 The modern tarmac surface (1001) of the pavement was 0.10 m thick and overlay approximately 0.60 to 1 m of yellow sandy gravel made ground (1002). This made ground was cut by pipe trench cuts [1004] and [1006]. The yellow sandy gravel was approximately 0.60 m at the western side of the trench and sloped down to a depth of approximately 1 m on the eastern side (Plate 2).

- 6.1.5 Cut [1004] was approximately 0.40 m wide by 0.60 m deep and more than 6.20 m in length. The cut was filled by type 1 greyish pink gravel (1003), which contained four modern plastic BT line ducts.

Plate 2: View of the north-west facing section of Trench 1 showing pipe cut [1004] and disturbed ground (1002) looking south-east.

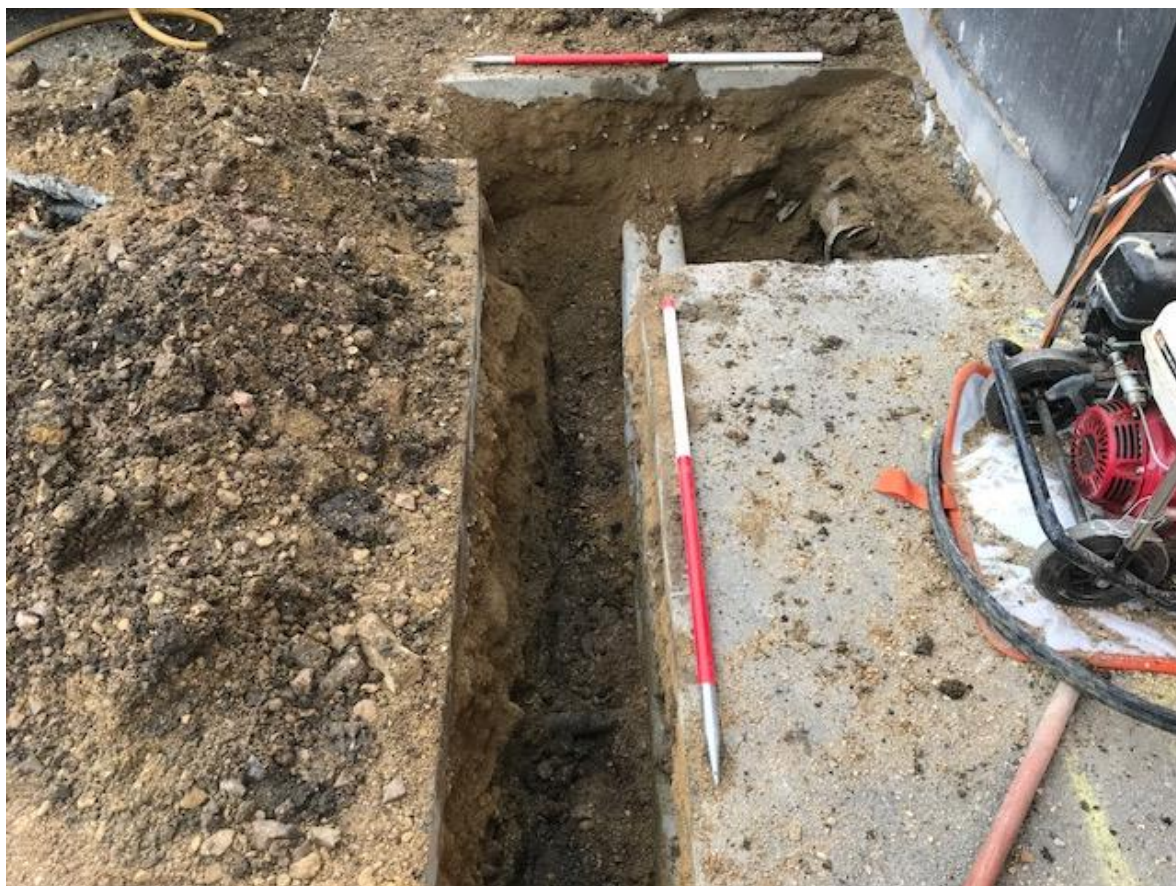
- 6.1.6 Cut [1006] was not clearly observed within the trench sides and was only exposed when the south-eastern side of the trench was extended beneath hoarding to connect to a modern residential development. However, it contained a single fill of mixed gravel and soil (1005) approximately 0.40 m deep which contained a modern 11kV high voltage electricity cable (Plates 3 and 4).

Plate 3: General view of Trench 1, looking south-east.

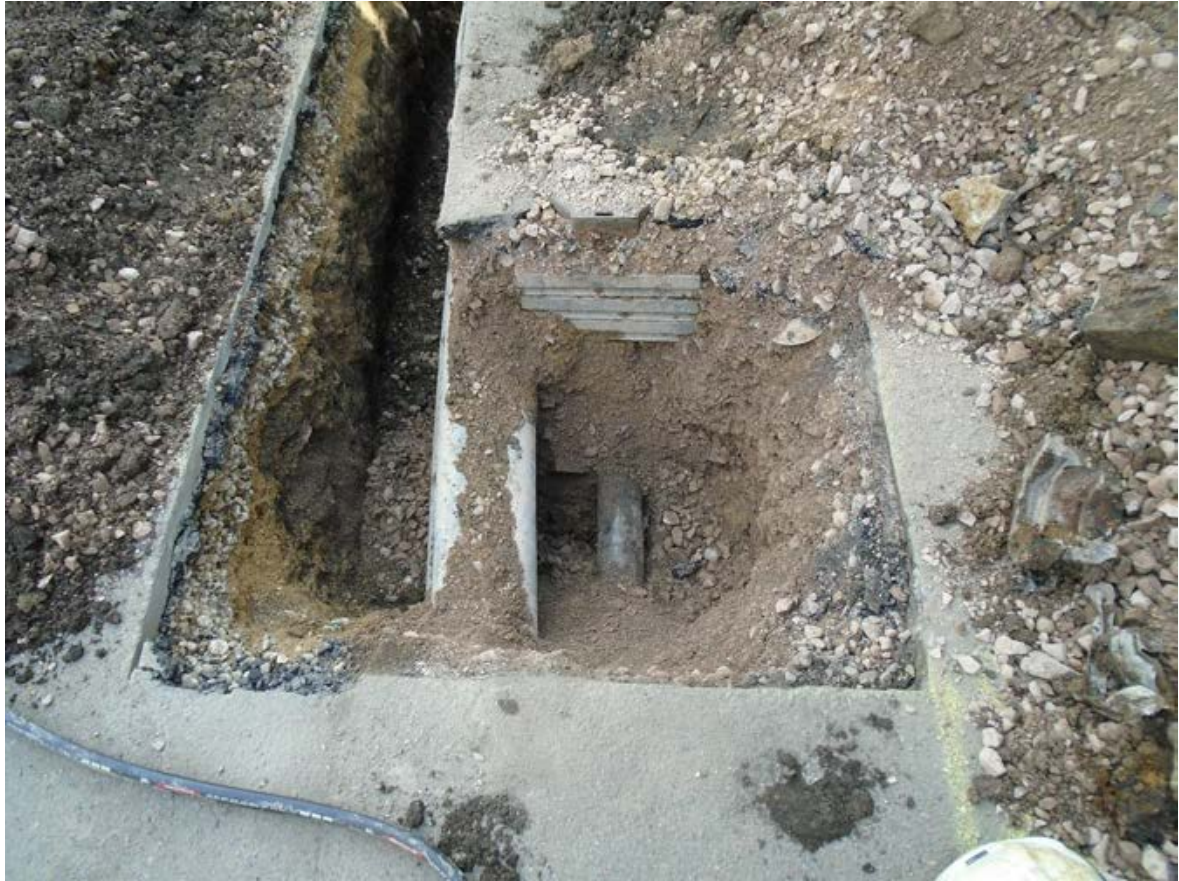
Plate 4: View of the north-western end of Trench 1 showing disturbed ground (1002), looking south-east.

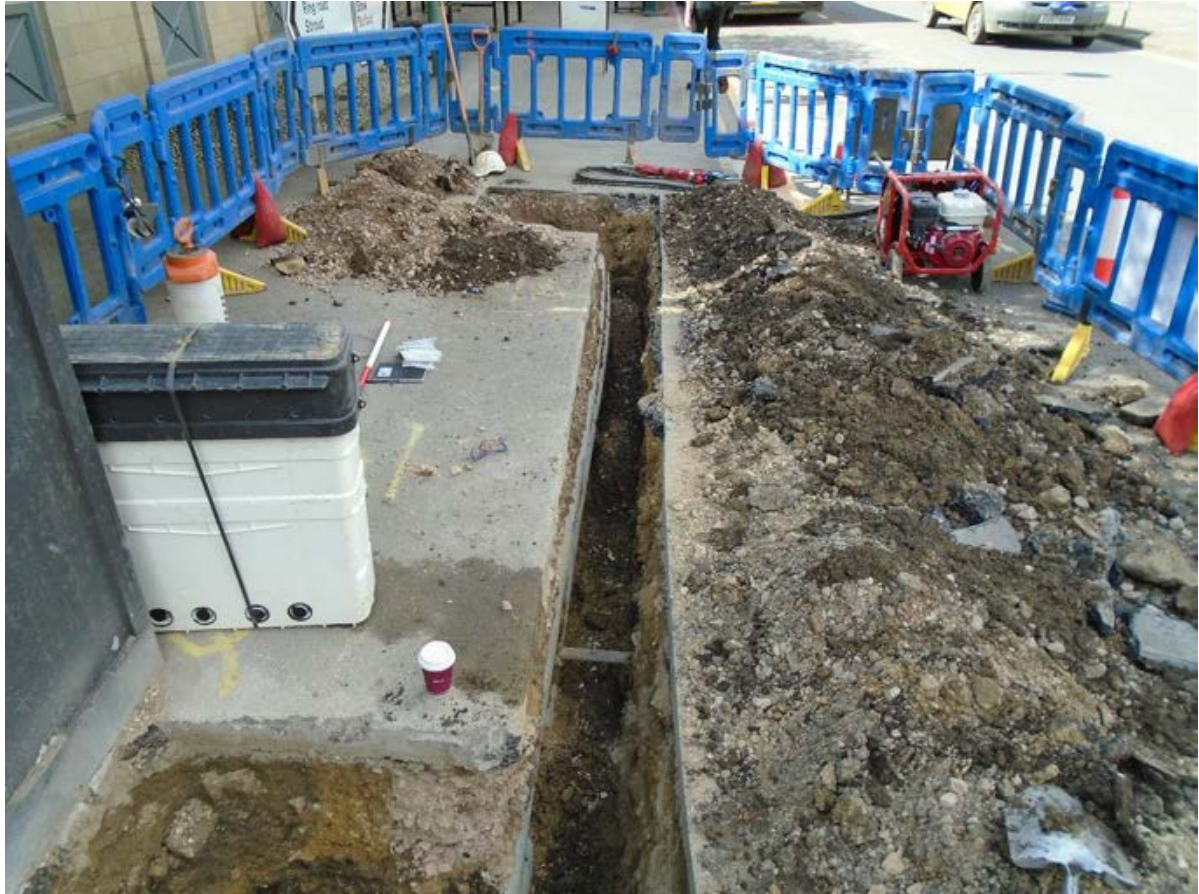
Plate 5: View of the extent of Trench 1 looking north-west from the south-eastern end of the trench.

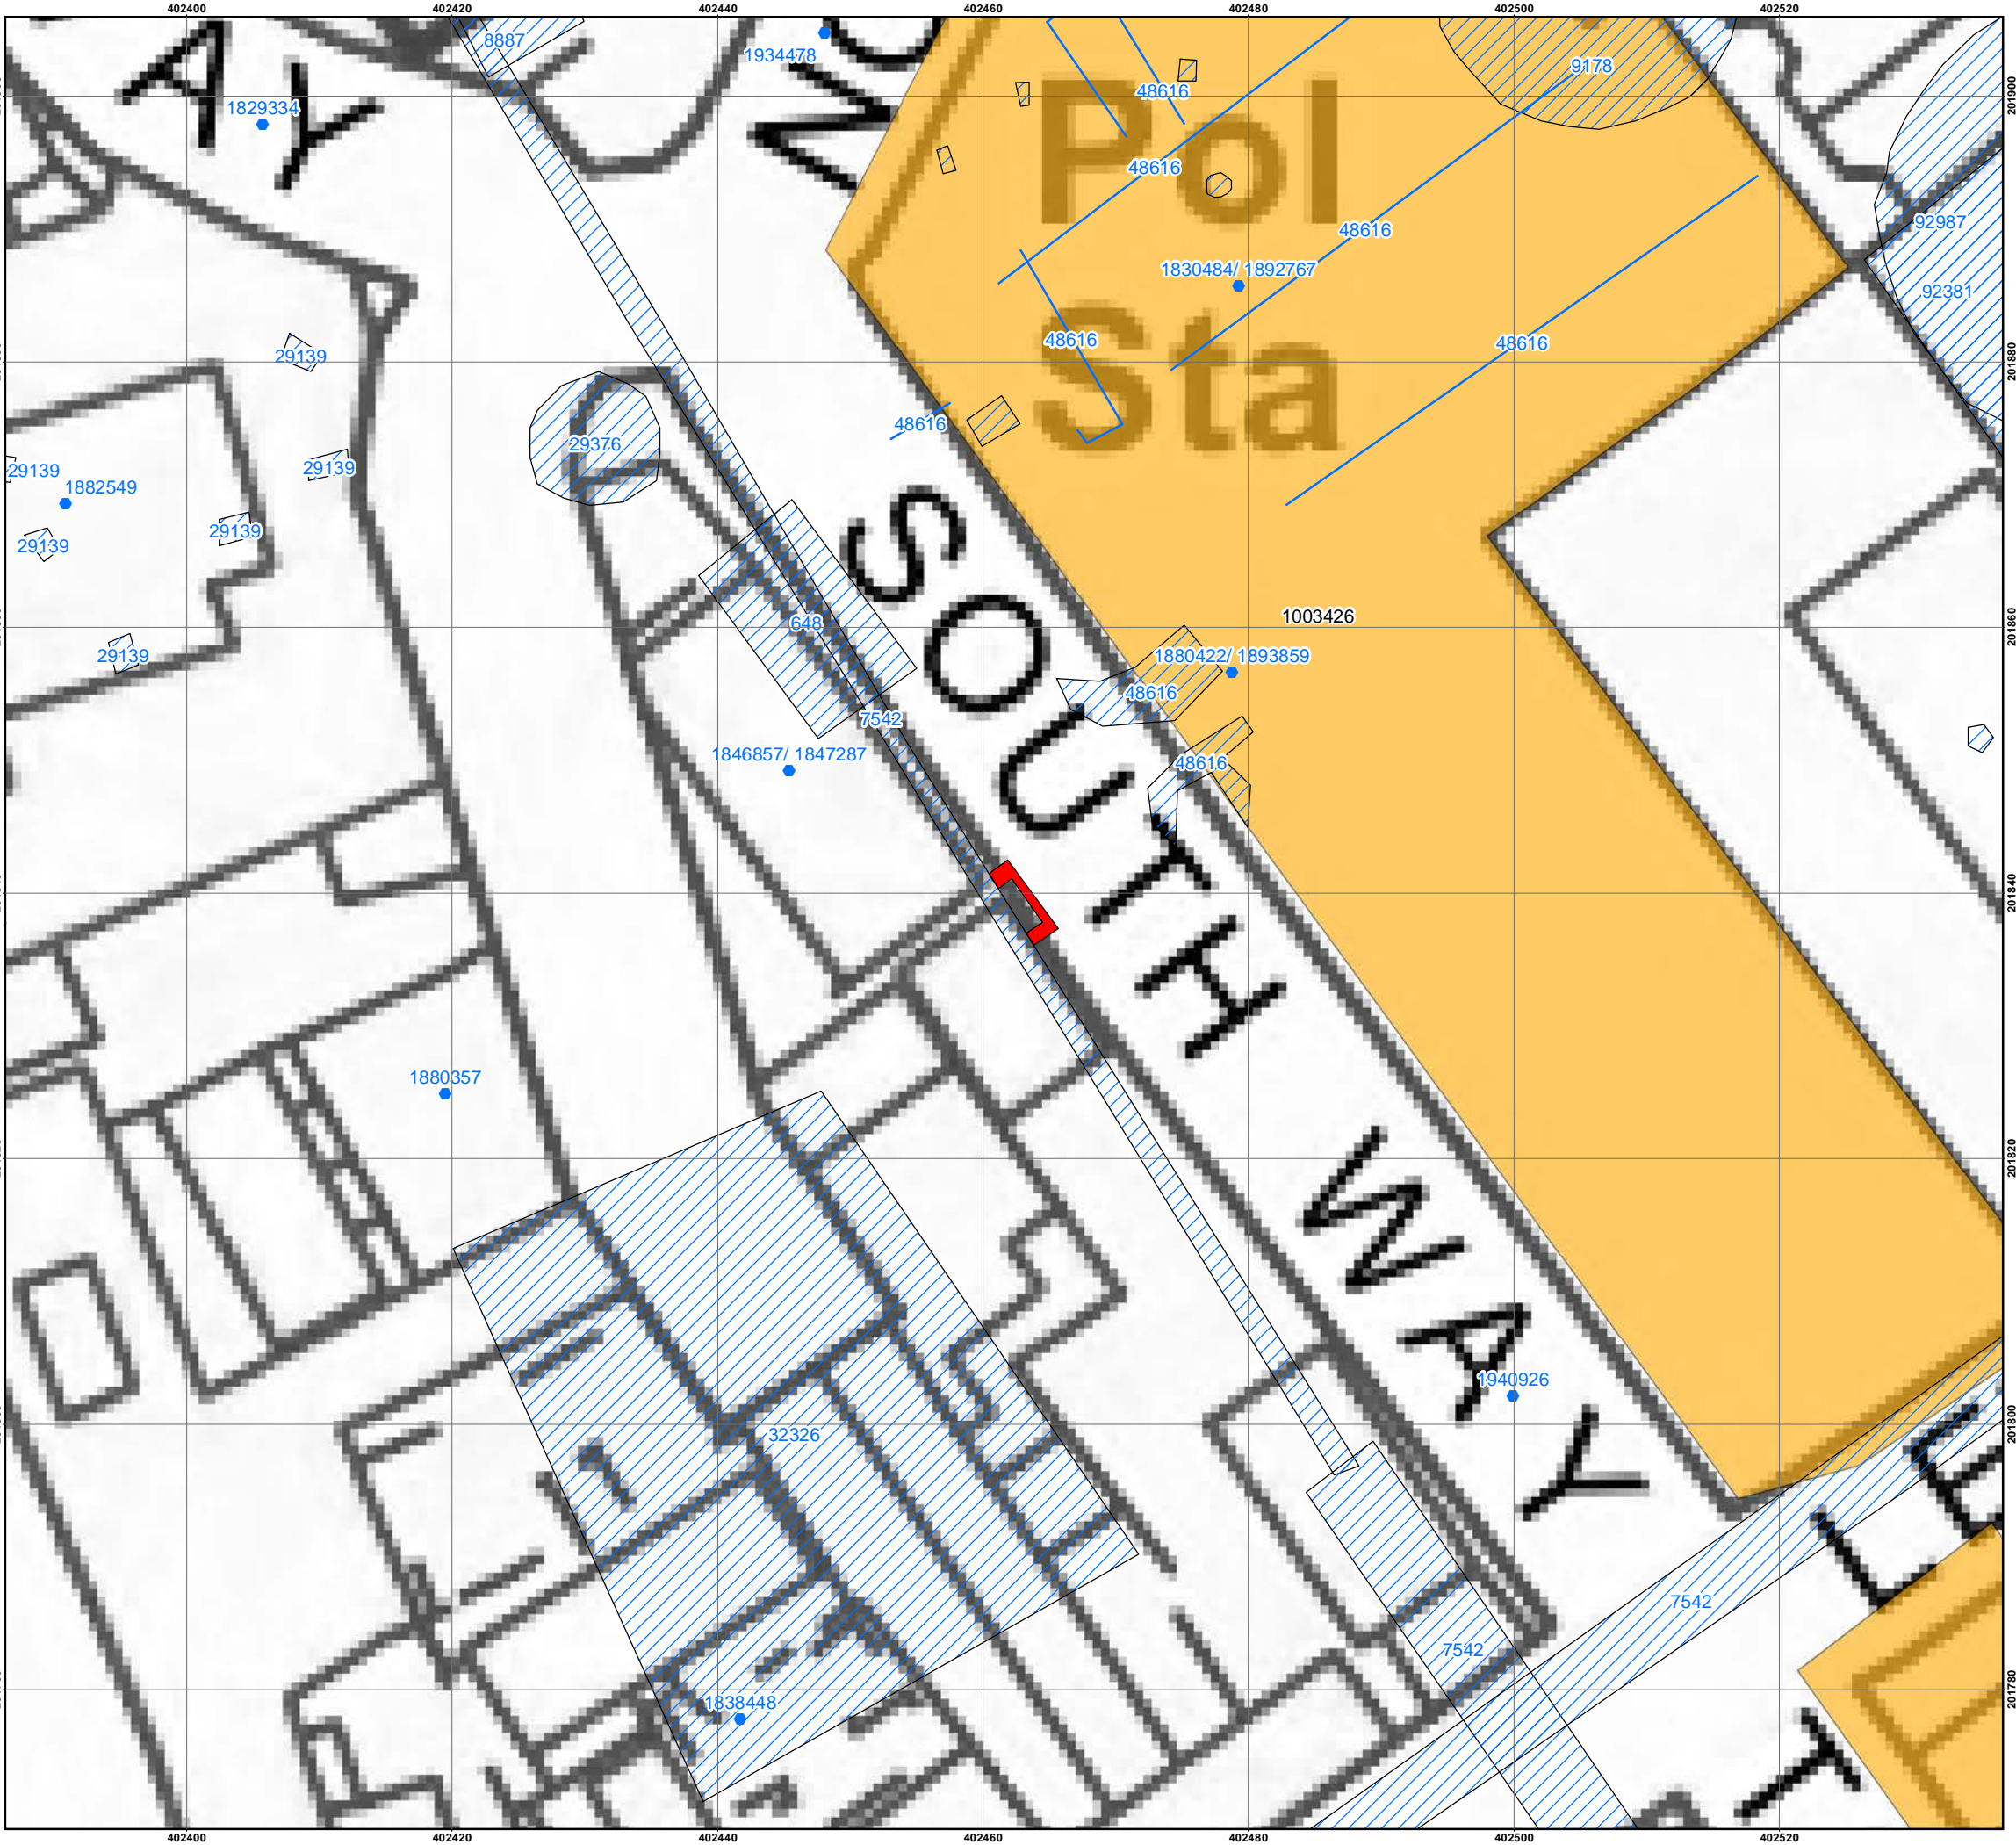
Figure 3: Location of Trench 1 outside Southway House.
