## Archaeological Monitoring and Recording Report: Three Bridges Main – Smallfield 132 kV Overhead Tower Line Diversion at Toovies Farm, Crawley

Report By: Stephenie Dalby BA MA PCIfA  
Issued by: Stephenie Dalby BA MA PCIfA  
Date: May 2018

## Summary

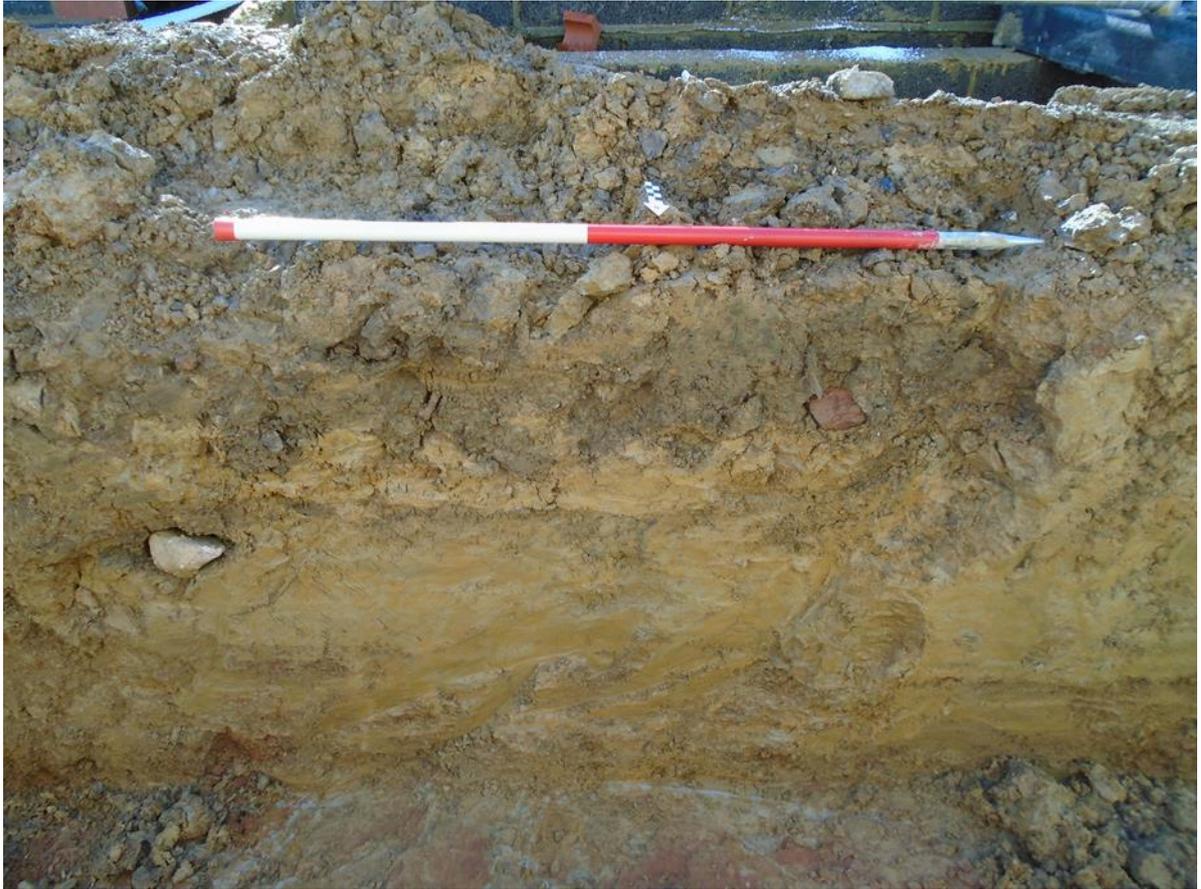
**Plate 5:** North facing section of trench at roughly CH 1000, with 1 m scale. At this location, made ground (1004) directly overlies natural substrate (1002).

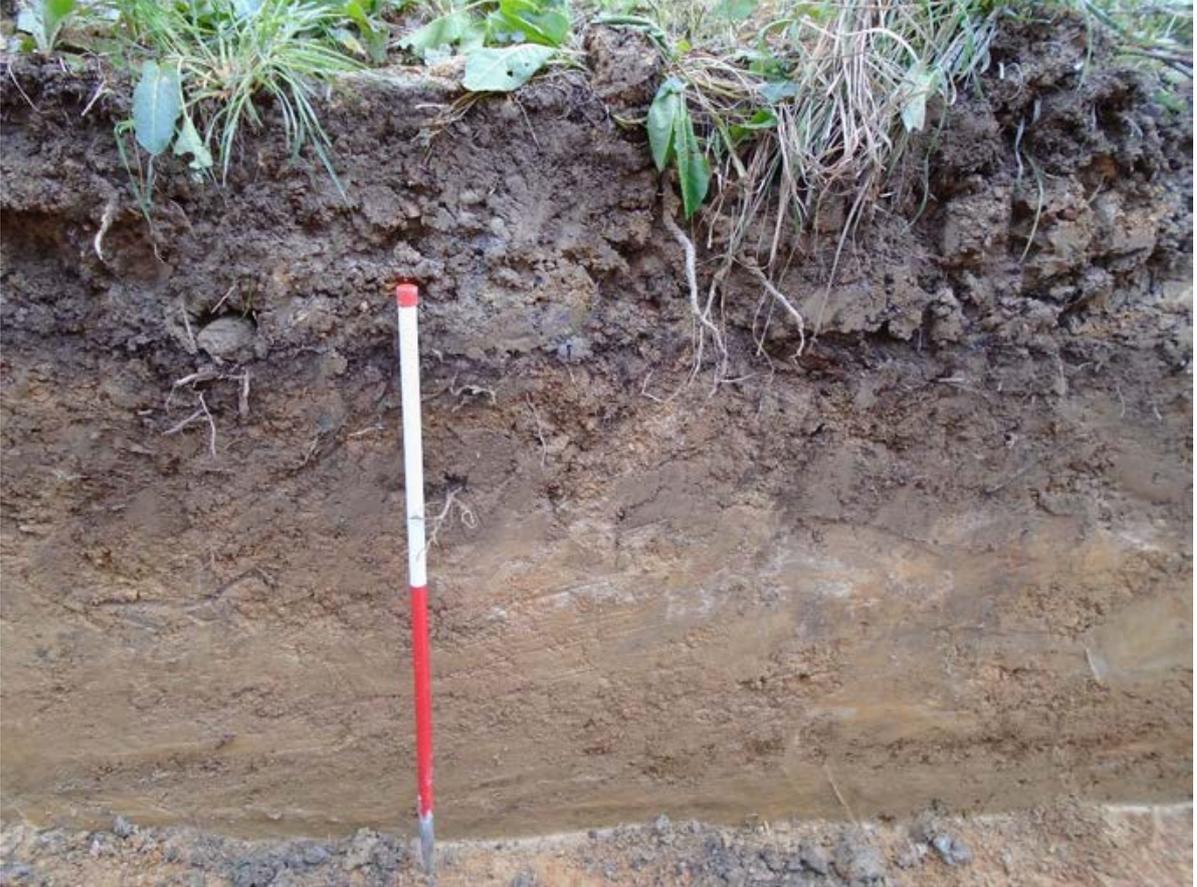
**Plate 9:** North-west facing representative section, located in Area B, with 1 m scale.

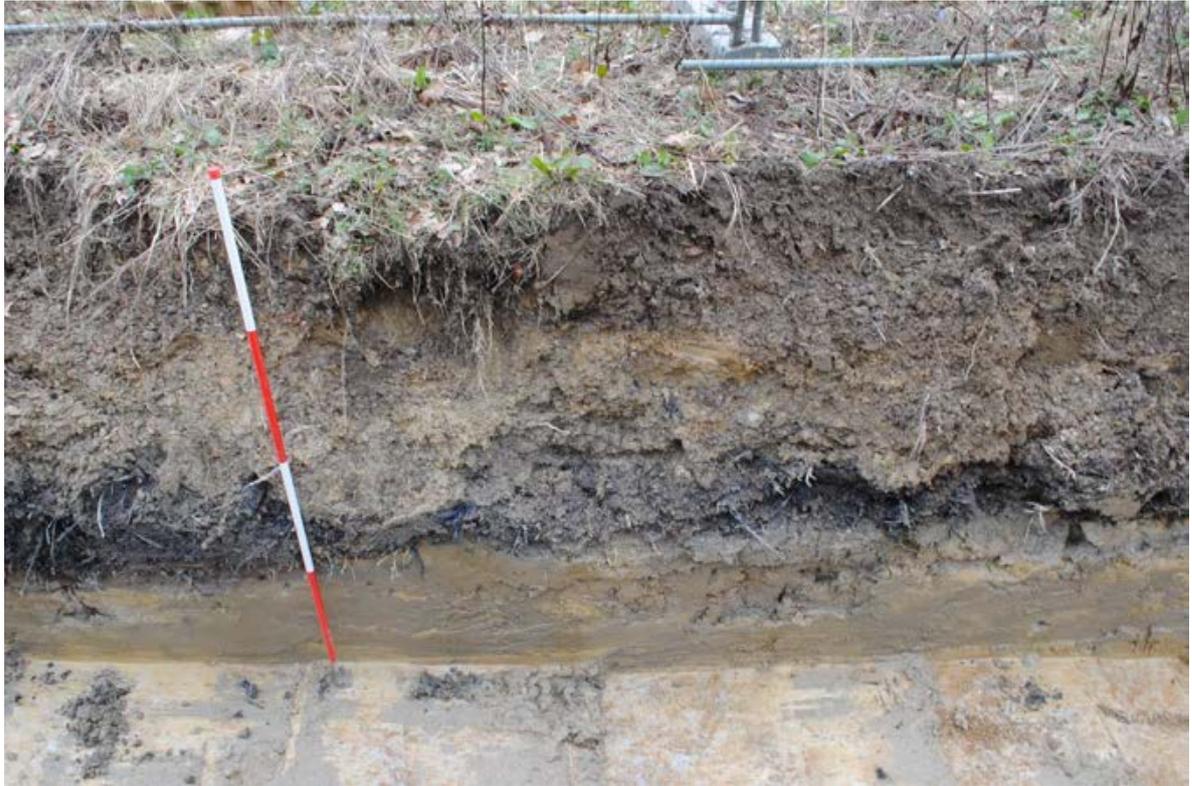
**Plate 10:** North-east facing representative section, located in Area C, with 2 m scale. Redeposited soils with waste building material inclusions (1004) overlies a possible buried soil horizon (1006). The natural substrate (1002) underlies this.

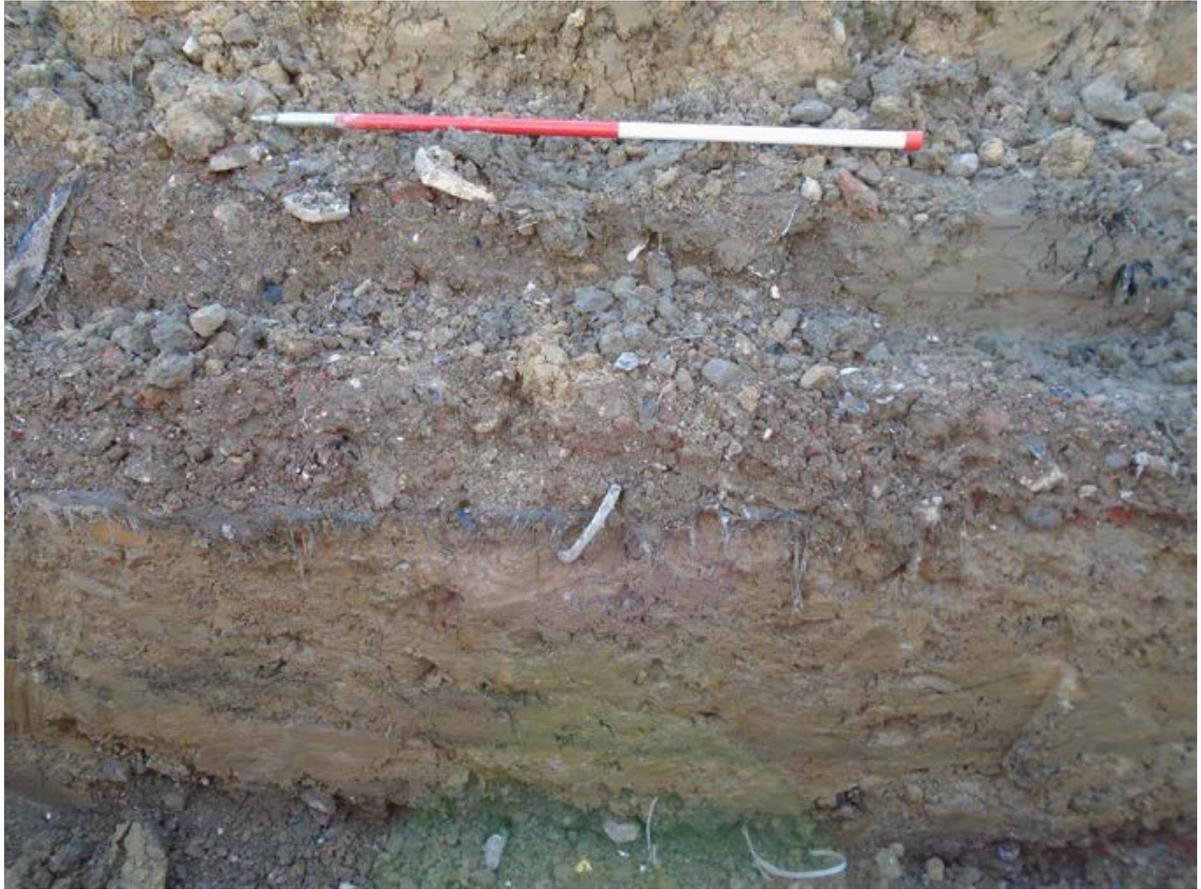
**Plate 11:** North-west facing representative section, located in Area E, with 1 m scale. In this area there are successive phases of made ground – hard-core (1005) underlies redeposited soils (1003) which is overlain by further hard-core (1005).

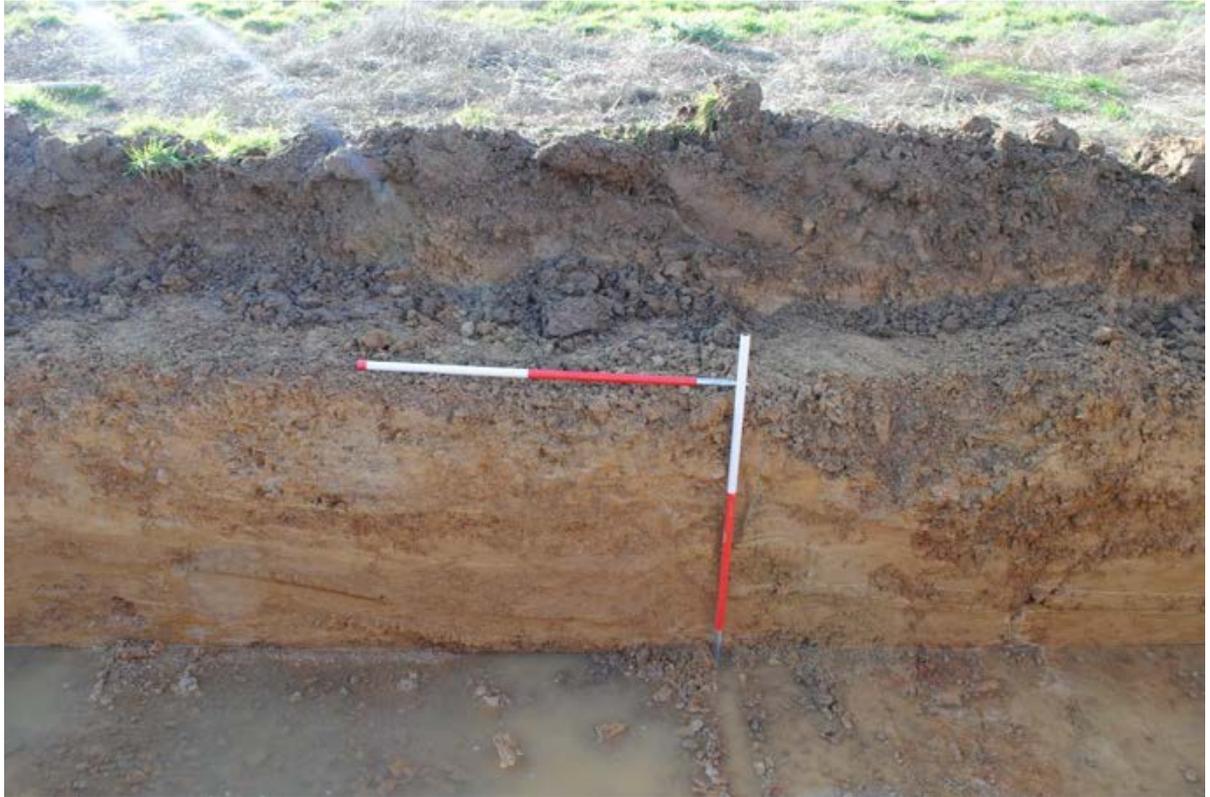
**Plate 12:** South-east facing representative section of Areas G to L, location in Area K.
