Archaeological Watching Brief Report: Swindon to Stratton 132kV Cable Scheme

Reference No: CEN3034
Issued by: Diarmuid O Seaneachain BA PhD PCIfA
Date: February 2015

Submitted to:
SSE Power Distribution Ltd
55 Vastern Road
Reading
Berkshire
RG1 8BU

Prepared by:
ADAS UK Limited
11D Park House
Milton Park
Abingdon
OX14 4RS

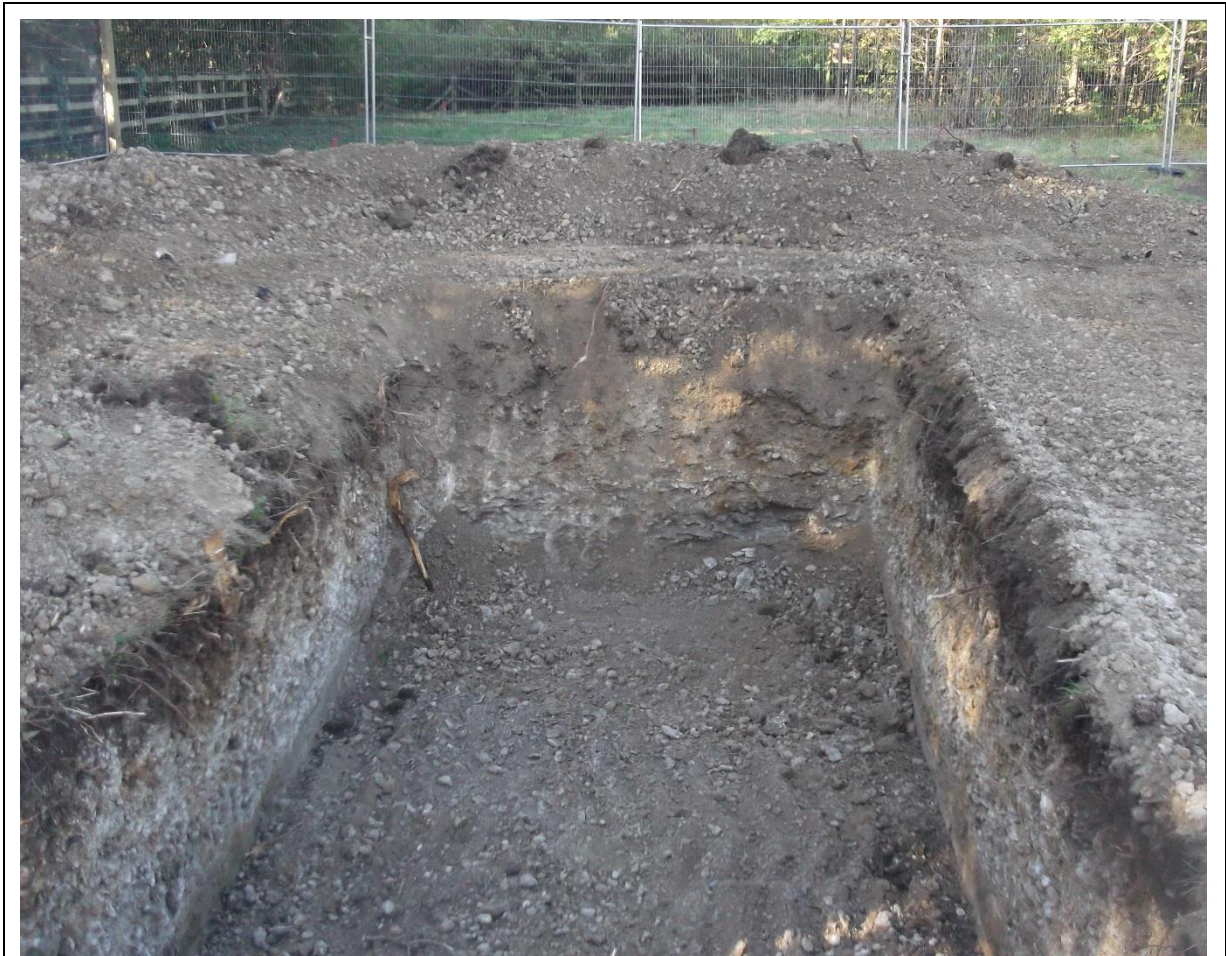
Plate 1: View of the Launch/Receptor Pit at Stratton Wood.

8.1.1 In Area A the topsoil horizon 100 was reduced to a depth of approximately 0.2m across the easement area (**Plate 1**). This overlay a an orange brown subsoil 0.3m thick which in turn sealed the natural substrate of green-brown clay or green clay with frequent small angular limestone cobbles and pebbles. Two modern services were observed in the cable duct trench near Stratton substation.

- 9.1.1 No features or artefacts of archaeological significance were observed during monitoring in Area A. Monitoring confirmed that any deposits which may have contained archaeological material in Area B had previously been removed/destroyed during the construction of buried water or sewage services trenches at this location.

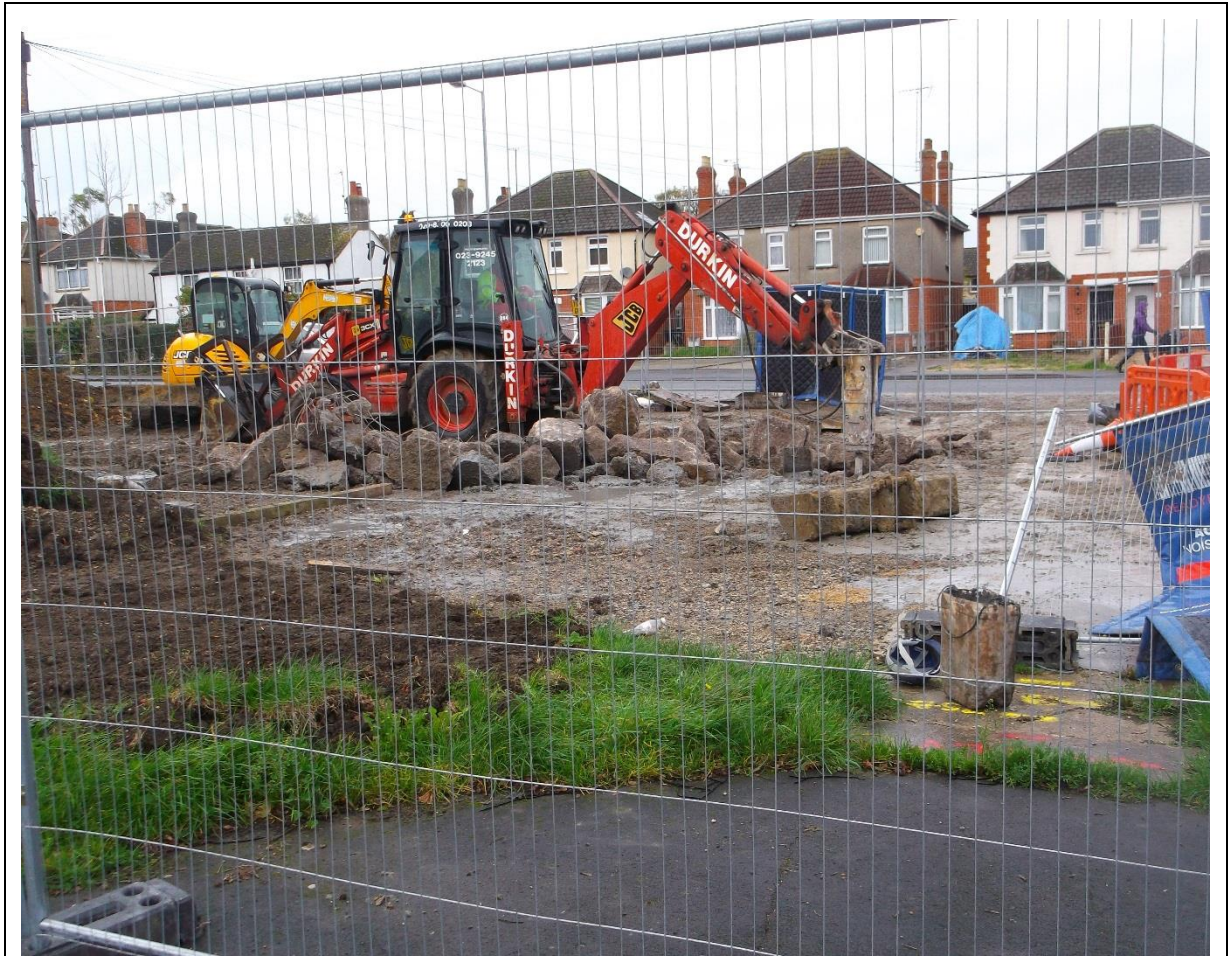
Plate 2: View of Launch/Receptor pit location at the Kingsdown Road, looking north.

8.1.1 In Area B the topsoil horizon 200 was reduced to a depth of 0.15m across the whole of the easement area to reveal a modern made-ground horizon 201. The made-ground horizon was removed to reveal modern concrete and service pipes 201 underlying the whole of the launch pit area (**Plate 2**). No artefacts or deposits of archaeological significance were identified in this area.

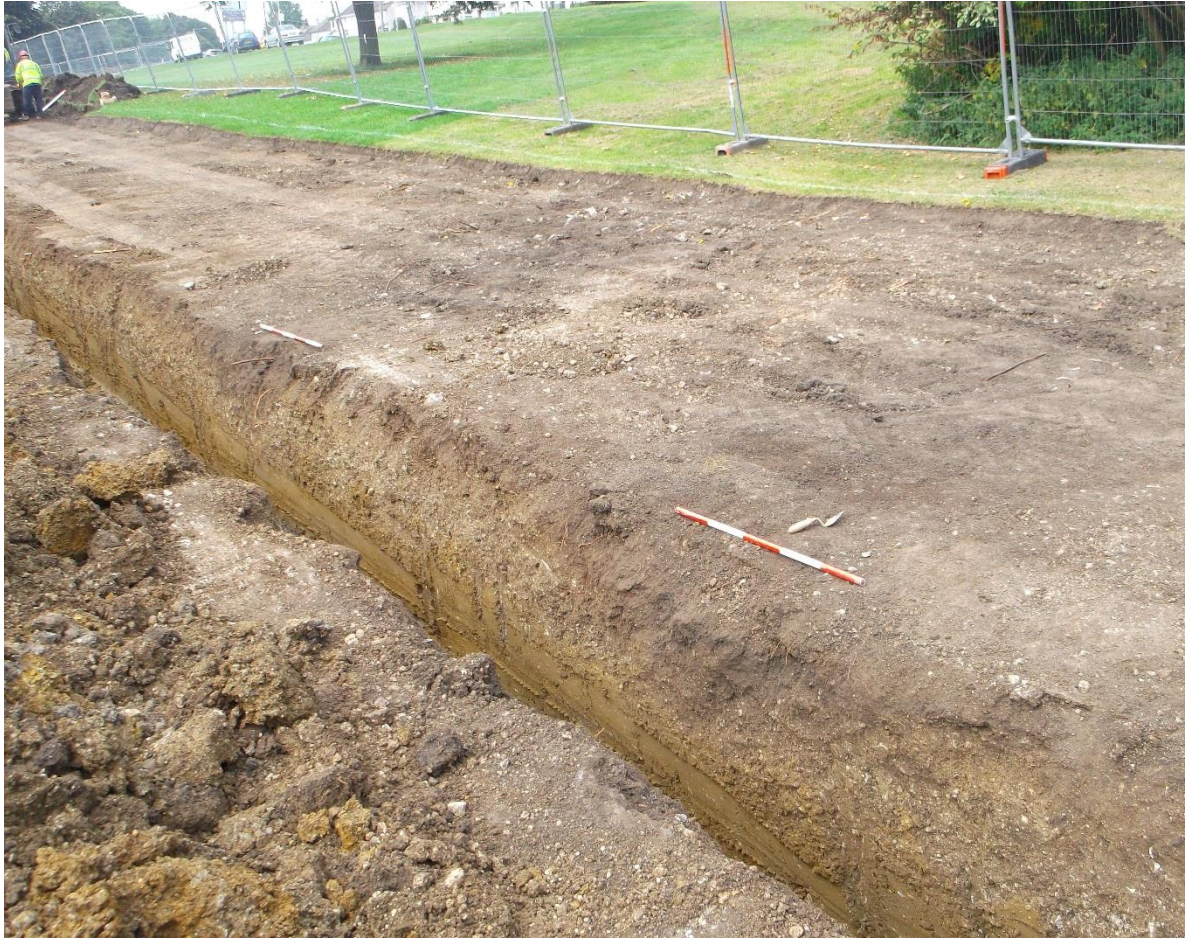
- 8.1.2 In the cable duct trench two parallel ditches, 303 and 305 were observed cutting the subsoil horizon 301 (**Plate 3**). Ditch 303 contained a single fill, 304. Ditch 305 contained a single fill, 306. Part of a 19th or 20th-century iron plough shear and three sherds of 19th or early 20th century ceramic pottery were recovered from 306. A modern concrete pipe was also observed cutting the subsoil at the eastern end of Area C.
- 8.1.3 Towards the eastern end of Area C the natural blue clay substrate was exposed when the topsoil and subsoil were removed to a depth of approximately 0.15m-0.2m below present ground level.

Plate 3: View of ditches 303 and 305 in Area C looking north-west.

- 9.1.2 In Area C ditches 303 and 305 both form part of a post-medieval field boundary visible on the First Edition Ordnance Survey map of the Area. The two spreads of loose bricks and other modern material observed in this area most likely represent dumped deposits of material used to level or firm up the ground close to the River Ray. In Area D all three ditches identified were clearly visible as earthwork features prior to excavation, and appear to have been created as a result of 19th or 20th century landscaping/drainage improvement works in this common land based on historic mapping and modern satellite imaging analysis. In Area E the ridge and furrow earthworks can be interpreted as the remnants of sustained arable agriculture in this field from the medieval period to the 19th century.

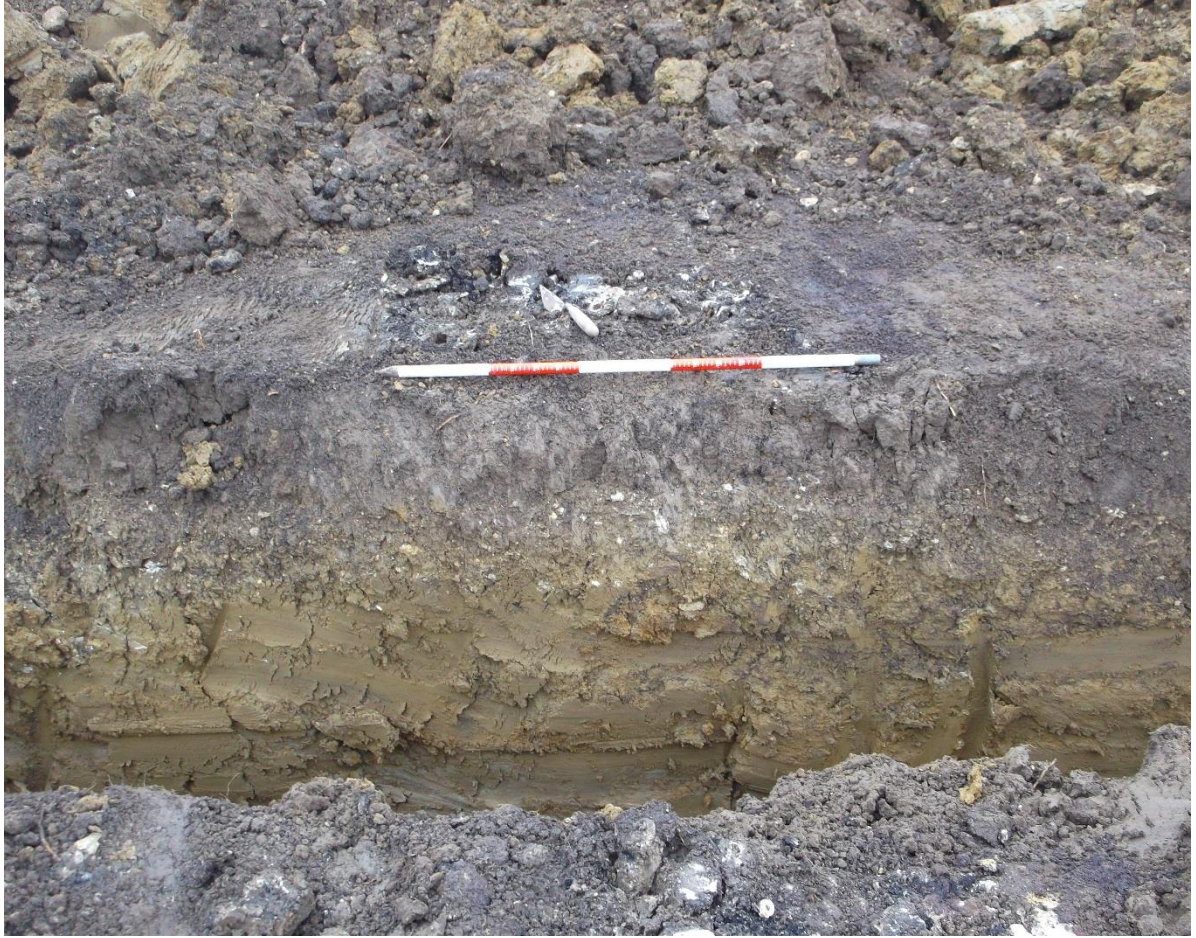
- 8.1.2 In Area D the subsoil was cut by ditches 403, 407 and 409. Ditch 403 was 1.3m in width but only 0.1m in depth below the reduced ground level. It contained a single fill, 404 which comprised of abundant small cobbles and charcoal inclusions in a silty matrix (**Plate 4**). Ditch 407 was approximately 1.8m in width in plan and in the cable duct trench was approximately 0.1m below the reduced ground level. It contained a single fill, 408 which comprised of dark grey silty clay and roots. Ditch 409 was visible as an earthwork feature prior to the start of groundworks and measured approximately 1.5m in maximum width. In section in the cable duct trench it was found to be approximately 0.1m below the reduced ground level. It also contained a single fill, 410, which comprised of dark grey silty clay.

- 8.1.3 Two modern land drains and a modern concrete pipe were also observed in plan across the easement and in section in the cable duct trench in Area D. The subsoil horizon 401 was generally found to be 0.3m thick across Area D and sealed the natural substrate 402. The natural substrate generally consisted of firm yellow sandy clay (**Plate 4**) except towards the River Ray where it gives way to white sand overlaying firm yellow clay.

Plate 4: View of ditch section 403 in Area D, looking north-east

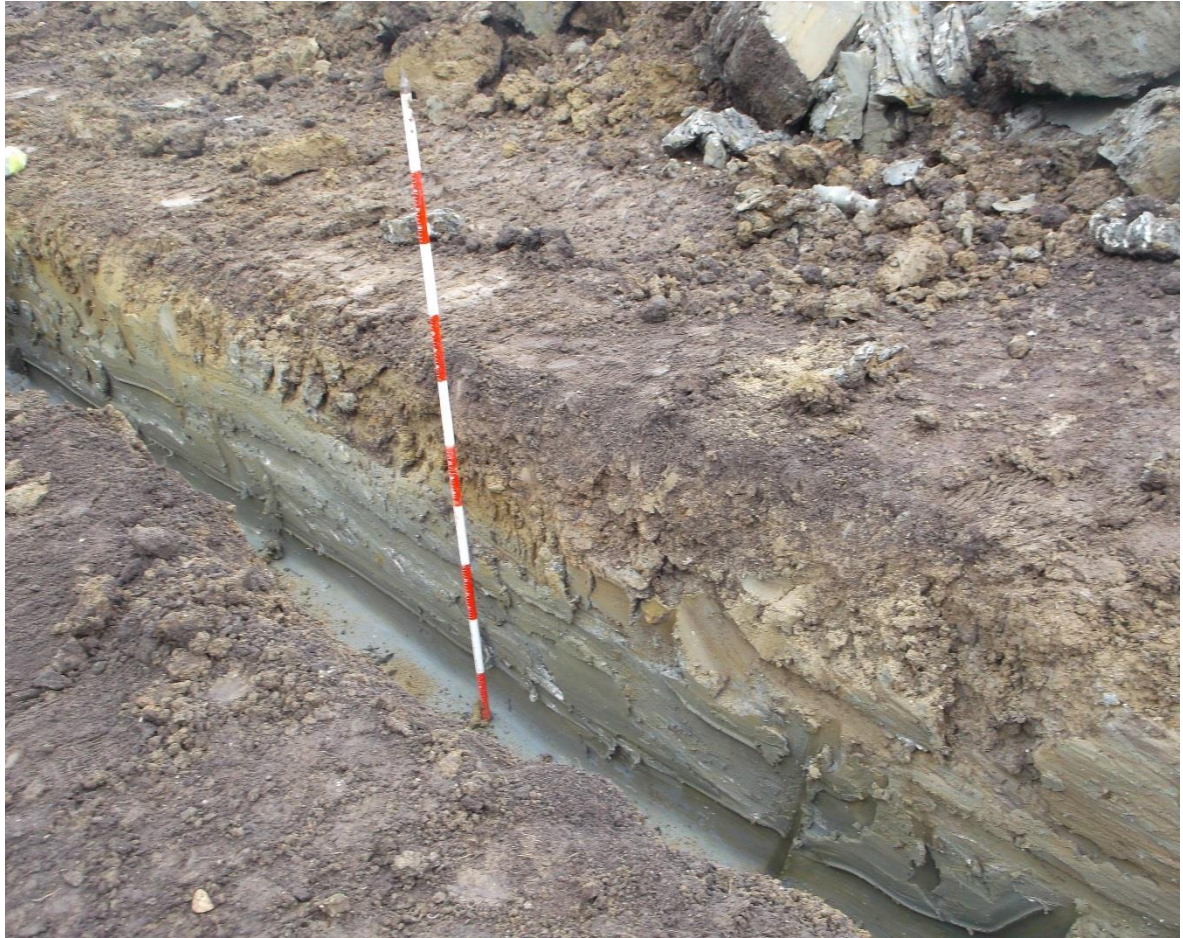
- 8.1.1 In Area E the topsoil horizon 500 was reduced to a depth of approximately 0.25m below present ground level (**Figure 3**). This sealed the subsoil horizon 501 in Area E. A cable duct trench measuring up to 2m in maximum width was excavated through the subsoil 501 and the natural substrate 502 through the eastern part of this area closest to the River Ray (**Plate 5**).

Plate 5: Representative section shot of cable duct trench at western end of Area D.

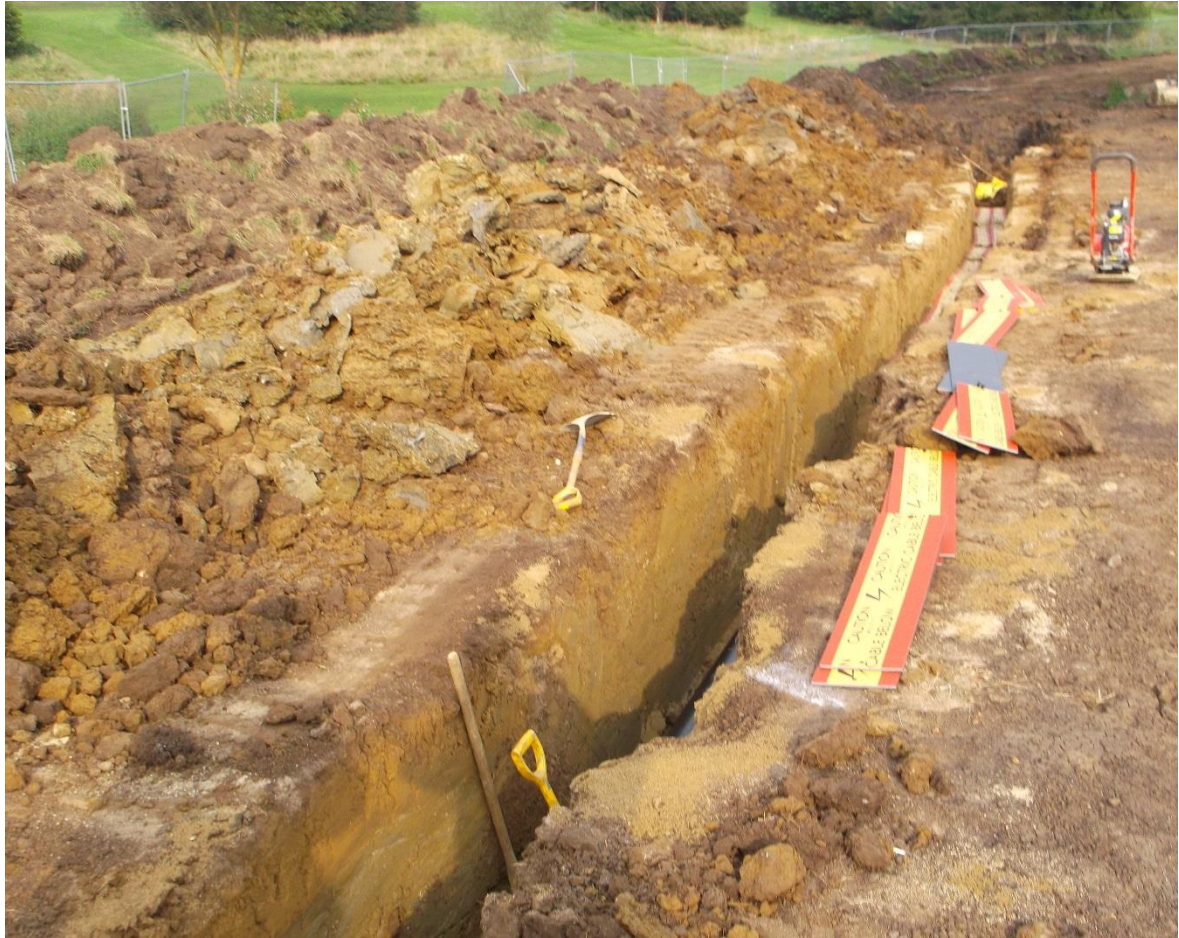
The cable duct trench measured 0.7m in width through the rest of the area. The cable duct trench was excavated to a maximum depth of 1.4m below the reduced ground level.

- 8.1.2 A series of parallel ridge and furrow earthworks, orientated NNE/SSW were observed across Area E prior to the start of groundworks (505, 507, 509 and 511). These ridge and furrows were also observed in section in the cable duct trench through this area. All of the furrows were observed in section cutting the subsoil horizon 501. The maximum depth of each furrow was approximately 0.1m to 0.15m below the reduced ground level in Area E. A post-medieval or modern red clay land drain was also observed at the base of each furrow. At the western end of Area E a modern high voltage cable 513 crossed the easement near Swindon substation.

Plate 6: Representative shot of cable duct trench in Area E, looking north-east.
