Archaeological Monitoring and Recording Report: Melksham – Chippenham 132kV OHL Refurbishment Project

Date: 25th October 2019

Submitted to:
SSEN

Prepared by:
RSK ADAS Limited
11D Park House
Milton Park
Abingdon
OX14 4RS
Tel. no: 01235 355638

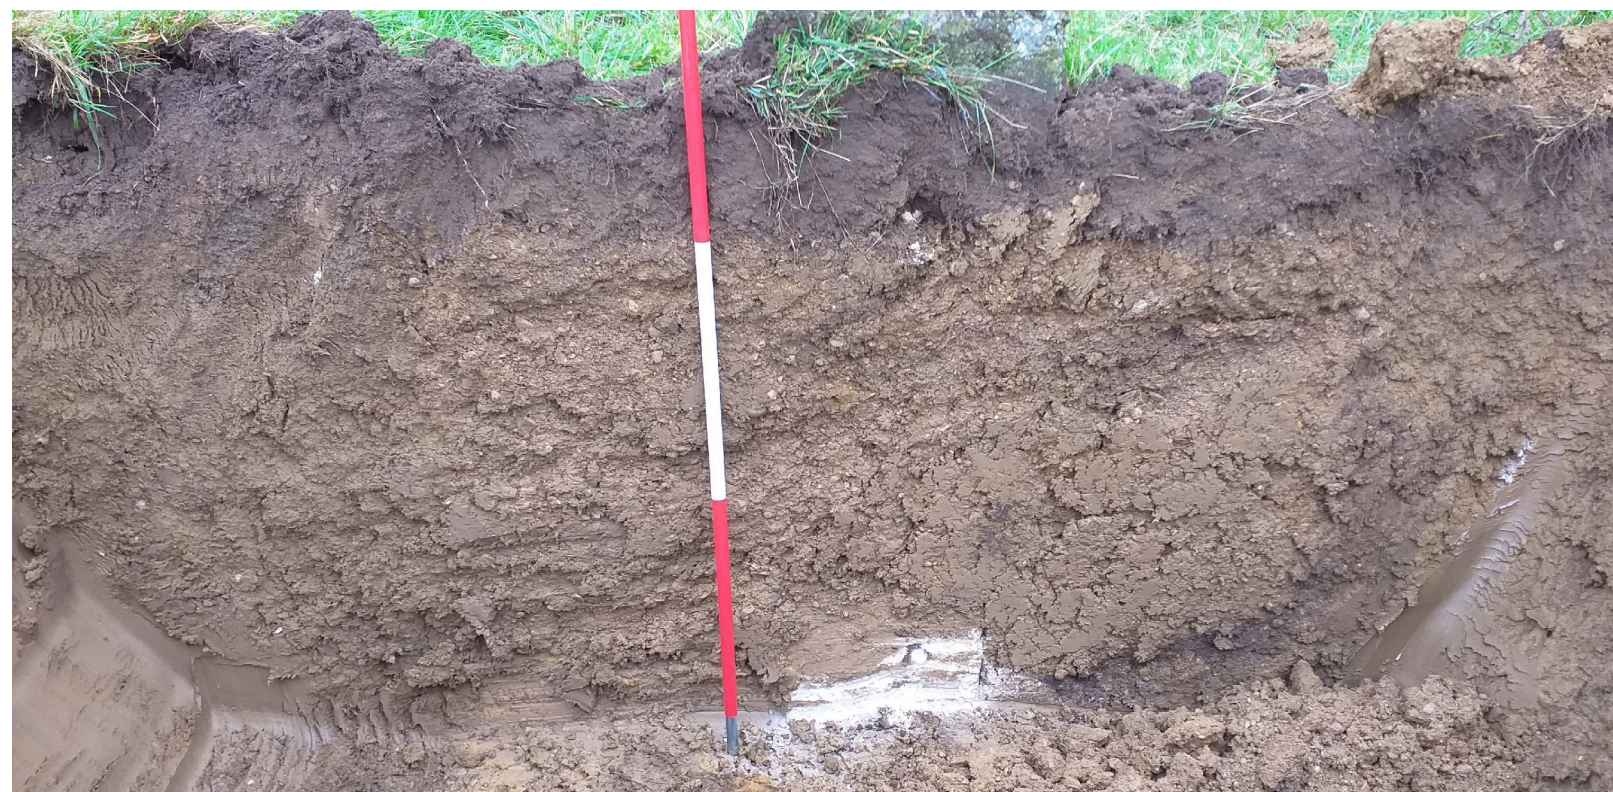
**Figure 6: South-East Facing Section
of Trench 2 (MC32)**

6.1.9 The topsoil (2001) consisted of a mid to dark brown, fine grained, very soft sand up to 0.25 m thick. This overlay a backfill layer (2002) of mid-brown, fine grained, soft silty sand up to 1.55 m thick.

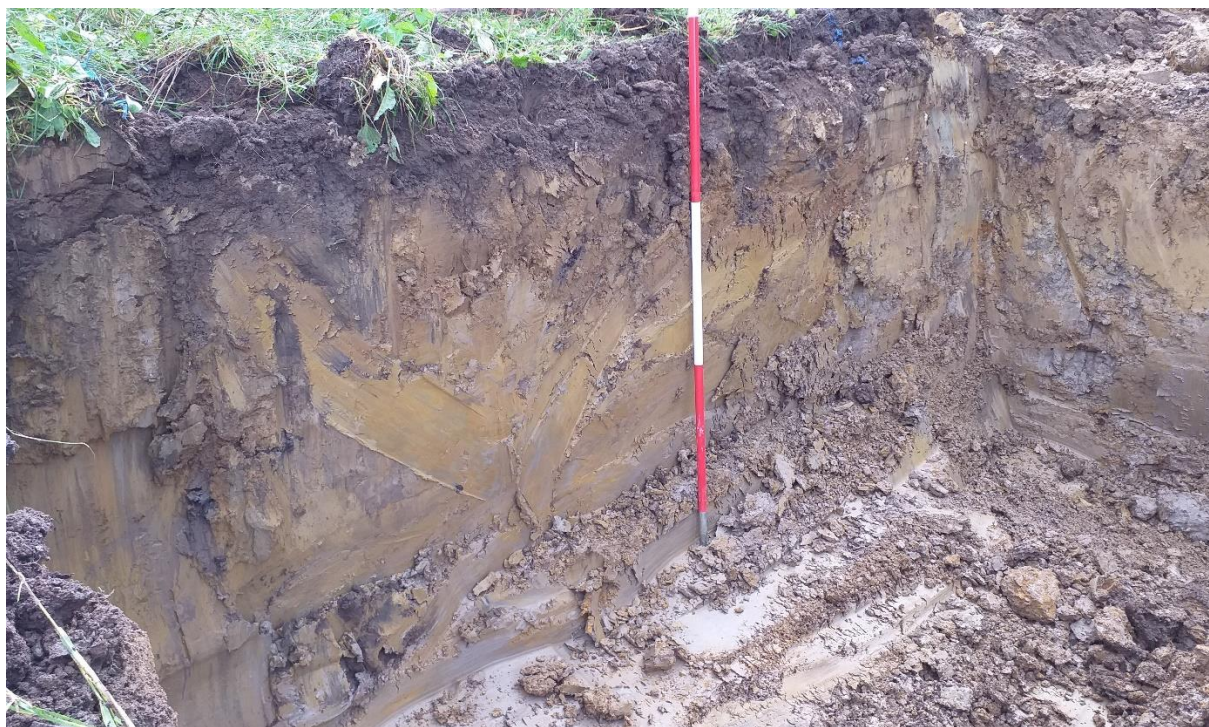
Plate 3: East facing section of Trench 11 at MC30.

6.1.38 In this trench the topsoil (11001) was recorded as 0.30 m thick, and as a fine-grained, soft, clayey sand. No inclusions were present and it was dark brown in colour.

6.1.39 The next layer consisted of a backfilled fine-grained, firm, silty clay. It was mid brown in colour. No inclusions were present. This layer (11002) was 1.50 m thick.

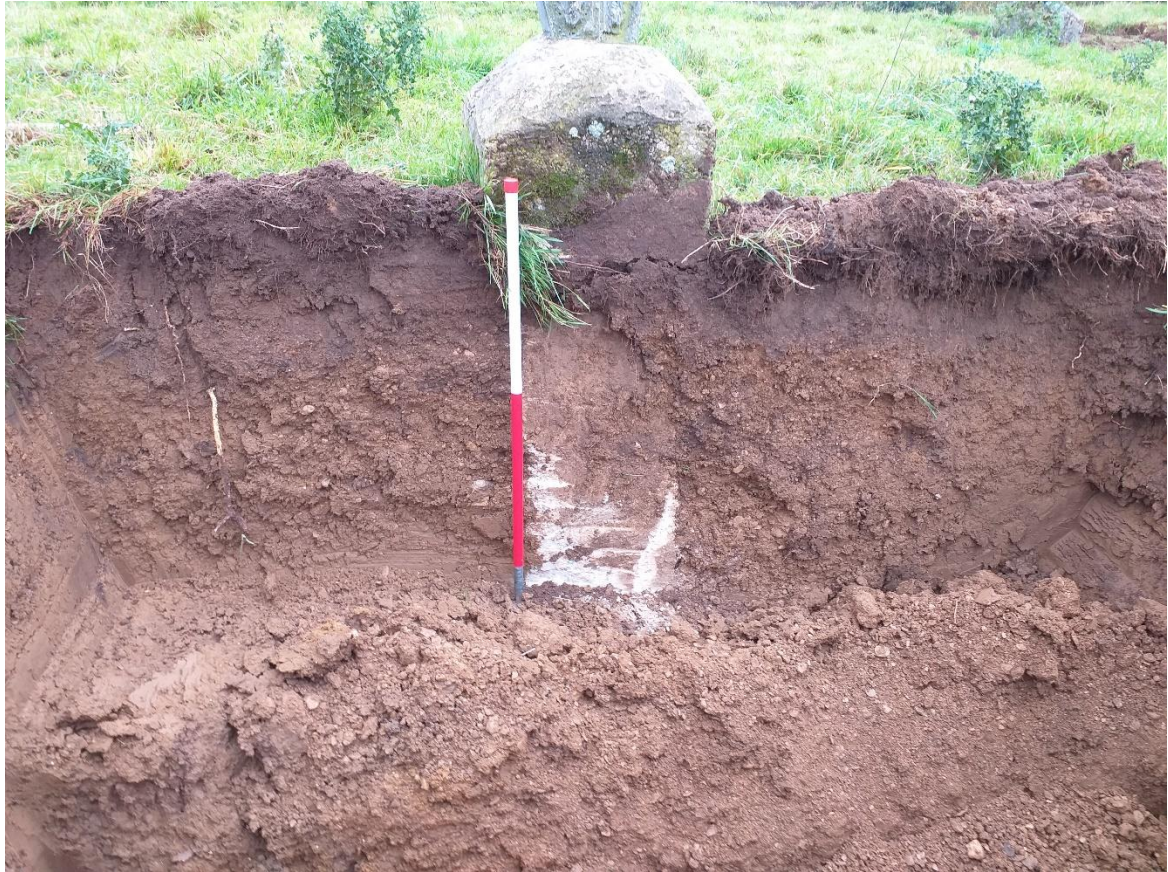
Plate 4: North facing section of Trench 3 at MC32.

6.1.11 The topsoil consisted of a fine-grained, friable sand. No inclusions were present and it was mid to dark brown in colour. The topsoil (3001) was recorded as 0.35 m thick.

6.1.12 The topsoil sealed a backfill layer (3002) consisting of a fine-grained, soft, silty sand. It was mid-to-light brown in colour with no inclusions present. This was recorded as 1.25m thick and overlay natural substrate (3003), which was 0.20 m thick to the base of the trench.

6.1.13 The natural geology was a fine-grained, soft, light reddish-brown, silty sand. This is consistent with the reported geology of the area (BGS 2019).

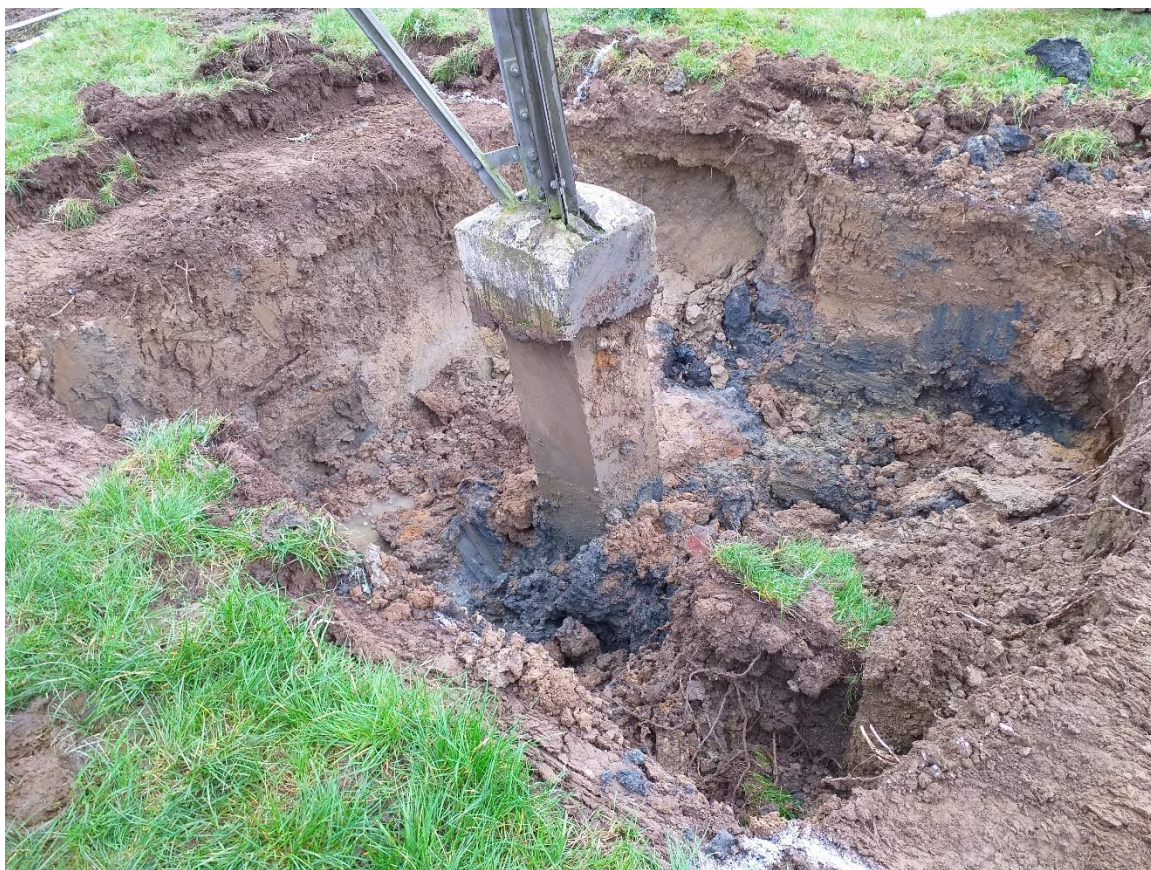
Plate 5: Oblique view of collapsed Trench 13 at MC31.

6.1.46 Upon completion of the trench the sides began to subside and collapse. Consequently, digging around MC31 was immediately deemed a major health and safety risk and the digging ceased. This could be due to the heavy rainfall experienced in the area in the days leading up to the digging and also on the day of digging as the ground was quite heavily saturated.

6.1.47 No further digging took place around any of the other footings of MC31 or anywhere else in the area.

6.1.48 After consultation with Ms Rachel Foster, the local authority archaeologist, it was agreed that archaeological monitoring around the footings of MC30, MC31, and MC32 could be discontinued.
