Botallack Cricket Club Truthwall, St Just, Cornwall.

Heritage Impact Assessment:

SH Ref BOTA1017 – NGR SW36633254 08/11/2017

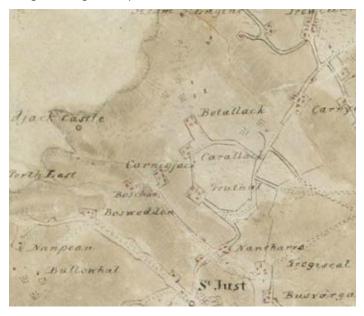
1Figure 3: 1809 OS Surveyors Drawing (B Lib ref OSD1, 18)

- 3.3 The earliest historic map consulted for this project is the 1809 Ordnance Survey Drawing by John Hewitt (figure 3). This drawing (of an original 2 inch to the mile scale is of limited use for landscape reconstruction although mining activity is shown to the north of Botallack.

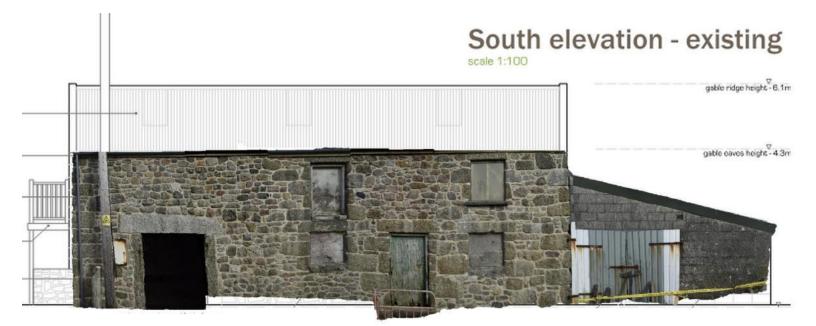
Figure 9: Ortho-recitfied southern elevation of Botallack Cricket Club – formerly Wheal Owles Stables (Statement Heritage photography registered to survey base supplied by MH Architects)

- 4.4 The building's southern elevation is presented in figure 9.
- 4.5 In plan the building is of two parts. The two storey section is built in angular fine grained poorly megacrystic granite rubble, likely to be mine spoil. with quoins from a quarried richly megacrystic granite. This part of the building is that shown on the historic mapping. The building has been recently repointed in appropriate lime mortar.

- 4.6 Against the eastern gable of the building is a late 20th century concrete blockwork lean-to extension.
- 4.7 The southern elevation of the two storey section is asymmetrical, with the western section showing clear evidence of rebuilding. The evidence for this rebuilding includes the megalithic orthostats and lintel which are from a different quarry source to the other architectural quoins in the elevation (they are more biotic in character and therefore greyer in colour). Above the lintel (which is augmented to its rear by an iron girder) the walling departs from the un-coursed nature of the rest of the elevation and becomes loosely coursed.

- 4.8 The eastern end of the elevation retains a probable late 19th century ledge and braced entrance door and features four further openings, one of which is a first-floor loading door.

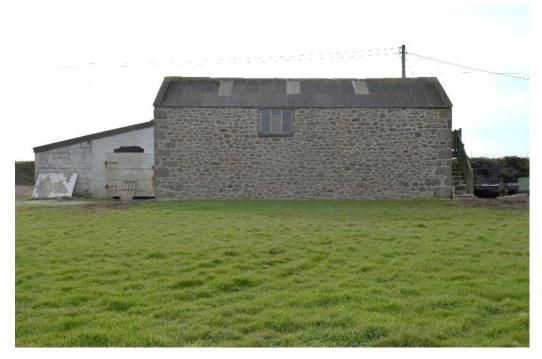
4.9 To the rear (north) the building presents an essentially blank elevation (figure 10) broken only by a horizontally emphasized modern opening (it is executed in concrete) at first floor level.

Figure 10: Rear Elevation (Archive ref: BOTA1017_023)

- 6.5 To the rear (northern) elevation new openings are made at ground floor level for a timber ledge and braced door, and for two modest new windows.
- 6.6 Roof coverings will be renewed by new metal corrugated coverings of sinuous profile. Again this material choice echoes the historic use of materials in the mining district and is considered entirely appropriate. A modern solar thermal water unit is proposed on the south facing elevation of the extension, ensuring that modern elements are kept to a minimum on the historic section of the building.

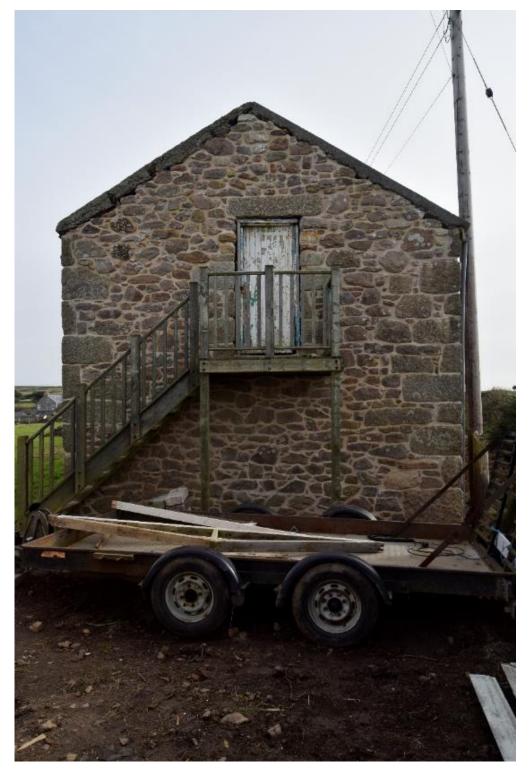
- 4.10 The building's current roof covering is of fibre cement corrugated sheet, into which are set polycarbonate skylights.
- 4.11 The north gable features a modern timber stairway giving access to the first-floor loft (figure 11)

Figure 11: West gable of the building (BOTA1017_0024)

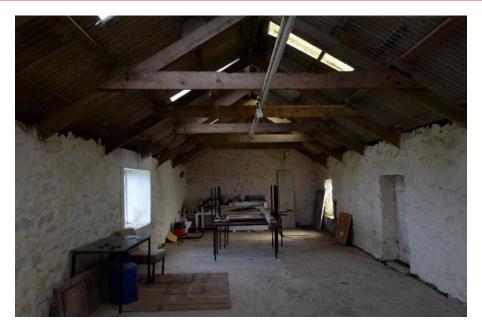
- 4.17 Figure 14 shows the internal space at first floor. The simply jointed 'A frame' trusses are original, resting in sockets along the tops of the masonry wall on simple stone plates, but the purlins are modern.

Figure 14: Looking east into the first floor of the stables. Note the concrete lintel above the window in the north elevation indicating its modern date and the loading door to right.

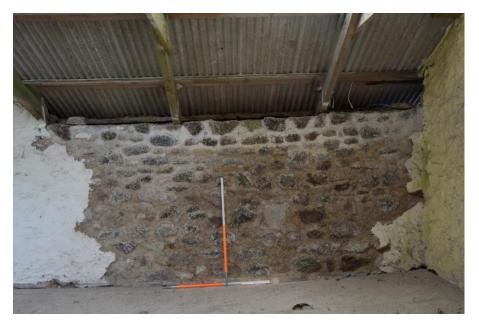
- 4.18 The original floor is lost, the current flooring being modern chip-boarding.
- 4.19 Figure 15 shows the area of the southern elevation (interior) above the cart entrance, where interior lime finishes have been removed and the rebuilt stonework repointed in cement mortar.

Figure 15: showing the interior of the rebuilt section of the south elevation.

- 5.8 The 'authenticity' of the building has been reduced by the likely collapse of part of the southern elevation, which means that it is no longer possible to verify that the current appearance of this part of the building is representative of its original form; through the loss of its original flooring (at both first and ground floor levels); through the loss of original fenestration detail; and through the poor visual and historic quality of the lean-to extension.

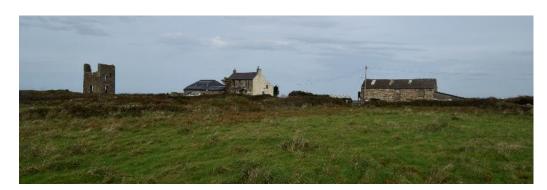
- 5.4 Figures 15, 16 and 17 show the buildings within the landscape, forming a coherent group with the Count House, Smithy and Engine House components of Wheal Owles.

Fig 15: The Wheal Owles group from fields to the south (BOTA1017_0010)

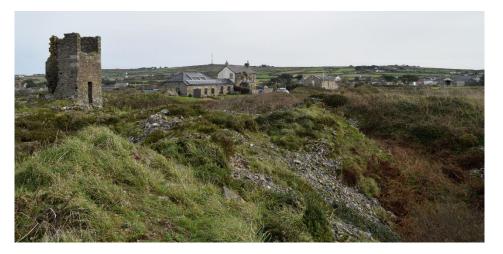
Fig 16: The group from the extant spoil heaps adjacent to the Engine House (BOTA1017_007)

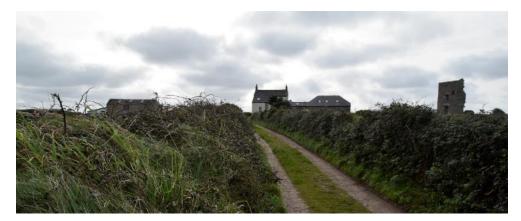
Fig 17: The group from the track (to north) leading to Wheal Parkanoweth (BOTA1017_0041)

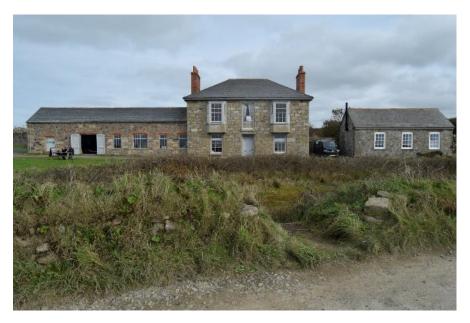
- 5.11 This landscape retains very strong mining related character, with some of the best preserved mine complexes here open to the public, including Botallack (fig 18) with its own Count House and Smithy group, Geevor Tin Mine and Levant Mine and Beam Engine.

Figure 18: The Count House and Smithy group (GII) at Botallack.*

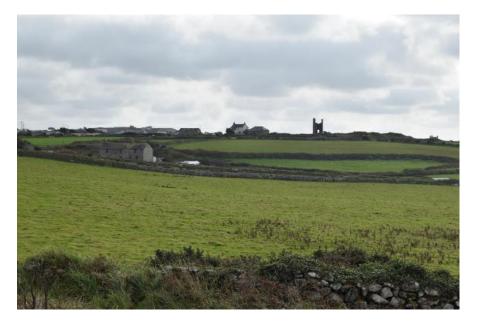
- 5.12 The Count House / Smithy groups at Botallack and Wheal Owles are inter-visible (figure 19), the stable forming a sky-line feature from in front of the Botallack Count House.

Figure 19: The view back from Botallack towards Wheal Owles

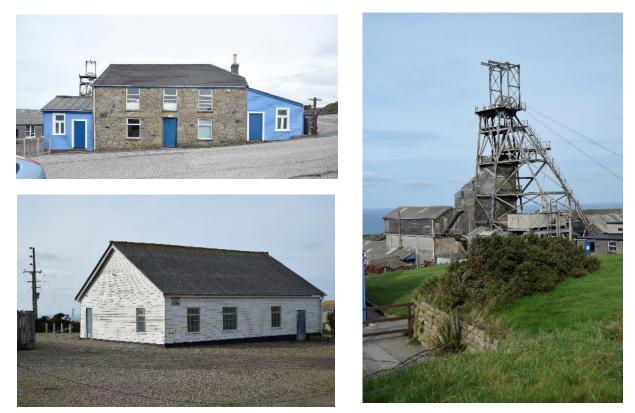
Figure 20: Uses of timber boarding around the Geevor Site within the St Just Mining District.

6.3 The revised design seeks to conserve and enhance the landscape contribution of the stables. The current concrete block extension is proposed for demolition and replacement with a two storey vertically timber clad extension. The design steps down slightly from the ridge height of the main range in order to ensure it remains subservient to the historic building. Wooden boarded buildings were commonly used to extend and augment mine buildings (fig 20). Its use here aims to reference this without pastiche. In discussion with the architect we have recommended the vertical boarding shown on previously supplied plans is amended to horizontal boarding.
