Statement Heritage

Kempthorne House, 4 St Peters Rd, Flushing, Falmouth, TR11 5TP

Archaeological Watching Brief KEMP0718wb

07/08/2018

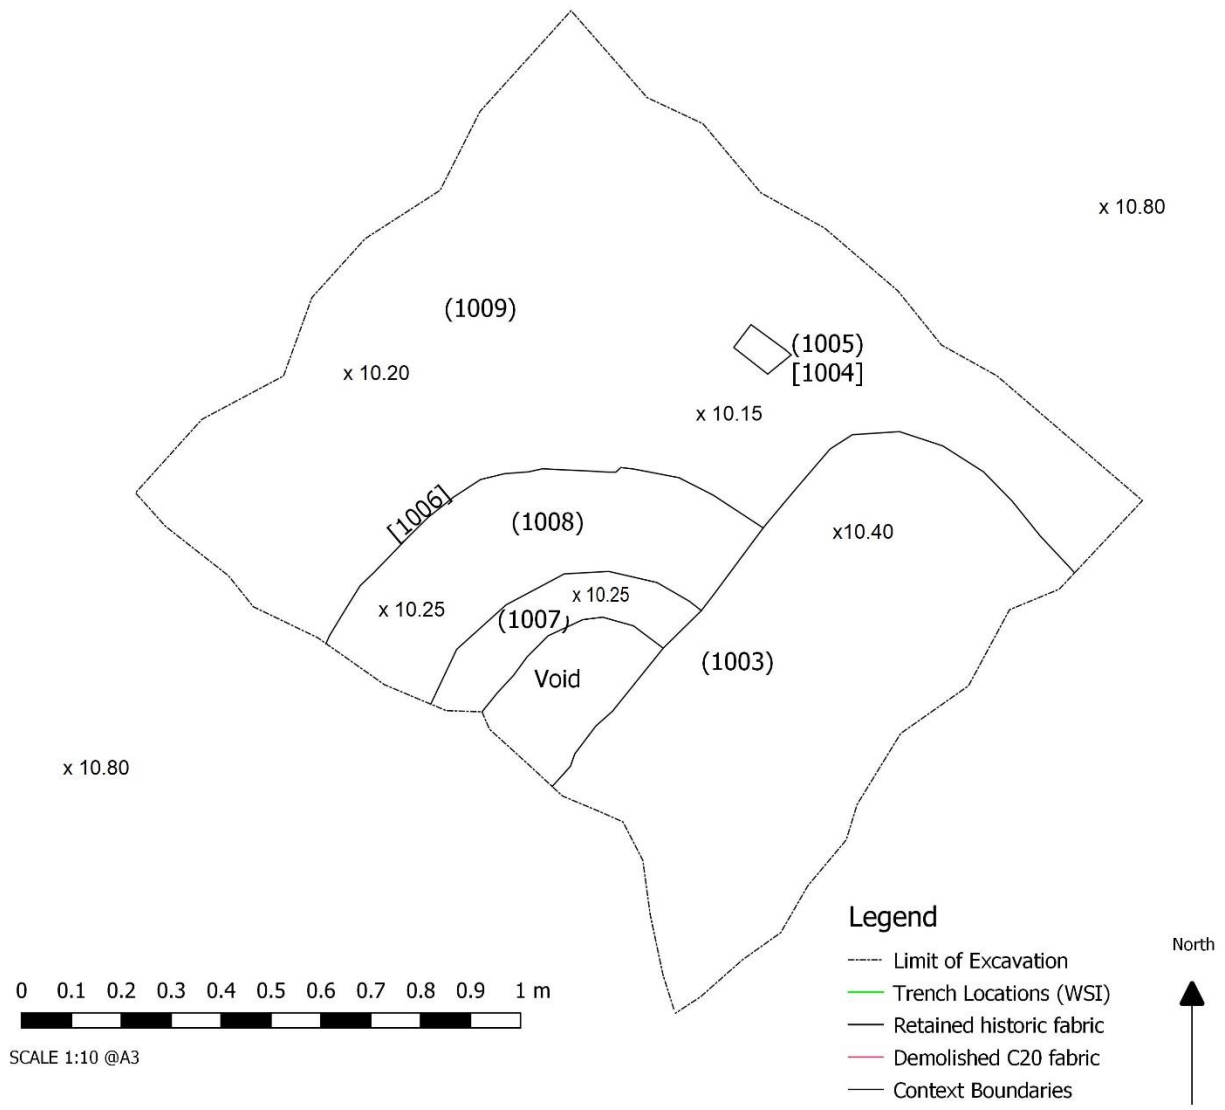
Plan 3 Trench 2	Project Code: KEMP0718 Project Name: Kempthorne House Flushing Surveyed: 18/07/2018 DJR Drawn: 09/08/2018 DJR	(c) Statement Heritage Do not scale from this drawing All dimensions to be checked on site.
----------------------------------	--	---

- 2.17 ***Test pit 1*** (plan 3 – photo figure 10) measured c.1700mm by 1400mm and lay in the south eastern corner of the site.
- 2.18 The latest deposit consisted of a late 20th century concrete screed (context 1001) averaging 80mm in depth. Below this lay an unconsolidated 80mm thick

layer (1002) of mixed lime and redeposited subsoil containing late twentieth century artefacts such as pvc wire sheathing along with 20th century pottery sherds. (1002) is interpreted as a modern sub-base laid in advance of concrete (1001) Directly beneath this layer is a circular well of approximately 500mm diameter (1007) which is constructed of regularly coursed killas blocks of approximately 100mm X 60mm set in a lime / clay mortar. The well is set in roughly backfilled (1008) construction cut [1006]. The well is cut into a natural periglacial clay (1009) with occasional slate stone inclusions and sealed by a massive limewashed granite flagstone (1003) to its east. Artefacts (mid twentieth century glass bottles) recovered from within the well by the demolition team prior to our inspection (figure 10 ii) indicate closure its closure in the mid 20th century. Examination of the well void from the surface revealed a culvert, presumably constructed to feed the structure leading from its south eastern side towards the adjacent property.

- 2.19 A square post-hole [1004] cut into natural (1009) may indicate a continuation of the stub wall 'G' across the range.
- 2.20 The demolition brief for the removal of the floor surface only required the removal of the consolidated concrete layer (1001) and so the well structure currently survives *in situ* and no further recording was carried out.
- 2.21 **Test Pit 2** revealed a simpler sequence of concrete overlying sub-base, overlaying natural.

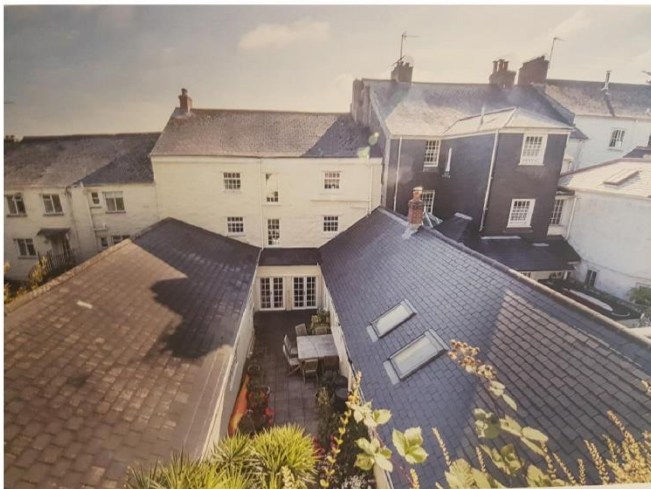
ii) *Below left - Modern (fibre cement slate) roof coverings of the rear ranges of Kempthorne House*

- 2.4 The entire range along the south east boundary of the curtilage is shown by **figure 3 ii** and **figure 3a**.
- 2.5 The **roof** of the structure was covered in late 20th century fibre cement slate, set on an entirely modern monopitch common rafter structure (**figure 7**). At its rear (along the property boundary) this structure rested on a historic stone wall to the north and south of the area consented for demolition.

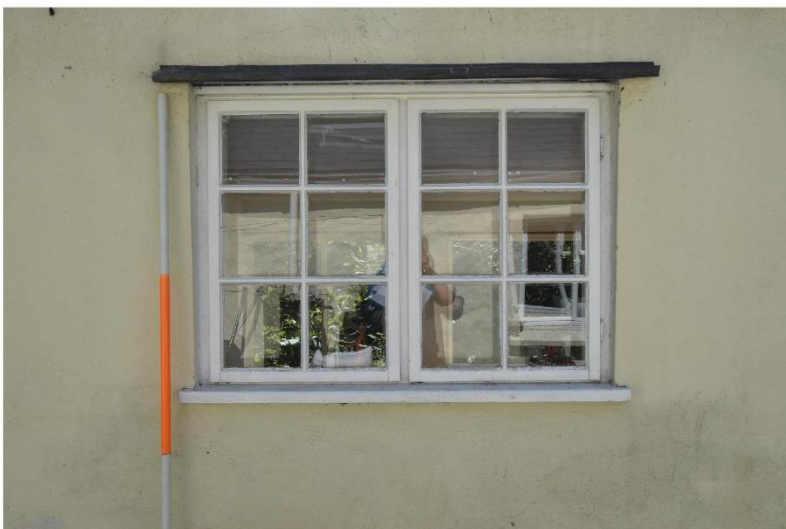
ii) Window 'A' Late 20th century 'weatherseal' type casement. The window has been set across the internal wall. Note cast iron rain hopper and downpipe to be retained (outside consented area).

wooden sliding sash. The central window ('A' on **Plan 1** / see **figure 3a ii**) was a late 20th century 'stormseal' type casement. The southernmost window ('B' on **Plan 1** / see **figure 3a iii and retained *in situ* during later work**) is a potentially reused 8 pane sash with lambs-tongue glazing bars, re-hung as a top hung casement. This window does not fit the space in which it hangs, overlapping the 19th century wall 'D'.

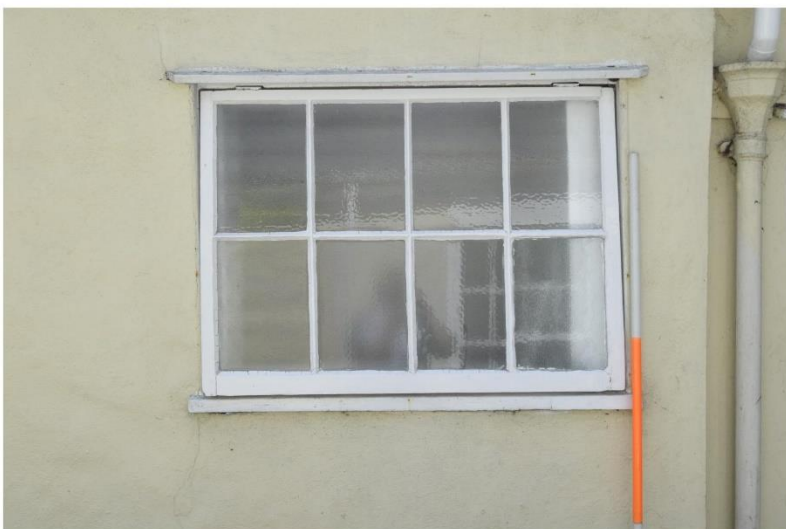
ii) Window 'B' Probably reset and reglazed 19C top hinged casement sash.

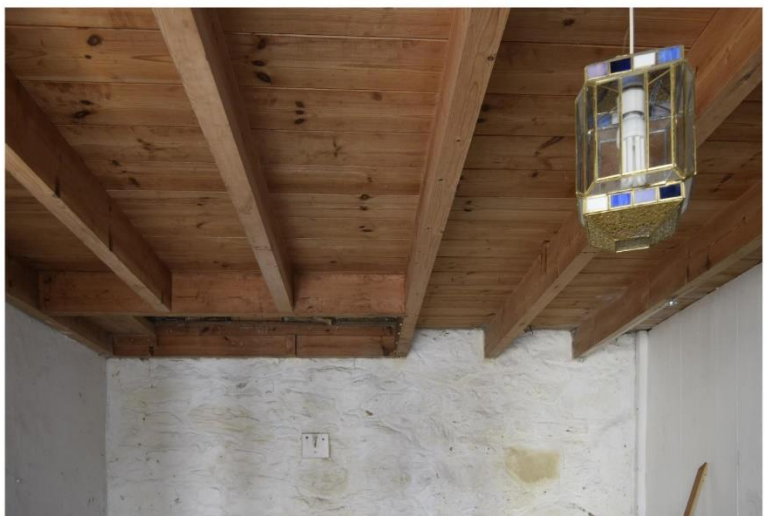
iii) Below right - modern first floor structure in room to SW of consent (to be retained).

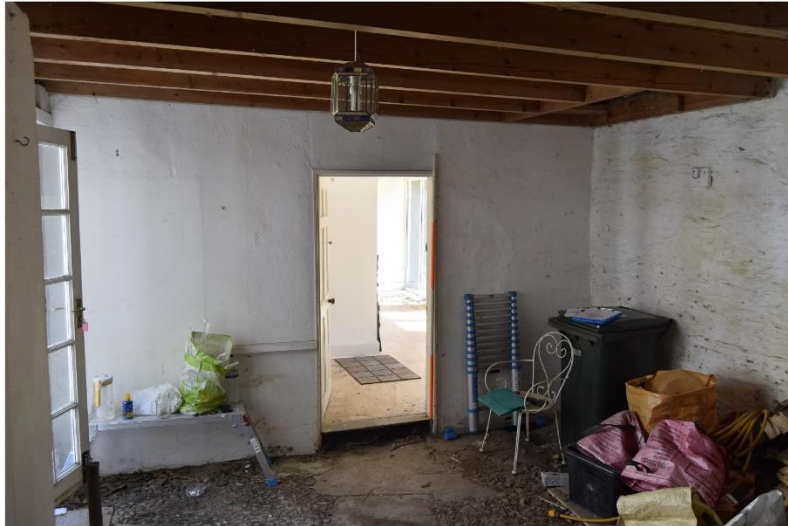
i) Dividing wall 'D' from the SW - - note evidence of older blocked door to left of shot. This wall is of thin stone construction - probably built as a non-supporting internal wall. Doorway is a wide stable-type internal door of early 19th century 6 panel style.

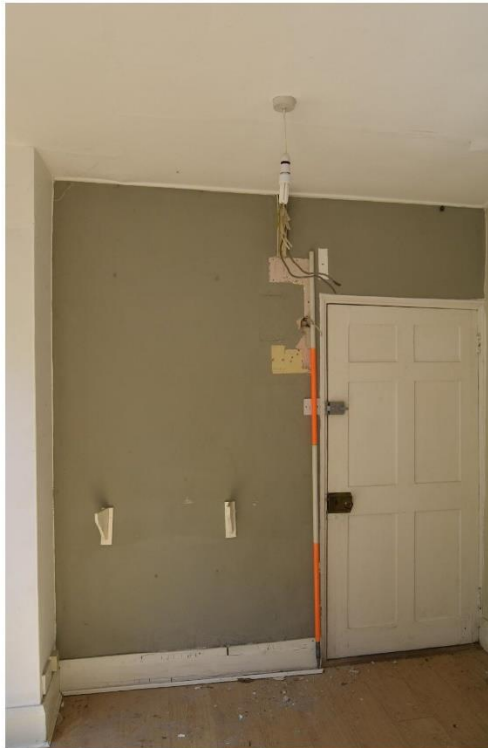
ii) NE elevation of wall 'D'. Modern cementitious plaster coating.

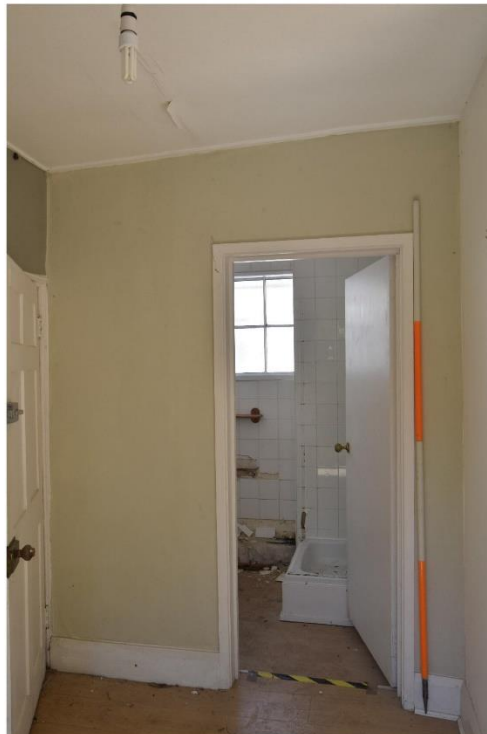
iii) Modern stud wall and door into WC / shower room - modern linings, ceilings and floor coverings

- 2.8 Internally the space was ceiled in modern plasterboard, and had been plastered out in modern gypsum based plasters or plasterboard. Modern walls as they existed prior to works are shown hatched in red on our sketch **Plan 1**. The WC / Shower area in the SW corner of the area for demolition was been formed in brickwork and timber stud / plasterboard.

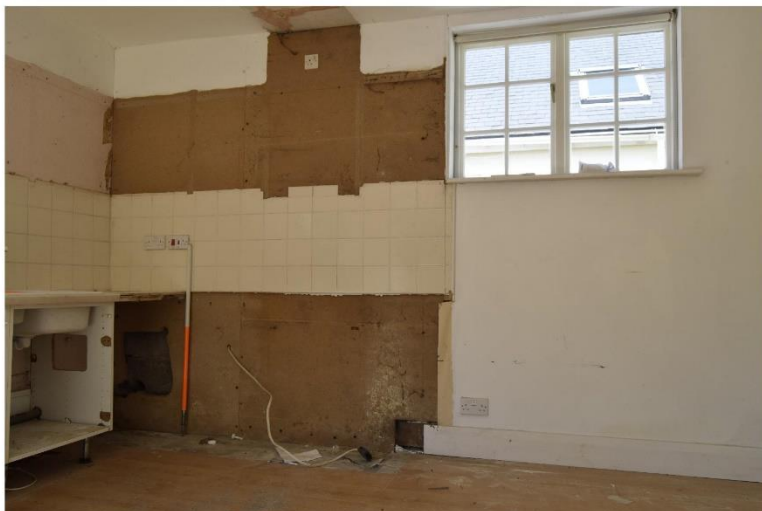
i) NW corner of space consented for demolition. Note exposed modern concrete blockwork to the left of ranging pole

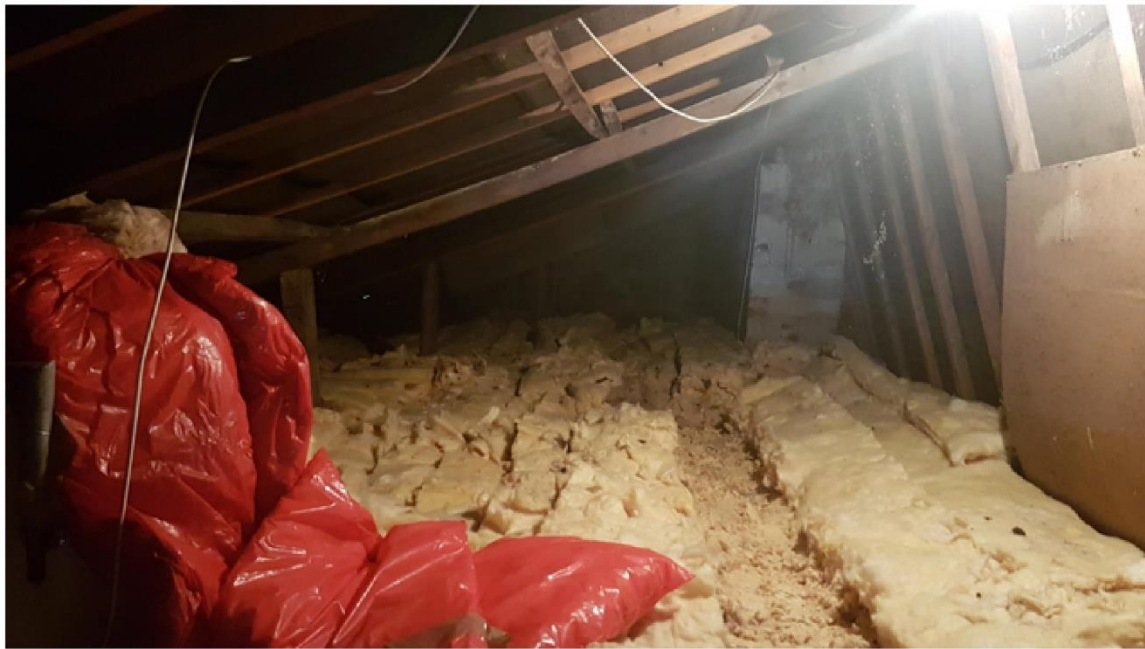
i) Interior of roof to be demolished looking NE. The roof structure is of entirely modern common rafter construction. The modern weatherboarding above the patio doors is to the right of shot. Behind is the top of historic stone wall 'E' which appears to be neatly quoined indicating that this wall always terminated at this point.

- 2.6 This **boundary wall** was broken by the current modern uPVC patio doors, which opened onto a small enclosed garden areas, shown on historic maps as having been a small rectangular building or glass-house. Above the uPVC doors this gap was closed by modern weatherboarding (see **figure 7** right of shot).

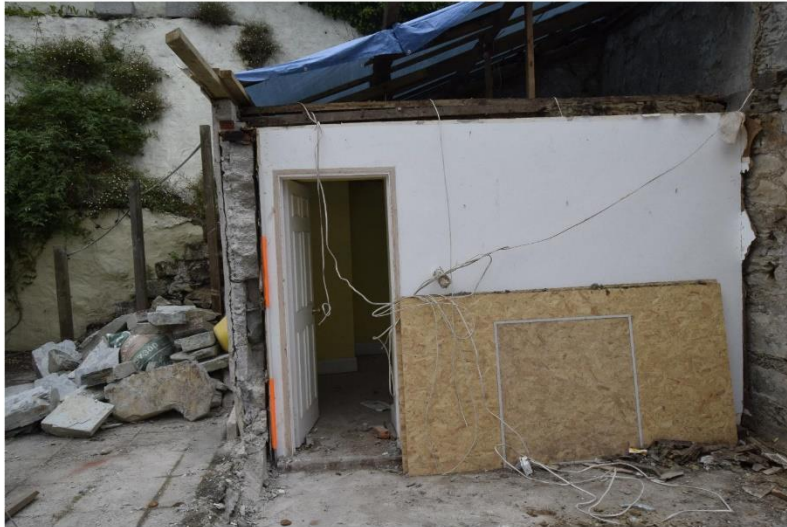
i) Looking north east towards retained wall at edge of site. This wall is a historic timber stud wall faced with blockwork to its south western face.

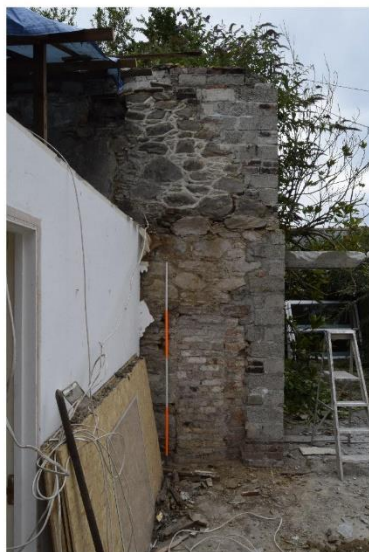
iii) Wall 'E' (see Plan 1), as predicted a historic stone wall.

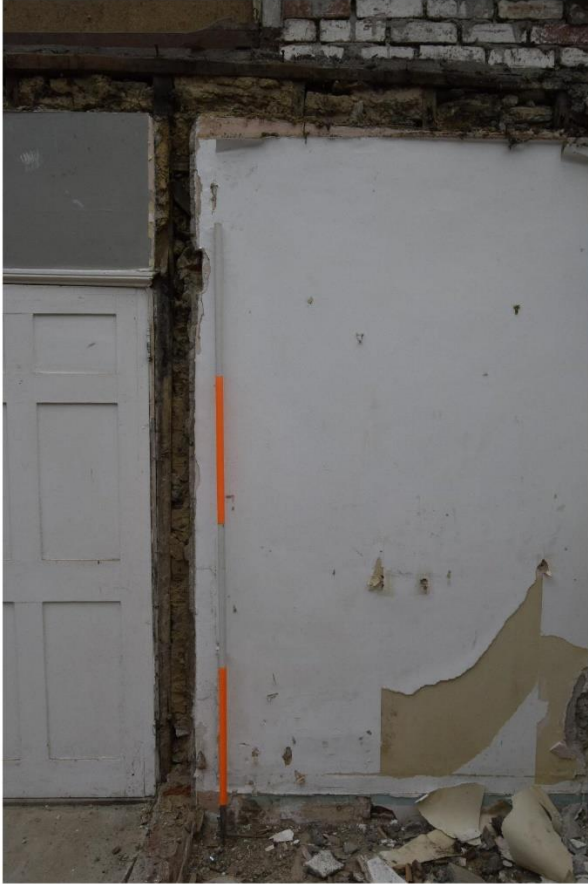
i)(above) Wall D. Timber stud construction with mud and stone infill visible at top where modern ceiling has been removed. Plaster is modern.

- 2.13 *Photographic recording* (figure 8) on demolition revealed further constructional detail of walling 'D', 'F' and 'G' (figure 9)
- 2.14 Removal of the modern ceiling above Wall D, revealed that this wall is constructed of timber studwork infilled with mud and stone. This constructional technique has the characteristics of early 19th century work, which would accord to our stylistic dating of the door set within it (see above). The plaster covering to the north east side of this wall is confirmed as being modern in character being composed of gypsum-based plaster.

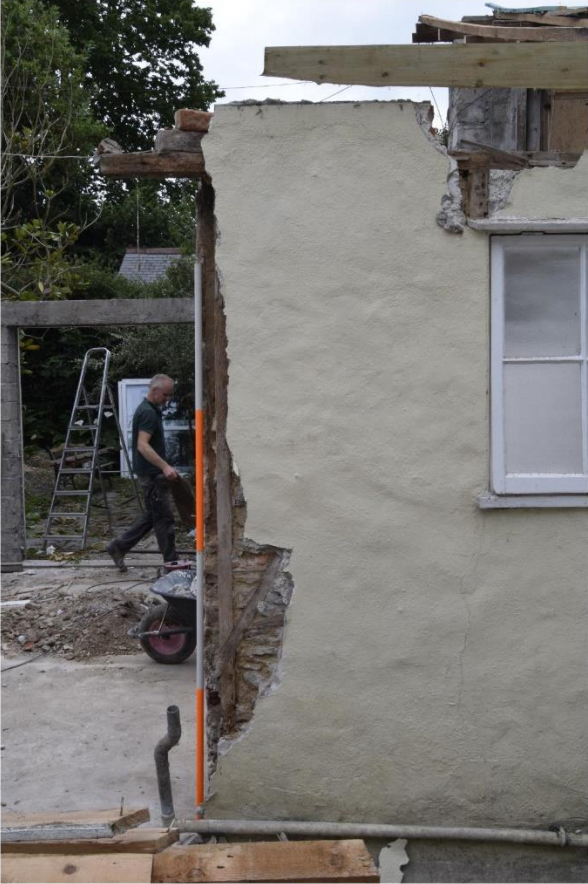
ii)(above) Wall F: Timber and stud construction visible at left-hand side beneath modern cementitious render

- 2.15 Removal of modern cement render as a result of the demolition of modern blockwork walling to its north east shows that the retained section of the north western elevation of the former stable 'F' is of similar character to that wall 'D'.

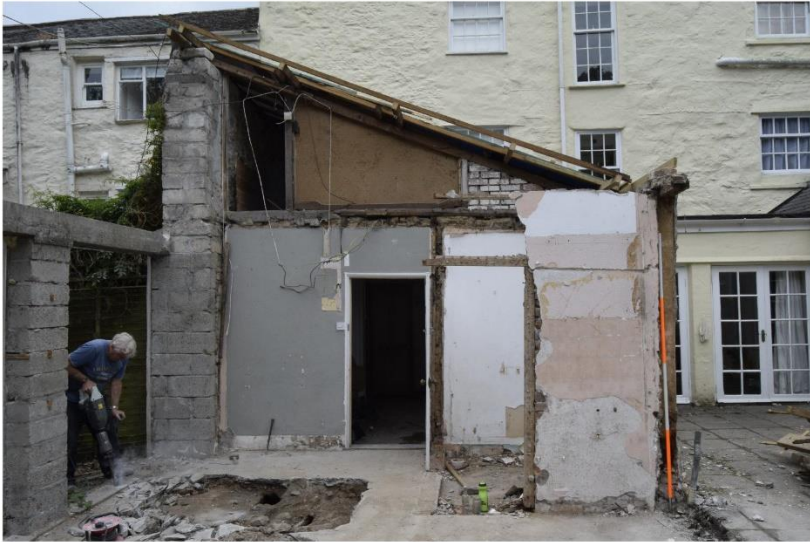
oii)(below) Wall G (nearest camera) is butt-jointed to 'F' and of timber and brick infill construction, faced in modern plaster.

- 2.16 Wall 'G' (at right angles to this stub) is also of 19th century date but is butt jointed to 'F'. This wall is constructed of timber studwork infilled by re-used brick. We would interpret this wall as later than 'F' as it is not joined into it, but has been constructed to abut it. To the south east of the section retained the wall had been rebuilt in modern timber and plasterboard stud work.

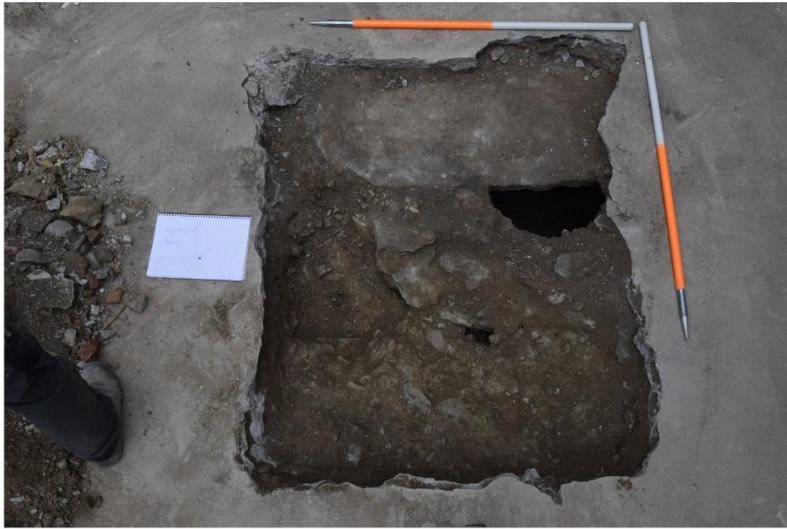
i) Trench 2: (NW to top of picture) showing the late 18th century / 19th century well and its covering slab

- 3.6 The survival of a post-medieval well may indicate an original feature of the stable, or it may be a feature pre-dating its construction. It is of local archaeological significance, is currently adequately conserved *in situ* and its retention in any future design should be considered.

- 4.2 The rebuilding of the range in the later 20th century (stylistically datable by the materials used) involved the laying of a concrete floor, sealing a well which may have been contemporary with or slightly earlier than the stable block, the rebuilding of a central section of the range in concrete block and its re-roofing with mostly modern materials. Any historic floor structures in the area of the site were removed in preparation for laying the new floor, although the well itself was retained, sealed by a large re-used granite slab.

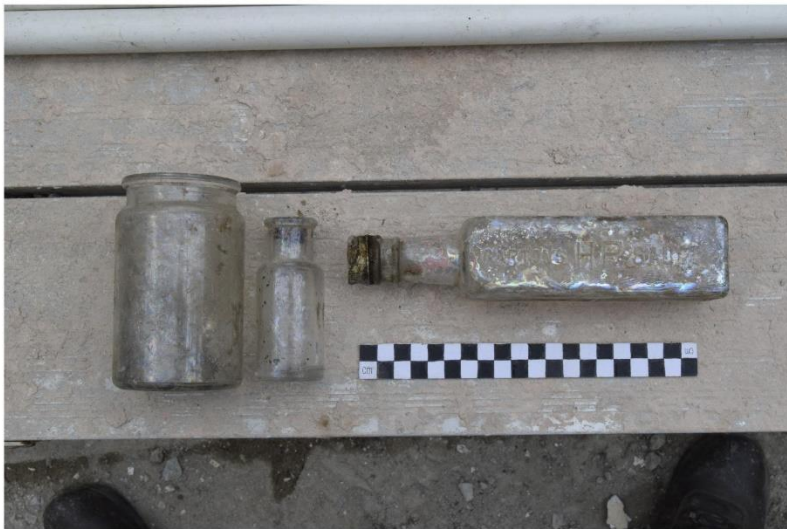
ii) early / mid 20th century bottles recovered from well by demolition team
