## Former Council Highways Depot, Access to Tredavoe, Newlyn, Penzance Cornwall.

Heritage Impact Assessment:  
SH Ref GOLD0918  
28/09/2018

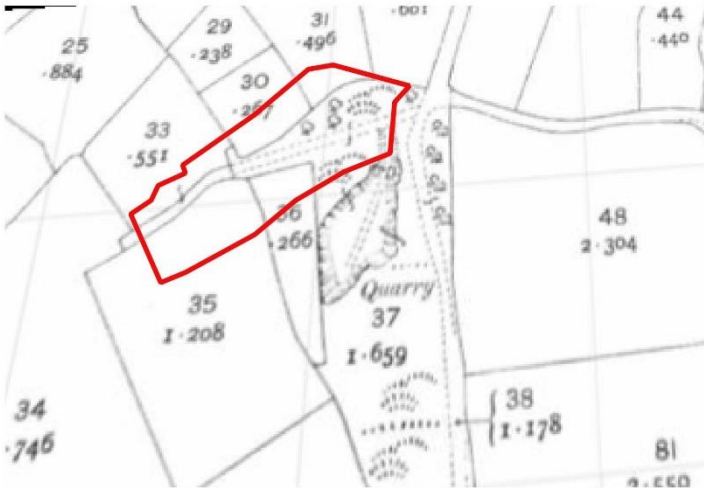
ii) 1908 OS 1:2500

- 2.9 The 1908 mapping shows that a small quarry (c 40m by 30m) had been established to the immediate south of the current proposed development area. No records of this quarry have been identified by this assessment, but it is recorded from the same source and from 1946 aerial photography by Historic Environment Record MCO 51693, which also notes 'an associated spoil heap to the north-west of the quarry at SW45427 29137.

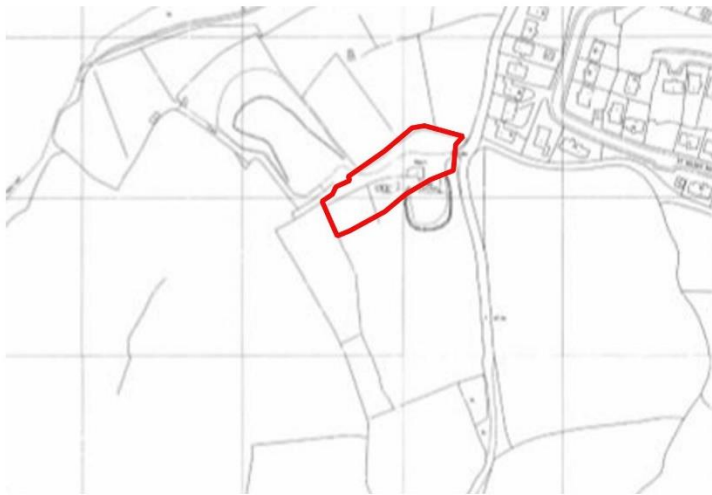
ii) 1994 OS 1:2500

- 2.12 No further significant changes to the site are indicated by the 1983 mapping, but the 1988 and 1994 1:2500 surveys show the largest of the former quarry buildings as a 'depot' (presumably the 'former council depot' that gives the site its current name), and indicate that an area of the mid-20<sup>th</sup> century spoil heap to its immediate south had been re-excavated to the width of the former quarry (approximately 25m at this point) as shown by the earlier mapping.

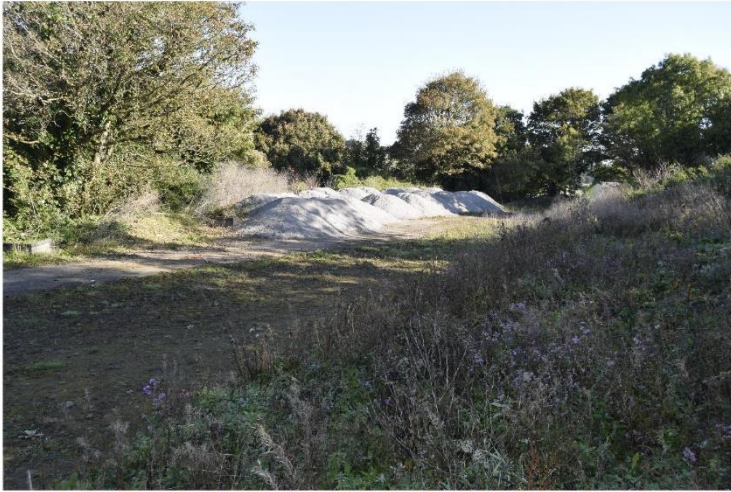
*i) Looking across the site facing NW from spoil-heap 3*

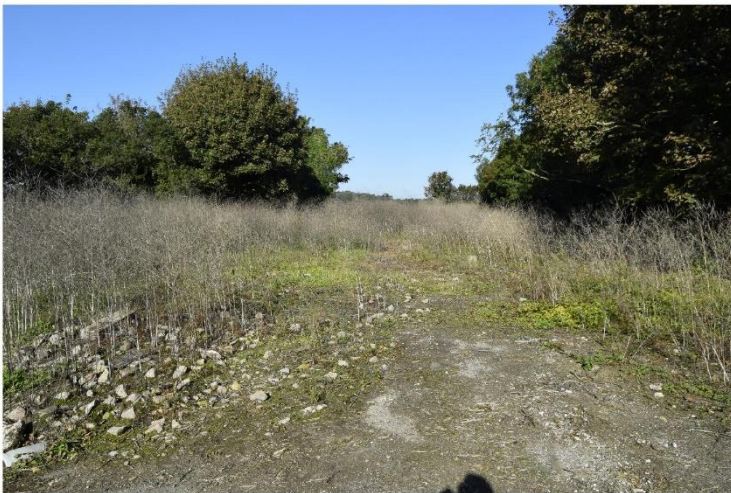
- 2.17 The compressed hardcore surface extends across the top of the spoil-heap to the northwest (spoil-heap 1). The sides of this spoil-heap are supporting maturing self seeding trees and scrub, whilst its level top is largely clear of trees whilst supporting low-level herbaceous scrub.

*ii) Looking NW from site along the top of spoil heap 1*

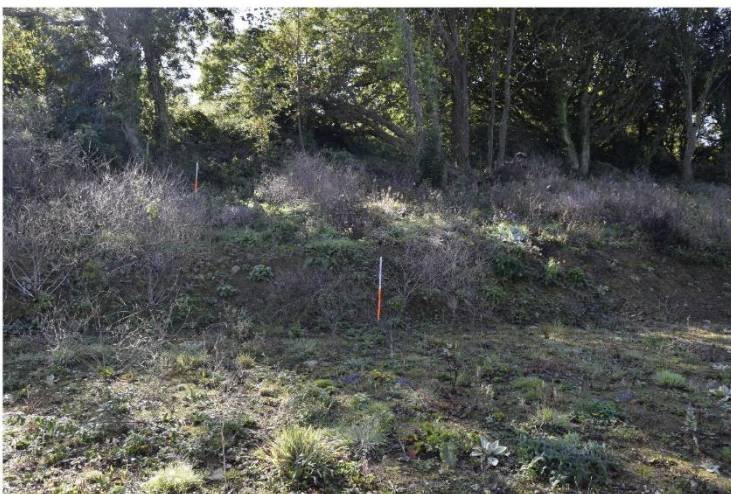
- 2.19 Spoil material 3 has been tipped against an older higher in profile volume of spoil (spoil heap 2) which lies between 10-20m to the south of the development site. This material is supporting maturing trees and well-developed scrub vegetation.

*ii) Looking S from the centre of the site. The nearer 1m ranging pole is at the edge of spoil heap 3; the further 1m pole marks the start of spoil-heap 2. Foreground is a mix of broken concrete and tarmacadam*

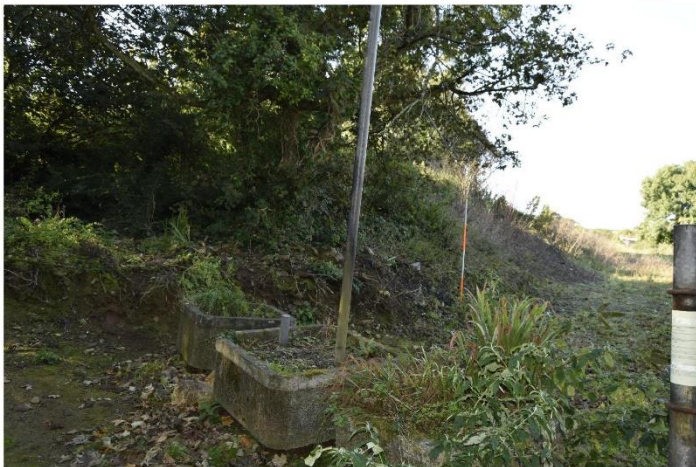
- 2.18 To the south of the site the area of the quarry re-excavated between 1983 and 1988 is no longer apparent, the southern boundary of the site being formed by a low (c1.20) bund of spoil which is relatively free of vegetation perhaps indicative of fairly recent deposition (see figure 4). This less vegetated material (spoil-heap 3) was observed to contain demolition material, tarmac and modern plastics.
-

*ii) Looking SW from site entrance towards the backfilled quarry entrance, now overlain by spoilheap 3*
