Statement Heritage

Farmhouse and Stable Block, Duporth Retirement Living, Bay View Road, Duporth, St Austell, PL26 6BD
Heritage Impact Assessment: SH Ref DUPO0518
17/05/2018

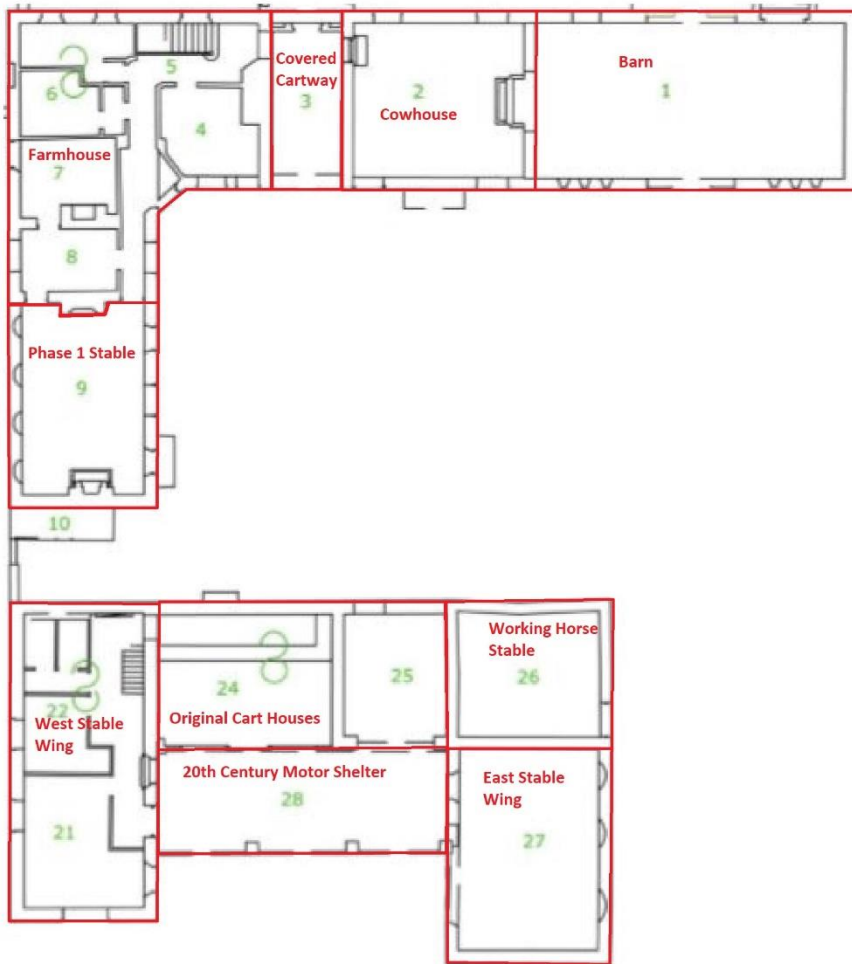
Figure 2: Room Numbering

Overlays in red show original functional use of spaces

- 4.1 The buildings are to be found at 'Duporth Retirement Living Bay View Road Duporth, St Austell, Cornwall, PL26 6BD.
- 4.2 The buildings are described in detail within the Cornwall Archaeological Unit's 'Historic Building Record' (Thomas, 2018). This provides a very comprehensive evidence base against which to make the current assessment. Whilst the buildings have been inspected on the ground to critically assess the interpretations contained within this work, we do not depart from their essential findings and have drawn upon this evidence liberally below and use the room numbering established by Thomas (reproduced at figure 2) in our text.

- 4.6 To the north is a 'L-shaped' '**Farmhouse Range**'. The original farmhouse occupied the footprint of ground floor rooms 4,5,6 and 7 and would have contained accommodation over two storeys.

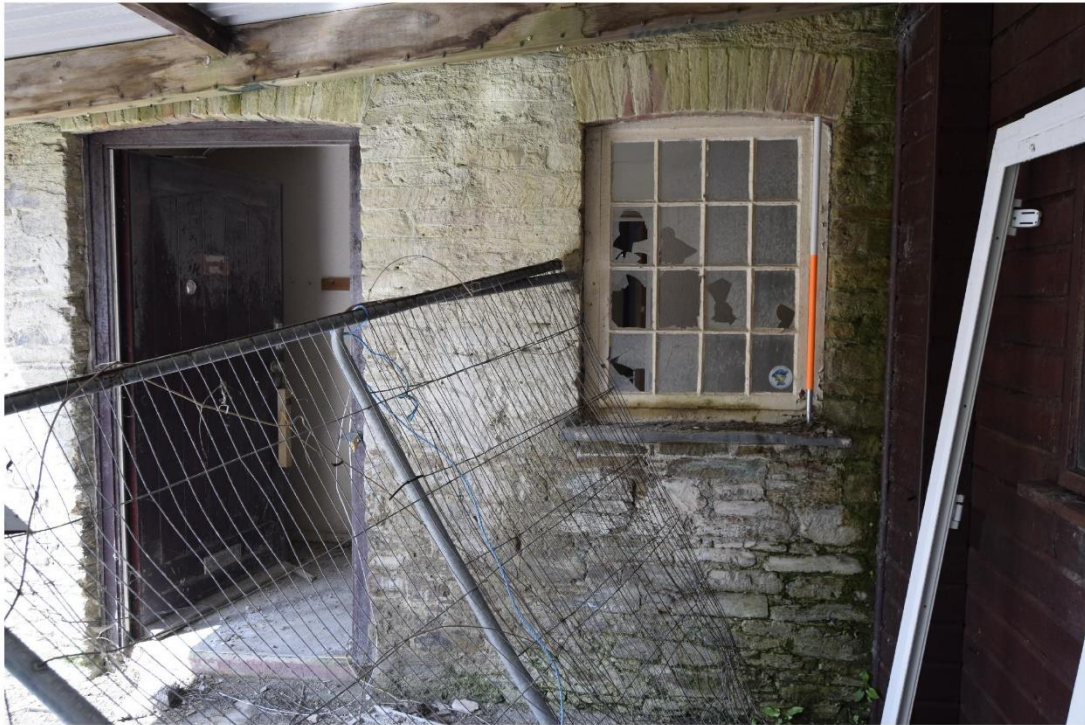
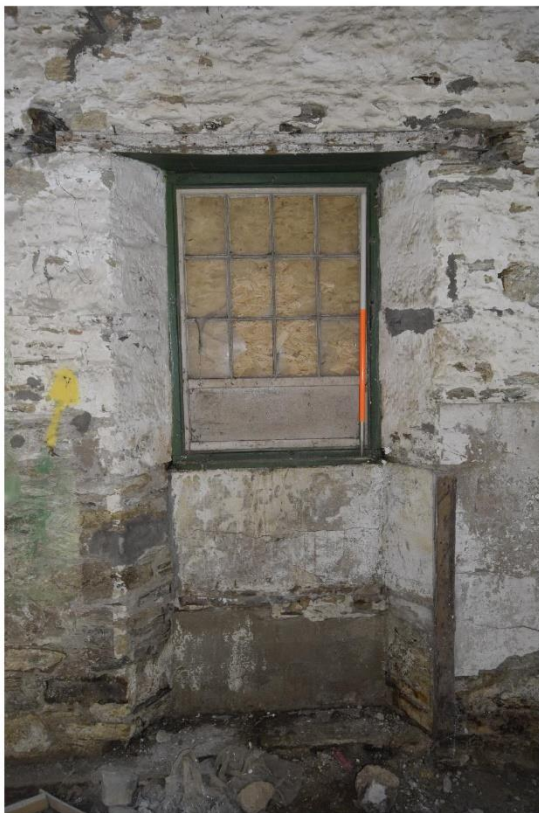
Figure 4 Stable Windows

The two surviving 19th century windows of the stables wings are multiple paned windows with internal lambstongue glazing bar details in horizontally pivotted units.

These windows look out into the 20th century motor vehicle shelter. (Scale divisions 500mm)

- 4.14 Original multi paned sash windows with horizontally pivoting fixings survive facing into the carriage yard from the side wings (figure 4). The 1947 aerial photograph shows that these windows are representative of the fenestration of other openings of the Stables wing, although some appear to have larger 4 pane windows.

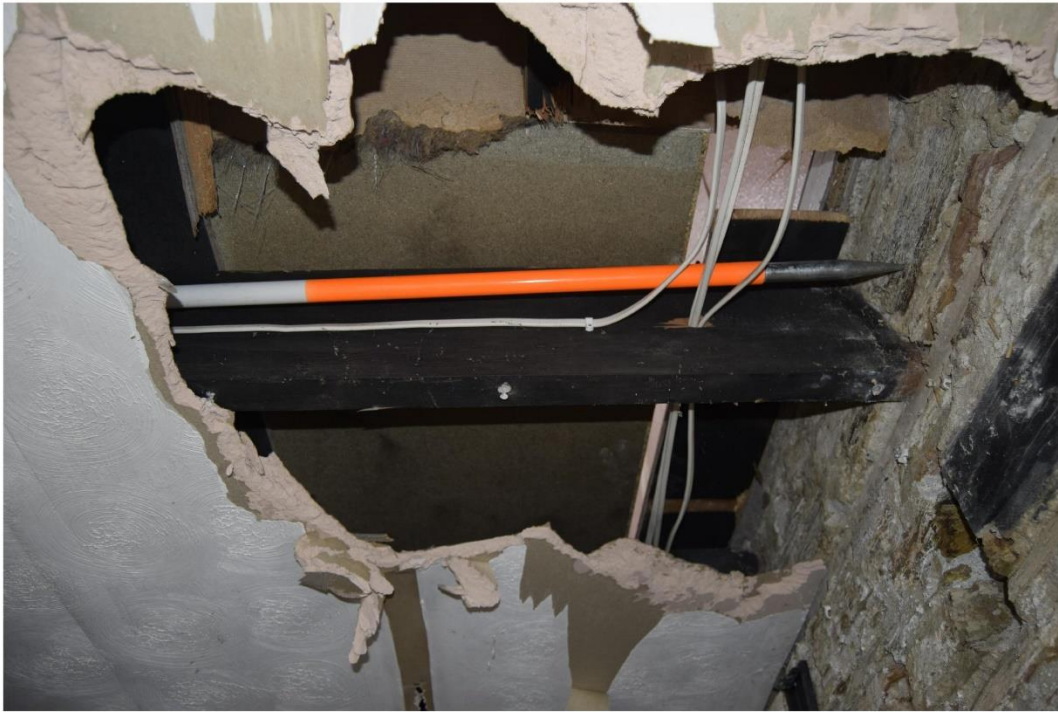
Figure 5 Stable Wing First Floor Structure

Opening up by structural surveyors (above) shows the modern and undersized joists of the first floor of the west wing of the stables.

Below, filled joist holes in the east wall of the wing (indicated in red) where the modern open string staircase has been inserted. These evidence the earlier floor beams, and that the original stair (if more than a ladder was provided) to the hayloft was elsewhere.

- 4.16 A 5th phase, dated by Thomas to the 1960s or 1970s involved the re construction of the 1st floor of the western wing (figure 5) and the insertion of a modern open string stair, the creation of a bar area and internal subdivisions. Much re-fenestration appears to have accompanied these works including small pane wooden casements and standard uPVC units. These are all of low quality and have failed (figure 6) the wooden examples being of much poorer build and material quality than those used in the 1930s works, and having 'stormseal' type overlapping closures rather than the concealed flush fittings of the earlier casements fitted to the Farmhouse range. As with the Farmhouse range there is a significant

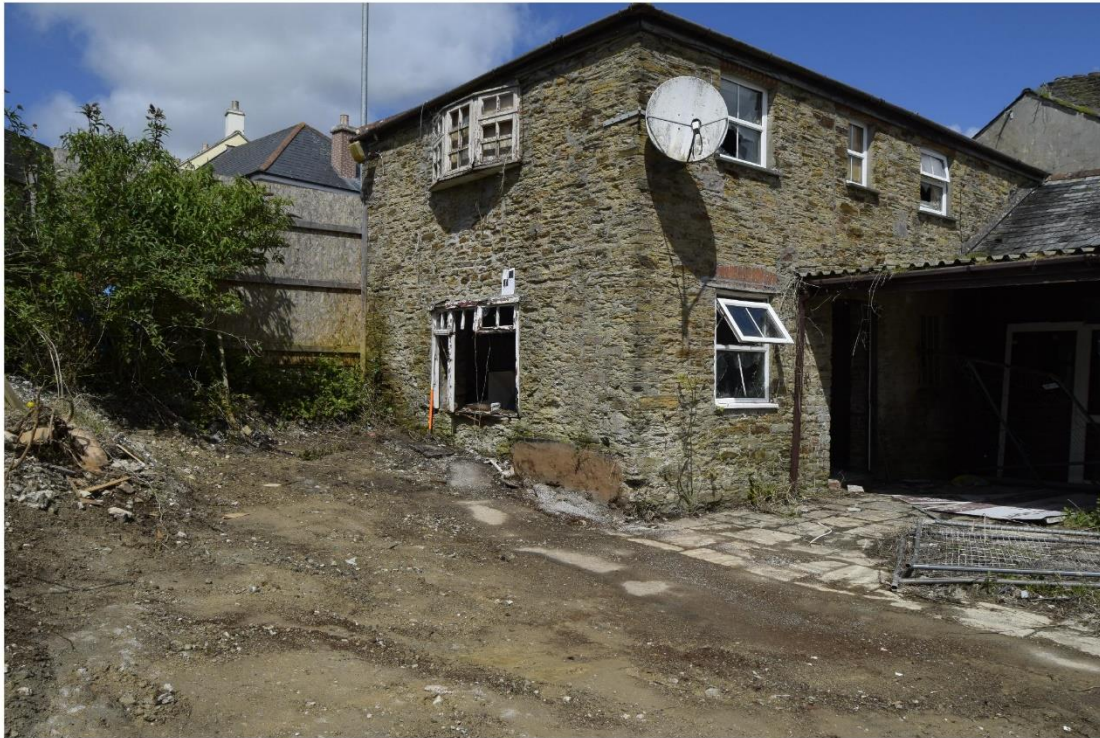
Figure 6 Stable
Wing modern
window joinery

Apart from those shown in figure 4 the windows of the Stable wing all post-date those shown in 1947 (fig 3) and are a mixture of very poor late twentieth century bay casements and uPVC units. The uPVC units are within historic openings, the wooden casements have been let into what was previously likely to have been a blank wall, although this is obscured on the 1947 photograph.

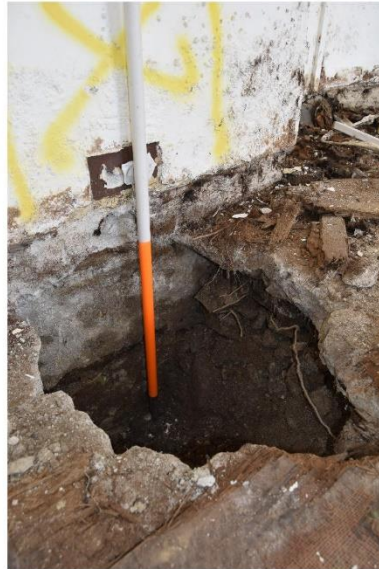
Figure 7 Foundation test pits showing concrete floor and historic levels.
(dug by structural surveyors prior to our visit)

This test pit is against the west wall of the Phase 1 Stable of the farmhouse wing (Thomas's room 9). The original floor level can be interpreted from the surviving limewash below the modern concrete floor level. The pit goes down to a clean natural clay approx 600mm below modern floor level, overlain by 450mm of loose unconsolidated stoney rubble overlain by 150mm of modern concrete without visible DPM.

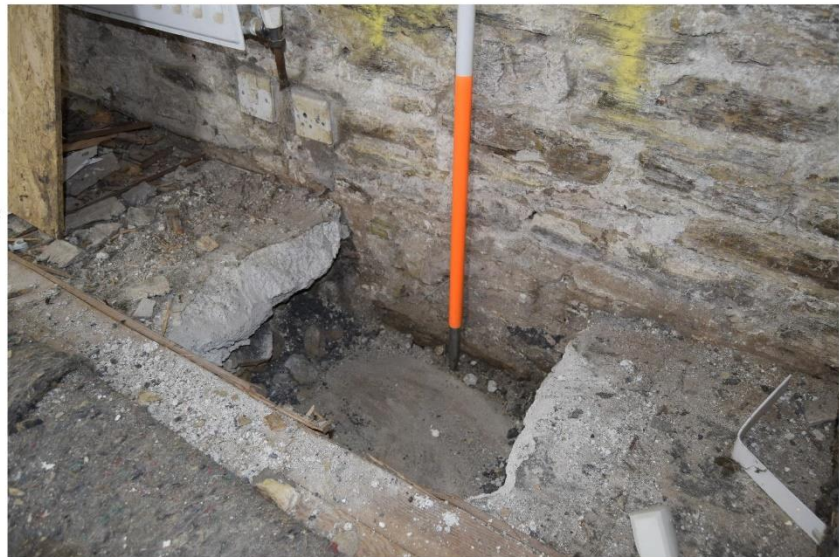
(right) Against the southern wall of the Cowhouse (room 2) this pit goes down to a surviving flagstone floor overlain by approx 200mm of rubble and 150mm of modern concrete. No DPM visible. Again limewash on the walls is older than the modern floor.

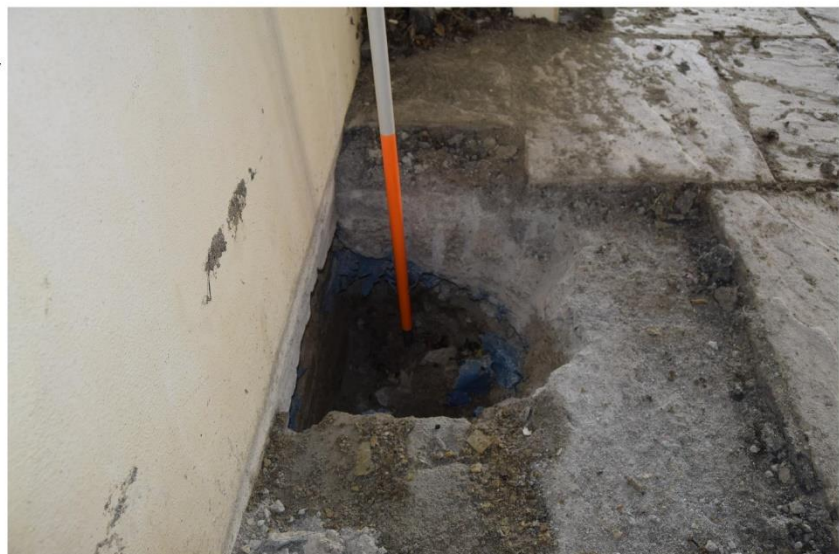
(below right) Against the eastern wall of room 25 (a former cart shed within the Stable Wing) showing evidence of later 20th century work here in the cement based render to the wall, the polyurethane DPM and the thicker dustier concrete screed.

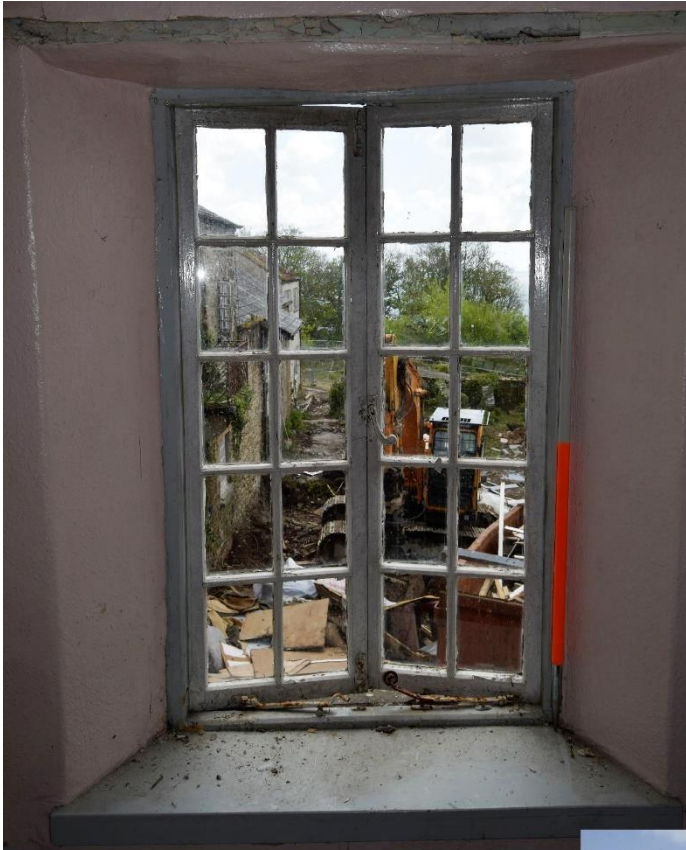
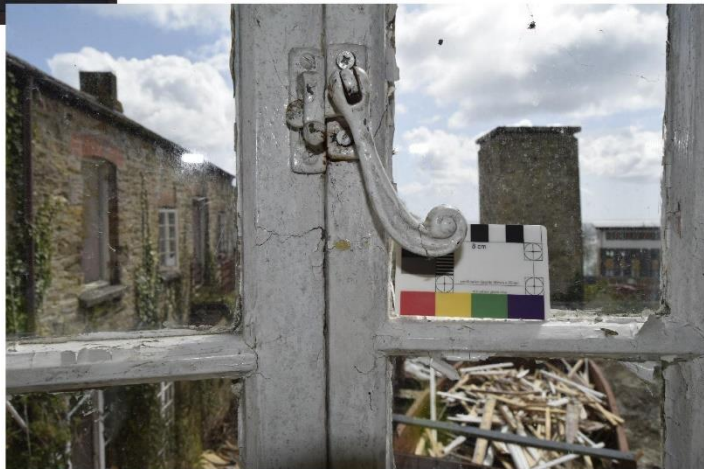
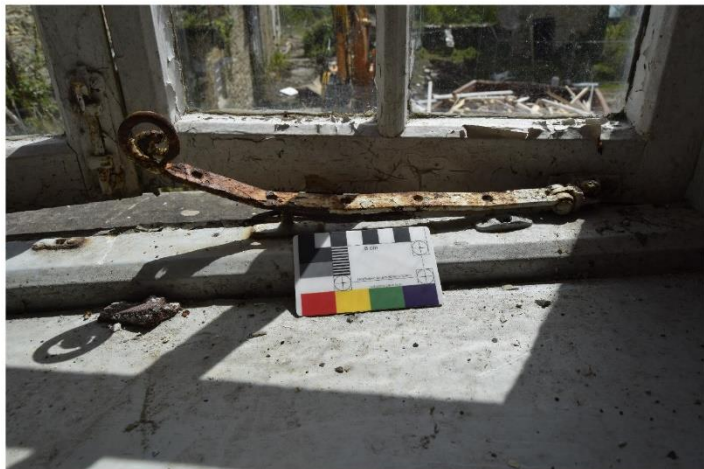
Figure 9 1930s Casement windows (farmhouse range only)

Left - typical pattern of 1930s casements within the stable range (the other side of the window shown on the cover illustration.

(right) Catch detail

(below right) stay detail
