Land to the West of Shute Lane, Pensilva PL14 5QE

Heritage Impact Assessment within a World Heritage Site: **SH Ref SHUT1218** 14/12/2018

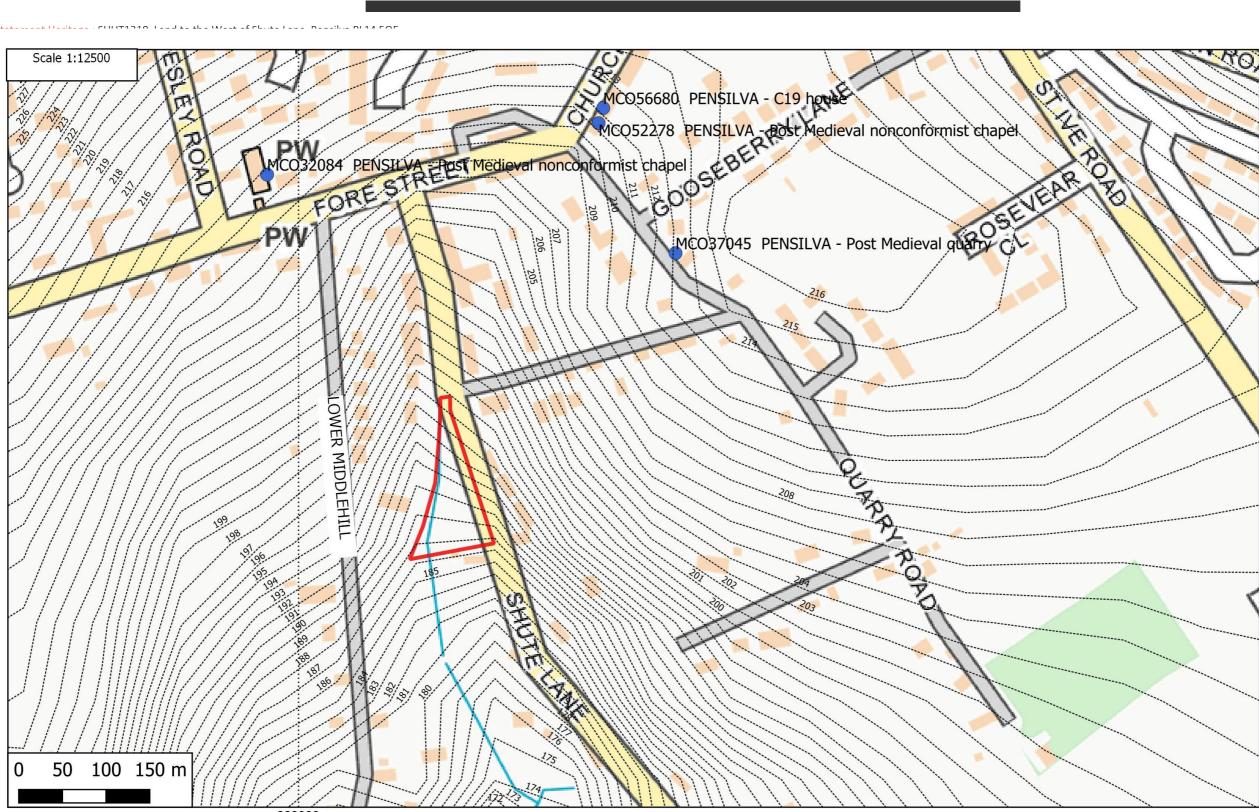
Figure 2 Topography and HER records	Project Name: Shute Lane, Pensilva Project Code: SHUT1218	Layout (c) Statement Heritage Contains OS Opendata (c) 2008 Crown Copyright and Database Right All Rights Reserved 100059271 Topography modelled using OS Terrain 50 opendata
---	--	--

- 2.5 <u>Topographically (figure 2) Pensilva</u> lies close to the east of the granite upland Bodmin Moor, with the summit of Caradon Hill at 375mAOD being about 2.5km north west of site. The proposal site lies on the upper eastern slope of the valley of a tributary to the River Tiddy. This stream, which only runs in wet weather (client pers.comm.). The stream forms the western edge of the site, with Shute Lane forming the eastern boundary. Beyond the southern boundary lies South View a mid-19th century cottage pair. The site lies between 194mAOD and 187mAOD with land to east and west sides at higher elevations.

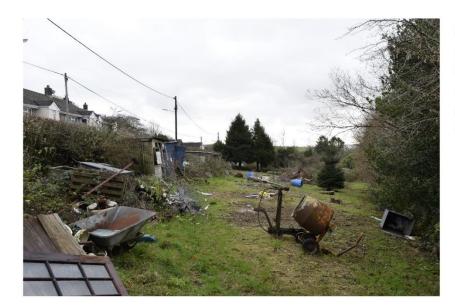
i) Looking south across the site note modern housing beyond the boundary to left, late C20 allotment sheds and outgrown Norway Spruces - leat is to right of shot

- 2.25 The general character of the interior of the site is shown at figure 7.
- 2.26 Evidence of abandoned allotment cultivation is apparent in the form of a range of derelict wooden and corrugated metal sheds along the eastern edge of the site. The site includes a number of modern trees, notably outgrown Norway spruces, probably originally planted as Christmas trees during this use.

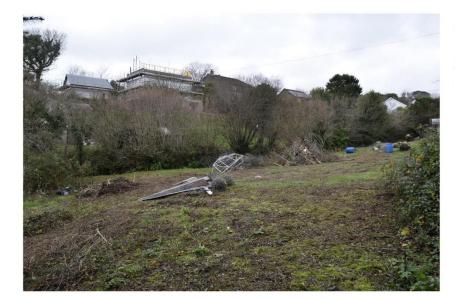
ii) looking north west across site towards the leat with outgrown hedgerow immediately beyond and (behind that) the modern housing along Lower Middlehill

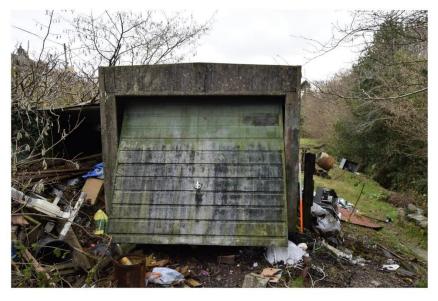
iii) Modern concrete panel garage at north of site

- 2.27 A concrete panel garage with up and over door is sited to the north of the site this building does not appear on any historic maps, but is considered likely, on stylistic grounds, to have been built between 1960 and 1980.

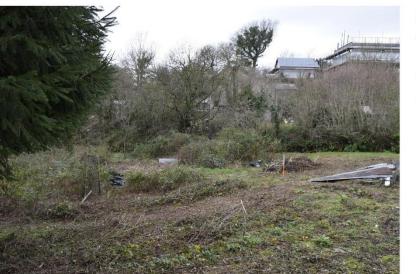
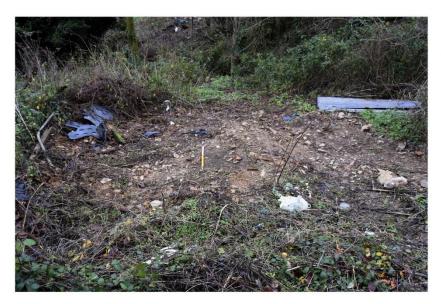
Figure 8 Site of demolished cottages

i) To left of shot is the site of the cottages demolished between 1888 and 1908, clearly discernable as a terraced in area of the site.

ii) site of recent geotechnical percolation test pit.

- 2.28 The site of the cottages shown in 1880 corresponds to an area of the site which appears to have been excavated and levelled (figure 8) Part of this site has recently been excavated in the course of percolation testing.

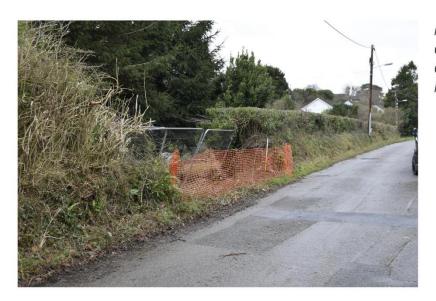
i) Eastern boundary of site. A Cornish hedge dating to the mid C19 with well established and laid hazel woody growth

- 2.29 The eastern boundary along *Shute Lane* (figure 9) is formed by a Cornish hedge boundary, consisting of a stone-faced earth bank of approximately 1.2m width and height along which well-established woody species, with traditionally laid hazel dominating, are established (Lees 2018). This boundary type has been noted as characteristic of those laid out across *Middlehill* (Payne 2008, 7-8) would support a mid-19th century date. The boundary is not

considered to constitute an *Important* hedge per the Hedgerow Regulations. An entrance has recently been formed within this boundary towards the south eastern corner of the site.

- 3.8 The sole surviving component within the site which contributes to the integrity of the OUV of this part of the World Heritage Site is the Cornish hedge boundary forming its boundary with *Shute Lane.* This boundary is contemporary with the establishment of the *Middlehill* smallholder landscape and is *authentic* in terms of its material, style of construction and botany.
- 3.9 Within the setting of the site, whilst compromised in terms of their *authenticity* by their adaption and modernisation, the surviving cottages to the south, and east of the site, in addition to those which survive elsewhere, and the underlying boundary pattern in which they are set, all contribute to the remaining *integrity* of *Pensilva* and *Middlehill*.

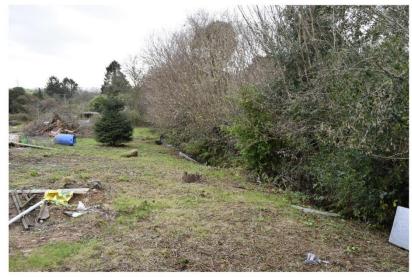
iii) leat along western boundary

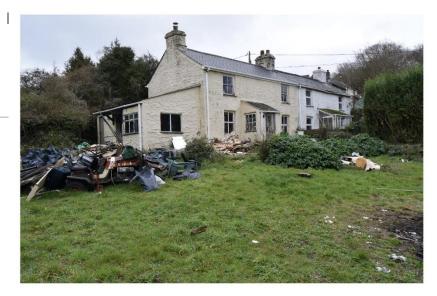
i) South View Cottages (immediately south of site). These south facing cottages are better preserved than most of the Middlehill cottages. Modern extension to left, replaced roof coverings, replaced windows (no 2), mid 20C porches. In 1888 these buildings were subdivided into 4 dwellings - evidence for blocked front doors survives in both of the current houses.

- 2.30 Surviving cottages (figure 10) have been identified at 1-2 *South View* to the south of the site; 1-3 *South View Cottages* to its south east; and at no 17 *Shute Lane*, as well as more generally amongst later 20th and 21st century infill between the lanes linking *Shute Lane* and *Quarry Lane*. All of these cottages have been significantly altered in their history, for examples the southern extensions added to nos 1 and 2 *South View Cottages*, the rear extension to no 2 *South View*, side extension to 1 *South View* and the external pebble dash rendering of 17 *Shute Lane* originally a cottage pair. *The Glen* to the west of the site may represent rebuilding of earlier conjoined short cottage rows on the same footprint, although the character of what remains is modern.

- 2.31 Of those surrounding the site 1-2 *South View* represent the closes to their original form, although both feature later extensions and porches, have been re-roofed, have had windows replaced, and may have been subdivided and (re)amalgamated in their history. Both show evidence in their principal elevations of having been subdivided into two dwellings at some point, before becoming the pair of cottages that survive today, an interpretation supported by historic mapping.

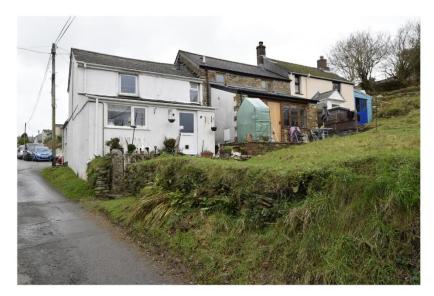
ii)South View Cottages (south east of site). Original character much harmed by late 20C extensions added to the south fronts of these single aspect dwellings, by the loss of original roof coverings and chimneys and by innapropriately replaced windows.

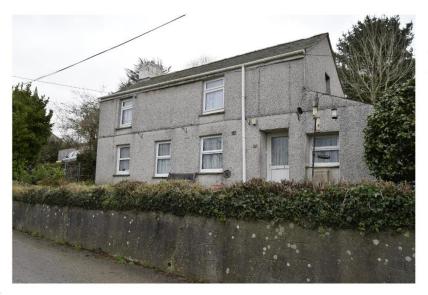
iii) 17 Shute Lane (NE of site) is shown on the 1883 map as a cottage row of three, which had contracted to two in 1906. The deep door reveal and overall mass of the building suggests the survival of at least some original fabric survives beneath modern finishes although nearly all the historic character and distinctiveness has been lost.

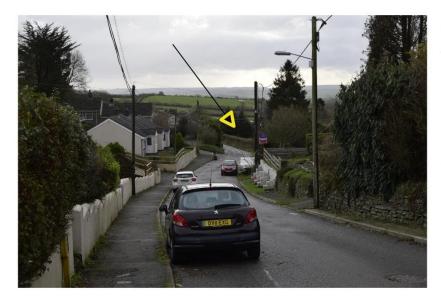
i) Looking south down Shute Lane from Pensilva village centre. Modern suburban property boundaries and the 1960s council bungalows to the left of shot show the modern character influences around the site. Older enclosed landscapes beyond.

- 2.32 To the north of the surviving cottage rows the remainder of *Shute Lane* has a late 20th century character (fig 11), illustrated by the Local Authority developed bungalows opposite and above to the east of the site. Development of a similar age contributes urban character to the west of the site, with the roofs of the modern detached housing of *Lower Middlehill* prominent along the ridgeline.

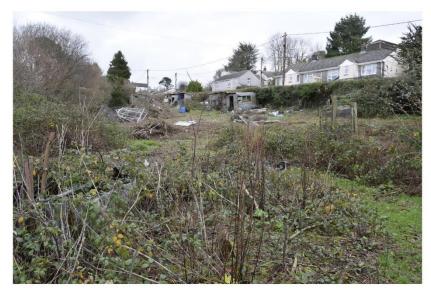
ii)Looking north east from site showing the degree to which the site is overlooked from the east by modern housing.

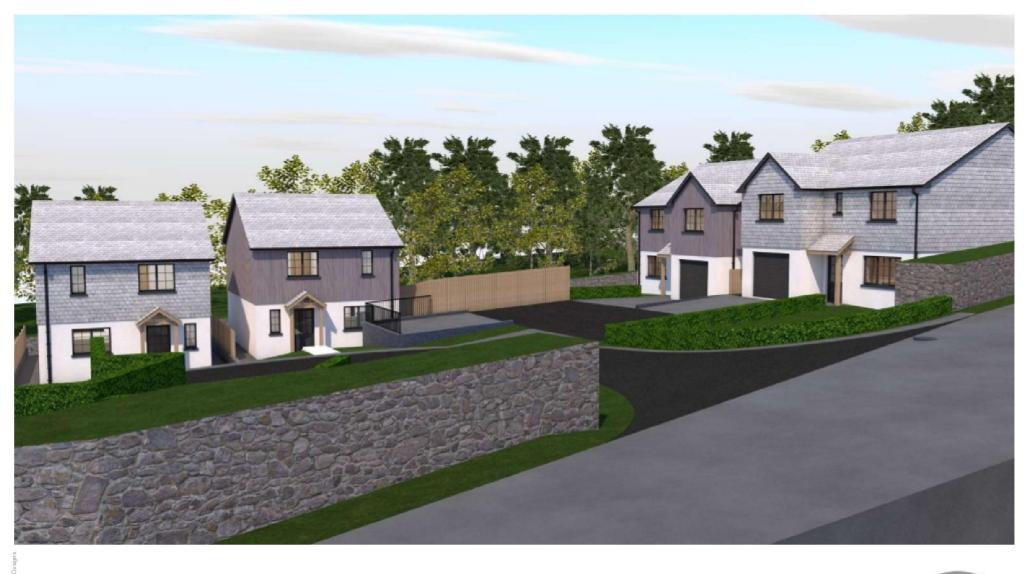
Figure 13 Proposals - 3D visualisation	Project Name: Shute Lane, Pensilva Project Code: SHUT1218	Layout (c) Statement Heritage Contains OS Opendata (c) 2008 Crown Copyright and Database Right All Rights Reserved 100059271
--	--	--

- 5.1 Development proposals are shown at figures 12-14.
- 5.2 The proposals will provide two pairs of detached houses, the larger (4 bed) units will occupy a similar site and have a similar aspect to the cottages that were present in 1888, whilst the 3 bed units will be situated to the south west corner of the site facing east.

- 5.3 The buildings are proposed to be finished in render to their ground floors, whilst first floors will be slate hung or timber clad. Roofs will be of natural slate. All these materials and finishes have locally distinctive precedent.

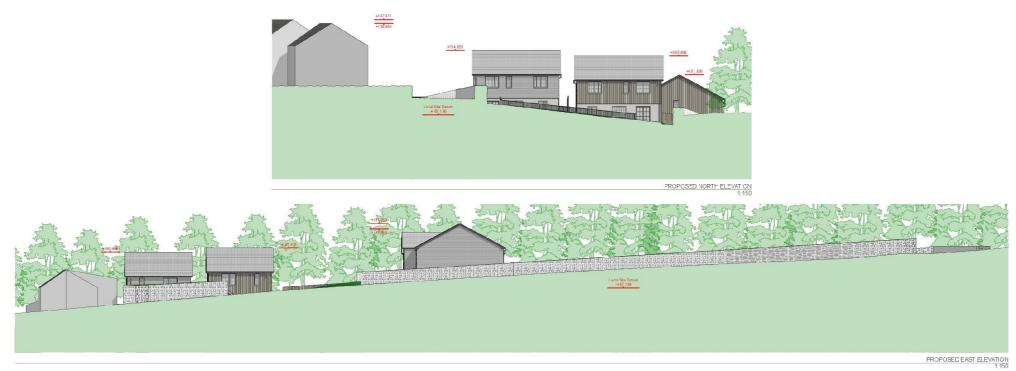
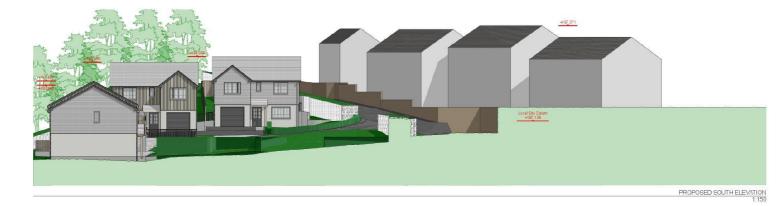
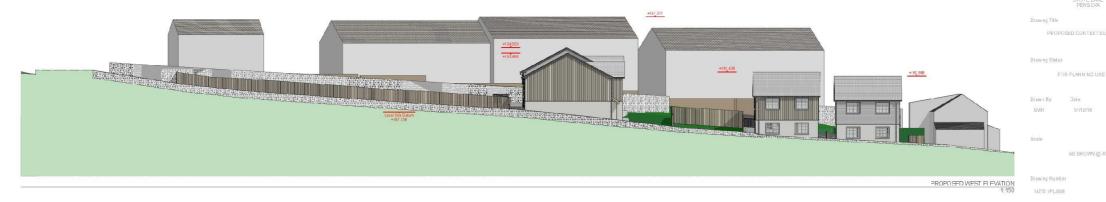
Figure 14 Proposals - Contextual Massing	Project Name: Shute Lane, Pensilva Project Code: SHUT1218	Layout (c) Statement Heritage Contains OS Opendata (c) 2008 Crown Copyright and Database Right All Rights Reserved 100059271
--	--	--

- 5.4 The mass of the development is shown by the contextual 3D drawings. It is clear that the scale of the development does not overbear the developments surrounding it.
