The Roundfield (aka: Carlidnack Round), Carlidnack Lane, Mawnan Smith, Cornwall, TR11 5HE.

Heritage Impact Assessment:

SH Ref CARL1018hia

02/01/2018

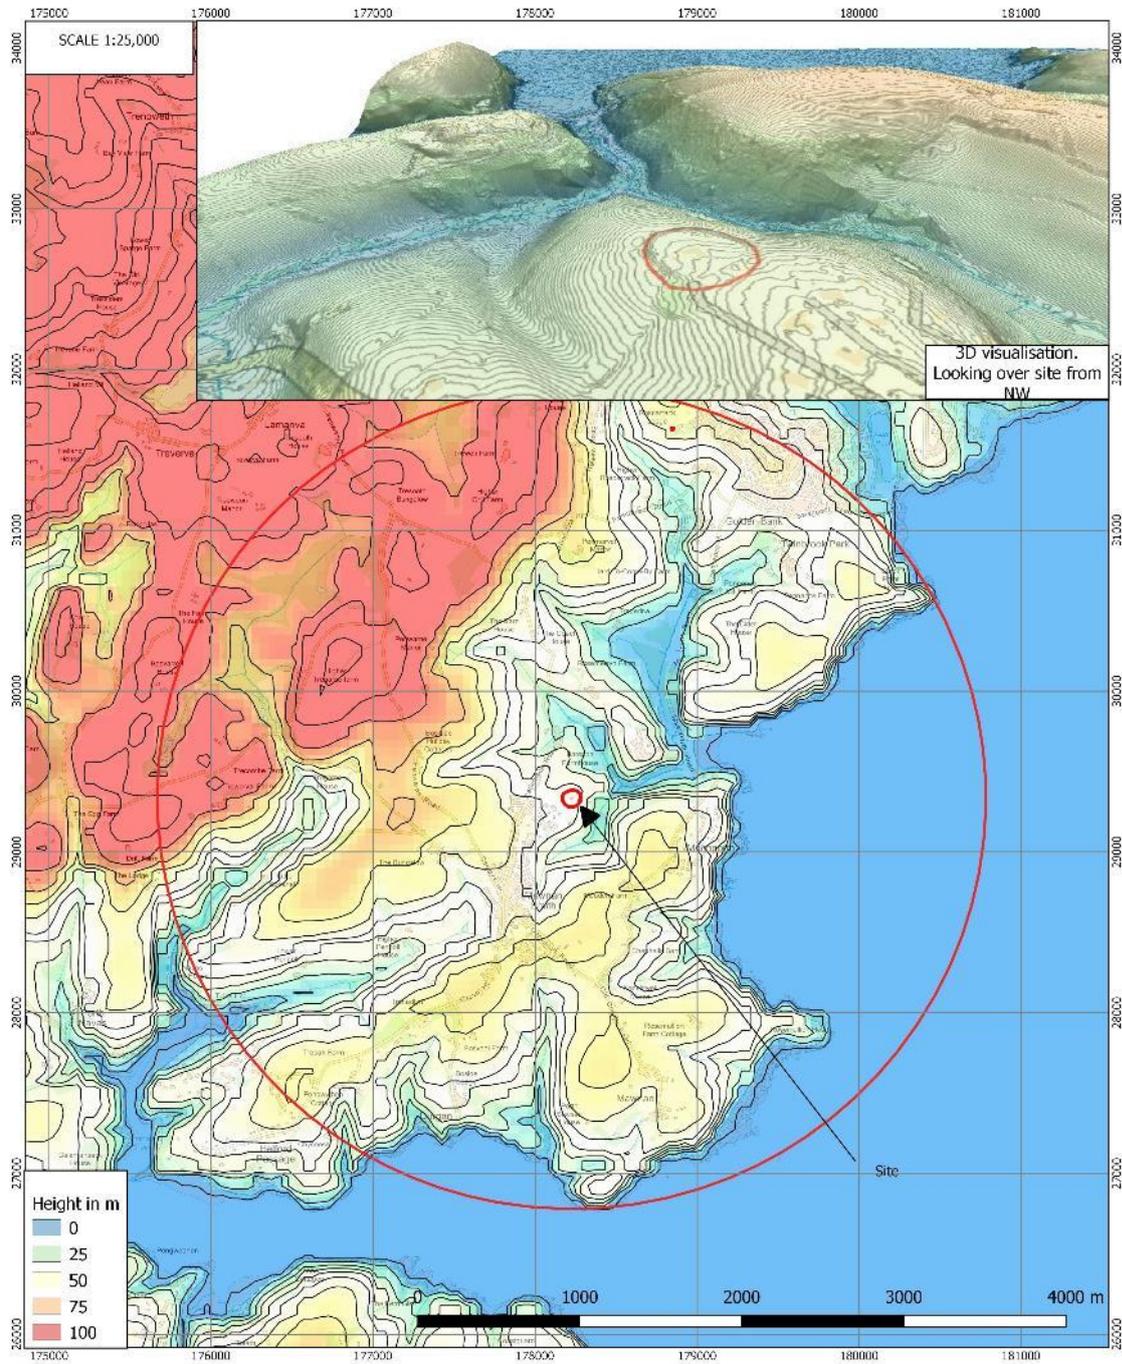
<p>Figure 2 Topographic visualisation</p>	<p>Project Code: CARL1018 Project Name: Carlidnack Round OSNGR: SW78182932</p>	<p>© Statement Heritage Contains OS Data © All Rights Reserved 100059271</p>
---	--	--

- 2.5 **Topography and Geology** (figure 2). The site, a univallate earthwork of some 90-100m diameter, lies at around 45mAOD in an essentially coastal location about 750m from *Maenporth Beach* and *Falmouth Bay* on the eastern slopes of the ridge leading into *Mawnan Smith* which is generally steeply incised by various creeks leading to the sea on its eastern side and to the *Helford River* ria system to its west and east. These cut into Devonian sandstones of the *Portscatho Formation* (BGS 2018). The site sits on a locally prominent eastern spur of this ridge with stream valleys to the north, east and south draining at *Maenporth*.

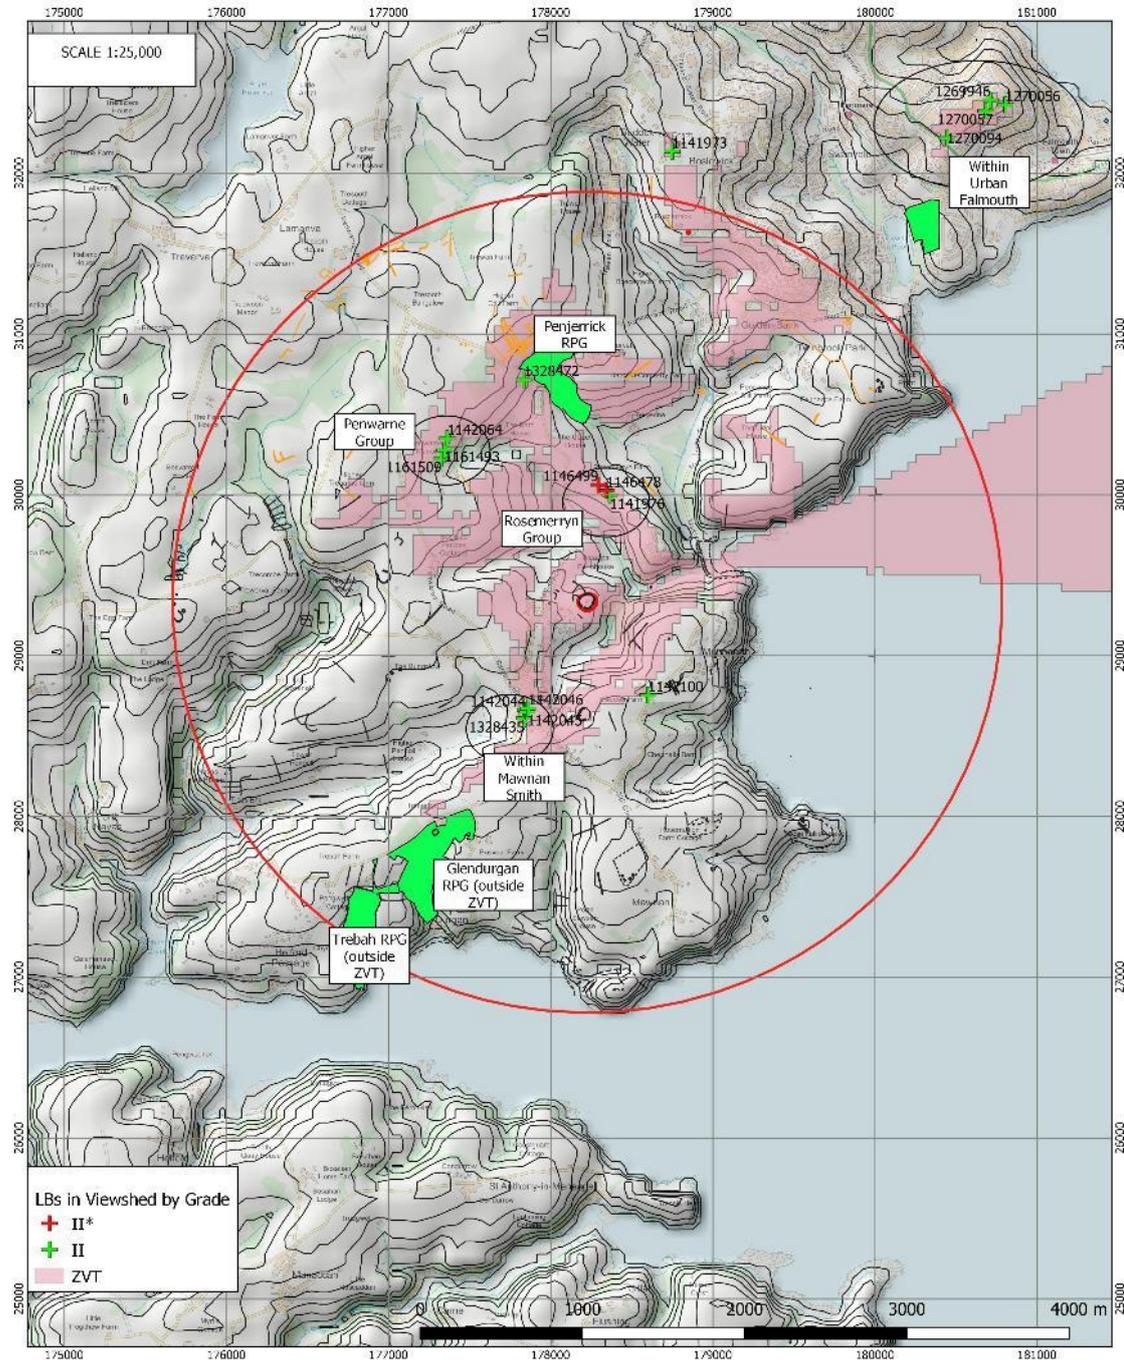
<p>Figure 3 ZVT and locations of Listed Buildings</p>	<p>Project Code: CARL1018 Project Name: Carlidnack Round OSNGR: SW78182932</p>	<p>© Statement Heritage Contains OS Data © All Rights Reserved 100059271</p>
---	--	--

- 2.5.1 **Our viewshed analysis** algorithm¹ suggests a relatively restricted 'Zone of Theoretical Visibility' reflecting the location of the site on a coastally facing slope, below the overall highpoints within the surrounding landscape. This is expanded on further below in our discussion of the **setting** of the monument.

- 2.6 **Designated Sites within the ZVT** (see figure 3) are tabulated in **table 1** below. The landscape relationship of these sites can be grouped and summarised as follows

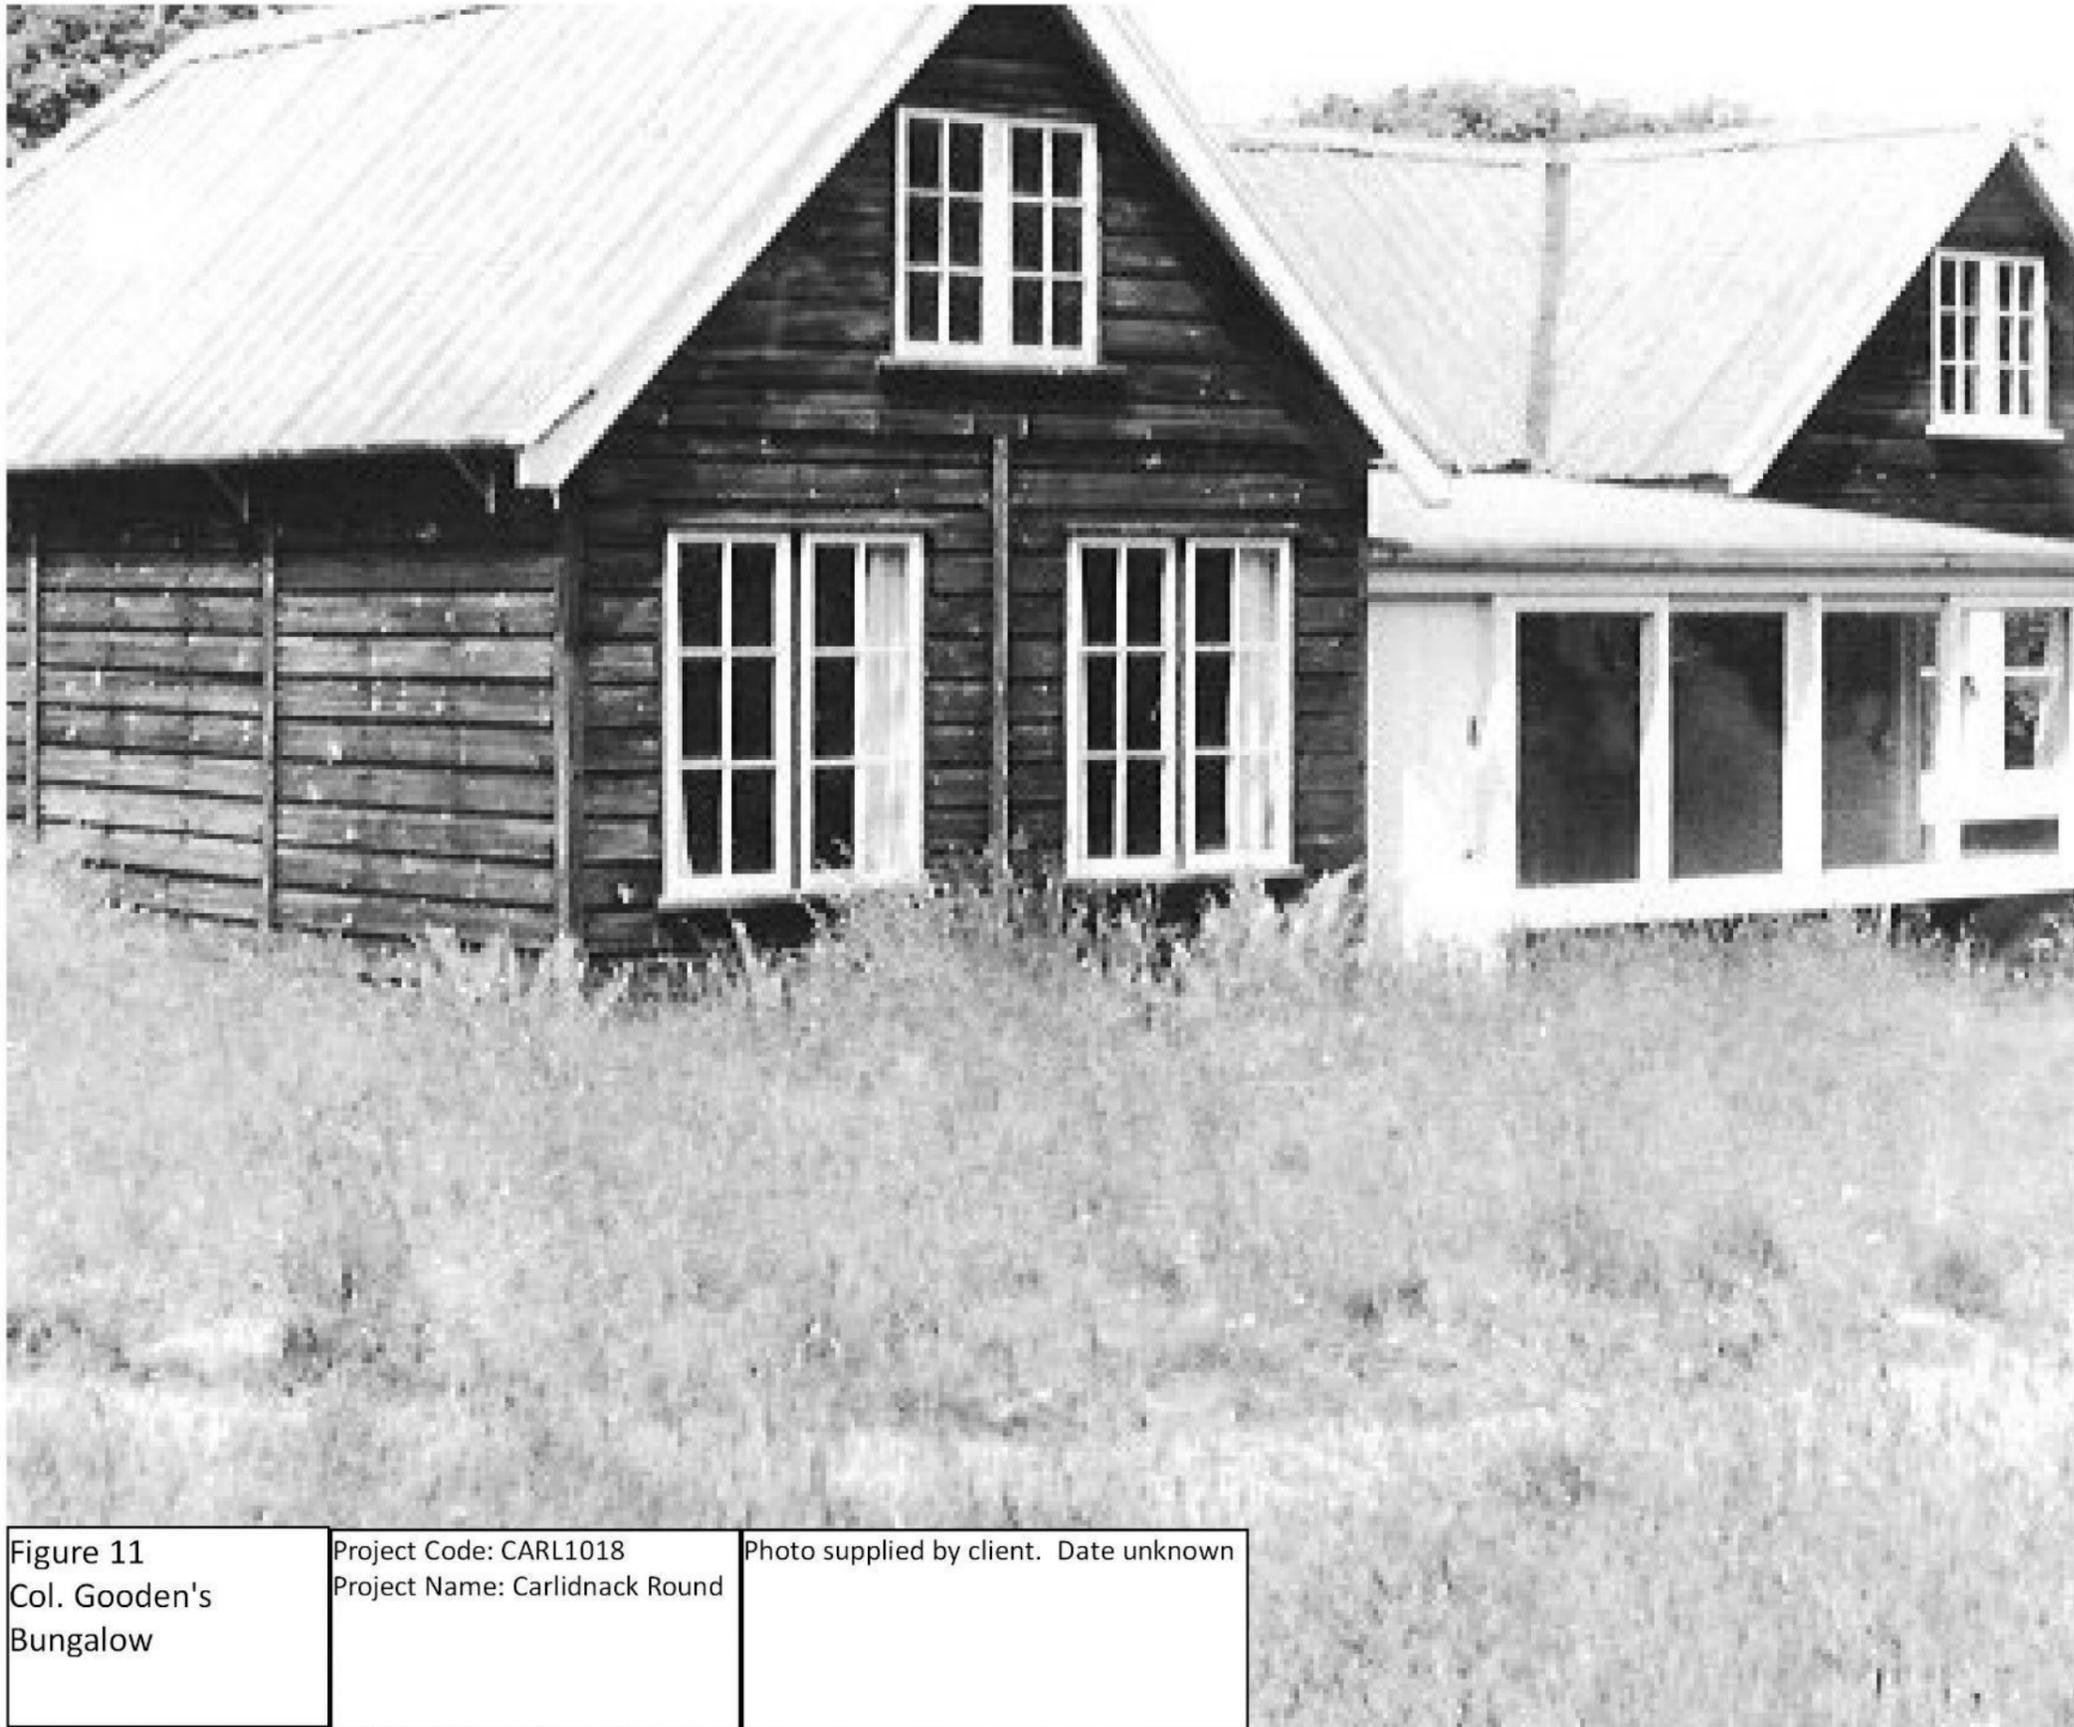
Figure 11
Col. Gooden's
Bungalow

- 4.4 A bungalow was first built on the site in the 1930s (Johnson and Harris 1976, 73), by a Colonel Gooden (client *pers.comm.*) at which time the current entrance and driveway were formed. A photograph of this building (figure 11) demonstrates that this building was a sectional wooden building under a profiled 'tin' roof. As such buildings require only the slightest of foundations it is unlikely that its construction involved much ground disturbance.

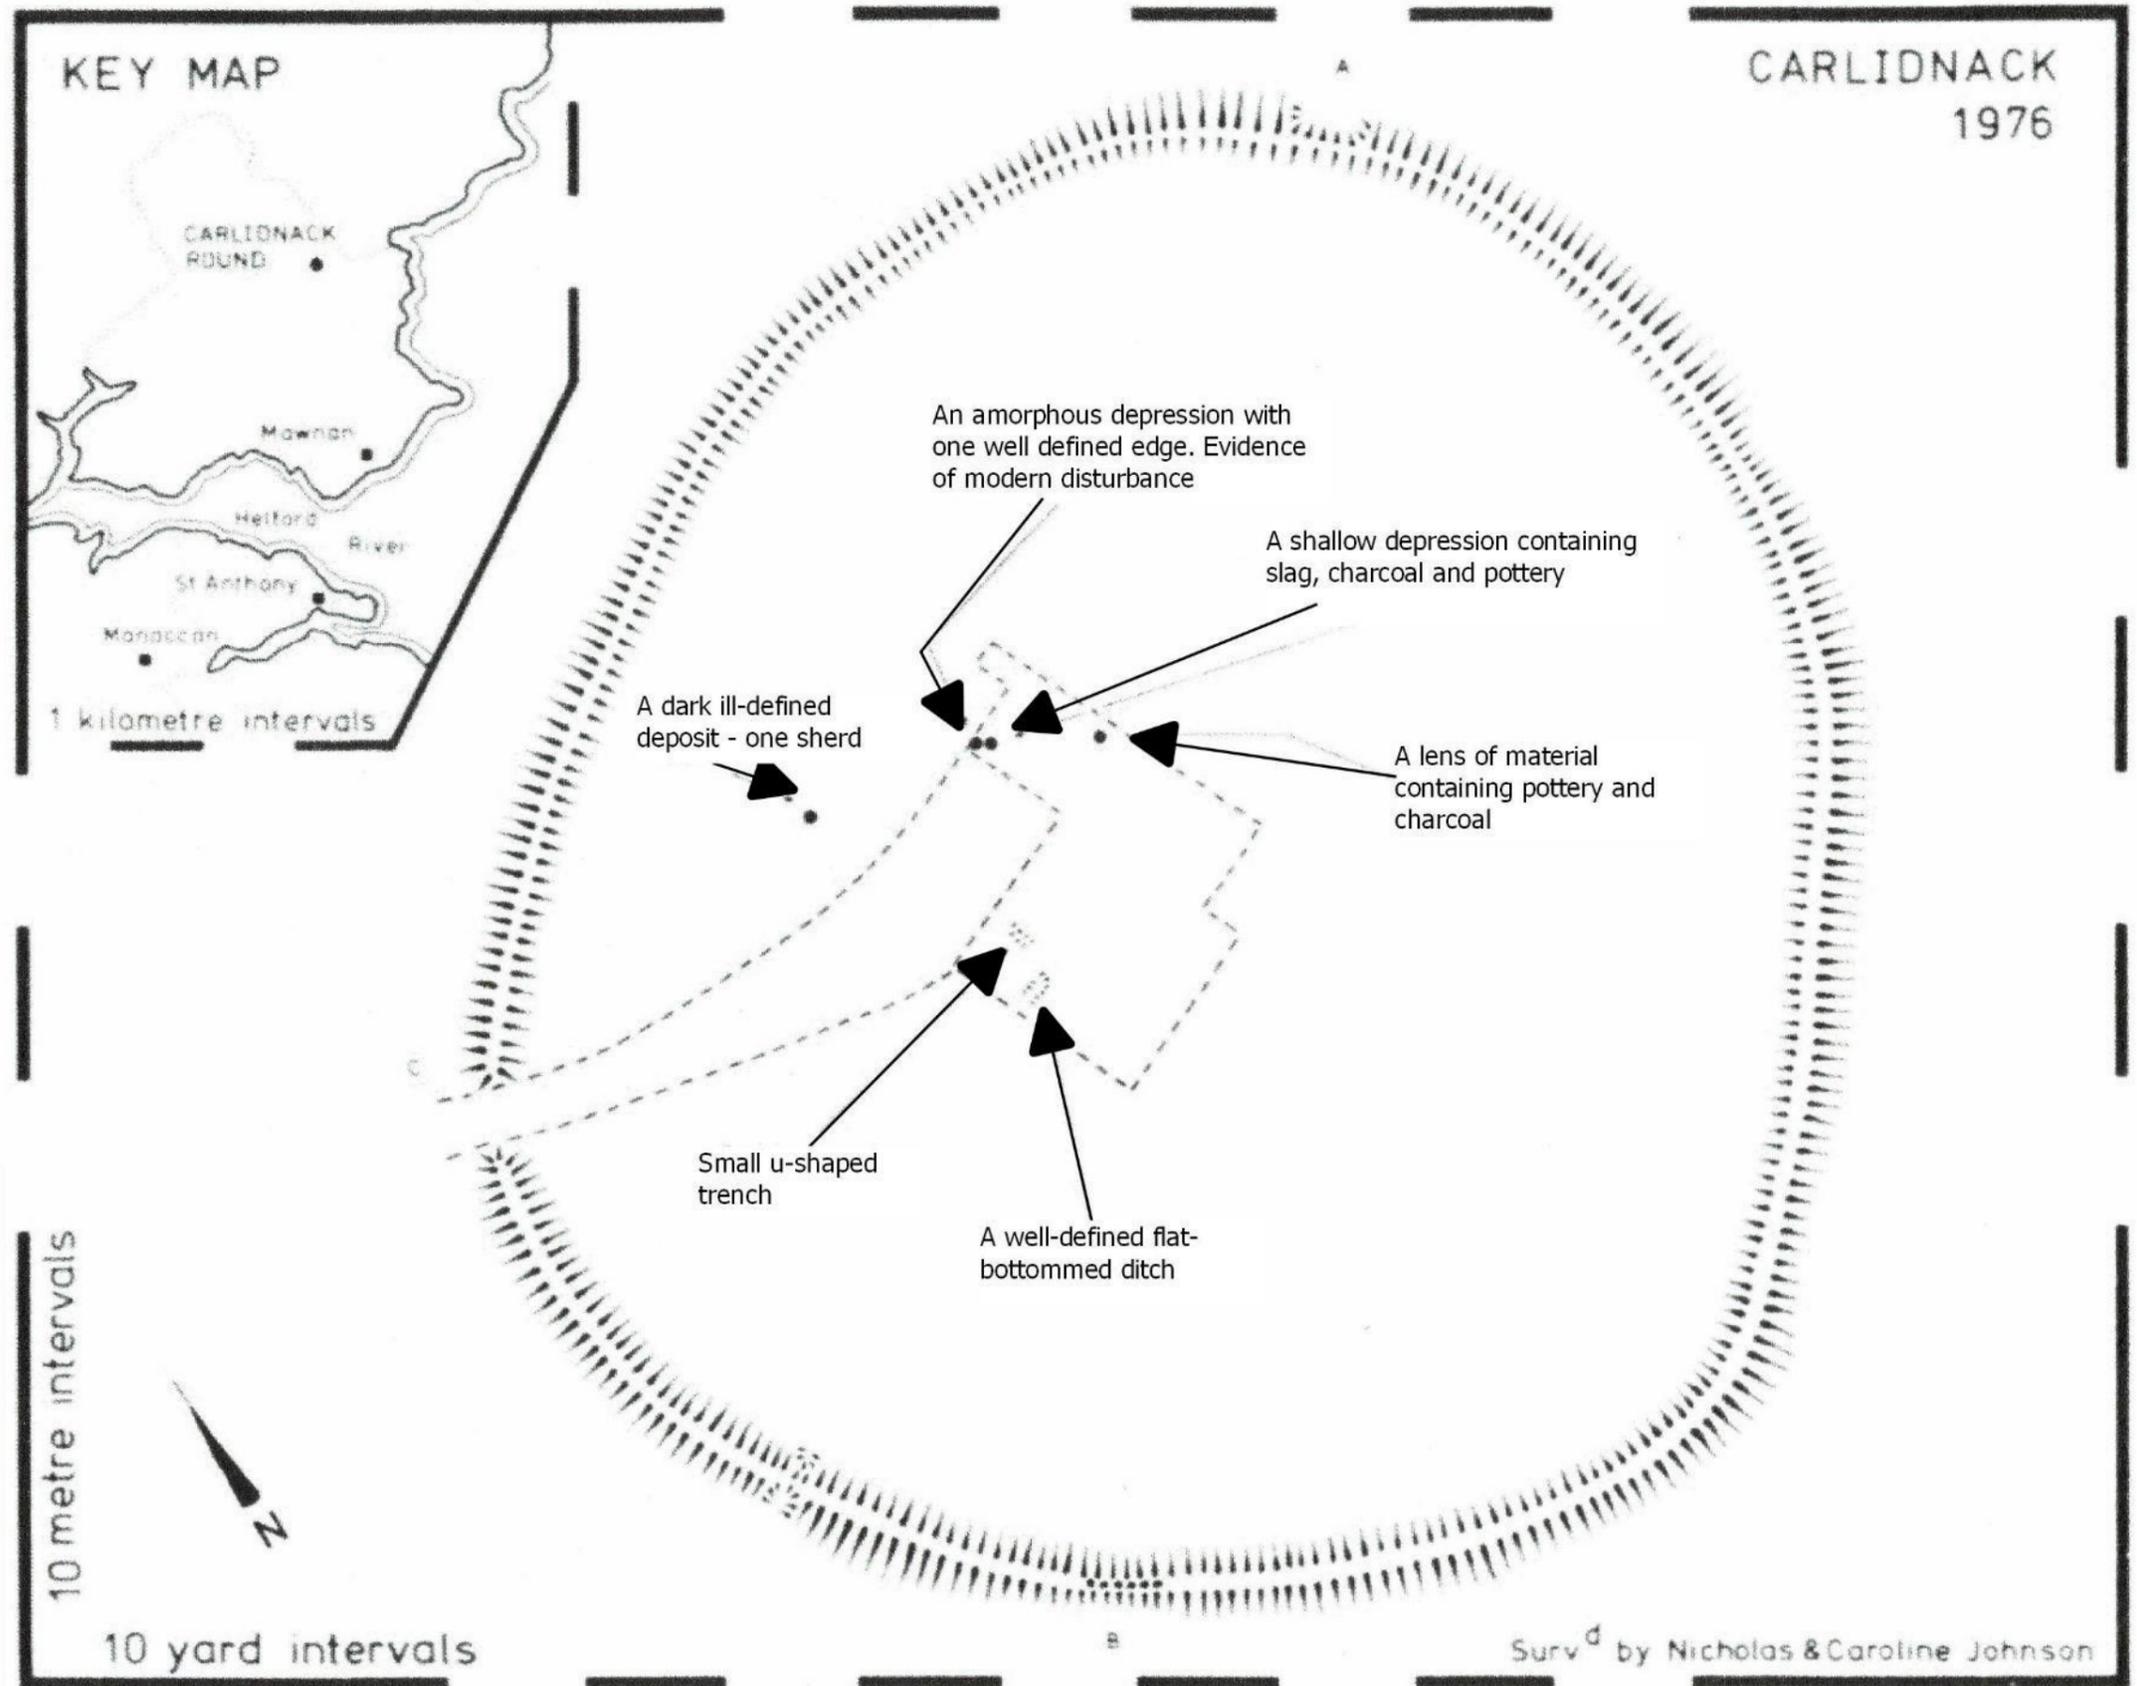
Figure 13
Excavation Plan (1976)

- 4.6 This bungalow was replaced re-using the site of the 1930s one in January 1976, this work being observed by Nick Johnson and Daphne Harris of the Cornwall Archaeological Society. The observations were made as a 'watching brief' rather than as a formal excavation, and with limited resources. Johnson's plan of the Round is reproduced at figure 13.

- 4.6.1 The report of Johnson's work in *Cornish Archaeology* 15 records that 1m deep trenches were made by machine for the foundations *'in very wet weather'*. *'The ground proved to be **much disturbed, presumably owing to past agricultural activity within the Round**, and to the drains of the previous bungalow; it consisted mostly of loose shillet soil with large patches of yellow clay.'* (my emphasis)

- 4.6.5 It is clear enough from the descriptions given in the report that ground was disturbed to a degree way beyond that which may be expected from the slight foundations of the 1930s building, suggesting that those artefacts encountered had been long disturbed by the action of the plough.

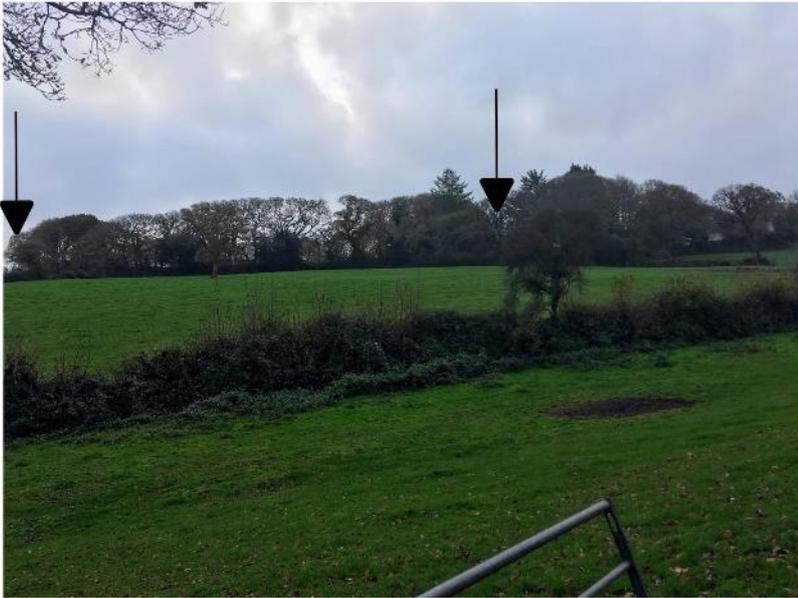
1) The round from approx 120m to the north - taken from private land within Norways Farm with the permission of the landowner. There are no publicly accessible views from this direction. Even at this distance the round is not easy to appreciate without fore-knowledge and could easily be mistaken for a well vegetated Cornish hedgebank. Note the degree of screening of the house.

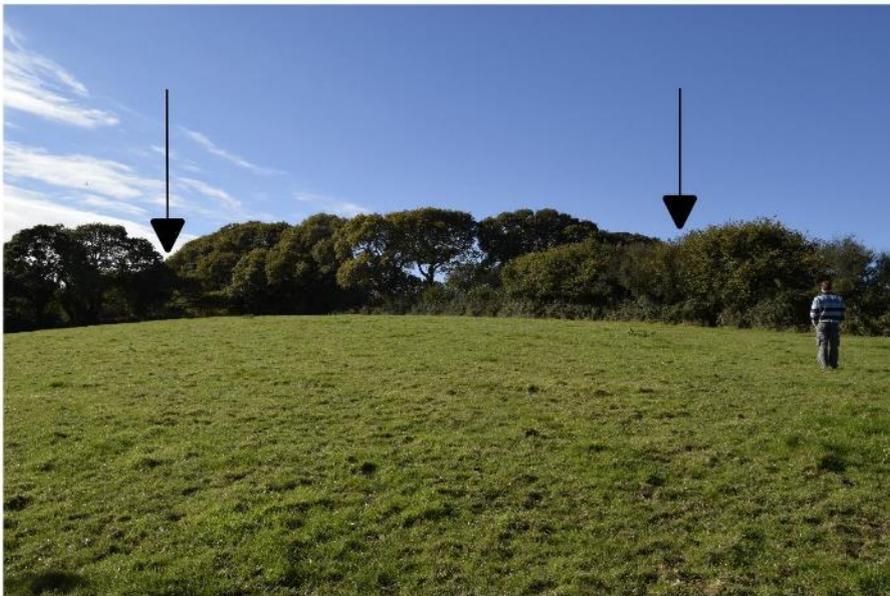
2) Looking west to the eastern edge of the round from a distance of around 50m. Again the round could easily be missed without prior knowledge of its existence

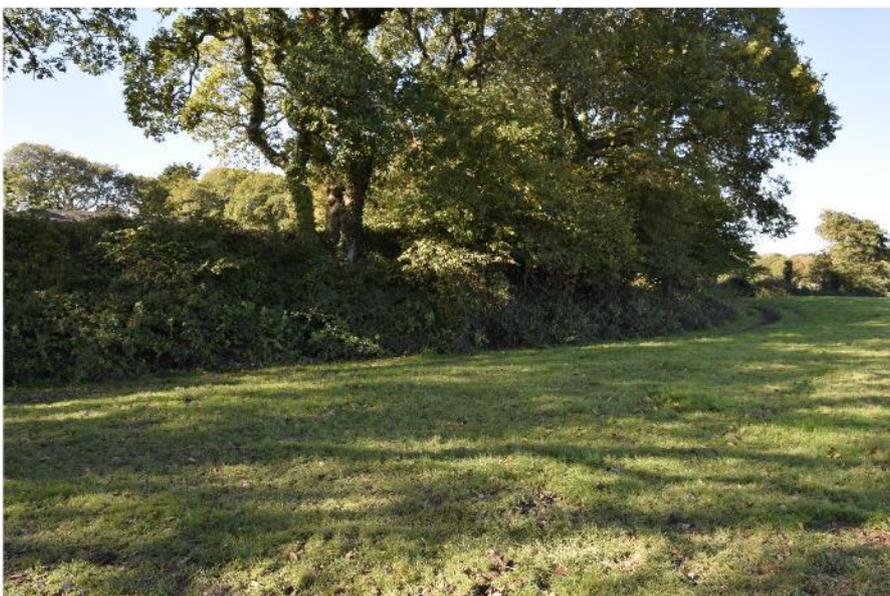
- 5.5 There is a pronounced difference in height between the interior and exterior of the monument (previously remarked on by Johnson and Harris in 1976), with only 1 metre between the internal ground surface and the top of the enclosing hedges, and as much as 4 and 5 metres between these hedges and the land around the outsides of the monument, particularly on its north, east and southern sides. A lesser but still significant difference was observed between the ground levels of the surviving northern boundary of the putative 'annexe' noted by Parkes in 2006.

3) Below left. Looking north along the bank and (at this point) external ditch from the adjacent field to the north east. Only at this proximity is the scale of the monument more apparent.

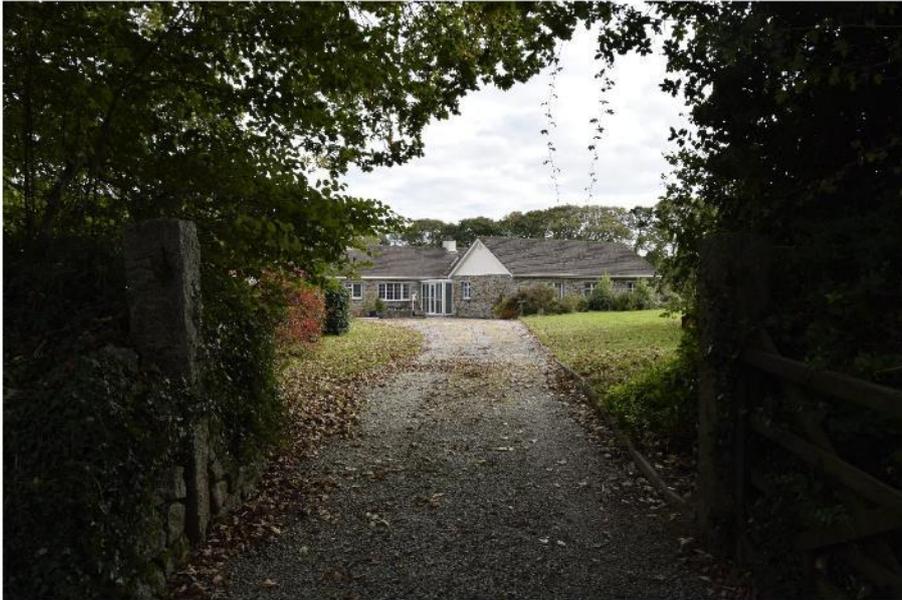
4) Looking east towards the house (west elevation) from the modern opening along the drive

- The proposals would be very likely to be screened from these viewpoints by existing vegetation. Nevertheless we would recommend that the dormers should be clad in tiles to match those already on the building, feature visually recessive (rather than white uPVC) frames and be glazed in minimally-reflective glass.

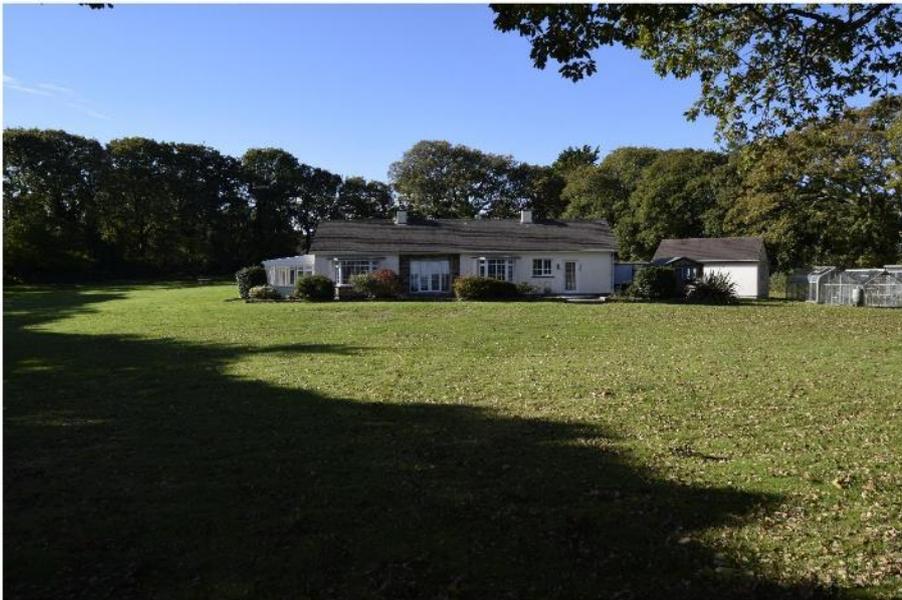
5) East elevation of the house

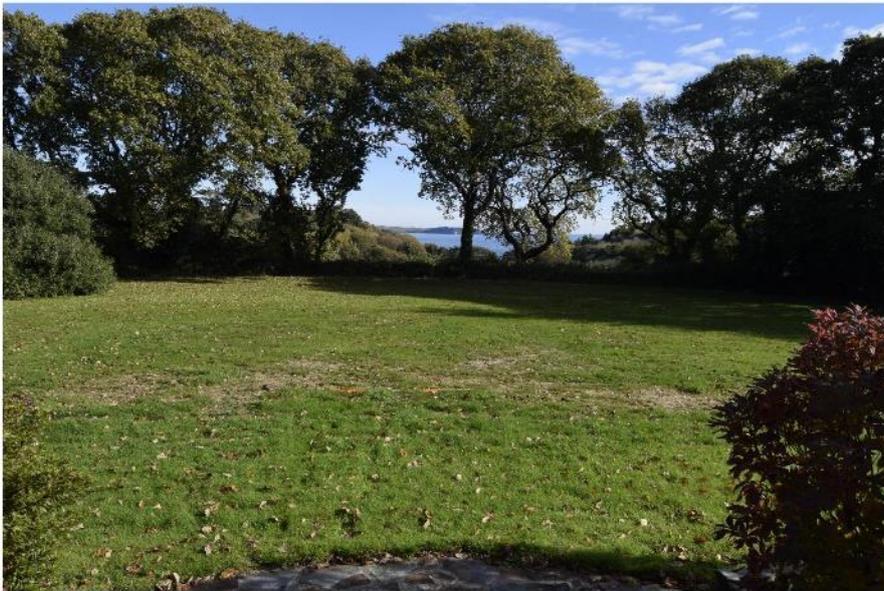
- 5.3 The majority of the monument lies under lawn, with some badger damage apparent in a number of locations. This is being appropriately managed by the site's owner by replacement of foraging divots as and when they arise and it is assumed that the badgers themselves are likely to be residing in the bank.

7) The only view from the inside of the round to the landscape beyond is to the due east of the house across the Carrick Roads towards St Anthony- note badger damage to lawn around scale.

- 8.3.3 Maintenance of the lawn and existing flowerbeds can consequently be lawfully carried out (within the restriction of depth of cultivation to 300mm without Scheduled Monument Consent. This would, include the repair of badger damage as currently undertaken.

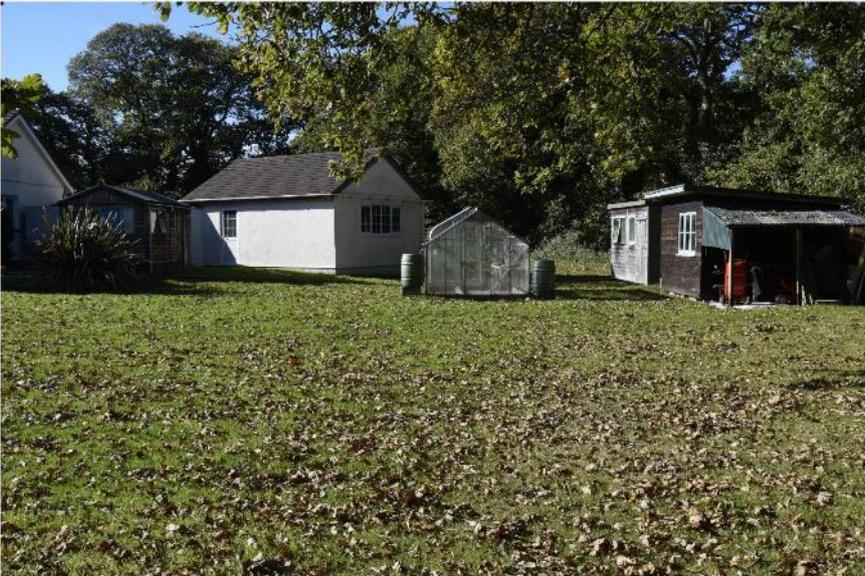
- The existing buildings have effectively sterilised their footprints of archaeological remains, although it has not been excluded that deposits below their impacts may survive. The sheds and greenhouses to the north of the house are lightly founded and unlikely to have significantly impacted any remains beneath.

10) Lightweight glasshouses and sheds to the north of the house and the garage built in the 1990s

- 8.3.4 In our opinion like for like replacement of the existing sheds and greenhouses would benefit from Class Consent 1. Any increase in size or works to the foundations of the buildings are expected to require Scheduled Monument Consent.

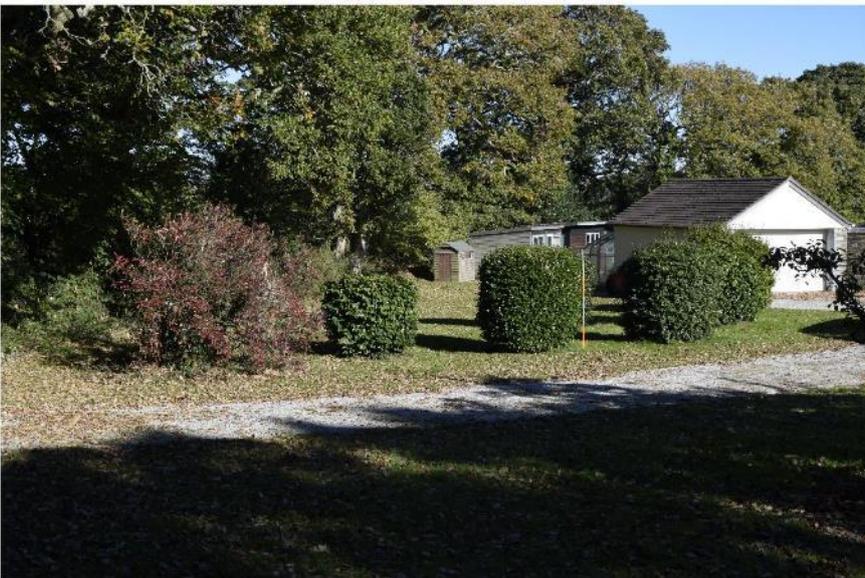
- Tree and shrub planting within the site may have impacted archaeological deposits both through planting and root growth.
- The bank will be vulnerable to damage from tree-root throw in the event of storm damage or disease causing future tree falls.

11) The shrubs to the north of the drive.

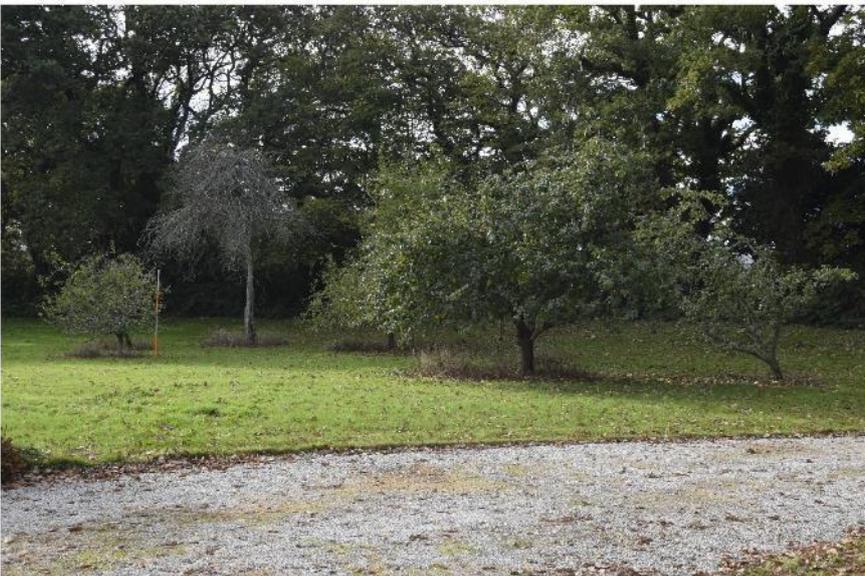
6) Fruit trees to the south of the drive.
