Statement Heritage

Stable and Groom's Quarters. 13 High Street, St Ives, Cornwall, TR26 1RS

Level 3 Historic Building Record

SH Ref LLOY0320_Archive 01/03/2023

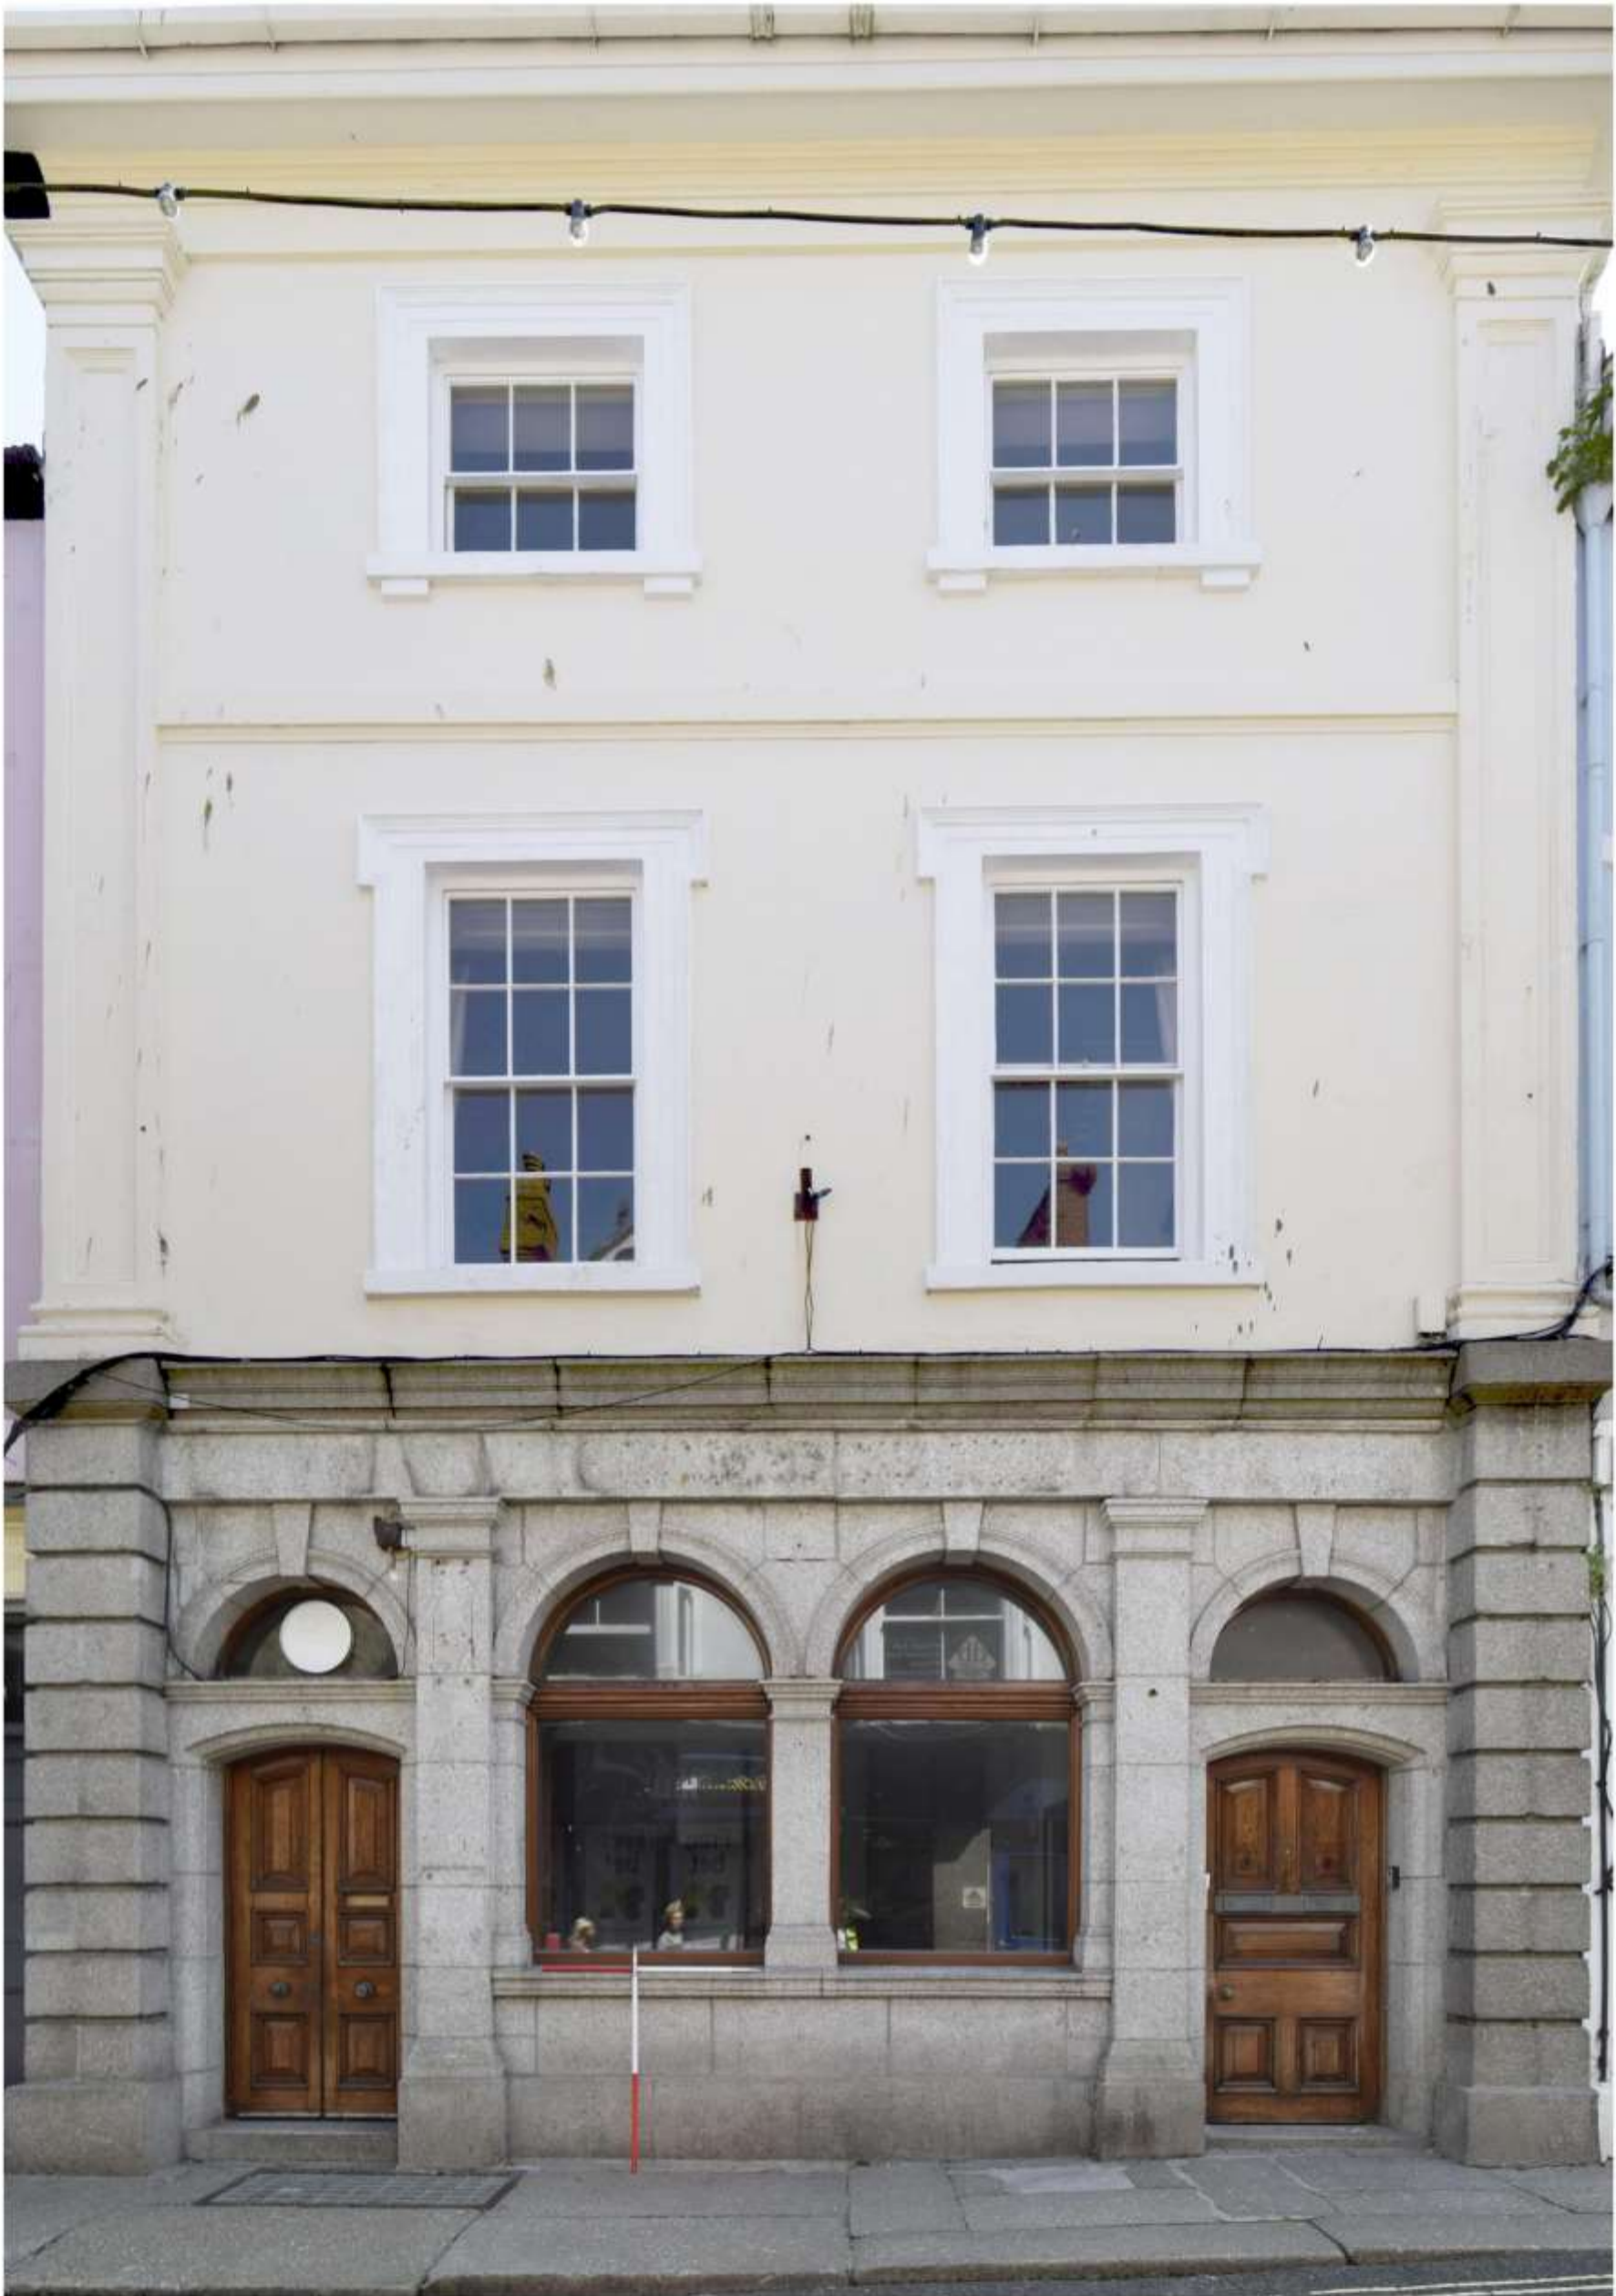
Figure 2: 13 High Street

ii) 13 High Street. Listed as 'Lloyds Bank' (NHLE1143352 GII).

Built as a Georgian townhouse on a medieval plot. The stucco details (panelled pilasters, moulded and shouldered arcitraves and classical cornice) date to the early - mid 19th century, the granite bank frontage to 1897, by Cornish architect Sylvanus Trevail for the Devon and Cornwall Bank

- 2.1. The No 13 High Street (Listed as HIGH STREET 1. (South Side) 1587 Lloyds Bank SW 54 SW 1/106) (**figure 2**) was *Listed* at GII in 1972. The List Description reads:
Early mid C19. Stucco. Panelled pilasters moulded and shouldered architraves to windows. Three storeys, two windows, sashes with glazed bars. Later granite ashlar ground floor with rusticated pilaster, round headed windows and fanlights. Slate hipped roof, moulded eaves. Group value.

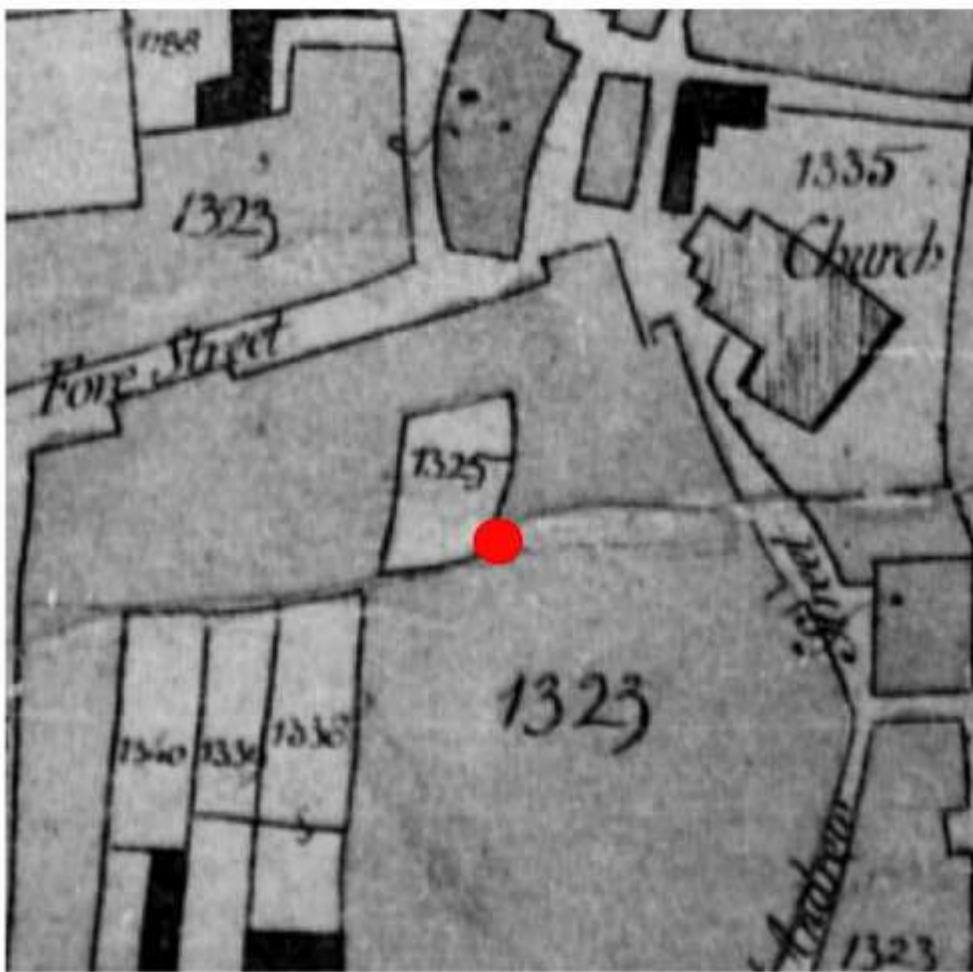
i) c1840 Tithe Map. Site location indicated by red dot. The tithe map does not generally resolved to individual buildings, although the 'garden, Duke of York Inn' (plot 1325) approximates to the current court behind no 13 High St

- 2.7. The 1840s Tithe Map of St Ives (**figure 3i**) shows the site within a developed urban block by the 1840s. No detail is shown of most property boundaries, however and notably the current court to the rear of what is today *13 High St* is separately enumerated within the Tithe Apportionment as *plot 1325 ‘Garden Adjoining the Duke of York Inn’* owned and occupied by a *Charles Richards*.

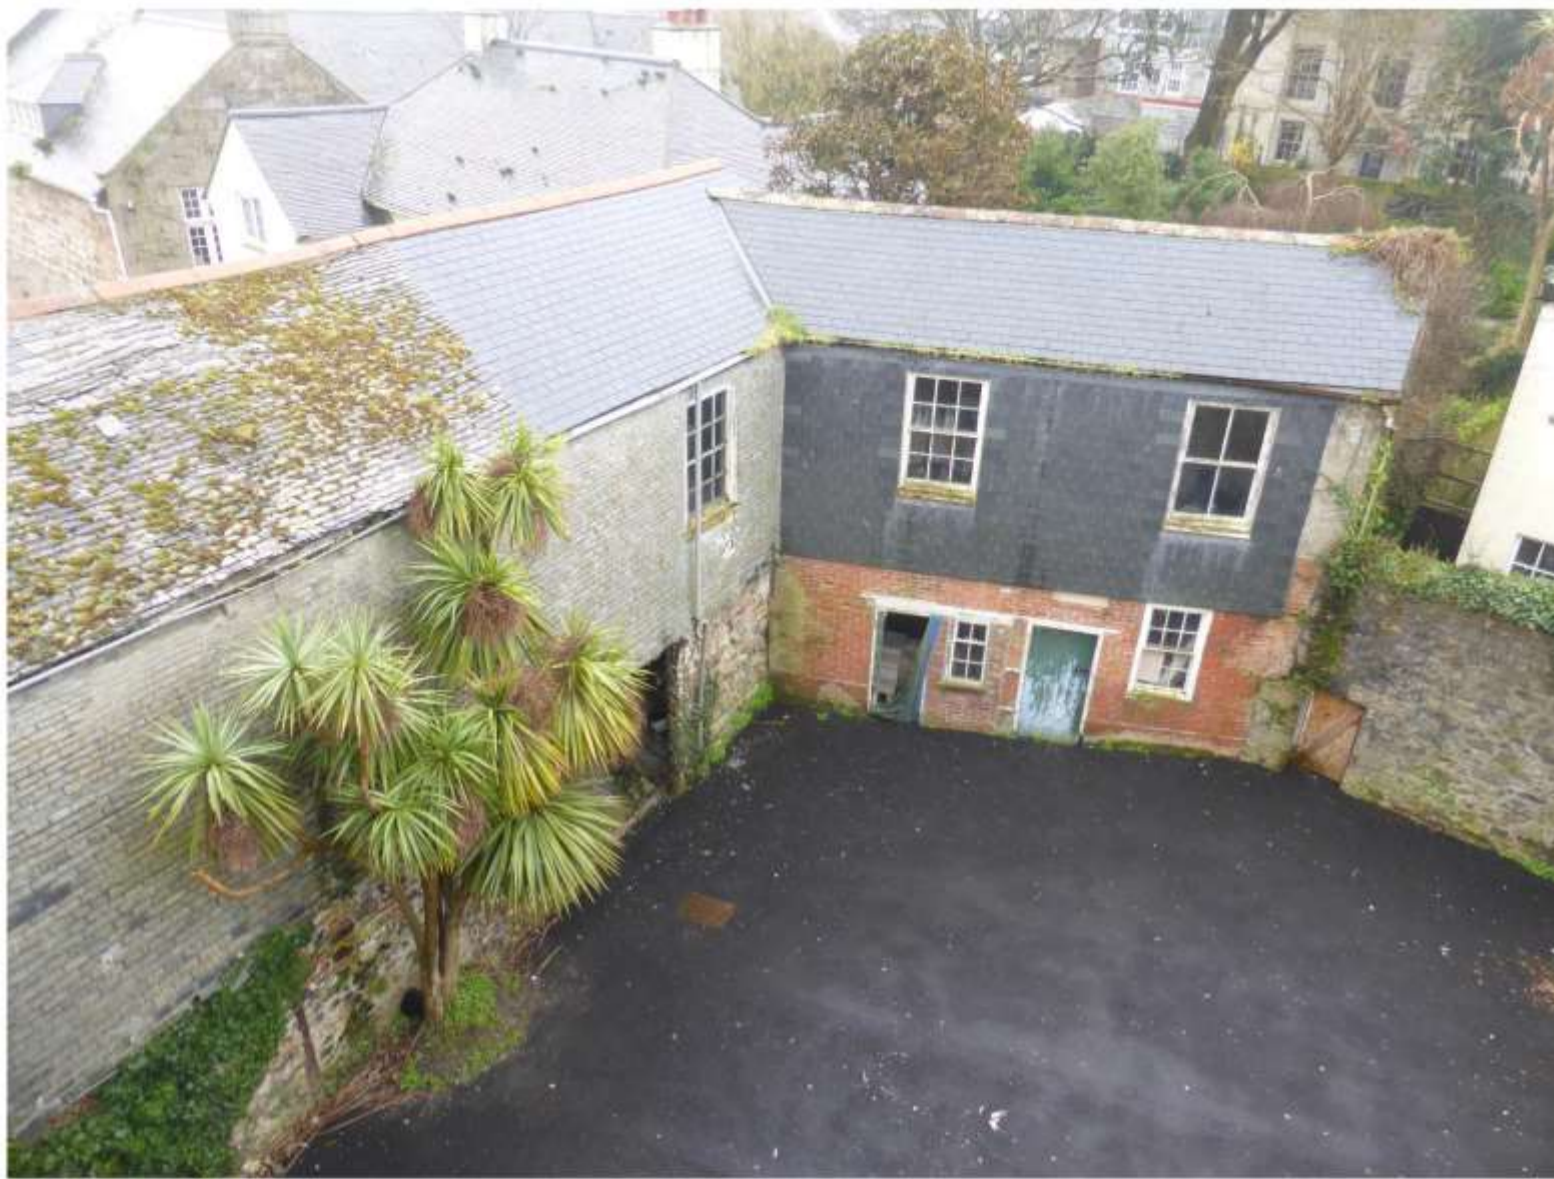
(Archive ref:
LLOY0320_1160184.JPG)

i) Looking south into the stable yard from the 2nd floor fire escape of number 13, showing east range to left and south range to right. The parts subject to historic building recording are those beneath modern imported slate roofs

- 3.7 **Figure 6** presents photographs of the elevations and immediate setting of the built fabric proposed for conversion, which are described in the application documents as *Stable and Groom's Quarters*. It is accommodated within two adjoining ranges set at an angle of approximately 105° to each other. The principal elevations of the property face into the court behind *no 13 High Street*.

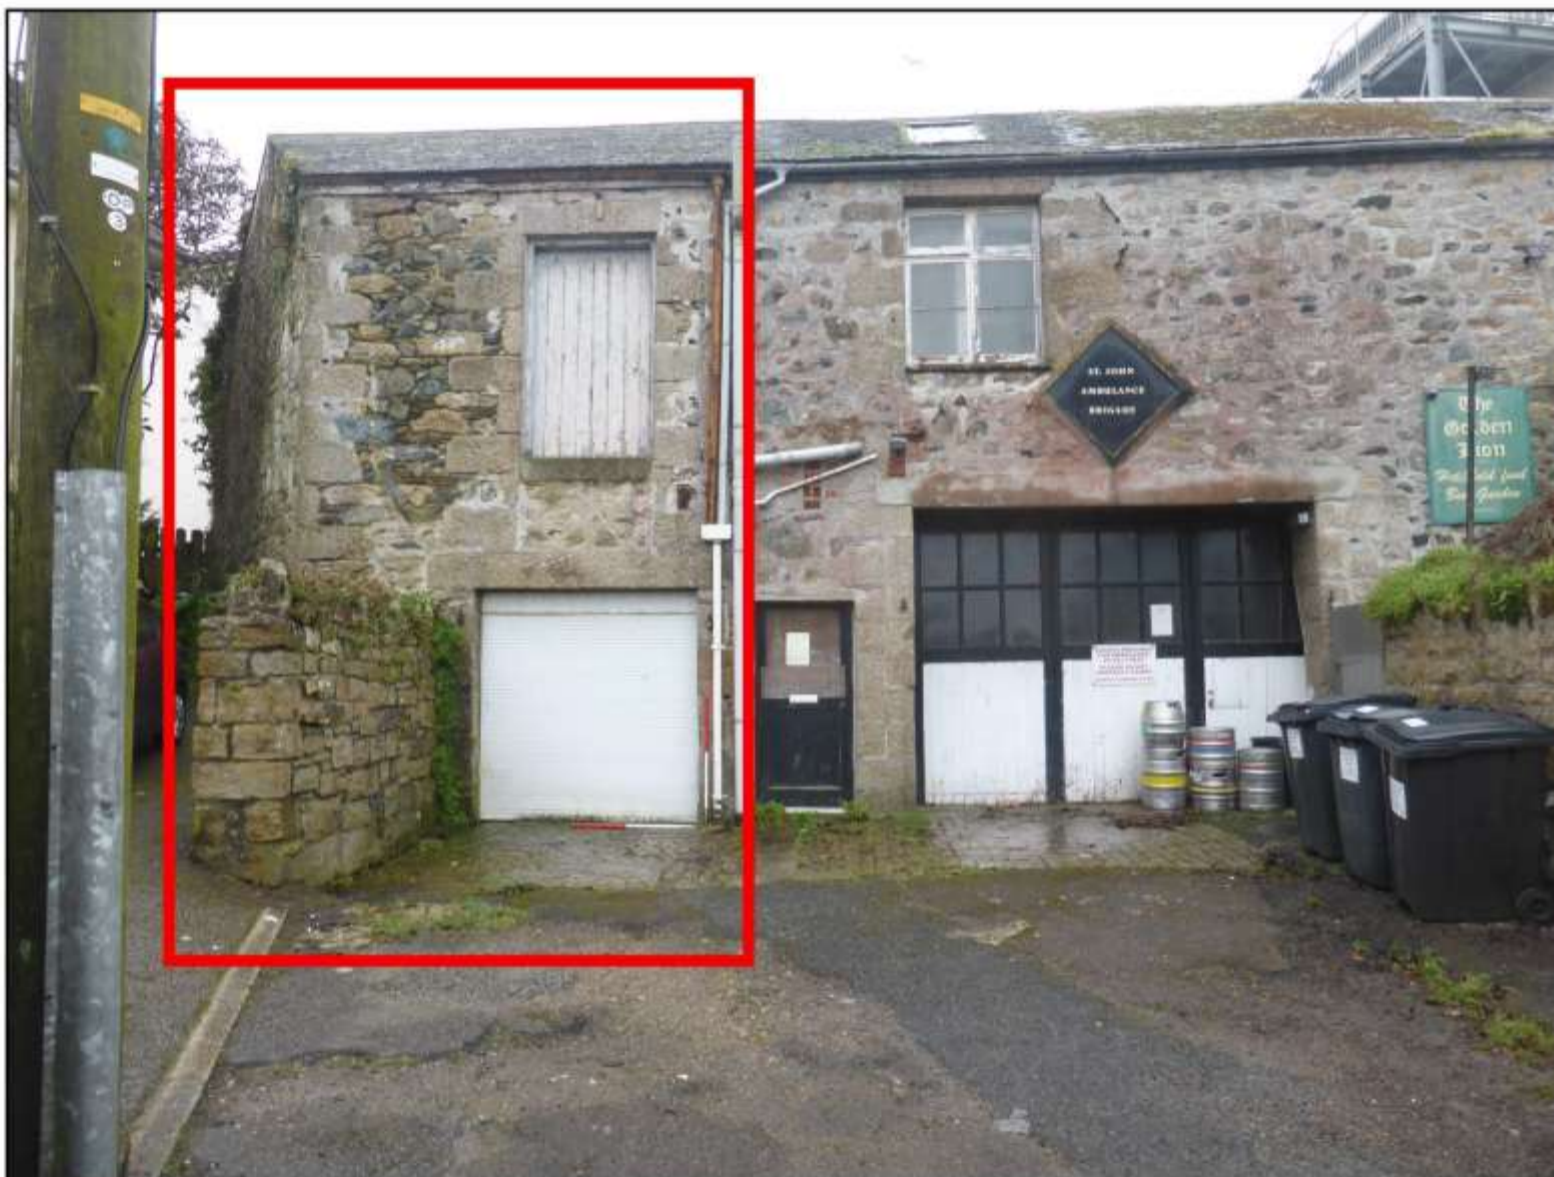
Ref: LLOY0320_1160081.JPG

ii) Looking east towards the west range. The area subject to recording is highlighted. Scales 1m.

- 3.10 The east elevation (**figure 6ii / 7ii**) is of mixed local stone rubble (some elvan, granite and killas evident) with cut granite dressings indicative of a post 1800 date. There is a loading door above a wider cart opening (fitted with modern metal slat roller doors), the loading door showing some evidence of a changed floor level, with a panel of stonework blocking between it and the cart entrance. To the north the continuing range (outside the area recorded in detail by this project) is occupied by a *St John's Ambulance* station.

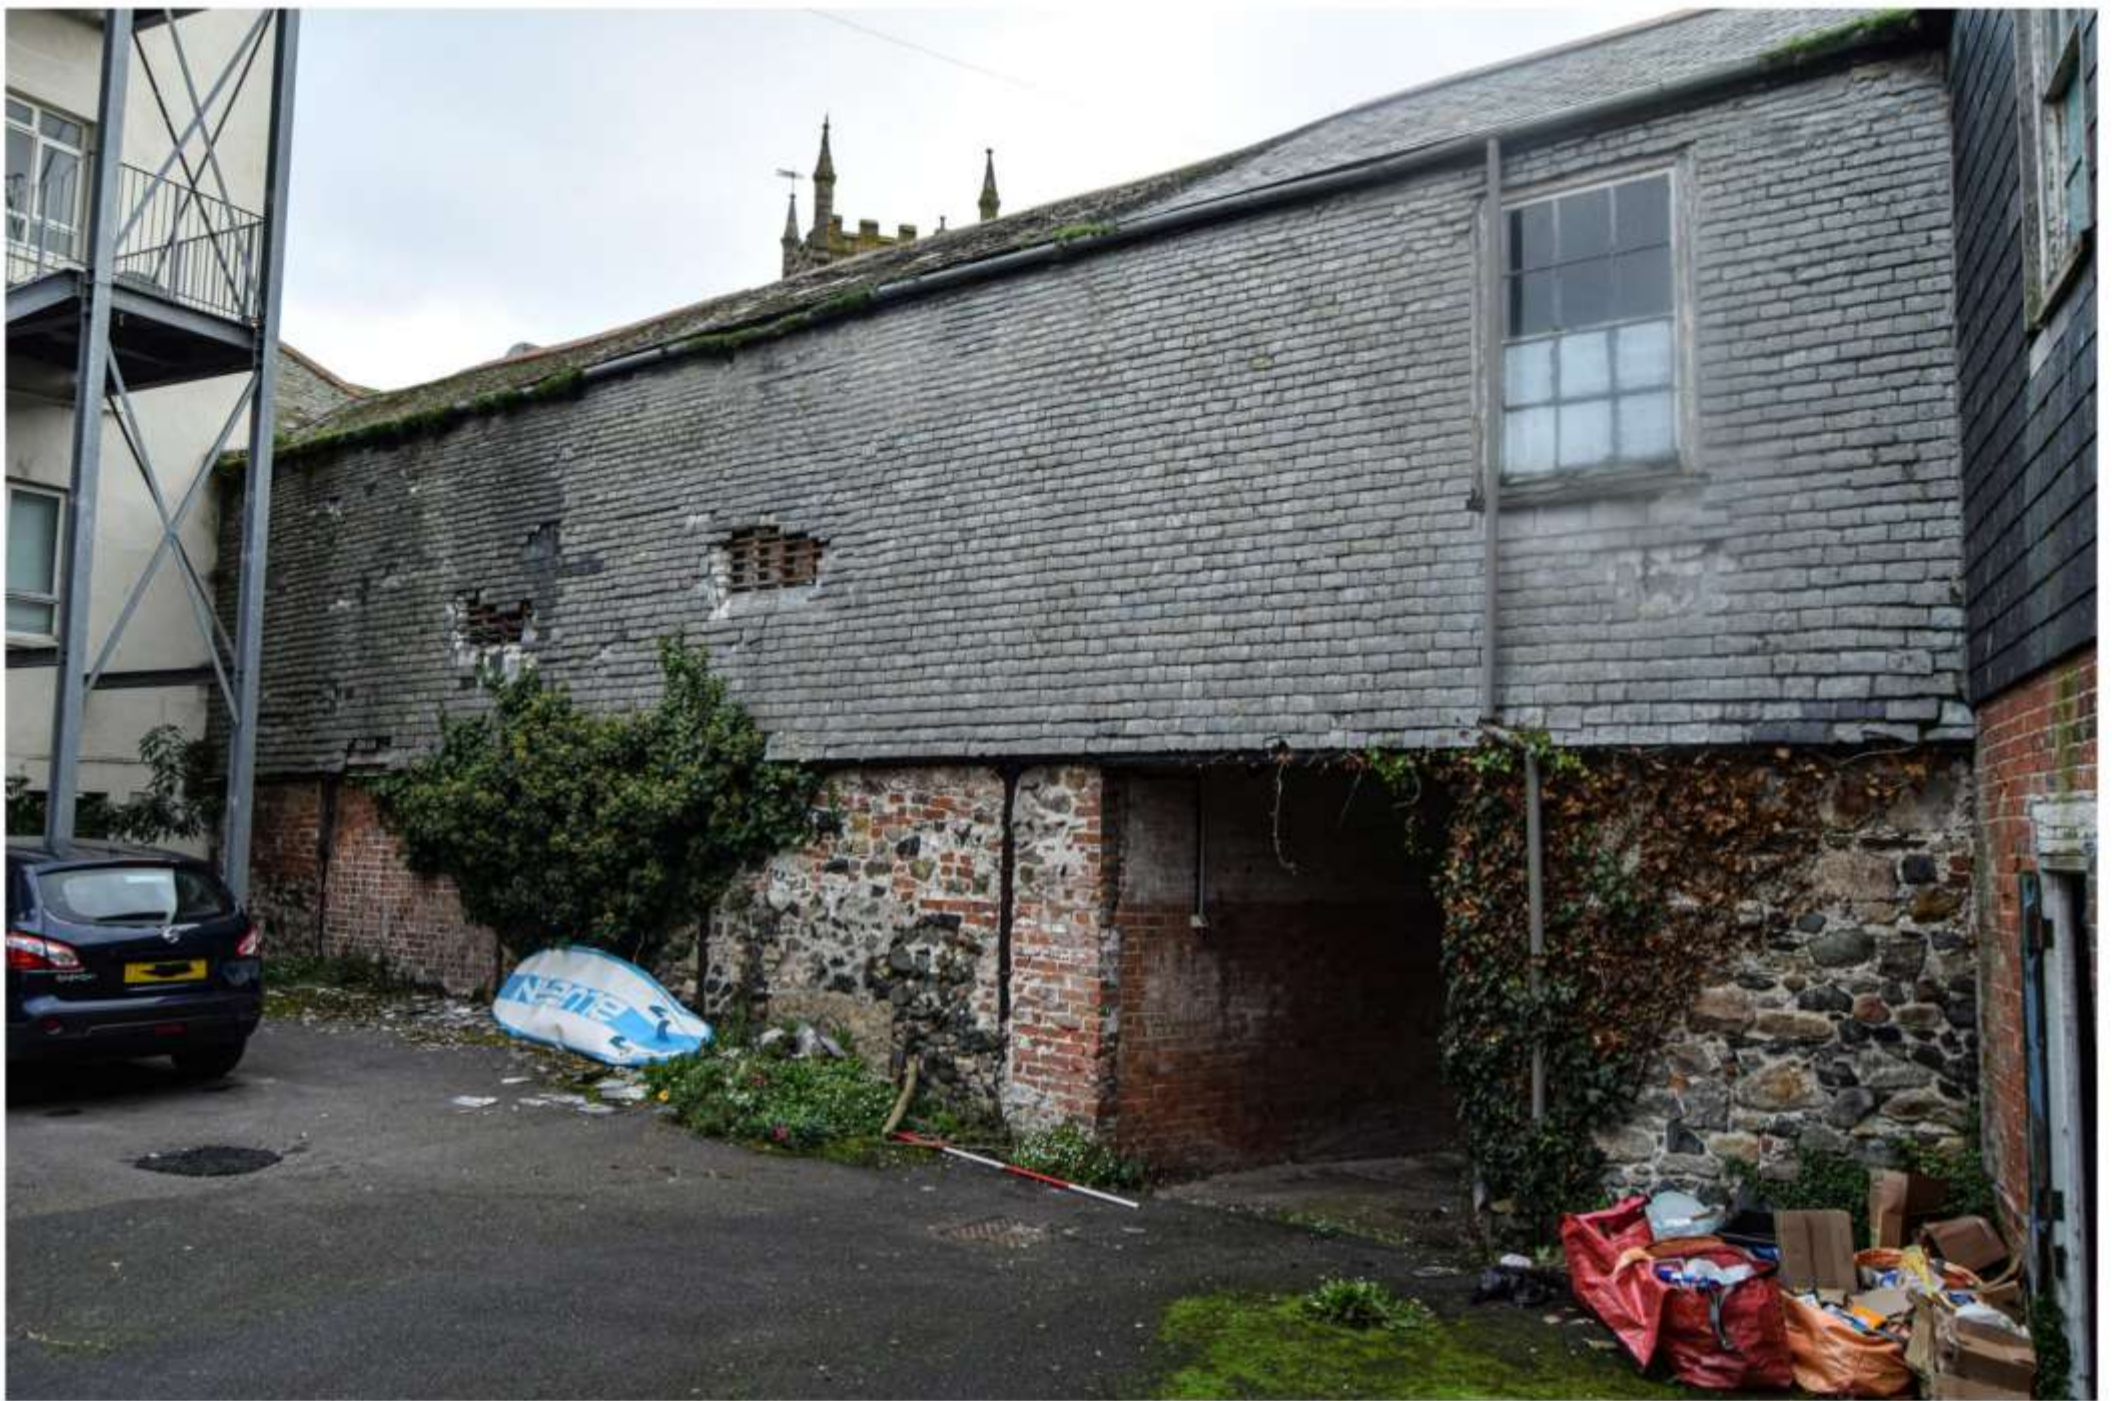
i) West elevation of the eastern range. The area subject to the current consent is that above and to the right of the left hand reveal of the passageway. The first floor level here is timber framed, clad in wet-laid hung slate, probably from Delabole. It was originally open-sided, the bays separated, and the upper floor supported by iron pipe uprights, most probably re-used sections of rising mains from a local mine. The infill between these uprights is mixed rubble mixed with reused brick. The range was likely originally stabling and coach parking for the inn recorded here in the mid 19th century.

- 3.9 The west elevation (**figure 7i**) is of local slate hung over timber framing at first floor level, with a single 12 pane fixed small pane window, in very poor condition. The ground floor is of mixed brick and stone infill between partly exposed iron pipe columns, of the type frequently used on Cornish mining sites as rising mains.

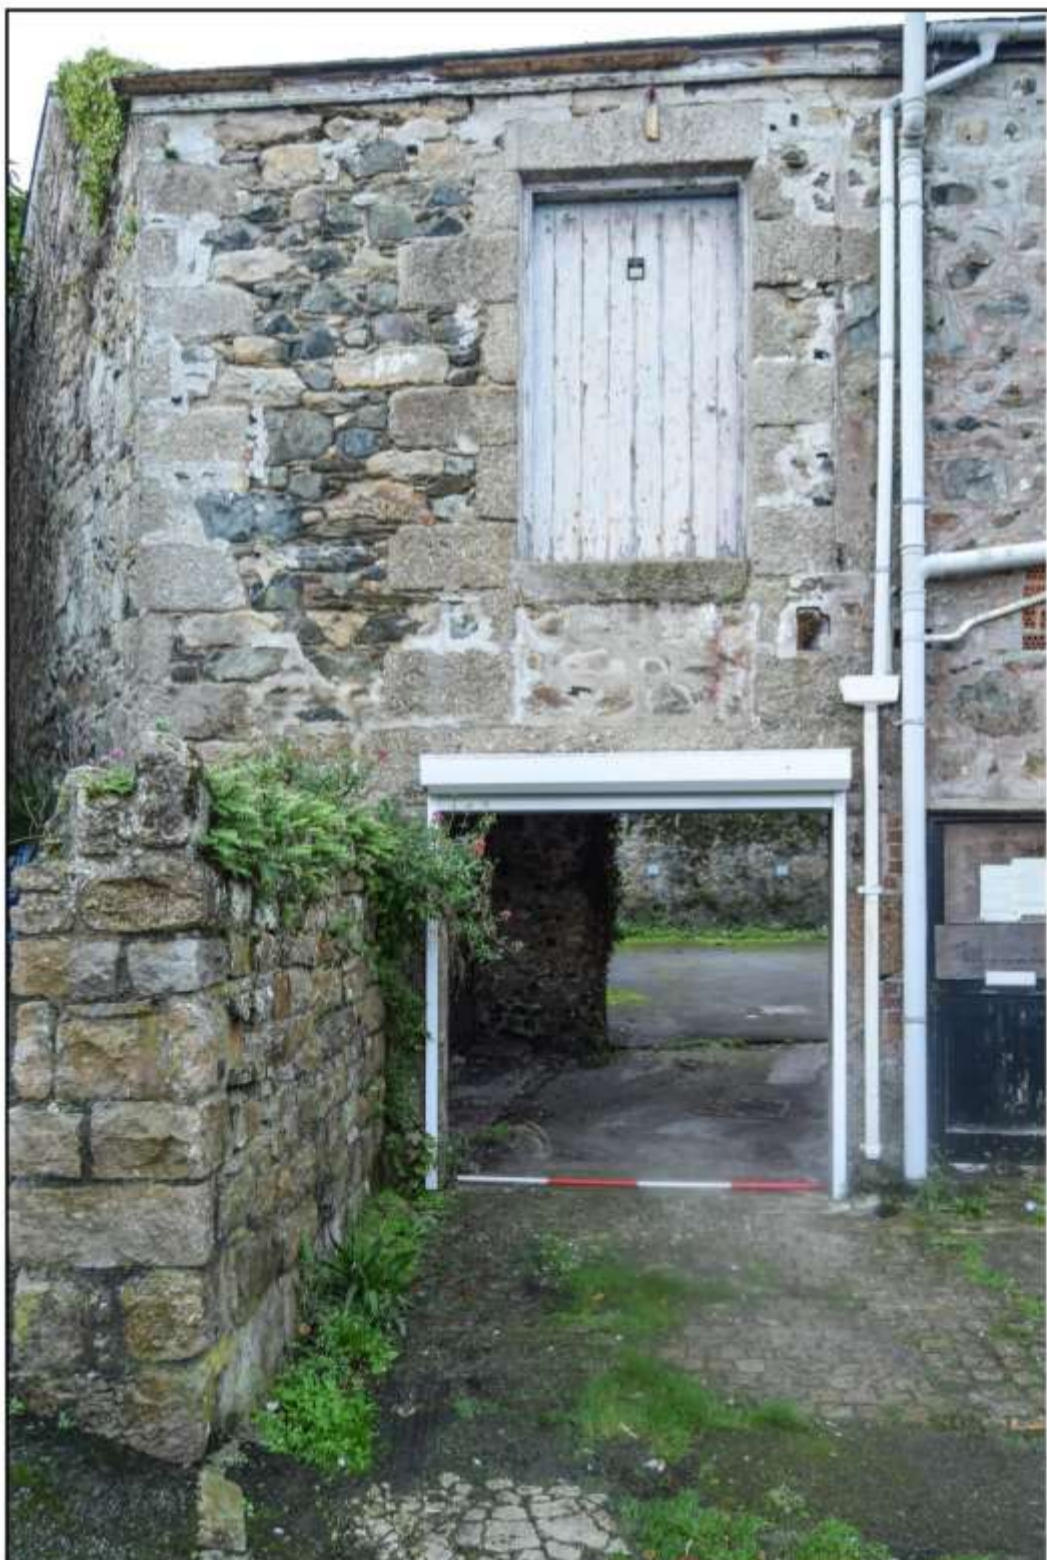
Ref: LLOY1022_0273. Scale 2m

ii) showing the east elevation of the part of the building subject to the current recording exercise. This elevation probably reuses and raises an earlier yard wall around the urban plot. Granite quoins here are drilled and cut indicative of a 19th century date, but there is evidence of alteration (below the threshold of the loading door), probably in Phase 2 (1850-1911) to raise the floor level of Space 4.

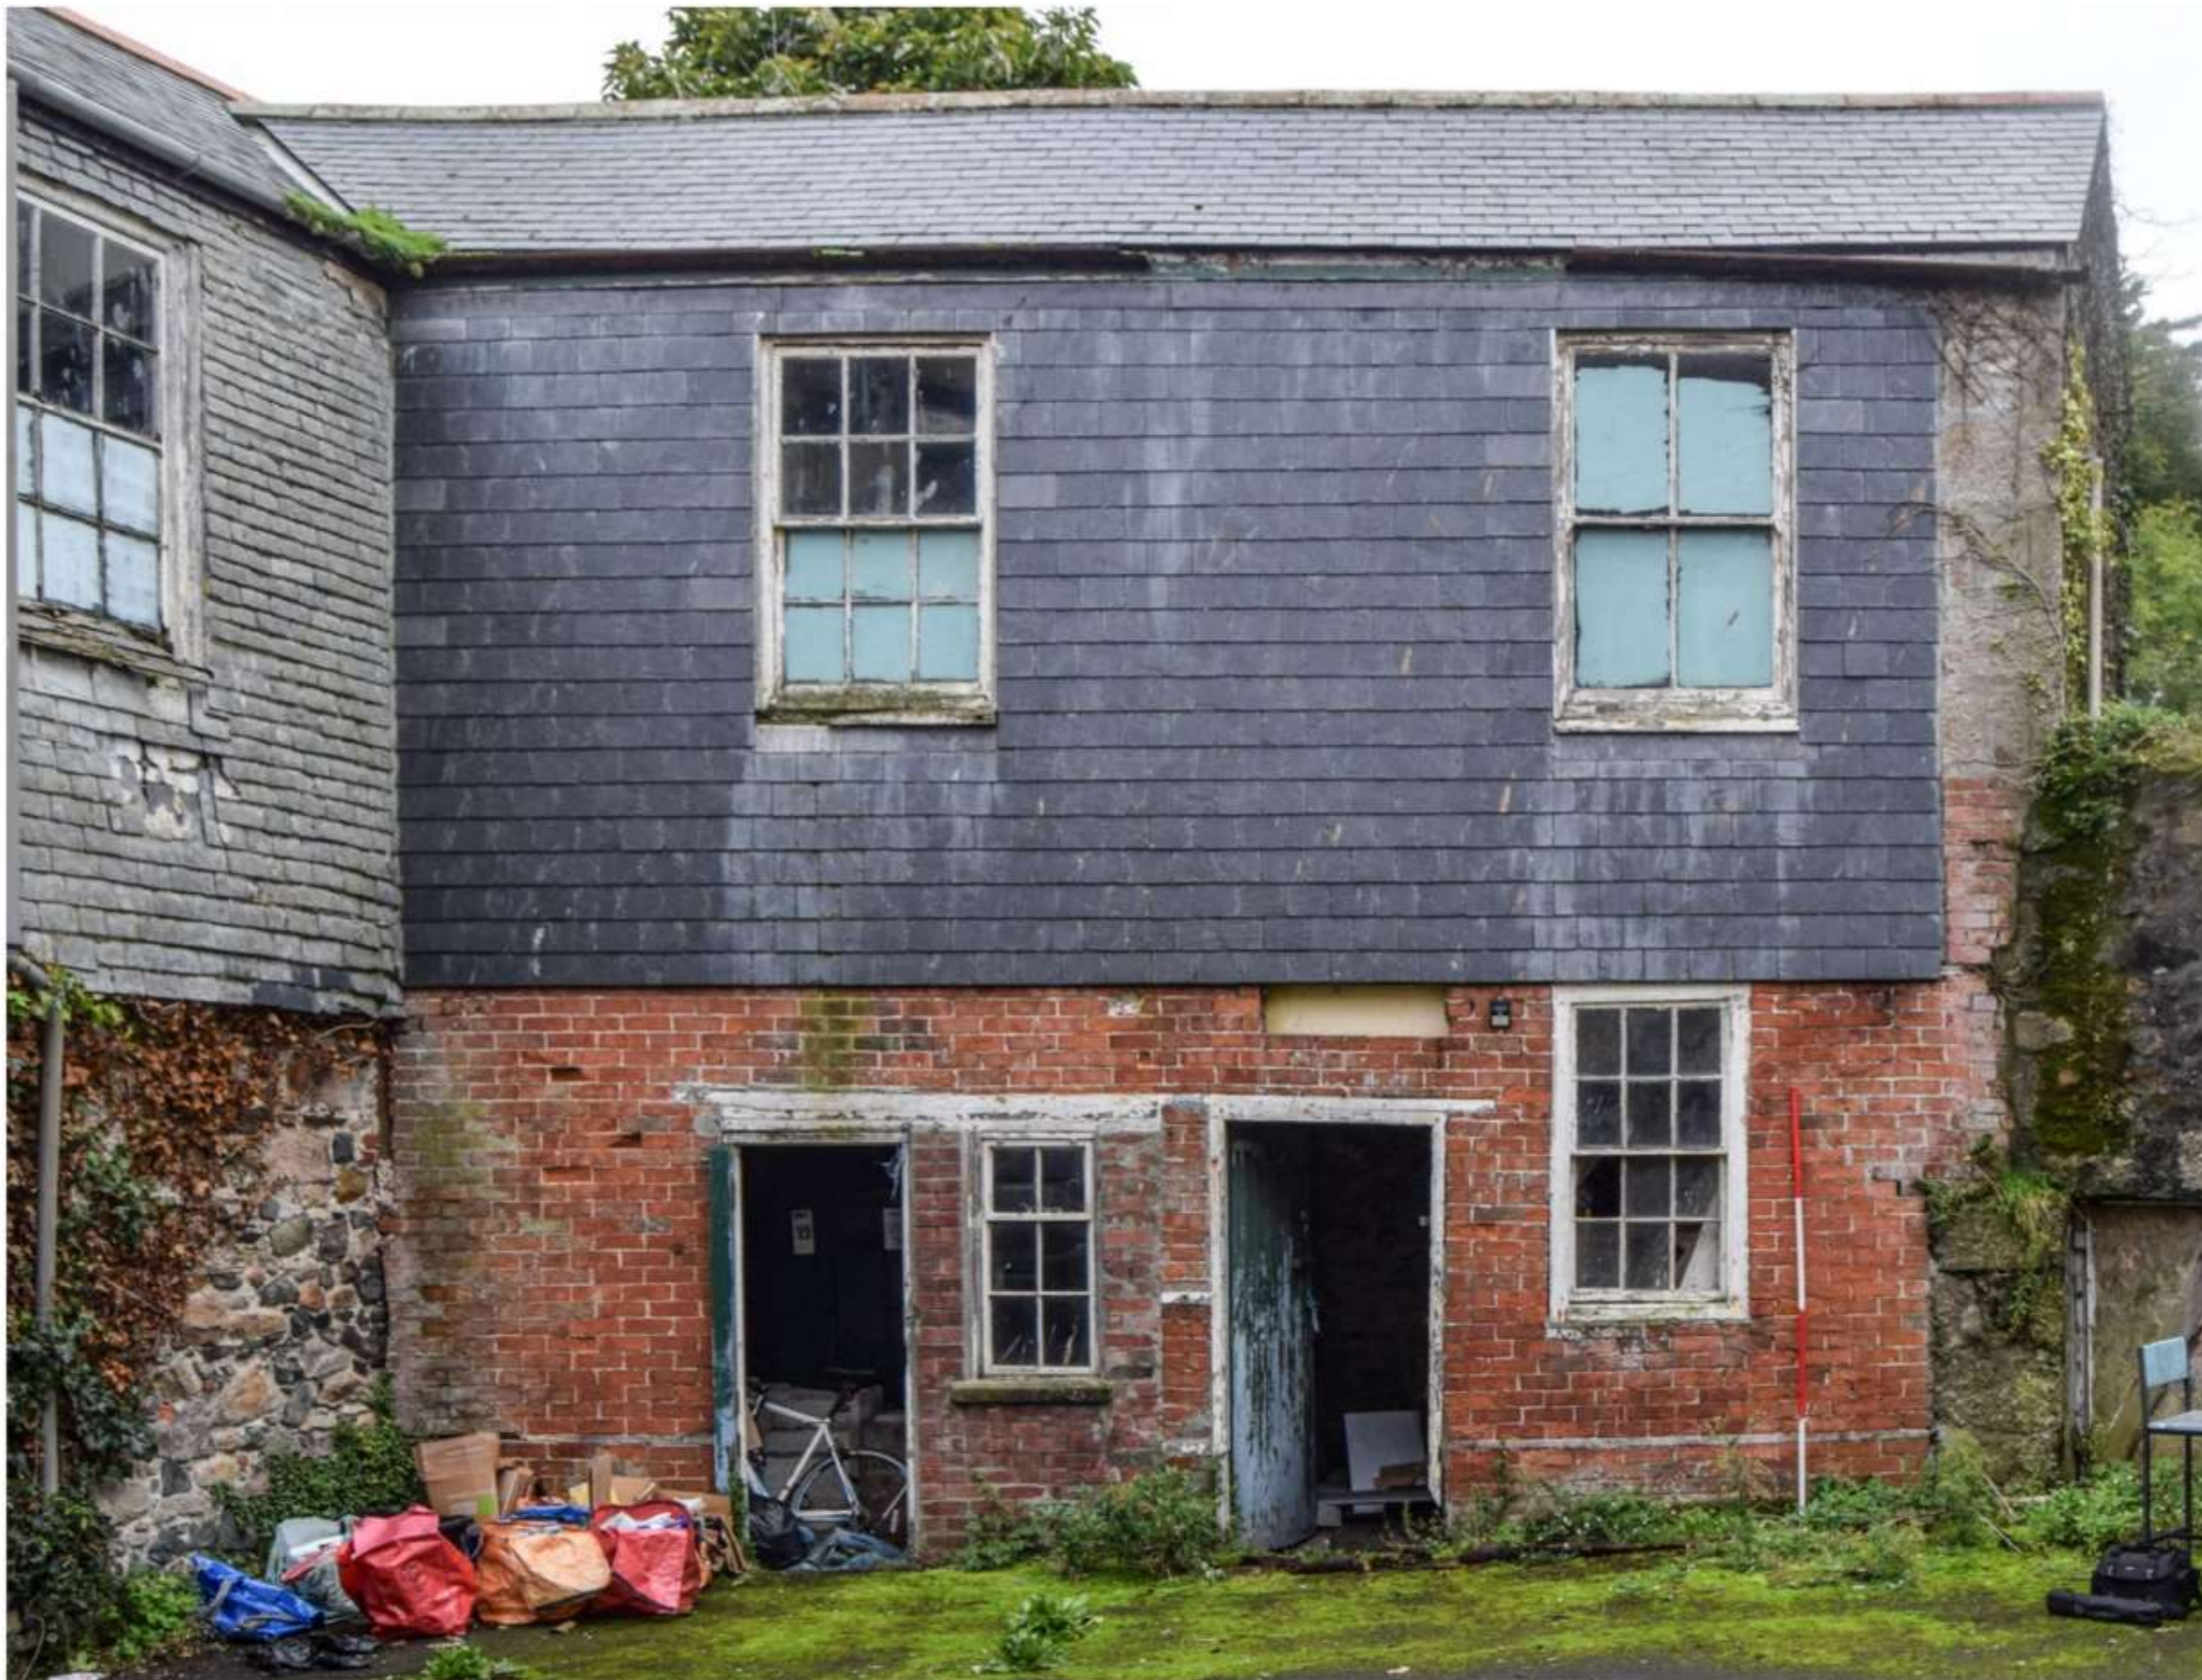
Reused, weathered ceramic ridge tiles

- 3.12 The northern elevation (**figure 8**) of this range (facing the courtyard) is formed of modern imported hung slate hung on a timber frame, in which is set a twelve pane (6 over 6) hornless sliding sash containing some crown glass and a later four pane horned sash. The lower storey is infilled with bricks in lime mortar. The openings in this walling show some reorganisation of this elevation. The right-hand side of the elevation contains a 12 pane hornless sliding sash window, and a simple plank door, probably in their original positions, while on the left hand side of the elevation a 20th century casement window and door way (the door itself is lost) sit in former cart opening blocked in more modern brick set in Portland cement based mortar.

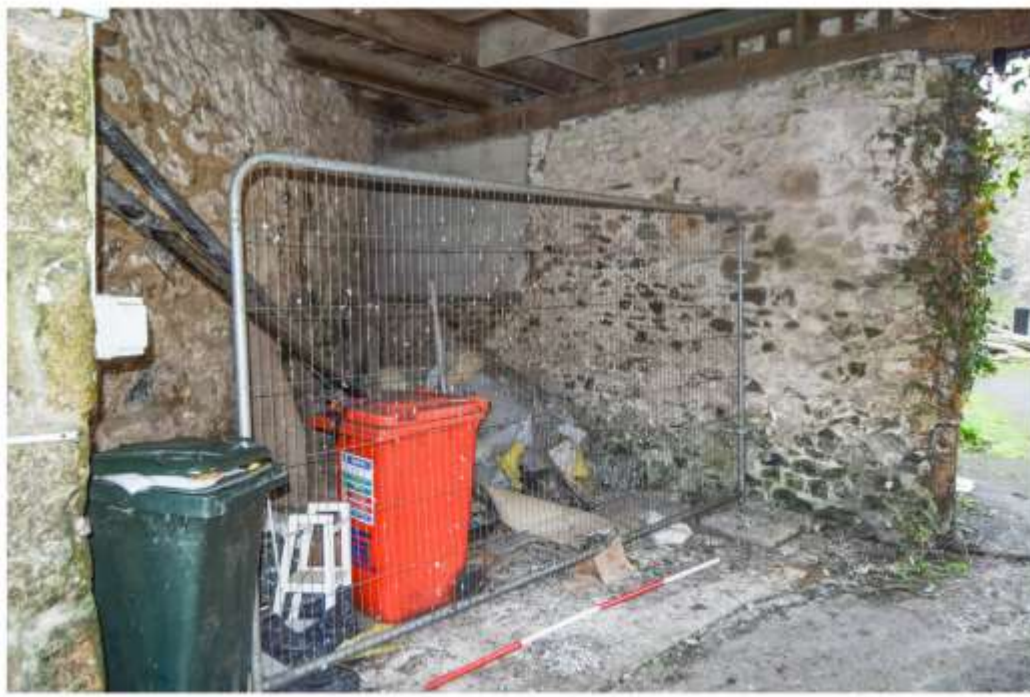
LLOY1022_0268.jpg scale 2m

i) Looking southwest into Space 1. The wall to left is stone rubble, likely the Phase 1 plot boundary, the wall to right is rubble infill between the iron pipe uprights of the west elevation of the east range. The concrete block infill panel corresponds to slate hanging over lath within Space 2.

- 3.14 Space 1 (**figure 9**) forms a wedge-shaped space open to the floor structure above, into which is set a large opening and structure, presumably for loading to, or a chute, from the first floor from first floor space 4. The east and south walls are of stone rubble bearing the traces of a lime wash finish. The northern wall of the space is a wall of machine-made *Fletton* bricks set in Portland cement mortar and likely to be a 20th century insertion, separating this part of the building off from the rest of the southern range to the north. There are traces of cobbles visible beneath a later concrete screed.

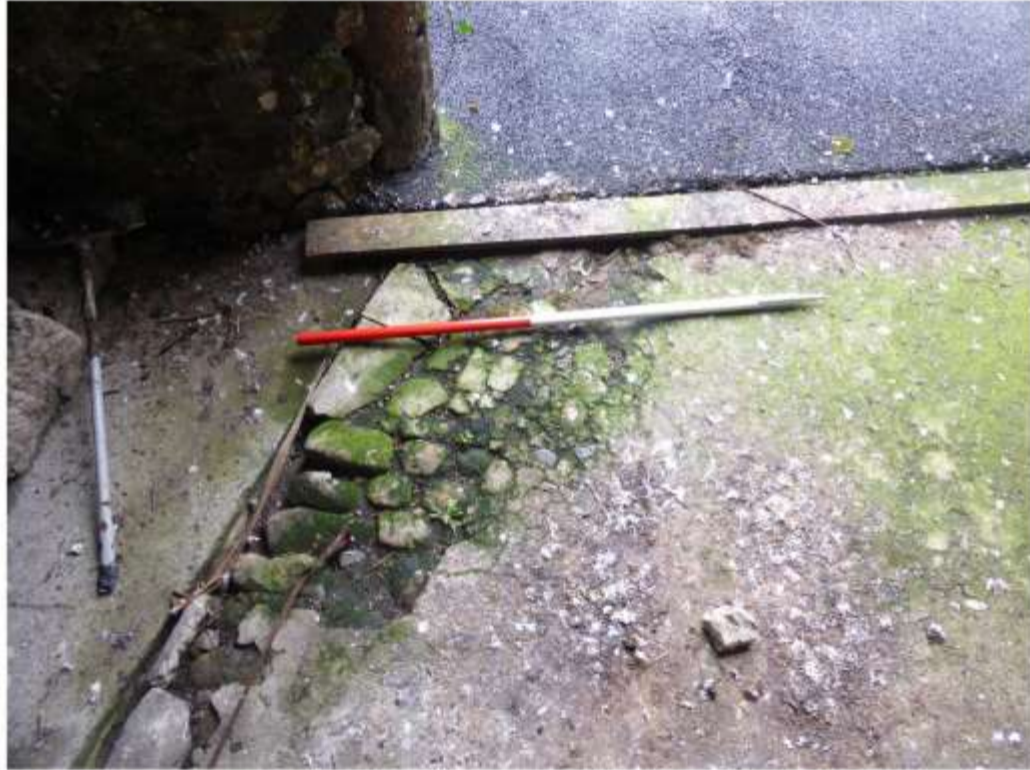
LLOY0320_1160176.JPG scale 1m

ii) small exposed area of cobbles in the southwest corner of the through passage

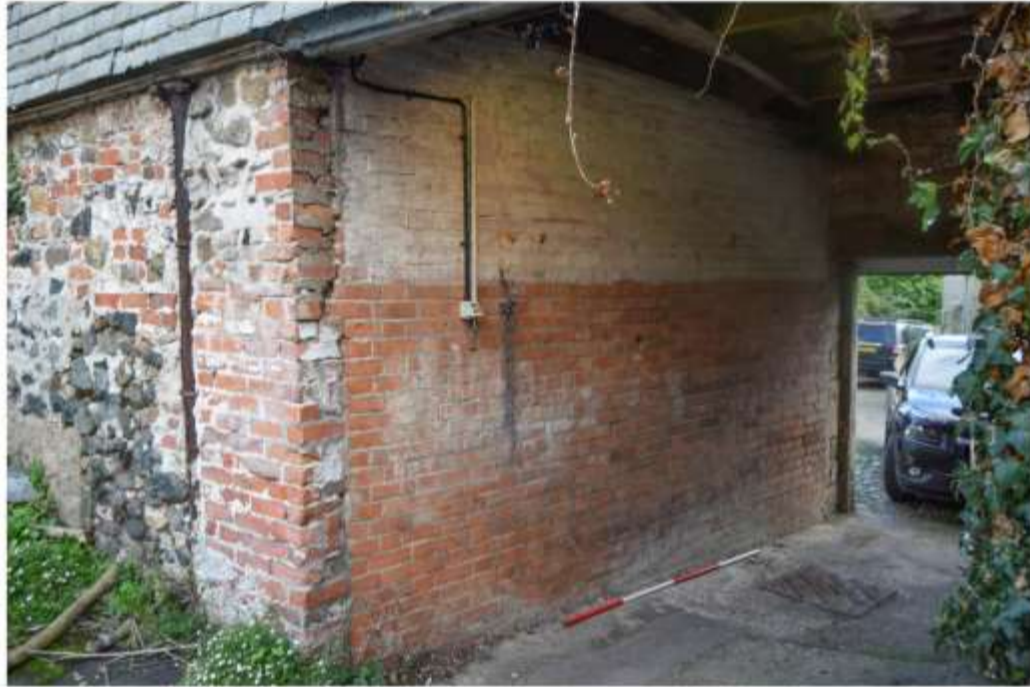
LLOY1022_0266.jpg - scale 2m

iii) North wall of Space 1. This wall represents 'Phase 3' infill - demonstratable with reference to its constructional material of pressed 'Fletton' brick within cement mortar.

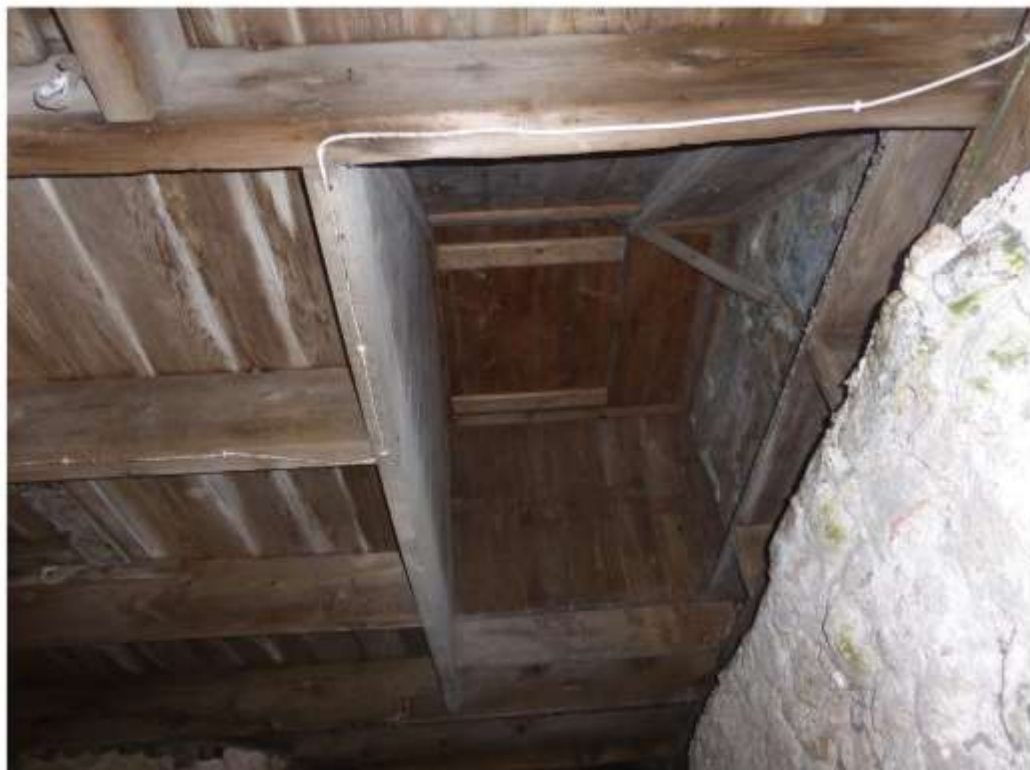
LLOY0320_1160159.JPG

iv) hoist hatch in the floor joists above Space 1

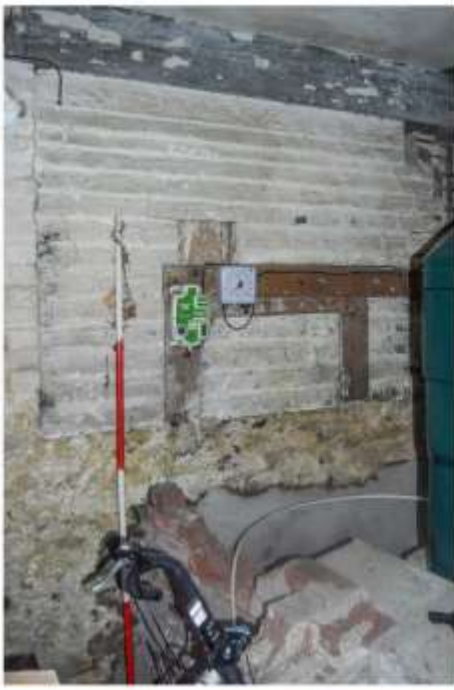
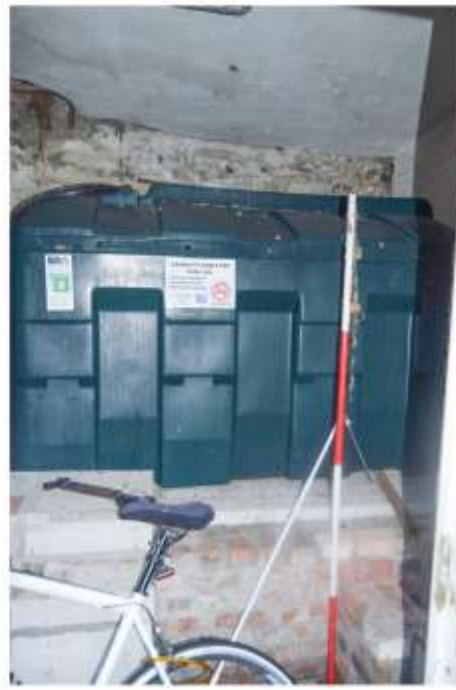
i) Space 2

[left image] East wall. Showing the slate hanging demonstrating that this wall was originally part of the external west elevation of the east range (LLOY1022_0275.jpg - scale 2m)

[right image] modern oil tank and ceiling in space 1 (LLOY1022_0276.jpg scale 2m)

- 3.15 The construction of the dividing wall between the central spaces 1 and 2 (**figure 10i**) demonstrates that the eastern range was in place before the construction of the southern range – with slate hanging surviving above a rubble base on its originally external, western,

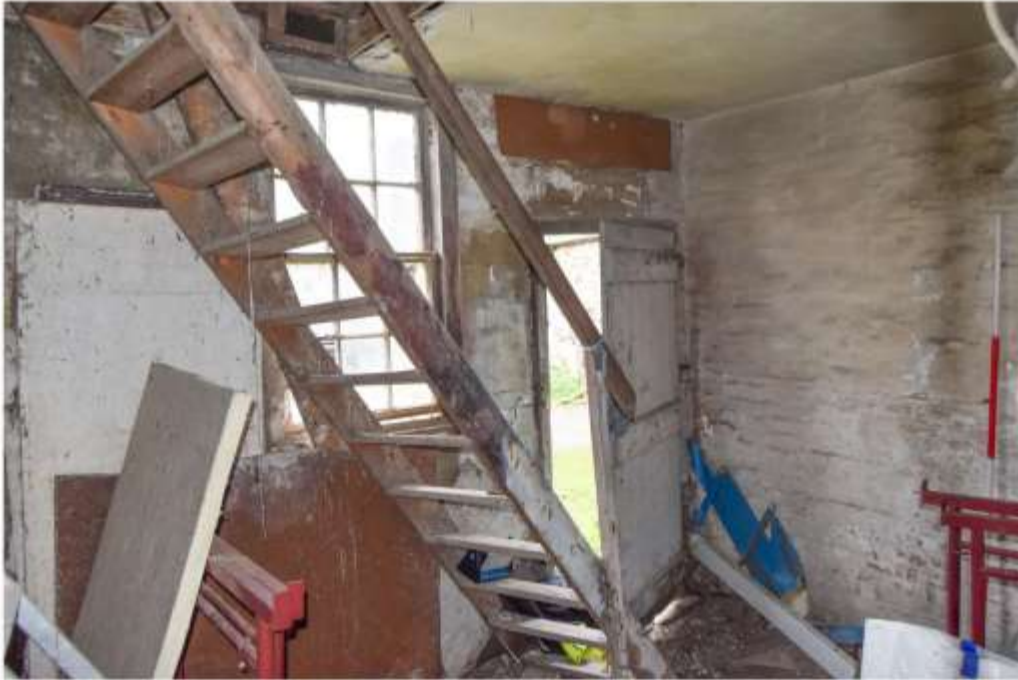
LLOY1022_0283.jpg Scale 2m

ii) north and east walls of Space 2, both of brick. the simple stair is considered relocated to this location, possibly from Space 1

- 3.17 Space 3 (**figure 10ii-iv**) has bare walls and houses a simple timber open ladder stair to the first-floor room 5. This stair which is in very poor condition, is unusually situated, being sited across the ground floor window. There is no evidence of heating in this space which has a large alcove in the rear wall of uncertain purpose and a brick floor with ceramic drain. The provision of this drain and the absence of heating may suggest that this space was originally a stable.
