Statement Heritage

Stable and Groom's Quarters. 13 High Street, St Ives, Cornwall, TR26 1RS

Level 3 Historic Building Record

SH Ref LLOY0320_Archive 01/03/2023

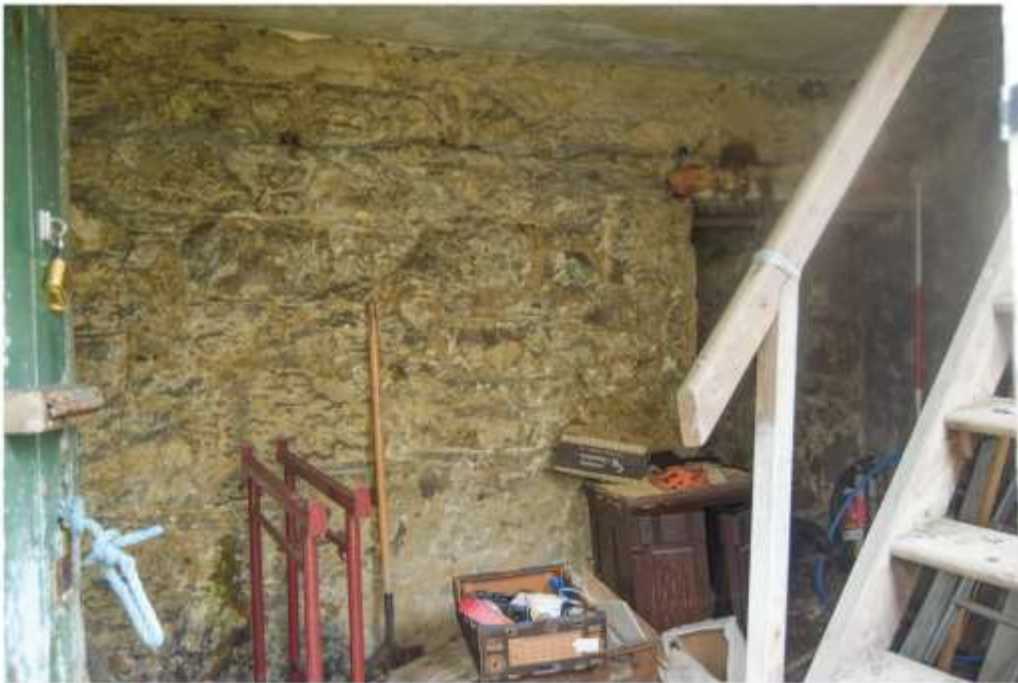
LLOY1022_0277.jpg - scale 2m

iii) Space 2, south wall

- 3.17 Space 3 (**figure 10ii-iv**) has bare walls and houses a simple timber open ladder stair to the first-floor room 5. This stair which is in very poor condition, is unusually situated, being sited across the ground floor window. There is no evidence of heating in this space which has a large alcove in the rear wall of uncertain purpose and a brick floor with ceramic drain. The provision of this drain and the absence of heating may suggest that this space was originally a stable.

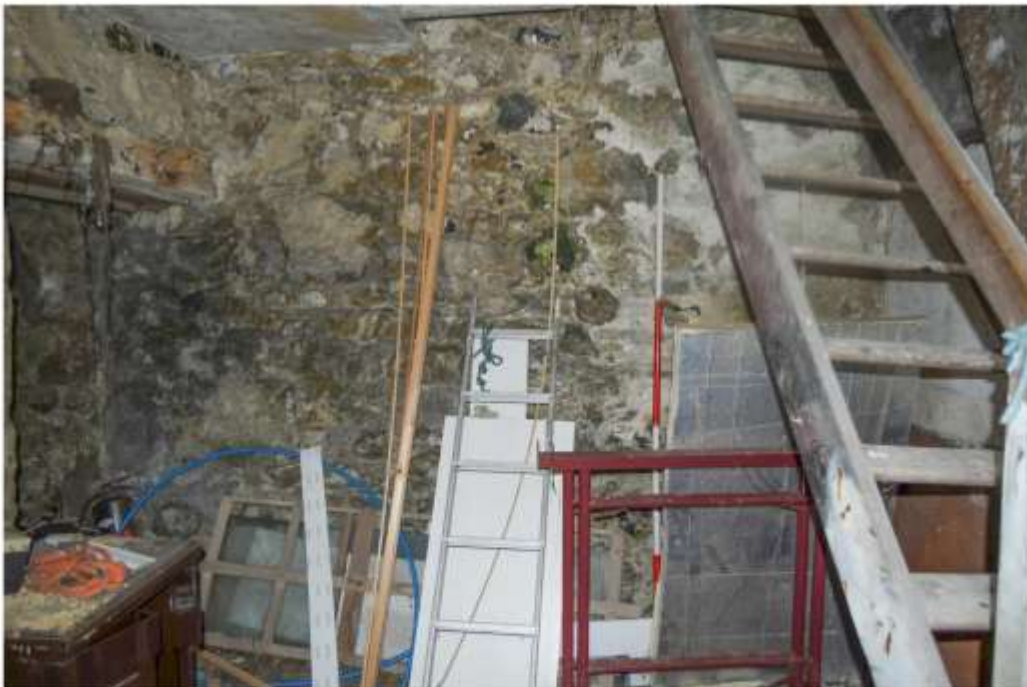
LLOY1022_0280.jpg scale 2m

iv) Space 2, south wall

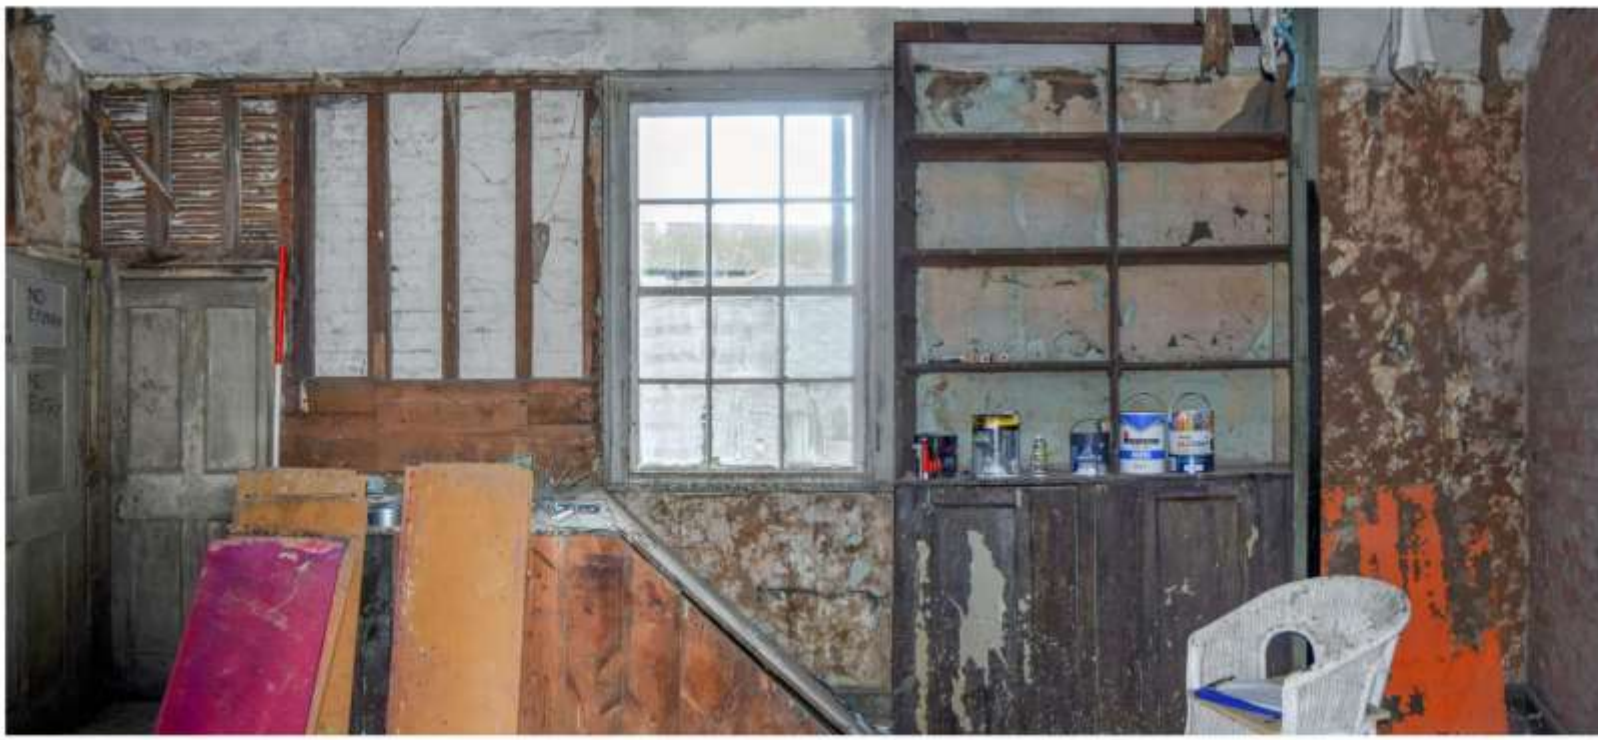
i) East wall.
(composite of LLOY1022_0296.jpg and LLOY1022_0297.jpg - scale 2m)

- 3.18 Space 4 (**figure 11 general** and **figure 12 details**) is directly above cart entrance 1. The *Fletton* brick subdividing wall noted in space 1 continues to the roof, of which the simple triangular principal trusses, probably of the late 19th century are exposed. The loading opening in the east wall has a robust plank door and affords views towards the harbour. The east and south walls are battened with traces of boarding fitted to these surviving (one, clearly reused inscribed in paint "19?? W Richards, St Ives", with some patterned wallpaper in places. There is a surviving mid-19th century fireplace *in situ* in the southern wall of the room whilst the loading hatch feature to the cartway below, also survives. There is a small narrow space in the south west corner of the room, formed of stud partitions with similar boarded finishes, which may have been the lobby of a stair from the cartshed 2 below.

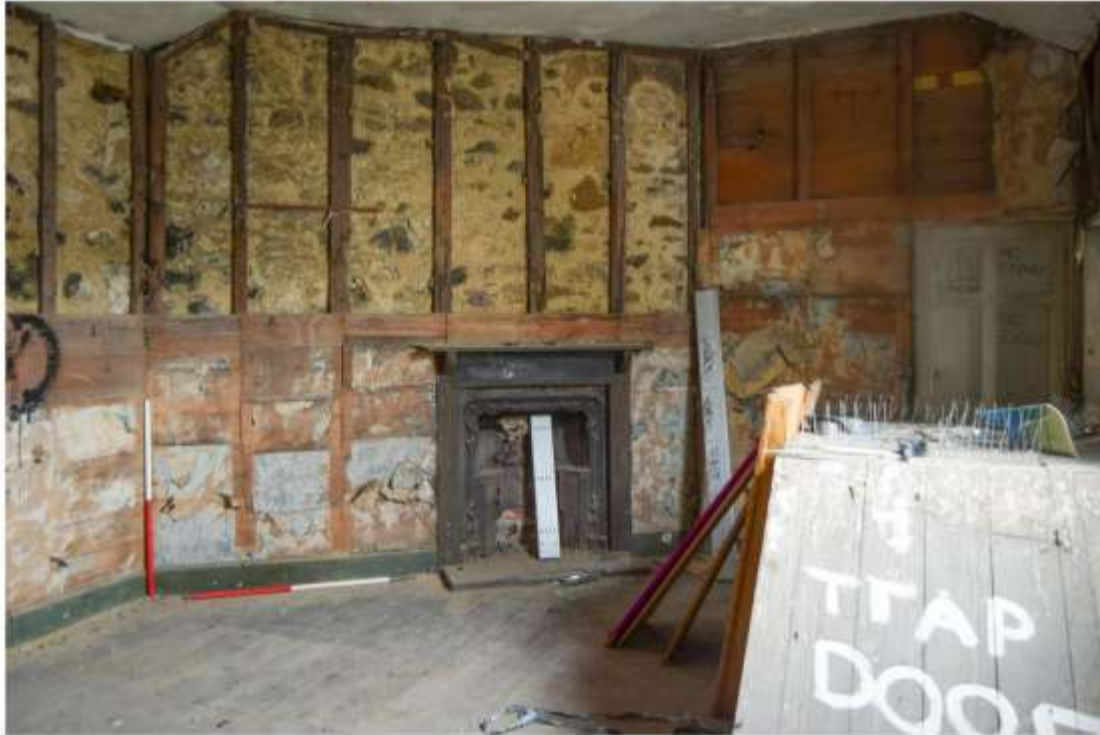
ii) south walls (see figure 12 for details)
(LLOY1022_0293.jpg - scales 1m)

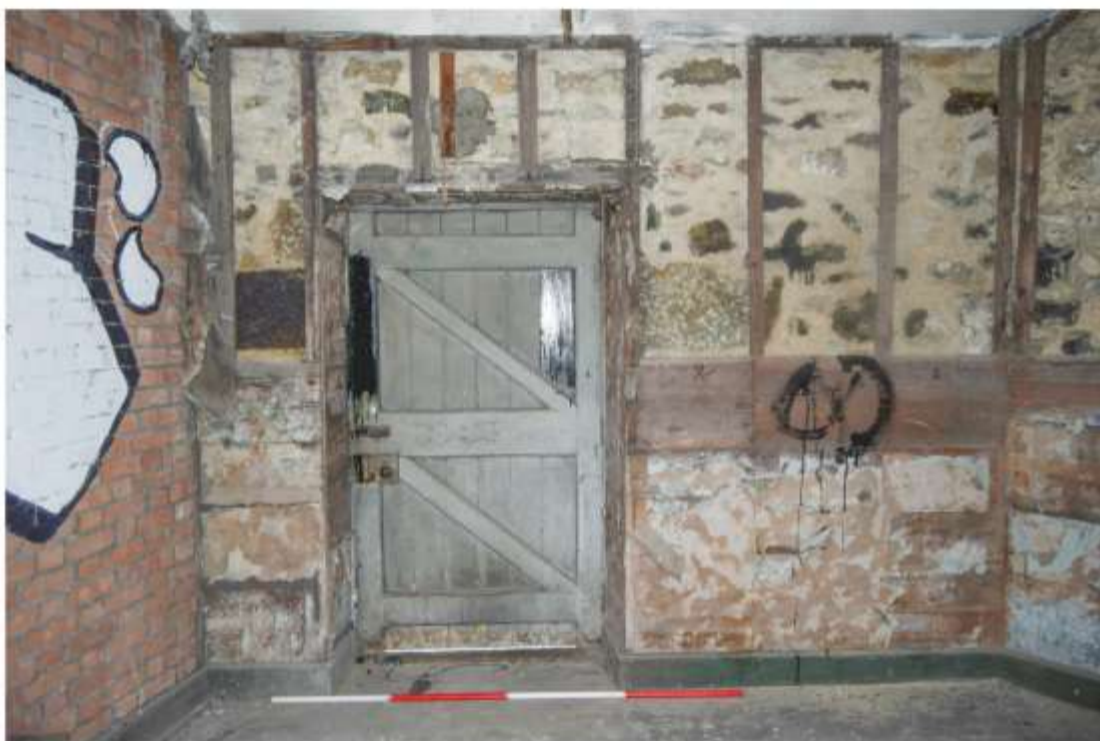
iii) East wall and loading door
LLOY1022_0301.jpg 2m scale

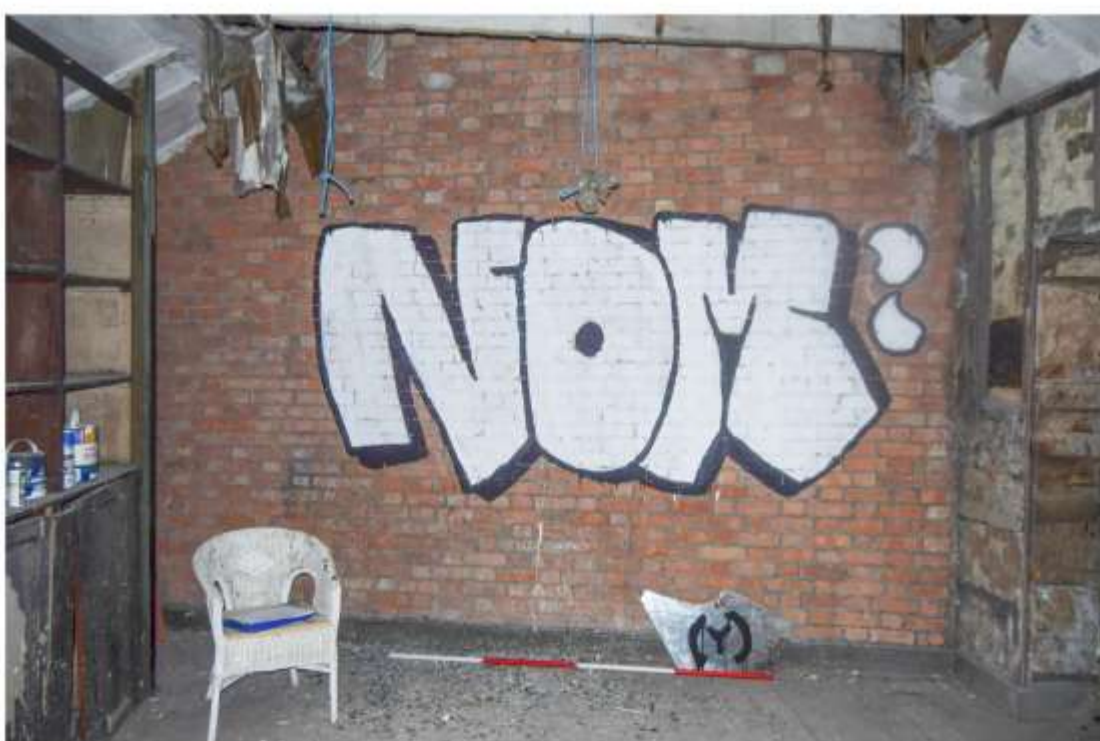
iv) North wall. Brush painted graffiti
dates to 2020-2022
LLOY1022_0301.jpg 2m scale

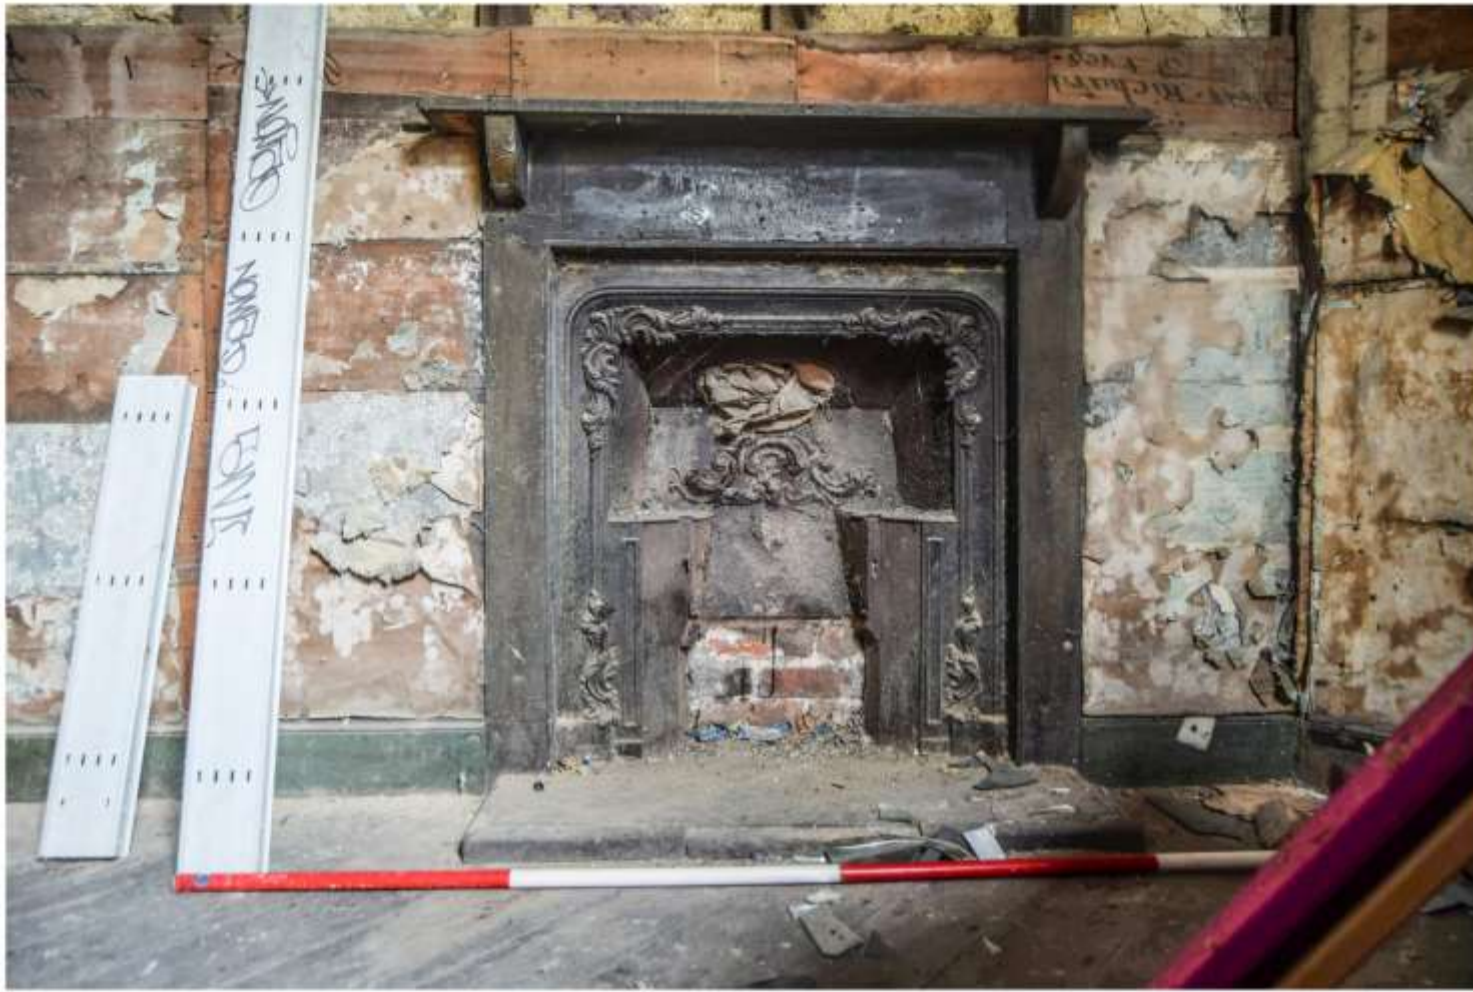
LLOY1022_0308.jpg 2m scale

i) Timber fire surround, Victorian cast-iron insert. 2m scale.

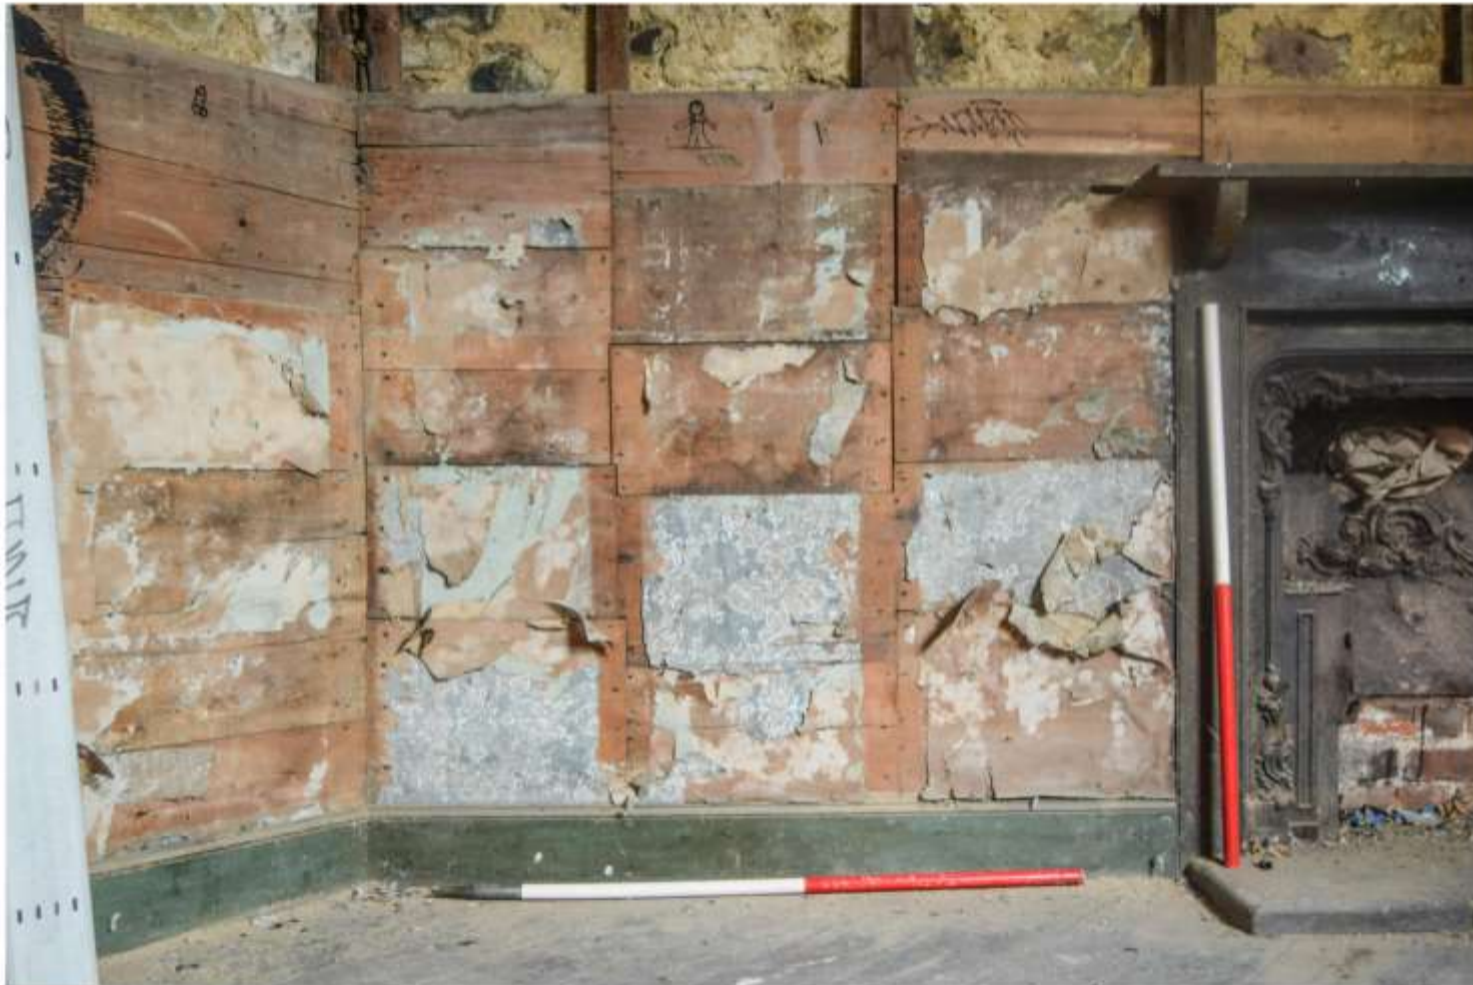
LLOY1022_0309.jpg 1m scales

ii) Detail of south wall to left of fireplace. Reused fish-crate timber dry lining and 2 phases of wallpaper

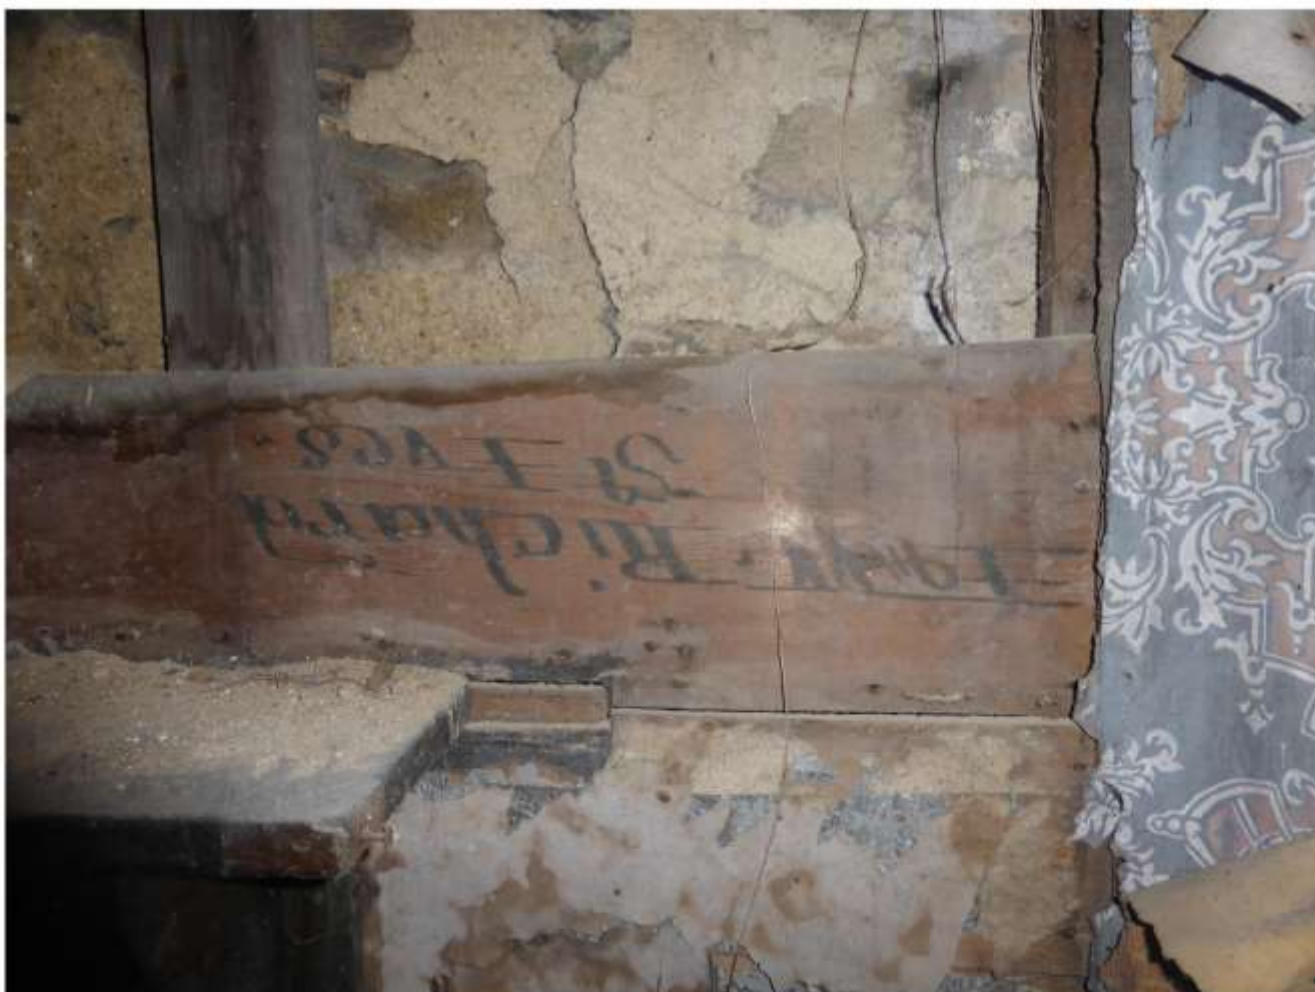
LLOY0320_1160129.JPG

iii) Detail, crate timber top right of fire-surround with painted label "19-11 Richard St Ives"

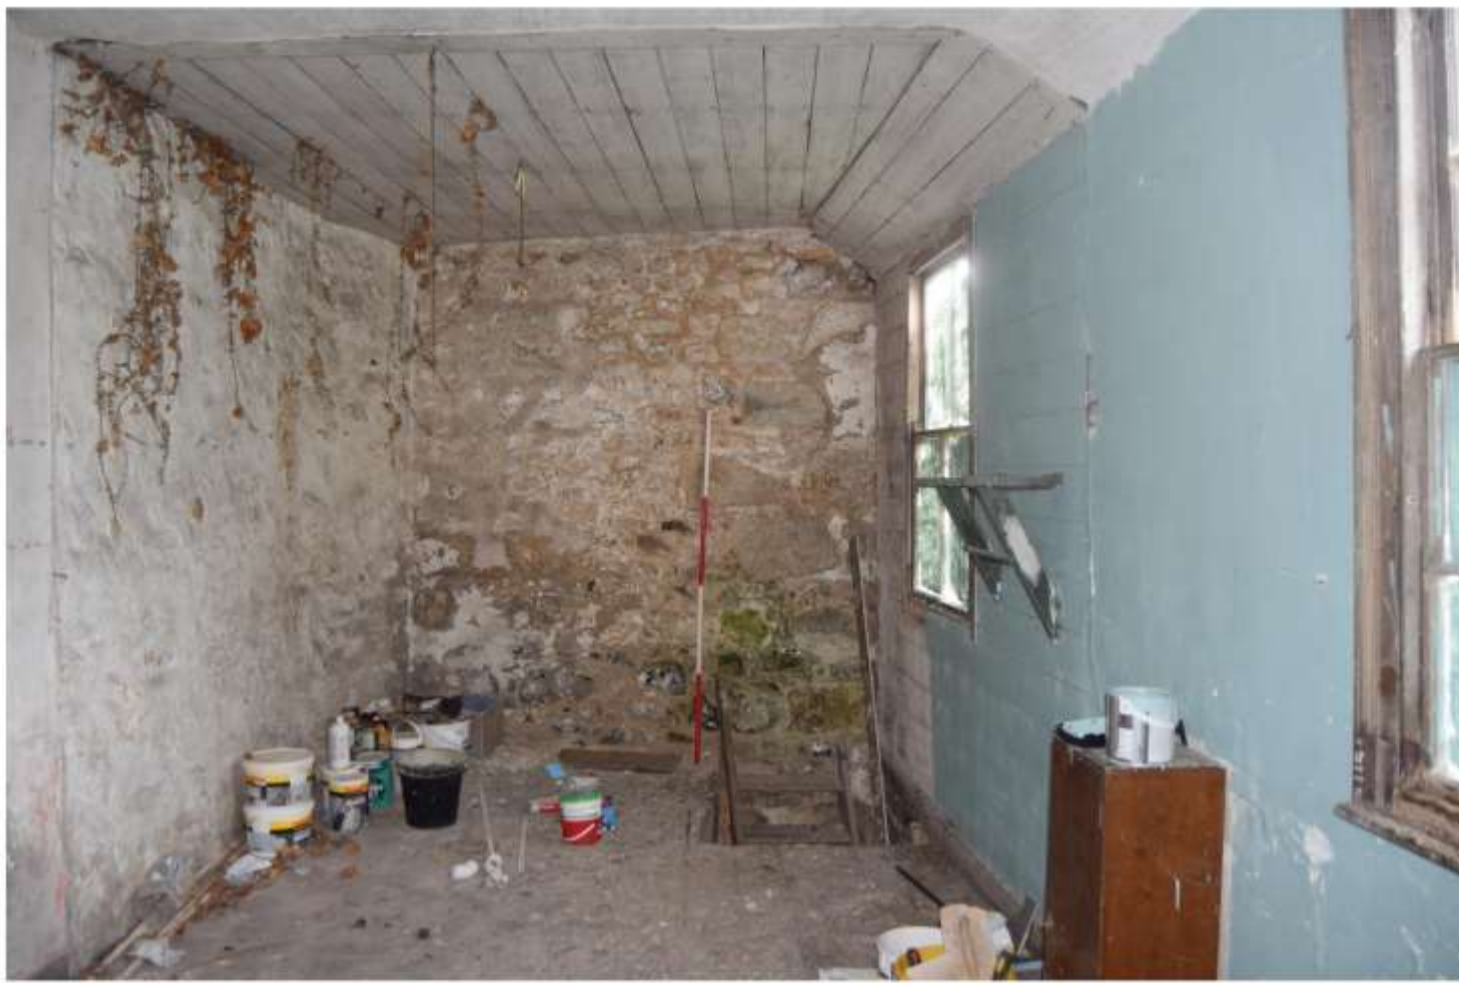
LLOY1022_0285.jpg 2m scale

i) room 5 looking west

- 3.19 Space 5 (**figure 13**) is directly above the stable, and was also historically heated by a mid-19th century fireplace surviving in the rear wall. The room is lit by the two windows in the north elevation. There are no safety barriers around the hole in the floor where the current stairs rise, and this may have been a later insertion. There is a simple 4 panel door between the two upstairs rooms (both of which originally had lathe and plaster ceilings – now in very poor condition.

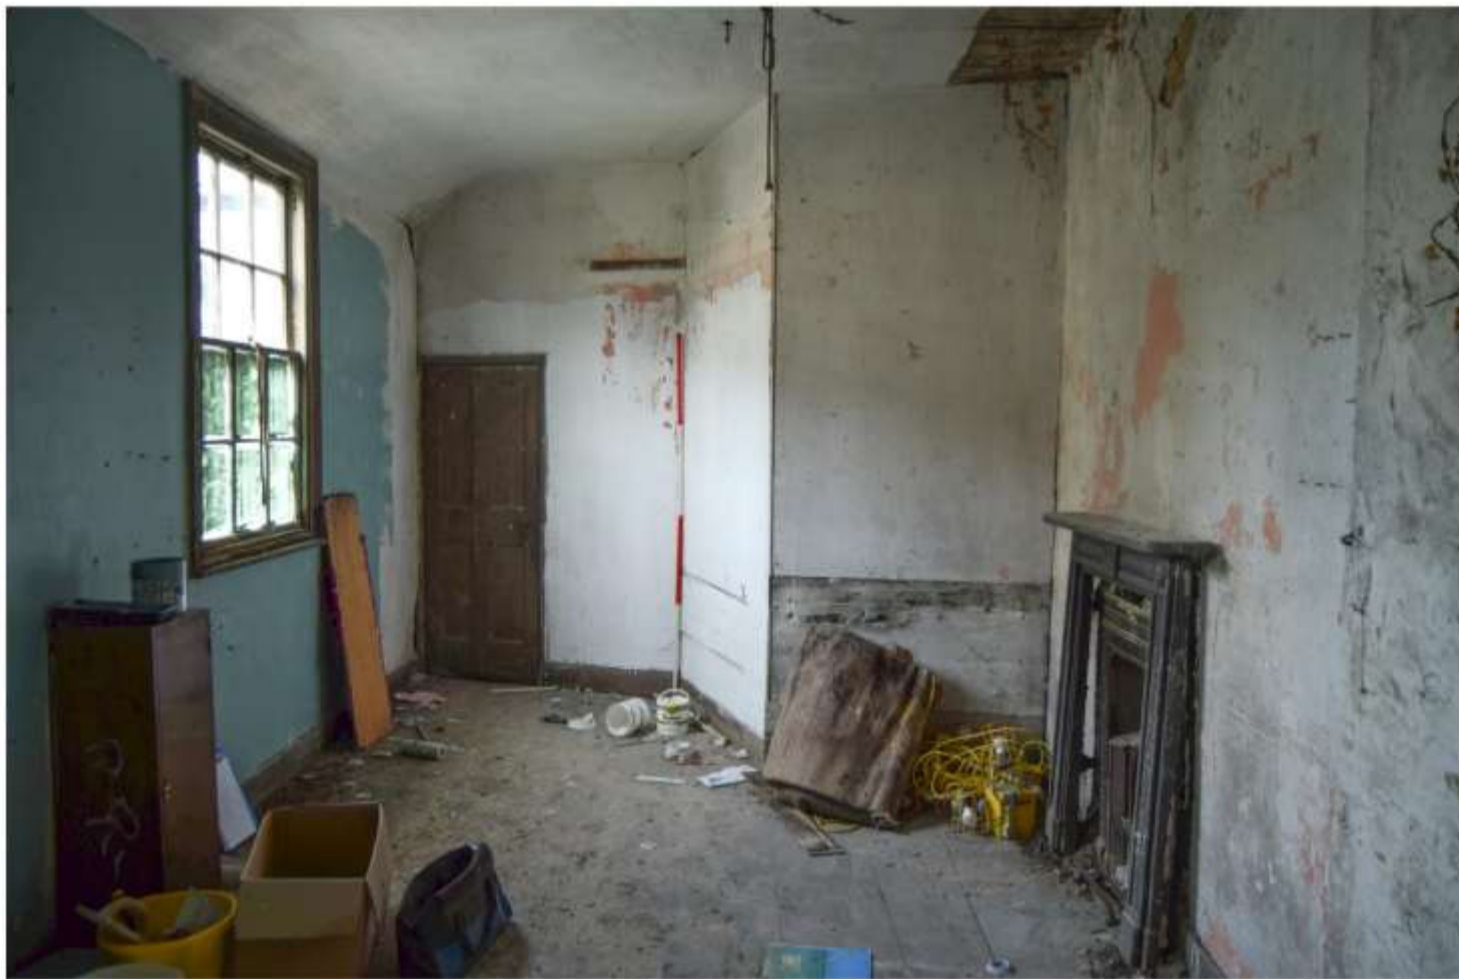
LLOY1022_0290.jpg 2m scales

ii) Room 5 looking east

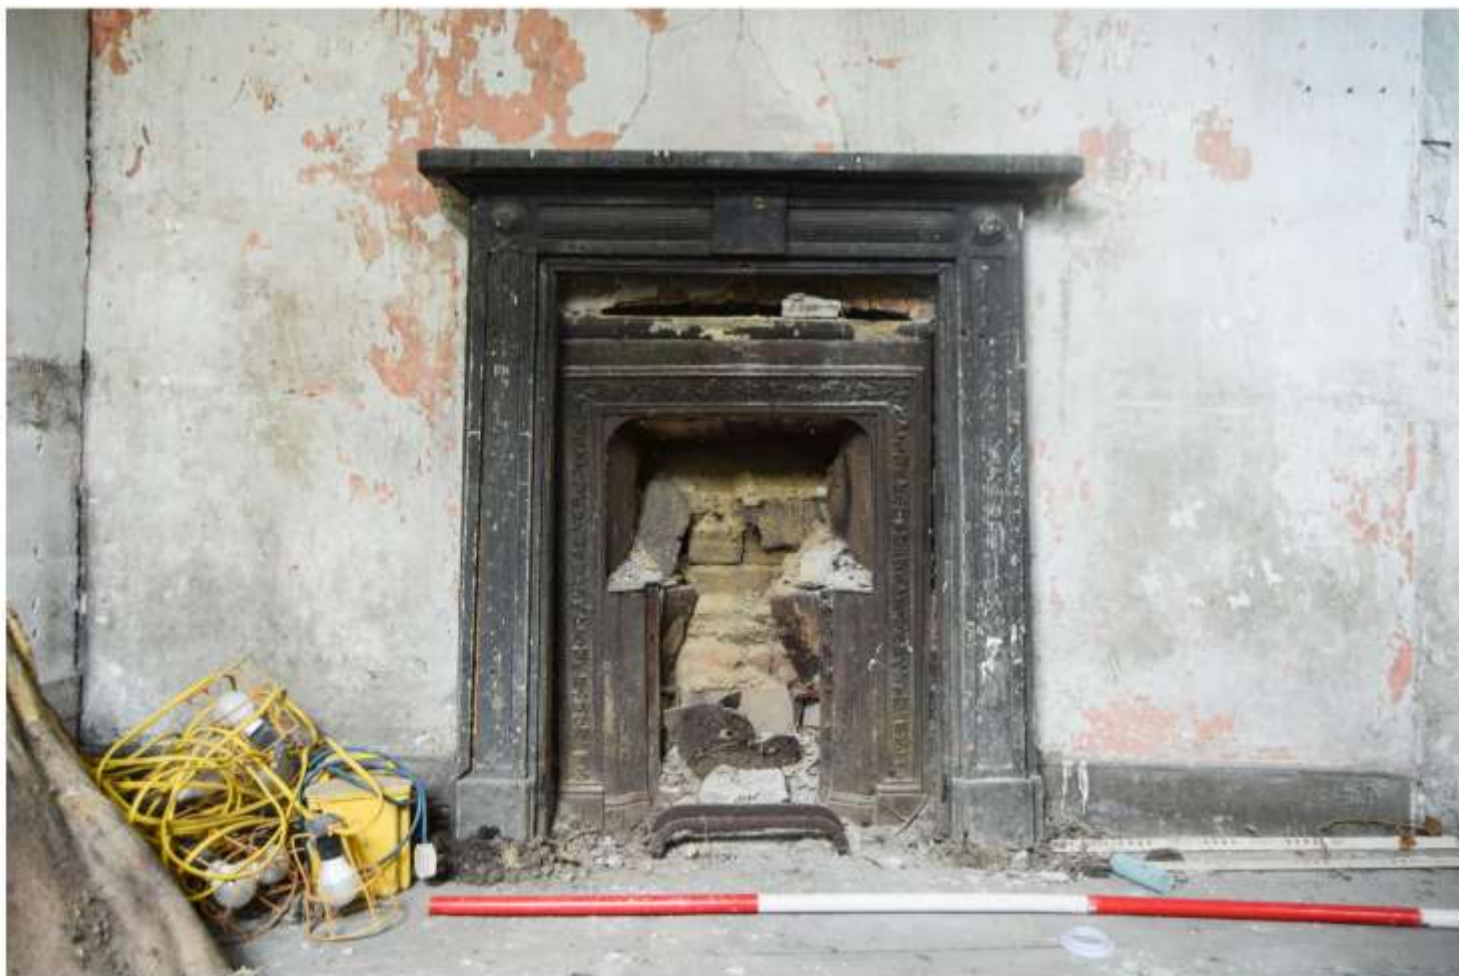
LLOY1022_0289.jpg

iv) Timber fire surround, Victorian cast iron insert
