# Great Bowden Heritage Archaeology

**Mud barn and paddock, Sutton Road,**

**Archaeological Test Pit Excavations and other investigations**

**2002-2014**

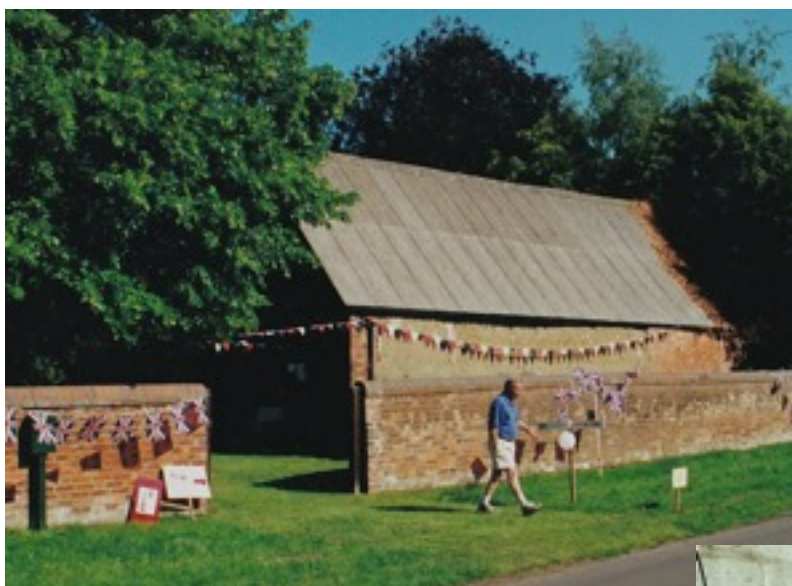
*Fig 2, left. showing the remaining mud wall of the barn from the road.*

The debris on the floor was a foot deep in places and contained much of the mud from the original walls, replaced by brick in the case of all walls except the one facing the road. The mud contained much animal hair, mixed in. There were reeds, probably used in the ceiling and harnesses, metal hinges and other door furniture from a variety of periods. The floor when revealed was mostly laid brick with cobbles in some places.

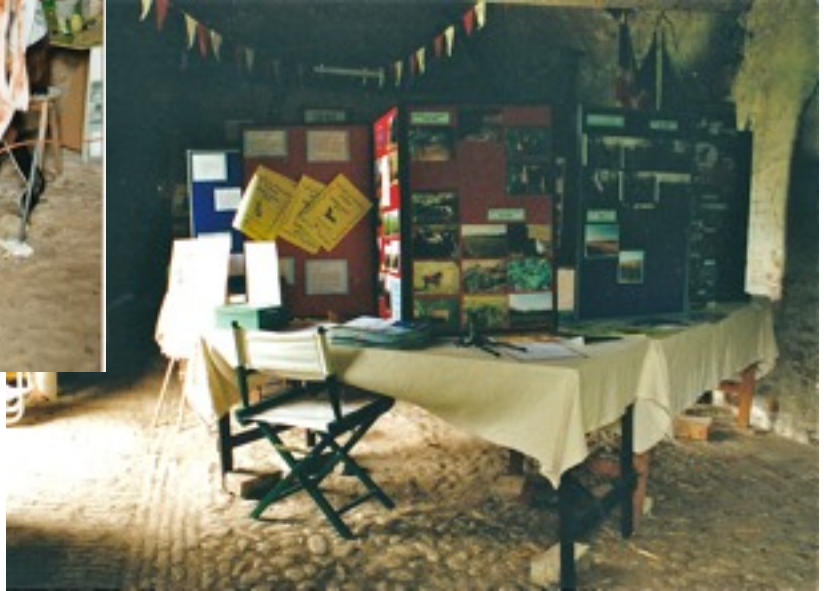
*Fig. 5 below, further displays and showing the excellent condition of the barn floor constructed with brick and cobbles.*

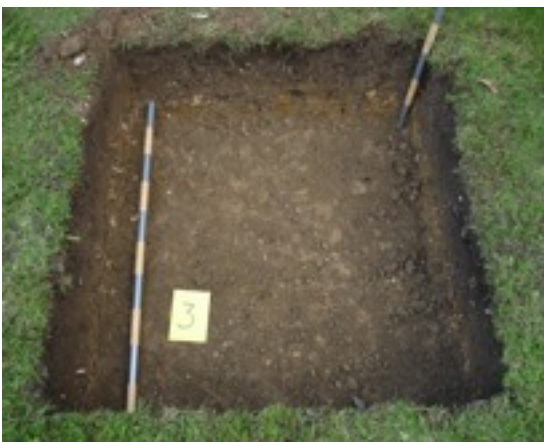
*Fig. 7 Photograph taken at the completion of Context 3 at a depth from the surface of 30 cms. The level of the possible mud barn yard can be clearly seen around bottom edge of context. Some ceramic white tile fragments and small fragments of terracotta were also found in this context. Soil starting to include more clay mixed with the loam.*

Context 3 was dug to a depth of 30 cm on completion. Again the earth was very loamy and still dark in colour with part clay mix at the bottom of the context. Post medieval finds are listed separately. Again a metal detector scan was made.

At the bottom of this context the possible level of the old mud barn yard was uncovered. This narrow layer consisted of tile, pot and stone and dried straw different to elsewhere in the pit and it could have constituted an attempt to create a simple yard surface close to the existing mud barn.

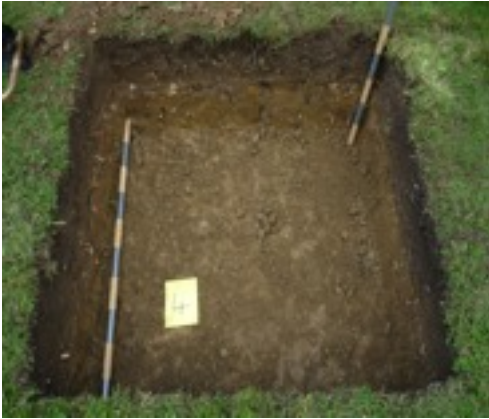
*Fig. 8 Photograph of context 4 clearly showing the transition from loamy earth to soil/clay mix. You can clearly see the barn yard floor level halfway down the cut. Surprisingly few finds had been found at this stage in the dig.*

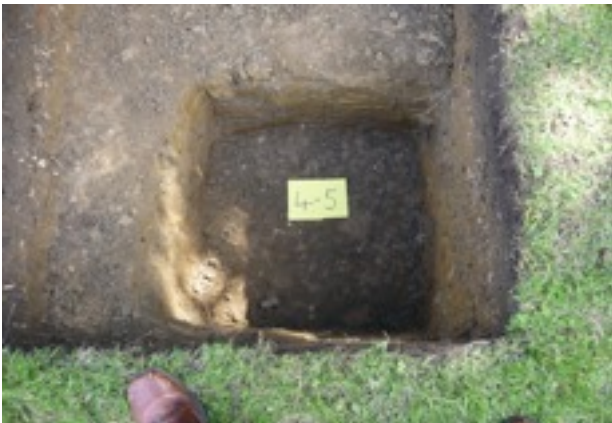
*Fig. 9 Photograph shows context 5 completed. As very little had been found in dig it was decided to extend the smaller corner pit to probe if anything lay between context 5 and the natural.*

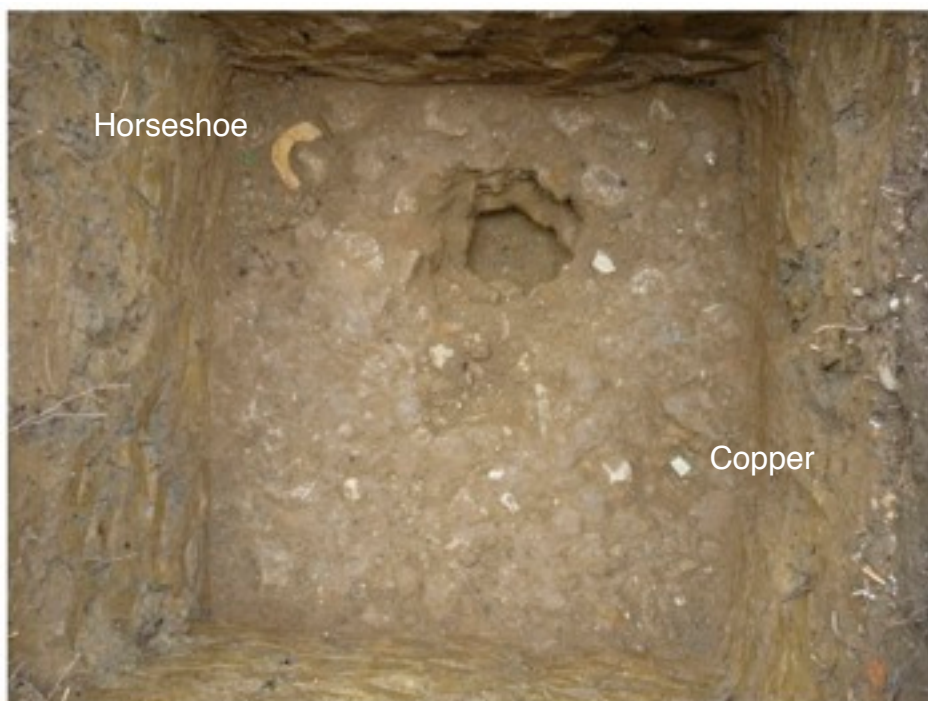
*Fig. 10 The floor surface, Context 7, can be clearly seen in this photograph. The positions of the three finds can be seen. A small hole was made in the floor to see the depth it extended down. This was found to be 23 cms with natural below.*

Context 6 (small area) was dug to a further depth of 50 cms (1 metre from the surface). We came across what seemed to be a stone surface. A metal detector scan of the small corner pit showed there to be a metal object under the stone surface. At this point it was not clear how far this stone surface extended.

Context 7 was dug to a depth of 1 metre from the surface. The full 1 metre x 1 metre was exposed and it was found that the stone surface covered the whole area and beyond. The metal detector signal obtained at bottom of small corner pit was investigated and found to be what looks like part of an old horse shoe. This was under the top surface of the floor. Once the whole pit was cleaned another metal detector scan was carried out and two further signals heard once again for objects within the floor. On investigation a very fine piece of copper band was found.

*Clearly further investigation, possibly using geo-physics, is needed to make sense of the stone surface and if possible to find the extent of it before further excavation is attempted.*

There is the possibility that this surface is the floor of Great Bowden's Tithe Barn. The tithe barn was on land belonging to Christchurch College, Oxford, as this site was, and permission was sought and granted in 1837 for the barn to be demolished. The tithe barn's location is not given but it was described as being some distance from the 'estate' (the arable fields) and in an area of pasture. Permission was sought and eventually granted in 1846 for a replacement barn to be built, as a proper building, as a substitute for the old tithe barn. The existing mud barn may date from the mid 19<sup>th</sup> century when mud was used extensively in the village for building. The pit was remarkably dry even at a metre depth unusual in this part of the village where the cellars of Rectory House were known to flood and the paddock to the north of the excavation site is also very damp

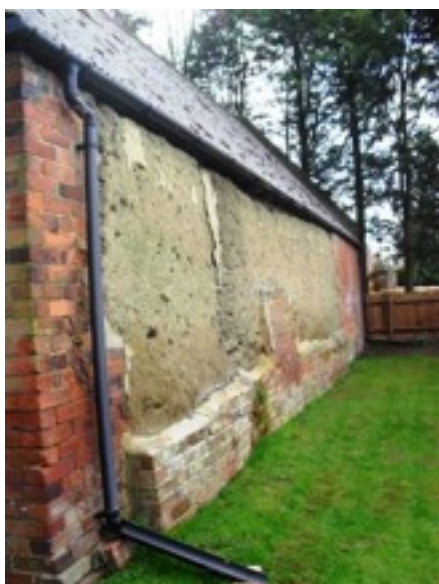
*Fig.14 External mud wall of barn*

Mud Barn Paddock is a small paddock whose name derives from a currently unused brick/slate and timber barn whose west elevation is of mud construction, and which, until mid 20th century, was used to house cattle. It is north of Rectory House, and the Parish Church, in that part of the village thought to be the land referred to in Domesday Book as held by the king. The paddock is pasture formerly part of the adjacent Rectory House home farm.

The current barn is thought to date from the 19th century when mud was used extensively in the village for building. The paddock is one of several contenders for the site of the original tithe barn, known to have been on Christchurch pasture land. Permission is known to have been sought in 1837 for the tithe barn to be demolished and for replacement cattle sheds to be built in 1846, but the site of the original tithe barn and its replacement remains unclear.

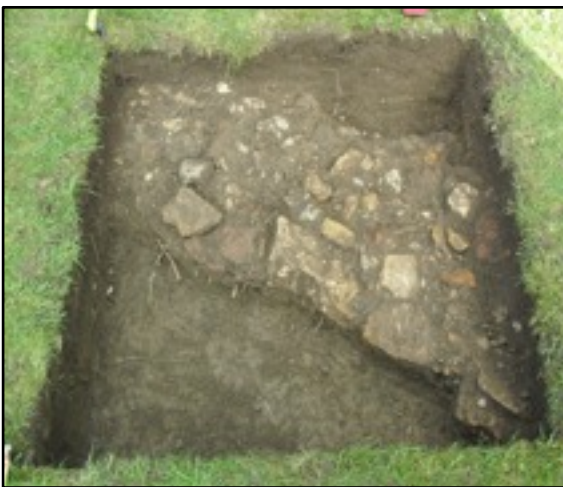
*Fig 15 Wall foundation at 20cm depth*

At the 20 cm depth evidence of a stony feature emerged diagonally SE to NW across the pit, which, when excavated, revealed a line of randomly laid stone, with one straighter edge formed by 2 larger pieces of local "iron" stone. The rest comprised limestone, some worked, cobble, two large pieces of clay floor tile with evidence of a glaze, and smaller fragments of ironstone, brick/tile, lime mortar and rubble.

No pottery was found in this context. At most the feature was 9cm or one stone deep, and

finished just above the start of context 4. Unlike the "floor" found in 2009 it was not set in the ground in any structured way.

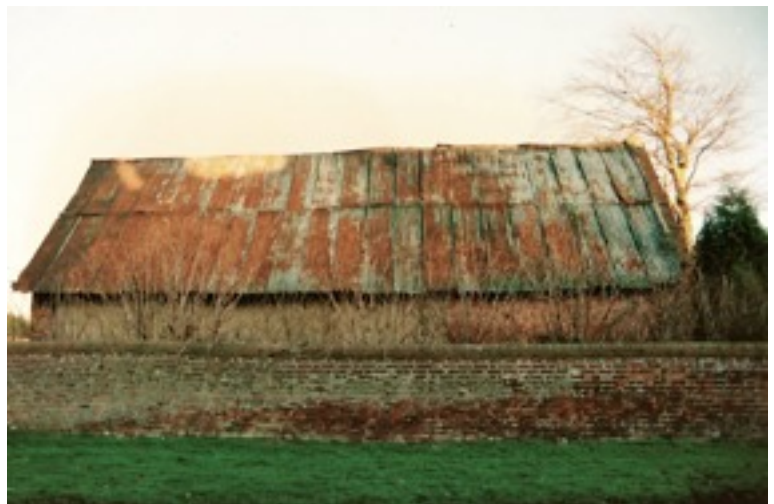
*Fig. 17 From the road showing the corrugated iron roof and mud wall.*

Extensive repairs were carried out to the roof in the 1992.

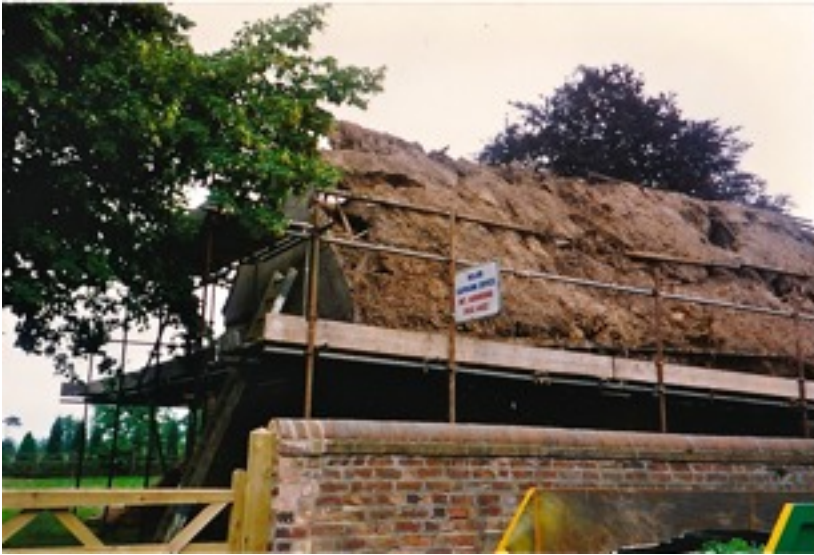
*Fig 18. From the road showing the remains of the thatched roof below the corrugated iron.*

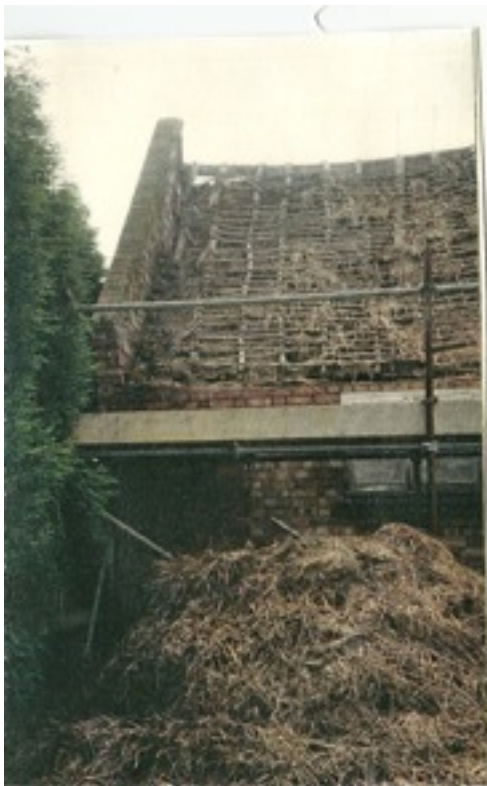
*Fig 19. From the paddock, roof timbers exposed after thatch removed. Old thatch piled up below.*

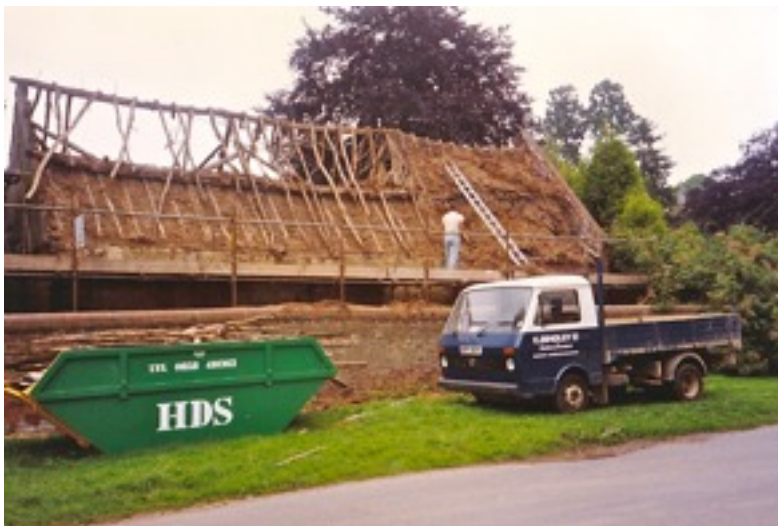
*Fig. 20 From the road showing the thatch removed and the original roof timbers exposed (most of these were replaced).*

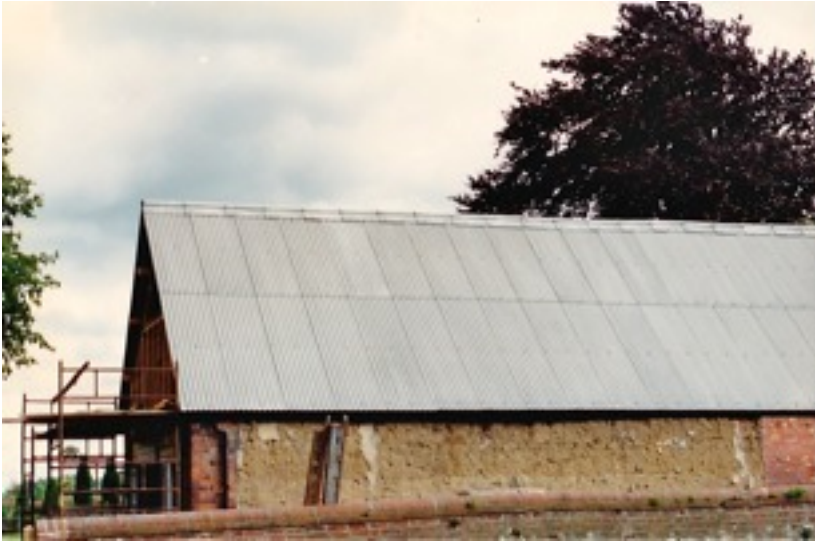
*Fig. 21. The 1992 repair work nearing completion*
